Damage of Railway Structures due to 2011 Great East Japan Earthquake

Jun IZAWA

Earthquake and Structural Engineering Lab.
Railway Technical Research Institute

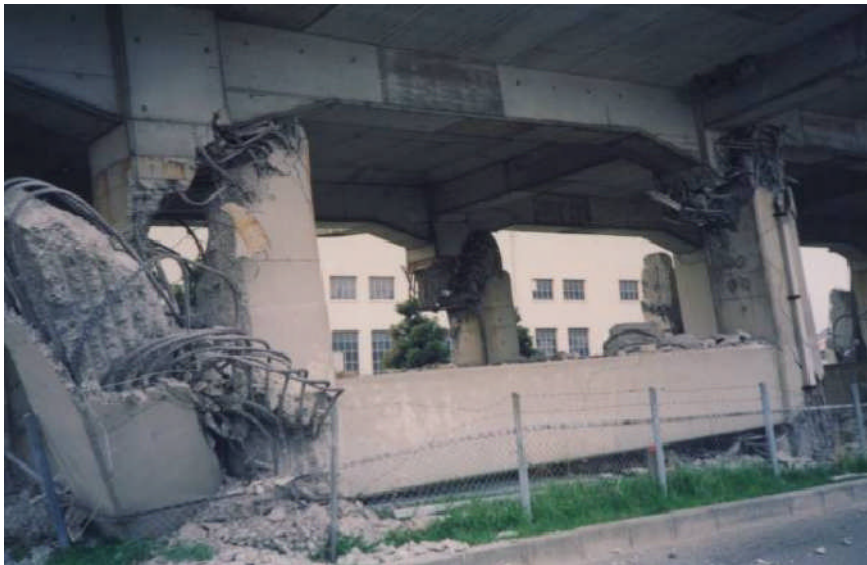
1995 Hyogo-ken Nambu EQ.

Shear Failure

brittle failure

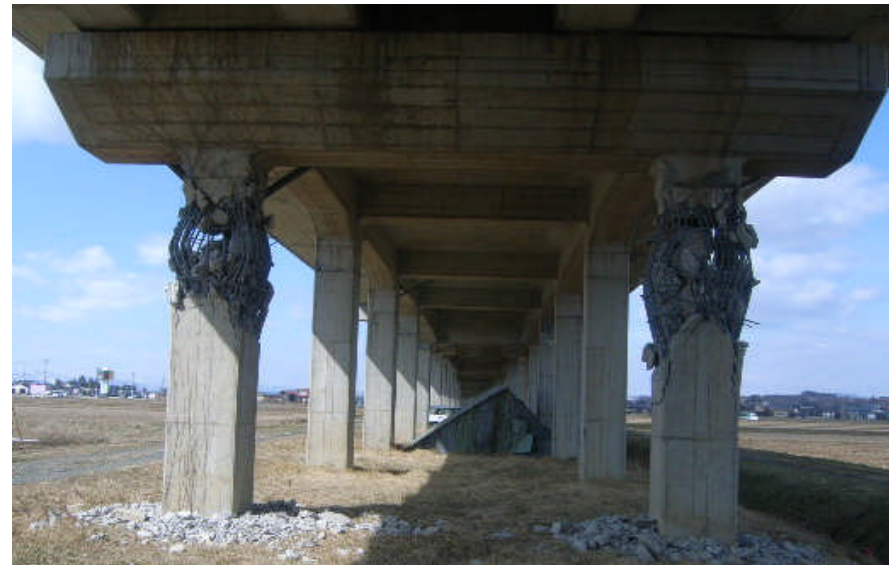
2011 Great East Japan EQ.

Bending Failure

ductile failure
Easy to repair

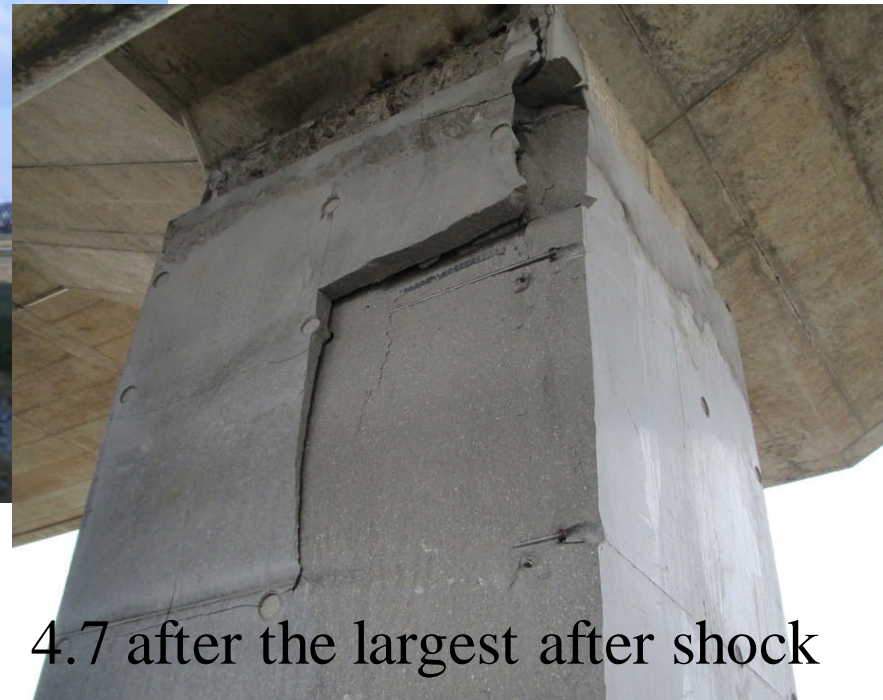
4.7 after the largest after shock

Damage due to After shock

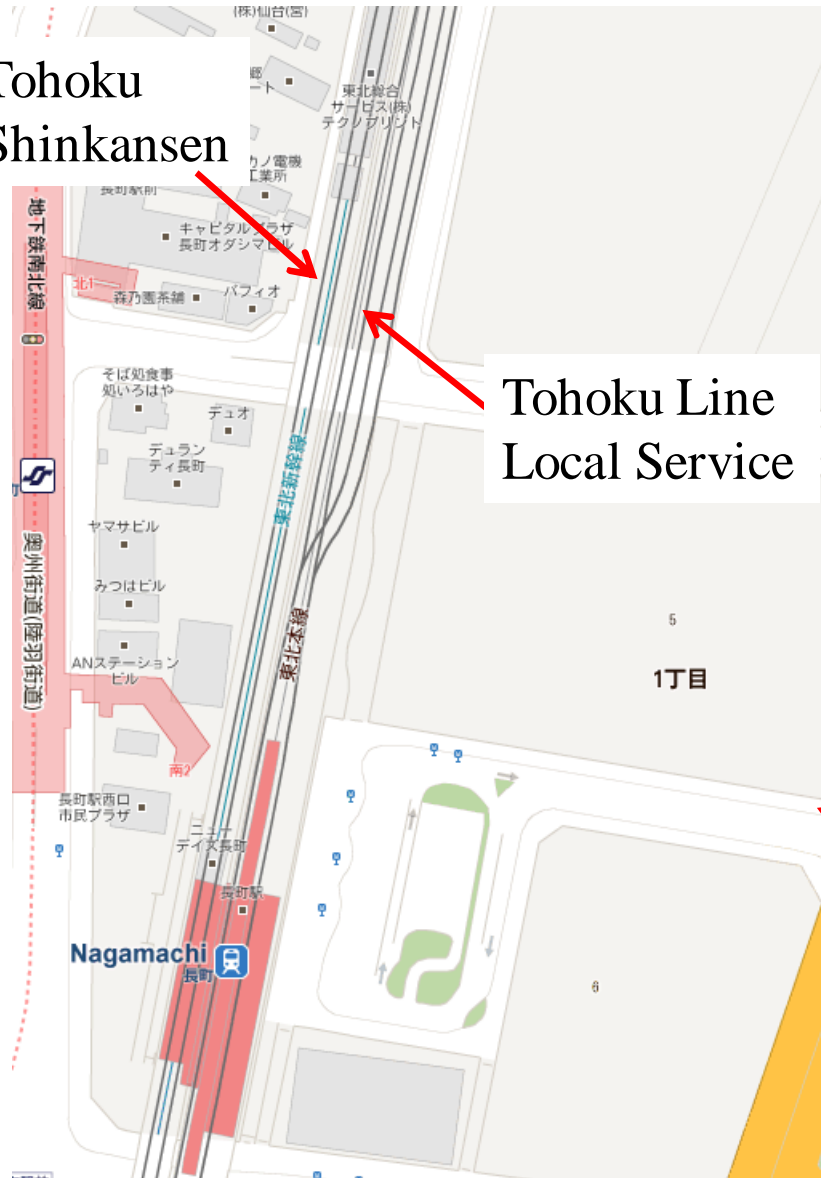
Damage of the Nagamachi viaduct

Tohoku Shinkansen
Designed with the old Standard
In 1970s.

Damaged

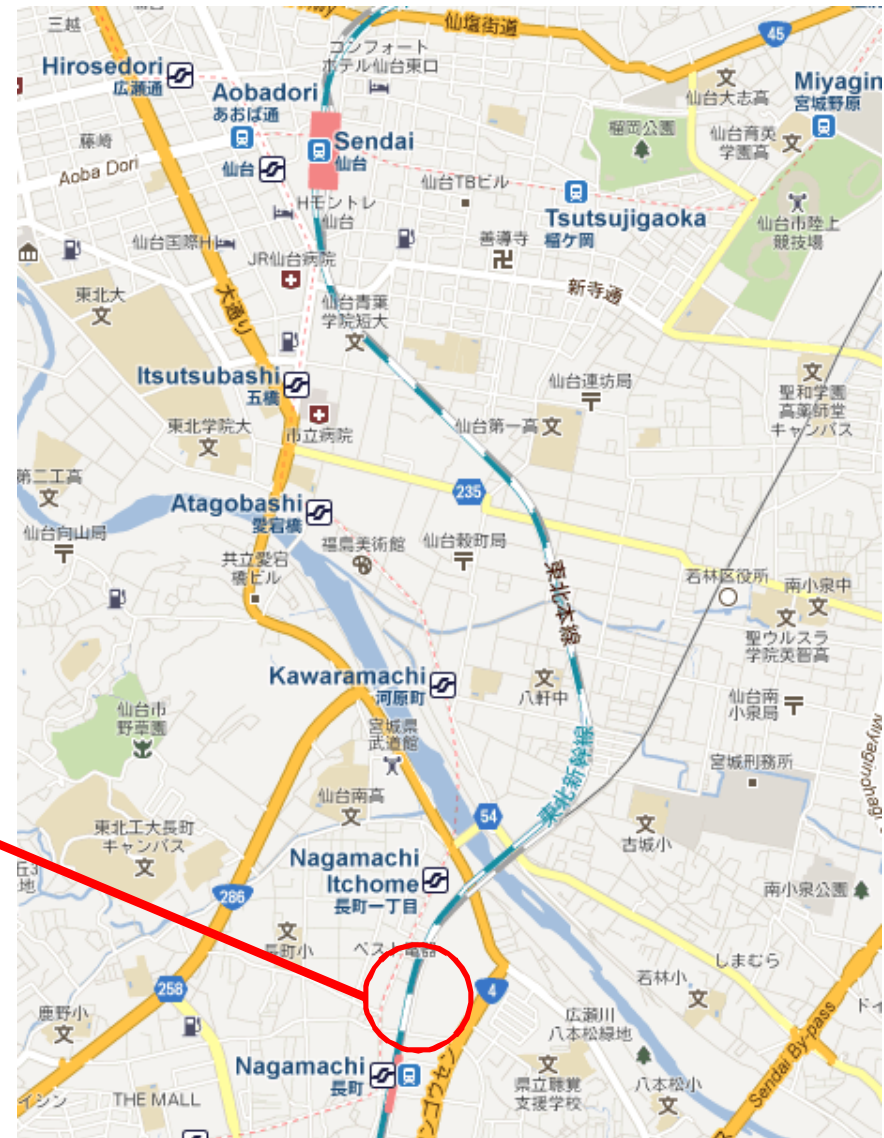
Tohoku Line
Local Service

Tohoku line Local service
Designed with the Current Standard

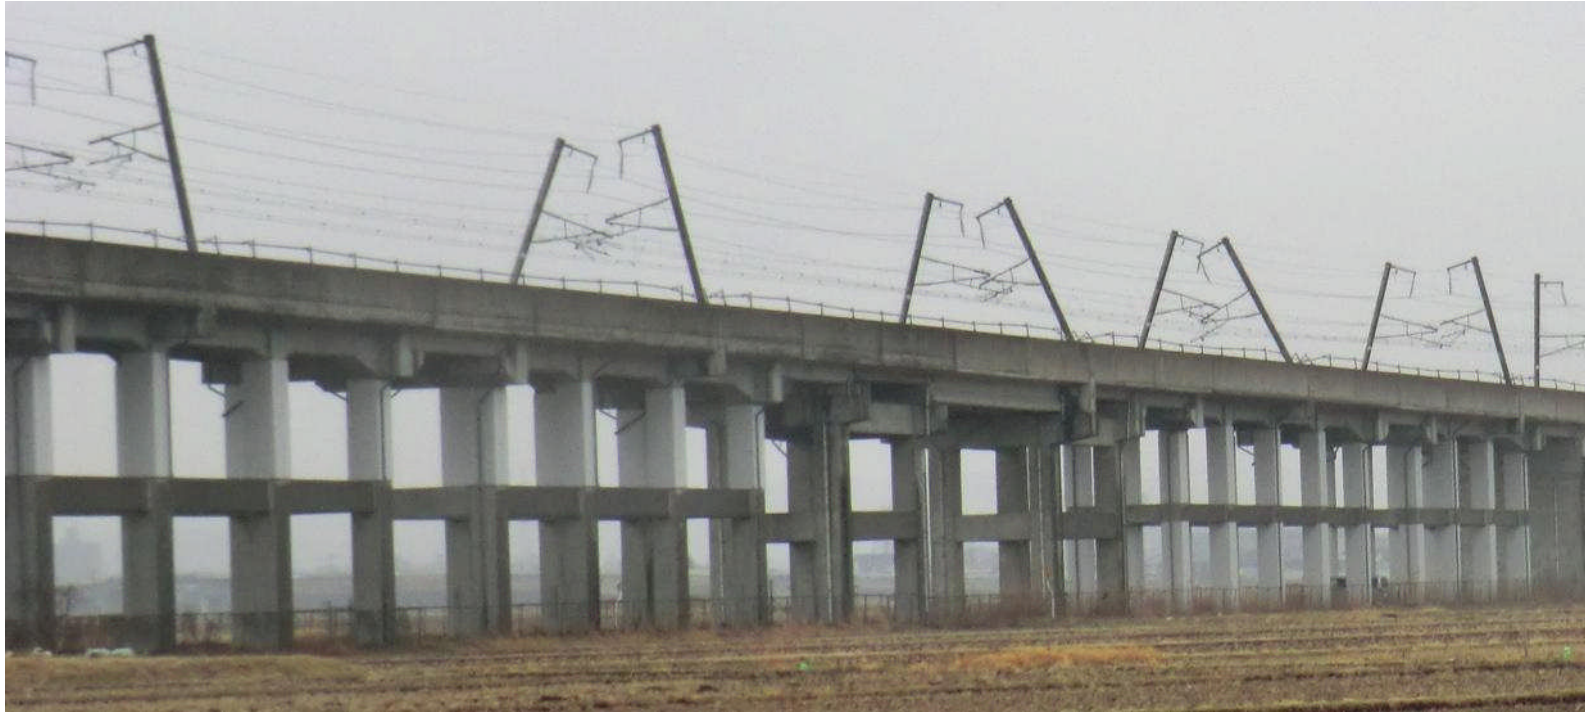
Many electric poles collapsed due to seismic intensity.

Restoration took long time as compared with other structures.

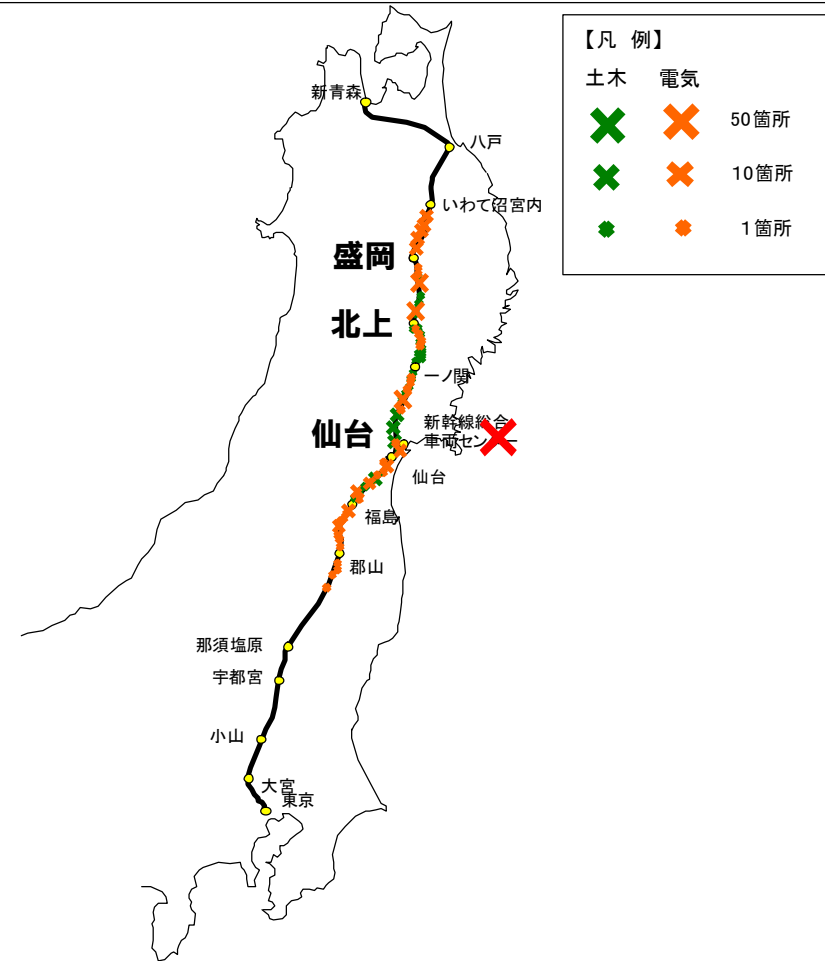
After shock (7th April)

Damage due to After shock

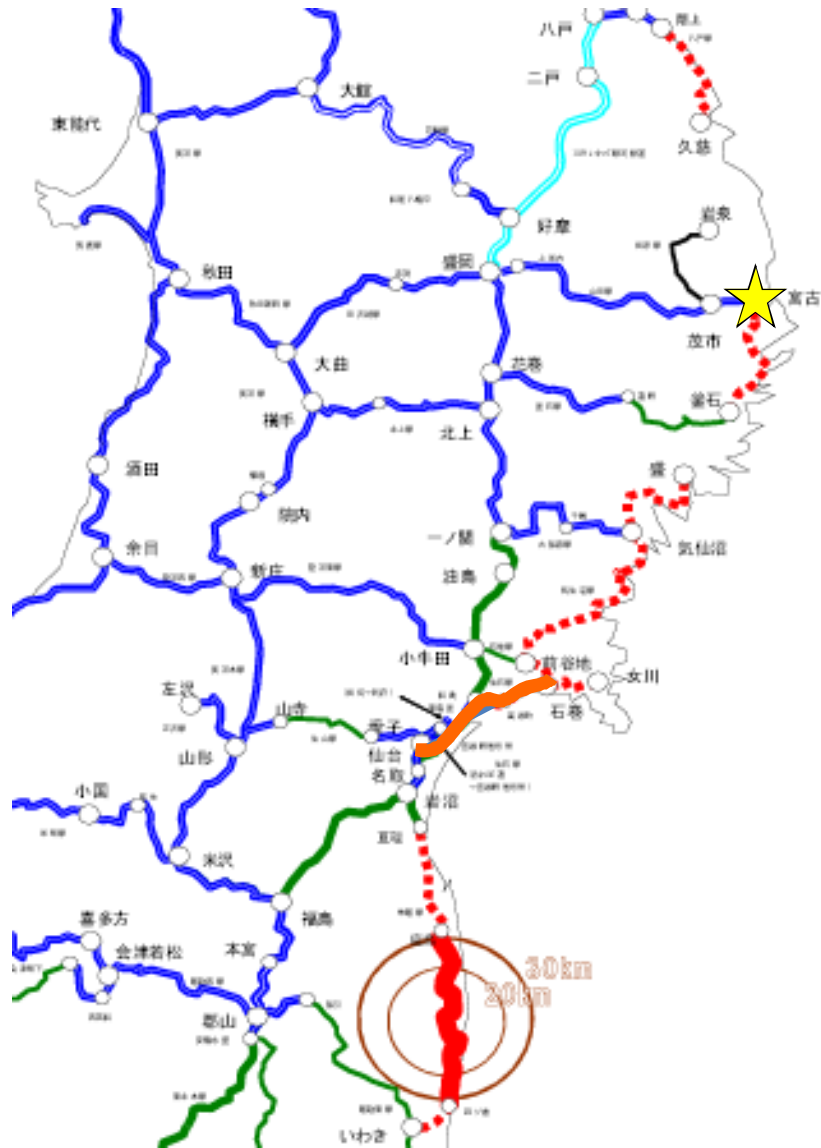
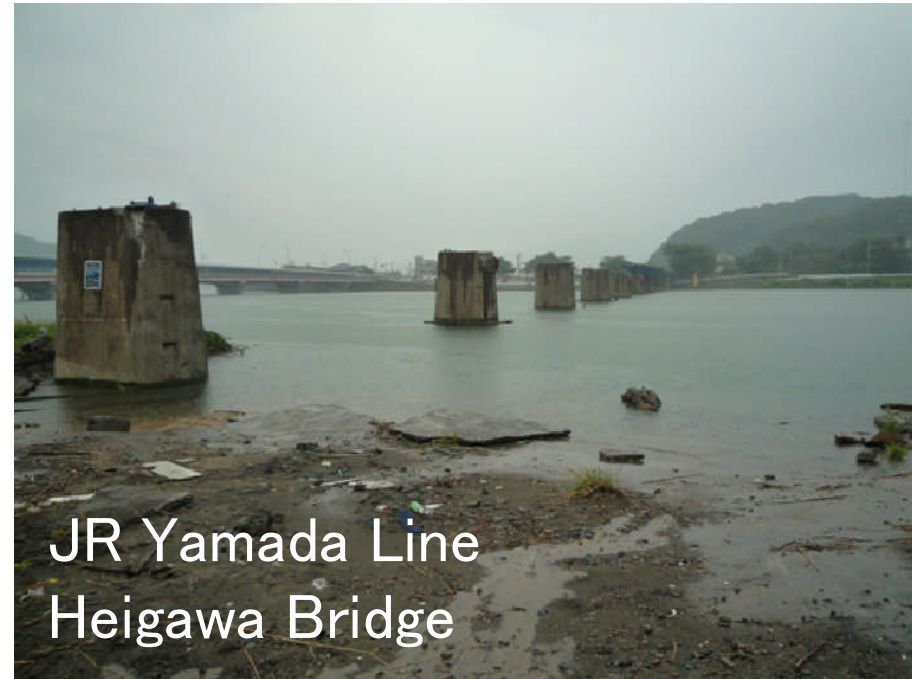
JR Yamada Line
Heigawa Bridge

The bridge girder was washed away
by Tsunami.

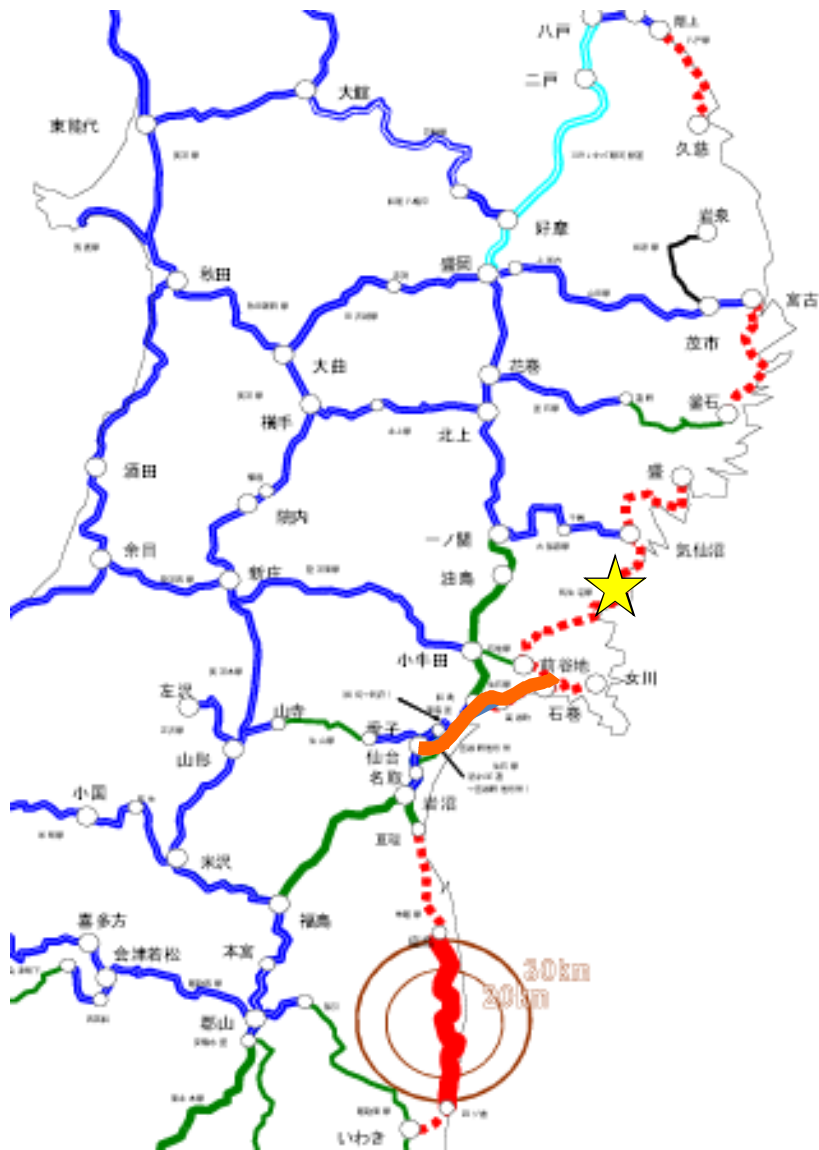
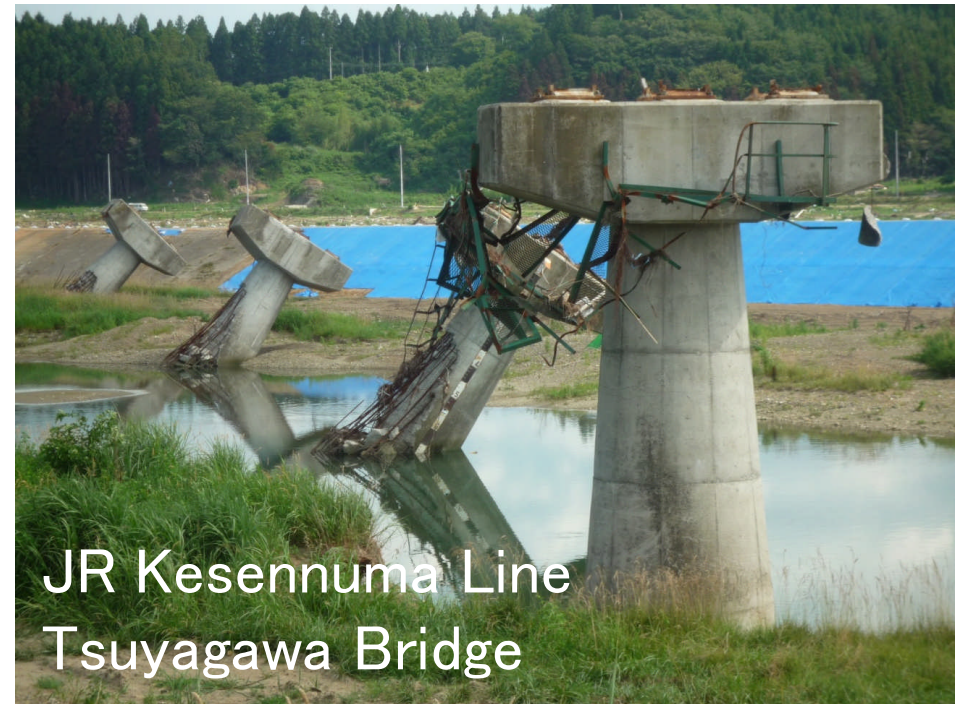
JR Kesennuma Line
Tsuyagawa Bridge

The bridge girder was washed away
and the piers were overturned
by force of Tsunami.

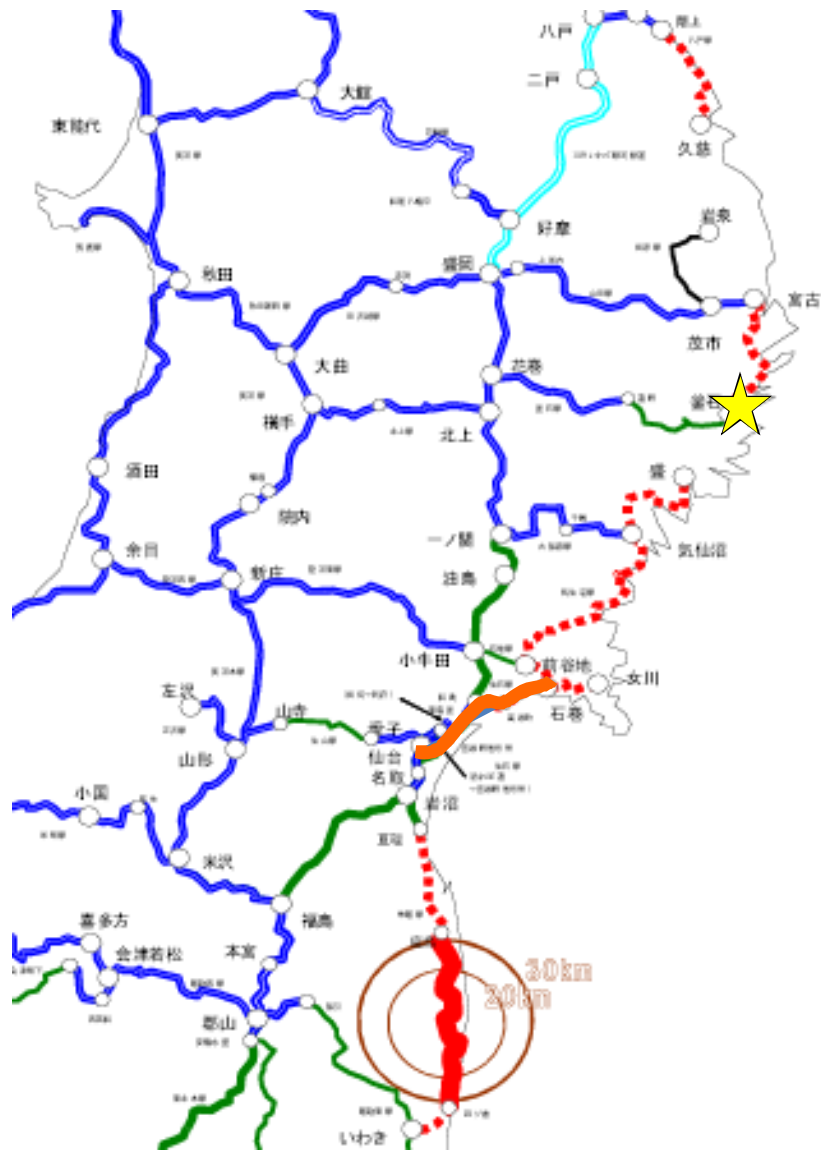
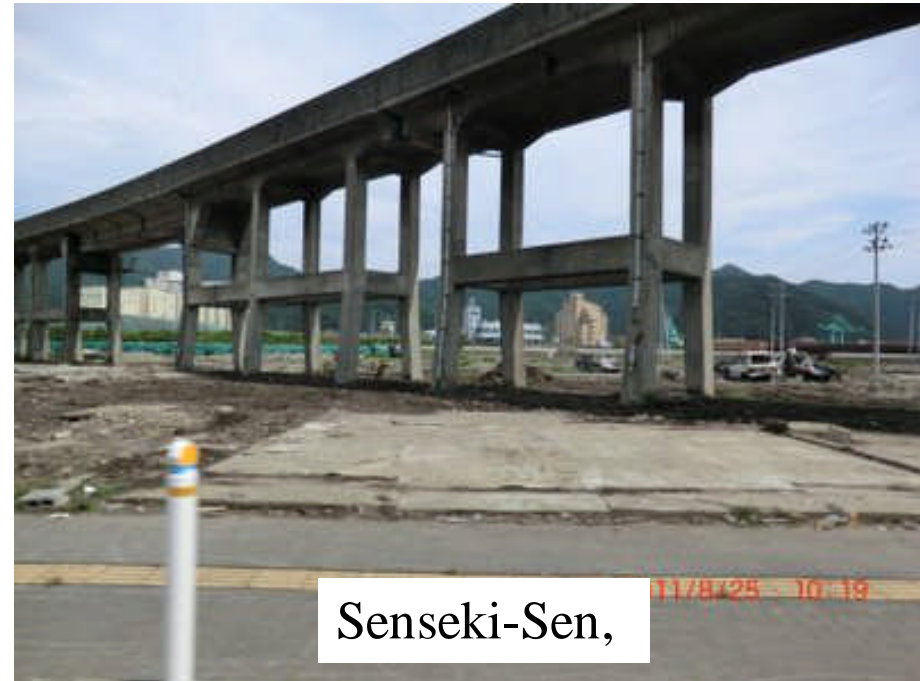
Senseki-Sen,

Some rigid frame viaducts bore tsunami.

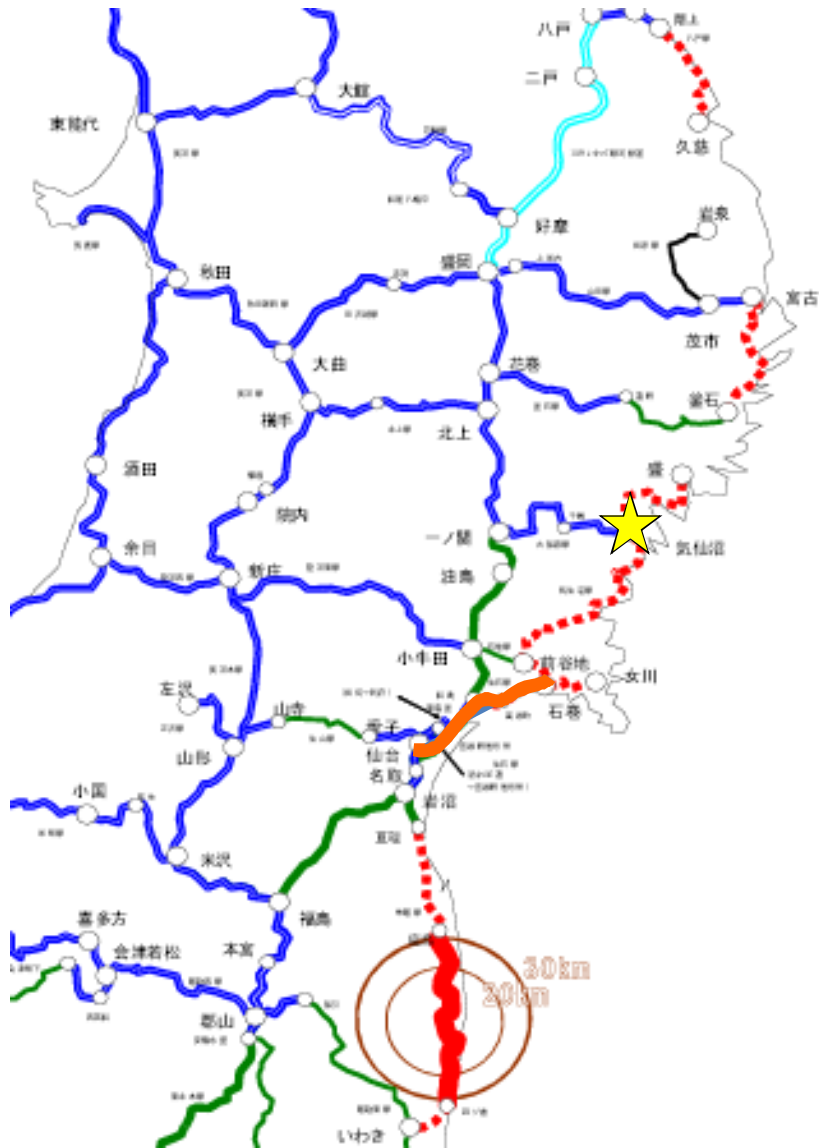
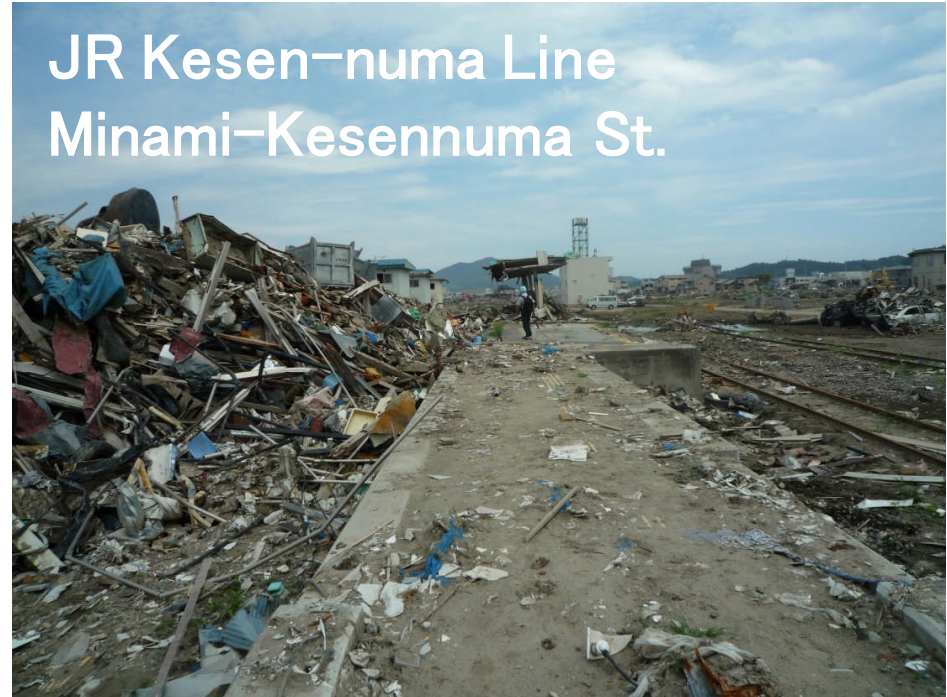
JR Kesen-uma Line
Minami-Kesennuma St.

No passengers on the trains were killed.
Train Crews properly guided passengers
to refuge from Tsunami.

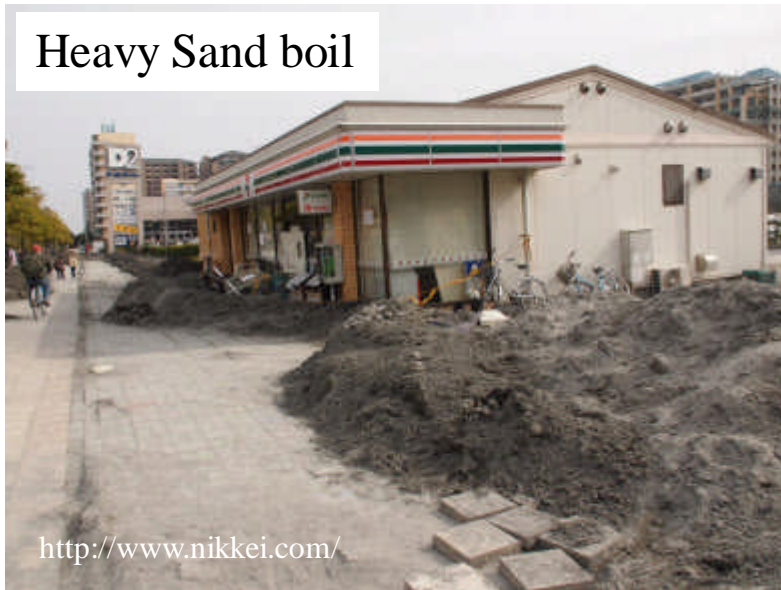
Heavy Sand boil

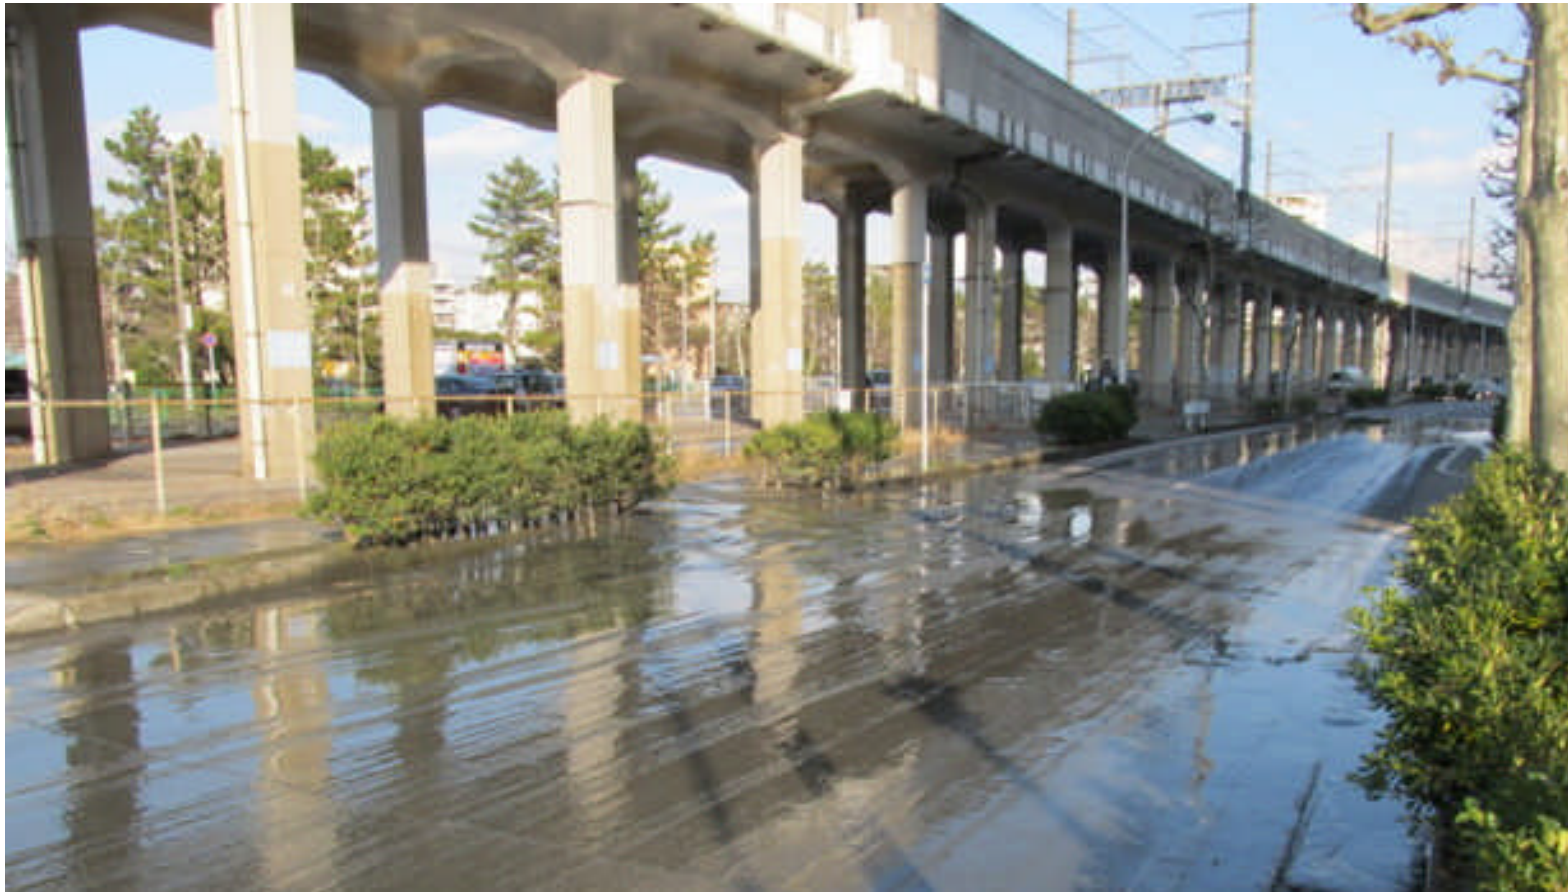
No damage was observed in viaducts which runs at heavy liquefaction area
Because viaducts were designed in consideration of liquefaction in 1970s.
