# Disasters of port facilities due to 2011 Great East Japan Earthquake

Yoshiaki Kikuchi  
Port & Airport Research Institute

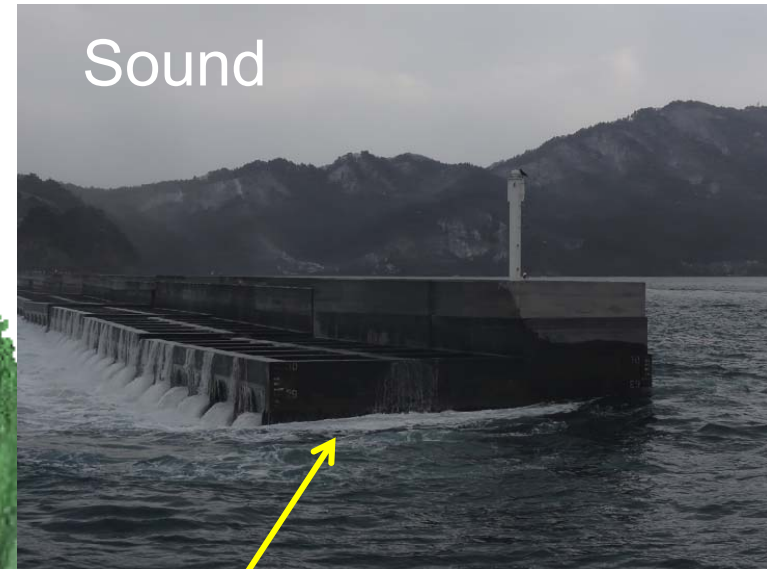
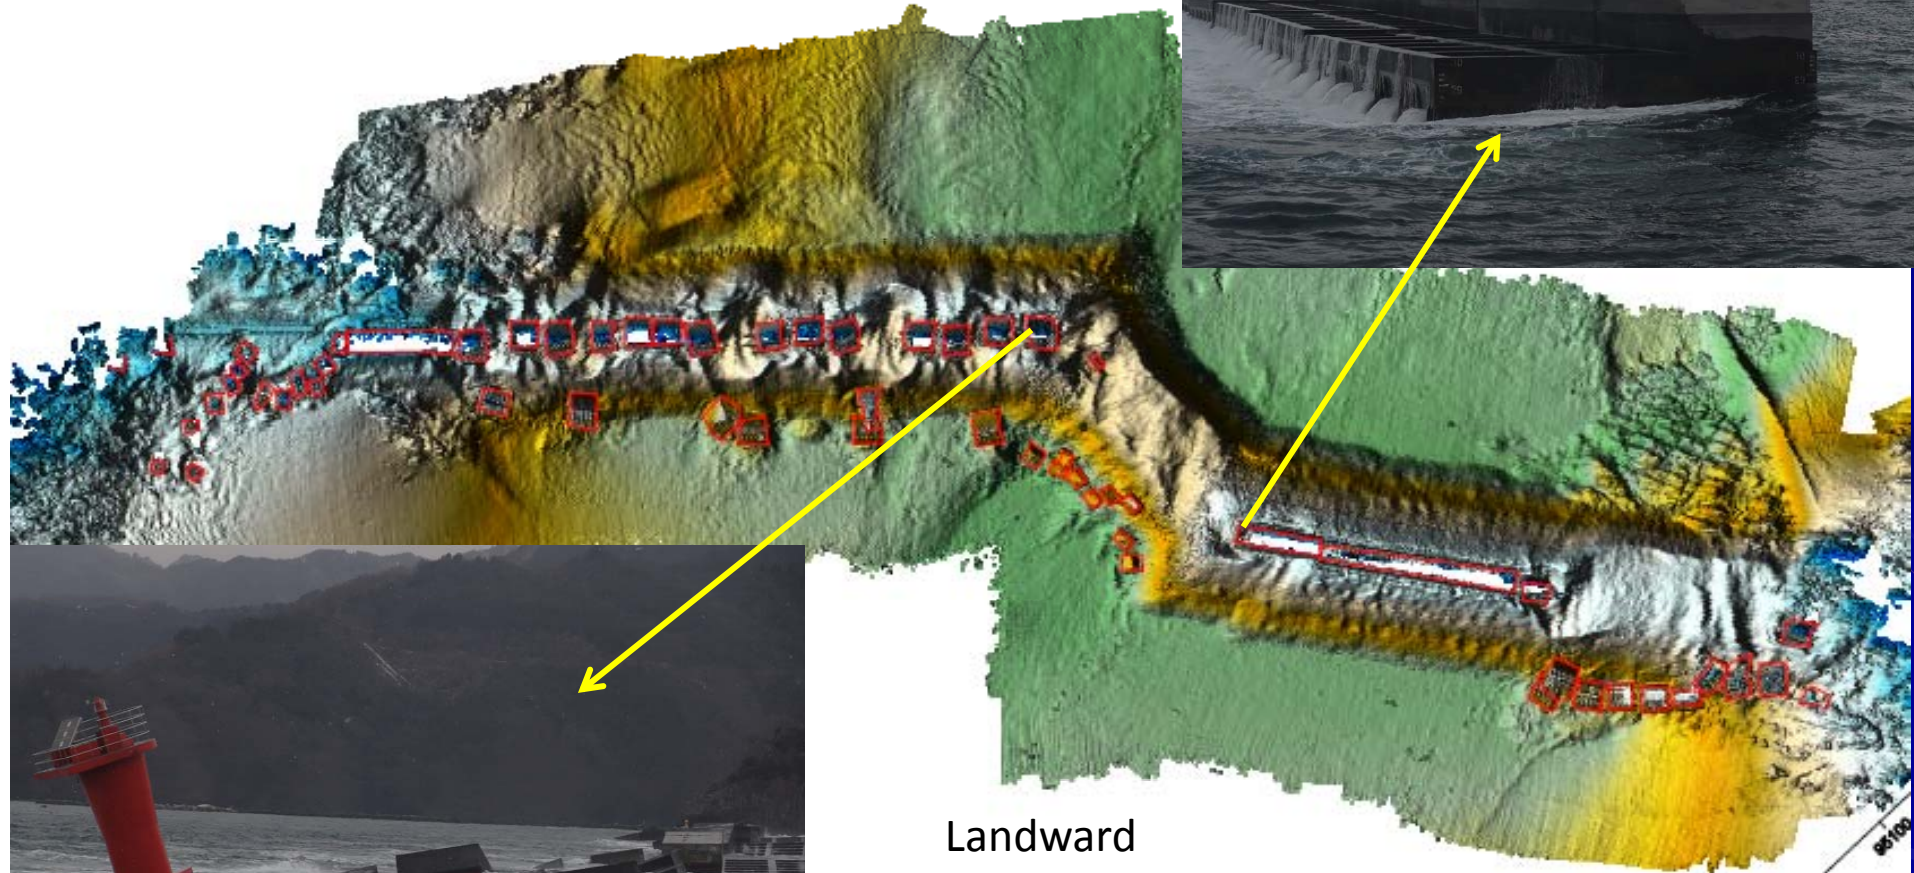
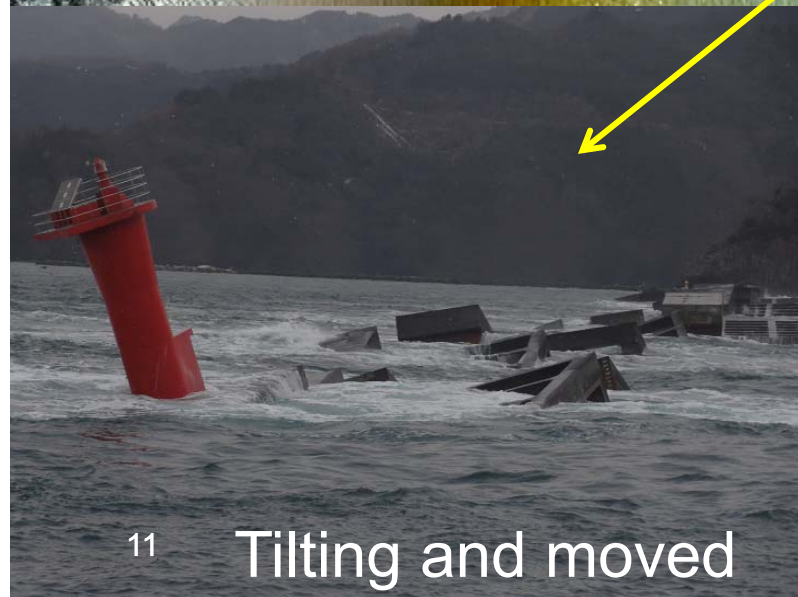
# Movement of the caissons and deformation of the mounds

Tilting and moved

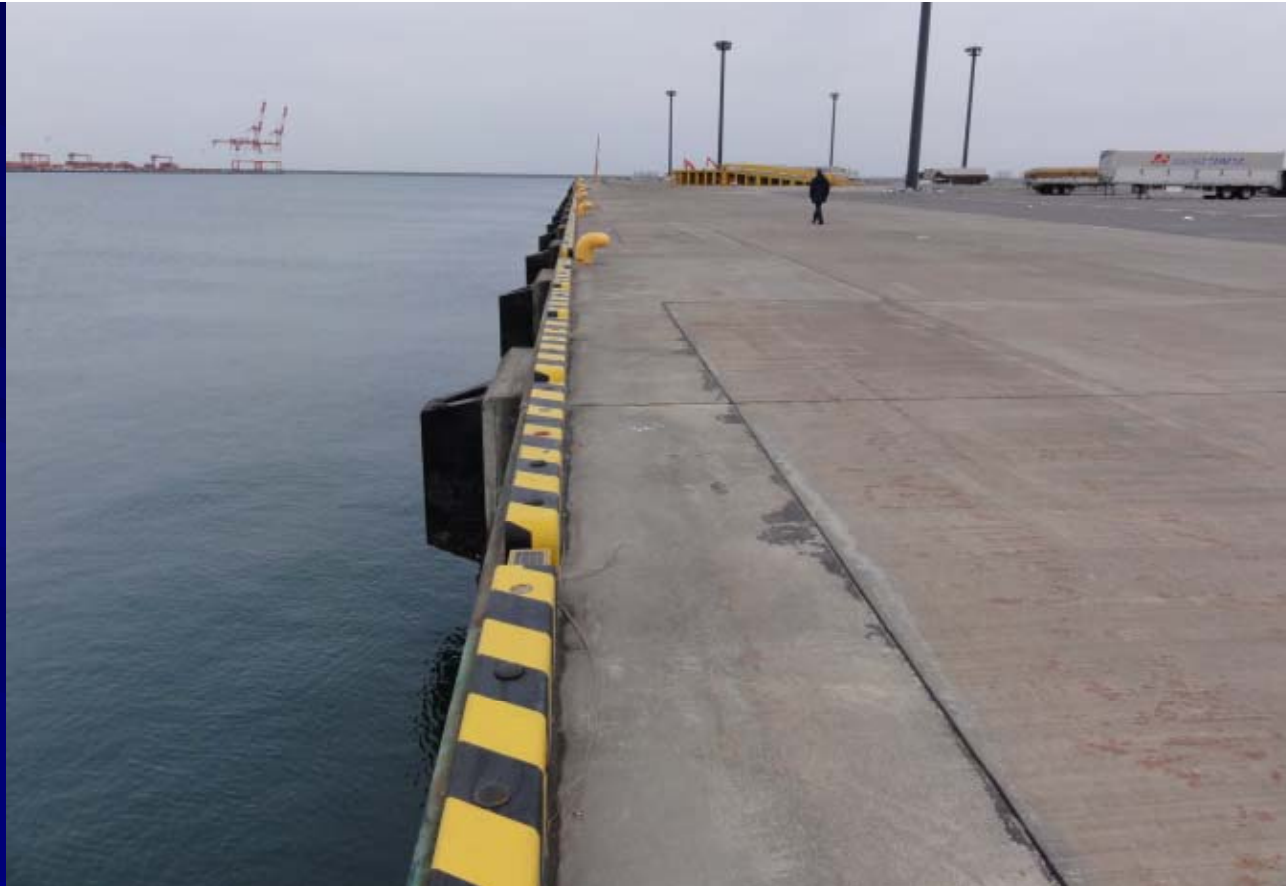
Central Wharf, Hitachi-naka District, Ibaraki Port

- Little lateral displacement of the quay wall.
- Liquefaction evidence was not recognized since un-sieved crushed stone is filled as liquefaction countermeasure.
- The high earthquake resistance quay wall showed good seismic performance. The quay went into service on March 15 after checking the burying of navigation channel by tsunami.

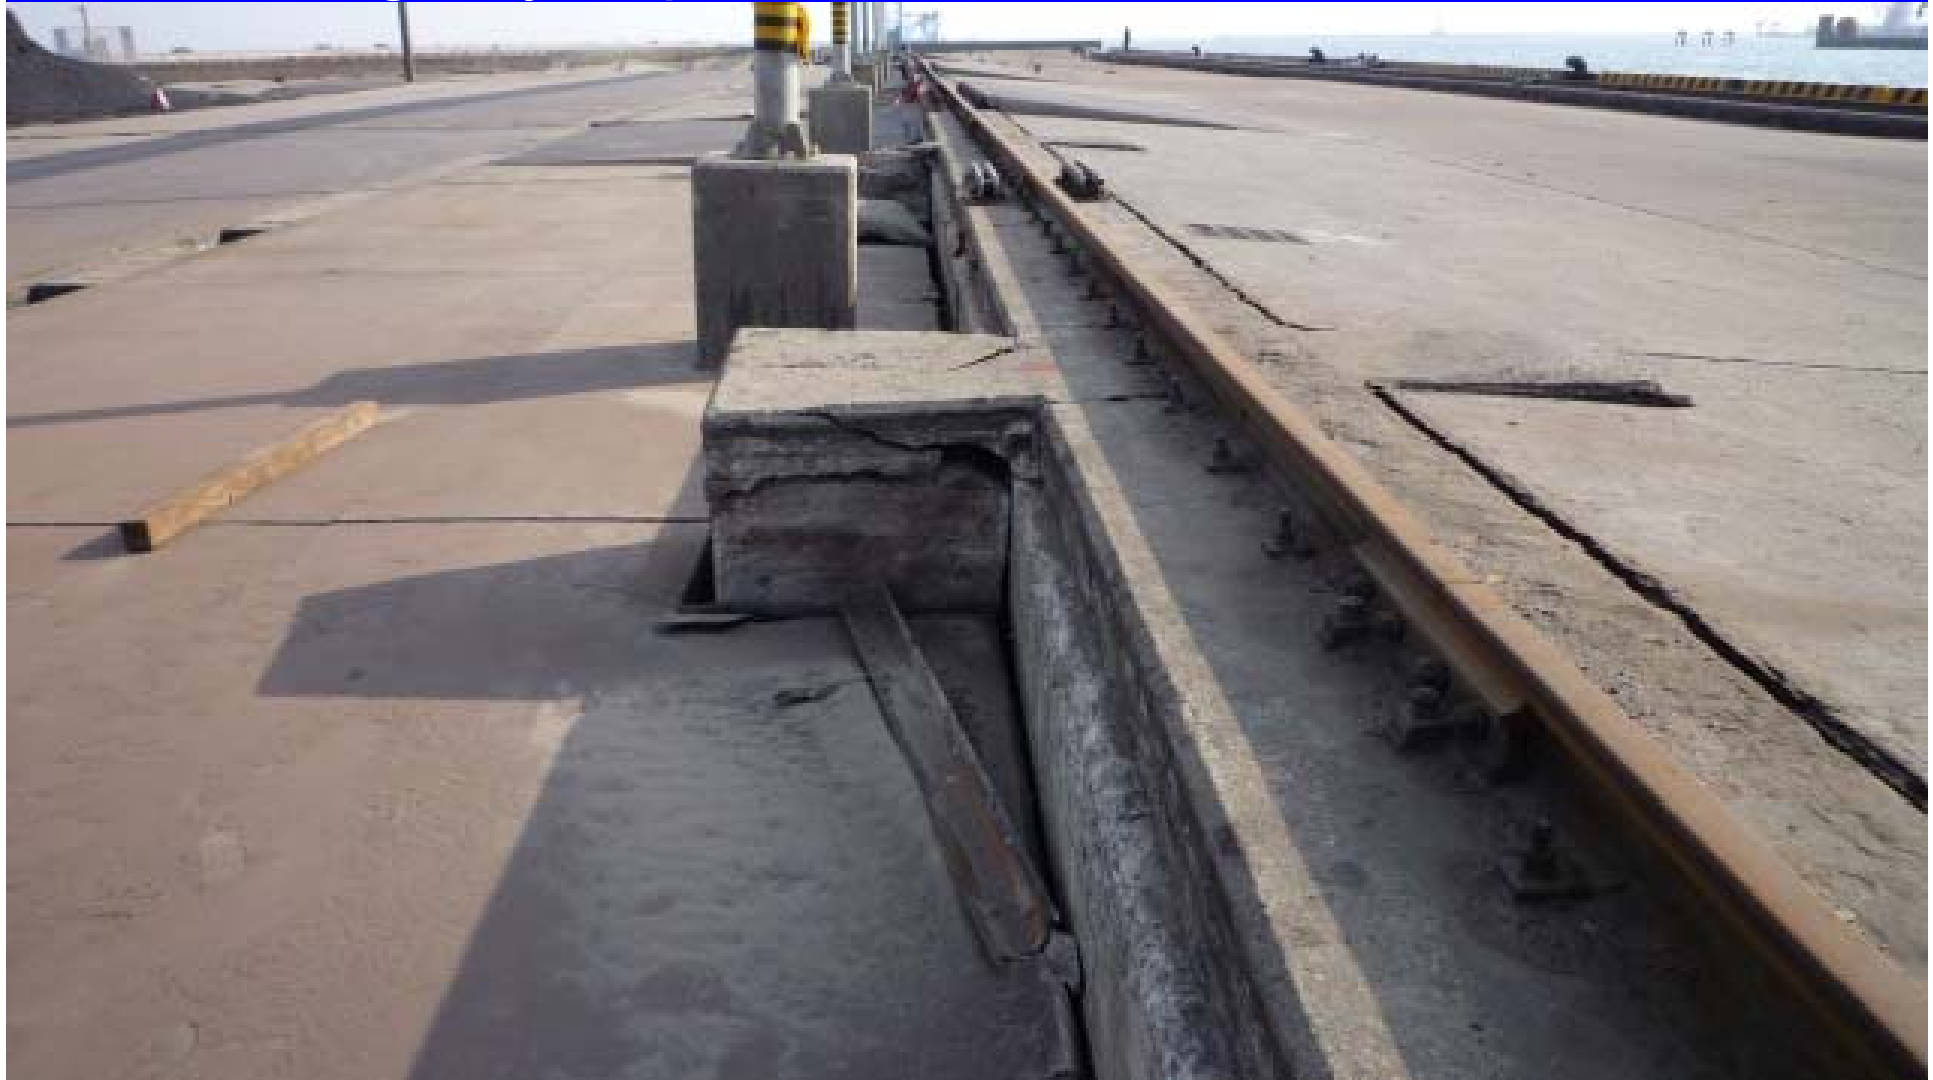
# Onahama Port

Because of liquefaction

Uneven settlement : pile supported crane rail and apron

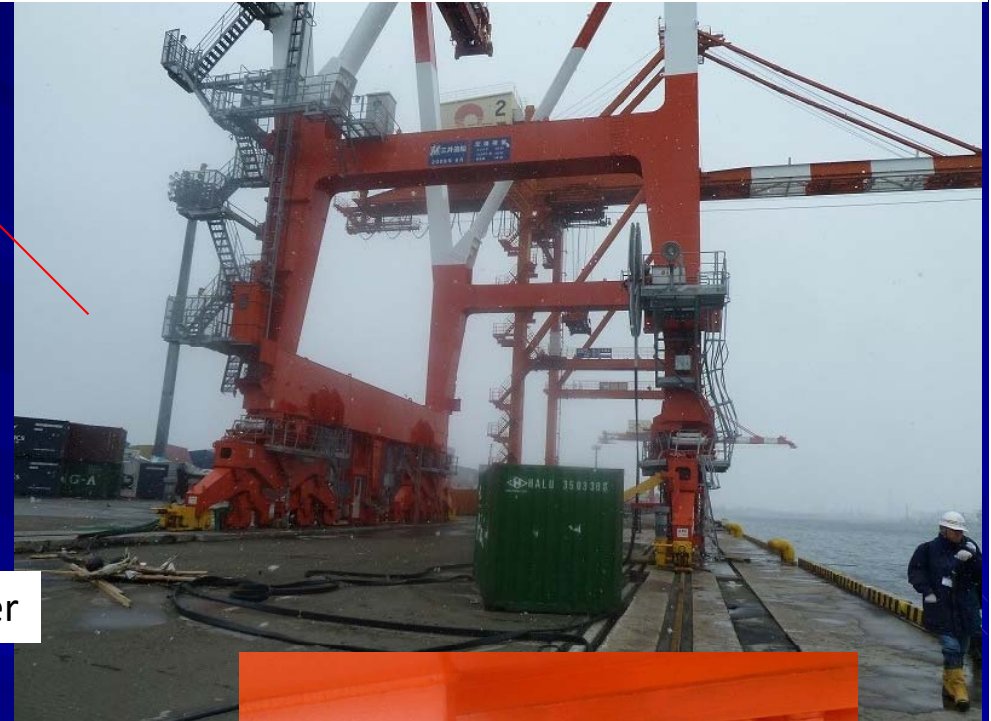
Damage occurred in one non-base-isolated crane

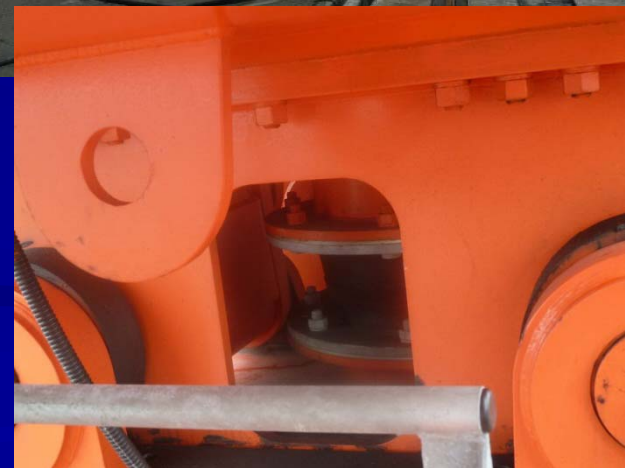
Base-isolated cranes: No structural damage

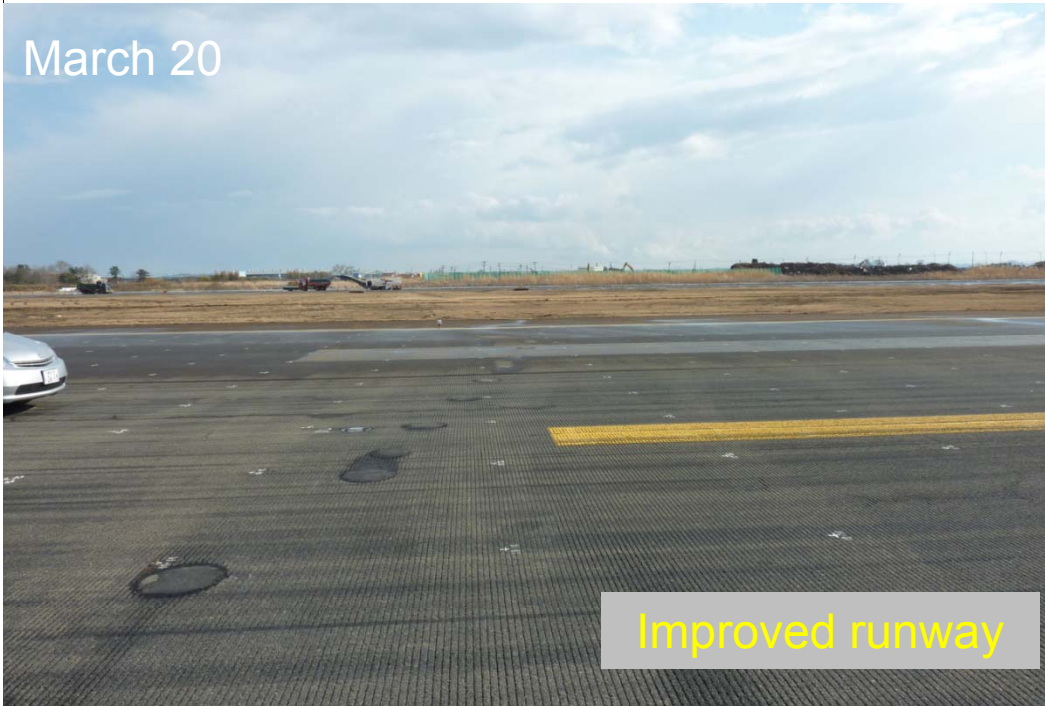
Improved runway

The runway keeps 'Serviceability' just after the Earthquake. However, It took one week to cleanup the debris due to Tsunami.

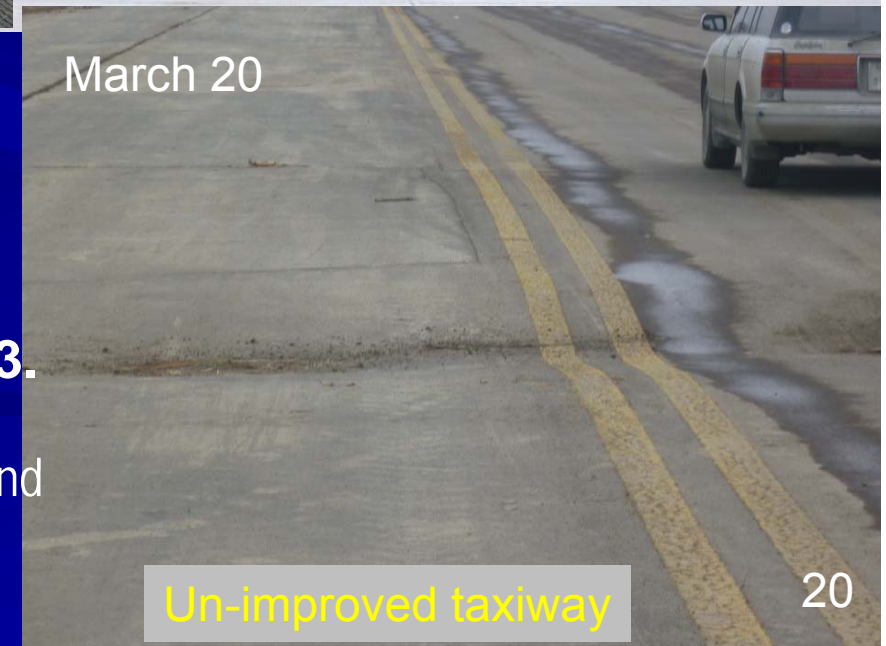
Un-improved taxiway

There are serious subsidence, uneven settlements and clacks on the surface of un-improved taxiway. It lost the 'Serviceability' and the 'Reparability.'

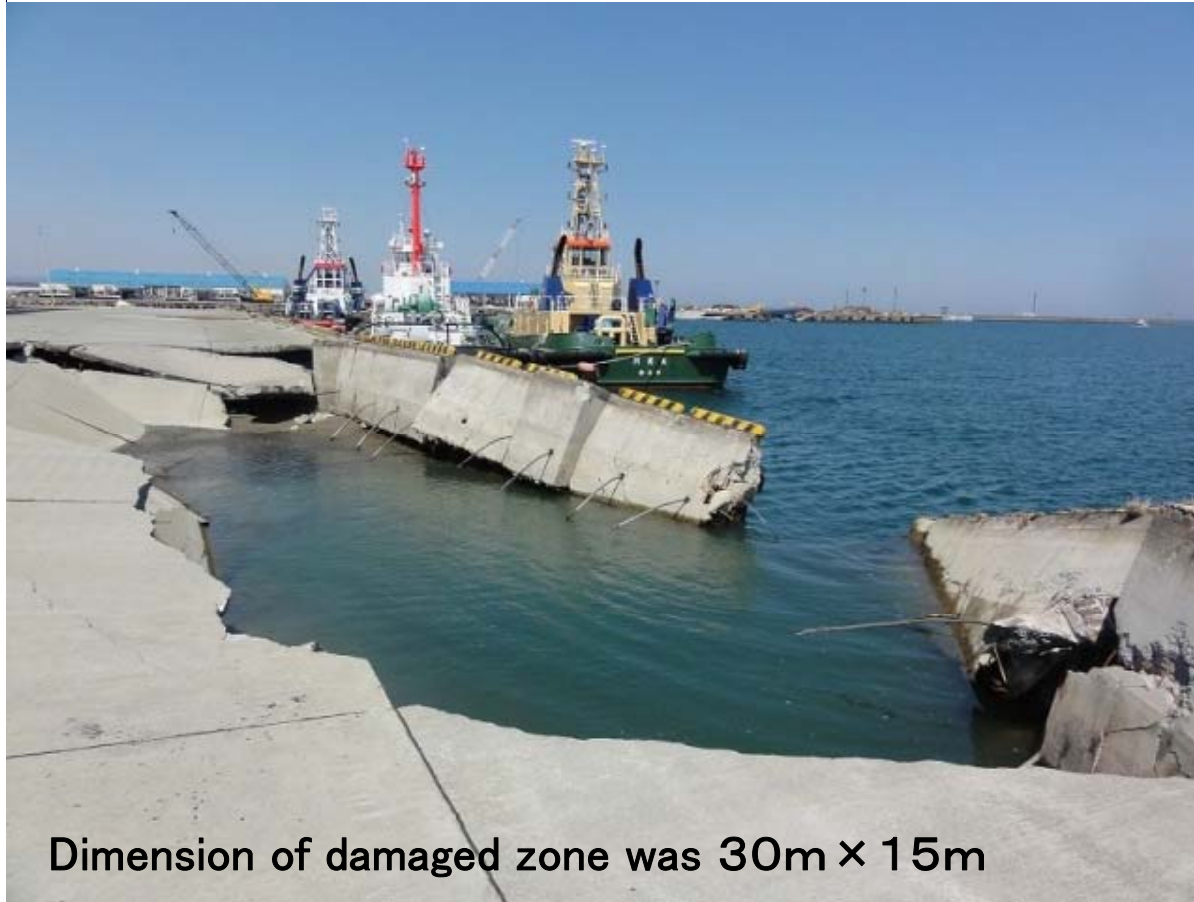
## Soma Port

Dimension of damaged zone was 30m × 15m

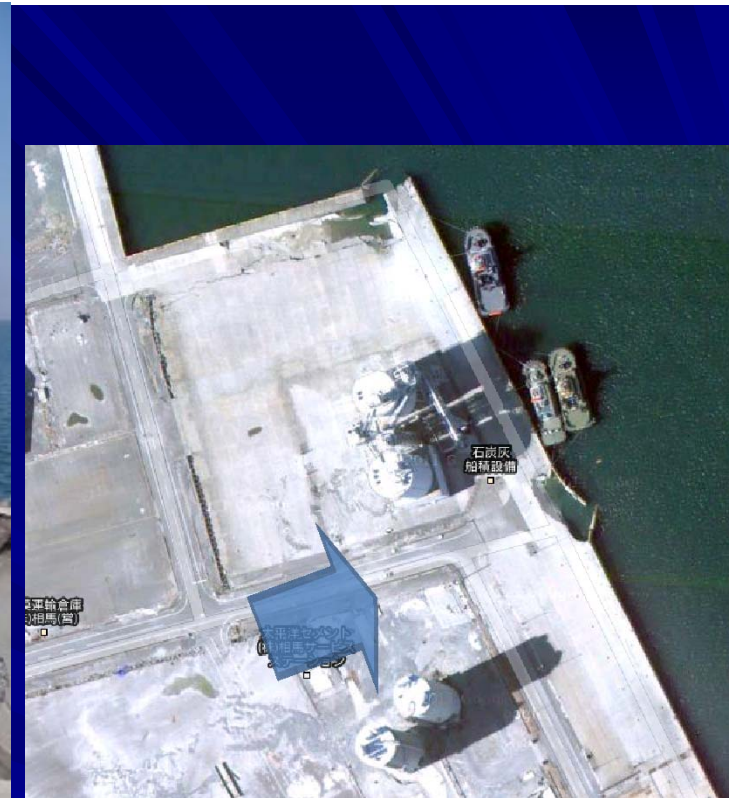
Backrush flow was concentrated to a small area because of the structures.

Damage was observed only in a small area. This kind of things have never observed only by earthquake.

**EQ > Liquefaction > damage of pavement and sheet pile > scouring of apron > Scouring of foundation of sheet pile > Damage of the quay wall was extended by backrush**
