Damage of Infrastructures due to 2011 Great East Japan Earthquake

Keiichi Tamura

Public Works Research Institute, Japan

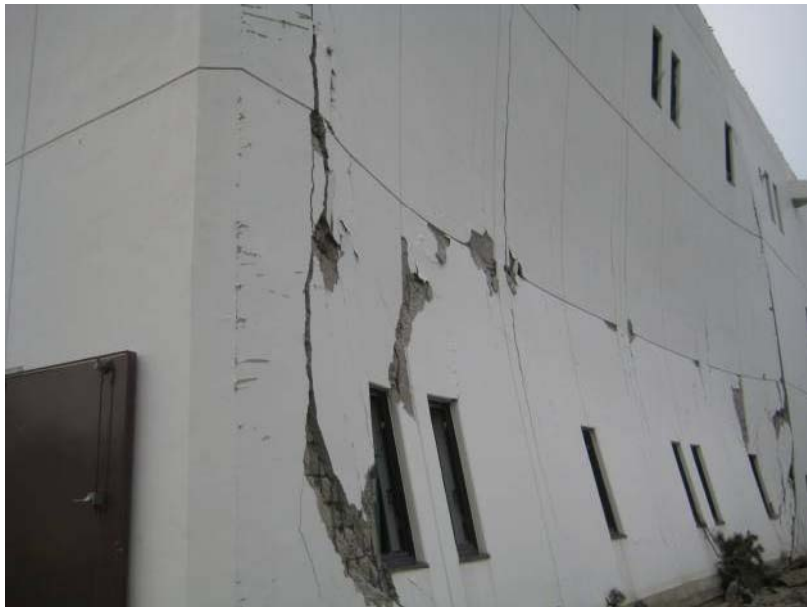
Pumping plant damaged by tsunami (Sendai City)

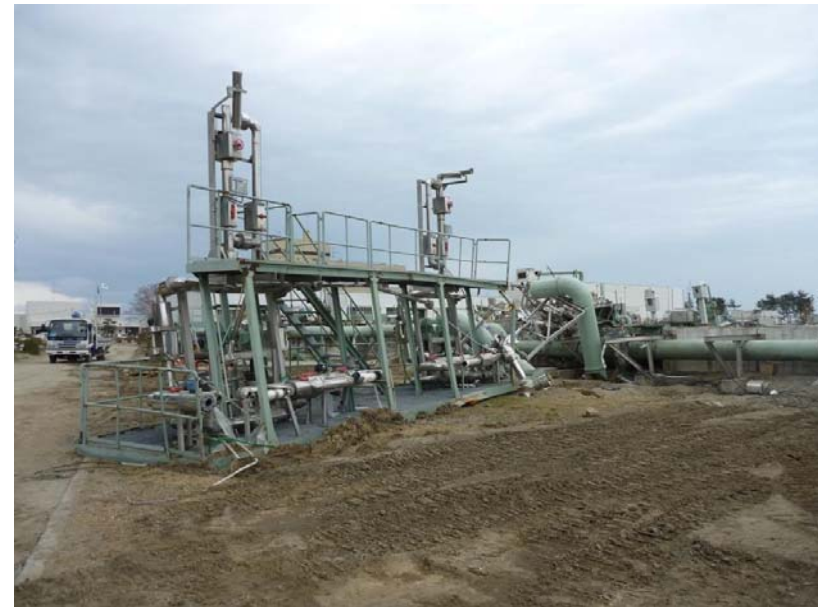
Machinery damaged by tsunami (Tagajoh City)

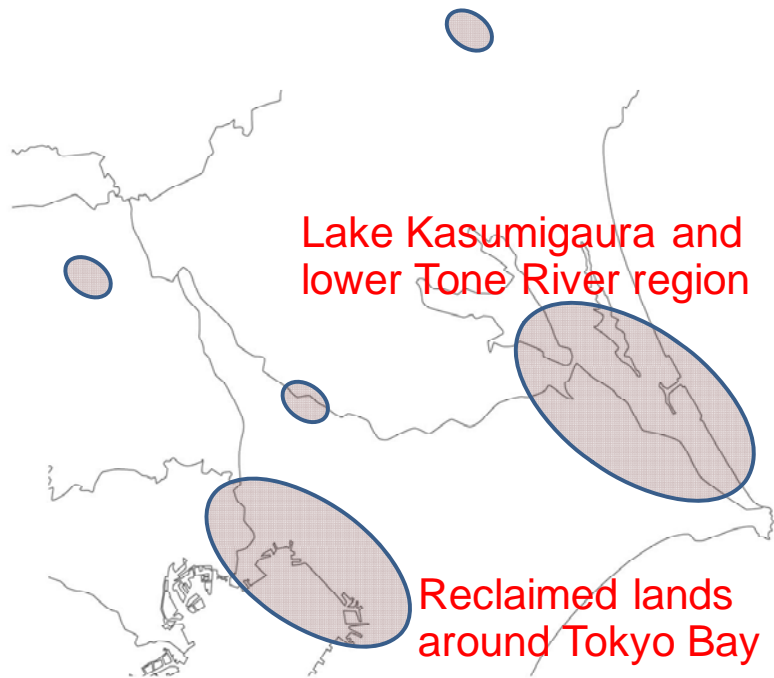
Waste water pipe
damaged area due to
liquefaction

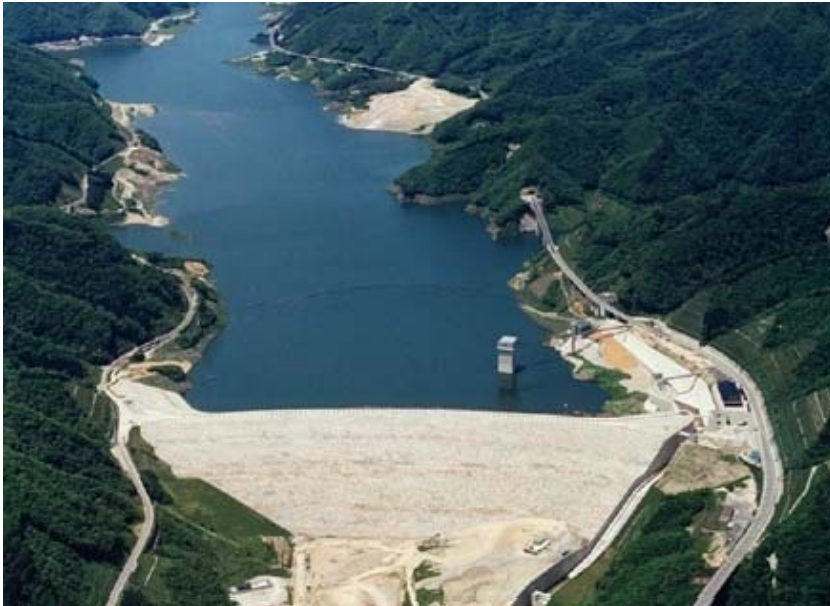
Surikamigawa Dam

- Earth core rockfill dam
- Dam height: 105m
- Year of completion: 2006

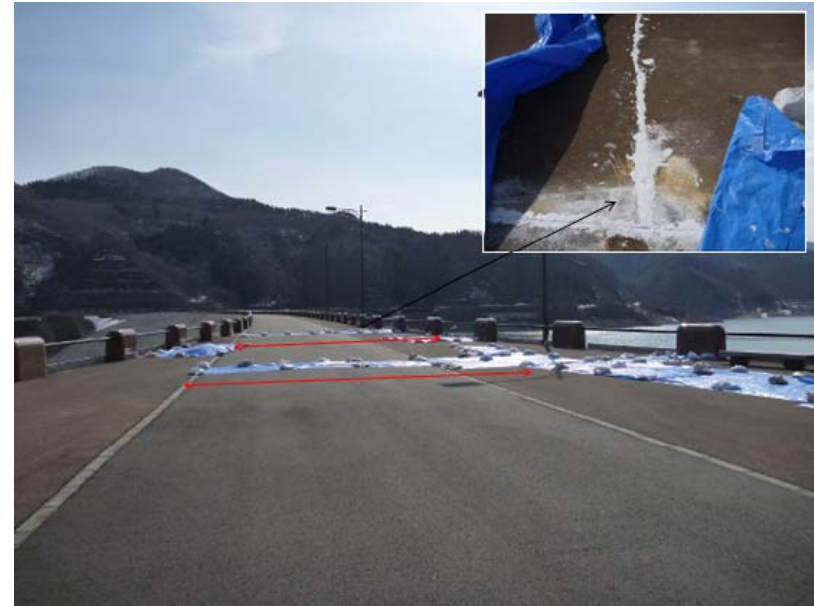
Damage

- Increase in leakage from 70 l/min to 100 l/min
- 17cm settlement at dam crest
- Cracks on dam crest pavement

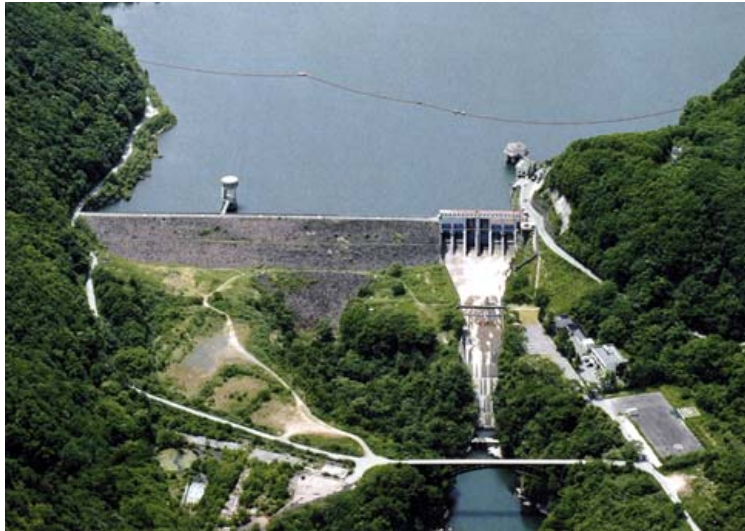
Ishibuchi Dam

- Concrete Face Rockfill Dam
- Dam height: 105m
- Year of completion: 1953

- Leakage increase in the river bed from 2,000 l/min to 3,000 l/min.
*Imperfection of flow measurement.
- 1cm settlement at dam crest

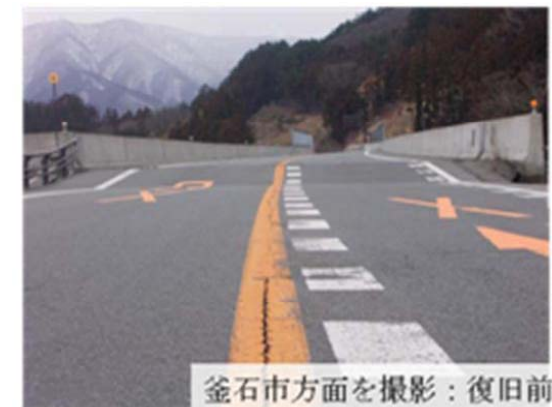
Settlement of approach

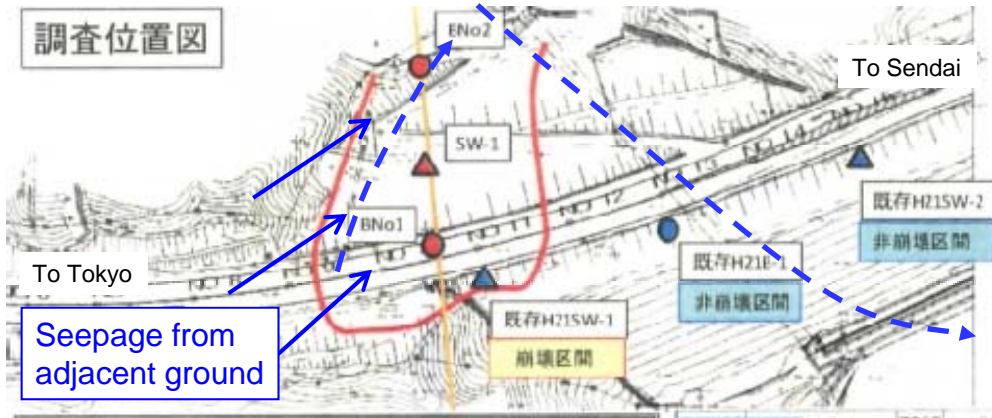
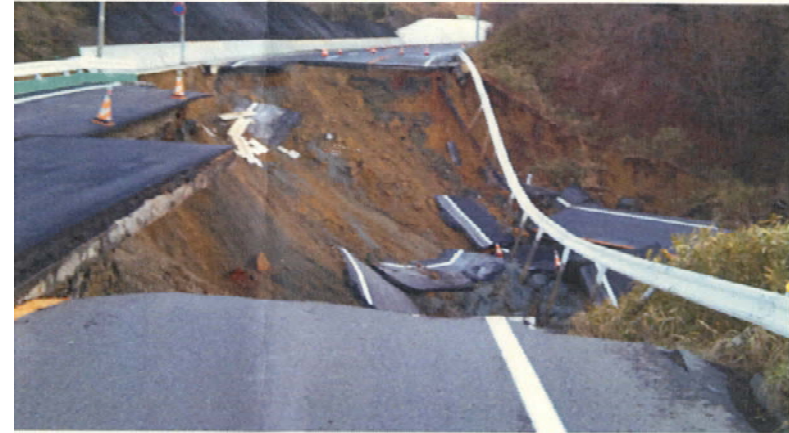
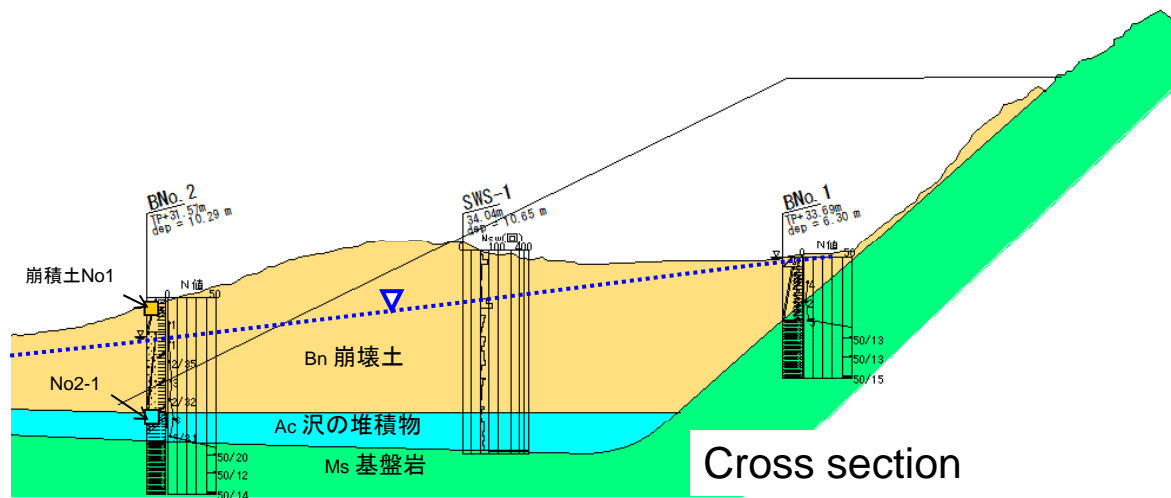
Damage of road embankment due to high groundwater table in embankment body

- Constructed by filling up a valley.
- Spring water seeps from upper portion of embankment.
- Groundwater table in embankment is high.

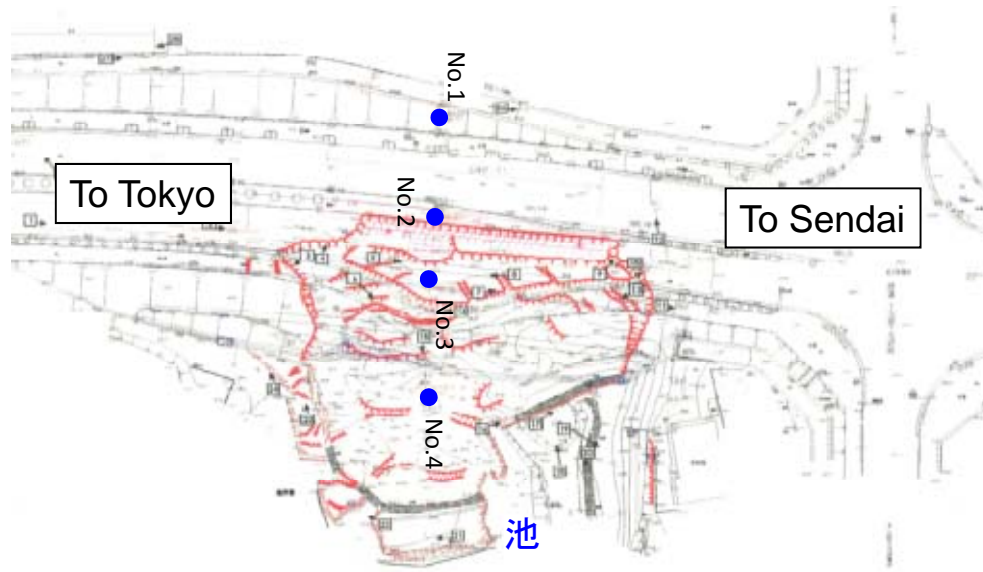
Plane view

Damage of road embankment due to liquefaction of foundation layer

- Embankment adjacent to a pond laterally spread about 20m.
- Foundation layer was judged to liquefy.
- Safety factor by circular arc method was less than 1.

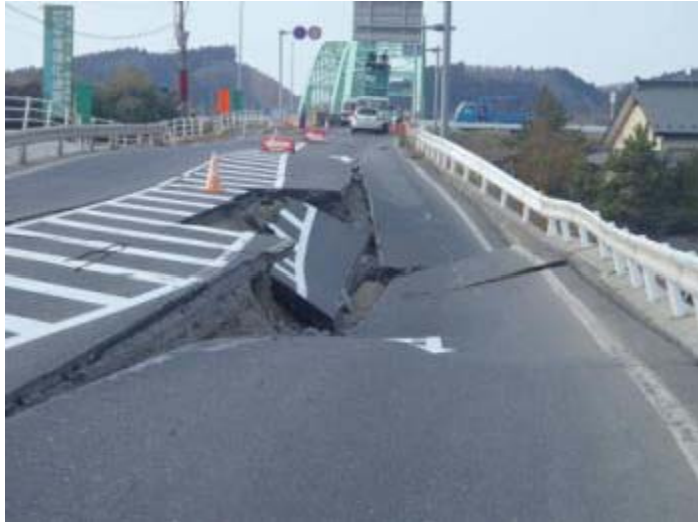
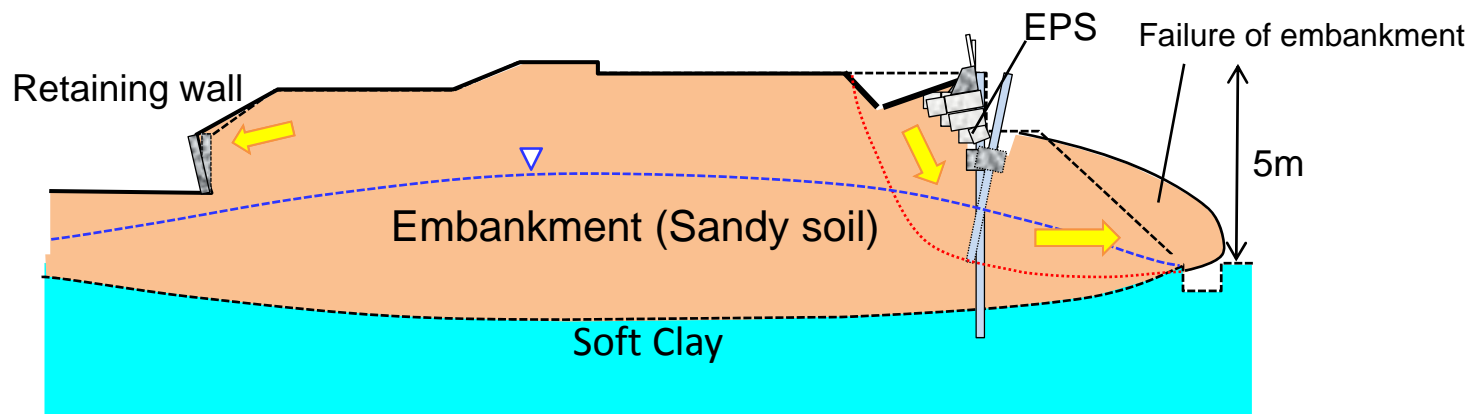
Damage of road embankment due to liquefaction of embankment body

- Constructed on soft clay layer with sand mat method.
- Groundwater table exists within embankment body.
- Embankment beneath groundwater level and sand mat were assumed to liquefy.

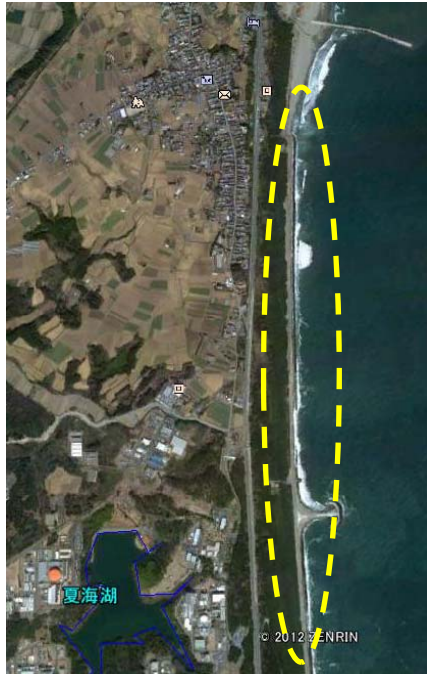
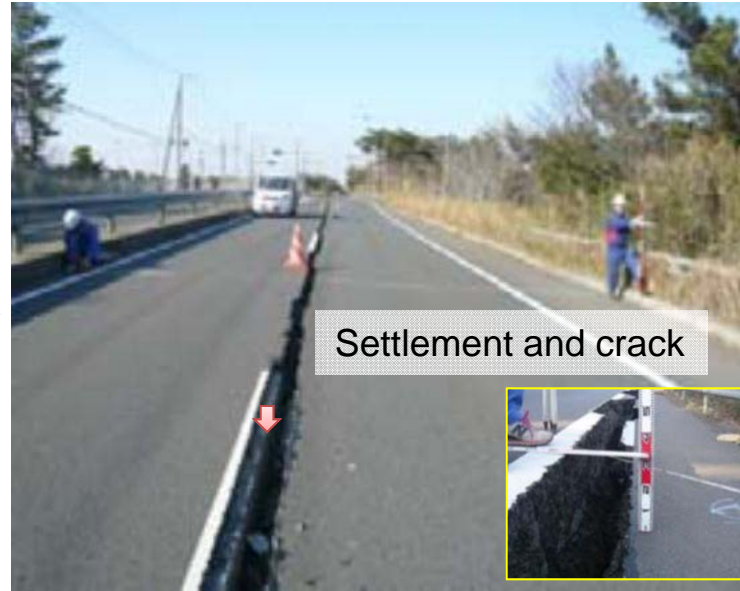
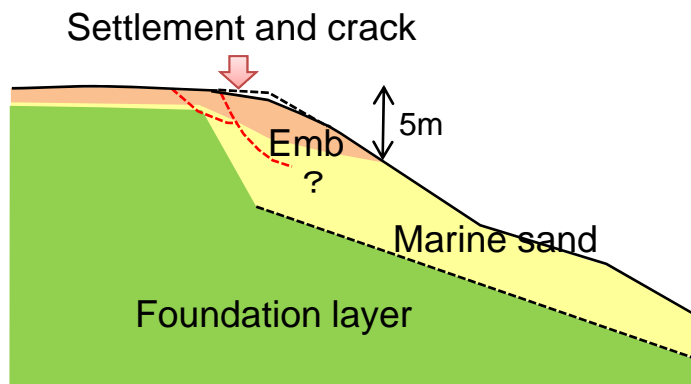
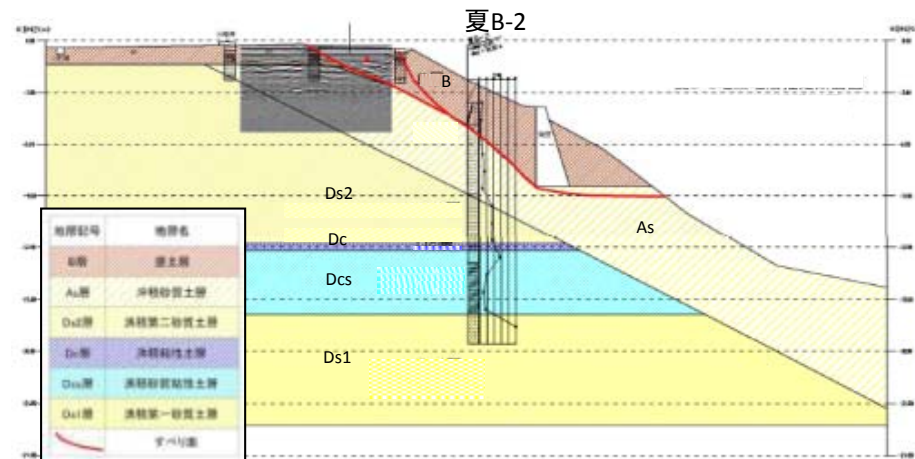
Damage of road embankment constructed on unstable slope ground

- Constructed on edge of marine sand deposited on slope ground.
- No design consideration was given to construction of embankment or retaining wall on slope ground.

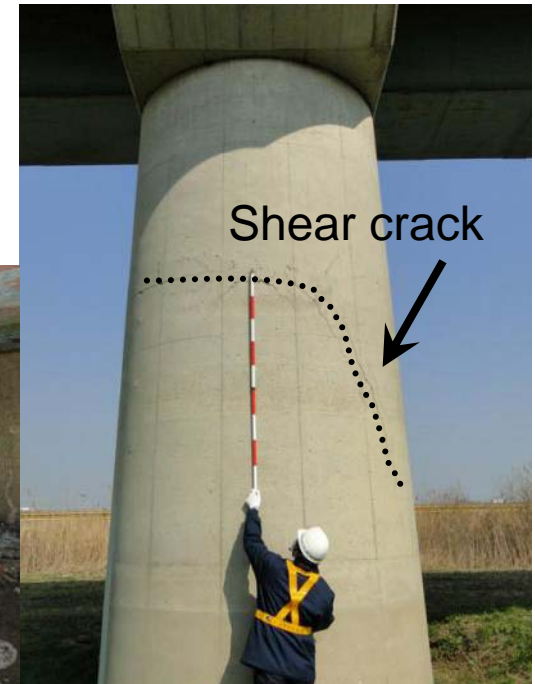
Damage to cut-off section of long. rebars

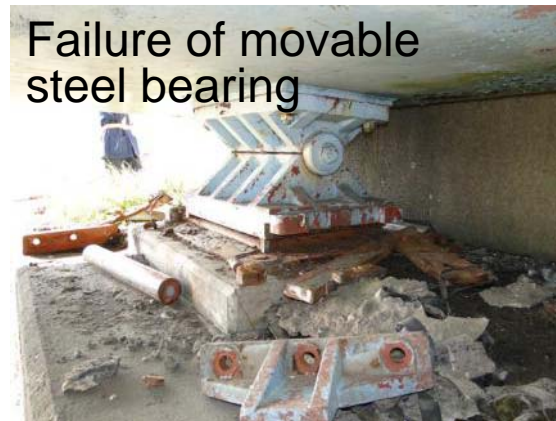
Failure of movable steel bearing

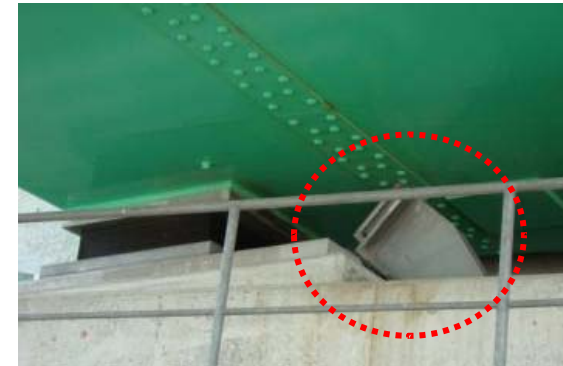
Rupture of elastomeric rubber bearings

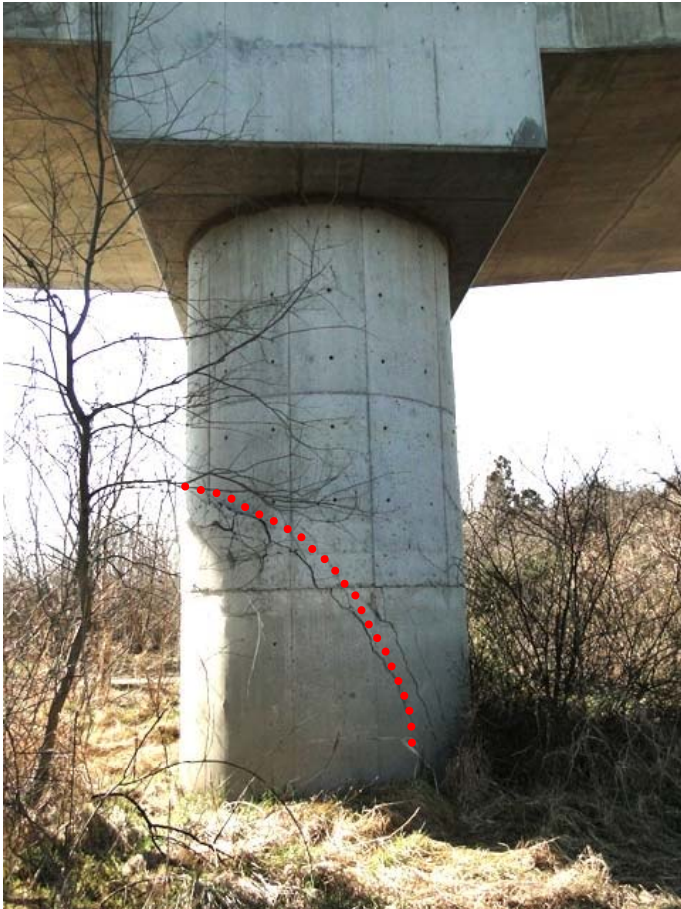
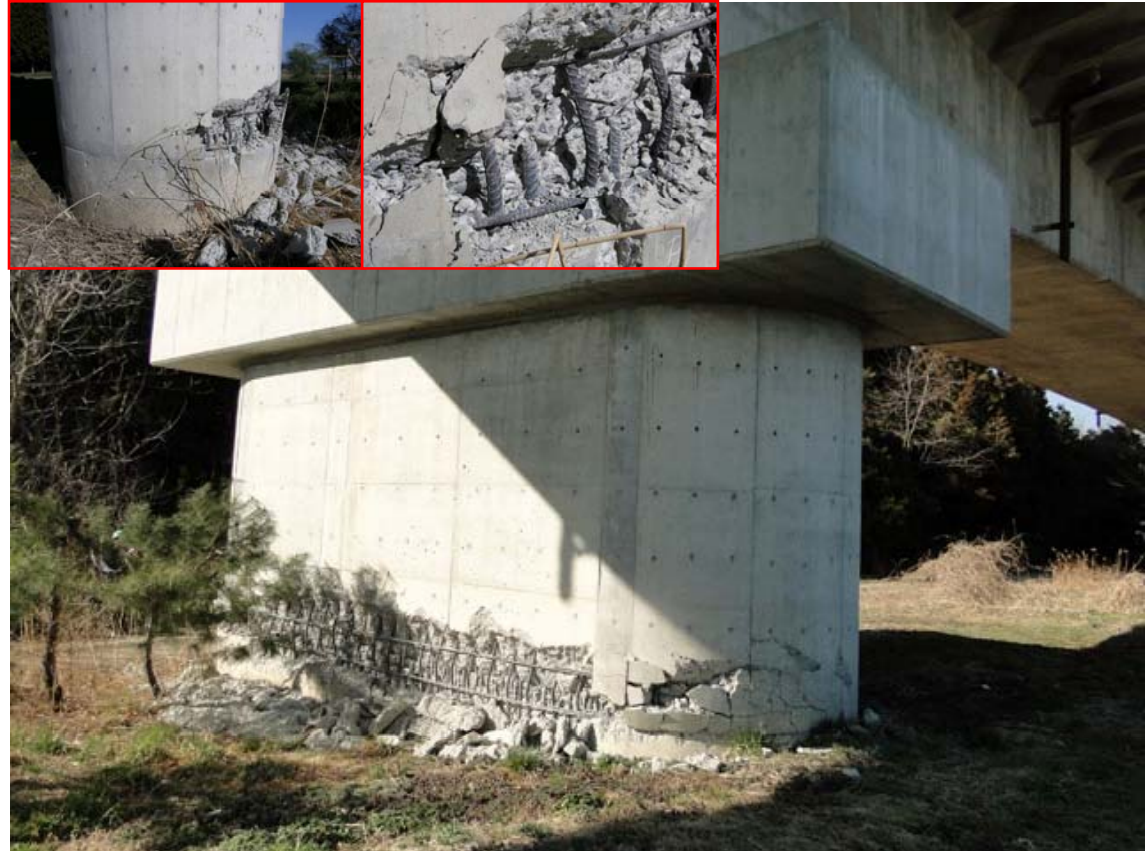
Damage of bridges not yet retrofitted

- Damage to RC column with cut-off of longitudinal rebars. Shear crack developed from flexural failure at the section of cut-off of longitudinal rebars.

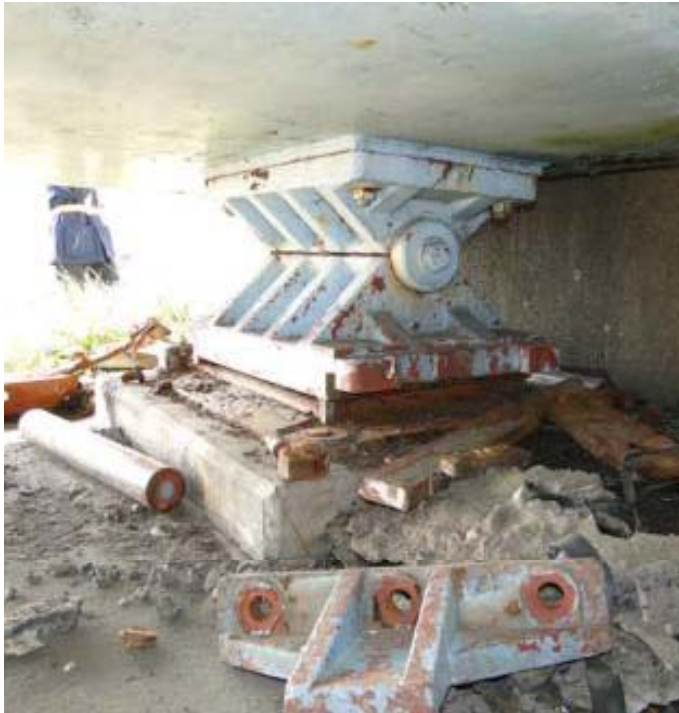
Subsidence of deck end resulting from broken movable bearing

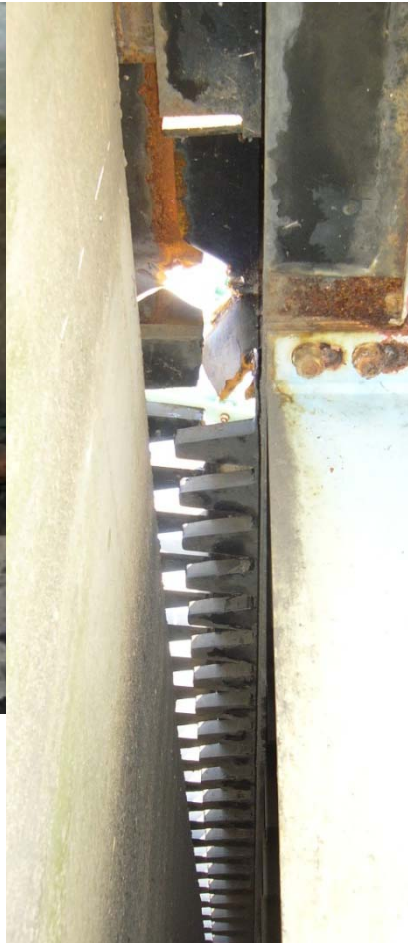
Damage of fixed bearing

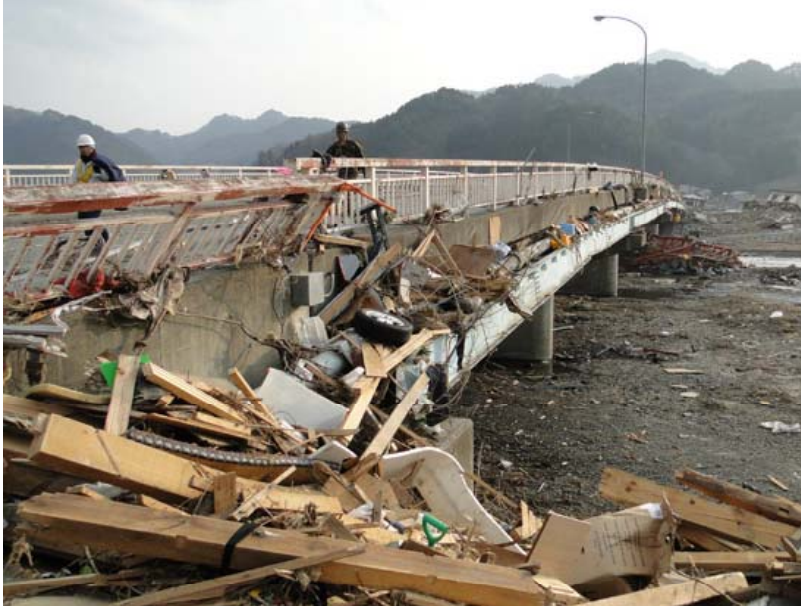
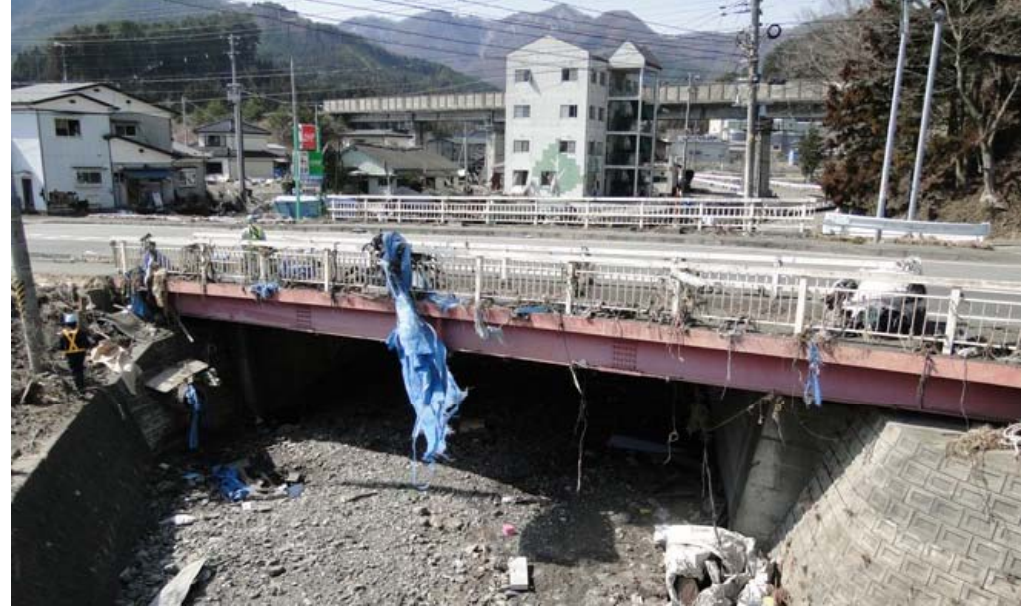
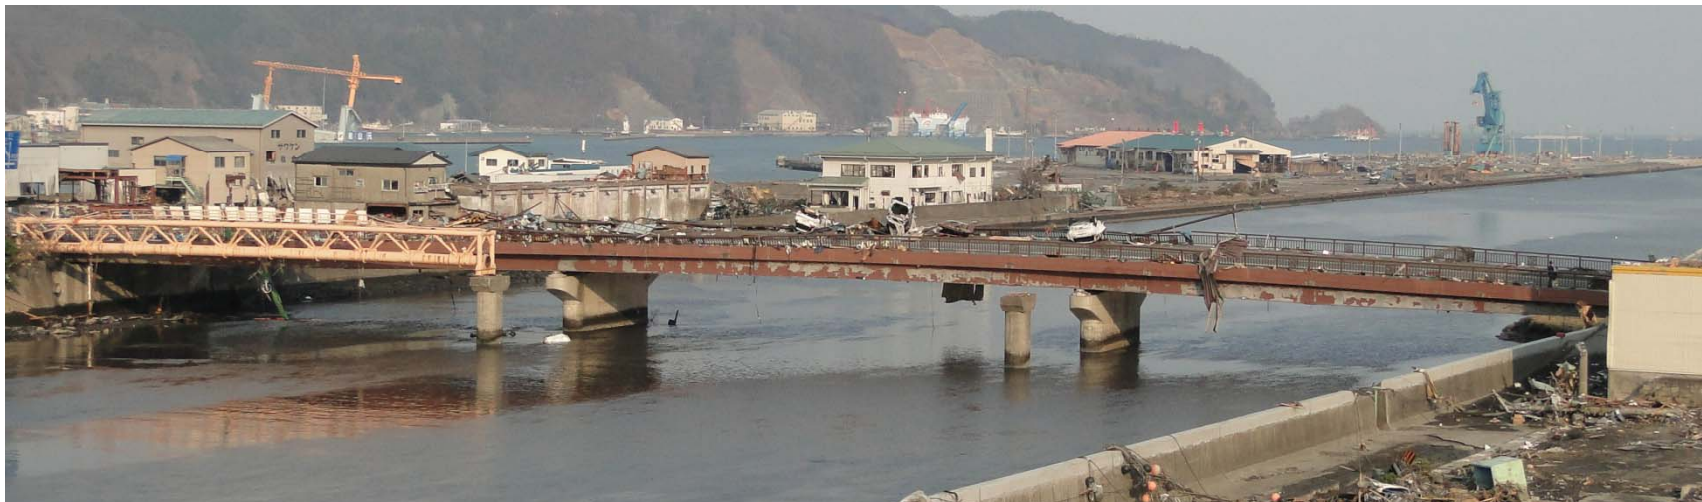
Effects of tsunami

- Bridge structure survived, even though girders were inundated with tsunami.

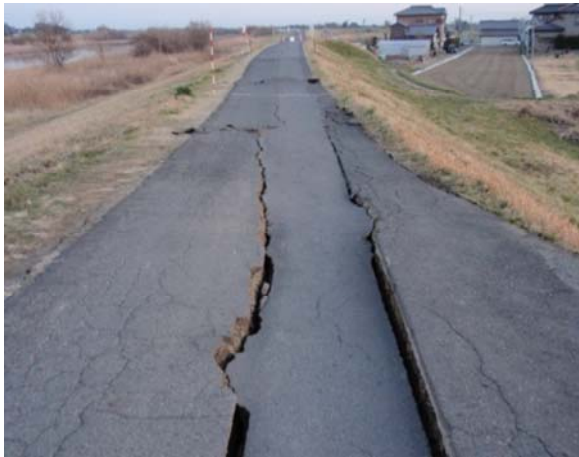
Kokai River, Ibaraki Prefecture

- Typical damage of levees includes crack, settlement, slope failure, etc.

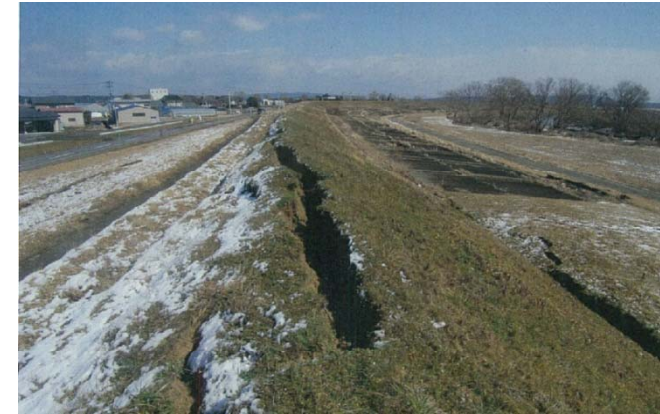
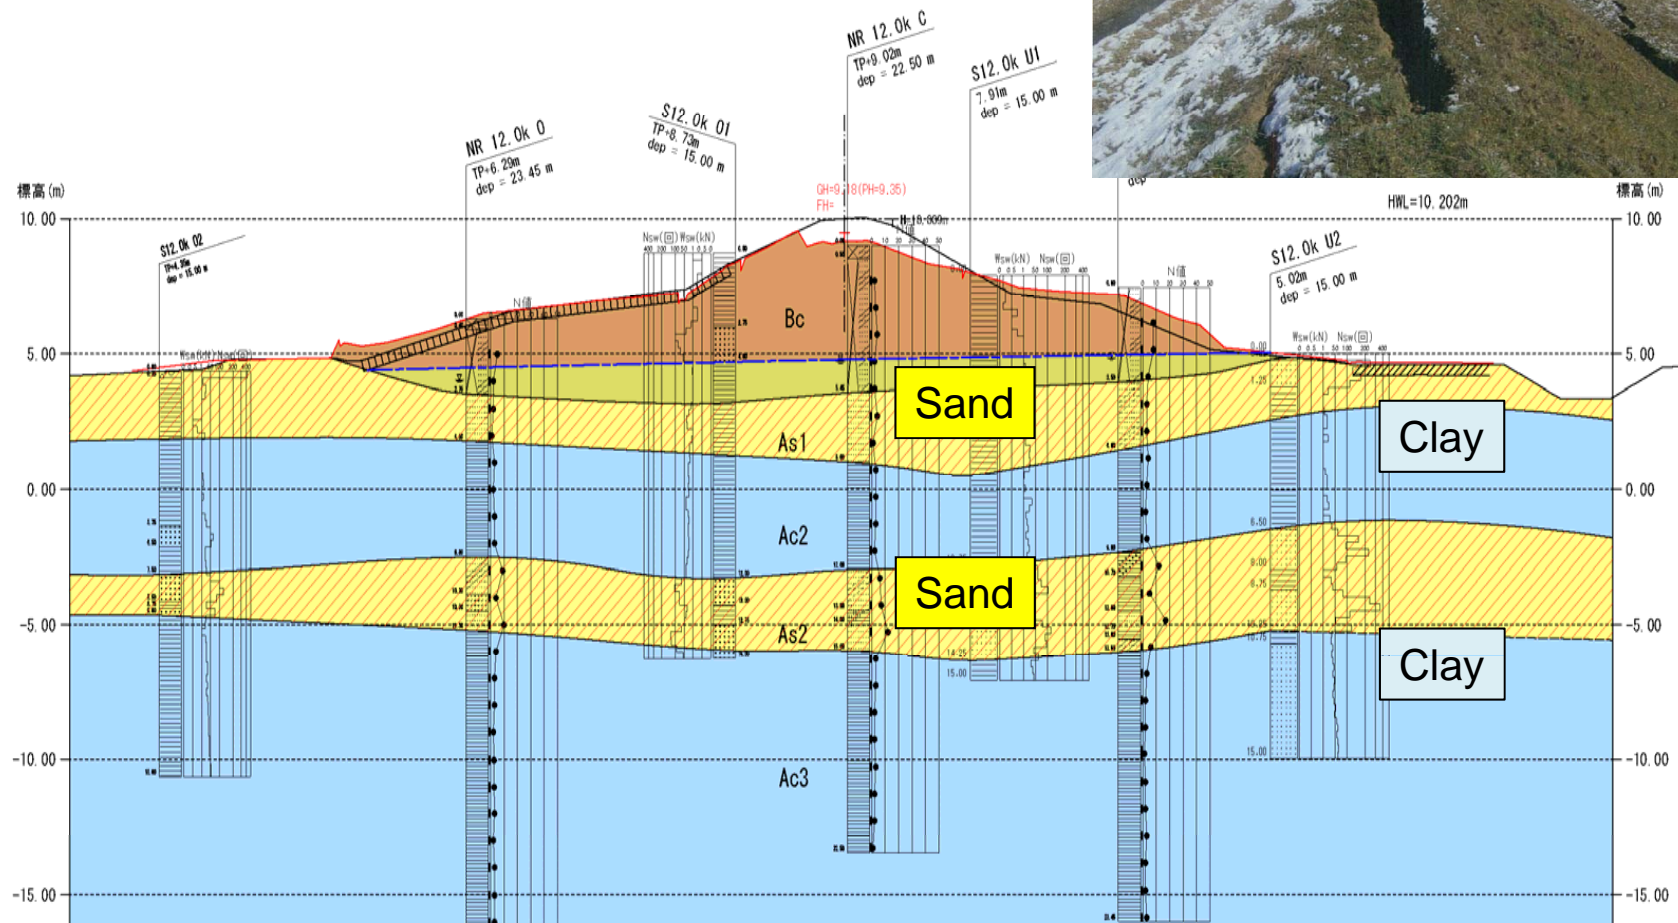
Cause of levee damage

- Sandy layer exists beneath the levee.
- Liquefaction of foundation layer.

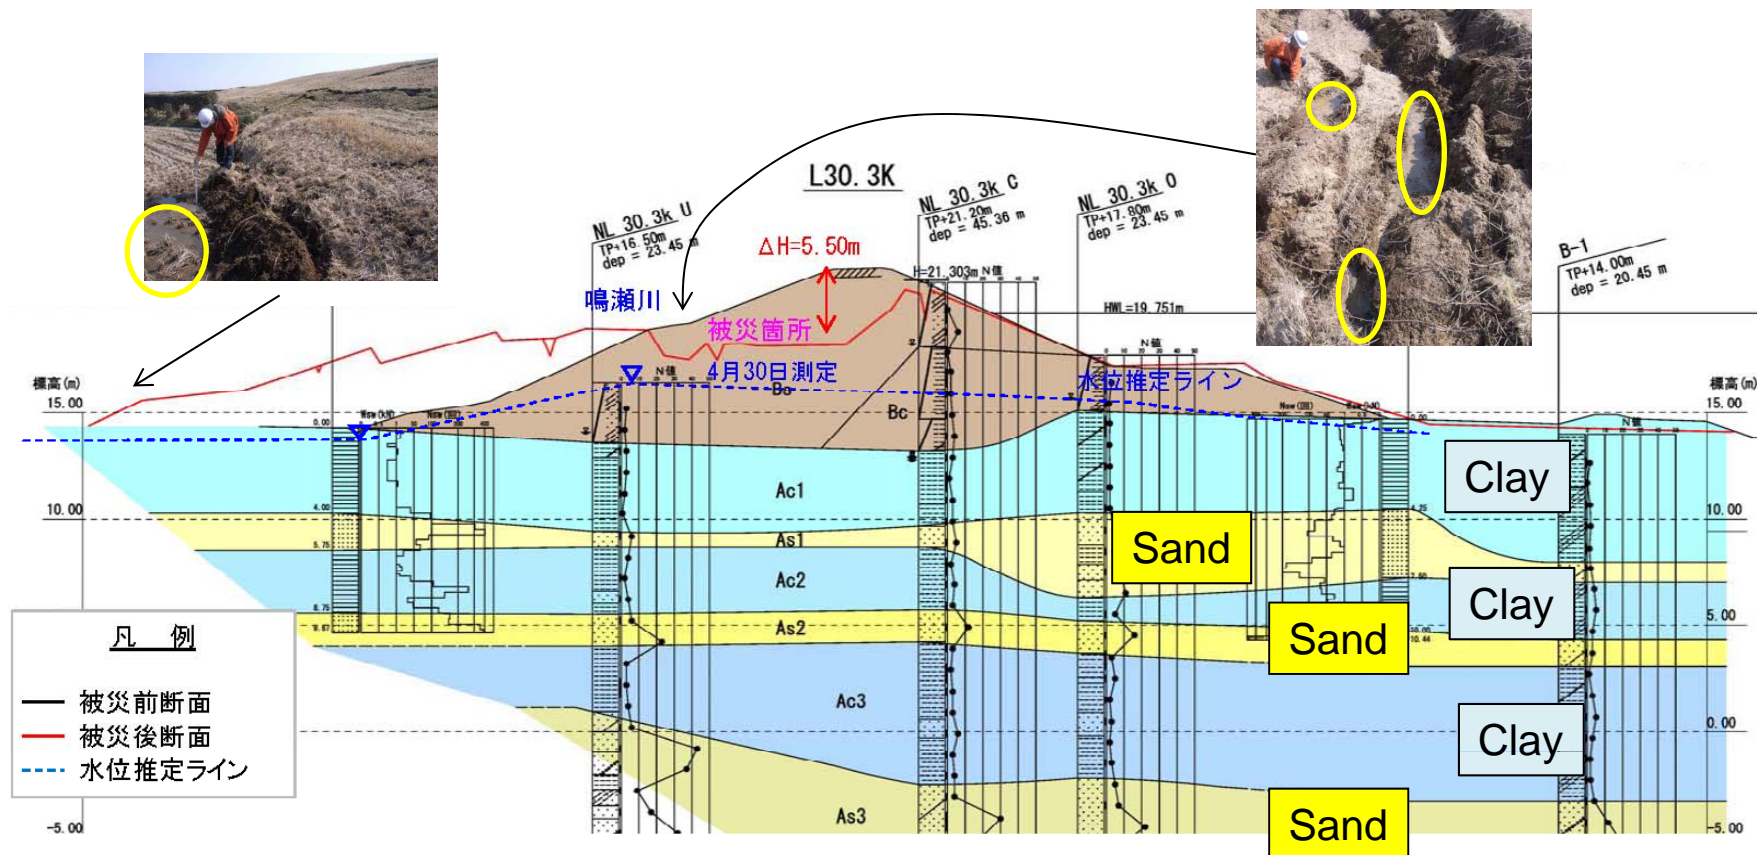
Naruse River (Shimo-naknome)

Cause of levee damage

- Sand boils were observed in the cracks of levee body.
- Foundation layer mainly consists of clayey soils, while the damaged portion of levee is of sandy soils and the water table was high.
- Damage resulted from liquefaction of levee body.

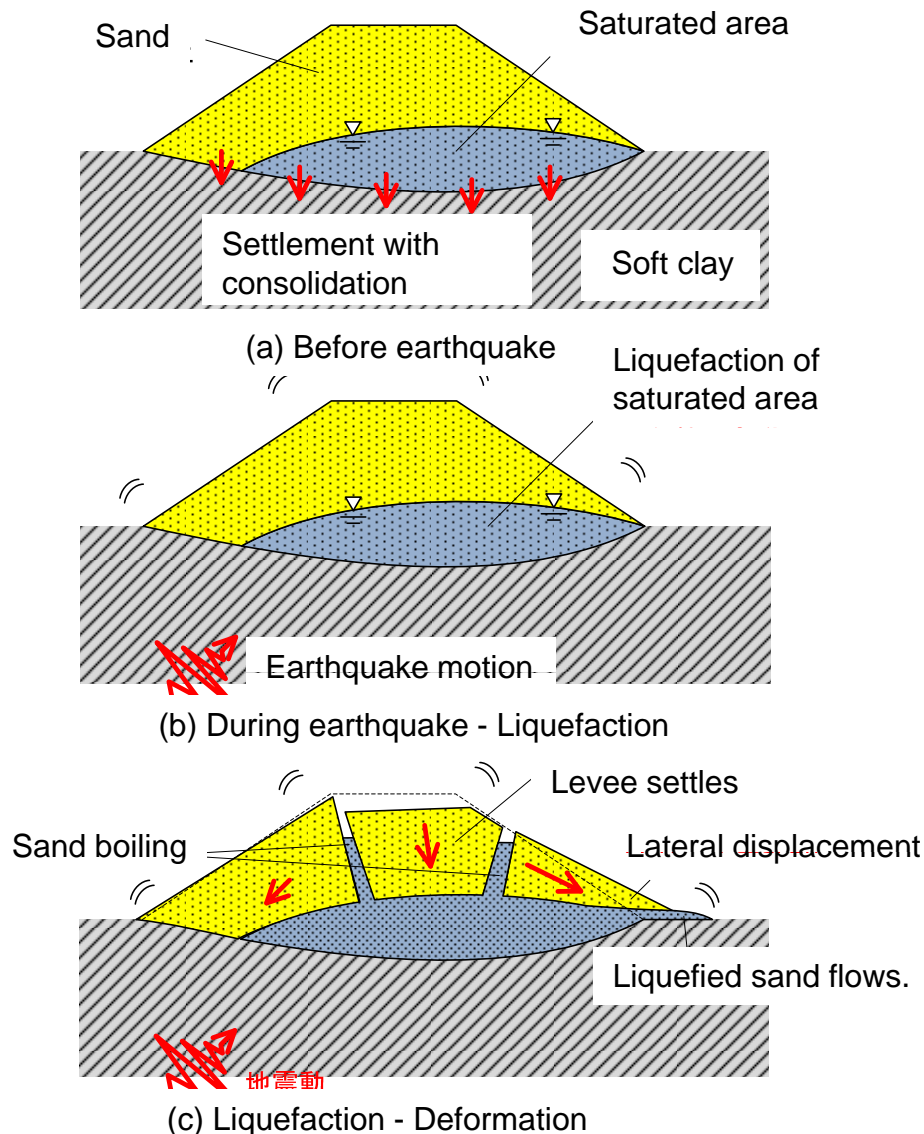
Assumed mechanism of damage by levee body liquefaction

(a) Levee body settled with the consolidation of soft clay foundation layer. Then, water was easily trapped, and the saturated area has expanded.

(b) Saturated sand liquefies during an earthquake.

(c) Levee settles and spreads to lateral direction.

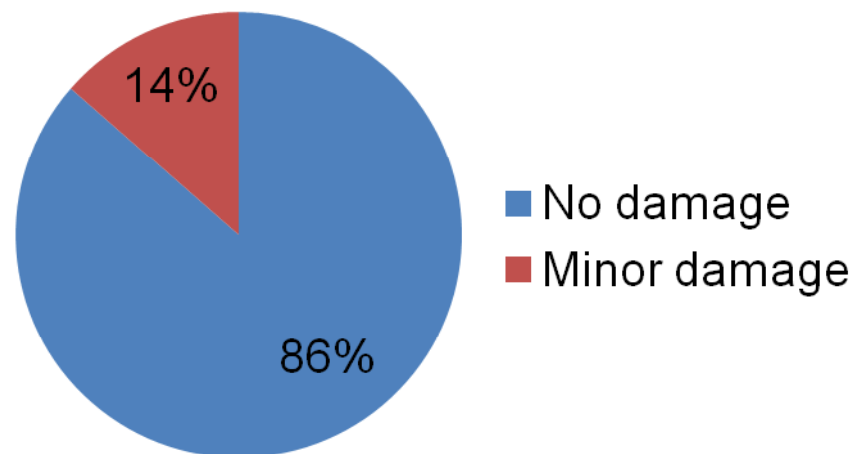
- No major damage was reported at the levees measured for liquefaction of foundation layers, which aimed for the level 1 ground motion.
- In Tohoku and Kanto regions, levees over 81.9km long were evaluated to be measured for the level 1 ground motion, and 17.7 km (22%) portion has been completed.

Measured for level 1 ground motion
