Site Investigation of the Ahar-Varzeghan Earthquake in NW Iran of August 11, 2012

Key Words : *the Ahar-Varzaghan Earthquake, field investigation, damage to houses and buildings, damage to lifelines*

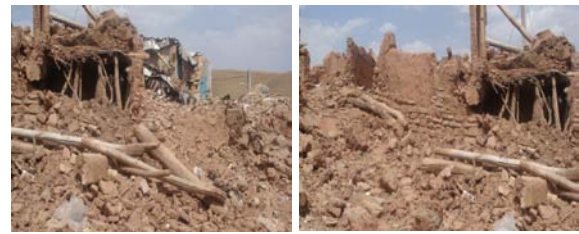
These types of buildings are very brittle and weak against earthquakes. And the significant amount of the death toll and structural damages are from these buildings. The mechanism of the damages that mostly in total is that the walls occurring across the earthquake waves are separated from the rest of the building and the roof that has lost its support collapses (**Photo.1**). The field observations showed that the main reasons of the collapse of these buildings are:

- (a) Lack of any kind of connection between cross walls.
- (b) Use of lumbars as the main beam in the roof without any effective connection between

themselves and the supporting walls. The used lumbars are sometimes very heavy.

- (c) Decay of the lumbars that are very potential for collapse even under the weight of the roof alone.

Photo.1 Damage to adobe buildings

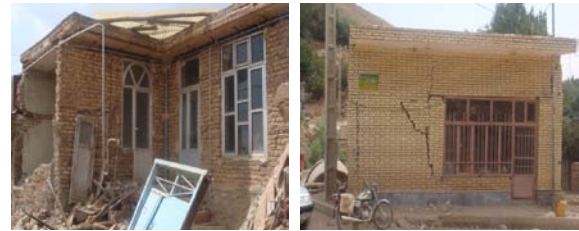
The observations showed that this type of building has not experienced total collapse. But the large amount of serious cracks in walls and wall and roof connections are apparent (**Photo.2**). The quality of bricks used in these buildings is very different. However, it was observed that this item has not effective parameter in the behavior of the building and rather the details of connections of walls to each other and to the roof or details around the openings are more important.

Observations showed that in the case of lack of bracing of roof beams, some major damages are encountered, likely:

- Fall of some part of arches between the steel beams.
- Break of arches near the supporting steel beams.
- Cracking of the roof and falling of covering gypsum.

There existed huge amount of shear cracks in this type of building. Wall collapse also was visible. Bending mode cracks were also observed, however, this type of crack was suppressed by falling off the walls.

Photo.2 Damage to brick buildings

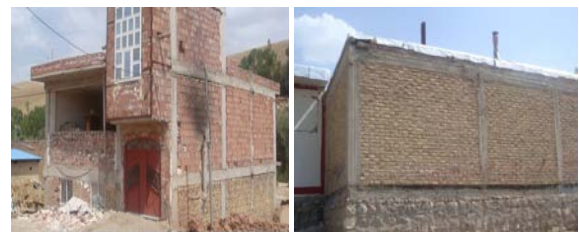
These buildings showed much better behavior in the course of the recent earthquake and there was not observed any total collapse in them. However, most of these buildings tolerated some minor damages and few of them even involved serious damages (**Photo.3**). The main reason for the damages can be mostly attributed to the following factors:

- Lack of construction of suitable connection detail of tie columns and bond beams. Or missing some tie columns amid long walls.

Photo.3 Damage to half reinforced masonry buildings

- Use of poor quality concrete and providing low diameter reinforcement. Also, compaction of concrete during construction is not done as appropriate.
- Construction of a specified map required by the Housing Foundation for use of loan according to the code of practice of Iran (Code No 2800) and addition of some rooms without tie columns and bond beams later.
- Lack of a proper connection of surrounding beam and columns to the filling walls. This factor is responsible for the utmost of the damages in these buildings.

Factors (b) and (d) are the major damages amount in the earthquake hit areas. However, it seems that if some more attention to be paid for the supervising the construction of these buildings and also a book of commented details are provided by the authorities for the connections, the future damage statistics would decrease significantly.

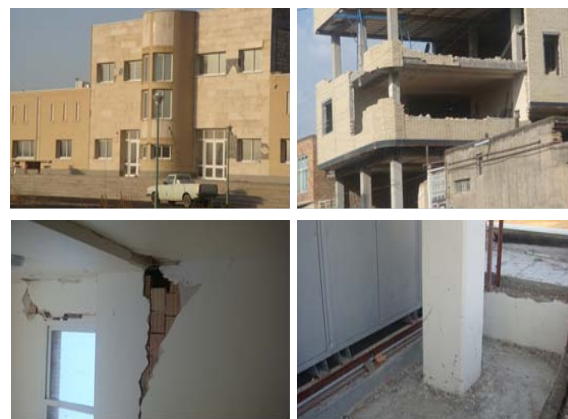
Concrete buildings are mostly constructed in cities like Ahar, Heris and Varzegan. These buildings are designed and constructed under supervision of engineers. The observations showed no serious damages in these buildings. This is expected in an earthquake intensity of 6.3. However, the most considerable damage for the concrete buildings could be mentioned as crack and collapse of in-filled walls (Photo.4). The other type of damage was throwing out of windows because of lack of proper connection of them to the surrounding walls, pour of façade also because of lack of connection of the façade material to the main wall body. It seems that a major reason for the existing damages of the half reinforced and concrete buildings is the lack of a qualified detail handbook specified by the authorities that should be used in the course of construction.

The other weakness of the concrete building is use of clay voided blocks which are very dense and brittle. These blocks do not provide proper bond with the poor quality mortar which is provided normally in construction of walls and therefore they crack or move during ground motion. The other factor is brittleness of the clay blocks which is not adaptable with the ductility of the concrete frames and with any draft of the frames the infilled clay walls. Eventually the walls crack or break and some time jump out in the transverse direction or tolerate serious diagonal shear cracks which cause spalling of gypsum in the walls.

Photo. 4 Damage to reinforced concrete buildings

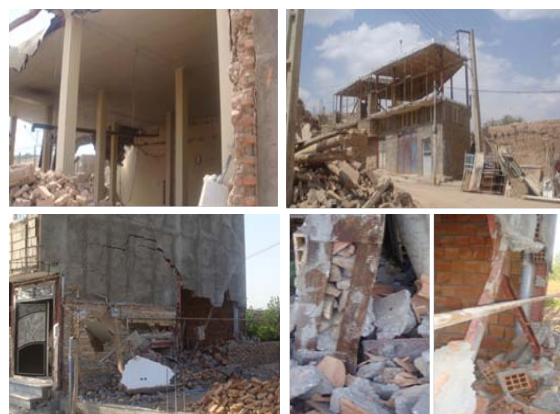
A case that worth of being considered specifically is a two story braced steel building. There was a

Photo. 5 Damage to steel buildings

buckling in one of the bracings of the building and also a rupture in the connection of the gusset plate to the web of the column. Also the main column had buckled because of pounding of a part of stair ramp connection to the column (Photo.5).

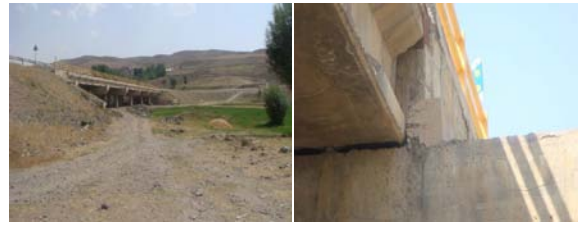
The masonry arch bridges also were safe and the reason is that they get low spans. From three major bridges that were investigated in the region, one was in the road of Ahar to Varzeghan. This bridge is a 5-span concrete bridge (No. 1), the second was an old 6-span composite bridge in Varzeghan and the last one was a new 3-span integral composite bridge. In all of the above mentioned bridges the expansion joints have become active during the ground motion. And all of the spans of the bridges adjacent to the joints have experienced some minor or moderate movements. In the case of the bridge No.1, some lateral movement was observed in the first span of the bridge (**Photo.6**). This movement was restricted by the shear block of the pier. However, some cracks have been induced in the shear block as a result.

Photo.6 Damage to 5-span concrete bridge (No.1)

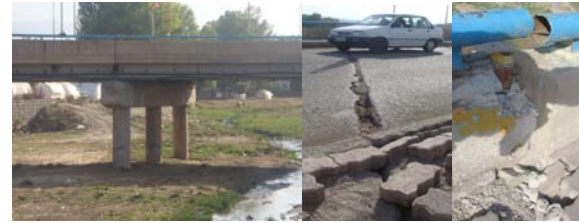
In bridge No. 2, the movement was clear and almost all the spans had lateral movement (**Photo.7**). The main reason for this fact was that no shear block was provided for the bridge and only the friction between the beams and pile has overcome the exceeding movement.

Photo.7 Damage to 6-span composite bridge (No.2)

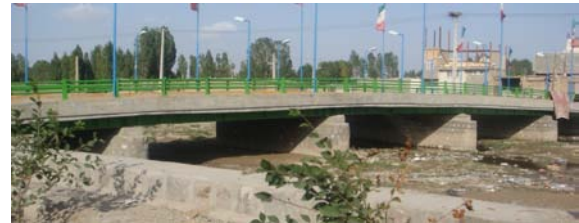
In bridge No. 3, no lateral movement was observed (**Photo.8**). Since this bridge was integral and the main beams was continuous composite beams, there was not any lateral or transverse movement in the body of the bridge. However, there were apparent cracks both in the beginning and at end of the bridge in the joint locations in the asphalt.

Photo.8 3-span integral composite bridge (No.3)
