Ground fissures that appeared in Aso Caldera Basin in the 2016 Kumamoto Earthquake, Japan

Key Facts

- Hazard Type: Earthquake
- Date of disaster: April 14th and 16th, 2016
- Location of Survey: Northwestern part of Aso caldera, Kumamoto, Japan
- Date of the field survey: April 29th to May 2nd, 2016
- Survey tools: Unmanned aerial vehicle (UAV), GPS

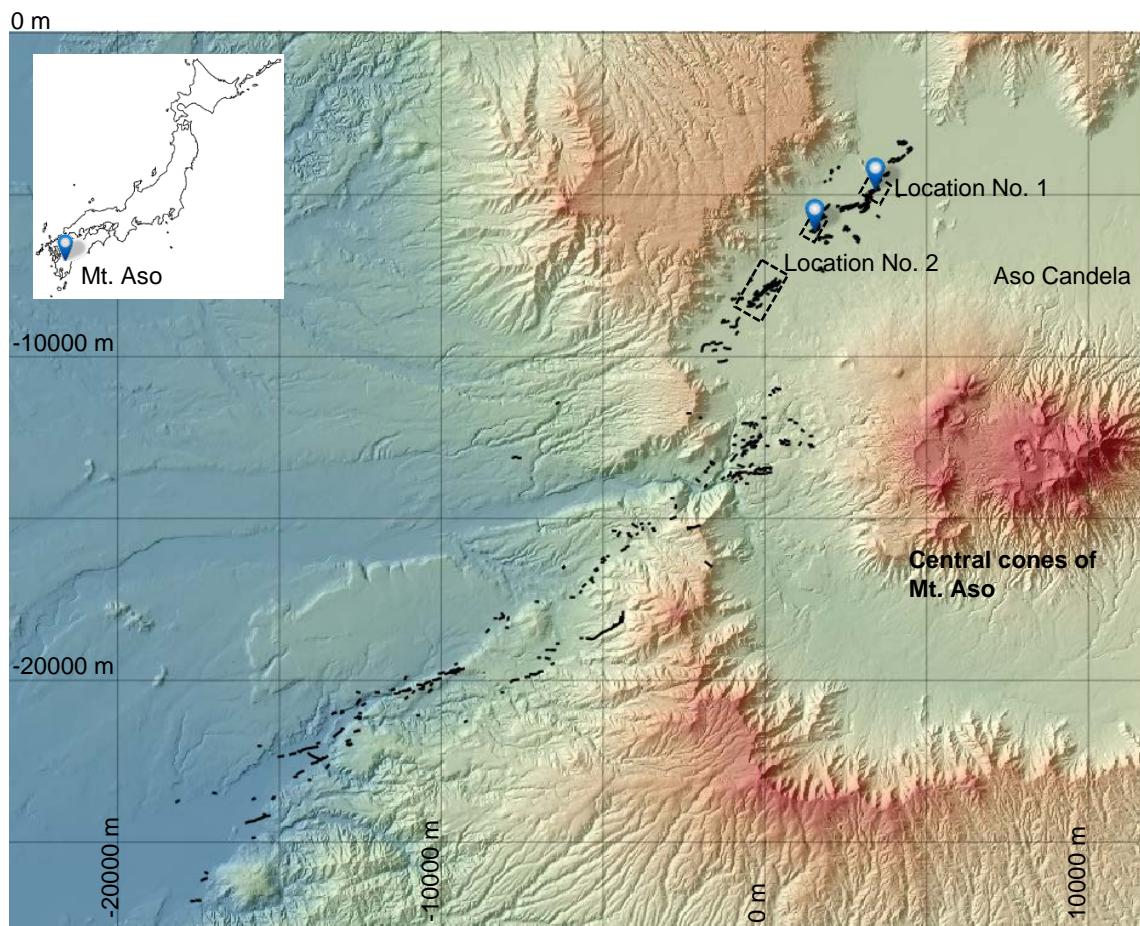
Fig. 1 Aerial photointerpretation of cracks that appeared on the ground surface: Interpretations of southwestern and northeastern segments of cracks were made by the Geospatial Information Authority of Japan²⁾ and Kokusai Kogyo Co. Ltd.³⁾, respectively. Authors' survey was conducted within areas enclosed in boxes of dashed line . UAV was flown over Locations 1 and 2 (Coordinate reference system: JGD2000 / Japan Plane Rectangular CS II)

Fig. 1 shows cracks that appeared on the ground surface. Aerial photo-interpretations of southwestern and northeastern segments of cracks were made by the Geospatial Information Authority of Japan²⁾ and Kokusai Kogyo Co. Ltd.³⁾, respectively. They include every visible cluster of cracks no matter what their causes are. Majority of cracks of the southwestern segment appeared along the Hinagu and Futagawa fault system, whose presence had been recognized, while northeastern segment of cracks exhibits a complex, interwoven pattern of fractures diagonally across the basin sediment of Aso Caldera. Though complicated, the latter is clearly characterized by a

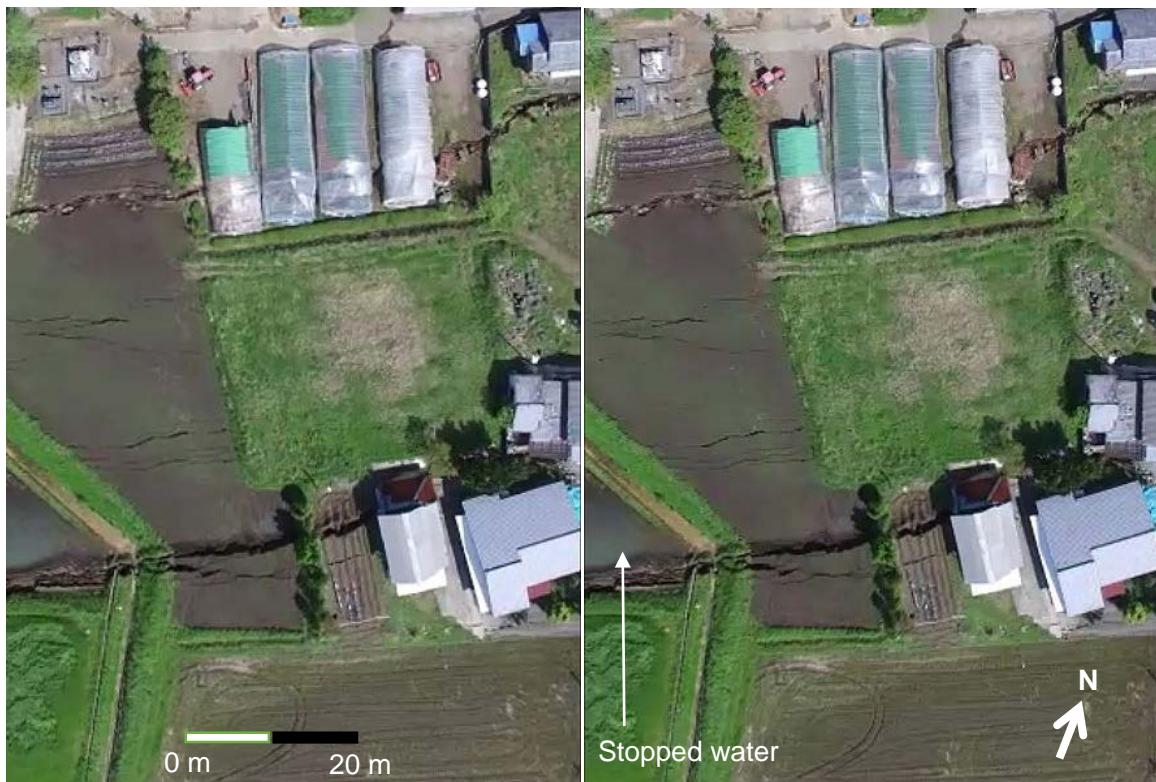
Flying over at a particular point at around N32.9662°, E131.0364 for example, one notices that the swath of ground depression is about 40 to 50m wide and 1 to 1.5 m deep (Fig. 2). A pair of UAV photographs shown in Fig. 2 can be perceived as a single image in terms of depths. As can be perceived, southeastern ends of plastic greenhouses dropped down onto the depressed ground. Water is stopped along the southern vertical offset of the ground. No clear indication of either right-lateral or left-lateral offset can be seen at this location.

Fig. 2 A pair of UAV photographs of ground depression with the center of each photograph located at around N32.9662°, E131.0364, Location No. 1 in Fig. 1 (Flight altitude: 75m)

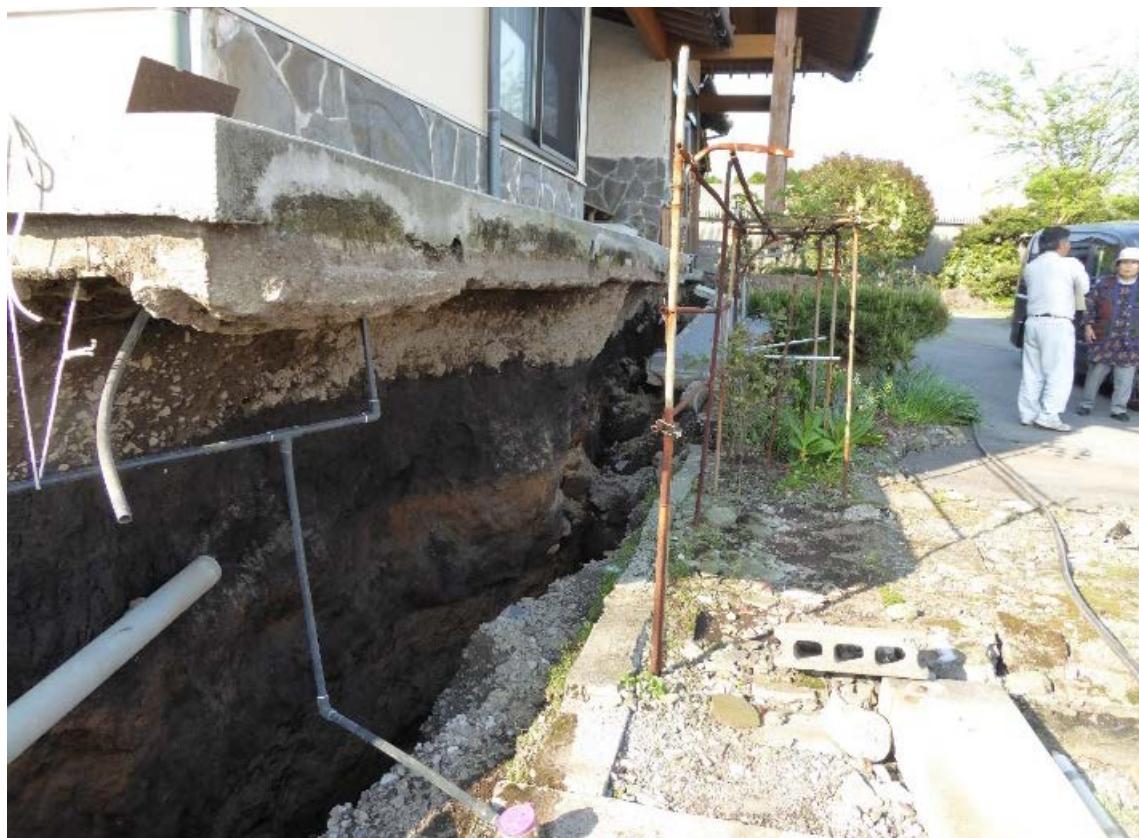
Being located several 10m NNE off the UAV picture frame, there is a house standing by the edge of northwestern offset of the ground at N32.9568°, E131.0368 (Fig. 3). The exposed soil wall shows a stratified structure of brownish volcanic ash, pumice and andosol, which is highly porous and dark-colored developed from volcanic ash mixed up with organic matters. The crack here was more than 1 m deep with no clear indication of sand ejecta. A lady, the owner of the house standing by the car on the right,

Fig. 3 House hanging a little over the northwestern offset of the ground at N32.9568°, E131.0368 (near Location No. 1)

witnessed that ‘her neighbor’s house behind her dropped all at once, keeping its shape as it was,

immediately when the intense shake of the main event of April 16th hit it. The drop of the ground was

anything but slow”.

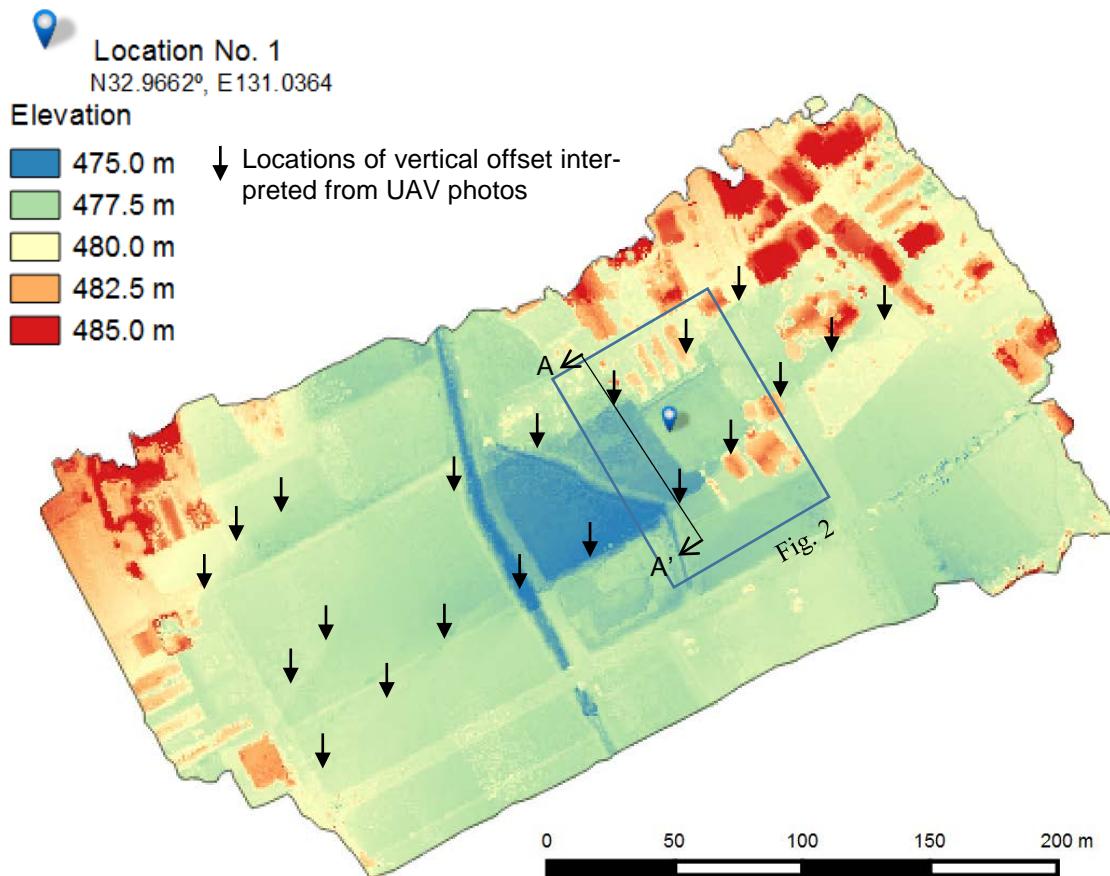
Fig. 4 Digital surface model of one part of swath of ground depression (Location 1, at N32.9662°, E131.0364°)

A UAV-based 3D digital surface model (DSM) was prepared as shown in Fig. 4. To fully define the coordinate system for the extracted DSM, four points were chosen off the swath of ground depression. Exact absolute positioning of these points with an advanced system such as dual-frequency GPS is mandatory, but for a quick and preliminary discussion, the coordinate values for these points were taken from “CyberJapan”, a digital Japan tile map layer provided by Geospatial Information Authority of Japan. The obtained DEM can be thus subject to change in later publications.

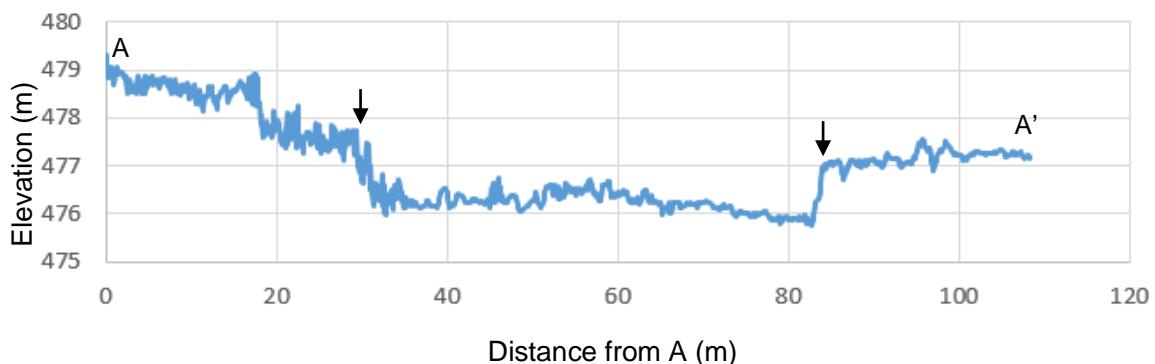
Fig. 5 Cross-section A-A' in Fig. 4

Though the cloud of points extracted from DSM shows not only the bare ground surface but also vegetation and artificial objects, the swath of ground can be clearly seen particularly in the middle of the covered area where the swath is narrowest and deepest enough to stop water. A cross-section was taken along Line AA' in Fig. 4 (Fig. 5). A pair of two clear ground offsets shows that the swath has fallen by about 1m here. The swath of ground depression becomes gradually shallower and wider towards west end of the UAV-covered area.

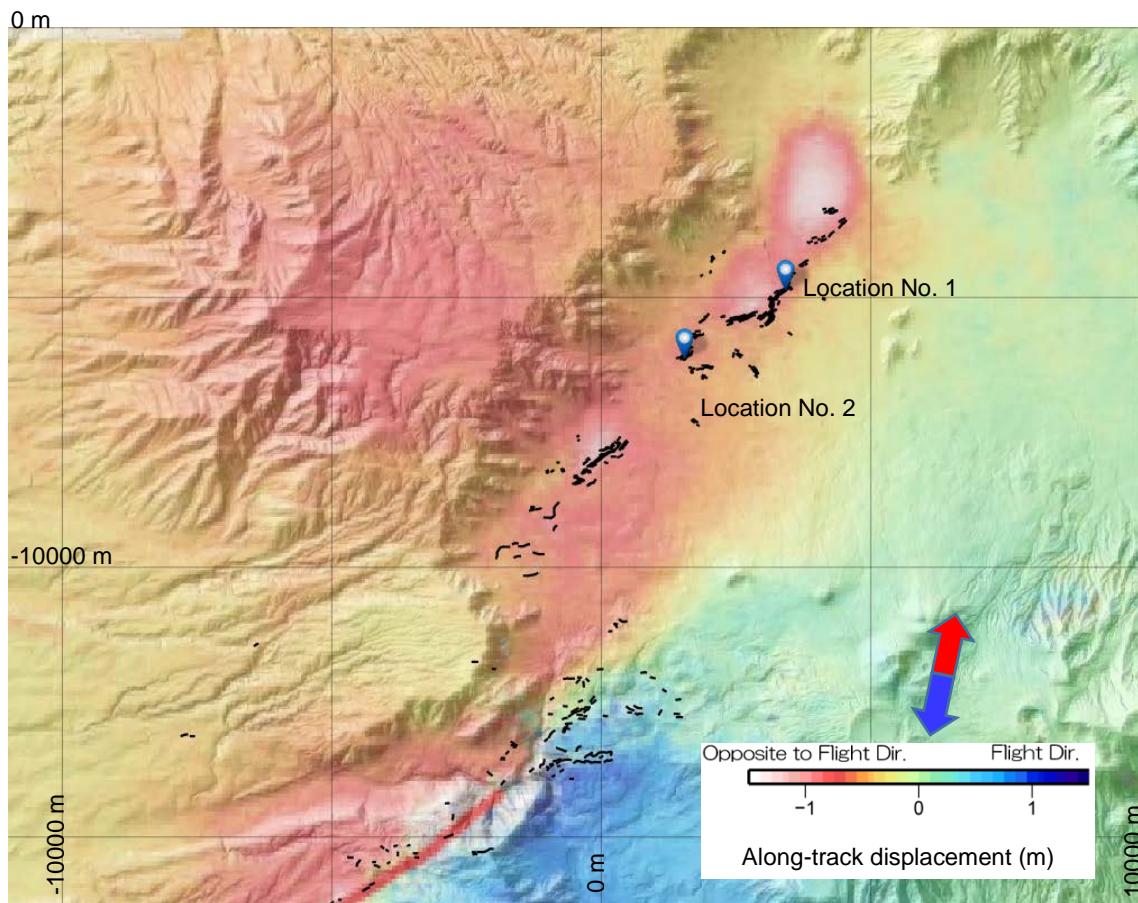
Fig. 6 Cracks laid over the along-track displacements pattern analyzed by the Geospatial Information Authority of Japan using MAI (Multiple Aperture Interferometry) method⁵⁾

It is controversial if the abovementioned features of the ground offset represent all of the ground depression that appeared over a 10 km distance in Aso Caldera. However, as far as the locations that the authors have visited (Boxes of dashed line in Fig. 1), soil profiles exposed on the offset walls are much alike. No clear indication of sand ejecta was found, which ejecta may have canceled the soil volume that have subsided. This depression may be due to shaking-down settlement, grain crushing of porous volcanic products, and/or just a reflection of deep-seated tectonic movements which exhibits some tensile components in the transverse direction of the swath of ground depression. By way of trial, the cracks were laid over the along-track displacements pattern analyzed by the Geospatial Information Authority of Japan using MAI (Multiple Aperture Interferometry) method⁵⁾. The cracks seemingly appear where large tensile strain built up (Fig. 6).
