Meeting with ASCE/TCLEE survey team on the 2011 Great East Japan earthquake at JSCE on June 13, 2011

Damage of wastewater utilities in the 2011 off the Pacific coast of Tohoku Earthquake

Gaku Shoji, Univ. of Tsukuba

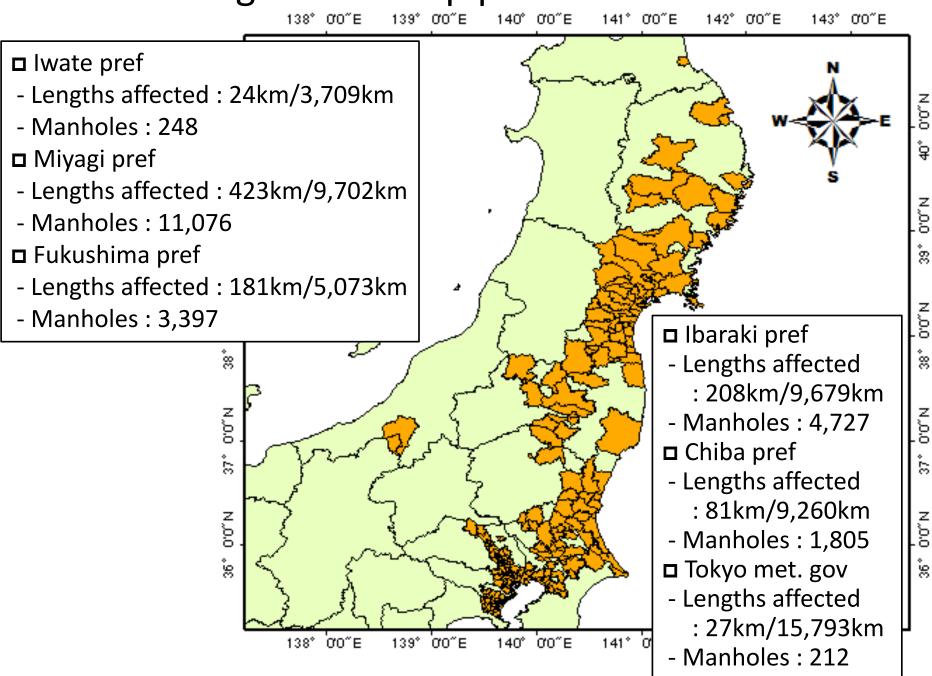
Damage of sewer pipes and manholes

Damage due to seismic excitations and induced liquefaction - courtesy of Urayasu city

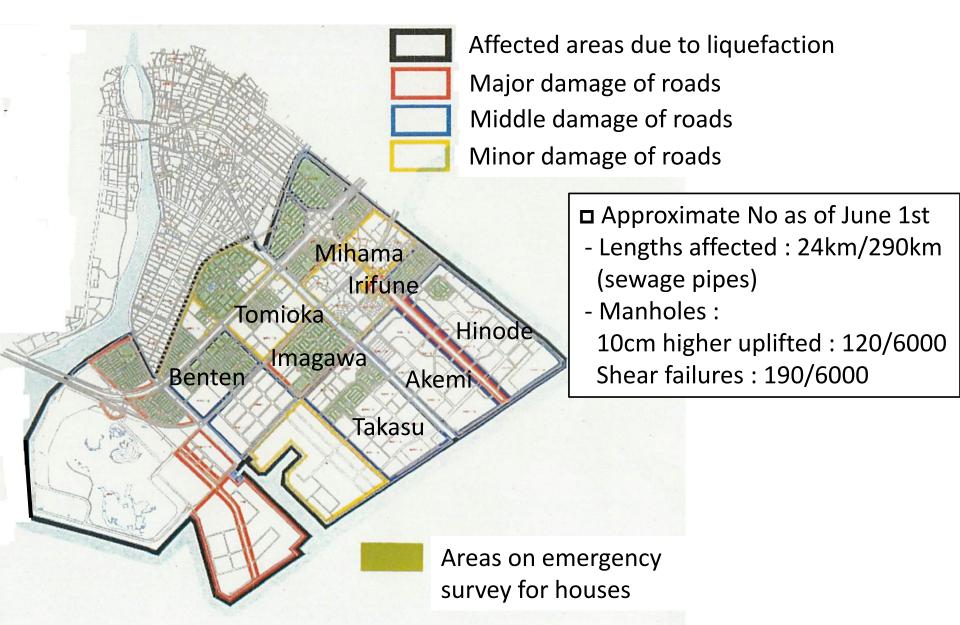
Damage and early restoration of sewage pipes at Urayasu city

Emergency restoration

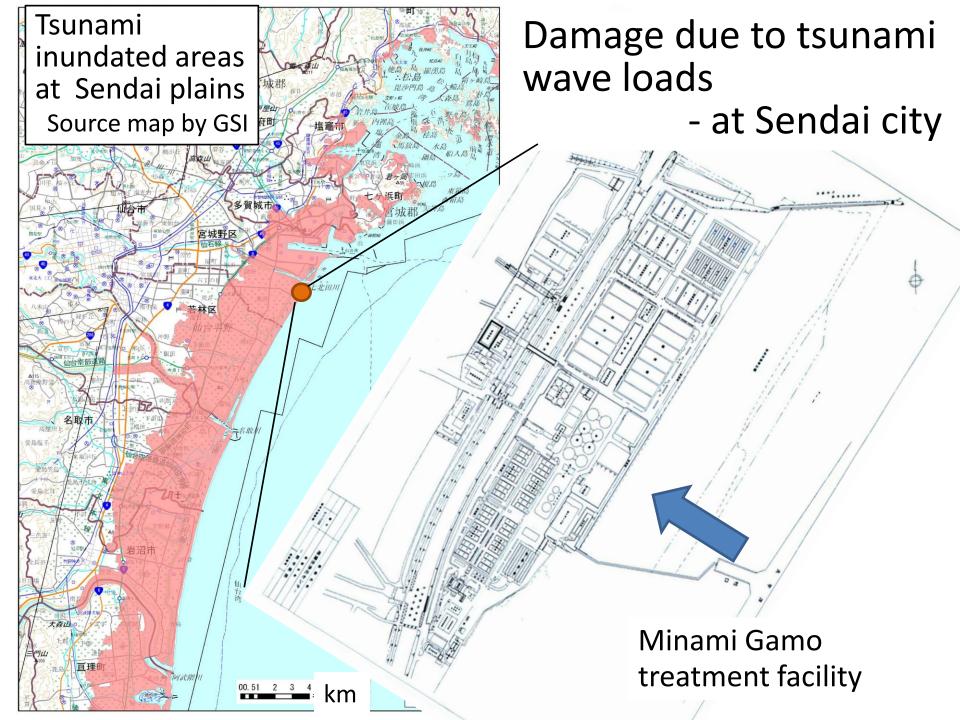
Physical damage of No.3 pump house due to tsunami wave loads at Minami Gamo treatment facility

Structural failure modes by inundation depth of about 8m to 9m
 Deformation of 1m or more in out-of-plane at the RC wall

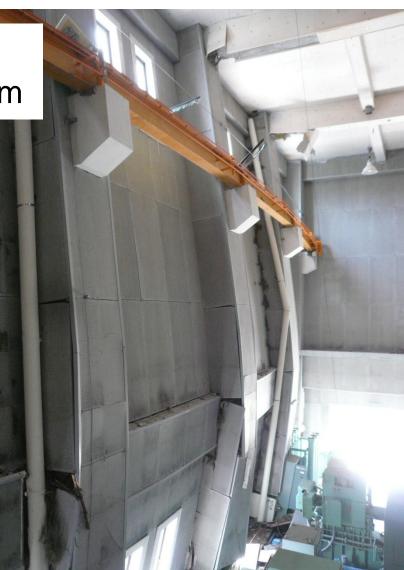
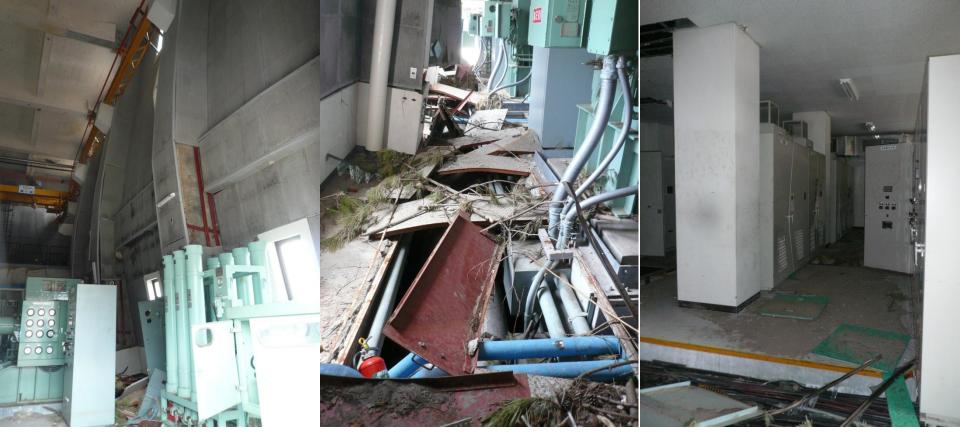
Physical damage in the No.3 pump house by 8m to 9m inundation from the ground level at Minami Gamo treatment facility
Physical and functional failure modes of mechanical systems
