Tohoku Off Shore Earthquake & Tsunami,
Japan
 $M_w=9.0$ 11 March 2011

Lifelines Performance Assessment
Preliminary Summary

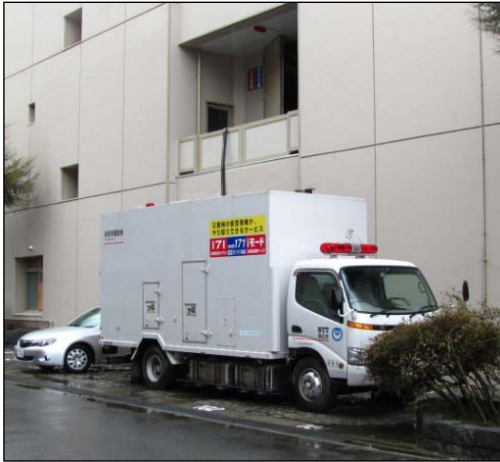
Miyako

- 16 Buildings had minor damage to its building but power facilities were lost due to water damage.
- Restored with mobile power plants.

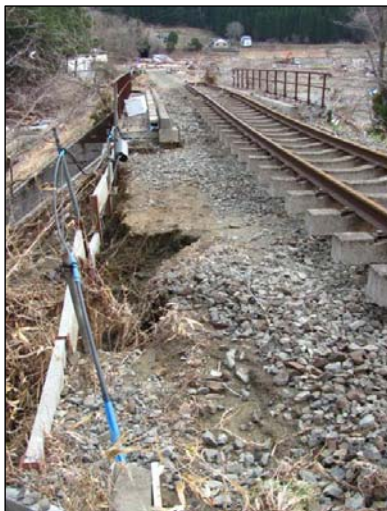
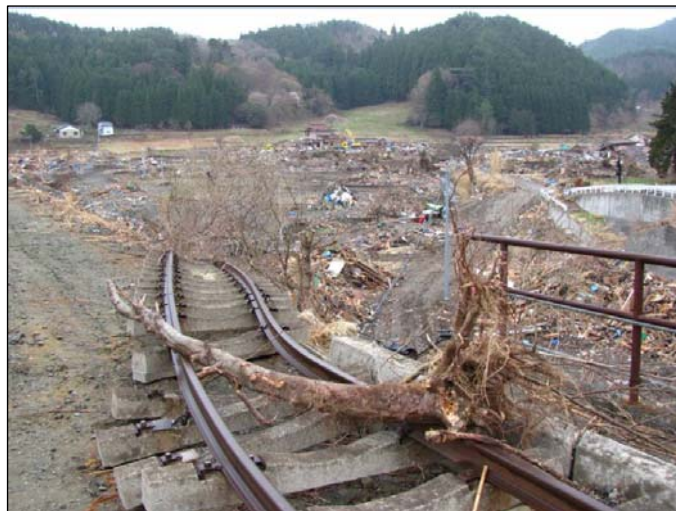
Sanriku

- 4 central offices lost service due to isolation from the rest of the network caused by severed transmission links caused by destroyed bridges.
- Restored with new by-pass transmission routes.

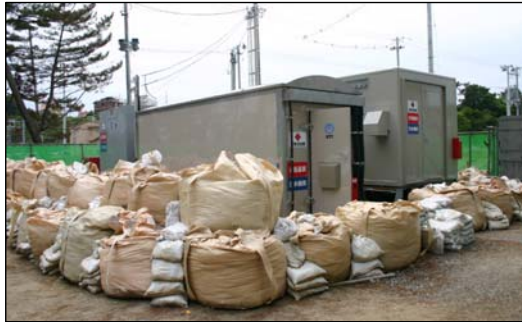
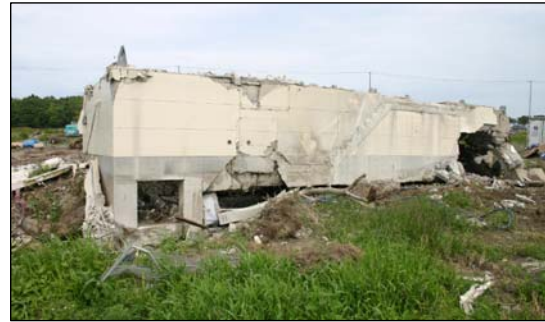
Telecommunication

- 26 Buildings were damaged by the tsunami and all of its equipment in its interior was destroyed..
- Restored with switches in shelters located at the location of the destroyed central office building, or remote subscriber line modules (RSBM) small cabinets (also called digital loop carrier or fiber to the curb systems) distributed along the destroyed central office service area.

Shichigahama CO building carried away 500 m by the tsunami

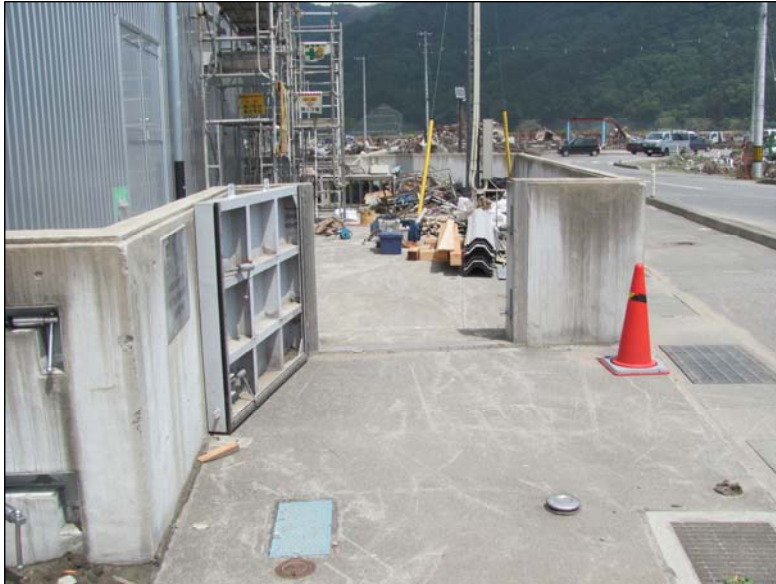
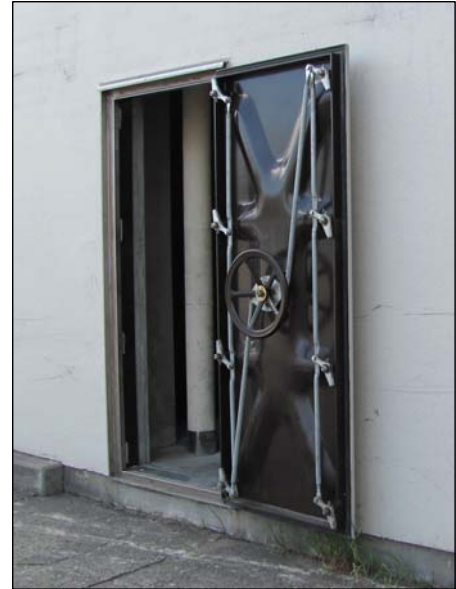
Water tight door and gate

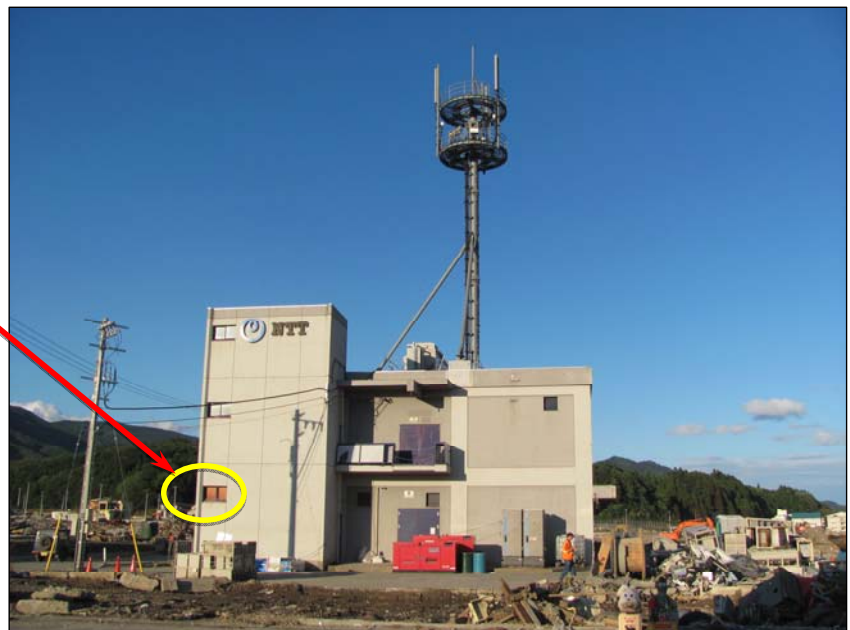
Note: this is the only building without structural damage in the whole area. This is true in all tsunami impacted areas that the only building standing is NTT building.

Need to add water tight shutter for window

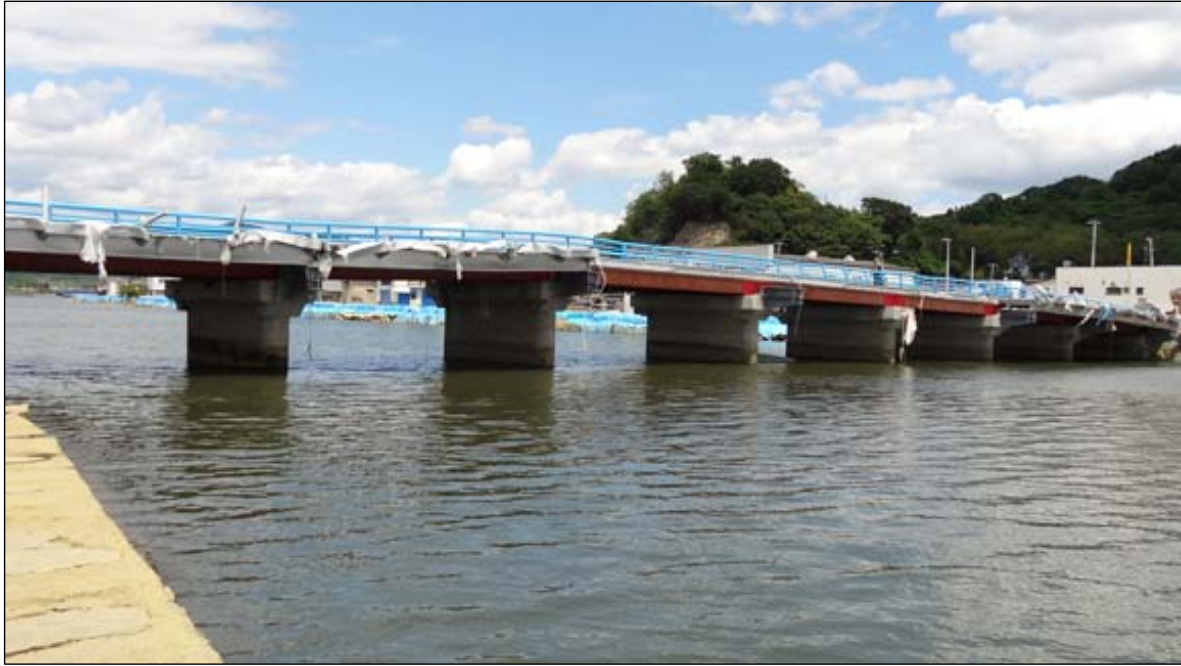
During tsunami why do a few spans get knocked off bridges but most spans stay on bridges?

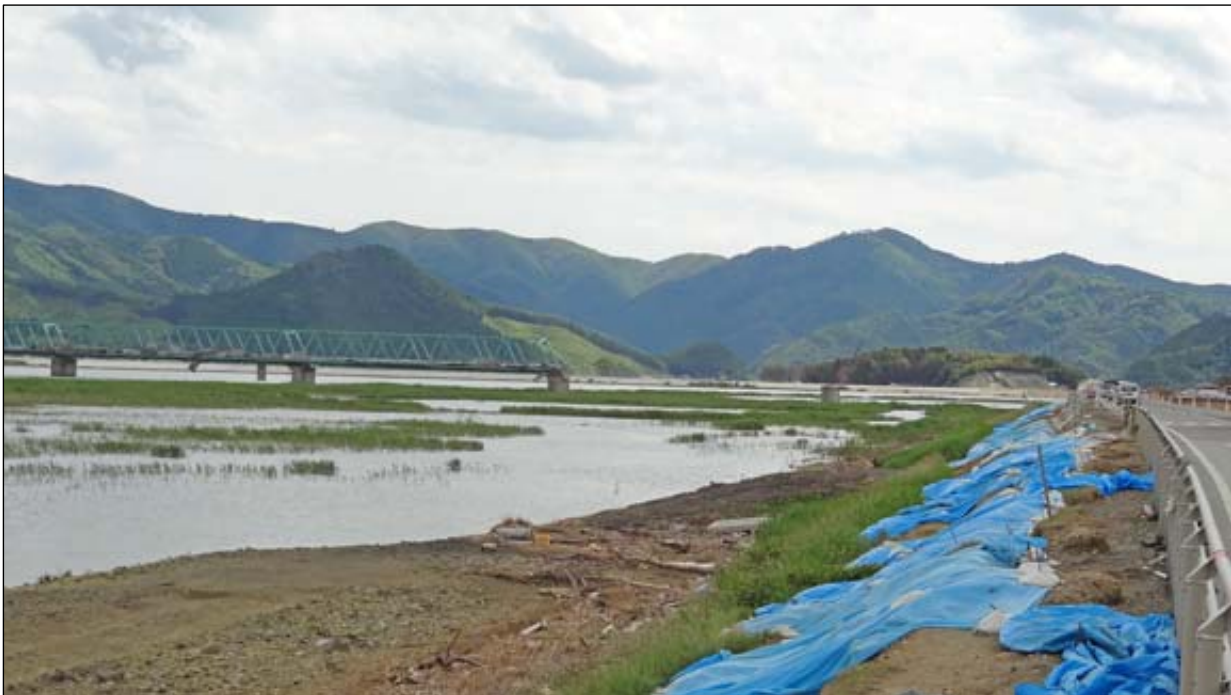
Is it better to tie the girders to the piers or will that just cause the piers to be damaged during tsunami ?

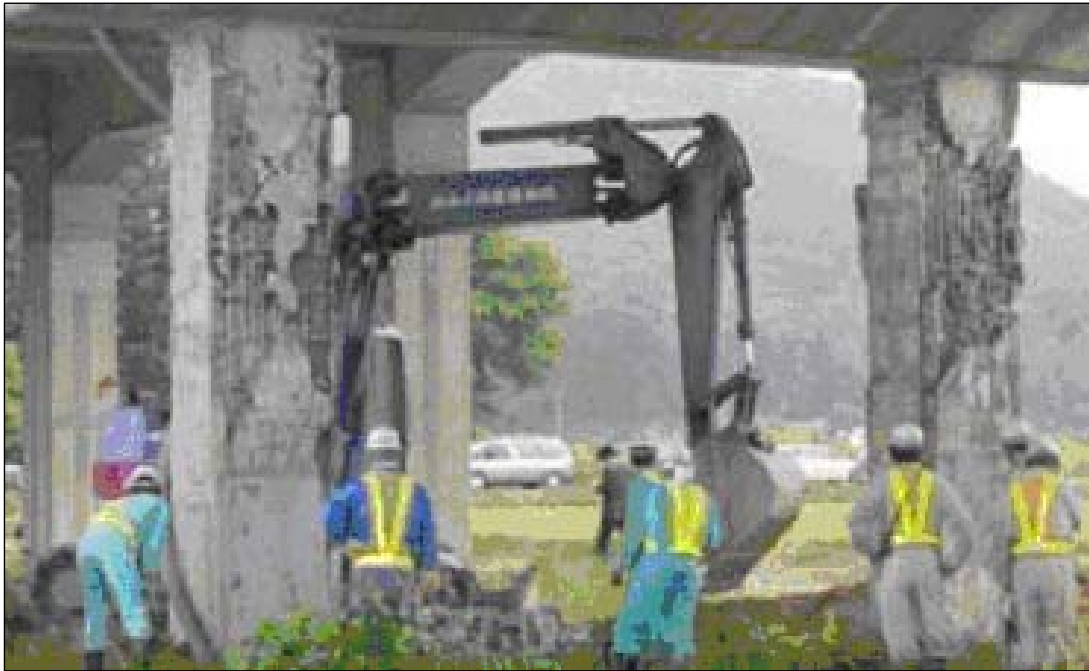
Is it better to retrofit Shinkansen viaducts or just repair them after each earthquake?

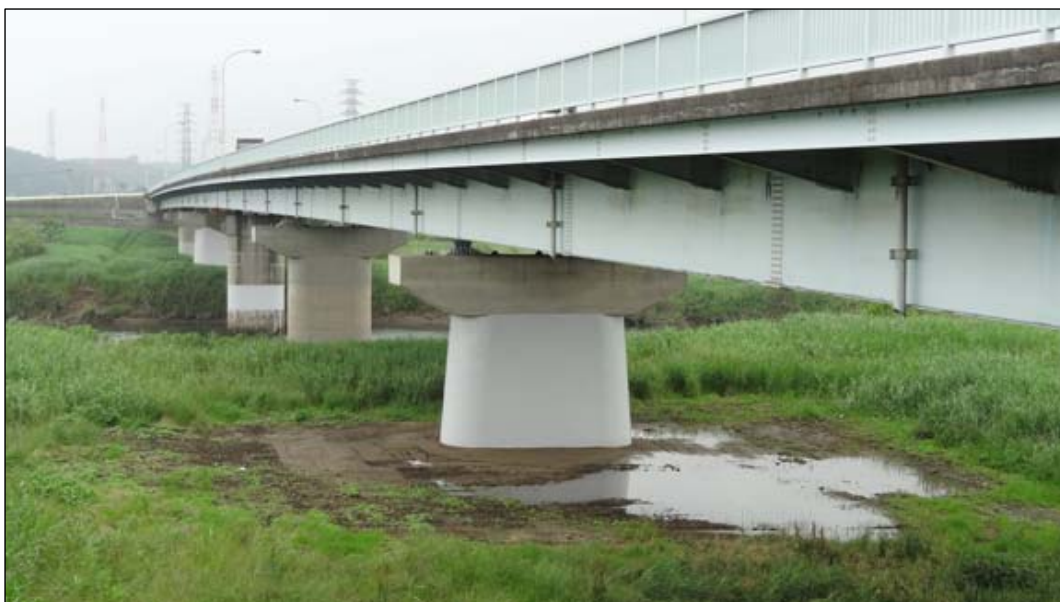
What are the consequences of designing tall columns and short columns on the same bridge?

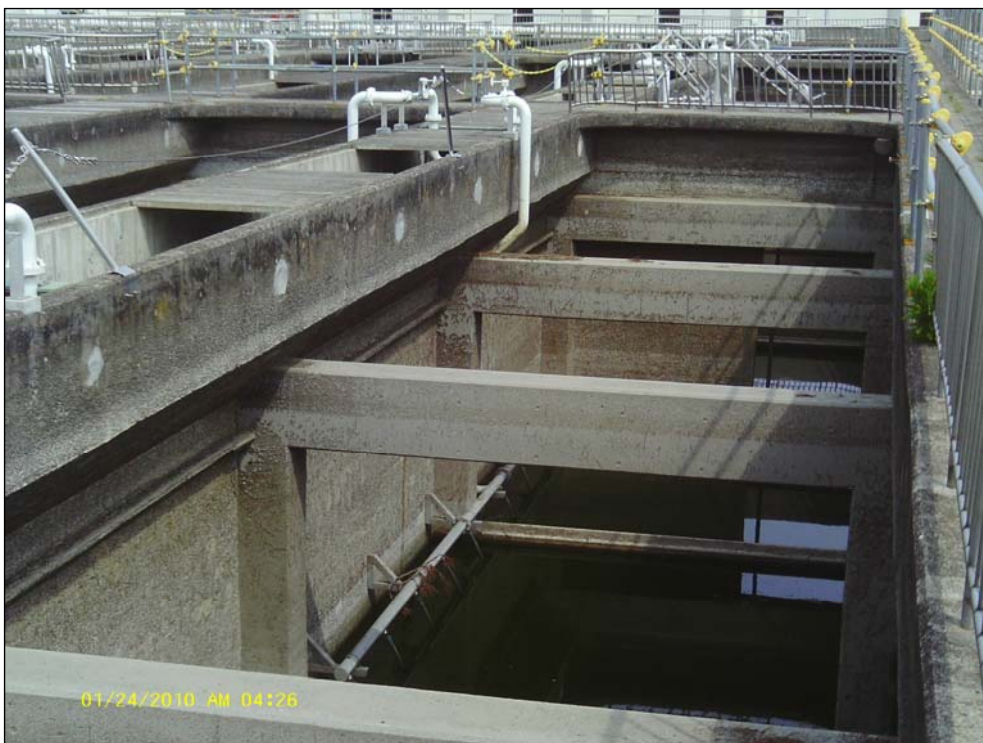
- Treatment plants in inundation zone
 - Impacted by flooding, debris, horizontal forces, electrical/control failures
 - Structural damage to buildings and equipment due to impact forces
 - Limited shaking damage inspection due to tsunami warning
 - Able to provide some levels of treatment with gravity settling and chlorination

- At Minami Gamou, decided to demolish 40+ year old structures and replace with higher structures to be above tsunami. Cost = 100 billion Yen and 3 years
- May be more cost effective to rehabilitate and provide electrical and impact protection
- Result – full treatment capacity sooner, less pollution
- Increase speed of collection system inspections to reduce flows and treatment demands and reduce potential for sinkholes
