2009年インドネシアスマトラ沖地震 復旧支援協力チーム被害調査報告会

調査日: 2009年10月16日-18日
開催日時: 平成21年10月29日(木) 14:00~17:00
開催場所: 土木会館2階講堂

東京大学生産技術研究所
都市基盤安全工学国際研究センター

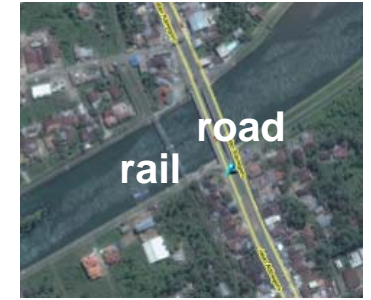
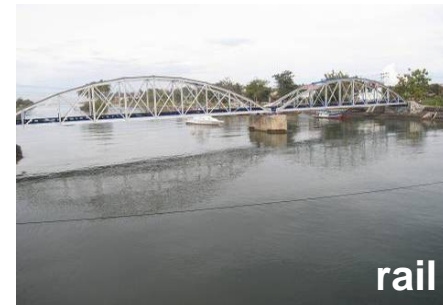
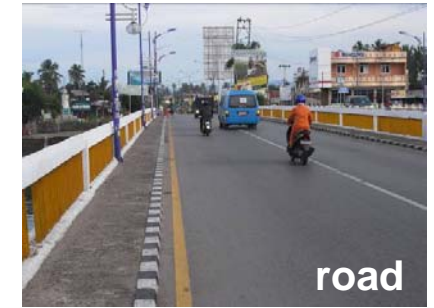
Bridge 5

Type: truss, concrete

Use: rail way, road

Damage: no

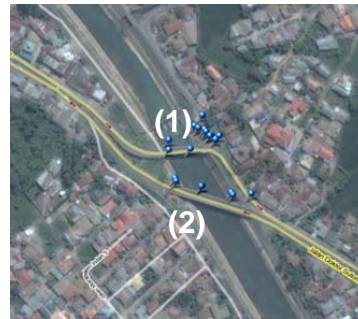
(1)

Type: beam

Use: road

Damage: (1)no
(2) slightly crack

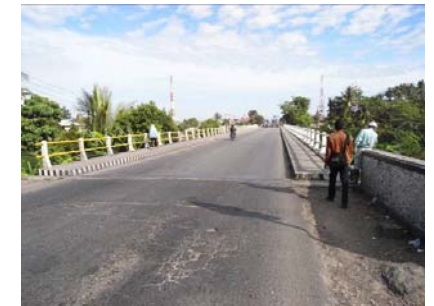
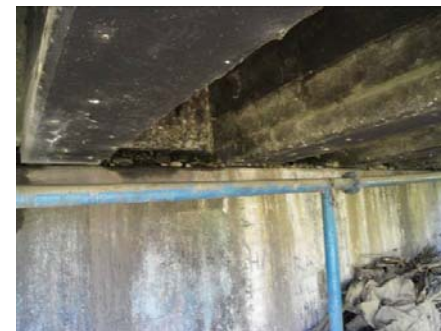
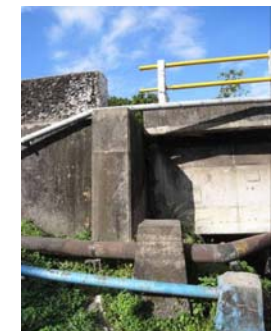
Bridge 7

Type: beam

Use: road

Damage: no

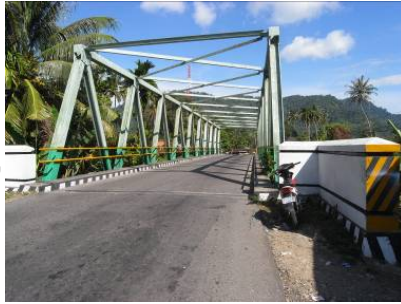
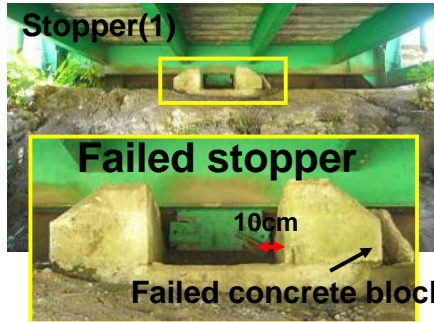
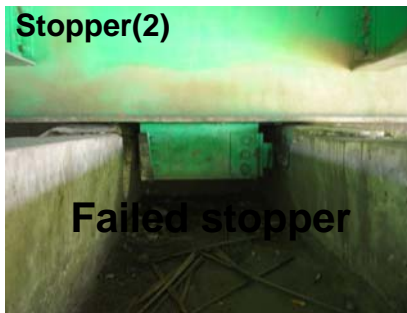
Bridge 8

Type: truss
Use: road
Damage: lateral deformation,
stopper worked

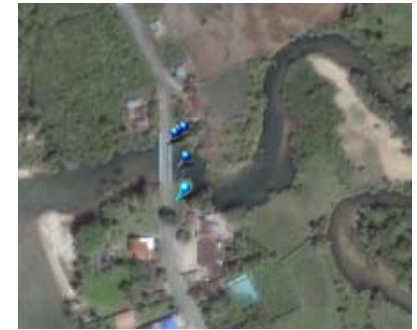
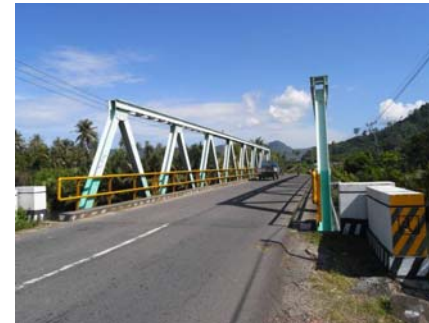
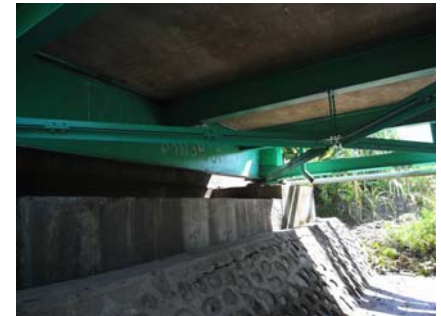
Bridge 9

Type: truss
Use: road
Damage: no

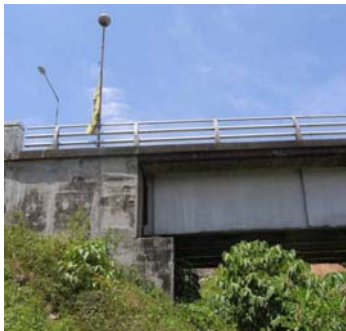
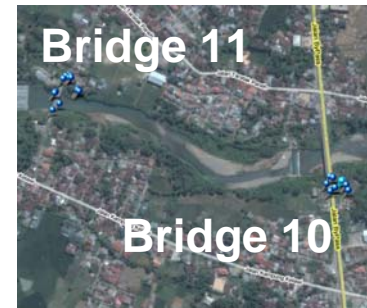
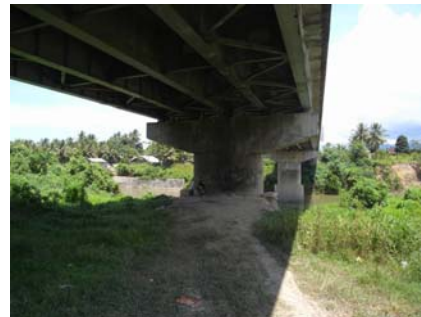
Bridge 10

Type: beam
Use: road
Damage: no

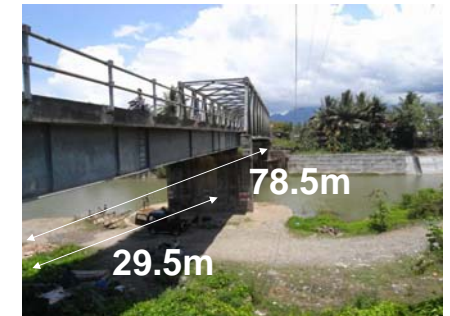
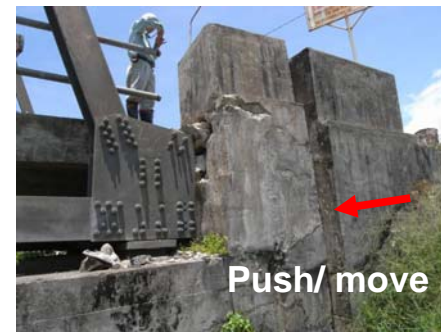
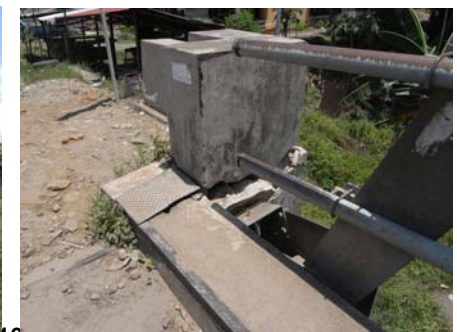
Bridge 11

Type: truss
Use: road
Damage: moved abutment

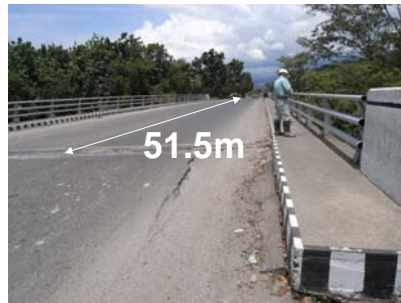
Bridge 12

Type: beam
Use: road
Damage: lateral movement
21.5cm

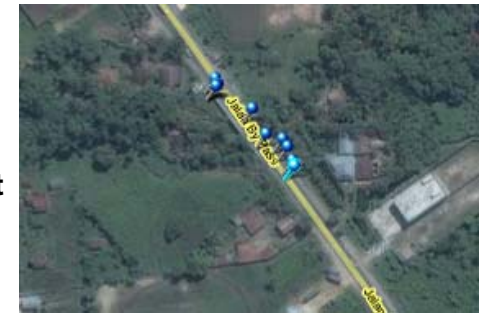
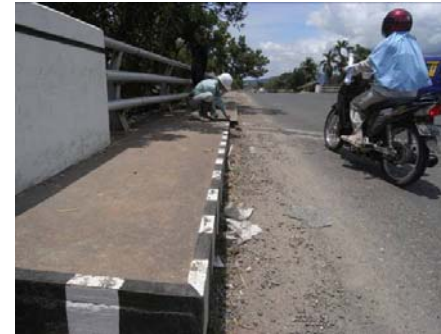
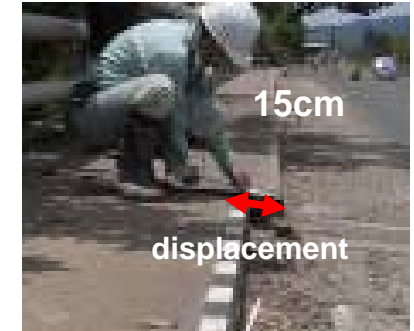
Bridge 13

Type: beam
Use: road
Damage: lateral movement
15cm

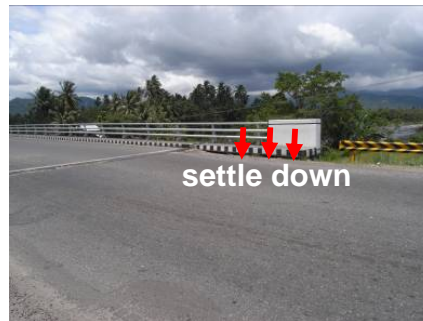
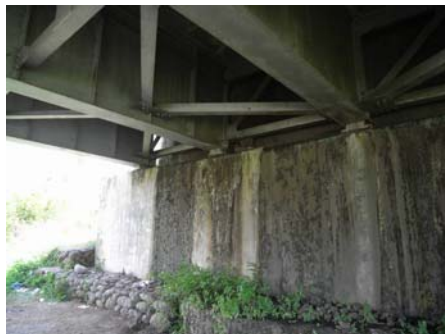
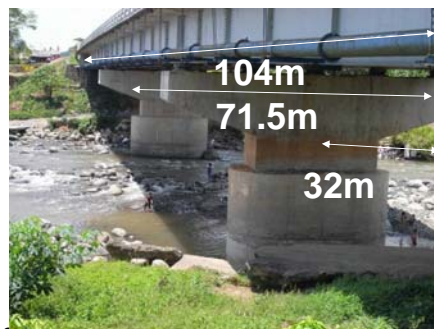
Bridge 14

Type: beam
Use: road
Damage: back fill soil
settle down

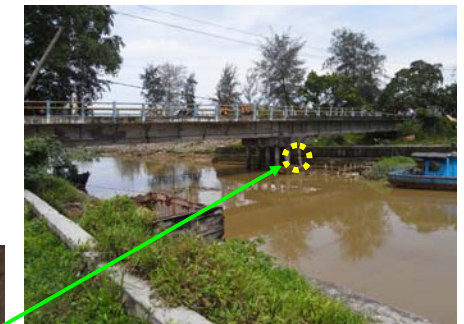
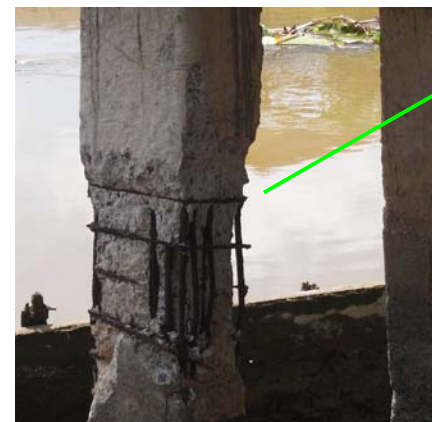
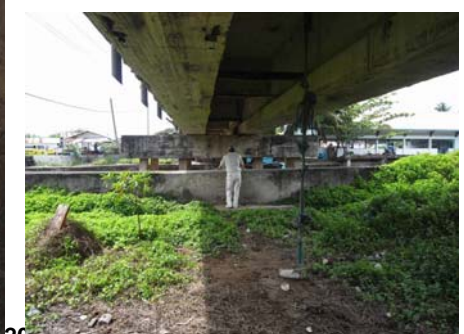
Bridge 15

Type: beam
Use: road
Damage: pier

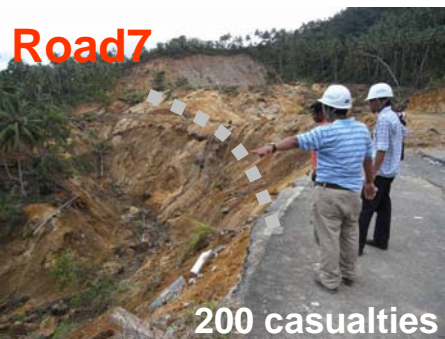
200 casualties

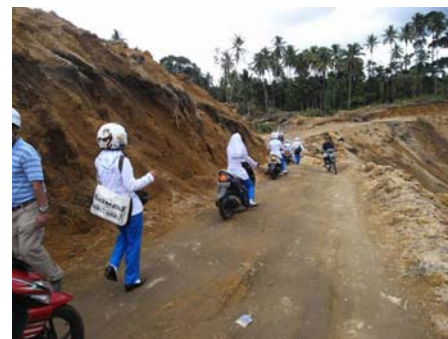
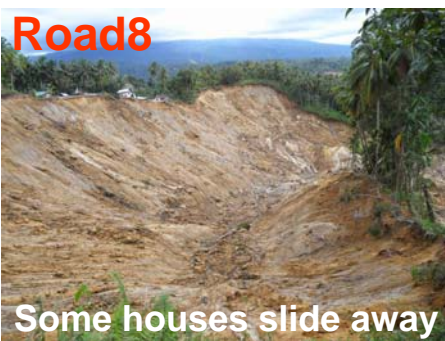
Some houses slide away

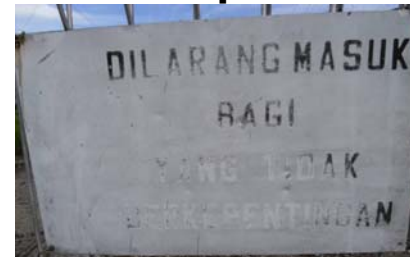
Electric power station

2 ceramic Isolators were broken, 2 days later, recovered.

Towers: No damaged
