# Piles for RC/Steel-frame buildings pulled up by tsunami at Onagawa Town, in the March 11<sup>th</sup> 2011 East Japan Earthquake

Kazuo KONAGAI, Takashi KIYOTA and Hiroyuki KYOKAWA  
IIS, University of Tokyo

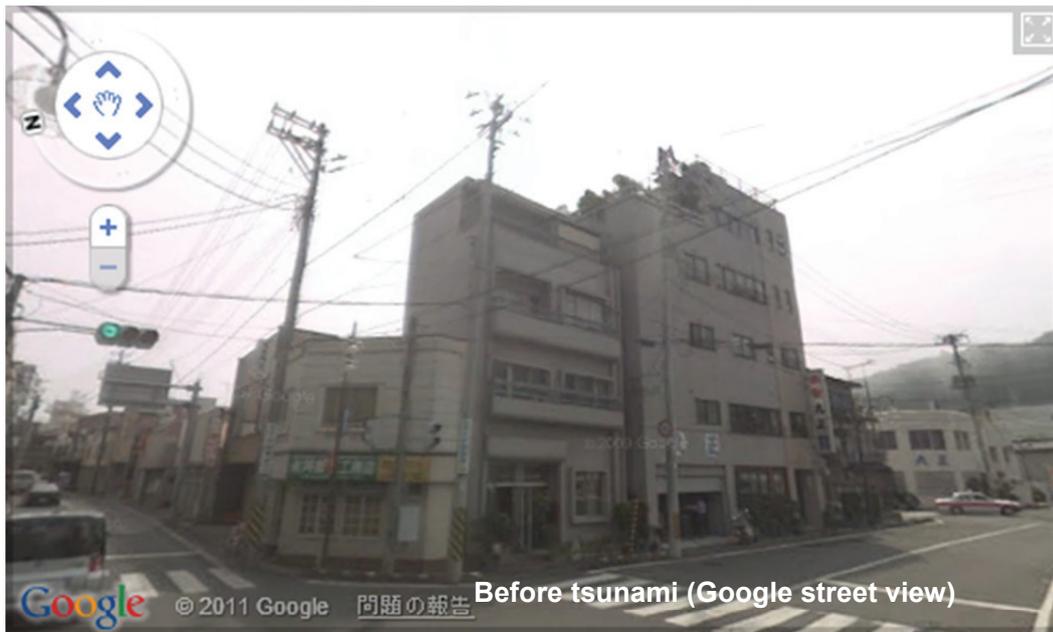
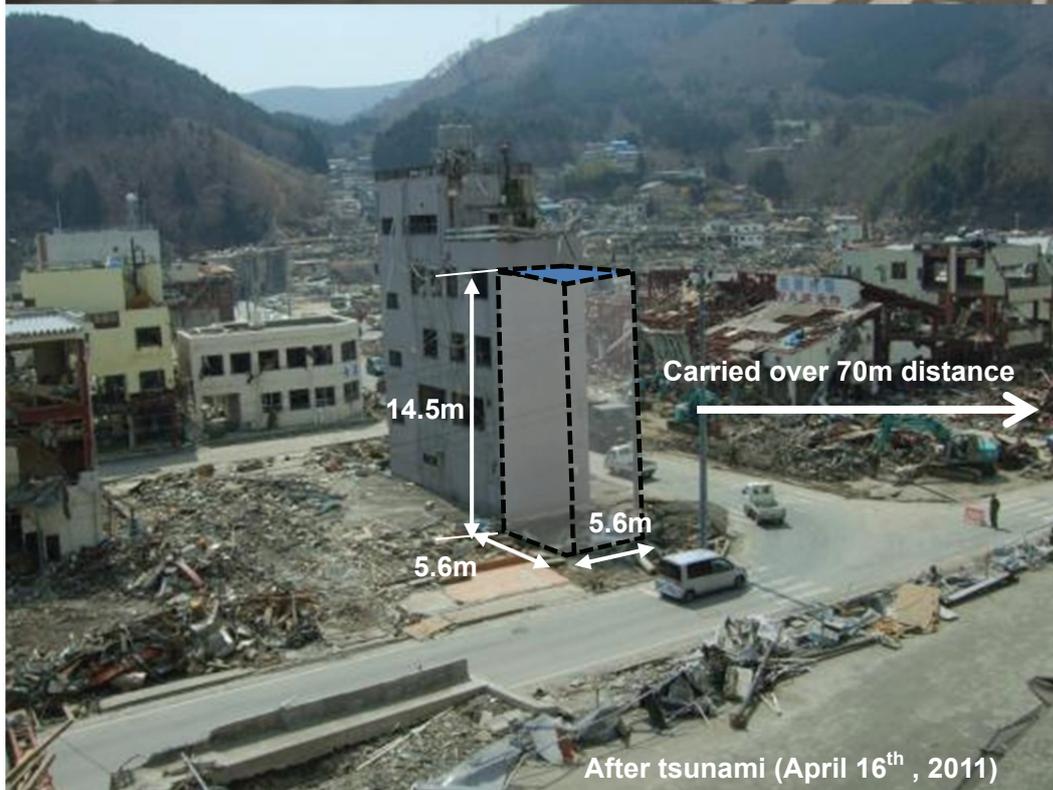
Fig. 3 Original location of Building #1 (38.442482, 141.445728): This 4-story building was carried over 70m distance to the west.

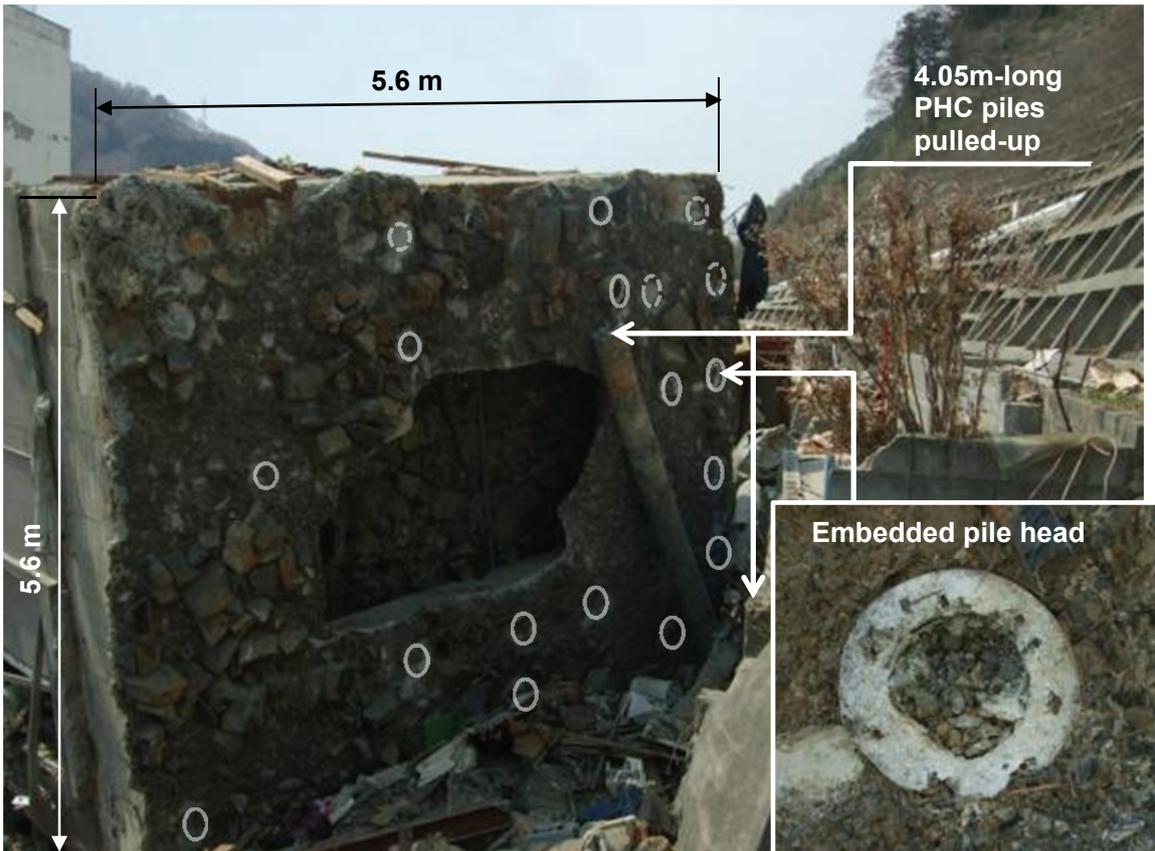
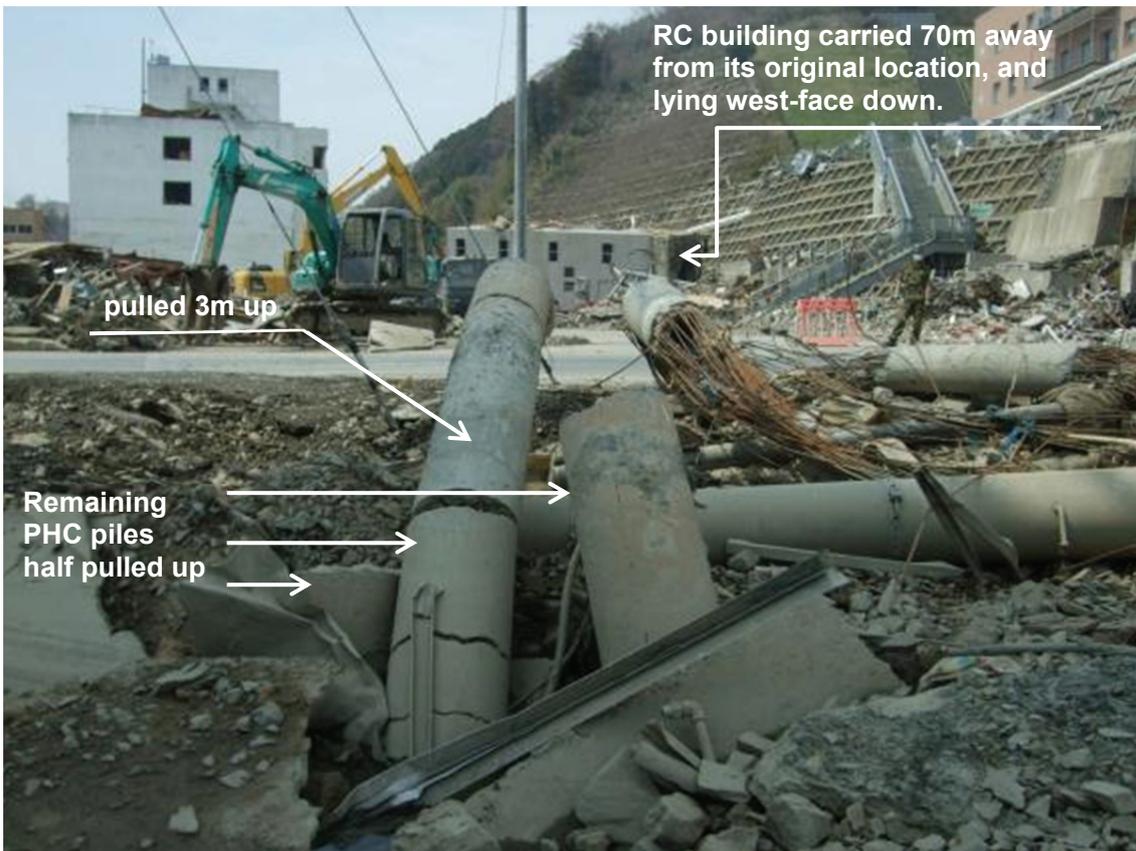
Building #1 was a thin and tall 4-story RC building (5.6m wide, 5.6m deep and 14.5m high) at N38.442482, E141.445728, which was carried over a 70m distance and lying west-face down with its bottom pushed against the cut-hillside of Onagawa Hospital (see Fig. 4).

Fig. 4 Bottom of foundation for Building #1 and piles left half-embedded in soil:

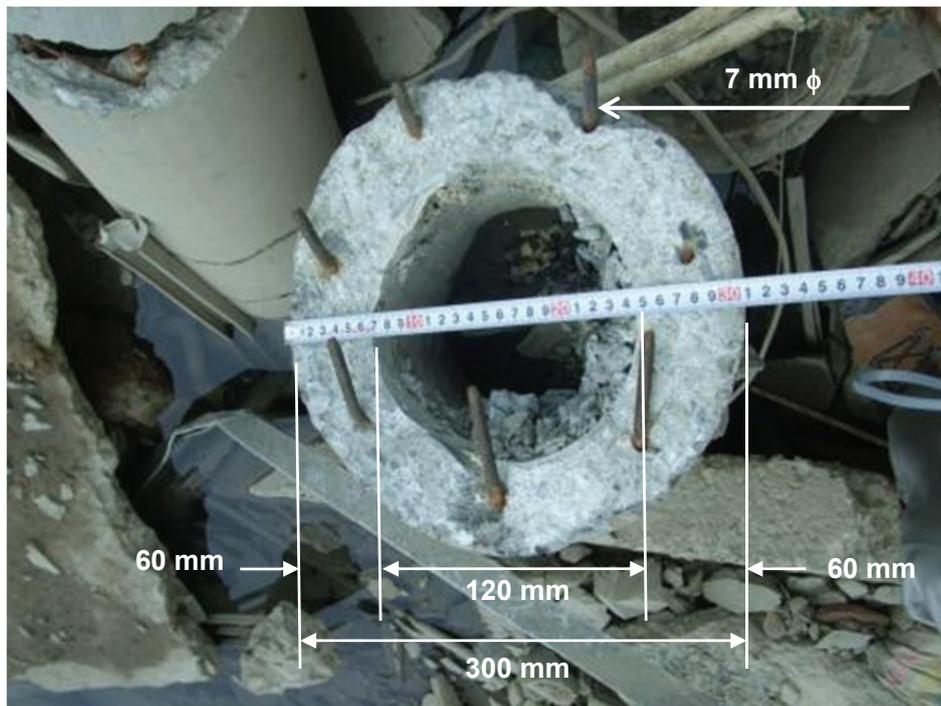
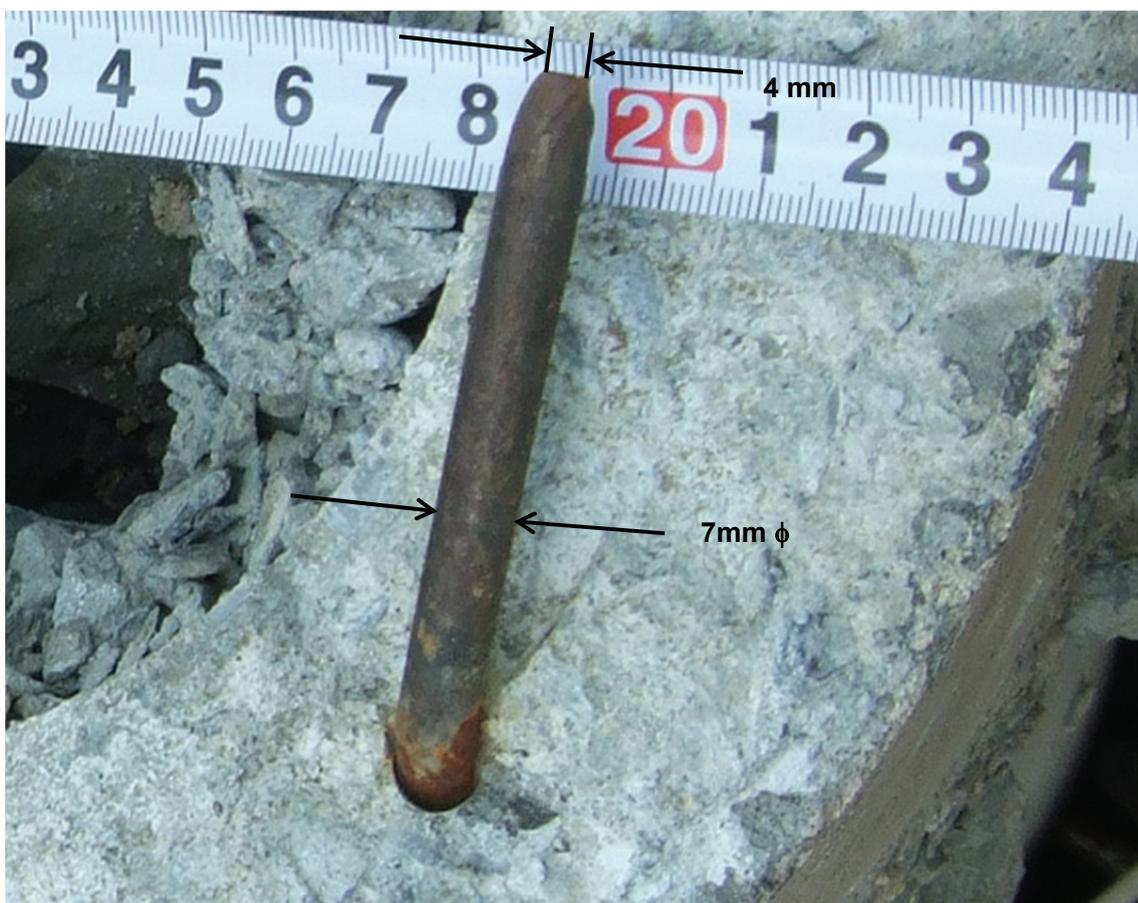
Fig. 5 Fracture surface of PHC pile for Building #1: A fracture cross-section of PHC (Pretension type centrifugal High strength pre-stressed Concrete) pile used for Building #1, 300mm and 120mm in outer and inner diameters respectively, has 7 PC wires exposed with cut ends thinning to about 4mm diameter.

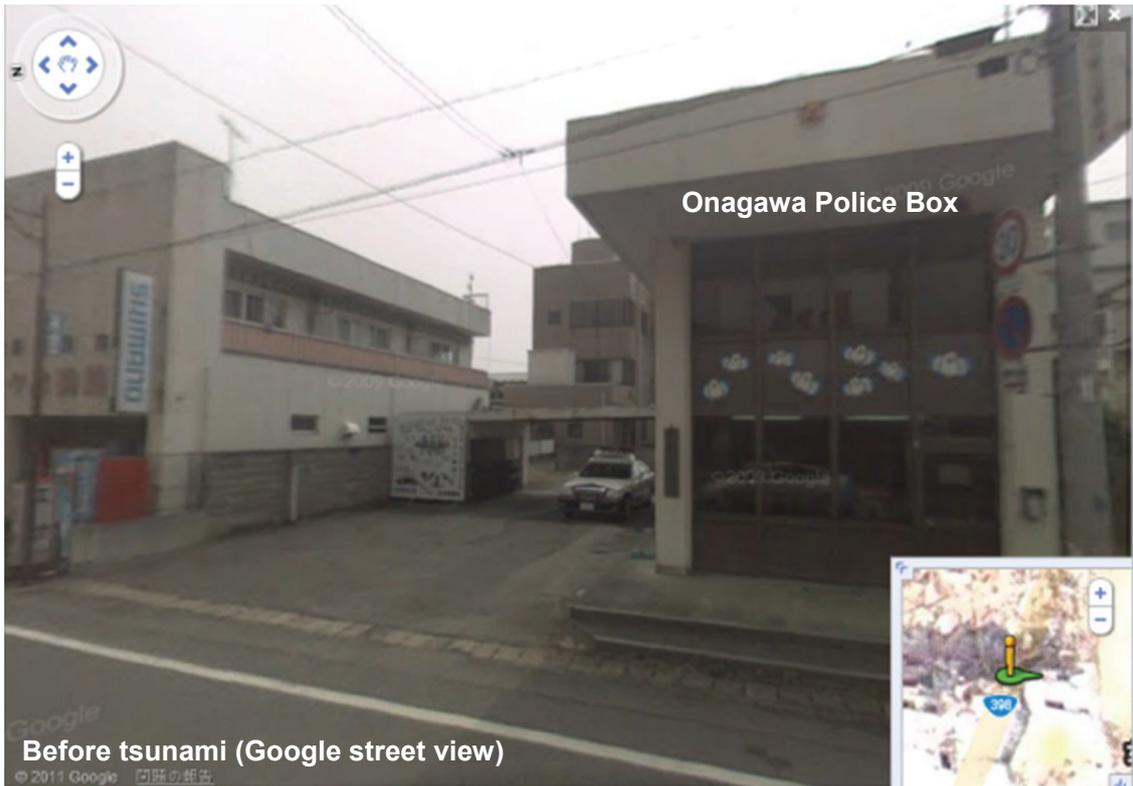
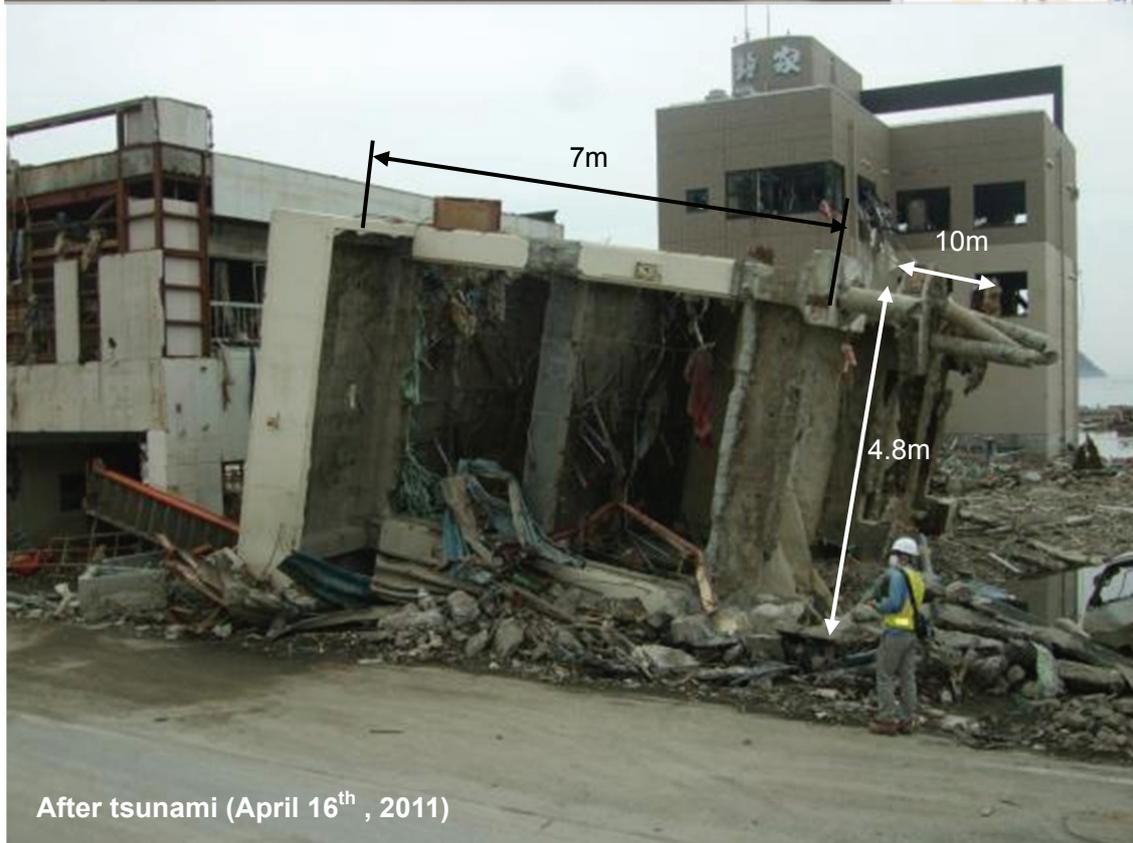
Fig. 6 Toppled Building #2 (Onagawa Police Box, Original location at 38.445086,141.446760): Onagawa police box was overturned north. Piles were broken and upper halves of them were uprooted. There is a dent on the roof indicating that something massive was pushed against it.

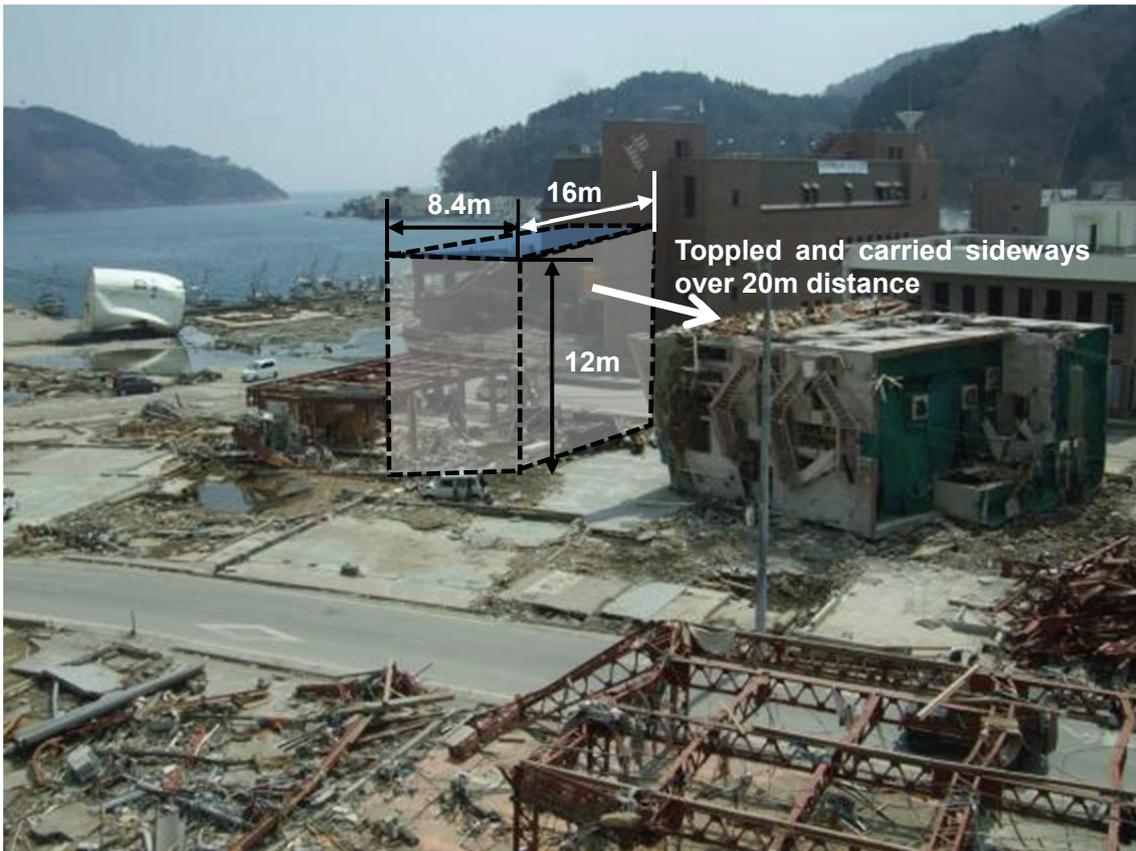
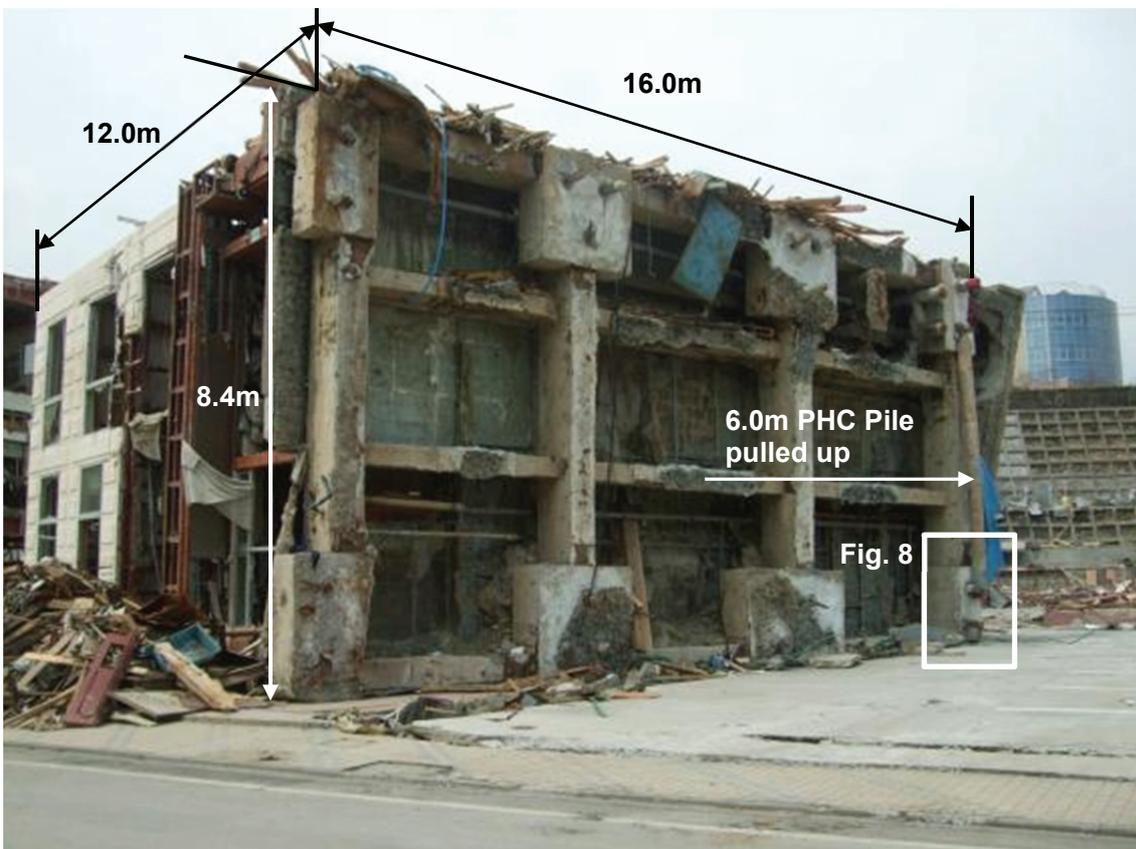
Fig. 7 Building #3 (Original location at Original Location: 38.442657,141.446590), A steel frame 4-story building was toppled and carried sideways over about 20m distance. A PHC pile of about 6m long is found hanging down from the upper right corner.

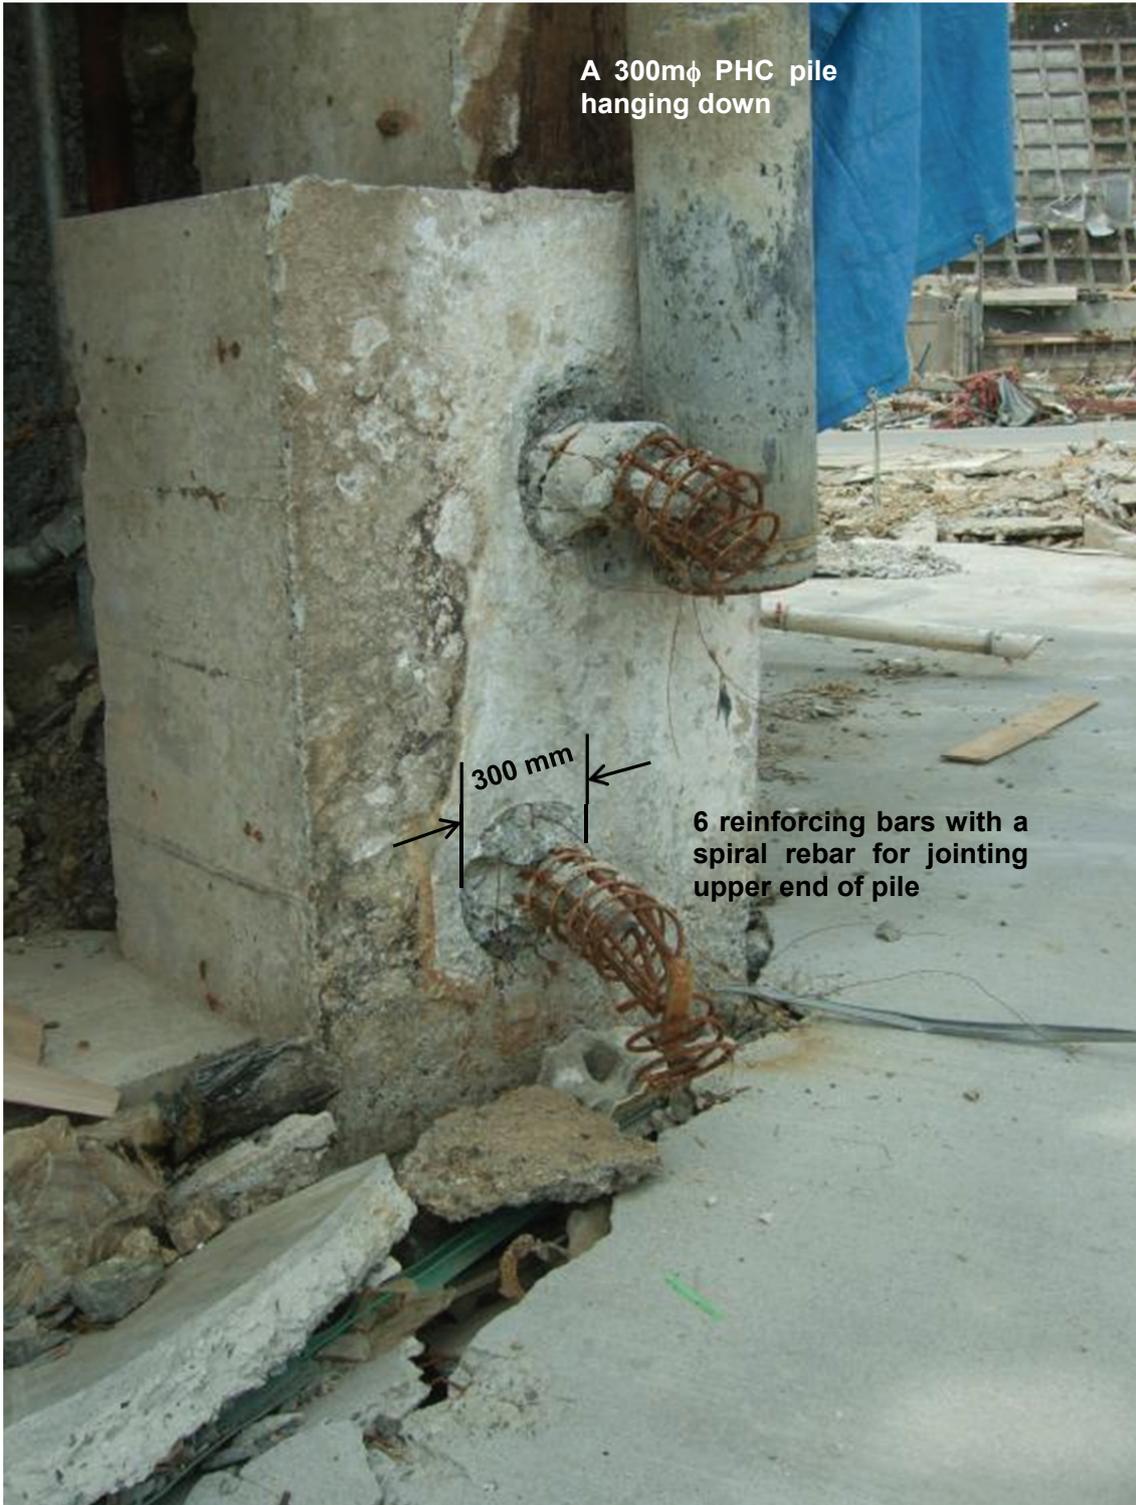
Fig. 8 Detail for Jointing pile heads for Building #3: Detail of rebars for jointing a pile head was exposed. There are 6 rebars coiled in a spiral bar for each pile head.

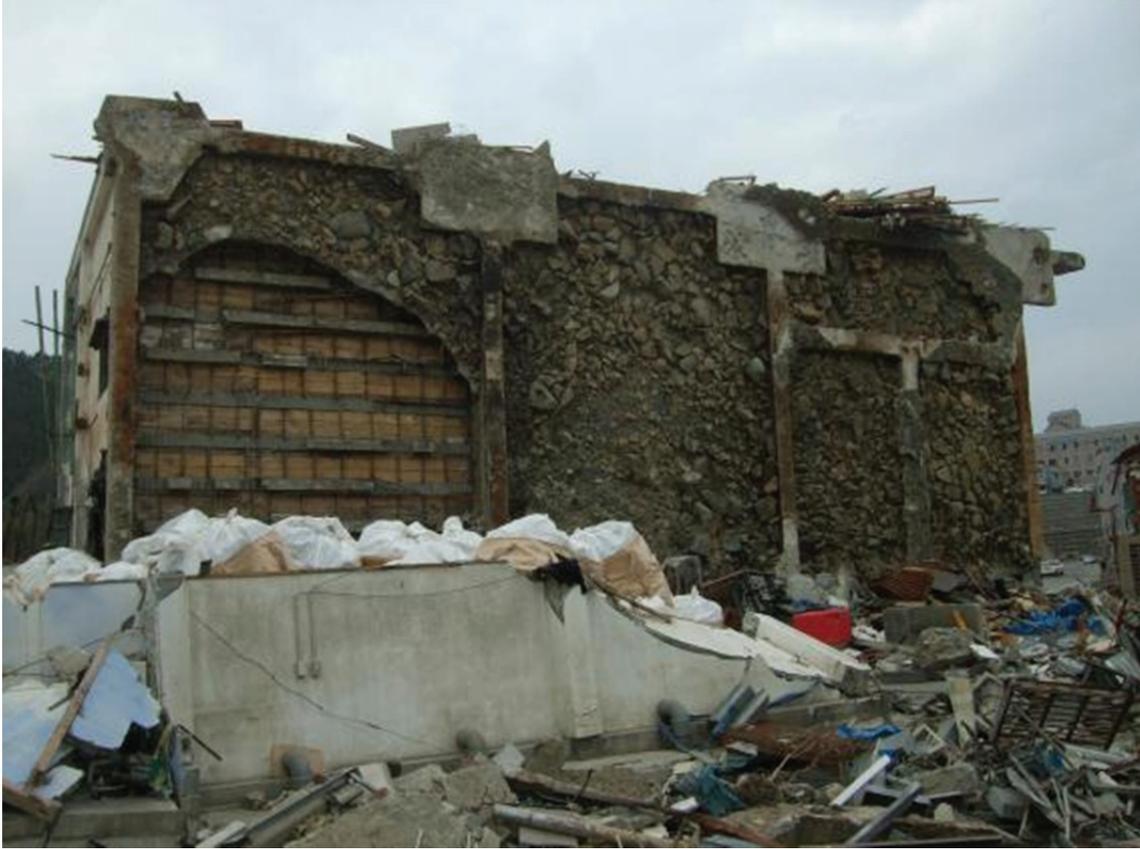
Fig. 9 Building #4: toppled west from its original Location at N38.440608, E141.446511. This was a steel-frame cold storage warehouse for fishes and seafood products. Dim marks of pile head are seen indicating the building was just resting on piles. This warehouse had a small door/window aperture.
