JAPAN SOCIETY OF CIVIL ENGINEERS

SITE INVESTIGATION AND ENGINEERING EVALUATION OF THE VAN EARTHQUAKES OF OCTOBER 23 AND NOVEMBER 9, 2011

February 2012

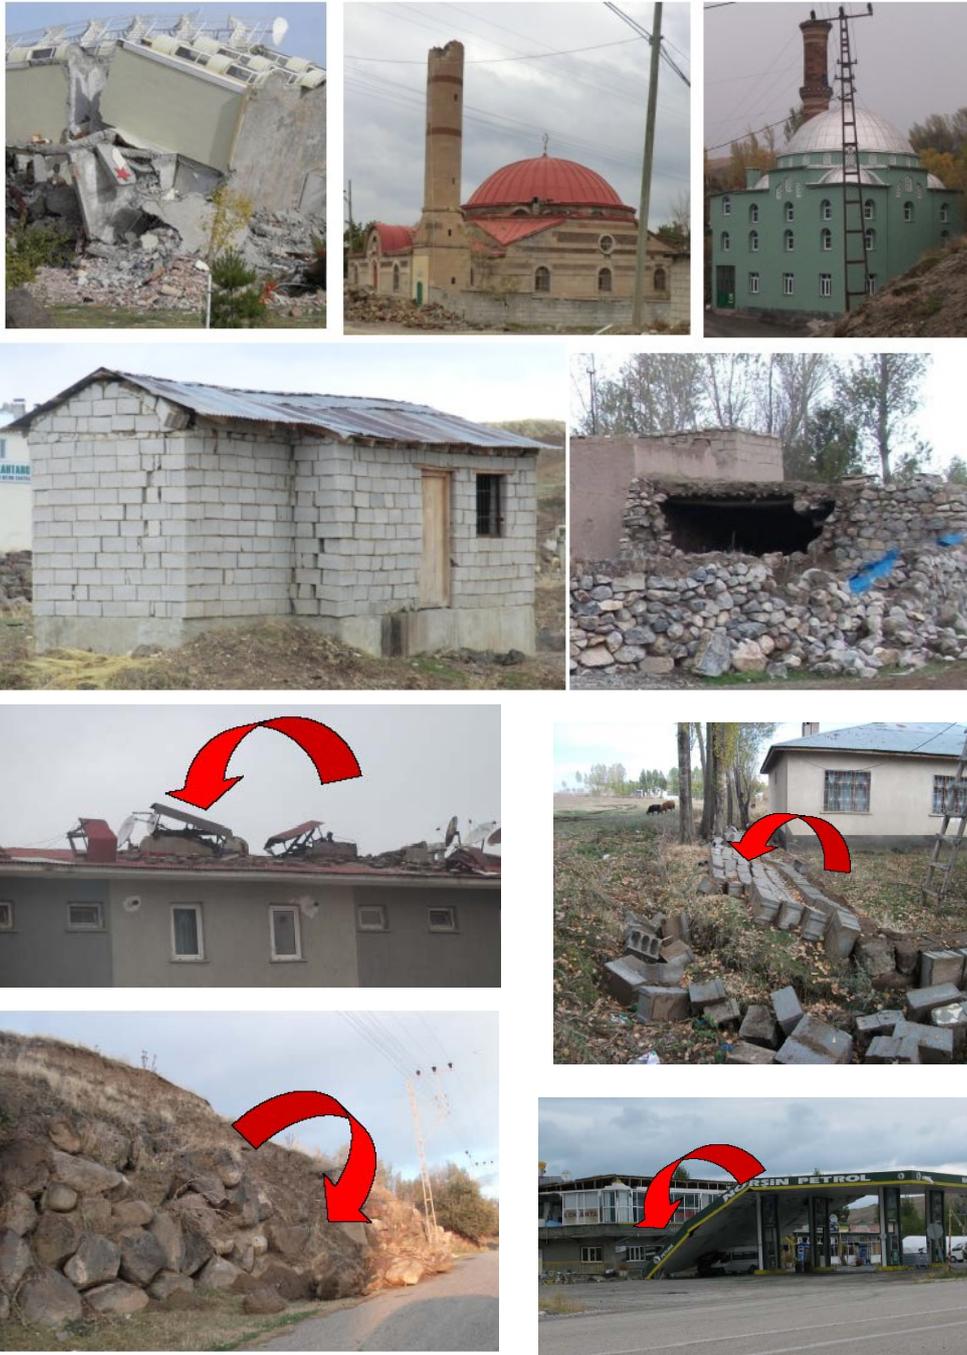
Figure 6.13. Views of failed, toppled and displaced some structures in the epicentral area

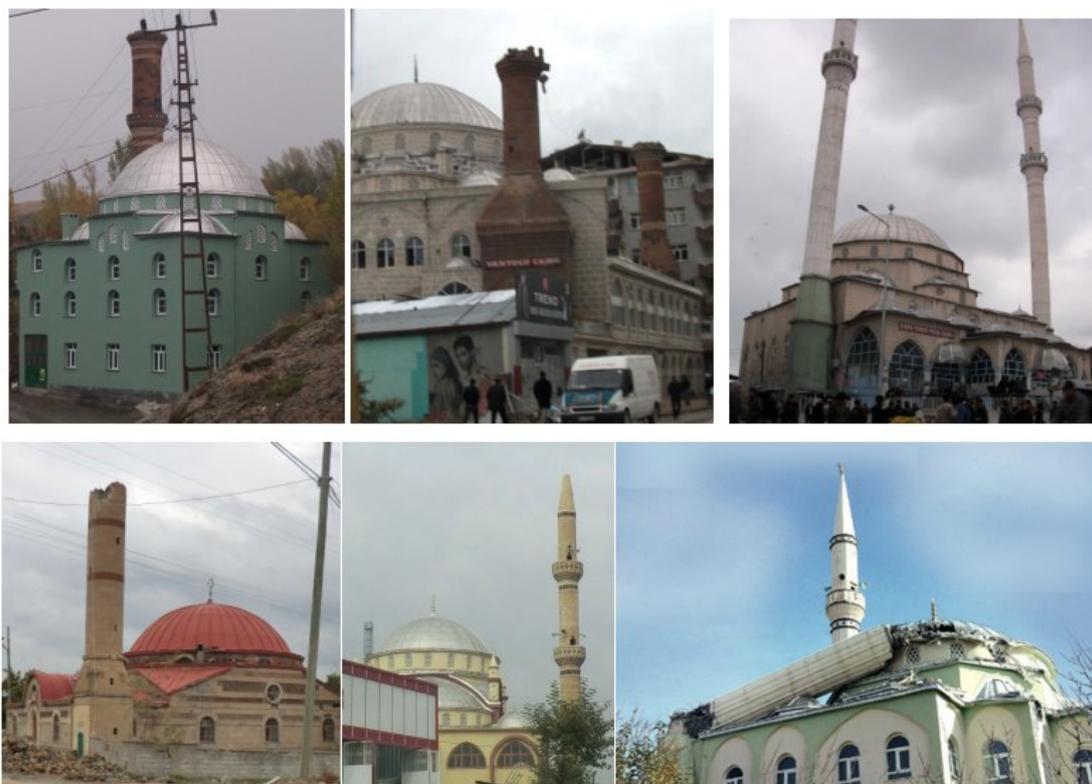
Figure 7.1. Views from damage to mosques and their minarets.

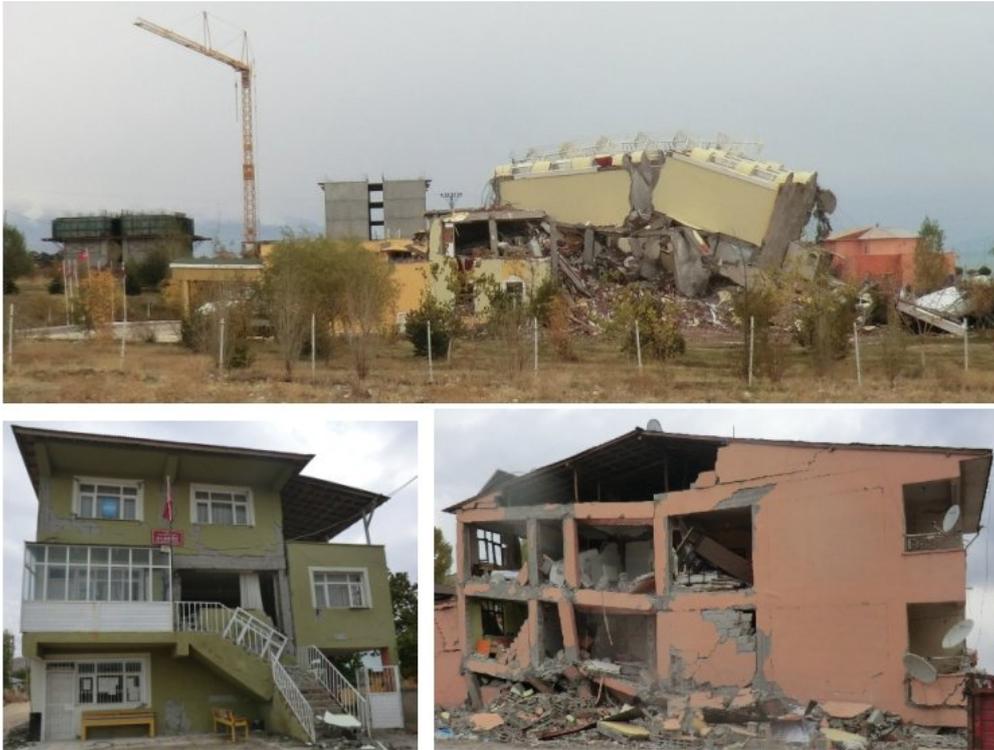
Figure 7.2. Views of collapsed or heavily damaged RC buildings.

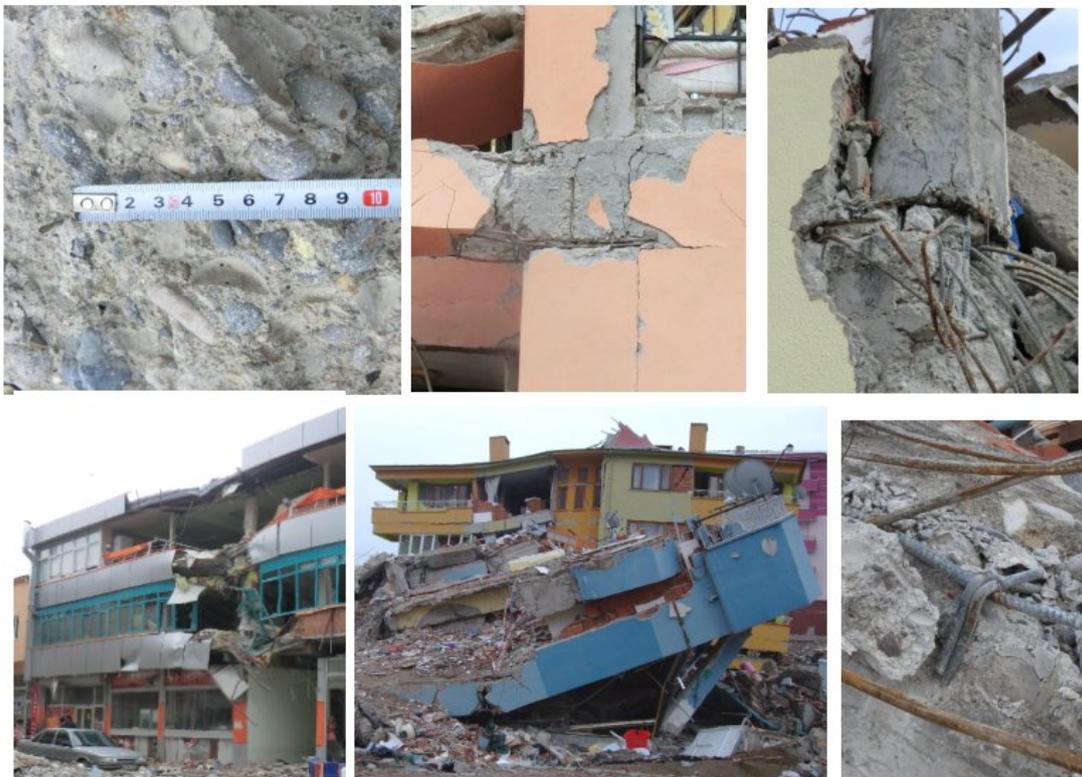
Figure 7.3. Views of constructional problems causing the collapse or heavy damage.

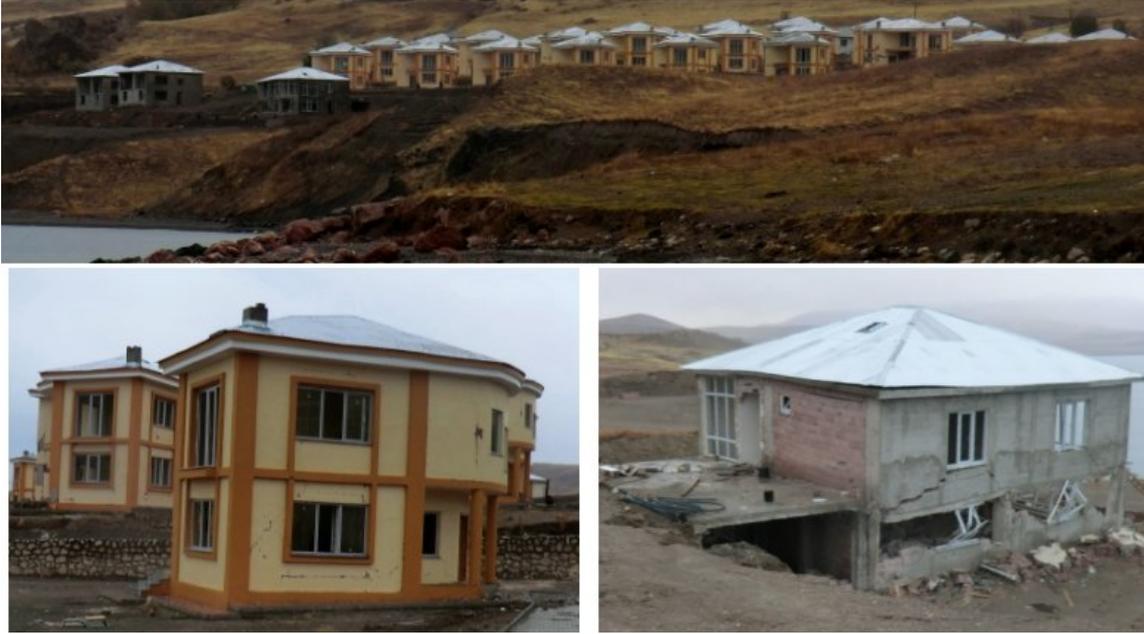
Figure 7.6. Damaged low story villa-type buildings constructed on sloping ground along the shore Van Lake.

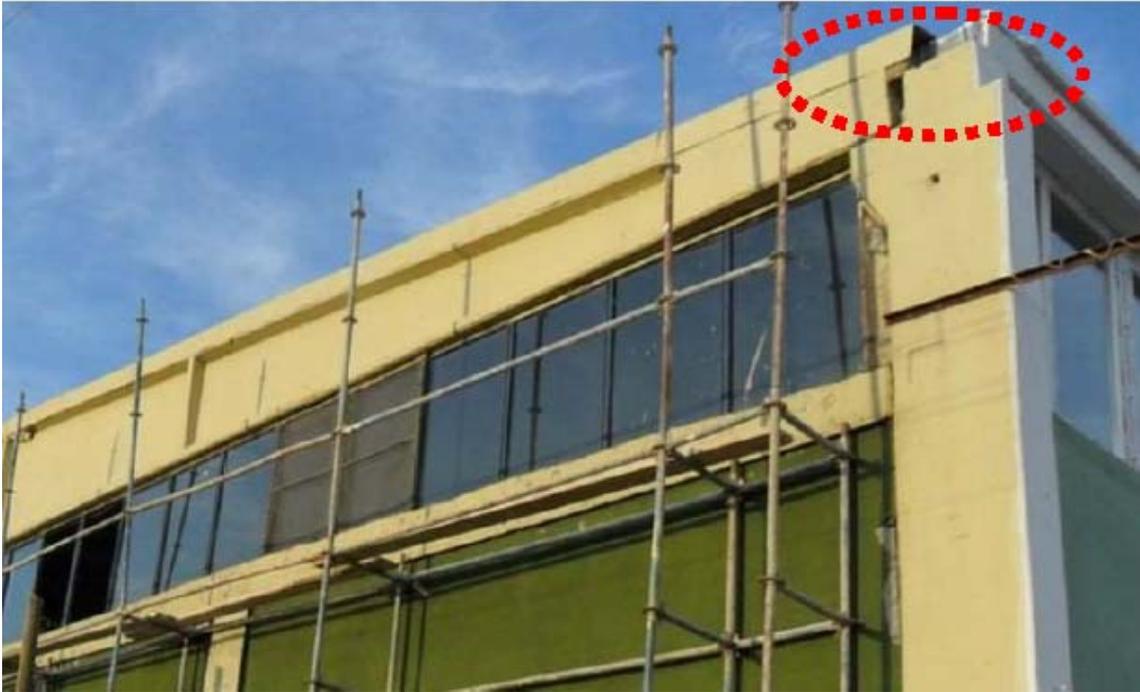
Figure 7.13. A typical damage to a pre-cast reinforced concrete structure in Van Industrial Complex (from KOERI, 2011).

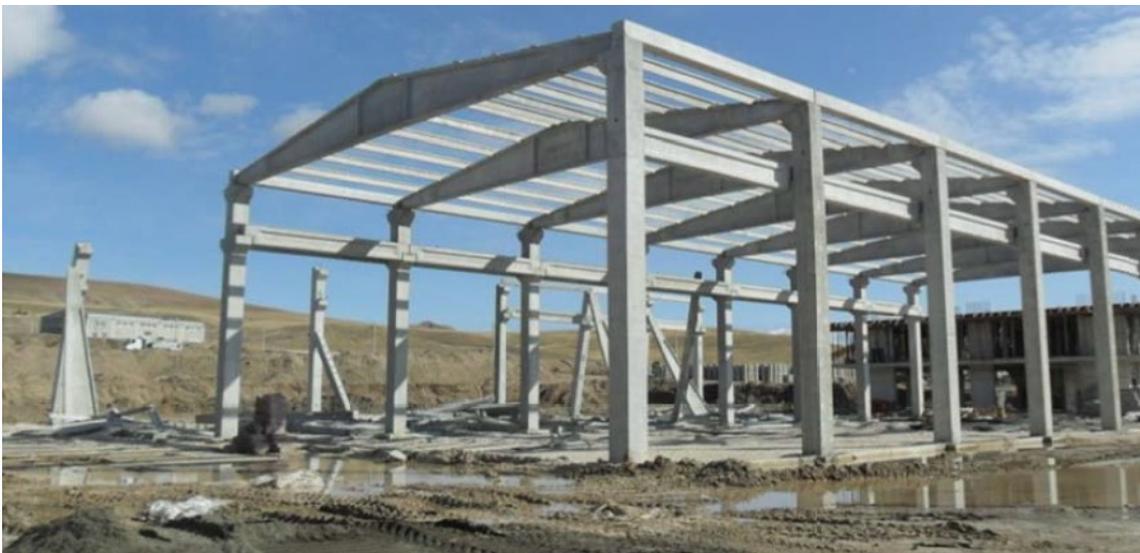
Figure 7.14. A view of heavily damaged pre-cast reinforced concrete structure in Van Industrial Complex (from KOERI, 2011).

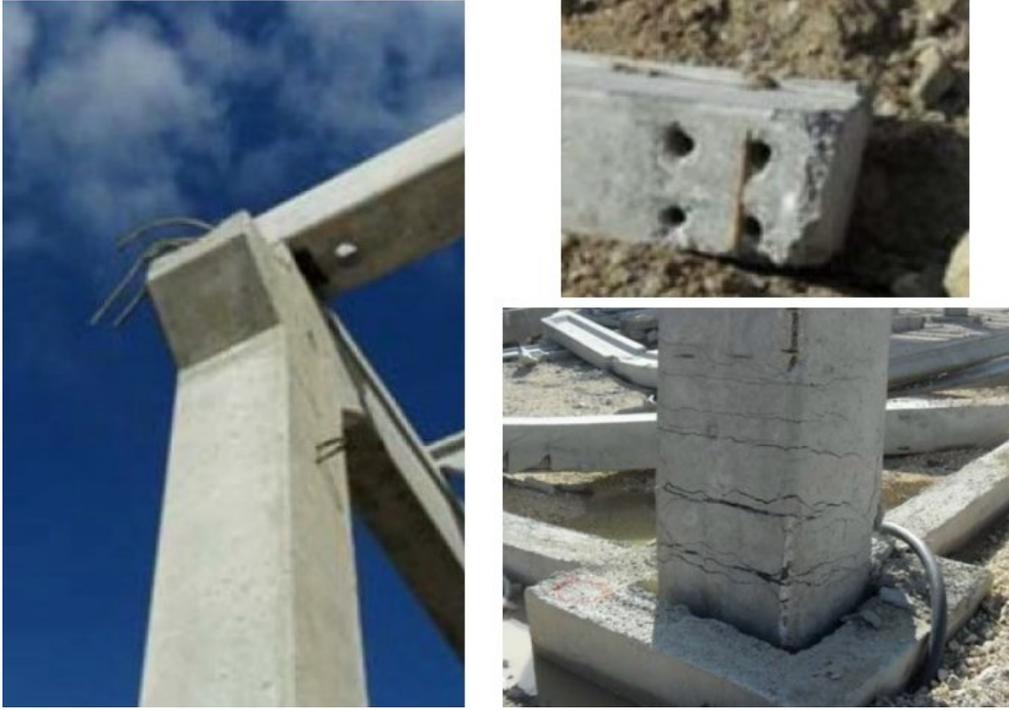
Figure 7.15. The details of poorly constructed beam-column connection of the pre-cast structure shown in Figure 7.14 (pictures arranged from KOERI (2011)).

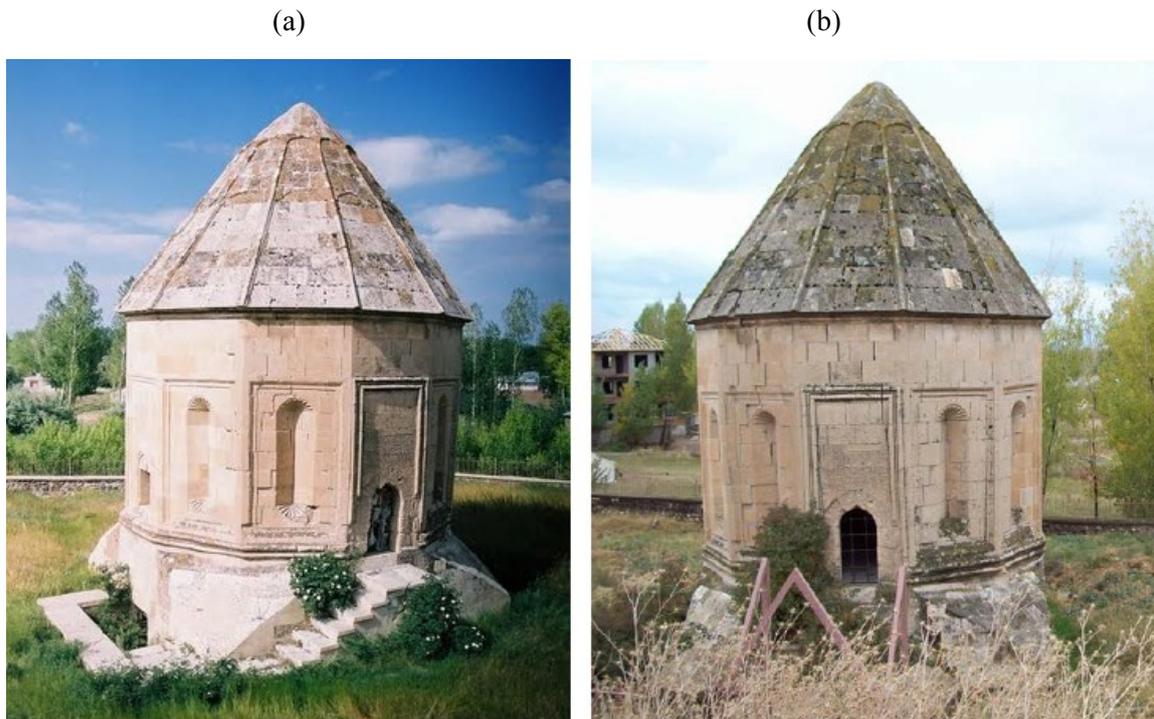
Figure 7.17. Damaged Kadem Pasha Hatun Kümbet: (a) before and (b) after the earthquake (pictures from Erciş Municipality and Çetin et al., 2011).

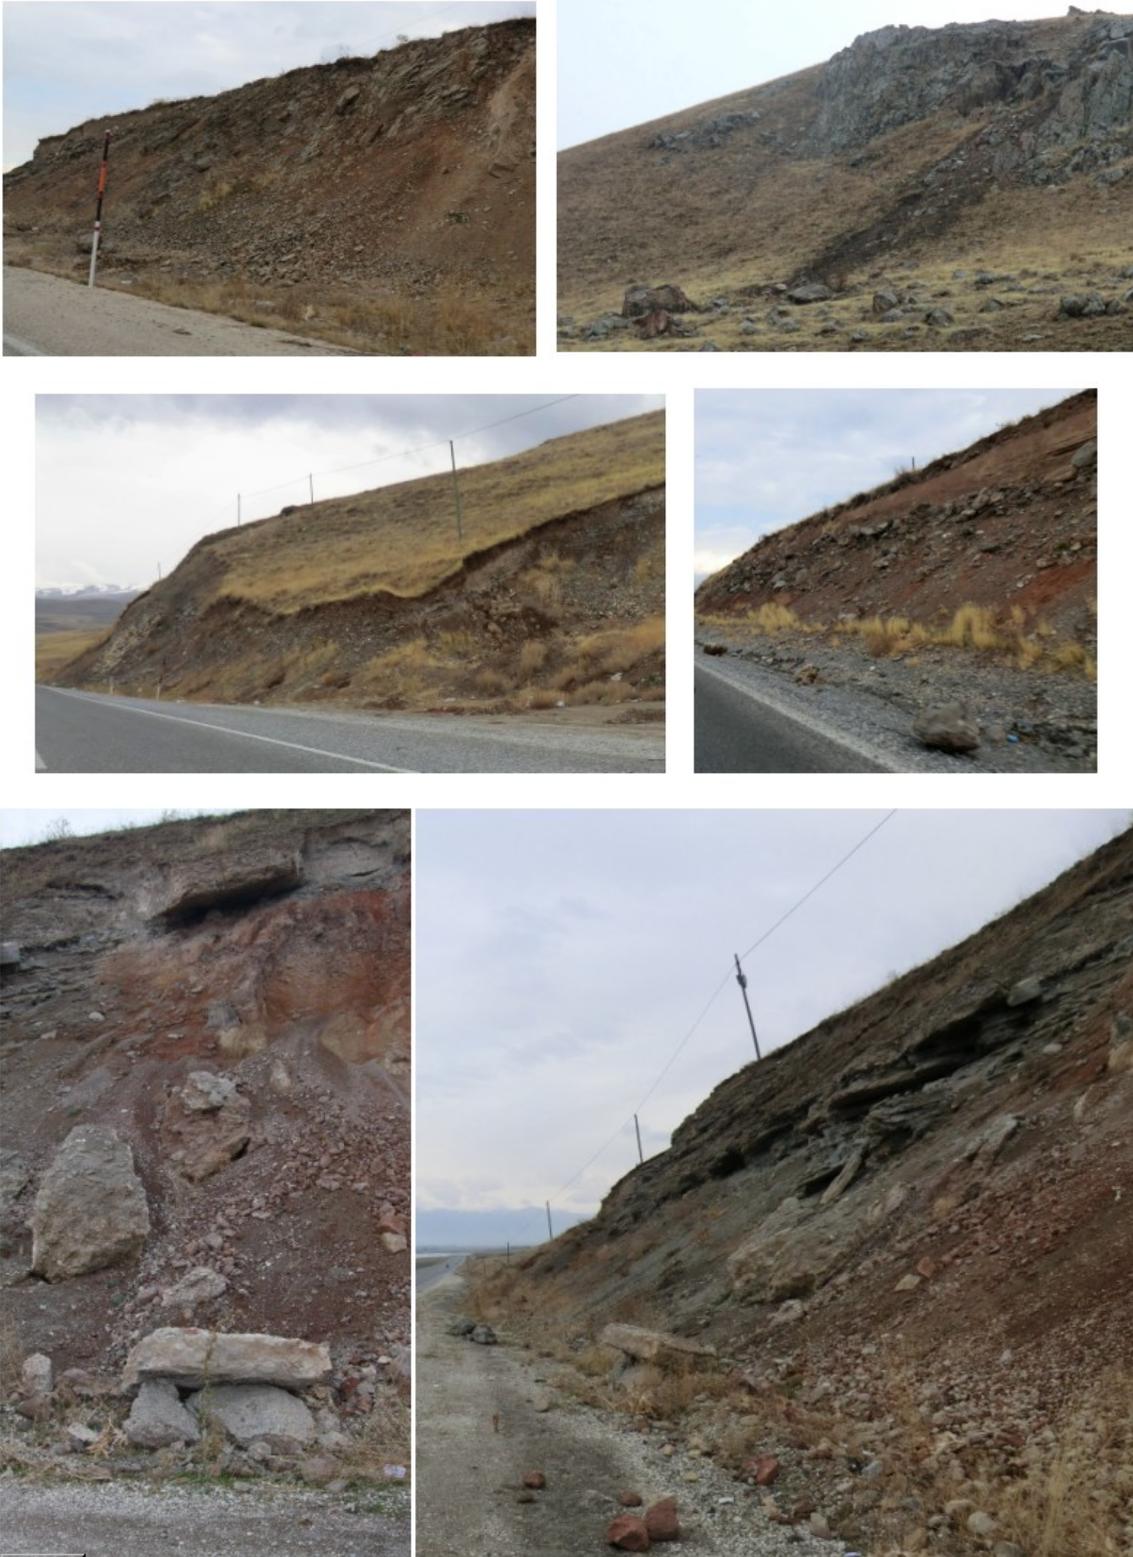
Figure 8.4. Slope instabilities and rock falls along Van-Ağrı Highway.

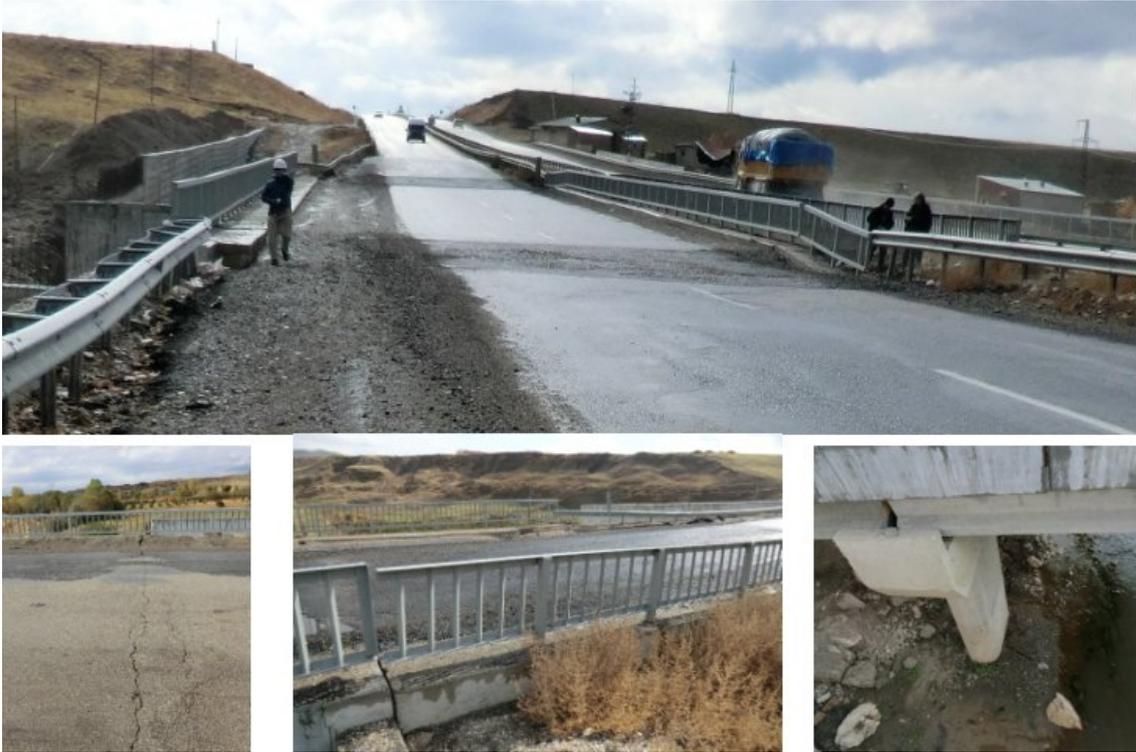
Figure 8.5. Views of damaged Tırleşin bridge over Karasu on Van-Ağrı Highway.

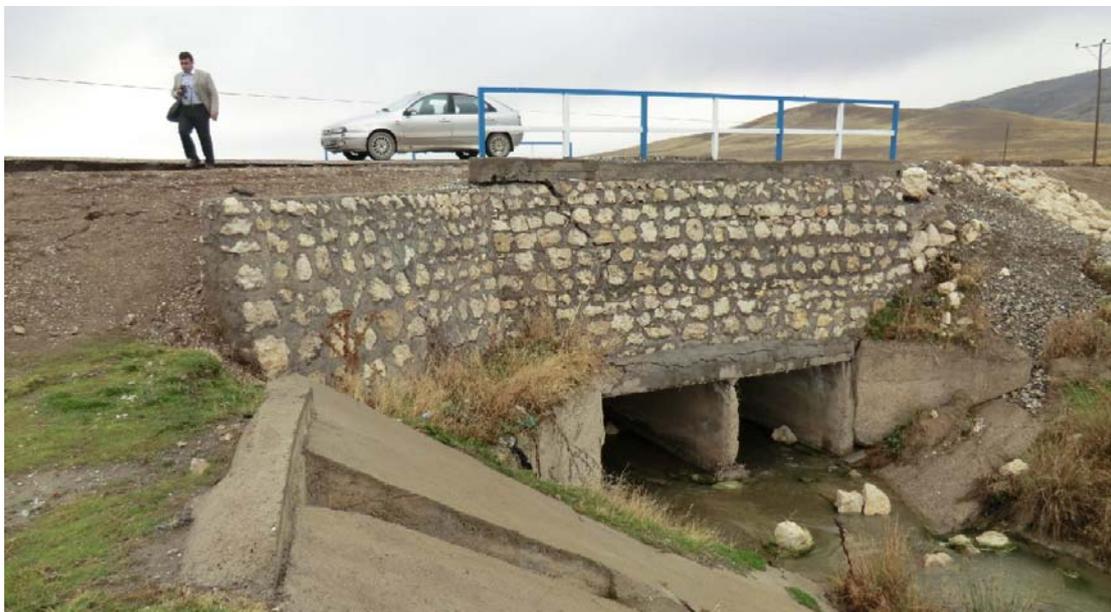
Figure 8.6 Damage to a bridge near Göllü village due to lateral spreading.

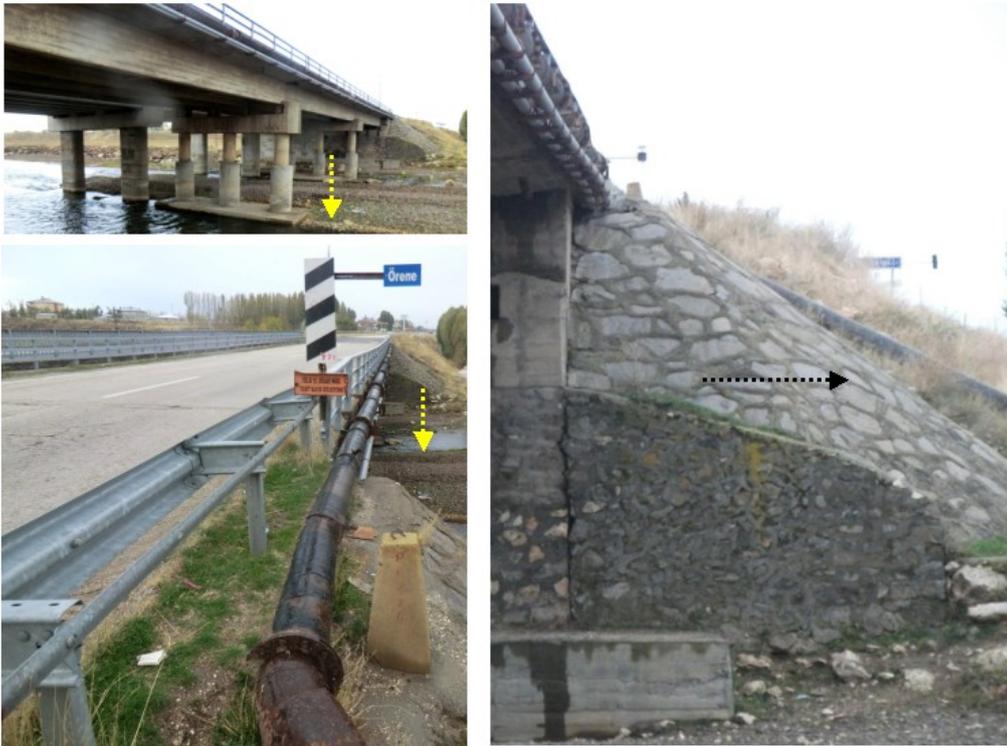
Figure 8.7. Settlement of piers and lateral deformation of embankments of Zilan Bridge.

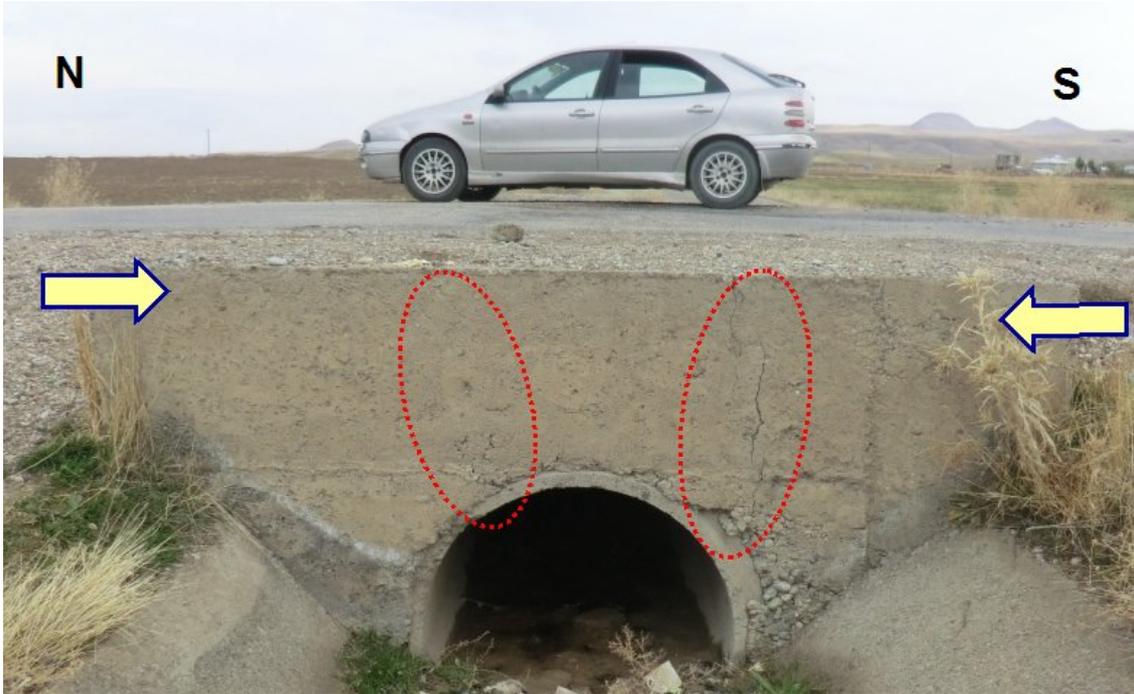
Figure 8.9. Cracking of wing-walls of a small bridge due to ground deformation caused by the thrust faulting.

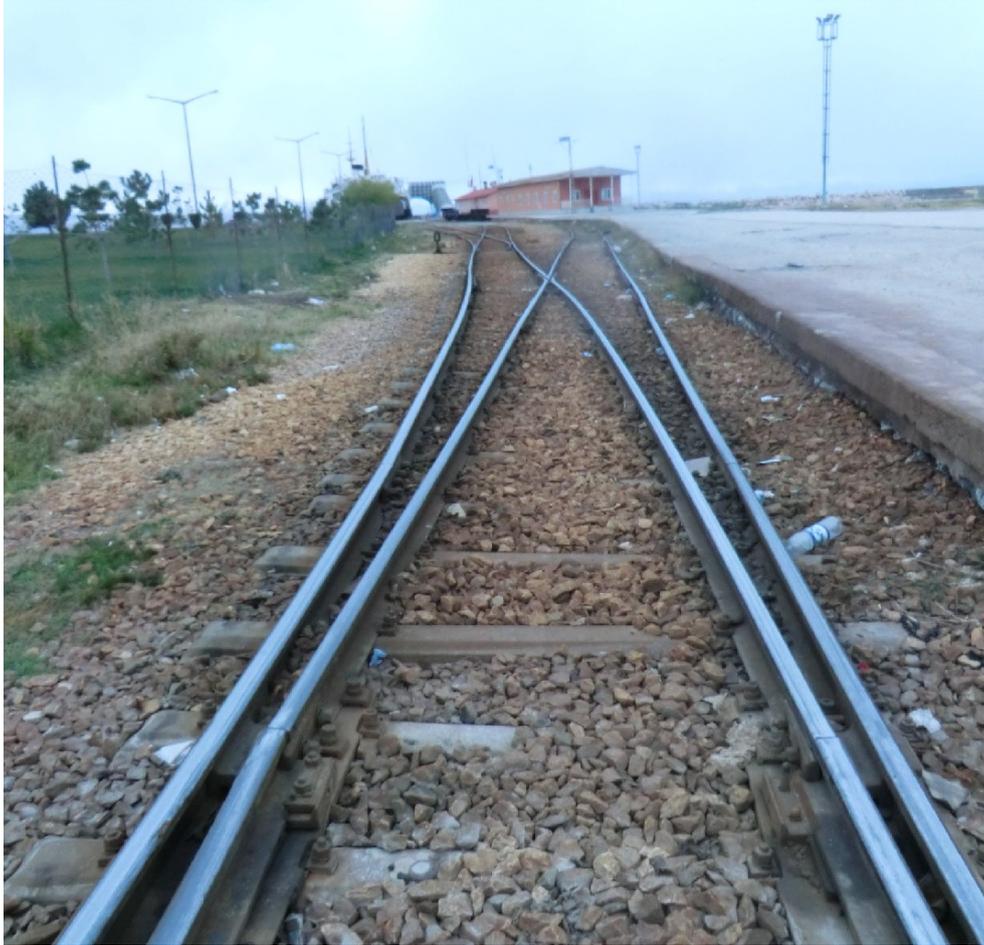
Figure 8.10. Views of deformed railways and liquefaction at Van Port.

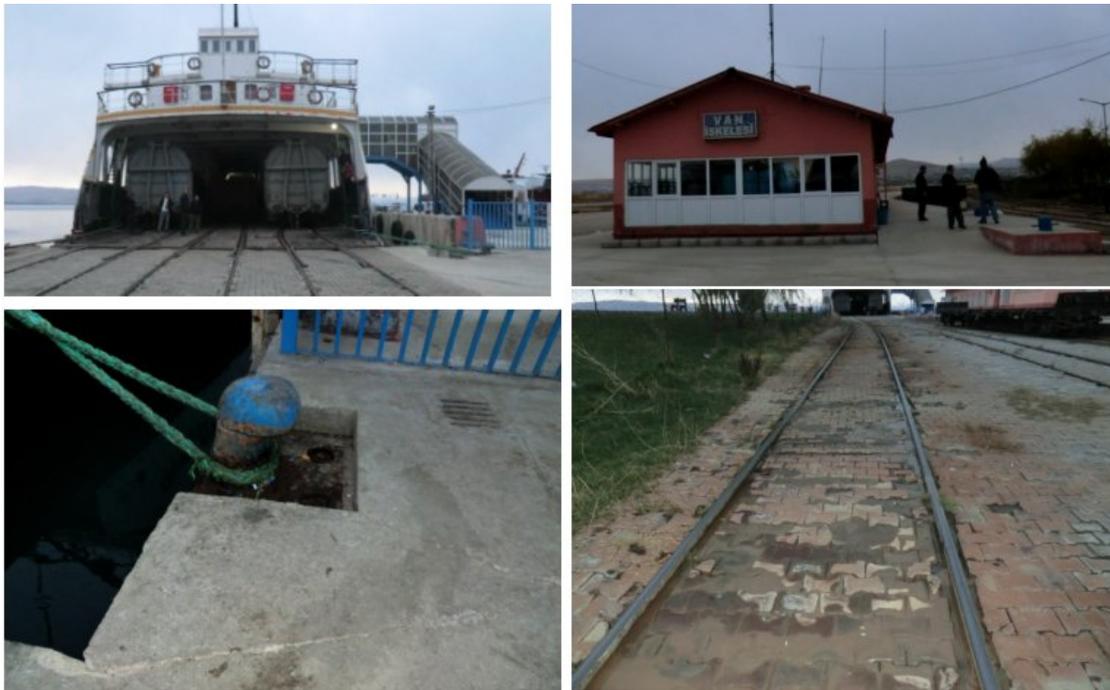
Figure 8.11. Views of slightly damaged Van Port.

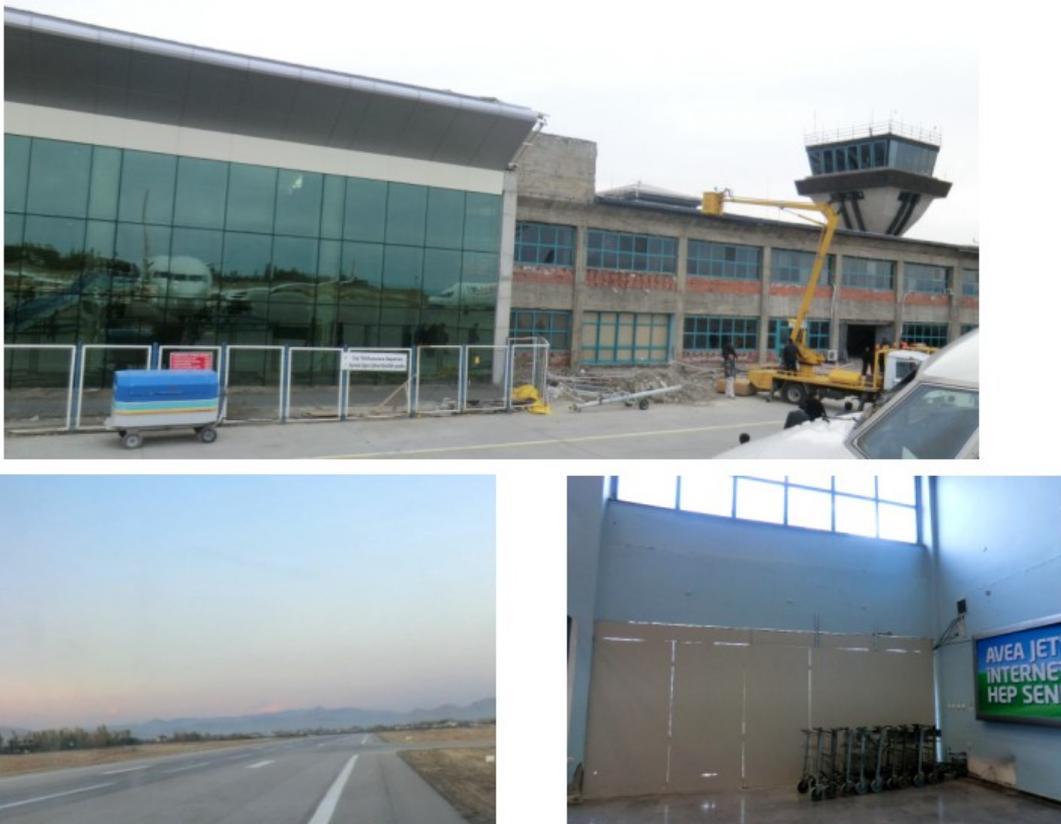
Figure 8.14. Views of runway and old and new terminal buildings of Van Airport suffered slight damage (note that the façade of the old terminal building thorn down before earthquake).

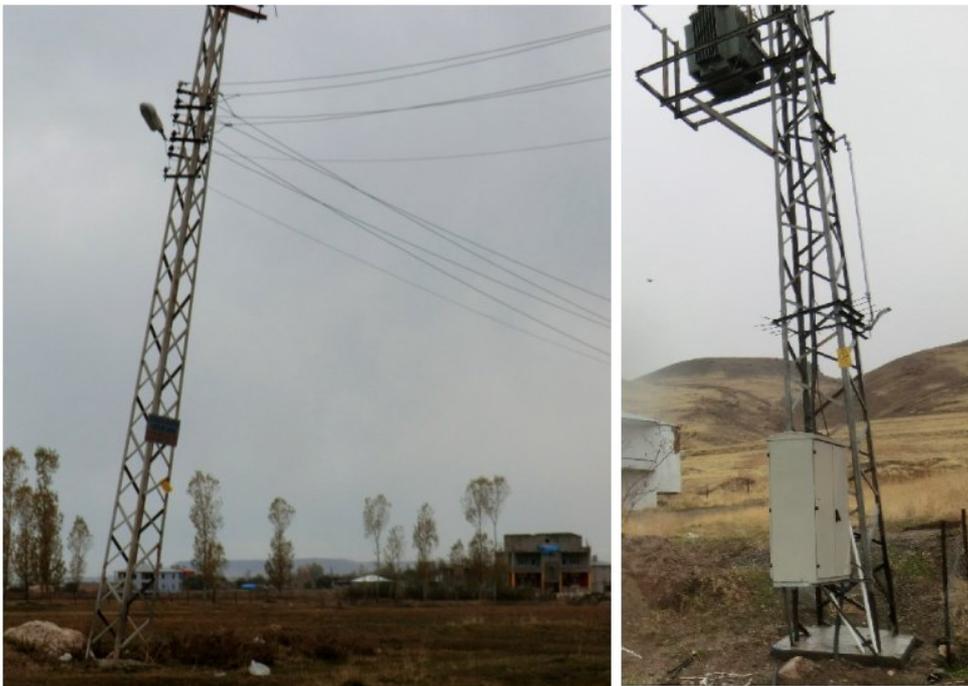
Figure 9.7. Tilted and bended utility poles in Van and Yeşilsu.

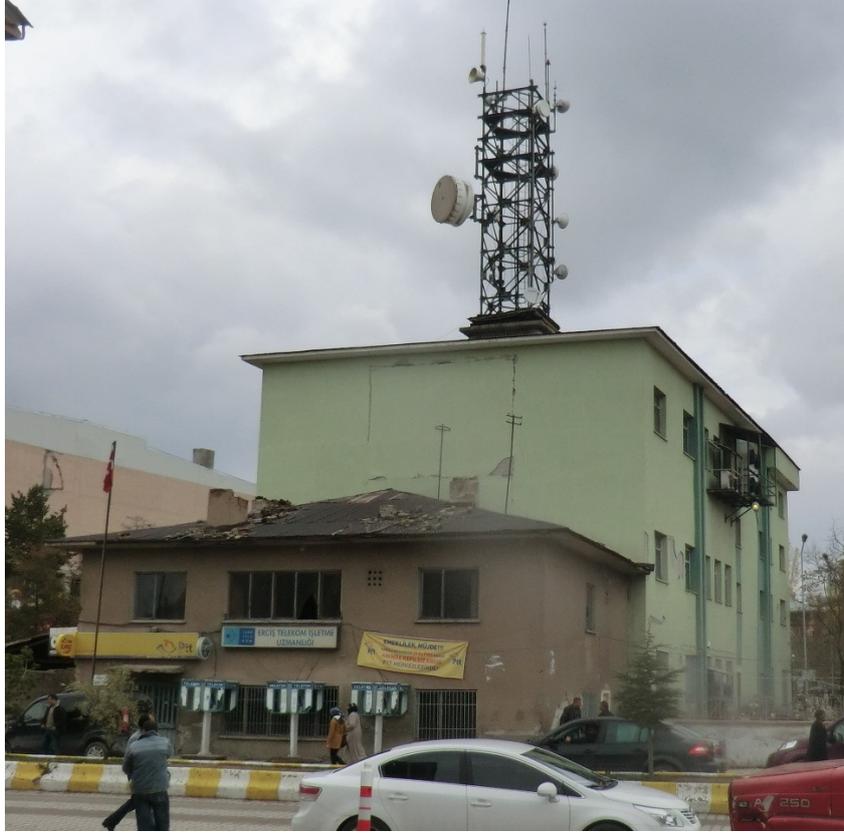
Figure 9.13. Slightly damaged main building of the TÜRK-TELEKOM in Erciş.

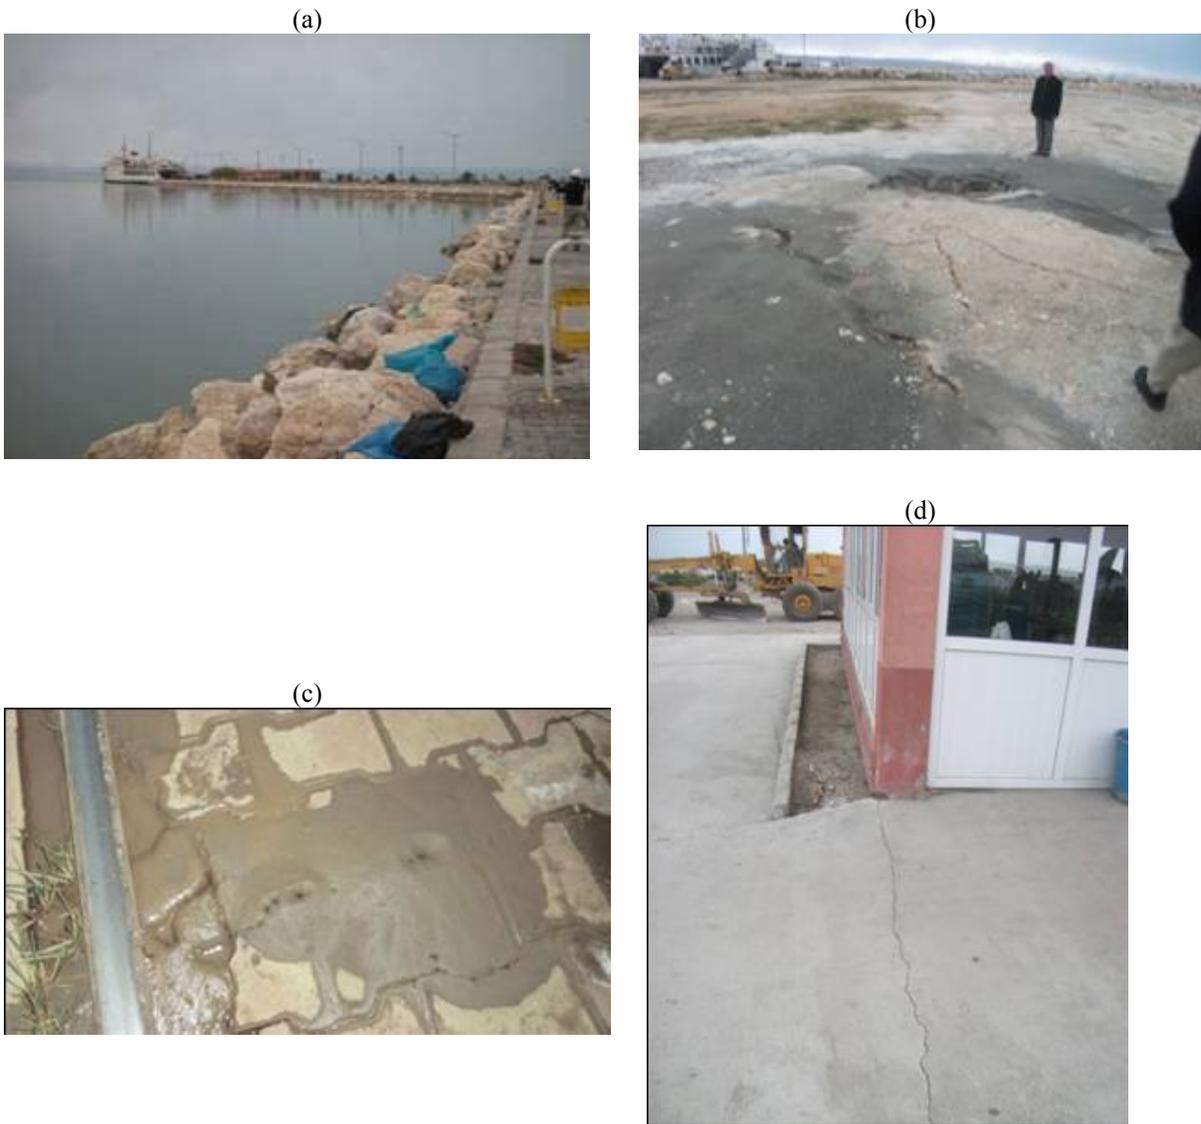
Figure 10.12. (a) A view from Van port, (b) liquefaction fissures and sand boils, (c) settled station building and (d) ejected sand along the contacts of pavement stones between rails (Van Port).

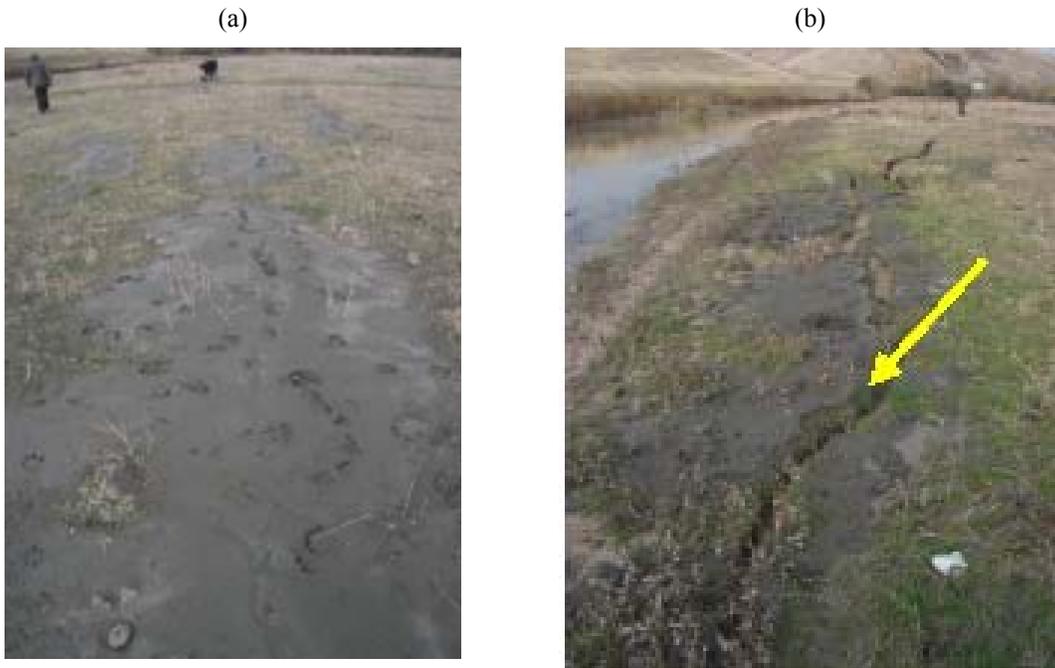
Figure 10.14. (a) Liquefaction and (b) liquefaction fissures occurred near the road between Topraktaş and Arisu villages.

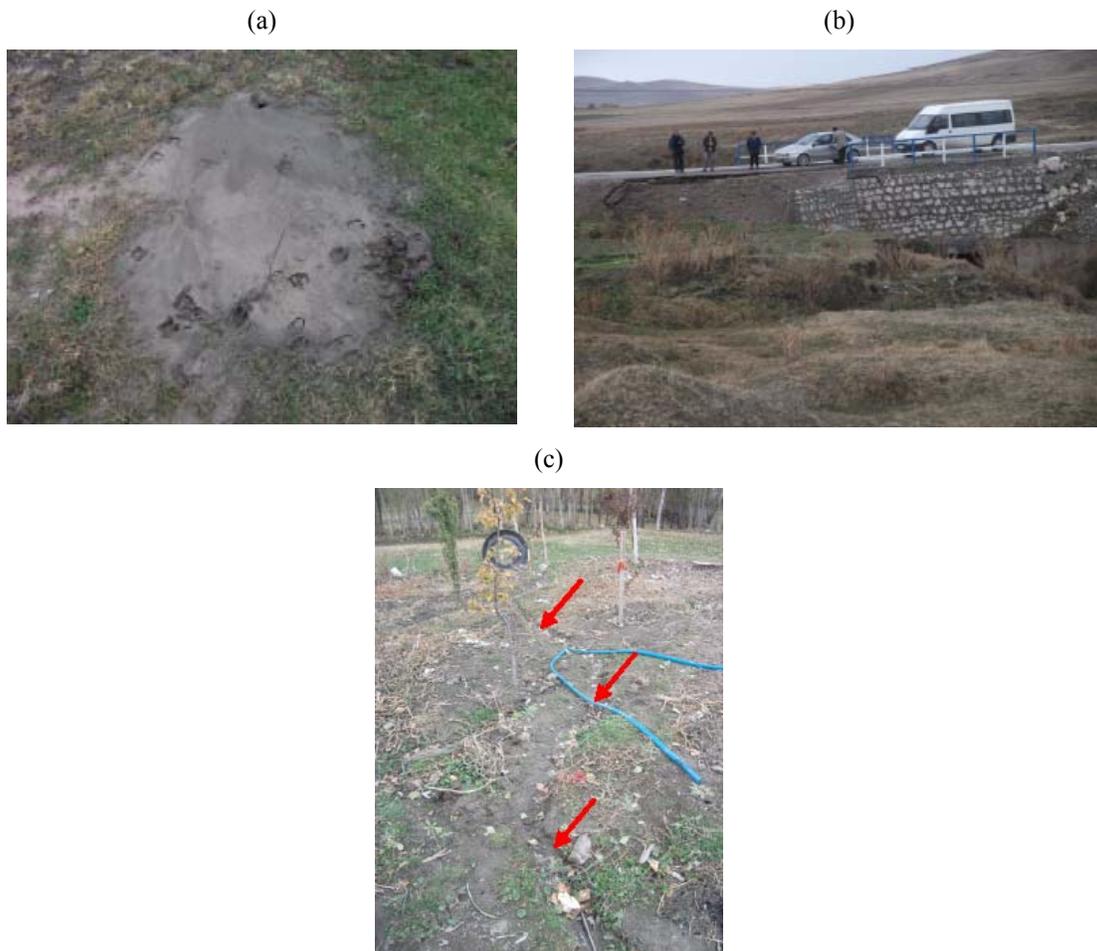
Figure 10.15. (a) Sand boil and (b) a bridge damaged due to liquefaction on the road between Göllü and Güvençli villages, (c) liquefaction in Güvençli village.

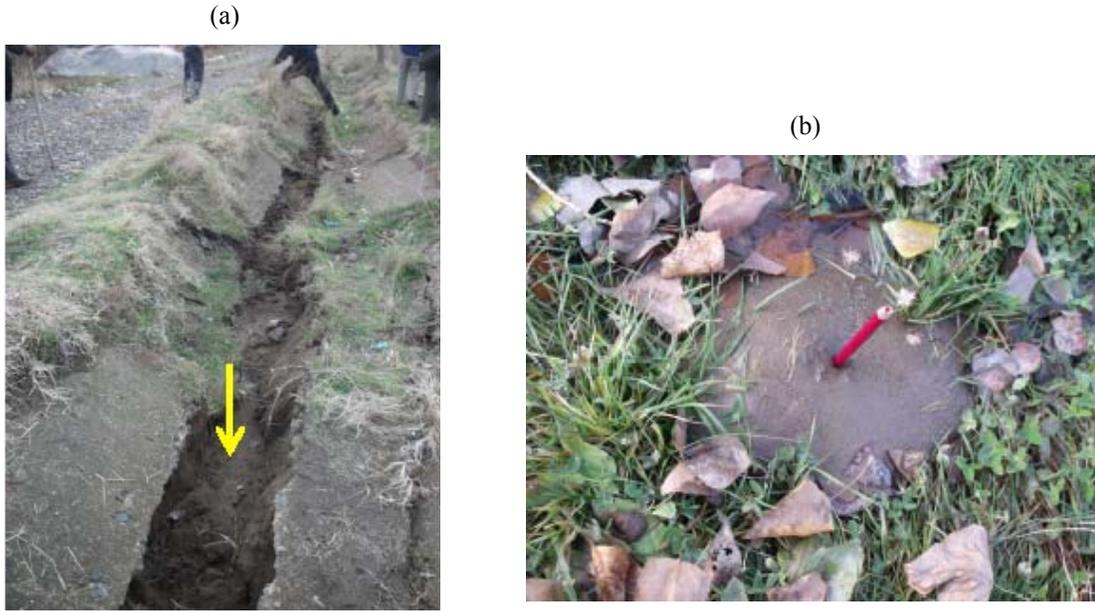
Figure 10.16. (a) Lateral spreading crack filled by ejected sand, (b) sand boil (Çelebibağ village).

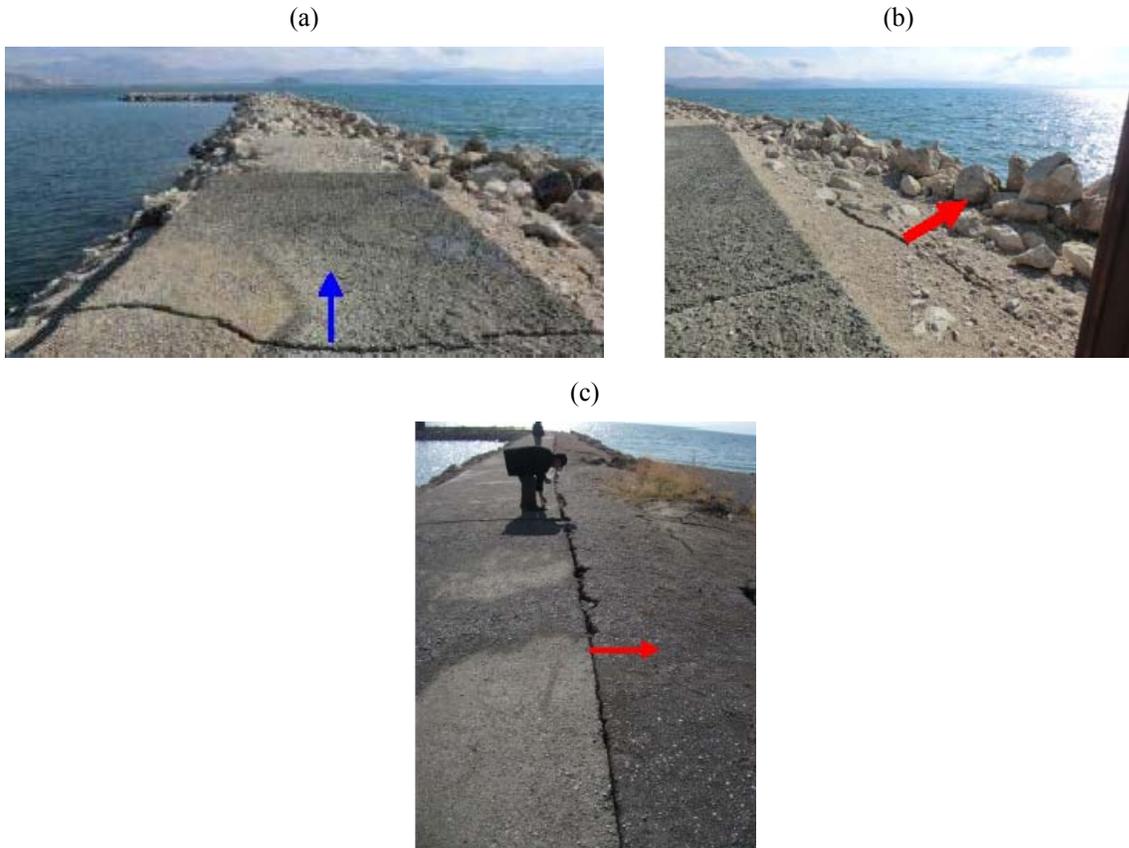
Figure 10.19. Movements probably due to lateral spreading on the breakwater of the University Port.

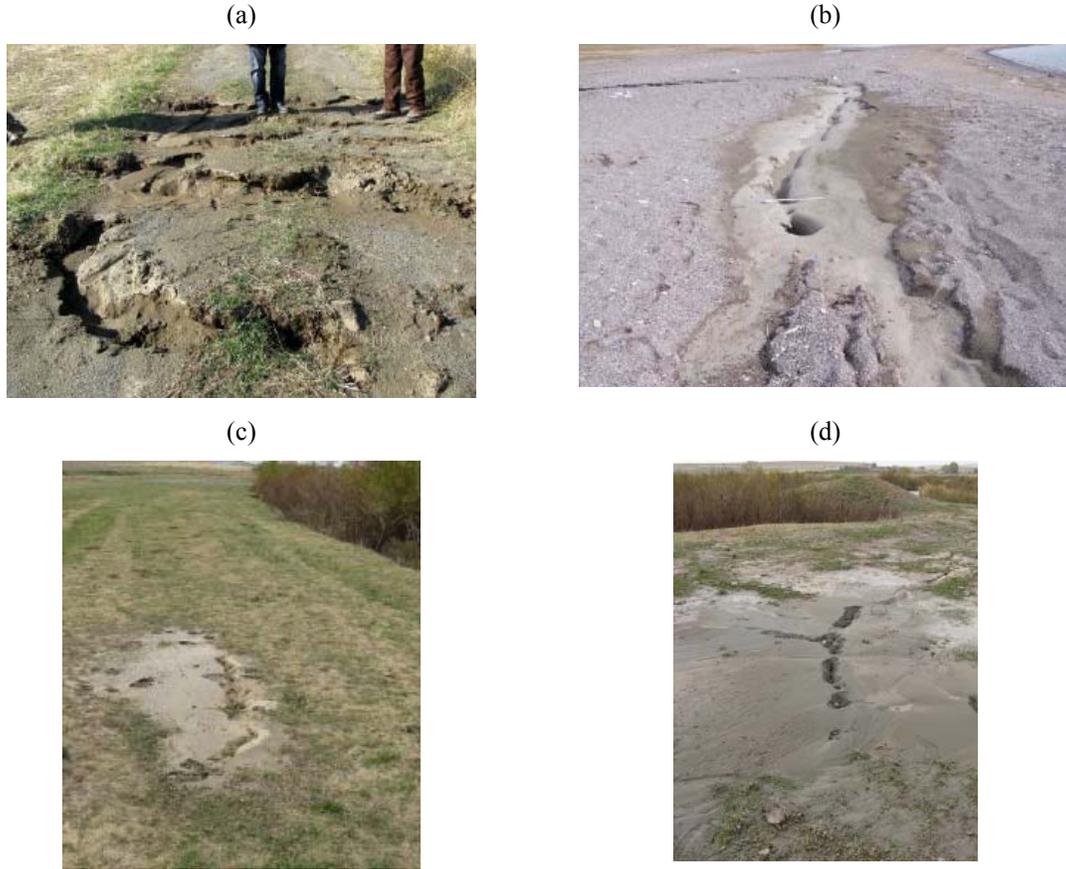
Figure 10.20. The some other sites where liquefaction observed: (a) Alaköy (JMO, 2011), (b) Esenkıyı (Göldüzü) (Emre et al., 2011), (c-d) Tevekli (Akyüz et al., 2011).
