JAPAN SOCIETY OF CIVIL ENGINEERS

SITE INVESTIGATION AND ENGINEERING EVALUATION OF THE VAN EARTHQUAKES OF OCTOBER 23 AND NOVEMBER 9, 2011

February 2012

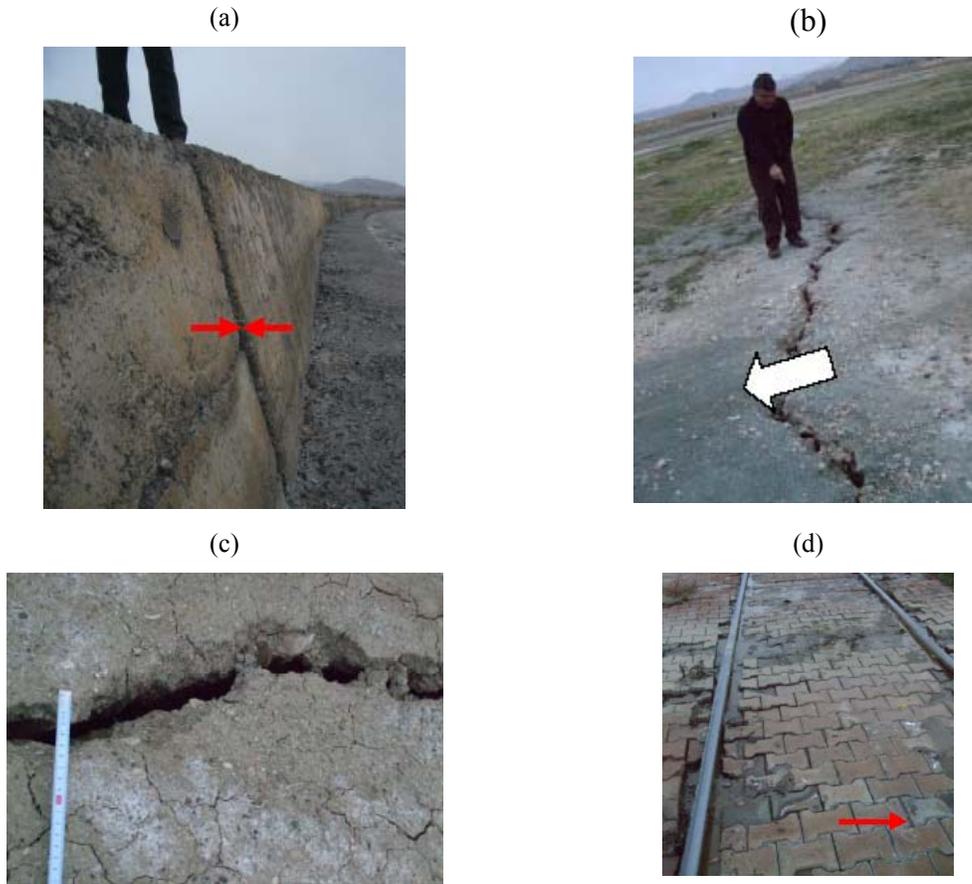
Figure 10.21. (a-b) Evidences of relative movement of the quay wall (c) separation of 5 cm lateral spread crack, (d) separation between rails due to liquefaction at Van Port.

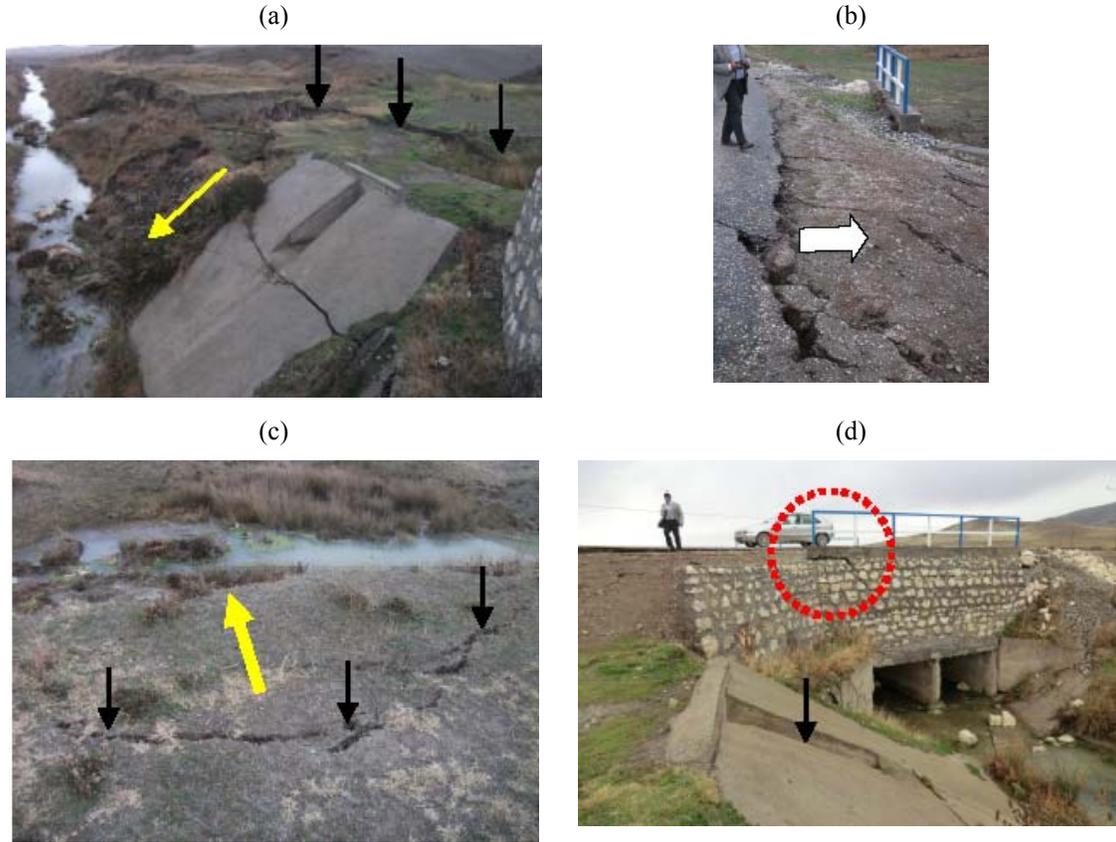
Figure 10.23. Damages to the road bridge and water canal between Göllü and Güvençli due to liquefaction and lateral spreading.

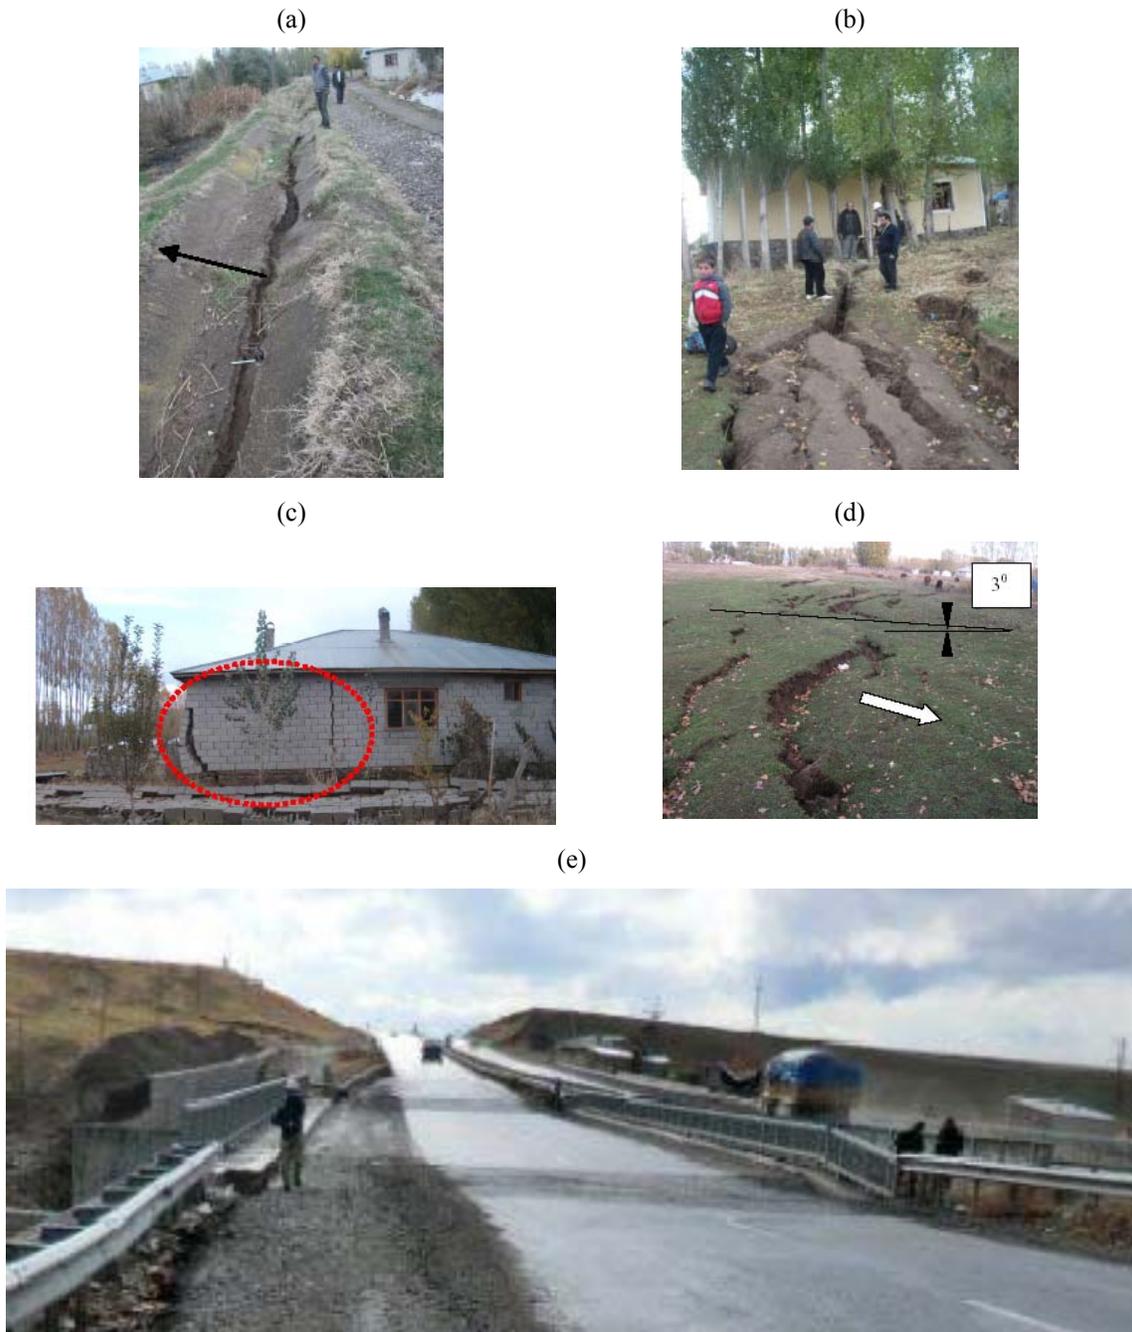
Figure 10.24. Lateral spread and resulted damages in Çelebibağ village: (a) damaged canal, (b-c) damaged residential houses and (d) movement and cracks due to lateral spreading, and (e) damage to piers and abutments of the Tirleşin Bridge due to settlement and lateral spreading of ground.

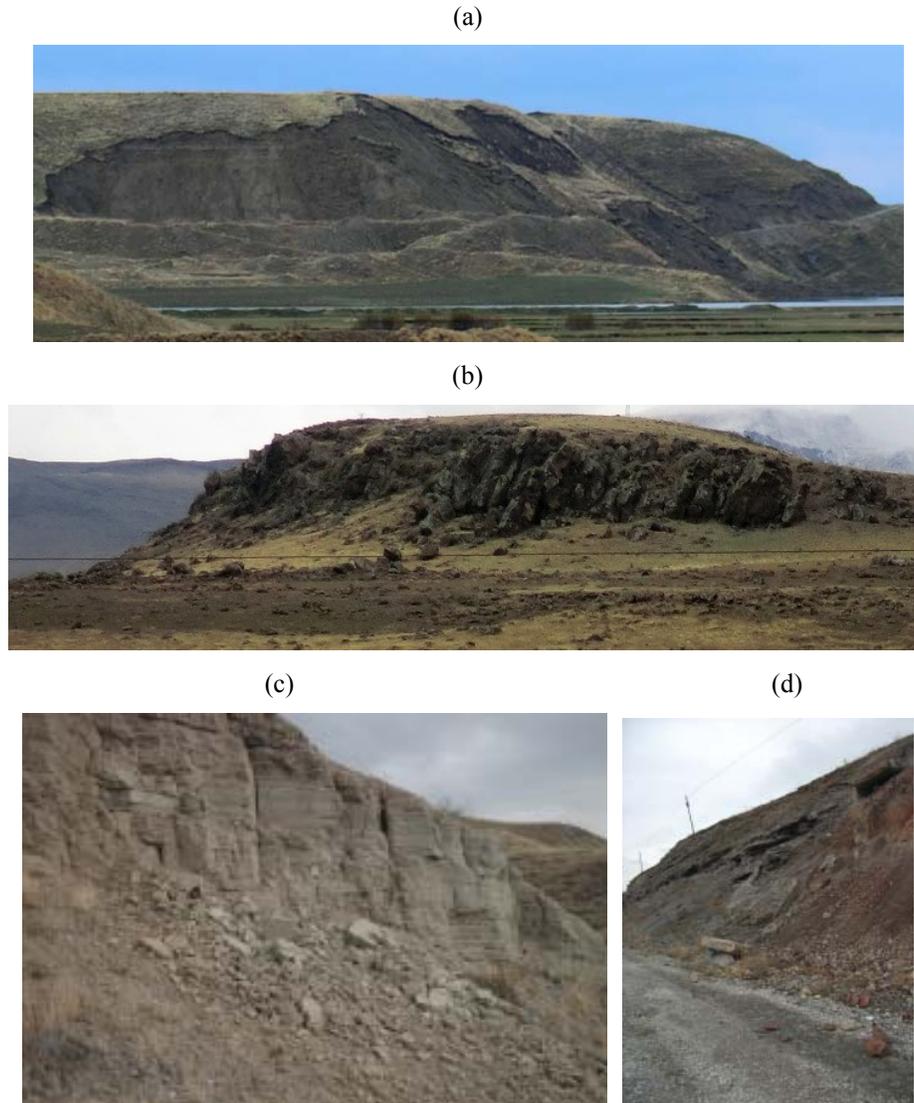
Figure 10.28. Slope failures triggered by the Van-Erciş earthquake: (a) slope failure near Topraktaş, and rock falls. (b) near Keçikıran and (c) between Topraktaş and Arısu, and (d) along the slope of the road cut (Van-Ağrı highway).

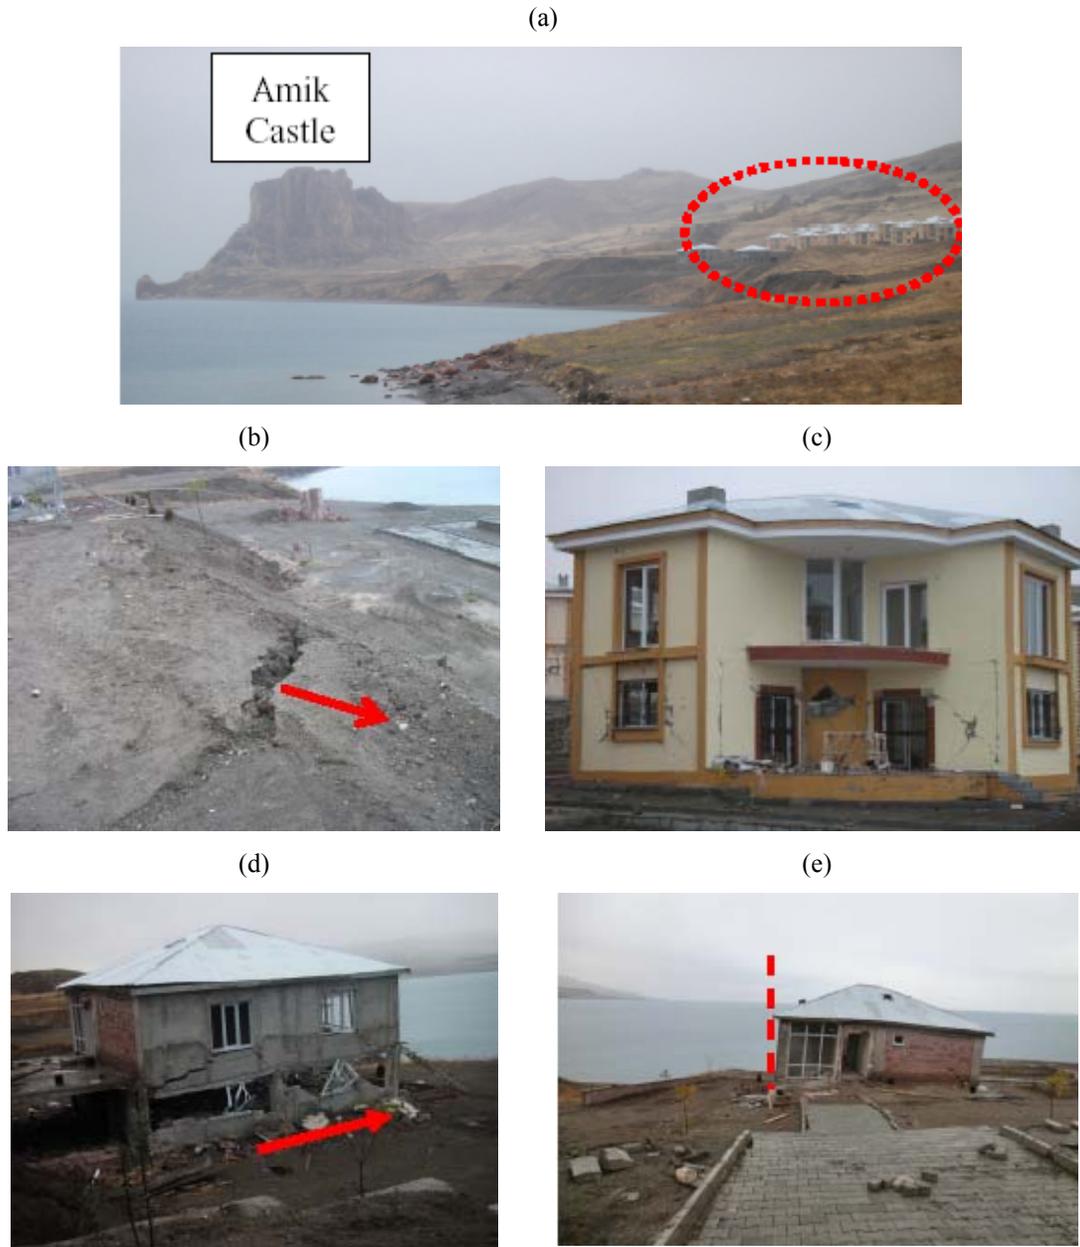
Figure10.29. Natural slope failure between on the coast of lake shore between Amik Castle and Yeşilsu village and damaged villas under construction.

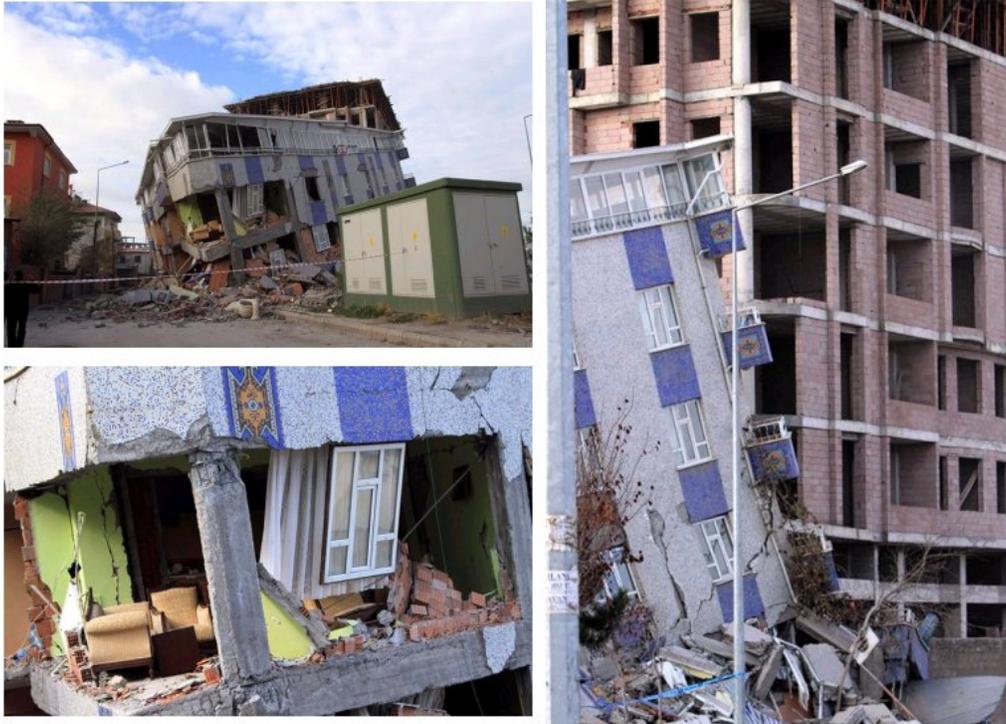
Figure 11.10. Views of a collapsed reinforced concrete building in Van (Van-Edremit earthquake) (Anadolu Ajansı, 2011).

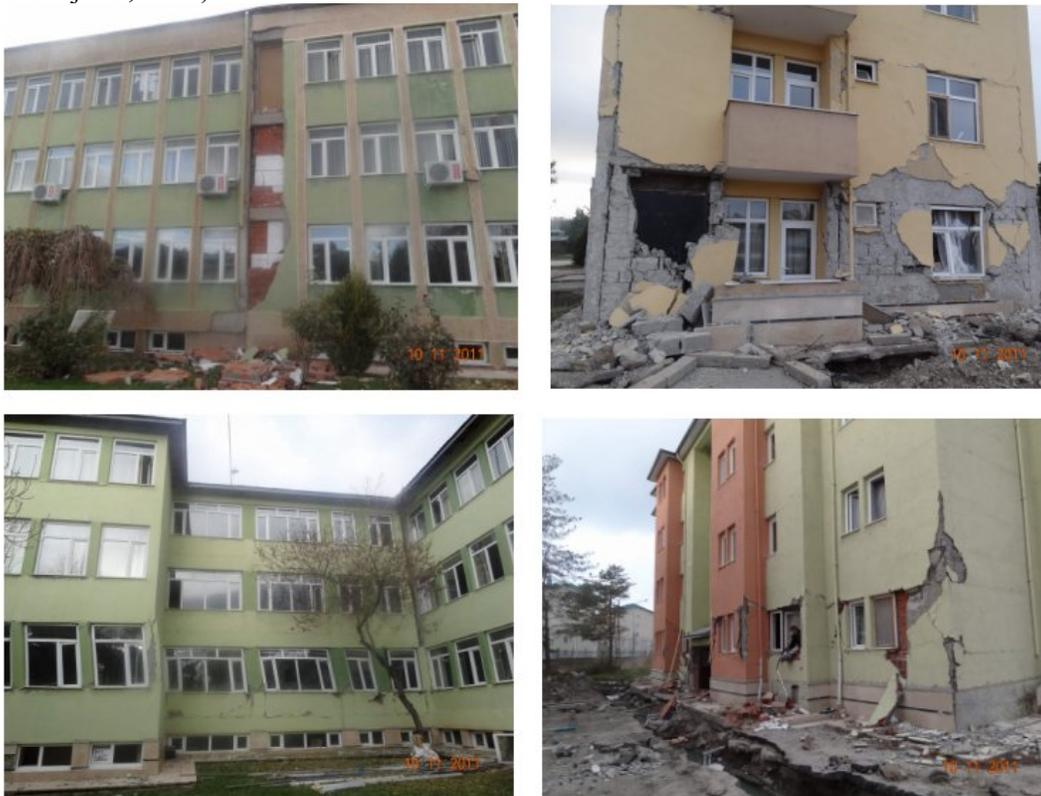
Figure 11.11. Views of heavily damaged reinforced concrete buildings of DSI in Van (Van-Edremit earthquake) (Photos: Ayhan Koçbay).

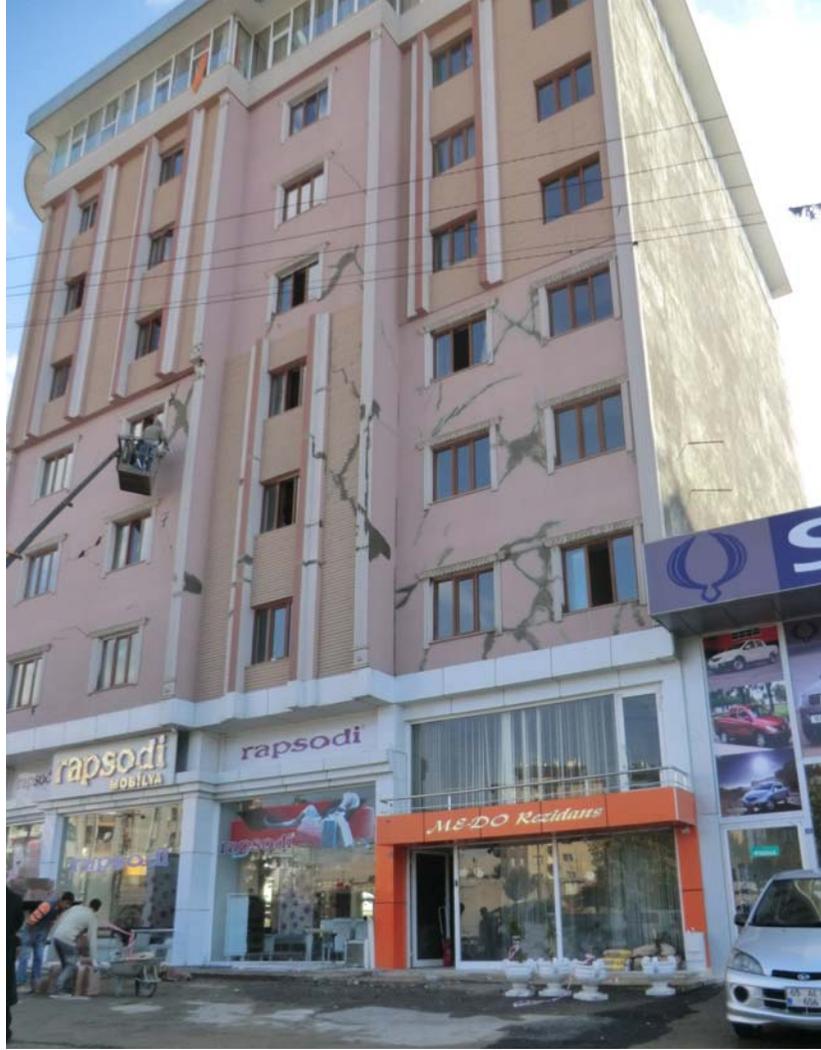
Figure 11.12. Cosmetic repairs applied to a damaged RC building in Van on November 5, 2011 after the Van-Erciş earthquake.

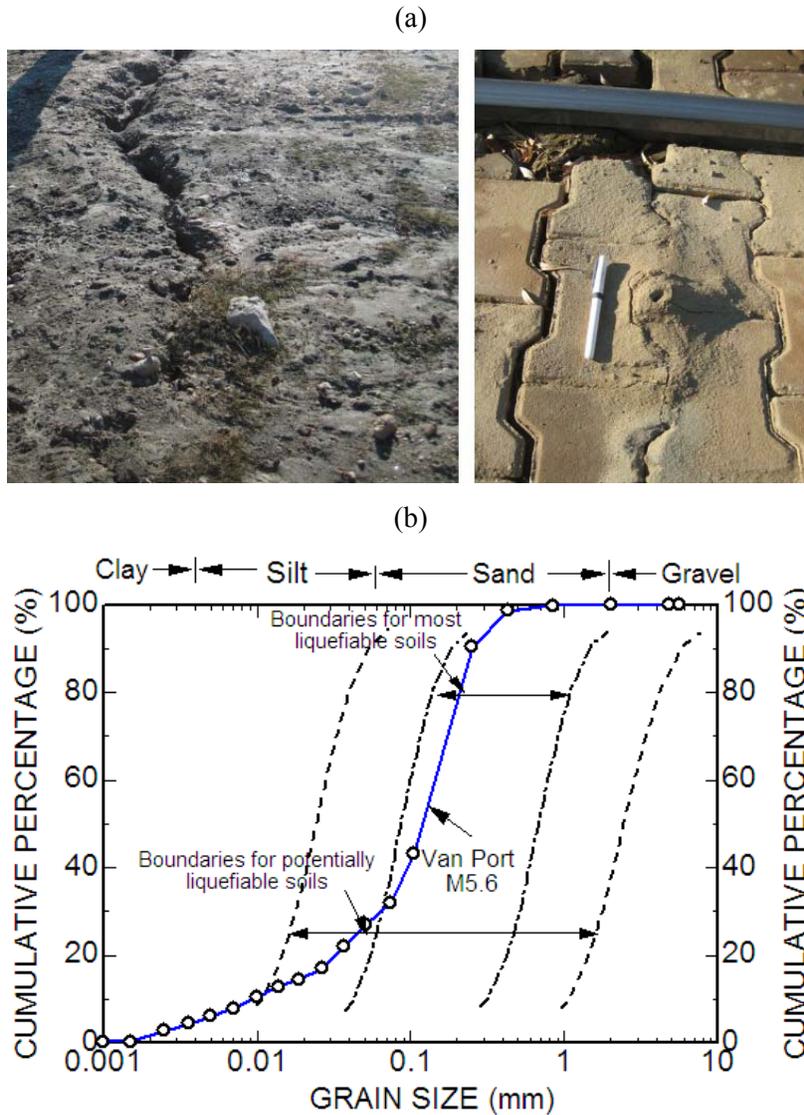
Figure 11.13. (a) Views of boiled sand in Van Port due to the M5.6 Van-Edremit earthquake and (b) its grain size distribution.
