SEISMIC PERFORMANCE ASSESSMENT OF EXPANSION JOINTS FOR WATER LIFELINES

Key facts:

- Hazard Type: Earthquake
- Date of the disaster : March 11, 2011
- Location of the survey: Shiroishi Interchange, Miyagi Prefecture
(38.039N, 140.63E)
- Date of the field survey (if any) : May 29-30, 2011
- Survey tools (if any) : none
- Key findings:
 - 1) Expansion joint failures of large-diameter buried pipelines of 1200mm and 2400mm water mains.
 - 2) The failure mechanism of these joints are investigated based on numerical analyses and field survey results.
 - 3) The expansion joints which were vertically settled before the main shock, have reduced deformation allowances for the seismic responses

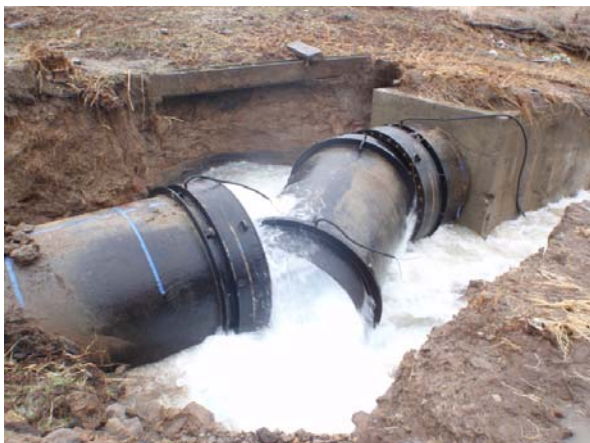
Photo 1 shows the large-scale water leakage from the expansion joint in the 2400mm diameter water pipeline immediately after the main shock. The accident occurred at both sides of the concrete encased pipeline under-crossing a water stream, as shown in Figure 4. It must be noted that this leakage occurred at the same time from both expansion joints. The concrete encased structure moved 700mm in the anticlockwise direction at site A and 100mm at site B.

Photo 1 Water leakage from expansion joint.

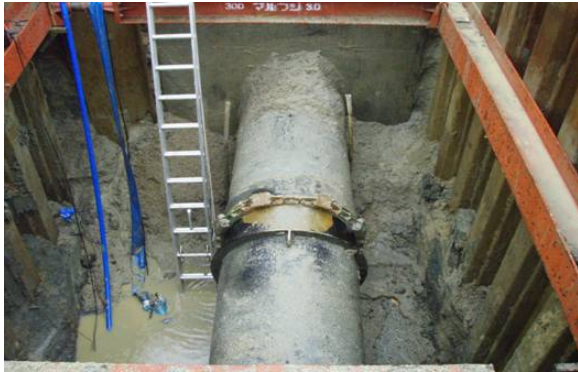
Photo 2 shows the damaged expansion joint in which leakage failure occurred at the upper portion of the expansion joint. The sealing bolt and ring at the upper portion were hydro-blasted by high pressure water and the half portion was worn out, as shown in Photo 3.

From this, the following failure mechanism could be deduced: (1)The main shock of March 11,2011

produced high pressure water leakage from a small gap in the joint; (2) this water leakage started to wear the metal portion of the sealing parts, and this wear continued for one month; (3) the deteriorated sealing ring could not stop the large scale leakage caused by shaking due to the aftershock of April 7th. In order to confirm this failure scenario, the possibility that these failure steps could occur as a result of the main and aftershocks must be evaluated by the numerical approach.

Photo 2 Excavation of joint failure portion.

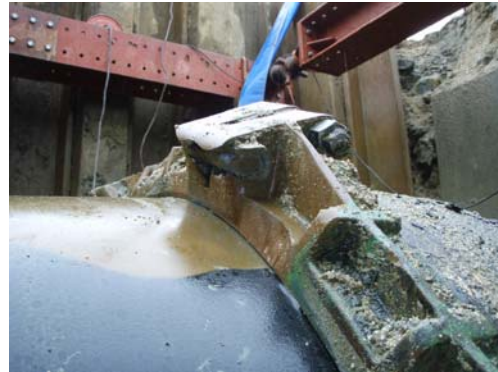
Photo 3 Sealing bolt worn out by hydro-blasting.
