Preliminary report of geotechnical and structural damage along the surface rupture in Nishihara Village caused by the April 16th, 2016 Kumamoto earthquake

Key Words: *The 2016 Kumamoto earthquake, Surface rupture, Structural and Geotechnical damage, Prefectural road 28*

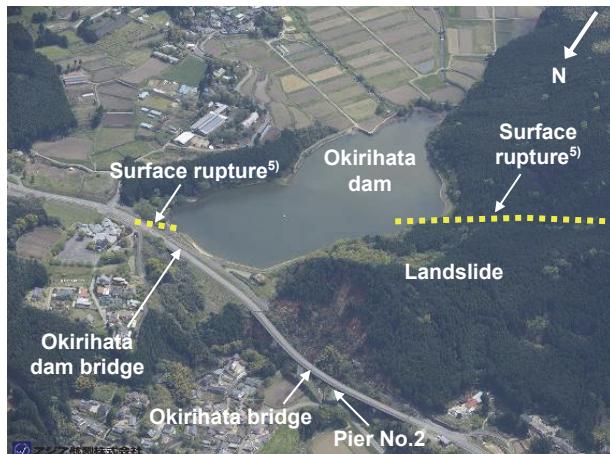
aerial photograph of Okirihata area.

Photo 1 Aerial photograph of Okirihata area on 17th April 2016 (provided by Asia Air Survey Co., Ltd.).

A large landslide occurred south behind Okirihata bridge (Photo 1). Surface ruptures appeared in the mountain at south side of the landslide⁵⁾. The distance between the landslide and the surface ruptures were more than 200m. It is thus suggestive that the

Okirihata dam is an earth-fill dam for agricultural irrigation originally constructed in 1865 during the Edo period. It was later greatly repaired in 1975. Photo 1 shows a bird-eye view of Okirihata dam.

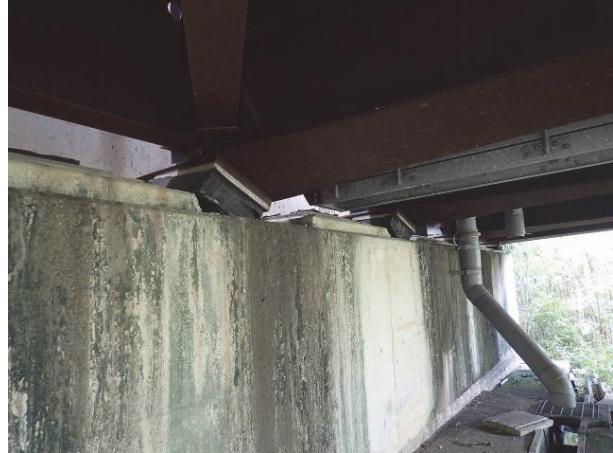
Photo 2 shows a damaged support bearing at the western end of the bridge. At this end, the bridge girders moved north in the transverse direction. The rubber bearings were detached at their upper or lower ends, and the bridge girders fell off the bearings.

Photo 2 Damaged support bearings at the western end of the Okirihata bridge. Bridge girders moved north in the transverse direction and fell down from their supports (32°50'33"N, 130°55'38"E).

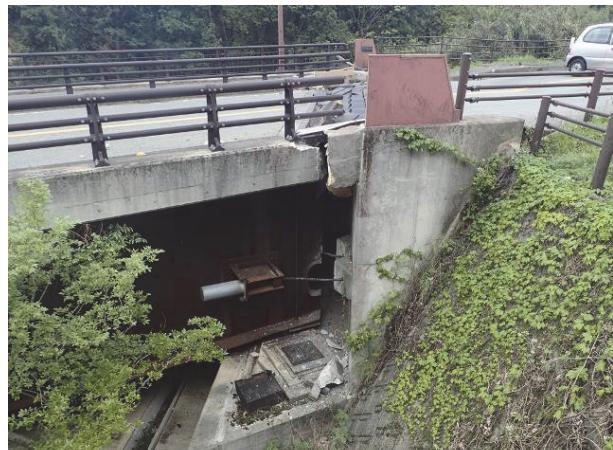
Photo 3 shows a damaged support bearing at the eastern end of the bridge. The bridge girders hit the curtain wall of the abutment. Furthermore the bridge girders shifted sideways in the transverse direction and the rubber bearings were detached from both their pedestals and the bridge girders.

Photo 3 Damaged support bearing at the eastern end of the Okirihata bridge. The bridge girders hit the curtain wall of the abutment and shifted sideways in the transverse direction (32°50'32"N, 130°55'47"E).

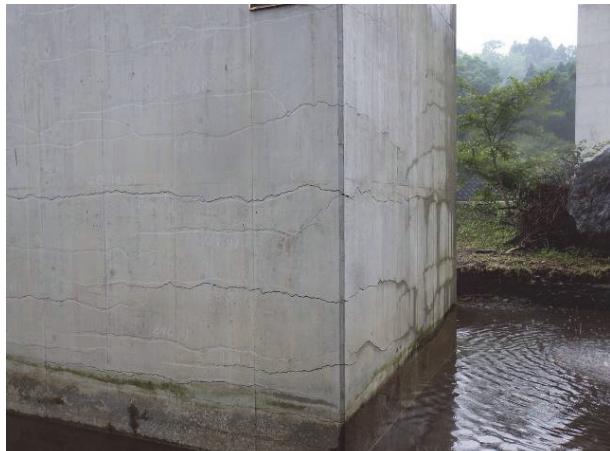
Total 20 bridge-fall-prevention cables connect the girders to both abutments. 19 of these 20 were found intact. These cables might have helped to limit the motions of girders in the transverse direction too. Photo 4 is the lower end of Pier No. 2. There were many flexural cracks on the surface. These cracks may have been caused by the strong ground acceleration.

Photo 4 Damaged bridge pier No.2 of Okirihata bridge. There were many flexural cracks on its south side ($32^{\circ}50'33''N, 130^{\circ}55'41''E$; provided by Mr. Takashi SATO).

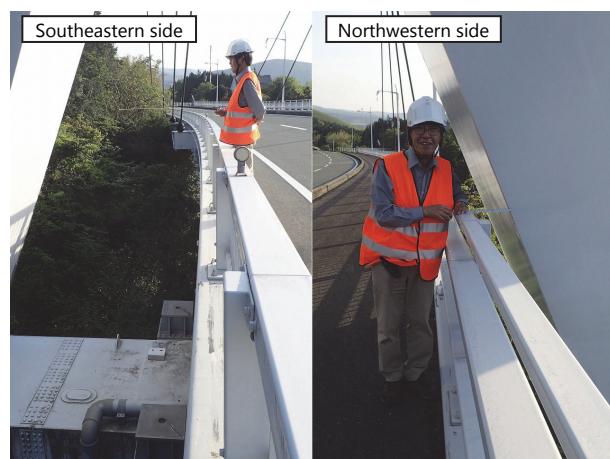
northwestern inclined column of the tower (*see Photo 6*).

Photo 6 Deck of Kuwazuru bridge detached from its tower: The deck moved apart from the southeastern incline column of the tower, and remained at rest getting much closer to the northwestern inclined tower column ($32^{\circ}51'05''N, 130^{\circ}56'45''E$).

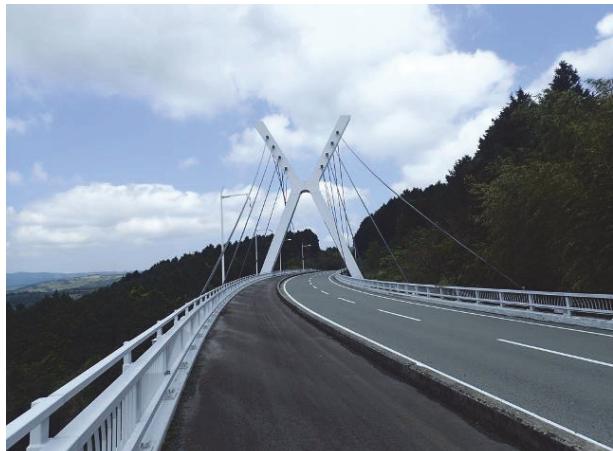
Kuwazuru bridge is a 160m long 2 span cable stayed bridge. The bridge is curved north. Photo 5 is the view of Kuwazuru bridge from south-west.

The bridge deck was pinned against the transverse beam of the X-shaped tower. The deck was detached from the tower and moved sideways to northwest. As the result, the entire deck moved apart from the southeastern incline column of the tower, and remained at rest getting much closer to the

Photo 5 View of Kuwazuru bridge from south-west. The bridge deck moved sideways to northwest ($32^{\circ}51'04''N, 130^{\circ}56'43''E$).

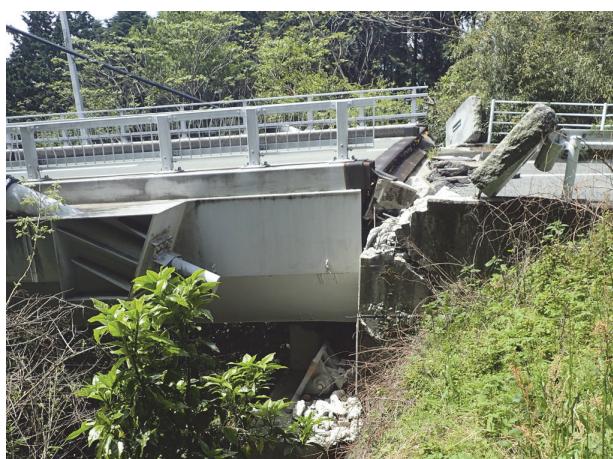
The entire deck as a whole was found bent downward with its northeastern end touching the curtain wall of the northeastern abutment (Photo 7) while the other end was lifted up from the southwestern abutment as shown in Photo 8.

Surface ruptures showing right-lateral offset were found diagonally across the south-eastern approach of the bridge⁶⁾, suggesting that not only the intense ground shake but also the surface ruptures may also be responsible for the damage to Kuwazuru bridge.

Photo 7 Damage at the northeast end of the Kuwazuru bridge. The bridge deck hit the curtain wall of the abutment ($32^{\circ}51'07''N, 130^{\circ}56'46''E$).

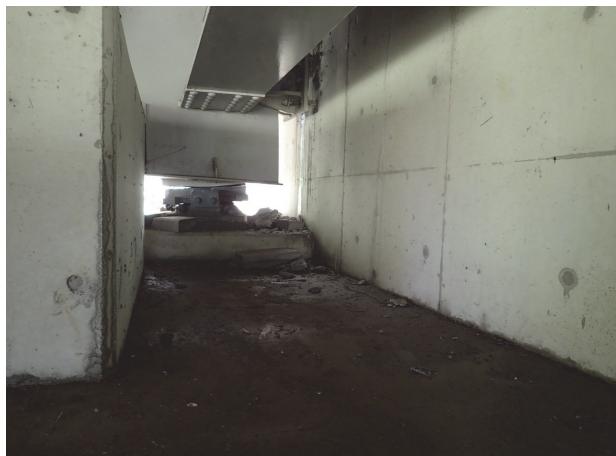
Photo 8 Damaged support bearing and abutment pier at the southwest end of the Kuwazuru bridge. The bridge decks moved apart from their supports ($32^{\circ}51'03''N$, $130^{\circ}56'43''E$).

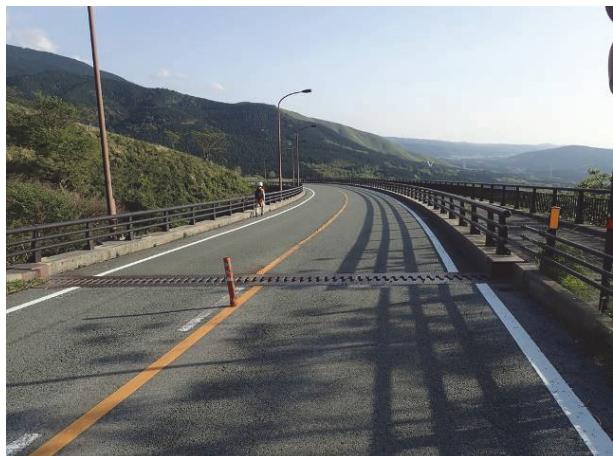
Photo 9 is a view of the Oginosaka bridge from its northern approach. The bridge is a 128m long 4 span continuous girder bridge. The bridge is gently curved west. Rubber bearings support the bridge girders.

The bridge girders turned clockwise, which

movement differed from those of the other bridges. Displacement in the transverse direction was measured to be about 30cm at the north end of the bridge. At the south end, the bridge girders collided against their stoppers, which were designed to limit the transverse displacements of the girders.

Surface ruptures appeared near east of the bridge⁵⁾ (see Figure 1(a)). Because the surface ruptures extend towards the bridge the damage to the bridge might have been affected by the fault rupturing.

Photo 9 Oginosaka bridge: The bridge girder turned clockwise ($32^{\circ}51'47''N$, $130^{\circ}57'06''E$).

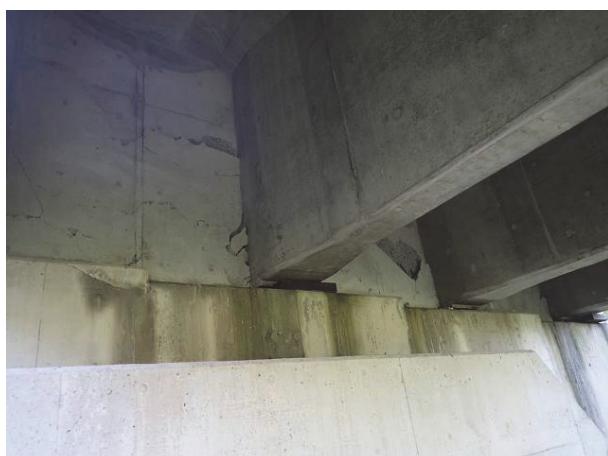
Photo 10 shows the damaged abutment at the western end of Susukinohara bridge, a simple beam pre-stressed concrete bridge of 43m long.

At the western end, the abutment was cracked seriously because the bridge girders collided against the curtain wall of the abutment. At the other end, also, the bridge girders collided and slid up against

the abutment curtain wall by about 10 cm.

Photo 10 Damage to abutment at the west end of Susukinohara bridge. The bridge girders collided against the curtain wall of the abutment ($32^{\circ}51'47''N$, $130^{\circ}57'29''E$).

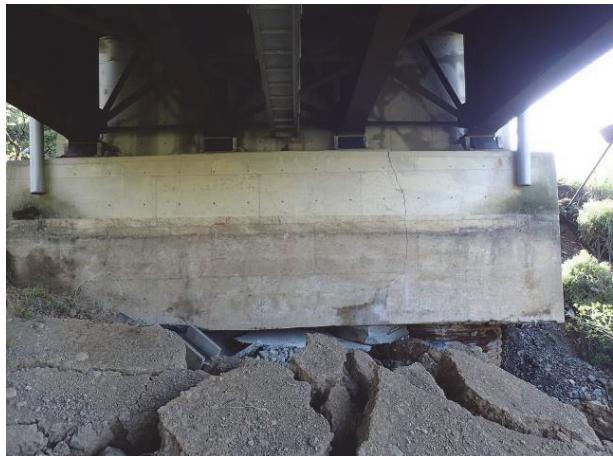
Tawarayama bridge is a 140m long 3 span continuous girder bridge. This bridge was found to be the most seriously damaged among all surveyed. At its western end, the backfill soil of the abutment has sunken seriously. Photo 11 shows the damage to the western abutment pier. The curtain wall of the abutment has been hit by bridge girders and gotten dented. Rubber bearings had been deformed in the longitudinal direction. The valley-side soil at the toe of the abutment has sunken and the heads of thick pile foundations of the abutment were exposed. Cracks have developed upright through the abutment.

Photo 11 Damage to the western abutment of the Tawarayama bridge. The valley-side soil at the toe of the abutment has sunken and the heads of thick pile foundations of the abutment were exposed. ($32^{\circ}51'48''N$, $130^{\circ}57'47''E$).

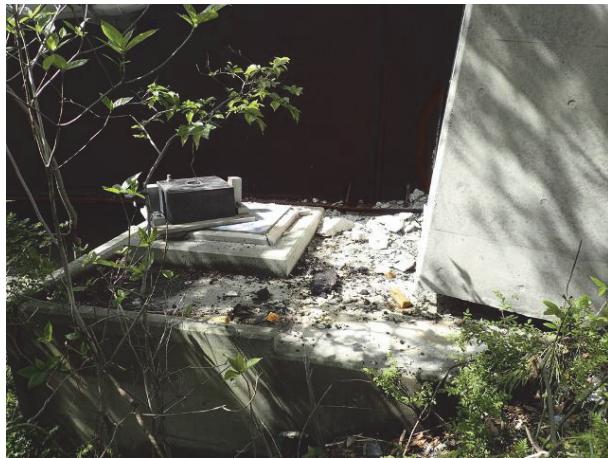
Photo 12 shows the bearing sheet of the damaged abutment at the east end of the bridge. The curtain wall of the abutment was pushed by bridge girders

and inclined outward. The backfill soil was pushed by the abutment and sunken seriously. At this end of the bridge, bridge girders shifted sideways in the transverse direction. Rubber bearings were detached from both the bearing sheet and girders. As the consequence, the girders fell down onto the bearing sheet. However anti-falling cables helped the ends of girders to stay on the bearing sheet.

Photo 12 Bearing sheet of the damaged abutment at the east end of the Tawarayama bridge. The curtain wall of the abutment was pushed by bridge girders and inclined outward ($32^{\circ}51'47''\text{N}$, $130^{\circ}57'41''\text{E}$).

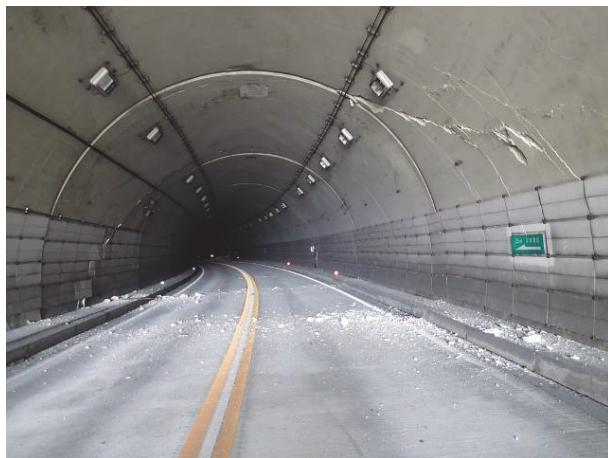
Photo 14 Damage of lining concrete at the Tawarayama tunnel. Diagonal cracks were appeared on the both side of lining concrete.

method and completed in 2002. Its total length is 2,057m. We investigated its western 300m stretch. Diagonal cracks appeared on both sidewalls of lining concrete at the 45-50m distance from the western tunnel mouth (Photo 14). Large chunks of concrete came off the lining joint at the 100-120m and 250m distances from the western tunnel mouth. Photo 15 shows a damaged embankment of the western approach to the tunnel.

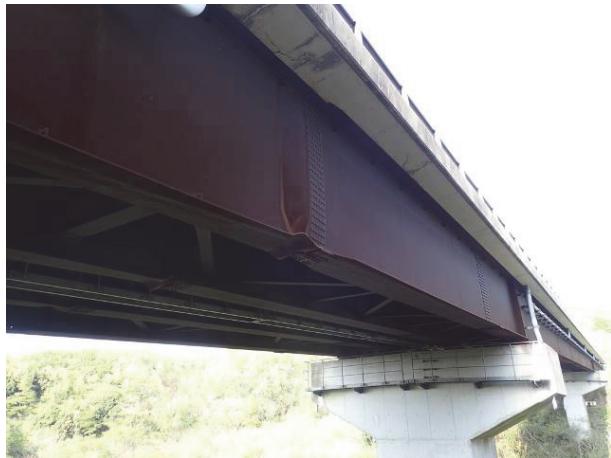
The damage to the both abutments suggests that both abutments moved toward each other eventually pushing the girders. The steel girders were thus bent upwards, and their flanges were buckled as shown in Photo 13.

Surface ground ruptures were found diagonally crossing the bridge⁶⁾. So it is thought that movement of both abutments were caused by the fault rupture induced right-lateral surface displacement.

Photo 13 Buckled bridge girders of the Tawarayama bridge. A huge compressional force might be applied to the bridge girders ($32^{\circ}51'46''\text{N}$, $130^{\circ}57'37''\text{E}$).

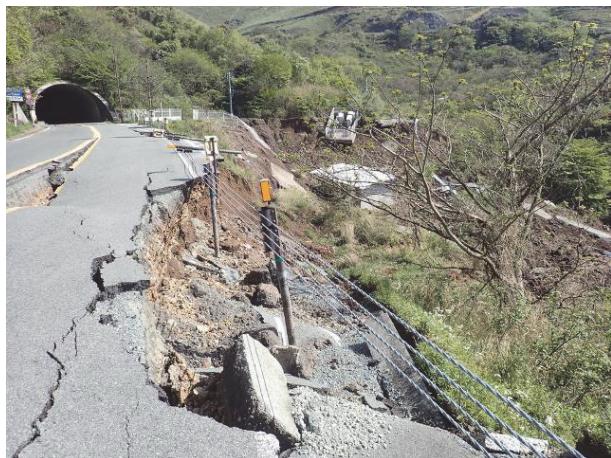
Photo 15 Slope failure at the western approach to the tunnel. ($32^{\circ}51'40''\text{N}$, $130^{\circ}57'48''\text{E}$).

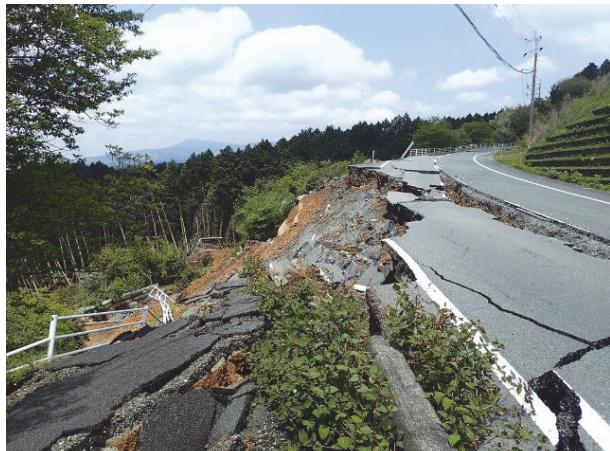
Photo 16 Slope failure of an embankment for Prefectural Route 28 between the Okirihata bridge and the Kuwazuru bridge (32°50'44"N, 130°56'24"E).

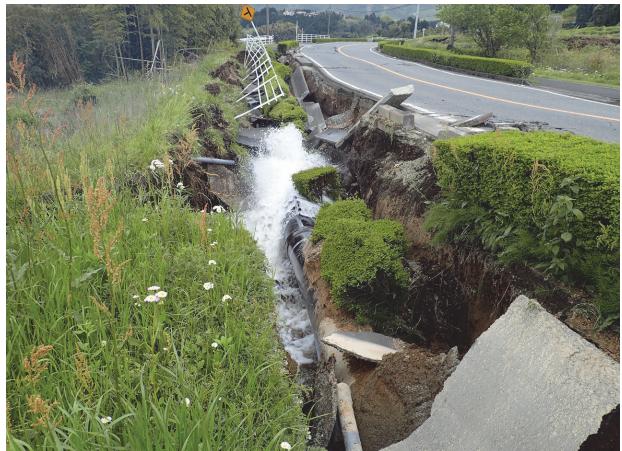
Photo 17 Break of the aqueduct by the subsidence of the road (32°50'37"N, 130°55'25"E).

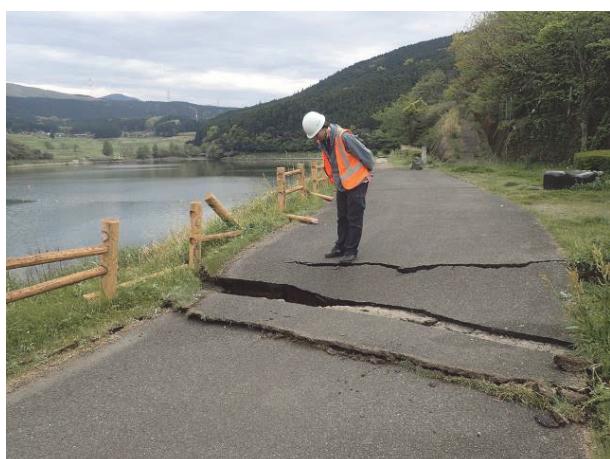
The fact that some large facing stones of Okirihata dam have moved about 30cm off their original locations suggests that the dam has experienced strong ground motions. The crest of the dam has sunken (Photo 18) and its concrete spillway structure was cracked and deformed. No clear evidence of water leakage was visible.

Photo 18 Subsidence of the embankment at the Okirihata dam. The concrete spillway was cracked and deformed but no clear evidence of water leakage was visible. (32°50'30"N, 130°55'49"E).

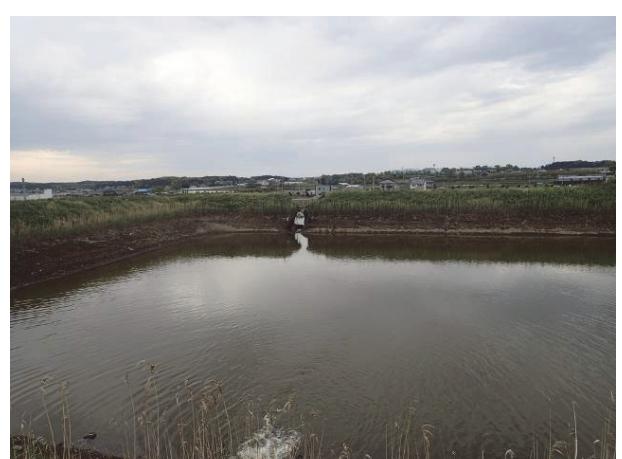
Photo 19 Damage of the Shimokomori pond. A small section of its north bank was breached in the earthquake and water flowed into the lower terrace of rice field (32°50'30"N, 130°55'14"E).

behind an earth-fill dam. A small section of its north bank was breached in the earthquake and water flowed into the lower terrace of rice field (Photo 19). Shimokomori pond is located on the extension of the recognized Futagawa fault trace. However, the relation between this breaching and the fault movement is not clear because the surface ground rupture died out before reaching this pond.

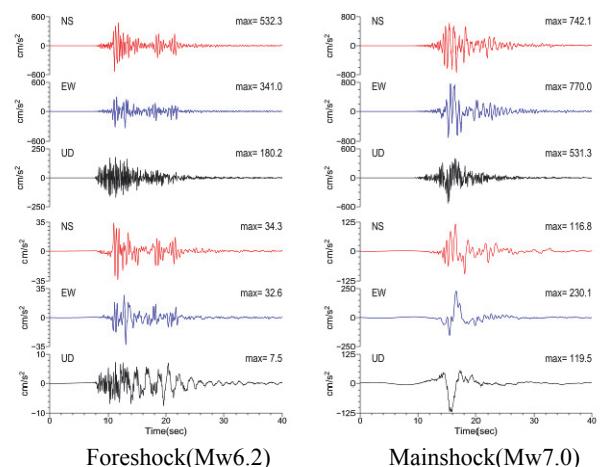
Table 2 shows three orthogonal components of the peak ground acceleration (PGA, cm/s²) and peak ground velocity (PGV, cm/s). Time histories of the ground acceleration were Fourier-transformed and integrated in the frequency domain. Then the obtained spectra were bandpass-filtered (0.1-10.0Hz), and Fourier-inverse-transformed to get waveforms in the time domain. Figure 2 shows the acceleration and velocity waveforms of the mainshock and the foreshock. Durations of the mainshock and the foreshock were about the same with each other. However, the PGA and PGV of the mainshock were much greater than those of the foreshock. In particular, the velocity waveform of the mainshock shows a clear pulse with its predominant period of about 3.0s. The PGV of the EW component of the velocity was larger than 200cm/s. The clear pulse may be attributed to the strike-slip faulting of Futagawa fault.

Figure 2 Waveforms of strong ground motion at Nishihara village office during mainshock and foreshock.

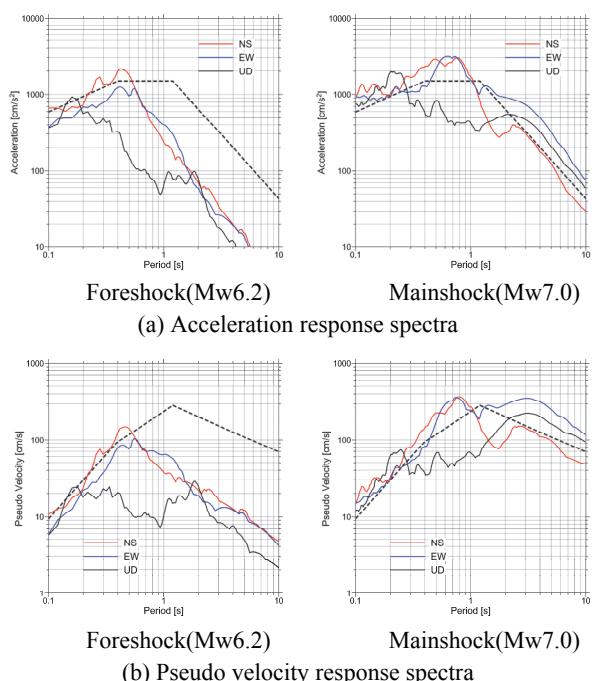
Figure 3(a) shows the obtained acceleration response spectra for the foreshock and mainshock assuming the damping factor of 0.05 and seismic regional coefficient c_z of 0.85. Broken line in each figure shows the seismic design spectrum of the Level 2 earthquake ground motion for the ground classification II⁸⁾. The response spectrum for the foreshock is generally smaller than the seismic design spectrum except for the period range of about 0.2 to 0.5 s. On the other hand, the response spectrum of the mainshock exceeds the seismic design spectra over a wide range of period. Figure 3(b) shows pseudo velocity response spectra. The response spectrum of lateral motion for the mainshock has clearly two predominant periods of about 0.8 s and about 3.0 s.

This indicates that the damaged road bridges may have experienced considerably large seismic loads exceeding the design load.

Figure 3 Response spectra of ground motion at Nishihara village office with damping factor 0.05. Broken lines indicate seismic design spectrum that was considering seismic regional coefficient ($c_z=0.85$) on the ground of Class II for level 2 ground motion for a crustal earthquake (Specifications for highway bridges).
