GEER Reconnaissance of the 2016 Kumamoto Earthquakes

- Hazard Type: Earthquake
- Date of the disaster: April 14th to 16th, 2016
- Location of the survey: Kumamoto, Japan
- Date of the field survey: May 11th through 13th, 2016
- Survey tools: Terrestrial LiDAR, Unmanned Aerial Vehicle (UAV), Digital Photographs, Manual Surveys
- Key findings: (1) major surface fault rupture occurred through a water reservoir, (2) an unusual “depression zone” occurred in part of the Aso Caldera, (3) a unique pre-and post-event aerial LiDAR data set is available to study surface fault rupture through an embankment, (4) a relatively small amount of liquefaction occurred, possibly a result of soil plasticity and sediment geology, (5) a valuable non-displacement lateral spread was observed at a major bridge.

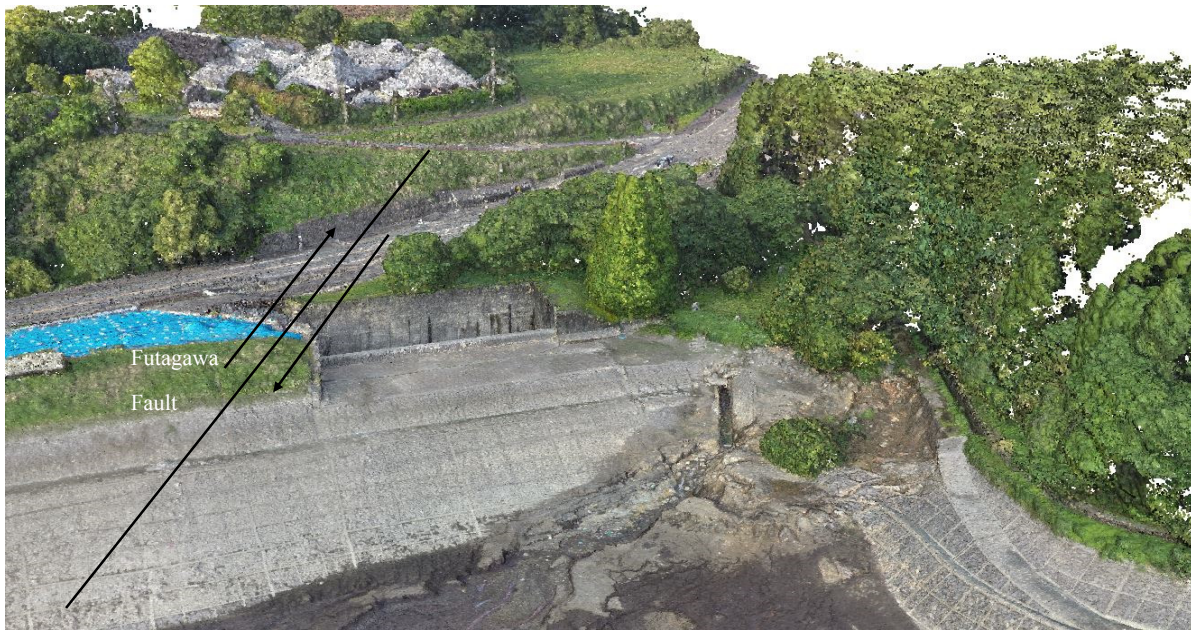
The Futagawa fault ruptured through an approximately 0.5-km long by 0.25-km wide water reservoir (32.8413°, 130.9317°). The fault rupture passed through the western flank of the reservoir and through the main spillway. No catastrophic release of water occurred; however, the reservoir experienced significant damage, both as a result of the surface fault rupture and as a result of the strong ground motions. This presents a valuable case history of the response of dams to surface fault rupture.

ervoir after the earthquake. A preliminary view of the spillway from the UAV-generated 3D model is provided in Fig.2. Preliminary, interactive 3D models are available at: <http://prismweb.groups.et.byu.net/JD/App/>.

Fig.2 Three-dimensional model of the spillway generated by UAV data.

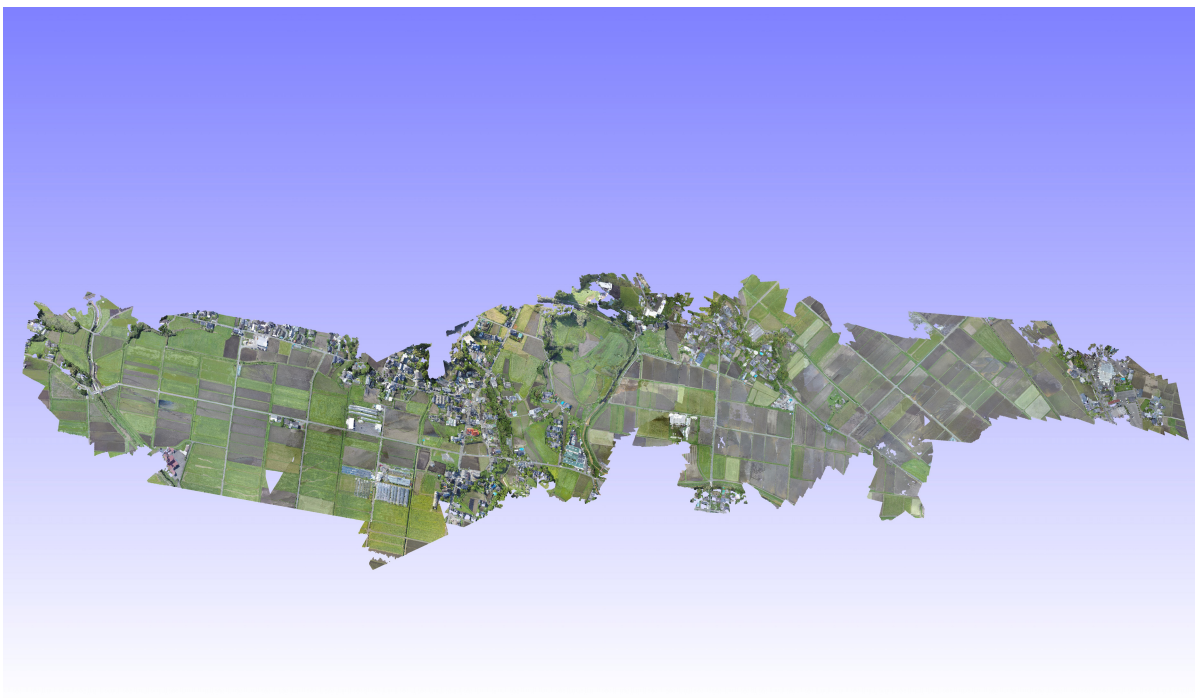
In the Aso Caldera, an approximately 10-km long “zone of depression” resulted from the Kumamoto earthquake mainshock²⁾. The zone of depression (32.9565°, 131.0368°) was typically 30-m to 110-m wide with roughly vertical offsets on each side of the depression zone of about 0.5 m to 2.5 m with a minor strike-slip component. The cause of the zone of depression is of interest. Potential causes include liquefaction, earth compaction, lateral spreading, and fault rupture.

Fig.3 Overall 3D model of the depression zone generated from UAV data.

of the deformation was also completed by GEER. A composite overview of the entire UAV-generated preliminary 3D model is presented in Fig.3. A preliminary, interactive 3D model of a residential house that was located immediately on the hanging wall of the depression zone is available at: <http://prismweb.groups.et.byu.net/JH/App/>.

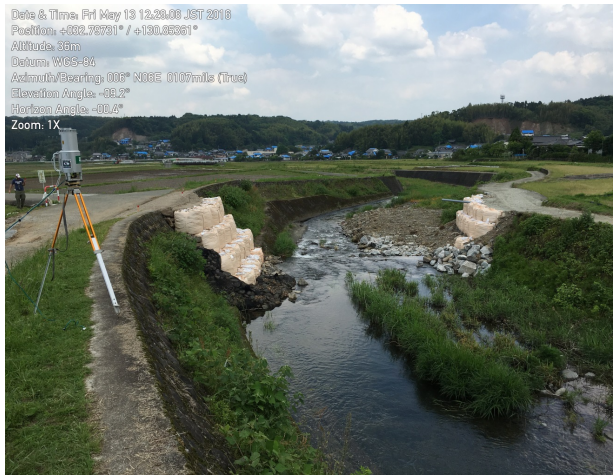
Fig.4 The terrestrial LiDAR setup and damage to the canal embankments. The main fault crossing is at the location of the repairs visible in the photograph.

Since this represents a relatively unique dataset for analyzing ground deformation resulting from surface fault rupture, GEER visited a number of sites in the aerial LiDAR coverage zone. Of particular interest was a location where the Futagawa fault crossed a canal embankment (Fig.4; 32.7974°, 130.8535°). The response of the embankment to underlying fault rupture might be useful for studies on the performance of levees, dams, and other earth structures subjected to surface fault rupture. GEER therefore

Although the canal was not full of water at the time of the earthquake, the damage observed by GEER was relatively minor, despite measured fault displacements of about 57 cm horizontal and 28 cm vertical. A second, conjugate fault, with opposite direction strike-slip motion, also happened to cross the canal embankment at roughly the same location, making the deformation field relatively complex. The estimated displacement on this fault was about 29 cm horizontal and 13 cm vertical.

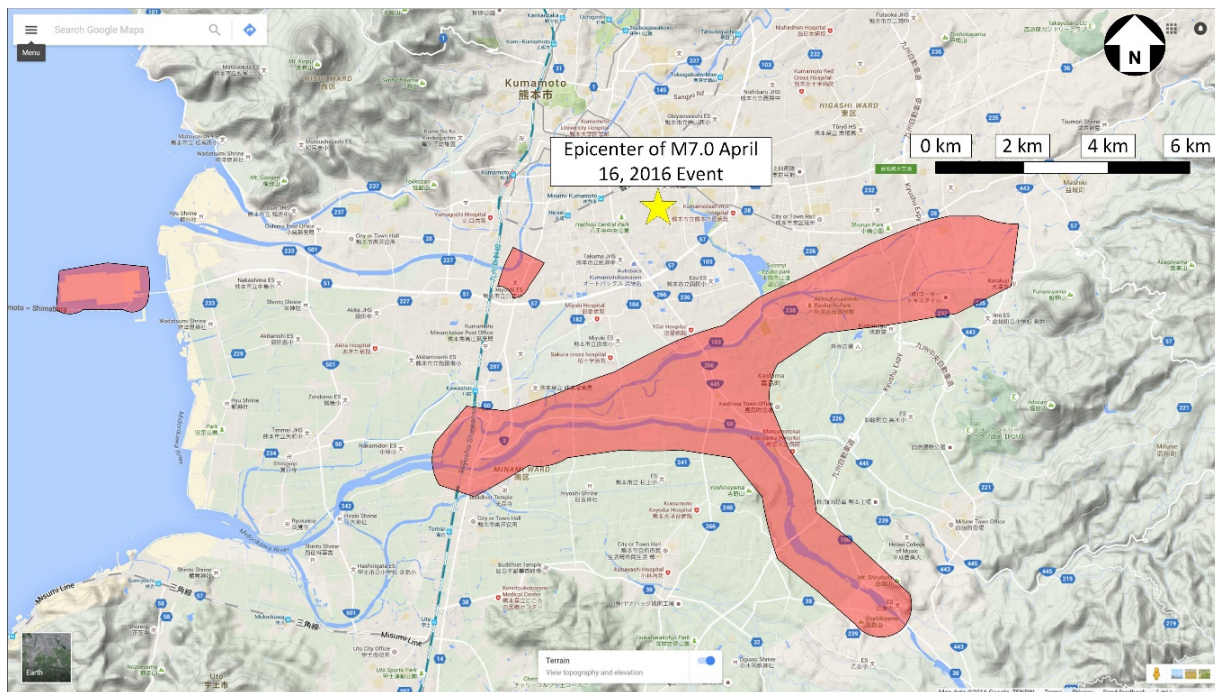
One of the striking features of this earthquake was the relatively low number of liquefaction sites observed given the extremely high ground motions recorded throughout the Kumamoto region and the large areas mapped as young alluvial deposits. GEER did visit a number of sites where liquefaction was observed, and other reconnaissance teams also observed a number of areas of liquefaction; however, many more areas of liquefaction was expected based on the team’s experience documenting liquefaction after earthquakes. A detailed map of liquefaction observed by GEER and as reported by others is provided in Fig.5.

Fig.5 A map produced by GEER of observed liquefaction in the Kumamoto region.

water levels, plastic (non-susceptible) soils, high soil relative density, age of the soil, volcanic geologic origin of the sediments, and non-surface expression of liquefaction. The GEER team expects that the soil plasticity, resulting from the volcanic origin of the sediments, is the most likely cause. The authors recommend that further studies (e.g., soil borings, laboratory testing, and in-situ testing) be conducted at liquefaction and non-liquefaction sites, where liquefaction would otherwise have been expected, to determine the causes of low amounts of liquefaction resulting from the Kumamoto earthquakes.

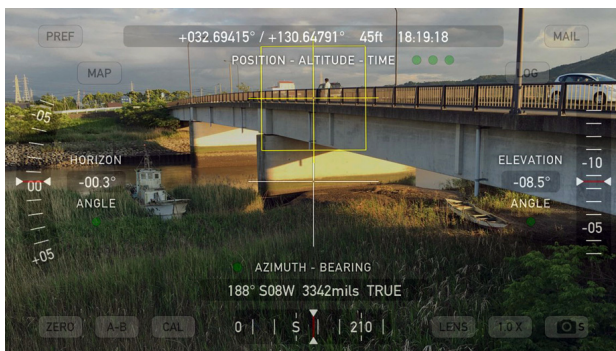
In addition to the relatively low amount of liquefaction observed, a relative lack of liquefaction-induced lateral spreading was noted by GEER. One case history in particular, a bridge along Route 501 crossing the Midorikawa River near Minamihashi-kami (Fig.6; 32.6934°, 130.6480°), may be valuable for understanding the lack of observed lateral spreads. The GEER team observed almost no visible movement of the bridge, the abutments, or the banks of the river. Only one minor sand boil, directly beneath the bridge in front of one of the abutments was observed, indicating that some liquefaction did occur at the site.

Based on boring logs from the construction of the bridge provided to GEER, very loose sands were reported here (with some SPT results as low as zero) at relatively shallow depths. Given these site conditions, lateral spreading would likely have been expected; however, none was observed to have occurred.

Fig.6 The Route 501 bridge that was not subjected to visible lateral spreading as would have been expected given the soil conditions at the site.

Therefore, the GEER team speculates that the plasticity, fines content, or angularity of the particles may have contributed to the relative lack of lateral displacement. Similar to the lack of liquefaction, the authors recommend that further soil testing be conducted here to evaluate this case history and add it to the wider database of lateral spreading case histories.
