Damage investigation of 2019 the Off the Yamagata Prefecture earthquake, $M_j6.7$

Key Facts

Key Words: *Off the Yamagata Prefecture earthquake, Earthquake damage investigation, tile roof, Aerial photograph, Site amplification characteristics*

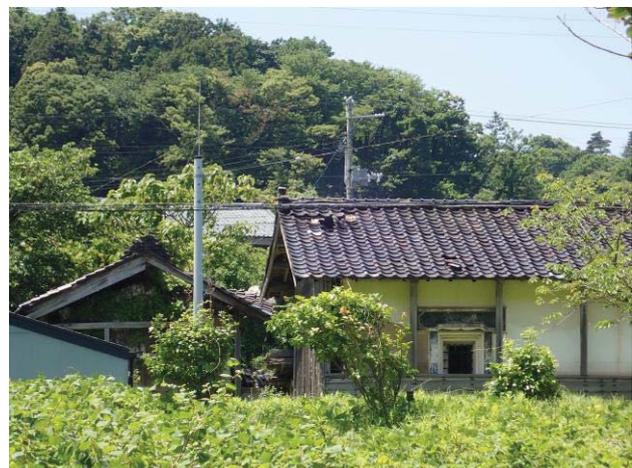
Photo 2 Slightly damage of the roof tile on the wooden house in Kangawa area (N38.451535, E139.496093).

We confirmed minor damage of tiled roof a little far from NIG006. **Photo 2** shows damage of tiled roof. But, there were no major damage around NIG006 as far as we investigated.

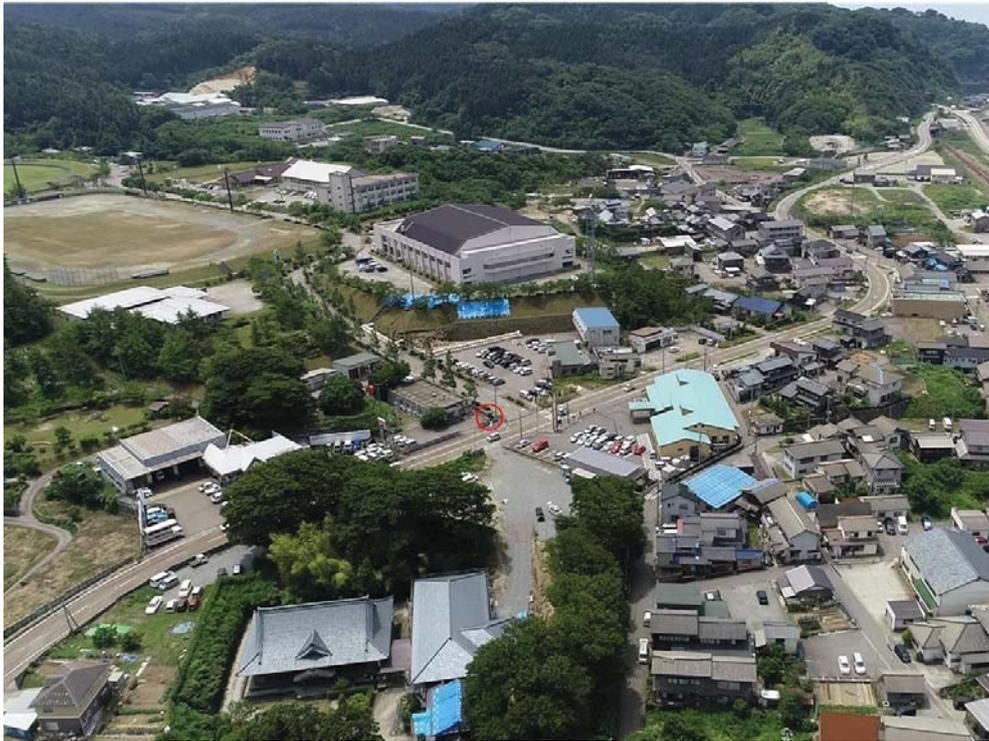
Photo 5 shows aerial photograph around Fuya station by UAV which was taken on the 21st of June, 2019. Red color circle indicates Fuya station. Serious damage such as total collapse of house is not seen in **Photo 5**. The building and housing near Fuya station were no major damaged. Furthermore, there were no

Photo 5 UAV photograph around Fuya seismic station on June 21st, 2019 where seismic intensity 6+ was observed. Red circle mark indicates seismic station (N38.514137, E139.534167).

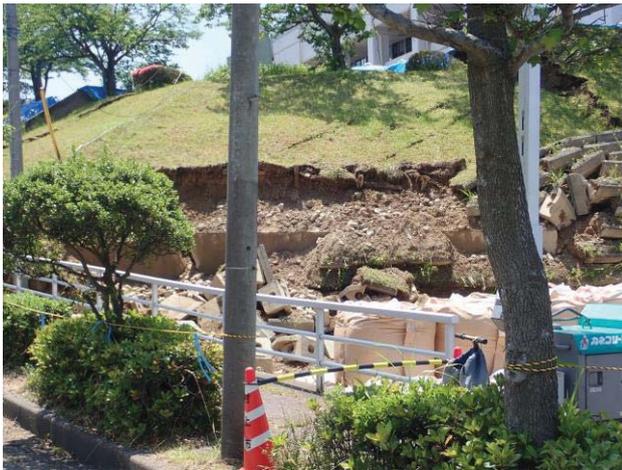
Photo 6 Slope failure of development land in near Fuya station (N38.513557, E139.534312).

damages in traffic lights and illumination poles. Minor slope failure of development land which was constructed by filling, occurred in near Fuya station. **Photo 6** shows situation of slope failure.

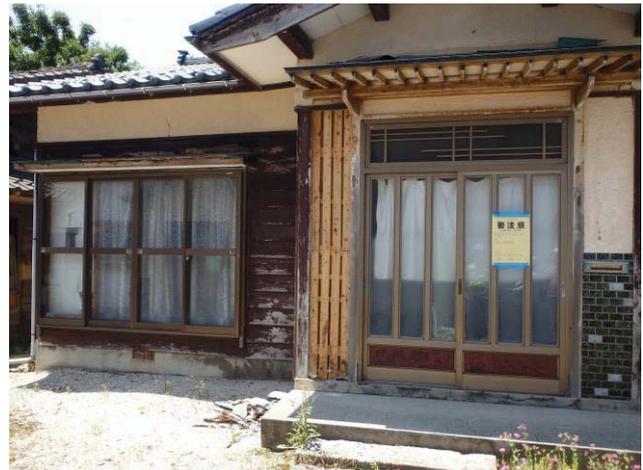
Photo 8 Damage of exterior building material of old wooden house in Fuya area (N38.516733, E139.534405).

Typical minor damages in Fuya area are shown in **Photo 7**, **Photo 8** and **Photo 9**. **Photo 7** is damage of tiled roof on the wooden house. Some roof tiles are slid off from their original position. **Photo 8** is damage of exterior building material of old wooden house. A part of the outer wall dropped and an emergency safety evaluation result of caution posted on the entrance door. **Photo 9** means tiled of the block fence with no reinforcement.

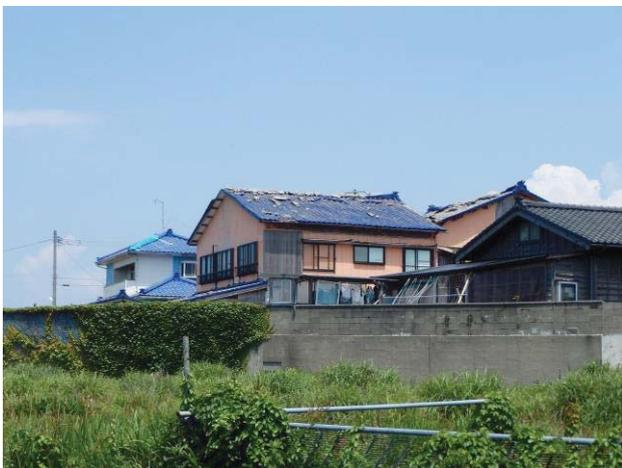
Photo 7 Damage of the tiled roof in Fuya area (N38.516572, E139.533605).

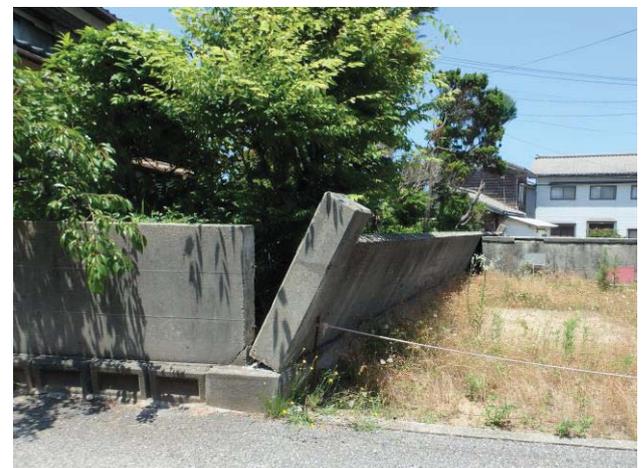
Photo 9 Tiled of the block fence without reinforcement in Fuya area (N38.514325, E139.53343).

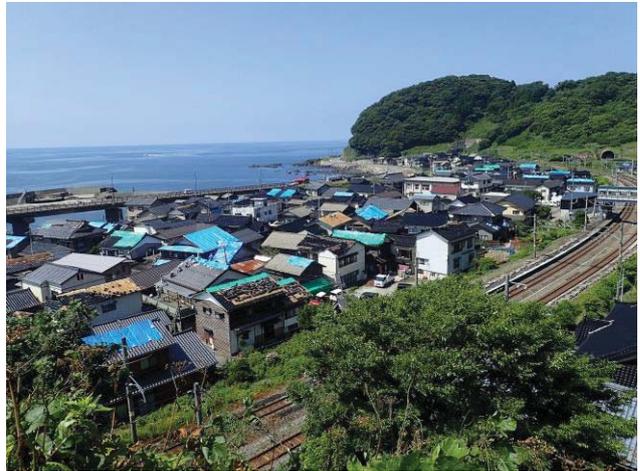
Koiwagawa area is located most close to epicenter. Main damage is tiled roof of wooden house. Many tiled roofs were damaged and covered with blue sheets for protecting rain. **Photo 10** shows damage situation of Koiwagawa area. Some of damage house has been repaired.

Photo 10 Damage situation of Koiwagawa area (N38.589305, E139.56581).

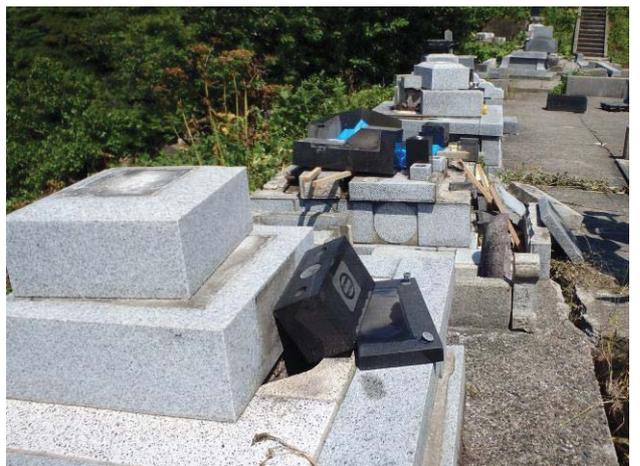
In the cemetery on the hill of elevation 30 m, many tombstones fell down. There are small scale slope failures. The damage causes are regarded as slope failure or amplification of the ground motion by the slope. **Photo 11** shows damage of cemetery. We discuss the tiled roof damage in next chapter in detailed.

Photo 11 Damage of tombstone at Koiwagawa (N38.589553, E139.565355).

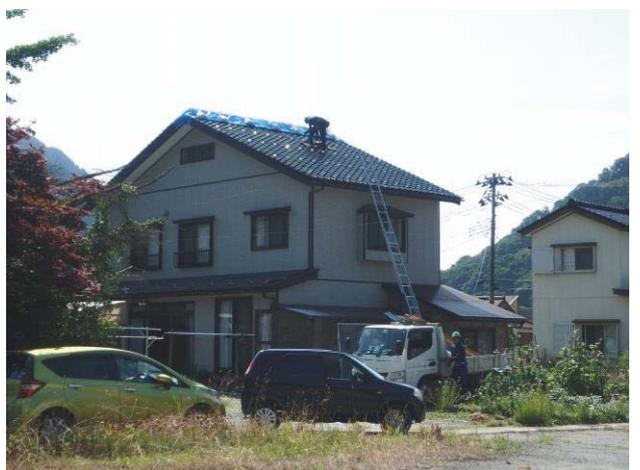
We investigated around Atsumi Onsen area along the Atsumi gawa river. The roof of a few housing was damaged. **Photo 12** shows damage of roof. From the position of the blue sheet, it is thought that the damage of the tile occurred at the upper part of the roof. Seismic station of YMT004, which observed intense ground motion with $PGA > 600 \text{ cm/s}^2$, has been installed at a distance of 1.6 km west from the investigation area (**Fig.3**). Damage of Yuatsumi area

Photo 12 Damage of the tiled roof at Yuatsumi area (N38.615022, E139.60404).

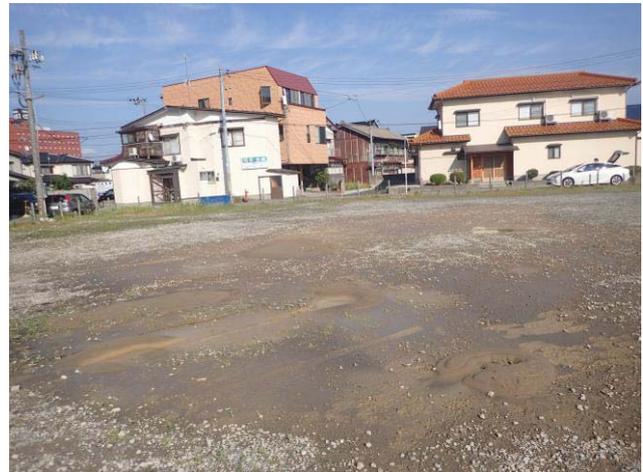
Soil liquefaction occurred at a parking space of the near Tsuruoka railway station. **Photo 13** shows soil liquefaction. There are many sand boils in parking space, but liquefaction occurred in a part of the parking space. Houses around liquefied parking space were no damage (see **Photo 13**). In this investigation, we were not able to find soil liquefaction in other site of Tsuruoka area. Soil liquefaction has been confirmed Sakata City, 15 km north of the Tsuruoka area⁸⁾.

Photo 13 Multiple sand boils by liquefaction at Tsuruoka area (N38.738543, E139.836162).

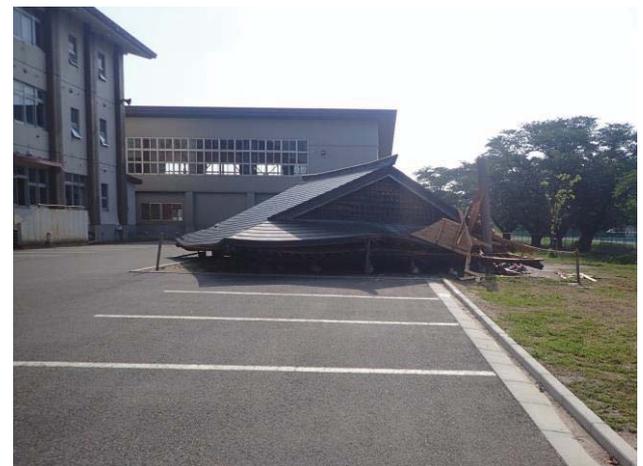
Roof collapse of Sumo ring occurred at Oizumi Elementary School in Shiroyama, Tsuruoka City. **Photo 14** shows damage situation. The damage was not seen in a school building and the near housings. YMT003 is located in two kilometers west from Oizumi Elementary School. Seismic intensity 5+ and PGA more than 180cm/s^2 were observed. But damage of near seismic station is not reported.

Photo 14 The roof of the Sumo ring in Oizumi Elementary School which collapsed (N38.615, E139.604167).

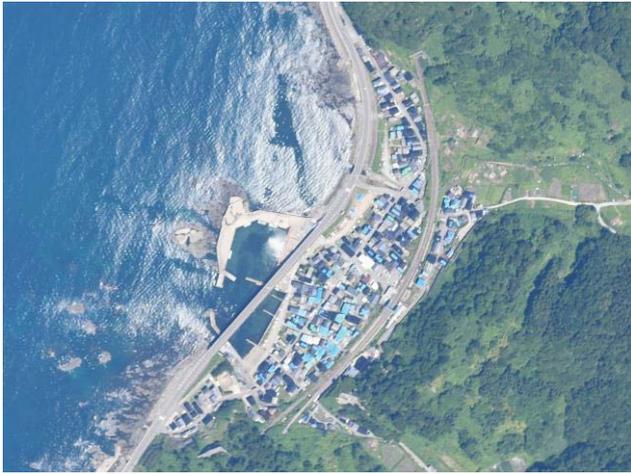
Photo 15 - 17 shows aerial photographs of Koiwagawa area, Wasada area and Oiwasaga area respectively. These aerial photographs were taken on June 26th. Many blue sheets are seen in Koiwagawa area. On the other hand, there are few blue sheets in Wasada area and Oiwasaga area. **Table 1** shows the results of roof damage evaluation by aerial photograph. In Koiwagawa area, 58 housings, about 30% of the target housing, were damaged. At the time of the field survey, some tiled roofs were repaired. Therefore, it is considered that actual number of damaged houses was greater than estimated. On the

Photo 15 Aerial photograph in Koiwagawa area on June 26th, 2019⁹⁾ (N38.5893, E139.5658).

different from other sites. Furthermore, according to the aerial photograph of Koiwagawa area (**Photo 15**), most of the damaged houses are located in the center of the area. From this result, it is estimated that the site amplification characteristics of Koiwagawa area is different by location. Detailed ground investigation is necessary to elucidate these results.

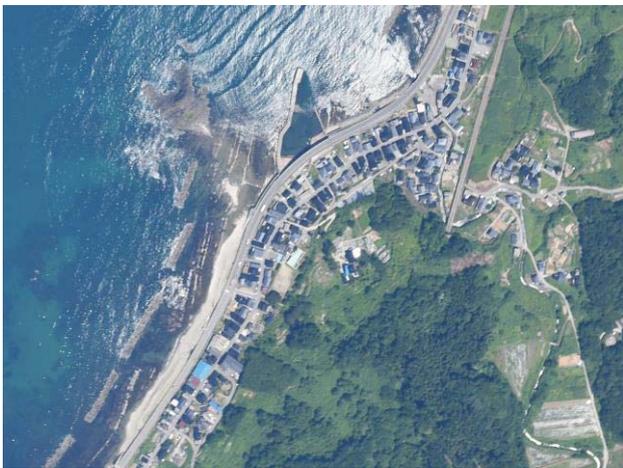
other hand, evaluated damage ratios of Wasada area and Oiwasaga area are 0.99% and 2.59% respectively. These values are clearly lower than Koiwagawa area.

Photo 16 Aerial photograph in Wasada area on June 26th, 2019⁹⁾ (N38.5740, E139.5564).

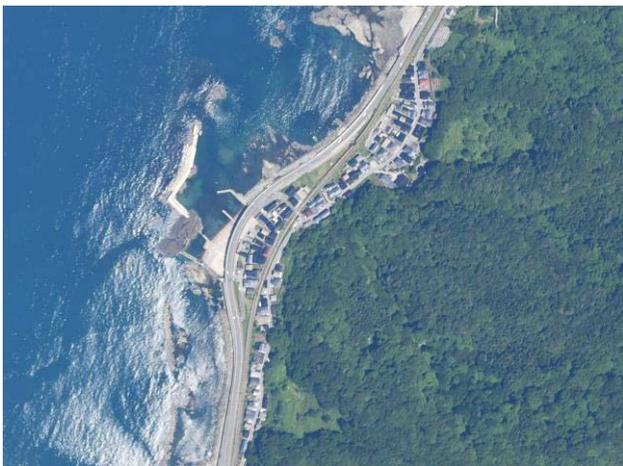
Photo 17 Aerial photograph in Oiwigawa area on June 26th, 2019⁹⁾ (N38.6084, E139.5758).
