RECONNAISSANCE REPORT ON THE EARTHQUAKE IN OSAKA-FU HOKUBU ON JUNE 18, 2018

Key Facts:

Key Words: *earthquake in Osaka-fu Hokubu on 18 June 2018, reconnaissance report, earthquake ground motion, source effect, lifeline damage, civil life*

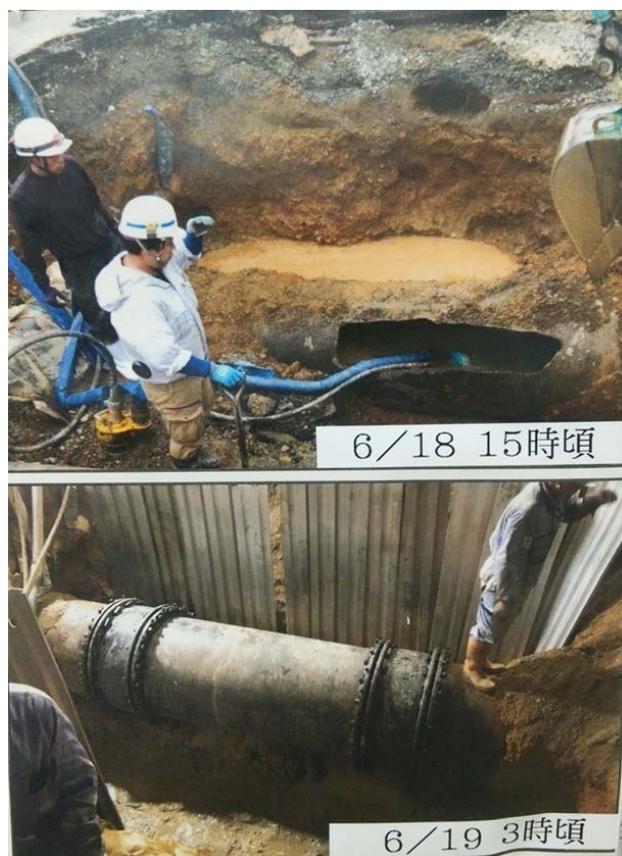
The most affected damage to the surrounding municipalities was the ductile cast iron pipe DIP (A) of the drinking water with the diameter of $\phi 900$ in Shimotanabe-cho, Takatsuki City (**Fig.17**). Water began spurting from the road surface immediately after the earthquake. Closing valves started by workers at approximately 10:30 on the same day and were completely closed by 11:00. Pipe breakage was confirmed at 15:00. The breakage was approximately 0.3×1.5 m in the 1–2 o'clock direction in the section against the water flow direction and its point was the body part of a 6-m straight pipe. The burial depth was 1.6 m from the ground surface to the top of the pipe. The construction year was 1963. The pipe was a ductile cast iron pipe with mortar lining. Extensive corrosion unevenness was confirmed on the damaged pipe body. Several pipes were buried in parallel under the road where the damaged water transmission pipe in the fourth extension line was buried, including the transmission pipe in the fifth extension line ($\phi 1600$), the industrial water transmission pipe ($\phi 900$), and the main distribution pipe of Takatsuki City ($\phi 500$). However, damage to the adjacent pipes owing to water leakage was not reported. The amount of water that leaked from the damaged transmission pipe reached $16,000 \text{ m}^3$ (50 times an elementary school's pool with 25 m in length) and flowed out to the idle land of the factory on the west side of the road. The pipeline was restored overnight; this work was completed by 9:45 on the day following the earthquake, at which point the road was reopened.

Fig.17 Damage of water transmission pipe DIP (A) ($\phi 900$) in Takatsuki City (from OWSA)

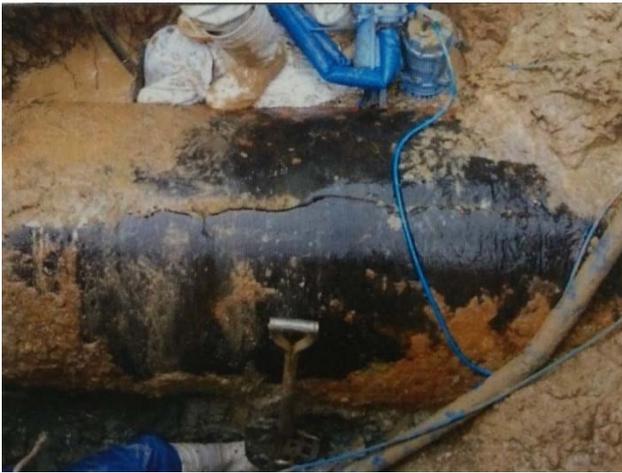
The second instance of damage to drinking water was a ductile cast iron pipe DIP (B) in Suita City ($\phi 800$) (**Fig.18**). The construction year of this pipe was 1965, and this pipe was in the same fourth extension line as that mentioned above. A crack approximately 1.6 m in length occurred in the pipe axis direction at the top of the pipe buried beneath the sidewalk. The damaged pipeline was a transmission line to Suita City and Toyonaka City. Until the restoration, the workers attempted to send water in the opposite flow direction from the Senri purification plant, but the valve did not move and the water could not be redirected. It took 54.5 hours to restore this pipeline.

Fig.18 Water transmission pipe in Suita City DIP (B) ($\phi 800$) S40 (from OWSA)

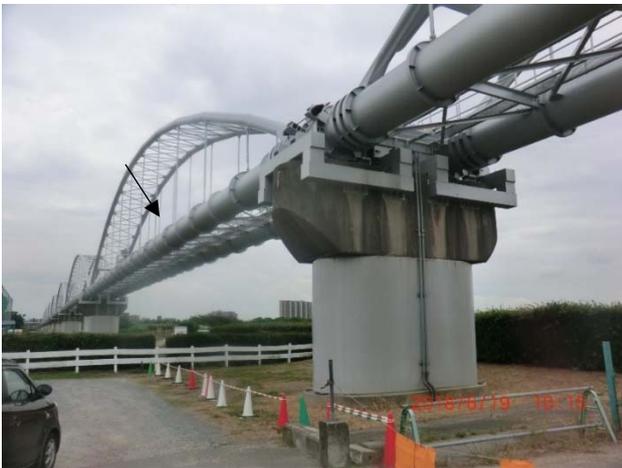
Much of the water leakage valve damage was caused by contaminant clogging. There is also the case of the Hirakata Water Pipe Bridge, which was completed in 1964 on the downstream side of the Hirakata Bridge over the Yodo River, the boundary between Takatsuki City and Hirakata City. Two air valves attached to the pipe on this water pipe bridge were damaged. This bridge is a Langer truss bridge with 10 spans and two pipelines of $\phi 1200$ each. The pipeline on the river's downstream side, which is part of the fourth extension line, was under suspension because of the renewal construction of buried pipes at the downstream side of the lines at the time of the earthquake (**Fig.19**).

In the pipe on the upstream side, which is a part of the fifth expansion lines, two of the five air valves were damaged on the water pipe bridge. The grey cast iron air valve boxes showed brittle failures at both points (**Fig.20**). After the earthquake, the air valves were closed. Three other air valves were renewed before the earthquake and there was no earthquake damage at this time.

Fig.19 State of Hirakata Water Bridge. Front 5 expansion line and rear side 4 expansion line. One of the leaked air valves is indicated by an arrow

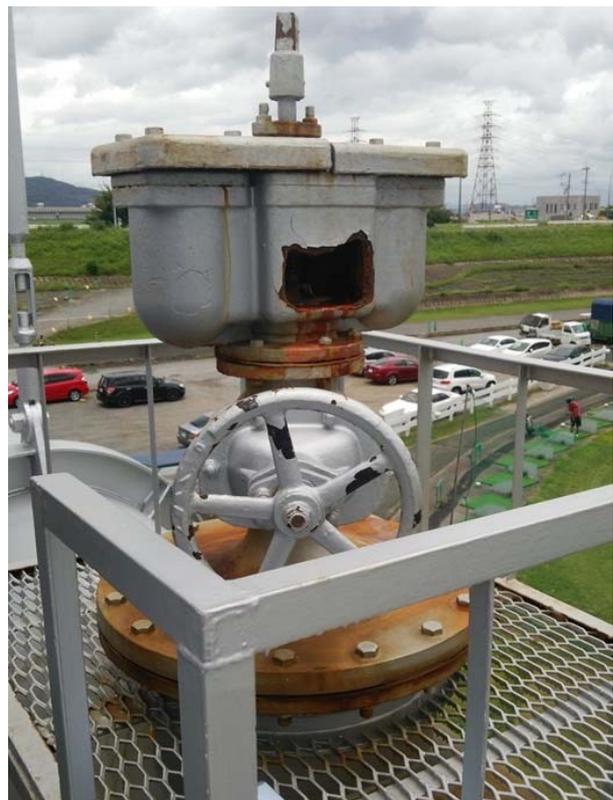
The damage owing to the destruction of the ductile cast iron pipes is similar to that in the grey cast iron pipes observed in the Hyogo-ken Nanbu earthquake in 1995 and previous earthquakes. Considering that only the fourth expansion line (1960–1965) of the OWSA was damaged, even though numerous major water transmission pipes of the fourth and fifth extension lines (1965–1972) are laid in parallel under the same road, it is assumed that the pipe material used during the construction period is responsible for the damage, not the local conditions (e.g., soil, topography, water pressure, geometric pipe shape). The damaged pipelines were all constructed in the mid-1960s, which was the transition period from cast iron pipes to ductile cast iron pipes owing to improved pipe materials. These were so-called early ductile cast iron pipes. The Japan Ductile Iron Pipe Association specified in 1959 that the elongation rate of the

pipe be at least 3%. This was later modified by the JIS standard in 1974 to state that the ductile (spheroidal graphite) cast iron pipe should have an elongation rate of at least 5%, and the JIS standard in 1982 stipulated that the ductile cast iron pipe should have an elongation rate of at least 10%. Therefore, the specifications of ductile cast iron pipes currently on the market differ from those of earthquake-damaged pipes. Considering that damage (e.g., joint leakage) was scarcely reported in this earthquake, it is unlikely that the damage was caused by ground deformation from the earthquake. It is also conceivable that at the time of the earthquake, water in the pipe had an inertial force and that temporary water column separation occurred (i.e., a vacuum state formed in the pipe) owing to the shaking of the seismic motion or some action, and when water was pulled back to the vacuum, a water shock pressure occurred. It is considered that the pipes deteriorated by age were likely to be damaged at the bottom by the stationary load, but that all of the damage was in the upper half of the pipes in this earthquake. Considering that pipe material quality is crucial, it is also necessary to examine the damage mechanism in detail.

Fig.20 Air valve of the Hirakata Water Bridge showing brittle failure of the air valve box

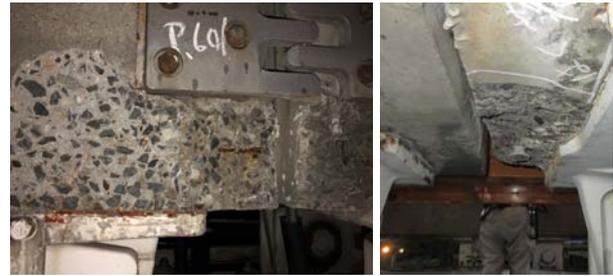
Fig.27 Concrete failure at the joint of the PC rail girder (from Osaka Monorail)

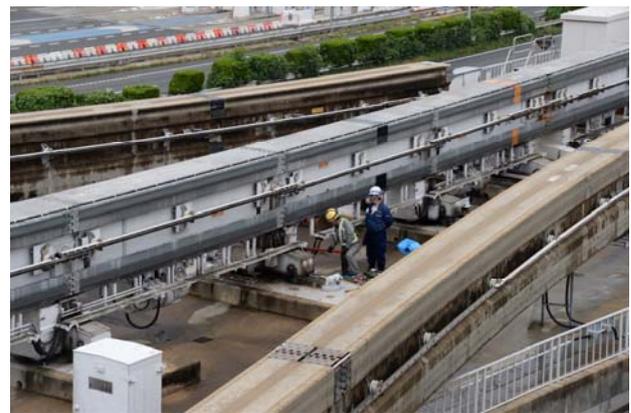
Although the damage to the civil structure remained minimal, the failure of the monorail switches hindered the resumption of operations (**Fig.28**). Because the switches were used not only for the turnout of the main line/branch line but also for exchanging the upper and lower lines (U turn) in the station building and exits of the repair train used for checking the rail girder, it became impossible to make them work.

Fig.28 Repair situation of the PC orbit girder branch taken on June 19, 2018

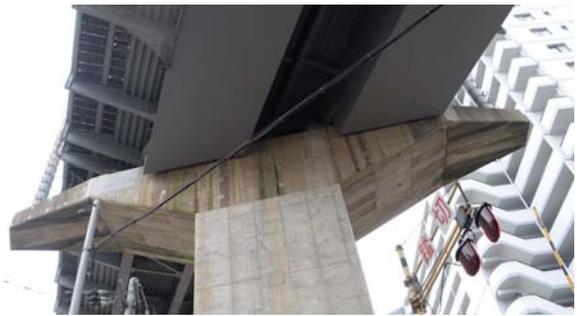
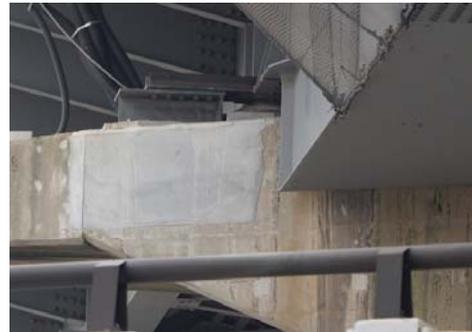
A report was published about the bridges over National Highway No. 176 west of Shin-Osaka station. The stopper at the mount part of one girder was damaged and the concrete piece was in danger of falling. This bridge is a box girder with a large skew angle (Fig.31). The 1995 Hyogo-ken Nanbu Earthquake damaged the stopper of the bearing, after which stoppers were added to the side surface of the girder. In this 2018 earthquake, the attached part of the added stopper was damaged. The damage is thought to have been caused because the distance from the edge at the mount could not be sufficiently secured because of the shortage of space on the side part. After the earthquake, a new stopper was installed and restored.

Fig.31 Damaged bridge (repaired left side)

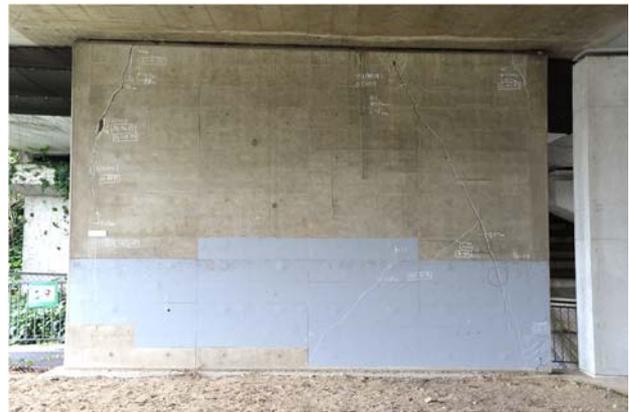
The rocker pier supports only the vertical force and the horizontal force is supported by the rigid frame pier and the abutment at both ends of the girder. Between Ibaraki and Takatsuki, piers were added during widening construction in several sections (**Fig.34**). When the girder was widened after opening, rocker piers were added to both sides of the original bridge piers, in addition to the bridge piers at the time of opening in the intermediate piers. In the 1995 Hyogoken Nanbu earthquake, severe damage occurred in the rigid frame pier in the viaduct with the rocker bridge piers. Thus, a seismic reinforcement, namely, a rubber bearing and damper, were installed at the bearing of the viaduct end. The stopper was installed in the transversal direction of the bridge (**Fig.35**). Shear cracks due to the earthquake were found in the initial constructed piers (**Fig.36**). In terms of the seismic reinforcement part of the rigid frame pier, a steel bracket on the stopper in the transversal direction hit the pier head (**Fig.37**). It is therefore understood that it moved in the transversal direction of the bridge within the allowable displacement. Although no damage was found on the rocker piers of the widened part, and no girder settlement was found even at the pier part where the oblique crack occurred, a vent for vertical support of the girder was set up when the site was revisited on July 11.

Fig.36 Damaged rocker pier (taken on June 21, 2018)

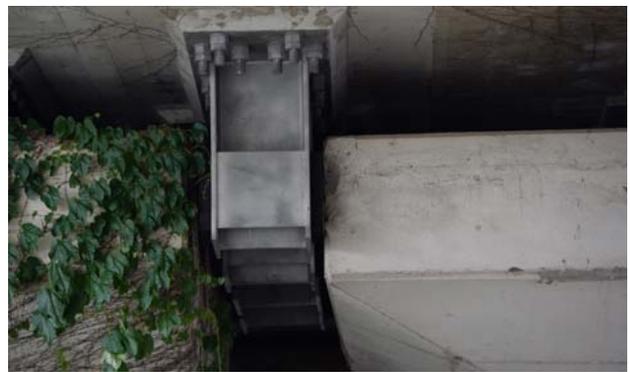
Fig.37 Collision of stopper in transversal direction (taken on June 21, 2018)

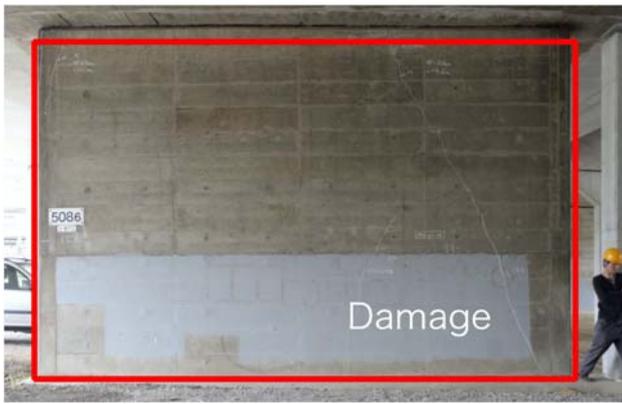
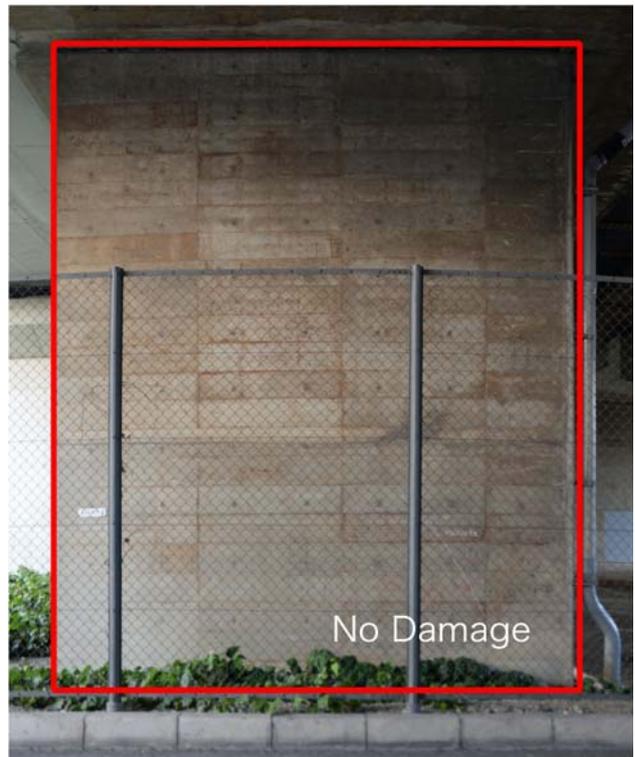
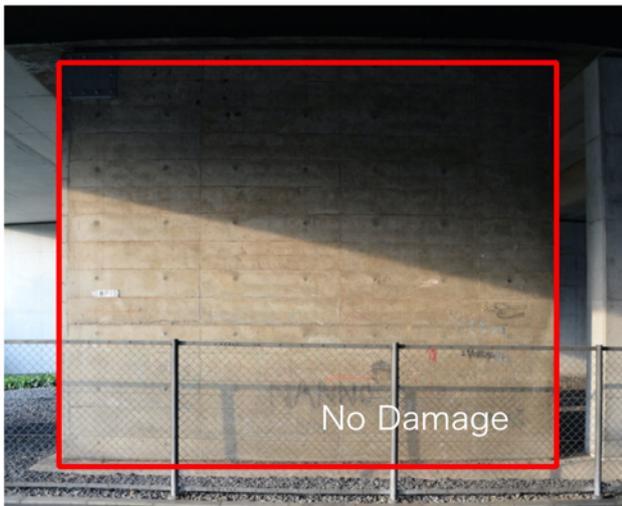
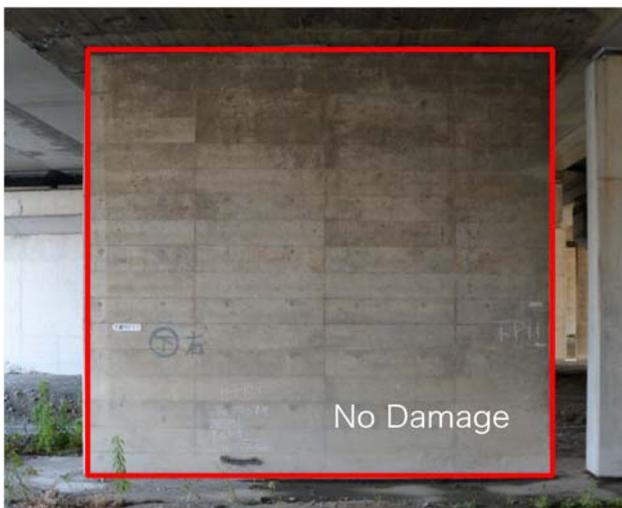
Surrounding viaducts with the same structure were assessed, but no other damage was found. It can be concluded that the influence of the shear was large and cracking occurred in this section because the height of the pier was lower than the others (**Fig.38**).

Fig.38 Comparison of damaged and undamaged rocker bridge piers
