Reconnaissance survey on geotechnical damage caused by February 6, 2023, Kahramanmaraş Earthquake, Türkiye

Key Facts

Key Words : Kahramanmaras Earthquake, geotechnical damage, liquefaction, lateral spread, landslide, inundation, settlement

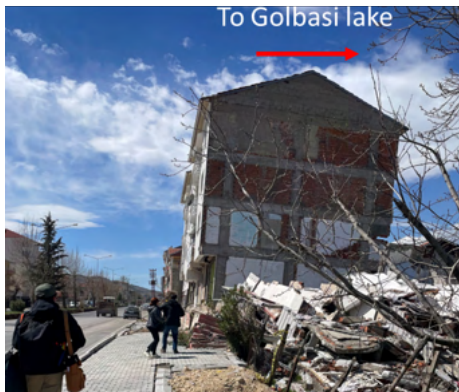
Fig. 2 Tilted houses in Golbasi, Adiyaman due to effect of liquefaction (37.79035N, 37.6519E).

During our survey, we observed many settled and tilted midrise buildings as typically shown in Fig.2 and Fig.3, due to the effect of liquefaction and bearing capacity loss. The largest observed settlement was about 1.5 m, which resulted in parked cars crashed under the 1st floor balcony level (Fig.4). Another structure with a 0.8 m thick mat foundation tilted until it leaned against the neighboring building. Ejected soil (Fig.5), which was mainly reddish-colored silt and clay was also observed with a plasticity index of 17.7. Additionally lateral spread in the region surrounding the Golbasi lake was observed.

It was not only the old buildings, but several newly built structures also experienced similar types of tilting and subsidence related damages. The region is classified as suitable for a settlement with earthquake hazard precautions, meaning that adequate soil investigations before construction and adequate design and construction of a foundation accordingly is desirable. Since the observations in the region showed the existence of ground with liquefaction potential, these precautions listed above should be followed strictly for the future structures.

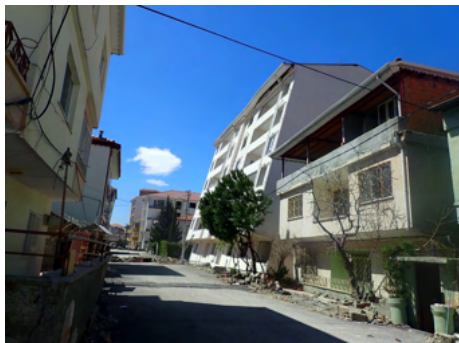
Fig. 3 Tilted houses in Golbasi, Adiyaman due to effect of liquefaction (37.787739N, 37.643769E).

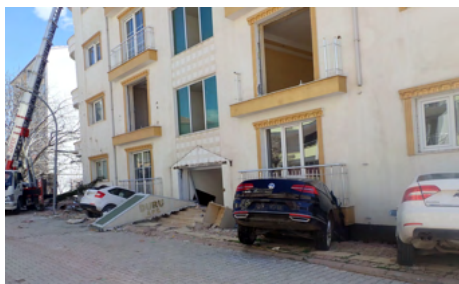
Fig. 4 Parked cars crashed under the settled building (37.787861N, 37.643083E).

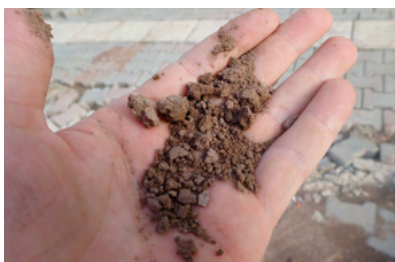
Fig. 5 A sample of ejected soil (37.788194N, 37.642861E).

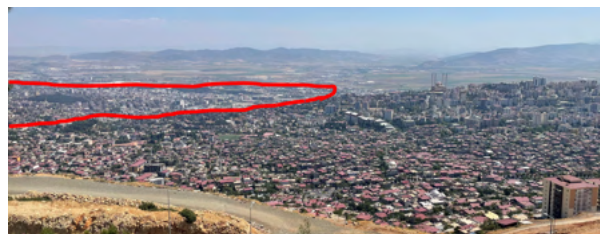
Fig. 6 A view of plain and hilly region of central Kahramanmaras (from a hill at 37.60141N, 36.91263E).

Fig. 6 is a view of Dulkadiroglu and Onikisubat Districts (from a hill at 37.60141N, 36.91263E) that forms the central part of Kahramanmaras City. Although both districts were affected by the earthquake, more severity was observed in the area circled with a

red line, which is located on the plain region. Being the central part of the metropolitan city, this region was as densely populated as the hilly region on the right side of the photo. Since several structures have either collapsed or demolished due to being heavily damaged, which resulted in clear observation of the different damage levels in the plain and the hilly area. Although it is hard to conclude that the damages are due to the ground effect only, it is clear that ground effect contributed to the damage level observed in the region.

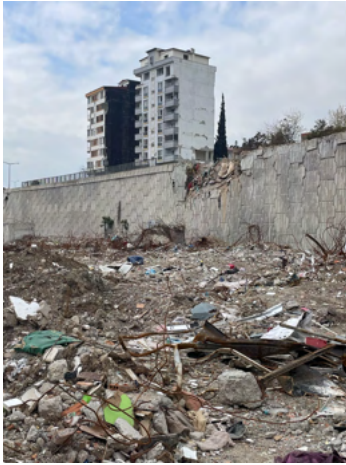
Fig. 7 A well-performed reinforced earth retaining wall with a damage occurred during the demolishing works of heavily damaged building nearby (37.57320N, 36.91964E).

The photo of the damaged region given in Fig. 7 was taken at Ebrar housing estate consists of 12 blocks, of which 8 totally collapsed and 4 heavily damaged, each block with 10 floors with 4 flats each floor (total of 320 flats totally collapsed). Tobita et al.¹²⁾ reported that the dominant period of this damaged site was about 0.24 s, longer than any other sites they measured in Dulkadiroglu and Onikisubat Districts. Although the reinforced earth retaining wall performed well during the earthquake, the damage seen in the photo happened during the demolishing works of the heavily damaged buildings.

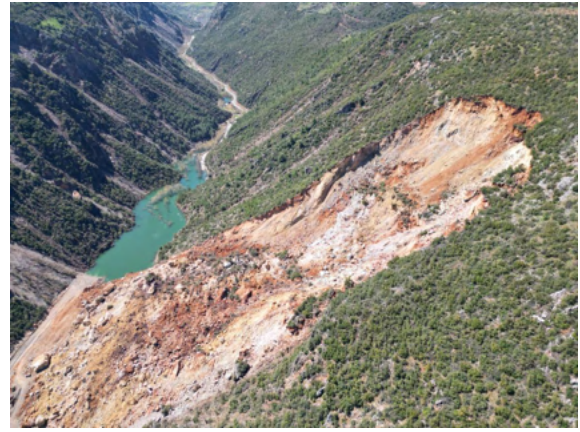
Fig. 8 shows a landslide triggered by the earthquake which resulted in formation of a natural dam at Degirmencik Creek Basin in İslahiye. Observations were made by a drone at a bauxite mine, which is on the top of the mountain where the landslide had happened. This basin is primarily composed of Paleozoic dolomites, Mesozoic limestones, and Quaternary slope debris-cone, alluvial, and basalt units¹³⁾. The altitude in the landslide region is around between 550 m to 1084 m above the sea level.

Fig. 8 Landslide at Degirmencik Creek Basin in İslahiye, Gaziantep (37.00537N, 36.59151E).

the road and the stream between Idilli and Degirmencik neighborhood was blocked with the landslide and a natural dam lake was formed. Since there is a risk of flooding The General Directorate of State Hydraulic Works (DSI) opened a spillway and the 15 m water level decreased to 6 m within five months¹⁴).

3. In Islahiye, formation of a natural dam due to the landslide and mitigation for the removal of water in the formed lake is observed. Since there are settlements downstream, this landslide dam should be monitored against the breaching risk.
4. In Tepehan, a landslide of a gentle slope occurred in a vast area. Since the soil blocks moved without losing their shapes, the possibility of a weak layer parallel to the ground surface is discussed.
5. Several road embankments were damaged by the earthquake. In particular, damages were observed on the road embankments where a water channel/river running alongside the road, which were caught in the liquefaction-induced lateral spreading of their foundation.

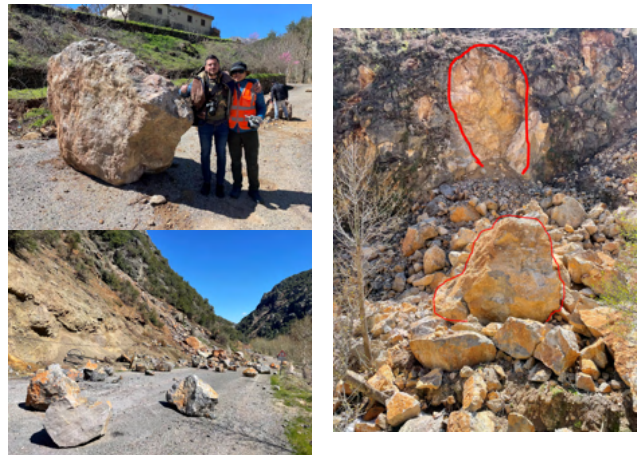
Fig. 10 Rockfall in Idilli (36.99072N, 36.57813E).

In Idilli, rockfall was also observed as shown in Fig. 10 at around 2 km distance from the abovementioned landslide and the observed type of rock was dolomite.

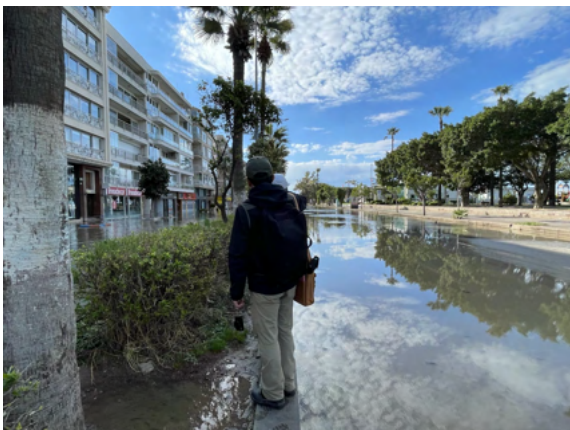
The main road called Ataturk Boulevard sits on the reclaimed area in the coastal region of the town. As shown in Fig. 11 this road is inundated after the earthquake due to severe ground settlement and damage to the lifelines underneath with liquefaction. Additionally, water coming out of the manholes and local residents removing water with pumps from the basement of the buildings was observed. Lateral

Fig. 11 Inundation of Ataturk Boulevard in Iskenderun (36.59280N, 36.16768E).

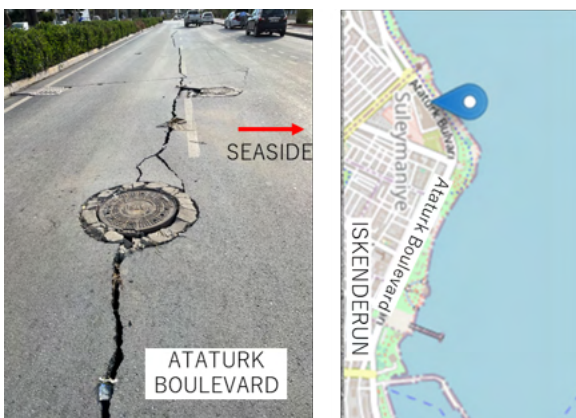
Fig. 12 Cracks along Ataturk Boulevard in Iskenderun due to lateral spreading.

spread and several ejected sands were also observed in this area. In Fig. 12 cracks on the road around the manholes are observed in longitudinal direction to the seaside. Seven months after the earthquake there were TV reports showing the region was still inundated¹⁶).

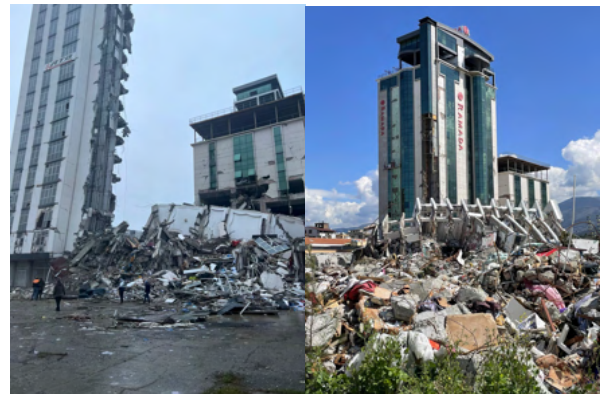
The collapsed structure in Fig. 13 was a structure consisting of two blocks, which was completed in 2019. First block collapsed by the effect of the first earthquake, while the second block lost the stairs and totally collapsed by the effect of the second earthquake¹⁸). A ground investigation in this region reported that the ground is mainly formed of quaternary silty sand and sandy clayey silt, which is formed

Fig. 13 A collapsed structure in front of Ramada hotel in Iskenderun (36.58899N, 36.17712E), photo on the left taken after first earthquake¹⁷), photo on the right during the survey.

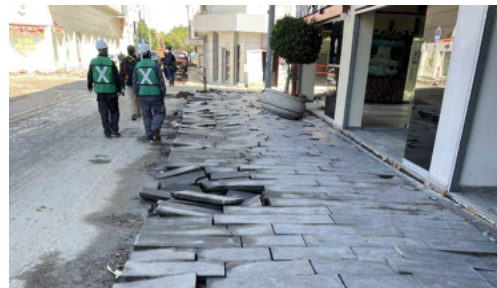
Fig.14 Sidewalk damage with the effect of liquefaction (36.58954N, 36.17355E).

At several locations sidewalk damage with liquefaction was also observed (Fig. 14). Additionally, there were differential settlements and tilting of several structures (Fig. 15).

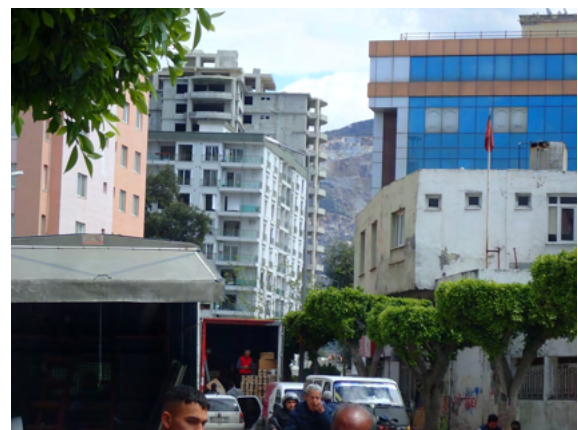
Fig.15 An example of tilted buildings in Cay Neighborhood, Iskenderun (36.587222N, 36.176639E).

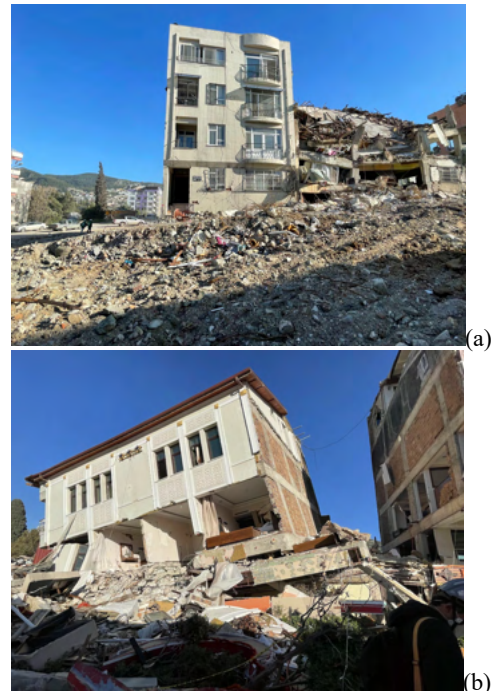
Fig. 17 Heavily damaged buildings in Antakya; (a) 36.19846N, 36.15393E (b) 36.20186N, 36.16133E.

The values of the natural periods are favorable for structures in terms of earthquake engineering; however, the observed heavy damage rate might be due to the basin effect causing localized amplifications of surface waves, which will be clarified with further detailed studies.

Several structures in Antakya were either totally collapsed or heavily damaged (Fig. 17) and the removal of debris was under effect during the survey. Similar to Kahramanmaras, damaged structures were concentrated in the plain and the damage rate was decreasing through the hilly region. Yet, it is difficult to conclude that the observed damage was only due to ground effect, but it did clearly contribute to the high damage rate. Since the effect was similar in both Kahramanmaras and Antakya, rather ground being the only reason to the damages, an appropriately

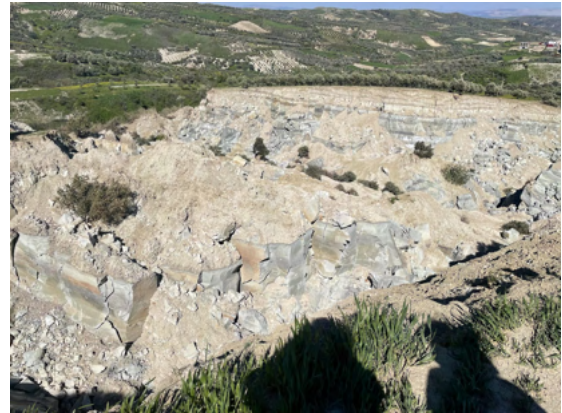
In Tepehan, a large slope failure at an olive field was observed (Fig. 19). In this region, Tepehan formation is mainly represented by sandstone and clayey limestone²³⁾. The weathered surface of the

sandstones within Tepehan Formation is light grayish-brown, while the freshly broken surface is yellowish-beige in color, which was also observed as shown in Fig. 19 during the survey.

Fig. 19 A close up of top part of Tepehan landslide (36.1609N, 36.2211E)

mately 4° . The landslide affected 500 m long and 100 to 150 m wide region and soil blocks moved while retaining their shapes, which are similar features observed in 2008 Aratozawa landslide²⁵). Hence the landslide may have occurred due to the presence of a weak thin layer almost parallel to the surface which is weakened with the effect of the earthquake and resulted in soil blocks above to move while retaining their shapes.

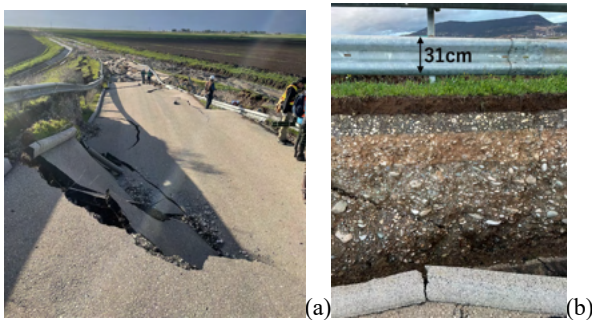
Approach embankment of an overpass bridge crossing the O-52 highway between Gaziantep and Nurdagi experienced a severe settlement damage at both north and south side of the highway. The settlement damage at the north side of the highway is shown in Fig. 21(a), and the cross-section of the embankment became visible at the north side with the settlement of the road is shown in Fig. 21(b). This damage is considered to have happened with the lateral spreading of the embankment as a result of liquefaction of its foundation ground, which resulted in its severe settlement. In fact, a 15 m wide water channel running along the embankment at a 5 m distance had around 10 m decrease in its width.

Fig. 21 (a) Settlement damage of the embankment observed during the survey (37.28379N, 37.11392E) (b) a cross-section of the embankment

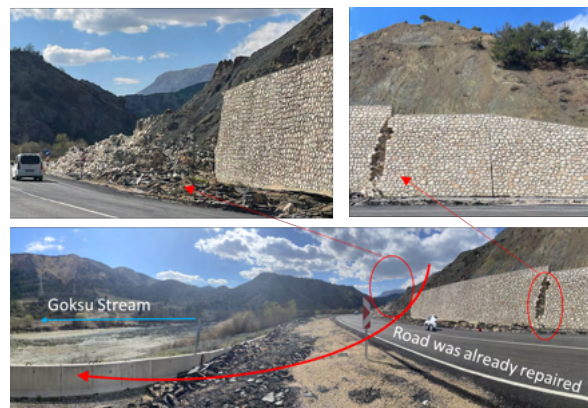
In Fig. 23 already repaired road embankment, which was reported to be damaged during the earthquake²⁶) and the damage of retaining wall on the Malatya-Golbasi Road is shown. This damage is possibly due to the liquefaction induced lateral spread towards Goksu stream running along the road embankment.

Fig. 23 On the Malatya-Golbasi Road: already repaired road embankment and damage of retaining wall (37.86332N, 37.76760E)
