# Preliminary Report of the Damage by the 2022 Off Fukushima Prefecture Earthquake Mj7.4, Japan

- Hazard Type: Earthquake
- Date of the disaster: March 16<sup>th</sup>, 2022
- Location of the survey: Fukushima and Miyagi prefectures, Japan
- Date of the field survey: March 18<sup>th</sup> and 19<sup>th</sup>, 2022
- Survey tools: Digital Camera, GPS
- Key findings:
  - (1) The superstructure collided against the western side abutment in the Date bridge.
  - (2) The bearing pin was unfastened in the Showa Bridge.
  - (3) The steps of intermediate piers can be confirmed in the Danzaki bridge.
  - (4) The viaduct tilt due to Shear failure of columns was observed in Kunimi Town.

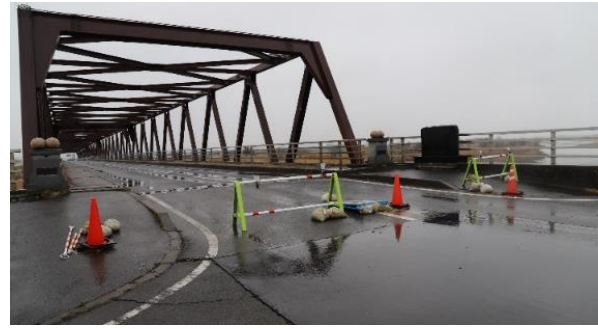
At the time of our survey, there was no apparent damage in the ground behind the abutment or the surrounding ground, but cracks were appeared in the pavement (Photo 2). In addition, the bearing pin was unfastened, as shown in Photo 2(b). The bridge was scheduled to be opened to traffic on March 19, 2022, from the rehabilitation work after the 2021 earthquake, but was closed due to the earthquake damage from the 2022 earthquake.

(a) The pavement cracked.

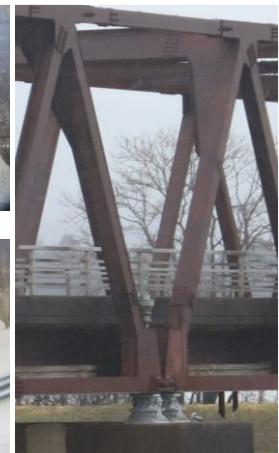
(d) The bearing pin unfastened.

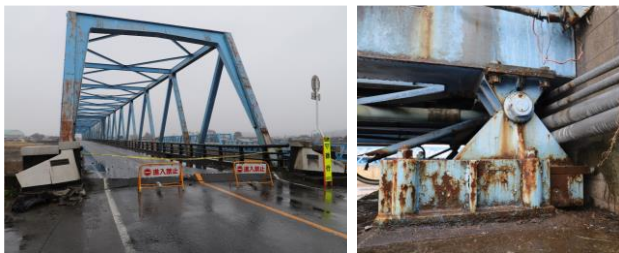
Date Bridge is located at 37°49'11.2"N, 140°30'37.6"E, crossing the Abukuma River in the east to west direction. It is a four-span truss bridge completed in 1967. In Date Bridge, the superstructure collided against the western side abutment. Photo 1(a) shows a large step occurred on the west side. Photo 1(b) shows a large clearance occurred at the expansion joint and the broken bearing on the east side. Emergency restoration of the bridge is expected to take from two to three years, and the bridge replacement is also considered<sup>4)</sup>. When our survey was conducted, the damage to the soil behind the abutment and surrounding ground was not observed. Therefore, the damage to Date Bridge is considered to be caused by inertial forces during the earthquake.

(a) West Side of Date Bridge.

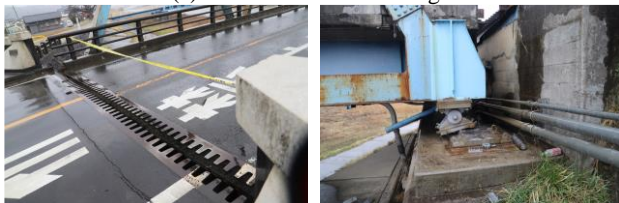
(b) East Side of Date Bridge.

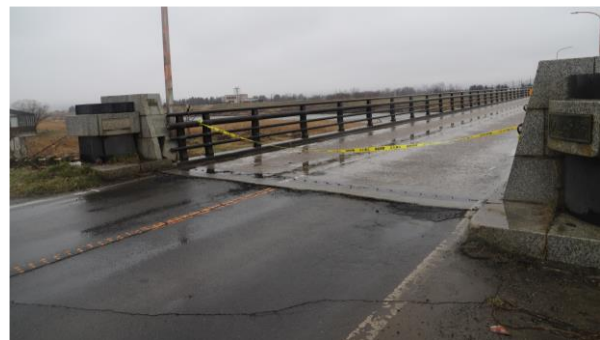
Danzaki Bridge is located at 37°50'55.0"N, 140°33'39.0"E, crossing Abukuma River in the east to west direction. It is a seven-span PC simply supported bridge completed in 1961. There was no apparent damage near the abutments, but the step between girder ends and abutment was caused by seismic damage to bearings as shown in Photo 3. In addition, cracks were found on the end of the girder as shown in Photo 3(d). There was no apparent damage on the behind of the abutment and the surrounding ground. Therefore, these damages are considered to be caused by the inertial force from the earthquake ground motion.

(a) Danzaki Bridge.

**Photo.3** Damage of Danzaki Bridge.

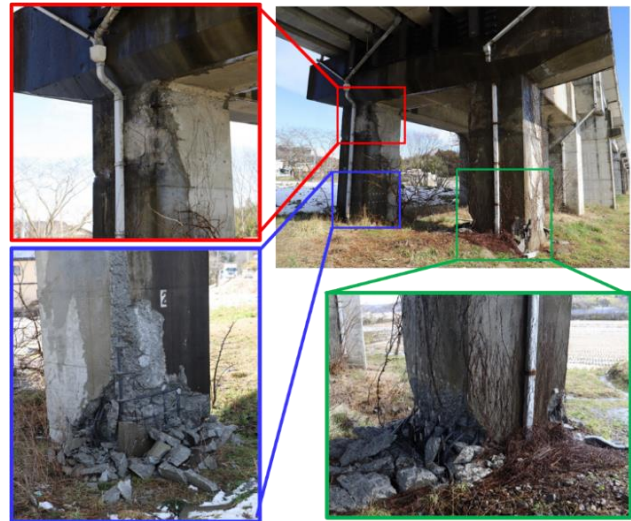
In the area from Date City to Shiroishi City, some flexure damage in the RC frame piers were observed. In the damaged columns, the longitudinal bars buckled, and the concrete was spalling (Photo 6, Photo 7, Photo 8). In particular, the survey revealed that the number of damaged columns was higher near Shiroishi City, Miyagi Prefecture than in other areas. However, compared to the number of damaged transverse beams described in (1), the number of damaged columns is small. Furthermore, damage occurred only to columns that had not been seismically retrofitted; no damage occurred to columns that had been seismically retrofitted with steel jacketing.

**Photo.6** Flexure damage of RC pier in Shiroishi City, Miyagi Prefecture(Saikawa BV).(37°58'14"N, 140°36'44"E)

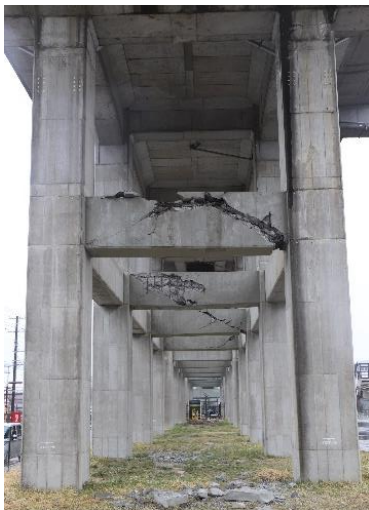
Damage to the transverse beams of the two-story RC frame of the viaducts of the Tohoku Shinkansen was observed over a wide area, from Koriyama City, Fukushima Prefecture, to Shiroishi City, Miyagi Prefecture. In particular, significant damage, concrete spalling and rebar exposure, was observed at several viaducts from Date City, Fukushima Prefecture, to Shiroishi City, Miyagi Prefecture (Photo 4, Photo 5). In

**Photo.4** Shear damage to horizontal middle beams in Date City, Fukushima Prefecture. (37°49'30"N, 140°29'39"E)

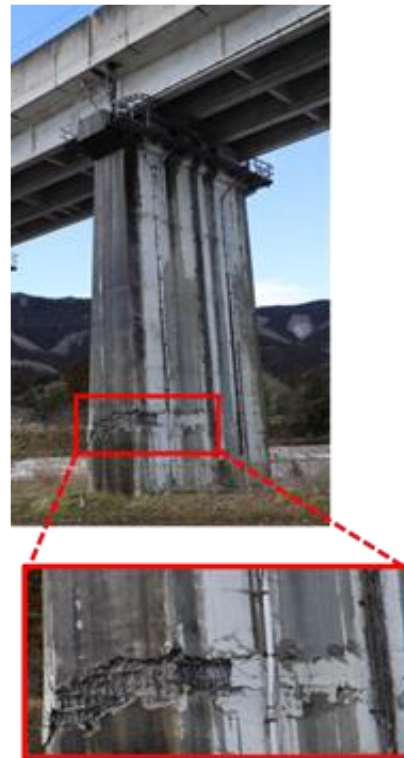
**Photo.7** Flexure damage of RC pier in Shiroishi City, Miyagi Prefecture.(37°58'25"N, 140°36'54"E)

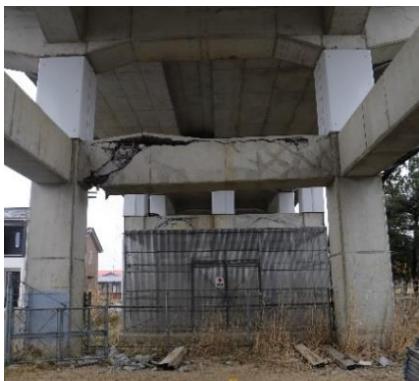
these areas, the seismic waves were observed to be larger than those of the 2021 earthquake, and the damage to the transverse beams was observed to be significant. In addition, in Shiroishi City, Miyagi Prefecture, the damage that considered to be developed from repair scars of the past earthquake was observed.

**Photo.5** Shear damage to horizontal middle beams in Shiroishi City, Miyagi Prefecture.(37°59'33"N, 140°37'50"E)

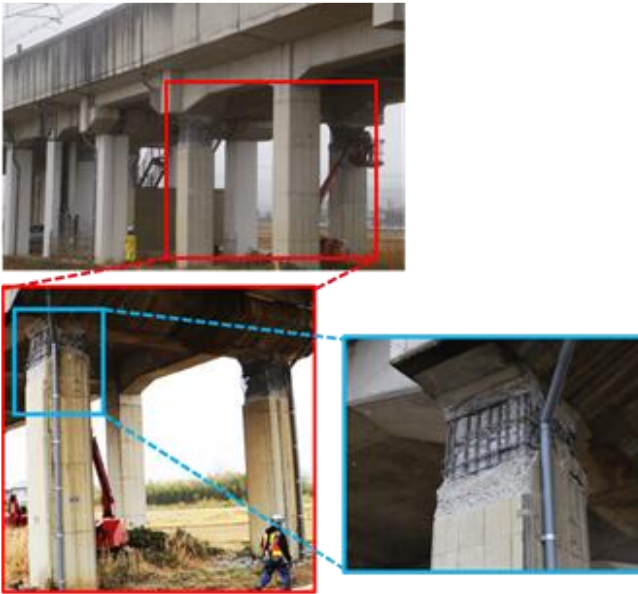
**Photo 8** Flexure damage of RC pier in Shiroishi City, Miyagi Prefecture.(37°59'13"N, 140°37'33"E)

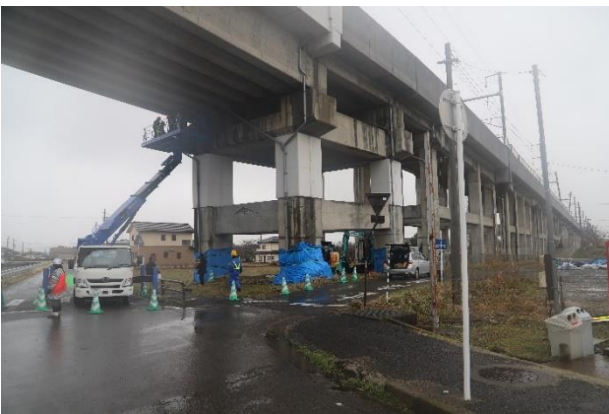
Shear failure of columns was observed in Kunimi Town, Fukushima Prefecture. The photographs show significant shear cracks in the columns, indicating that the loss of the capacity to support the axial load of some columns caused the viaduct to tilt (Photo 9). For the viaduct, the damage occurred only on the columns that were not seismically retrofitted; the columns above the middle beams were not damaged because they had been seismically retrofitted with steel jacketing.

**Photo 9** The viaduct tilt was caused by shear damage to RC frame pier in Kunimi Town, Fukushima Prefecture. (37°52'43"N, 140°32'06"E)
