# Field Investigation Report on Damage from the March 2025 Myanmar Earthquake

## Key Facts

- Hazard Type: Earthquake
  - Date of the disaster: March 28, 2025
  - Location of the survey: Sagaing, Mandalay, Myanmar
  - Date of the field survey: August 15, 2025

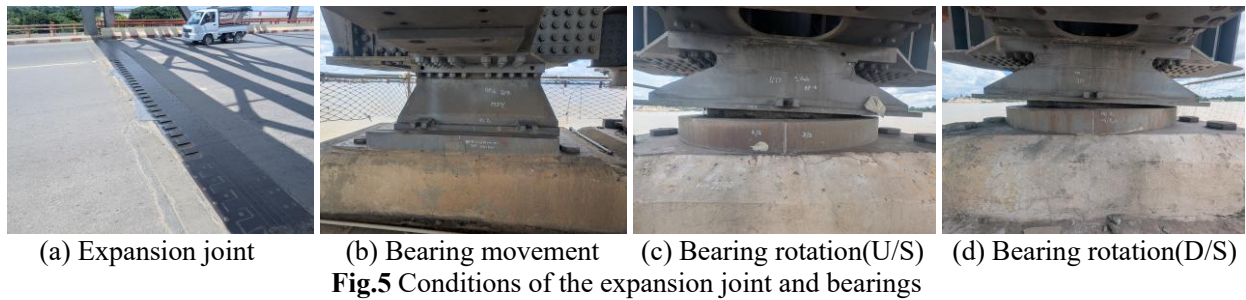
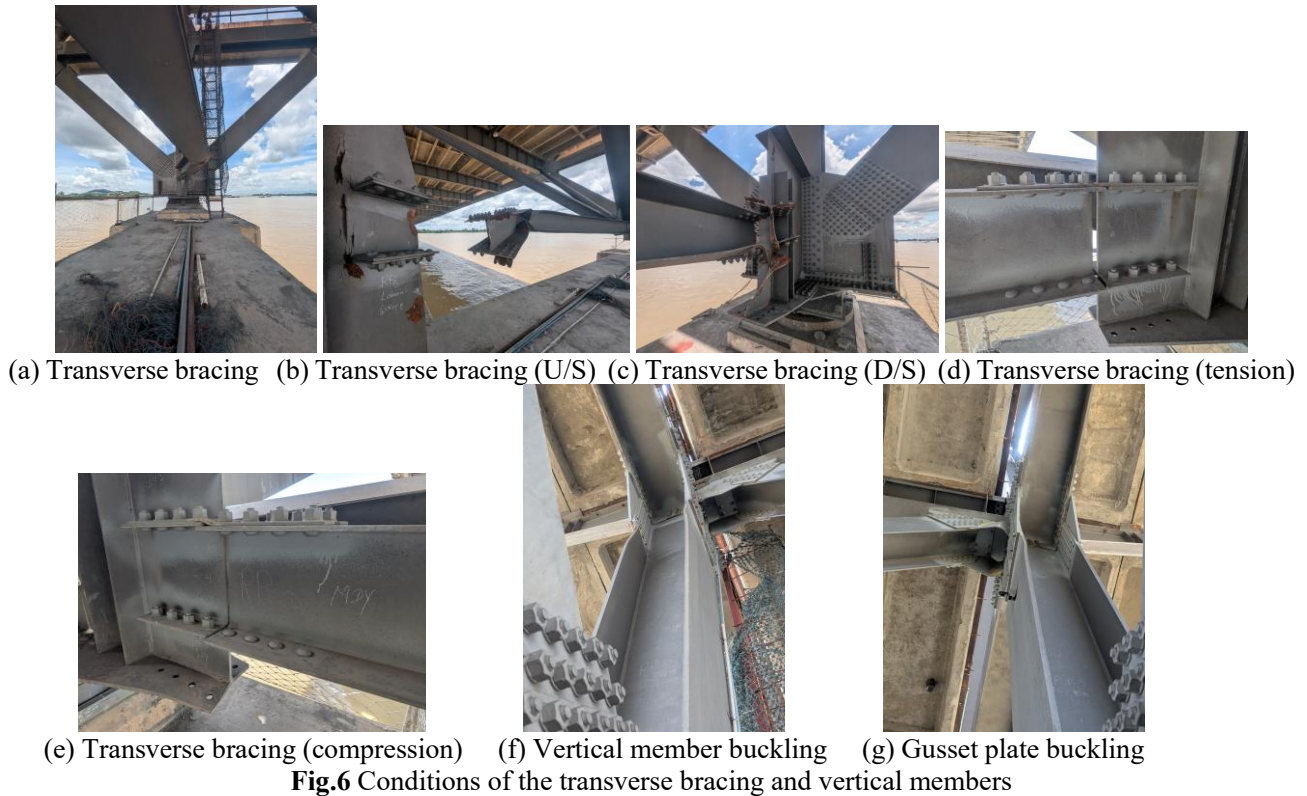
Photographs taken during the survey are presented in **Figs.5-7**. Although the bridge did not collapse, clogging of the expansion joints associated with longitudinal displacement of the superstructure, as well as translation and rotation of the bearings, were observed. In addition, buckling and fracture were identified in members in the vicinity of the bearings.

**Fig.5(a)** shows the expansion joint on the Mandalay side, where the river-span superstructure was found to ride up onto the approach-side component. **Fig.5(b)**, taken from the transverse direction, indicates a 75 mm displacement in the longitudinal (bridge-axis) direction at the bearing region. **Figs. 5(c) and 5(d)** are longitudinal views of the bearing region, with the upstream side on the left. These figures indicate that both the upstream and downstream bearings rotated toward the downstream side. This suggests that the arch ribs are in equilibrium while the overall bridge structure is inclined to the downstream side.

**Fig.6(a)** shows the transverse bracing between the bearings (cross-frame) viewed from the transverse direction, where global deformation and buckling are observed. **Fig.6(b)** shows the upstream side of the same member, confirming buckling and fracture near the connection. **Fig.6(c)** shows the downstream side, where torsional-type failure near the connection is observed. **Figs.6(d) and 6(e)** present the connection region of the transverse bracing on another pier. Although the bracing did not fracture, slip marks associated with tensile force at the upstream connection are observed (**Fig.6(d)**), whereas buckling of the connecting plate due to compressive force is observed at the downstream side (**Fig.6(e)**). **Figs.6(f) and 6(g)** show members directly above the bearings, where buckling of vertical members and gusset plates is confirmed.

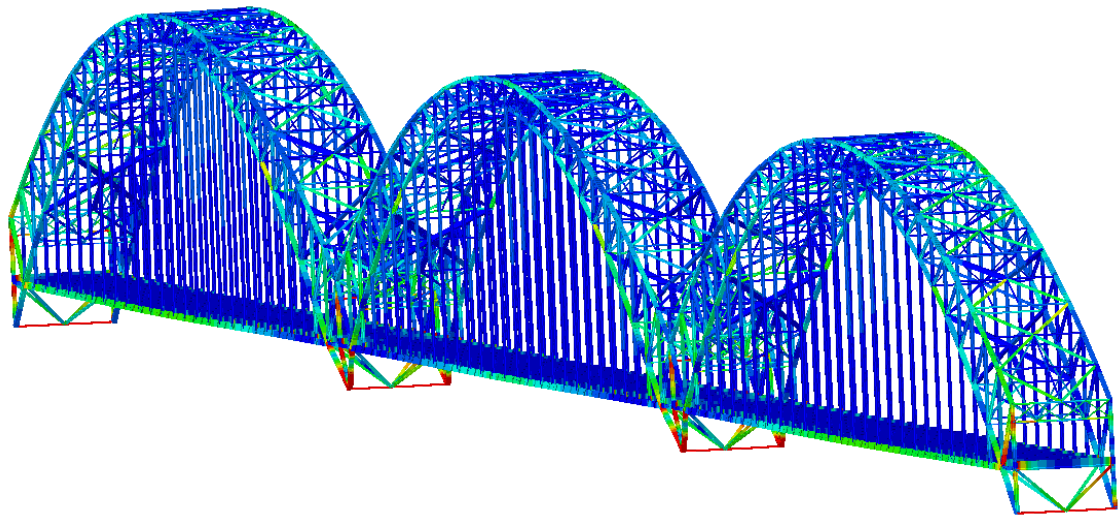
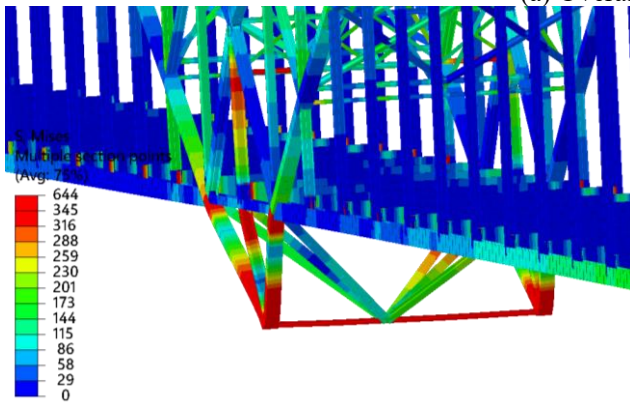
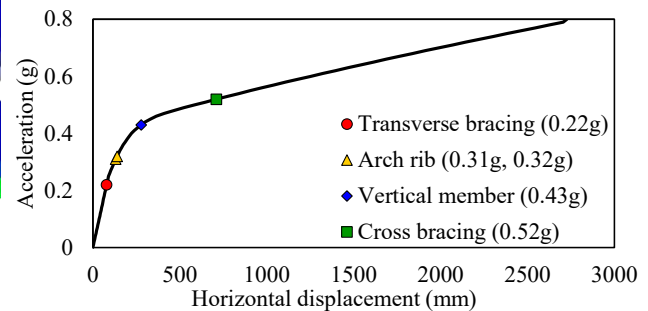
**Fig.8** Results of a FEA

Notable damage was observed in the transverse bracing between the bearings. **Fig.8** presents the results of a transverse-direction pushover analysis conducted for the bridge. The FE model geometry is based on the design drawings. The deck slab was modeled as an elastic shell, while the other steel members were modeled as bilinear elastoplastic beam elements with a post-yield stiffness of  $E/100$ . The analysis confirms that the transverse bracing

yields first, which is consistent with the observed damage pattern. Furthermore, when seismic forces act in the transverse direction, excessive stresses develop near the connections of the members directly above the bearings, which is in line with the damage shown in **Figs.6(f)** and **6(g)**.

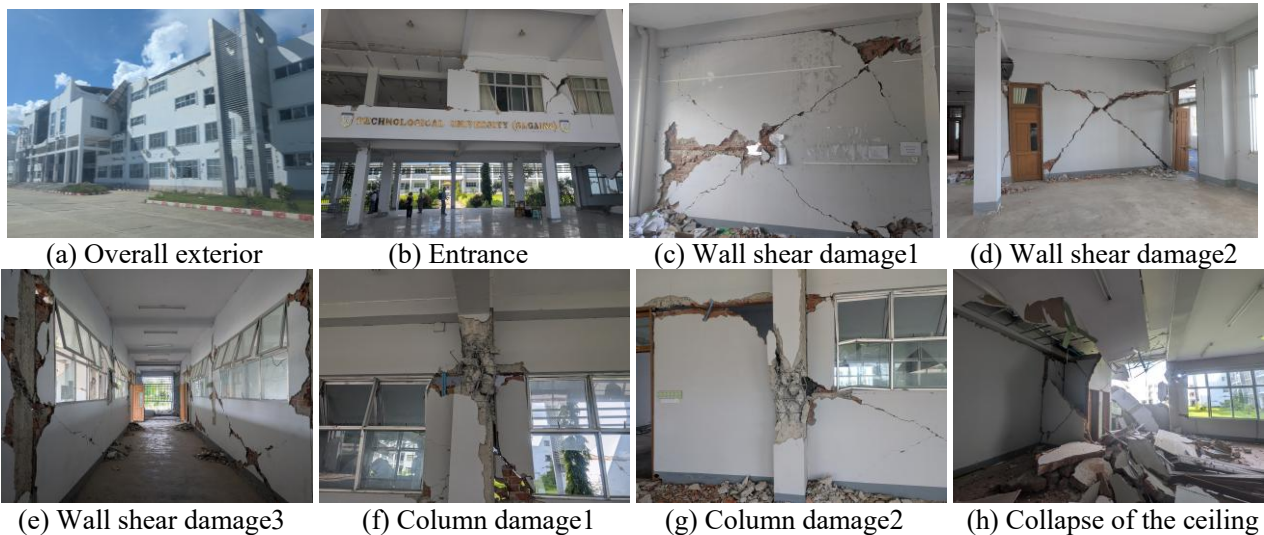
**Fig.9** Conditions of the Sagaing Technological University buildings and ground offset around the university

A damage survey was conducted for buildings on the campus of Sagaing Technological University, located 10.43 km from the epicenter (**Fig.2**). The Sagaing area was one of the regions most severely affected by the earthquake. Photographs of the investigated buildings are shown in **Fig.9**. **Fig.9(a)** shows the overall exterior, where damage to the exterior walls and roof can be identified. **Fig.9(b)** shows the entrance area, confirming shear failure of walls and cracking near the bases of columns. **Figs. 9(c)–(e)** present details of wall shear damage; diagonal shear cracks oriented at approximately  $45^\circ$  are observed in concrete-based walls incorporating brick masonry. **Figs.9(f)** and **9(g)** show column damage, where concrete crushing and buckling of the internal

reinforcing bars are confirmed. **Fig.9(h)** shows the collapse of the ceiling.

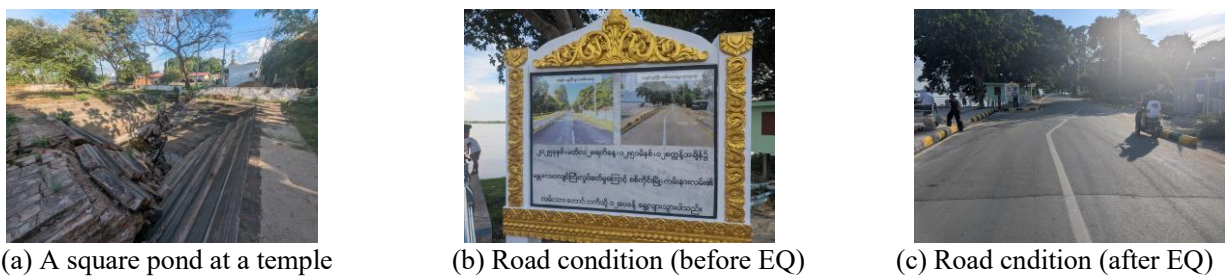
**Fig.10** Ground offset near the Sagaing Technological University

In addition, surface ground offsets associated with fault slip were observed in the vicinity of the university. As shown in **Fig.10(a)**, a square pond within a nearby temple compound was damaged due to the ground offset. As shown in **Figs.10(b)** and **10(c)**, a road located along the Ayeyarwady River exhibited a large lane misalignment attributable to the ground offset.

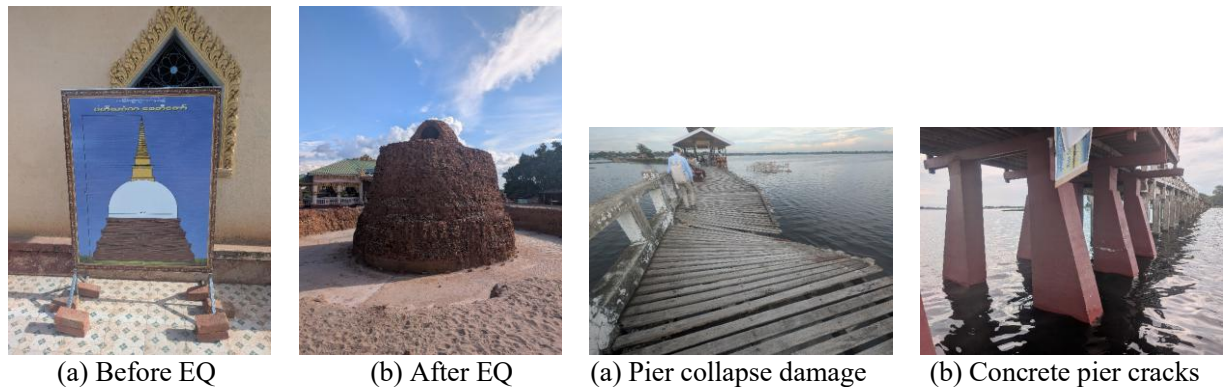
**Fig.11** Damage to the Pagoda

A damage survey was conducted on historic structures in Myanmar. **Fig.11** shows a pagoda lo-

cated in the Sagaing area. The earthquake caused the collapse of the upper spire and the mid-level dome, leaving only the lower structural portion remaining. **Fig.12** shows the U Bein Bridge crossing Taungthaman Lake in Mandalay. As shown in **Fig.12(a)**, the collapse of one side of a pier due to the earthquake led to the fall of the railing and a significant tilt of the deck. In addition, **Fig.12(b)** indicates that cracks developed in the concrete pier.
