# The October 15, 2013 Bohol Island, Philippines earthquake and its damaging effects: An investigative report

Lessandro Estelito GARCIANO<sup>1</sup> and Patrick TACLIBON<sup>2</sup>

## Key Facts

- Hazard Type: Earthquake
- Date of the disaster: October 15, 2013
- Location of the survey: Bohol Island, Philippines
- Date of the field survey: October 26 and 27, November 4 and 5, 2013

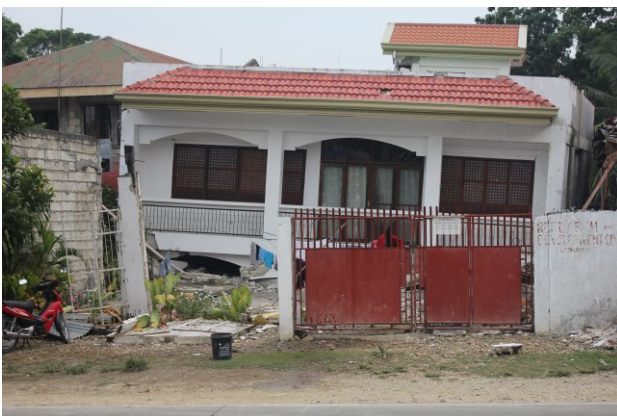
**Figure 4** exhibits a soft-storey failure where the ground floor columns failed and the ground floor was crushed by the second floor. In **fig. 5**, the columns of the houses on the left and right failed causing it to lean on the house found in the middle of the photo. Other observed failures of houses are the following: (a) beam to column connection failure (b) corroded reinforcements (c) under reinforced columns (d) no lateral supports of walls and (e) inadequate anchorage.

**Fig. 4.** Soft-storey column failure of a two-storey house.

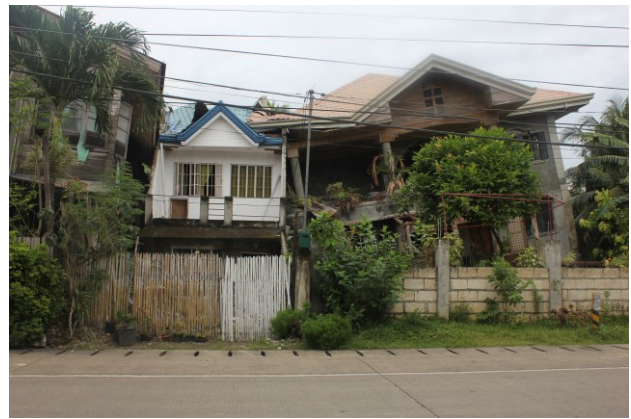
**Fig. 5.** tilting of two residential houses due to column failure

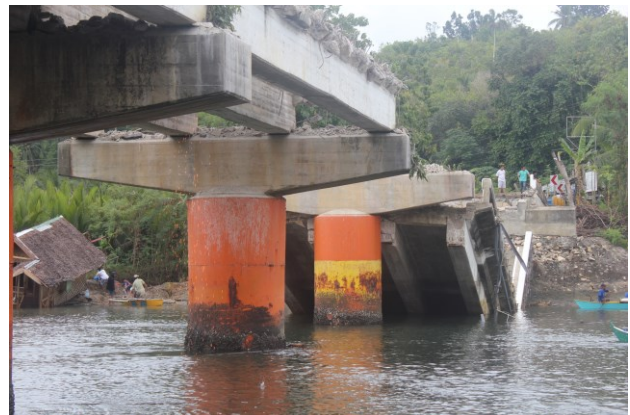
A total of 41 bridges were also reported damaged. The two spans of Abatan bridge which connects the Municipalities of Cortes and Tagbilaran (**Fig. 6**) fell to the river. The abutment tilted towards the embankment causing the spans to fall off. Damaged to reinforced concrete piles were also observed.

**Fig.6** Unseated superstructure of Abatan bridge.

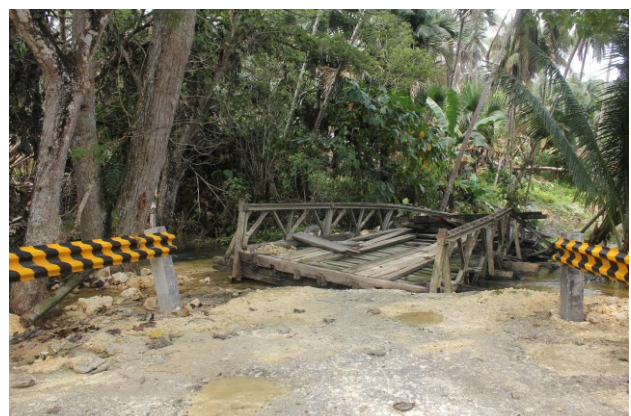
In Catigbian a bailey bridge with wooden deck swayed to one side while the other end fell into the river (**Fig. 7**).

**Fig.7** Failure of a Bailey bridge in Catigbian.

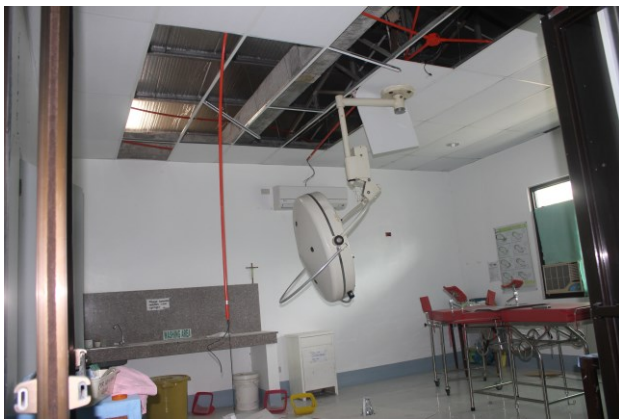
Hospitals also sustained structural as well as non-structural damage. The Catigbian District Hospital (see **Fig. 8**) sustained minor to moderate damage. The damage were mostly confined to non-structural damage such as falling ceiling panels, dislocation of medical equipment, broken glasses etc.

**Fig.8** Non-structural damage to Catigbian District Hospital.

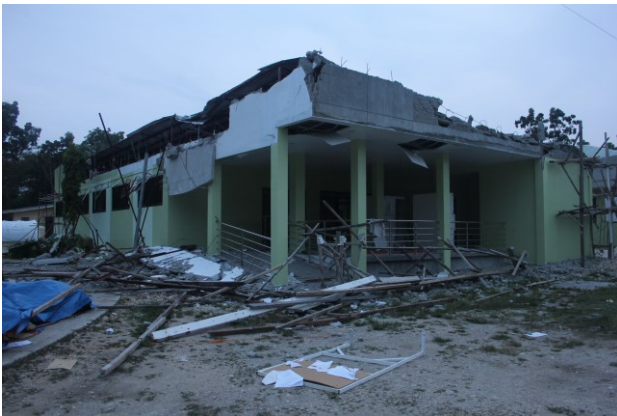
The Natalio P. Castillo Sr. Mermorial Hospital however (**Fig. 9**) suffered major structural damage. This hospital was almost ready for occupancy but unfortunately was badly damaged during the earthquake. The building housing the emergency room located across this structure was also damaged and is now subject to detailed structural investigation.

**Fig.9** Structural damage to Natalio P. Castillo Sr. Memorial hospital.

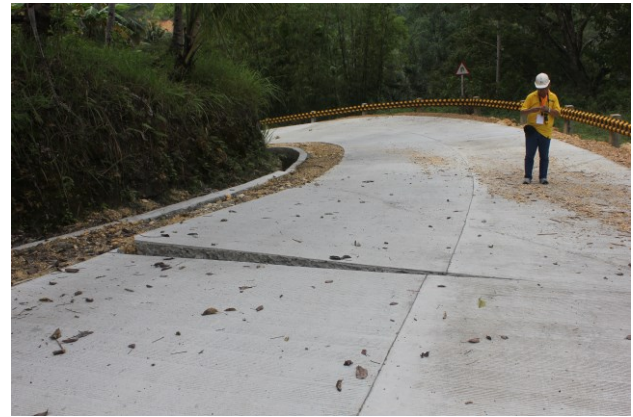
Roads and highways also sustained damage due to the intense ground shaking. Large cracks in the concrete pavement (**Fig. 10**) were observed in many areas as well as failure of concrete guide rails.

**Fig.10** Large crack in concrete pavement.

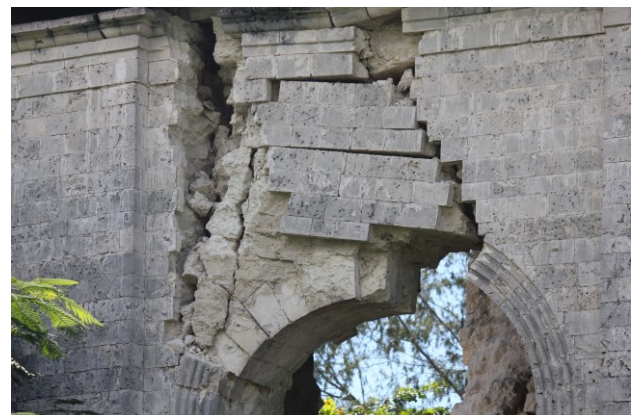
- arch collapse – the loss of compression in the arch caused the failure of this structural element. This type of failure was predominantly found in the Our Lady of the Assumption Church in Dausi (**Fig. 11**).
- wall collapse - walls which did not have enough resistance to large shear and moment forces toppled quickly (**Fig. 12**). This failure was observed in many churches such as the Sto. Niño Parish Church in Cortes.
- facade walls with no horizontal supports nor diaphragms also collapsed due to the strong lateral movement (**Fig. 13**). This failure was observed in many churches such at the Our Lady of the Immaculate Conception in Baclayon.
- total collapse – the St. Vincent Ferrer Church in Maribojoc (**Fig. 14**) and the Our Lady of Light Church in Loon were totally damaged (**Fig. 15**)

**Fig. 11.** Arch failure at Dausi Church

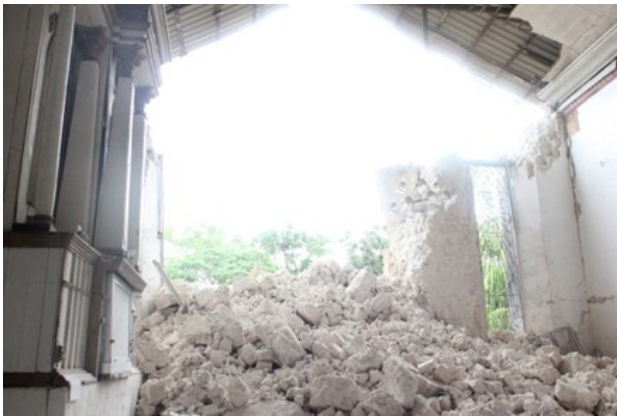
Fig. 12. Observed wall failure

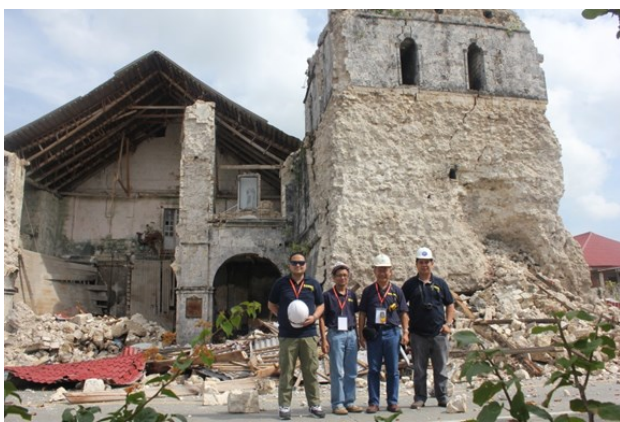
Fig. 13. Façade wall failure at the Our Lady of the Immaculate Conception in Baclayon

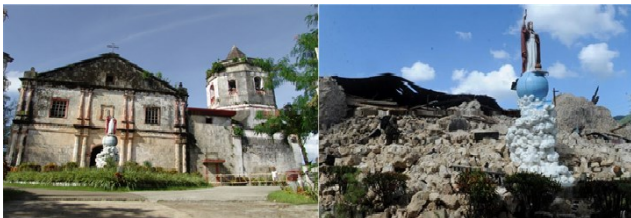
Fig. 14. St. Vincent Ferrer Church in Maribojoc, before and after the earthquake

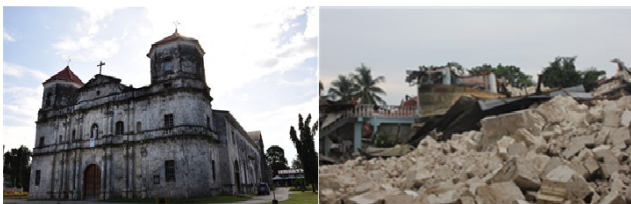
Fig. 15. Our Lady of Light Church in Loon, before and after the earthquake
