A preliminary report of *Kermanshah* Earthquake M 7.3, Iran earthquake of November 12, 2017

Building damage

Toshikazu IKEMOTO
Masakatsu MIYAJIMA
Abdolhossein FALLAHI
Farzad TALEBI

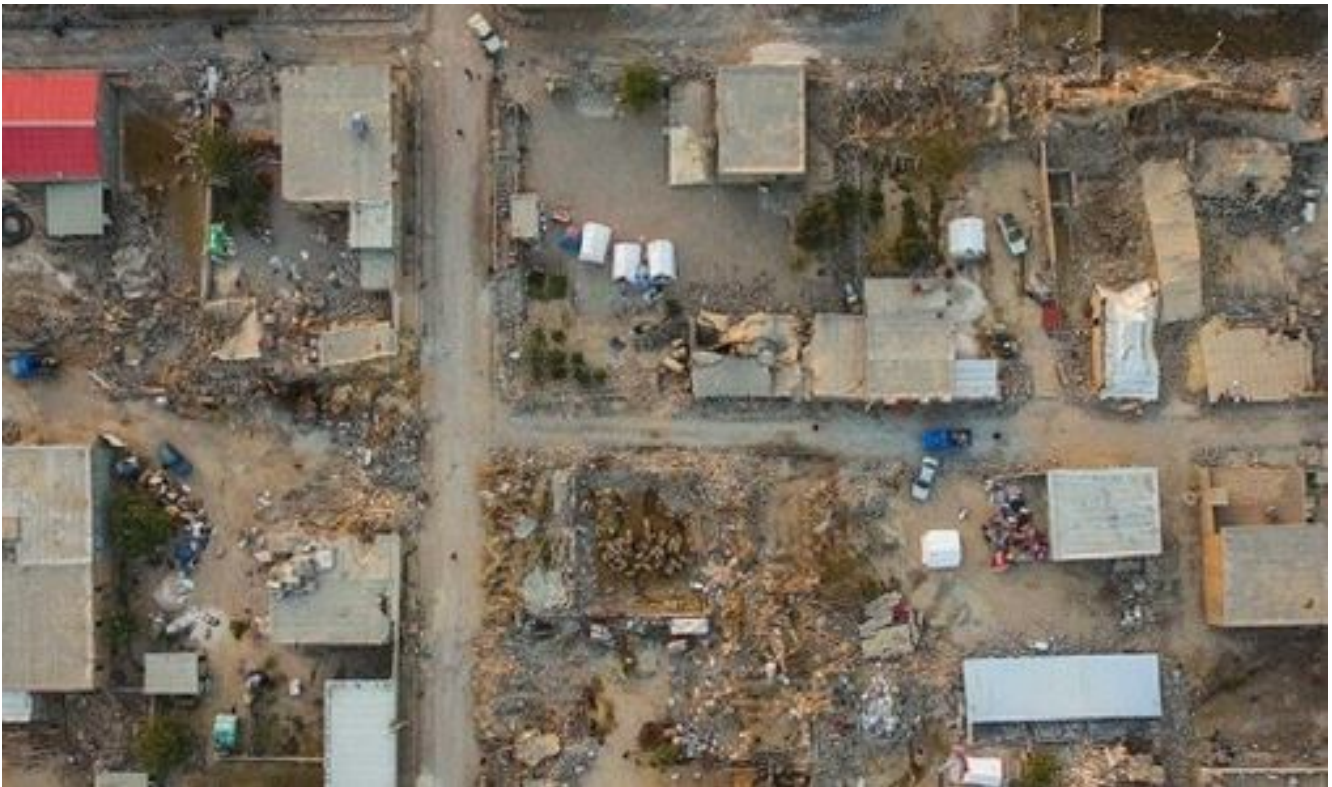
An example of a collapse residential building (www.tabnak.ir)

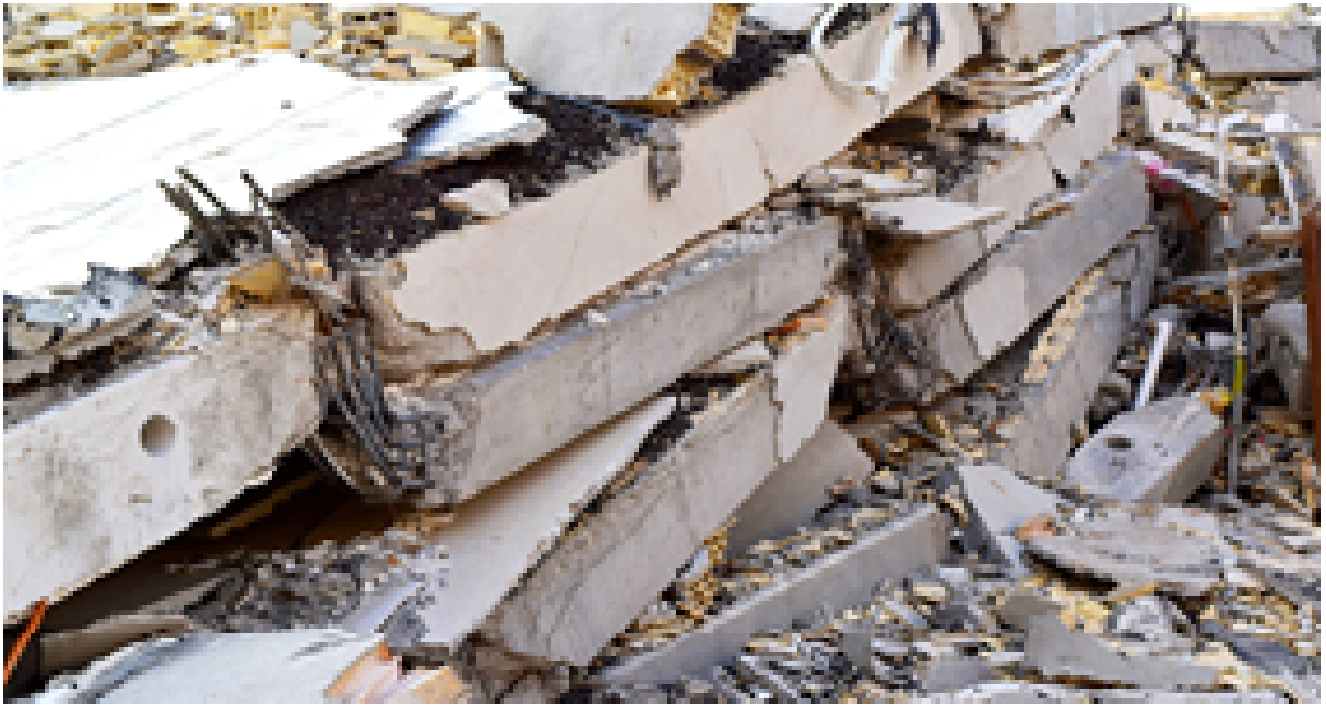
Soft story failure at Sarpole-Zahab city.

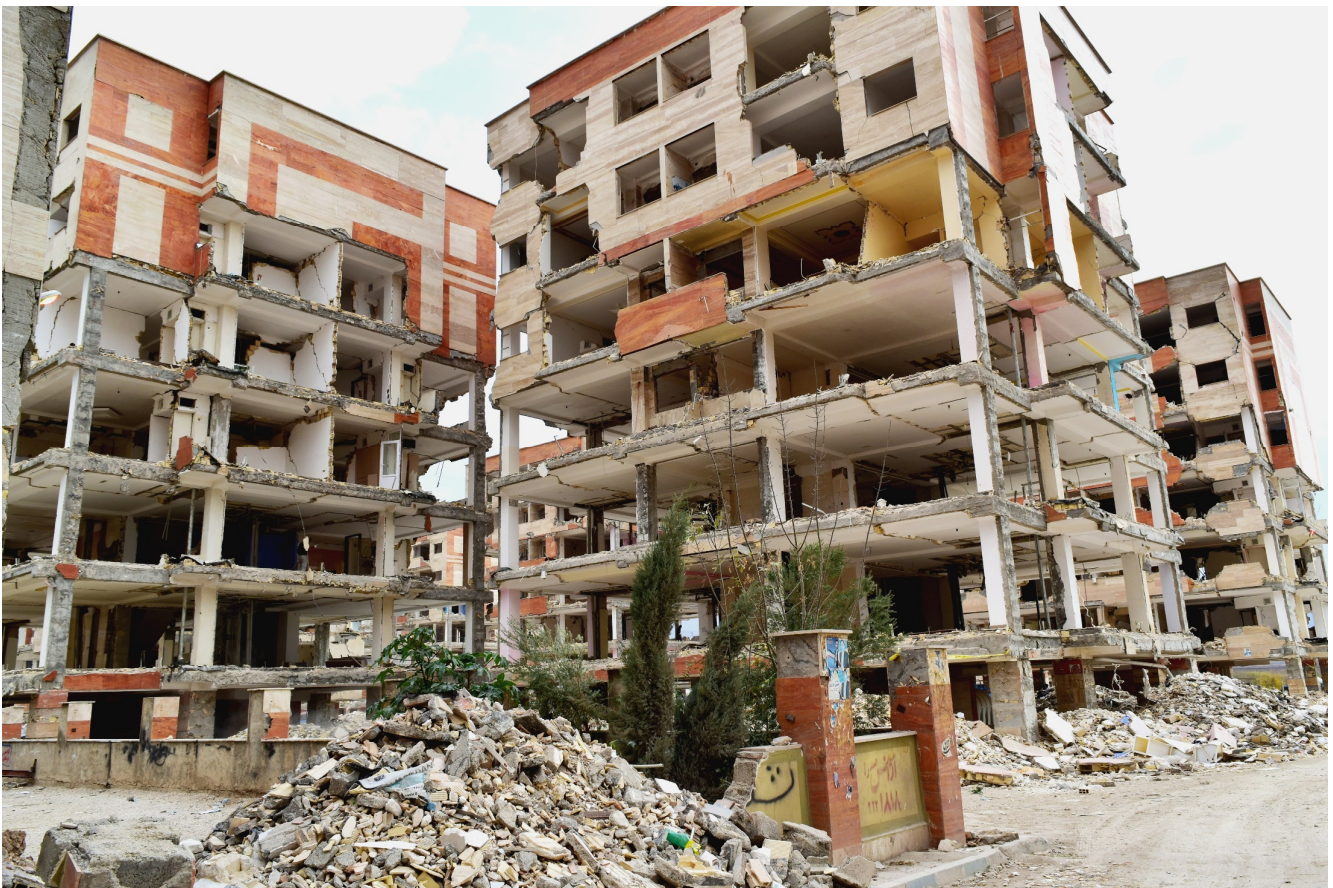
Severe non-structural elements damage at Maskane-Mehr of Sarpole-Zahab city.

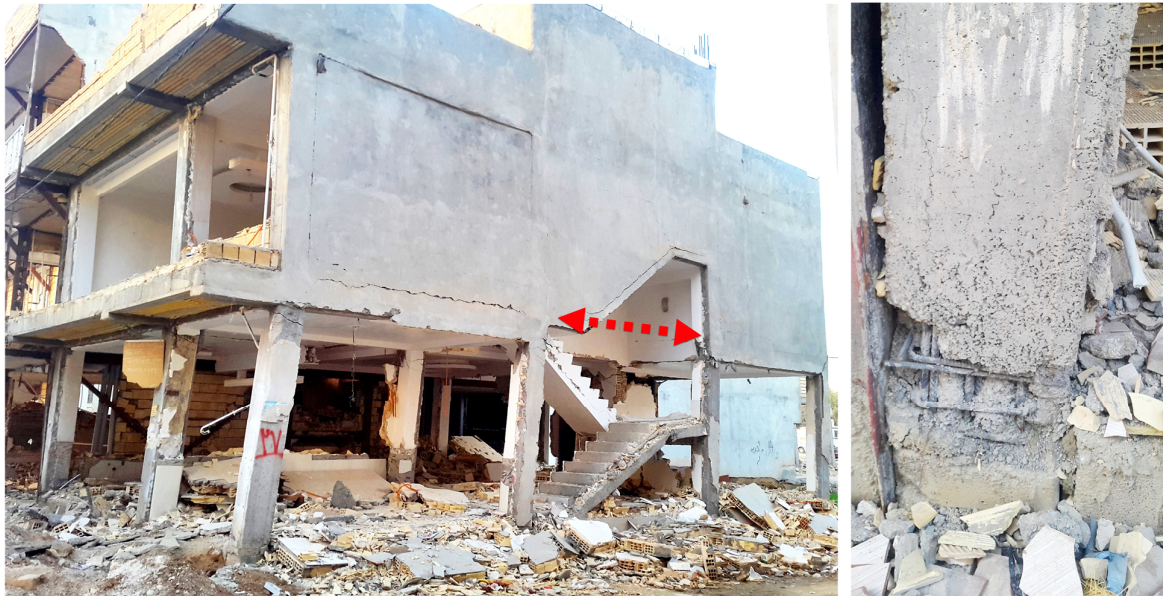
**Horizontal irregularities due to lack of one of the beams
poor quality of concrete and Utilize of 90° hooks
instead of 135° hooks in columns**

Damage to building at Sarpole-Zahab.

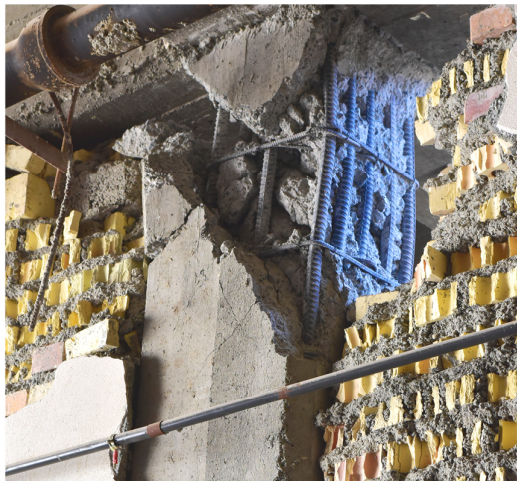
(a) Wide spacing between transverse rebar of columns

The improper detailing of rebar at Shohada Hospital of Sarpole-Zahab.

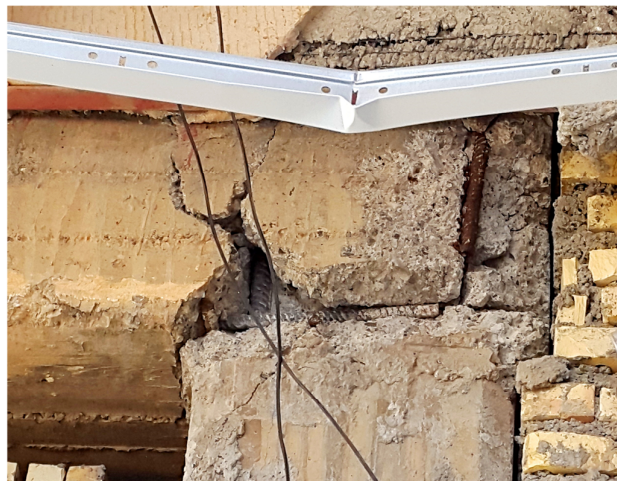
(b) Short anchorage length at rebar of the beams.

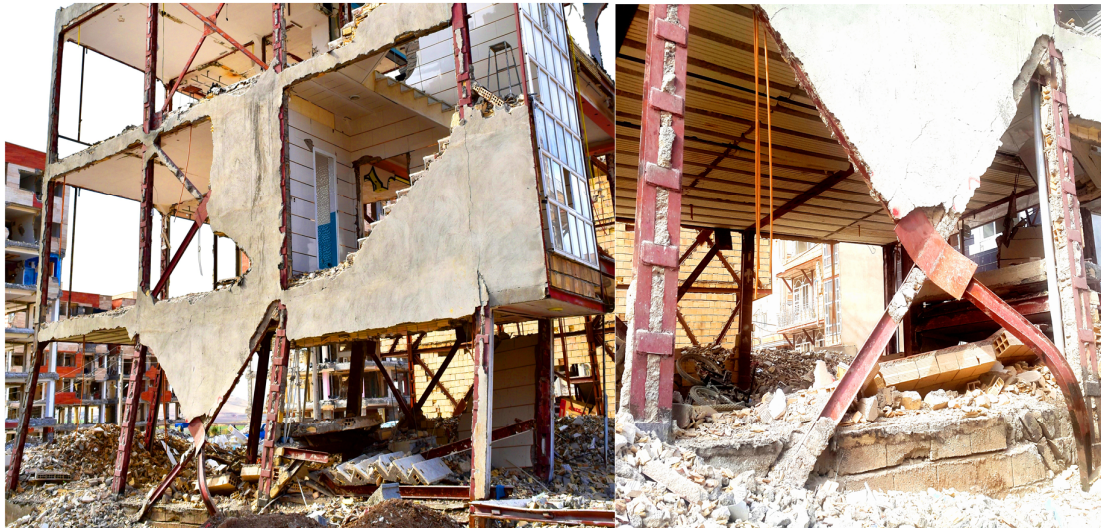
Severe damage to a steel building at Sarpole-Zahab city.

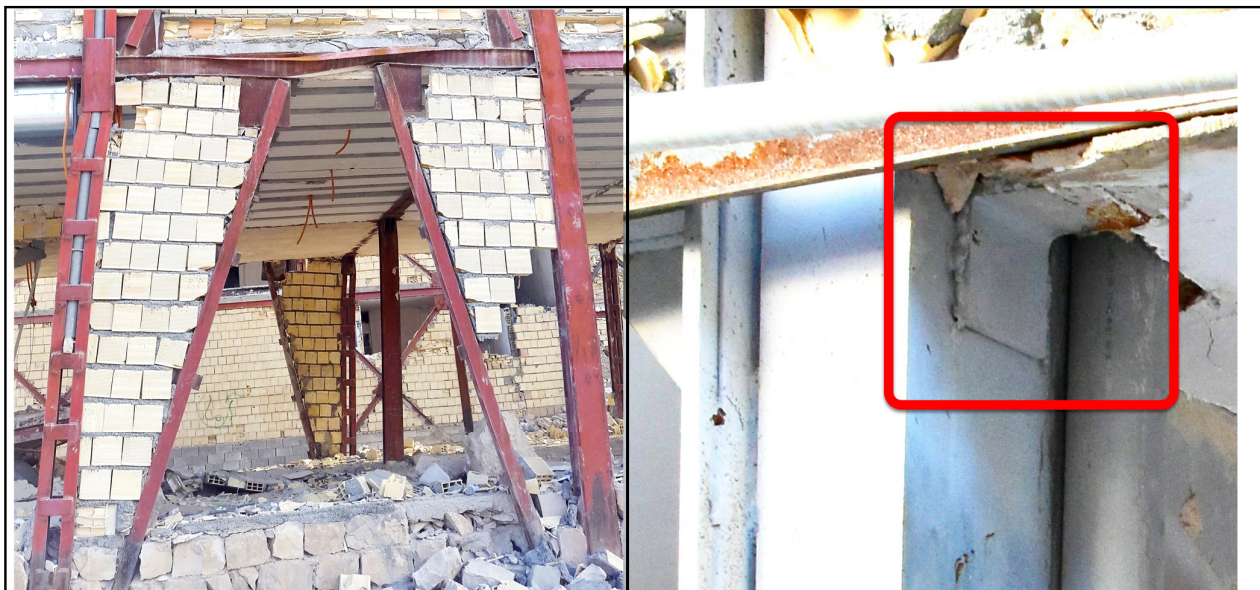
(a) Damage to beams which had no stiffener

(b) Utilize of pinned joints instead of rigid joints at a building with moment-resisting frame system

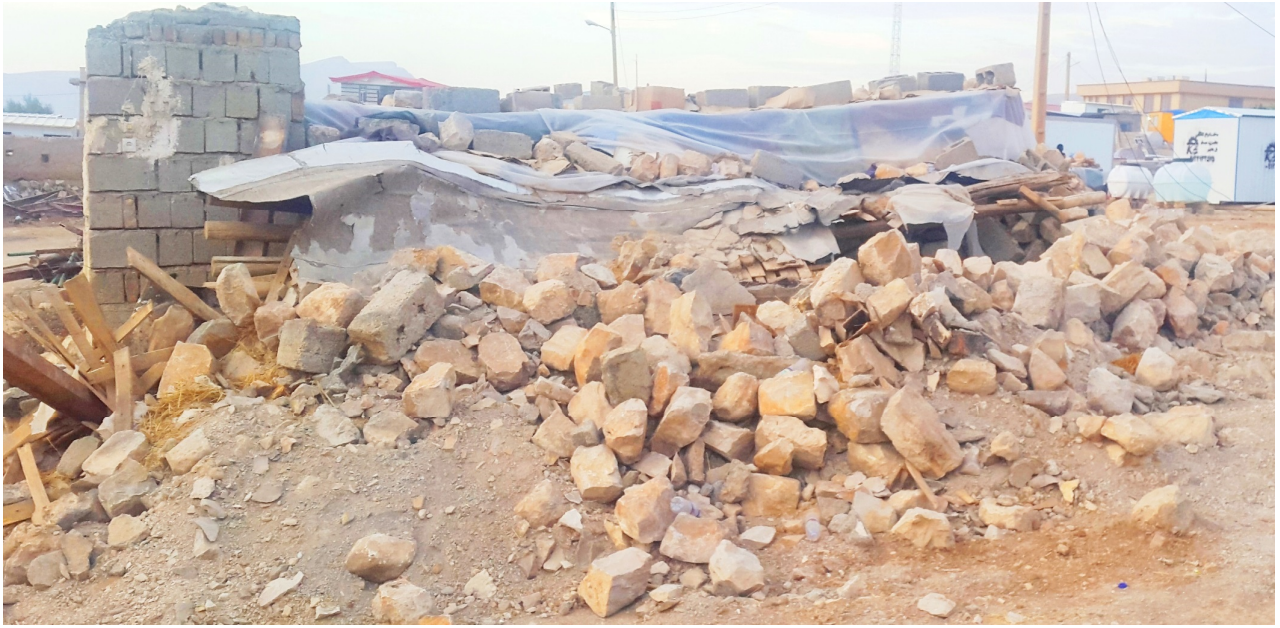
Failure of most of stone buildings in Kuik Village.

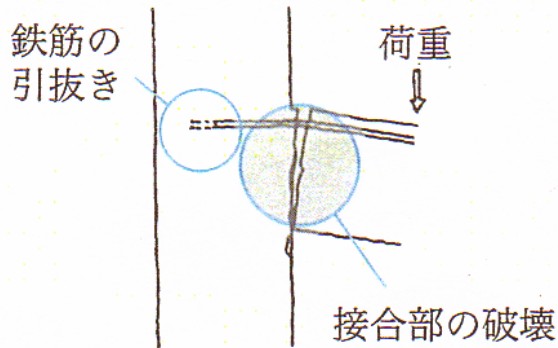
- ・接合部の破壊、欠損
- ・コンクリートの破壊 など

定着長さの不足

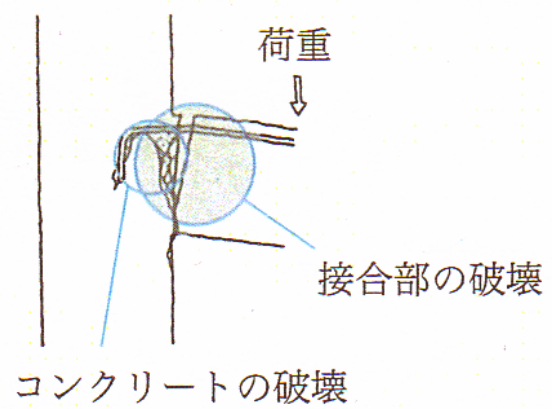
位置不良の場合
