# Preliminary Damage Survey Reporting Seminar of JSCE at University of Tokyo

## Nepal Gorkha Earthquake, 2015

Earthquake Engineering Group  
Ehime University Team  
JSCE, JGS, JAEE and ATC3 delegates

Shinichiro Mori, Prof., GPI

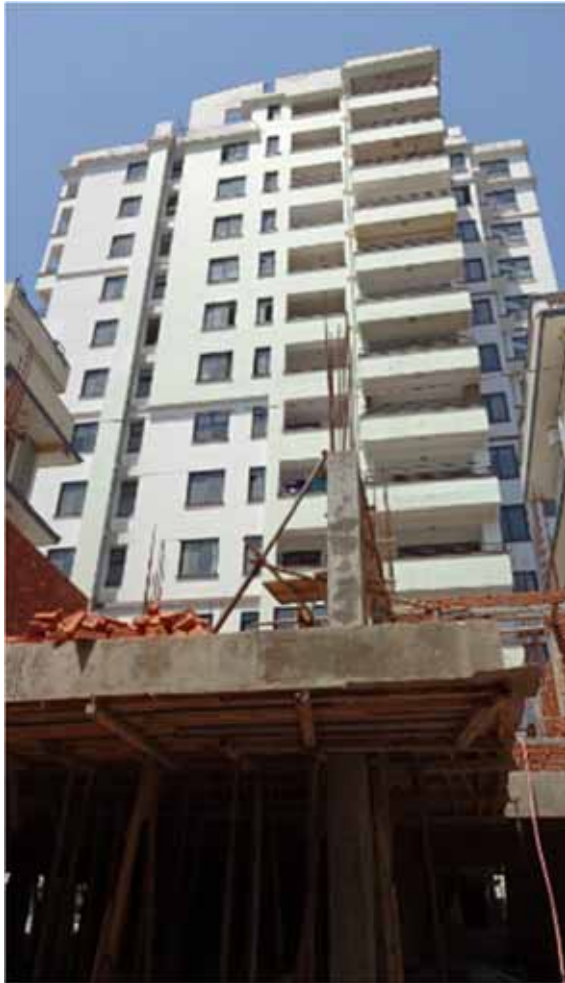
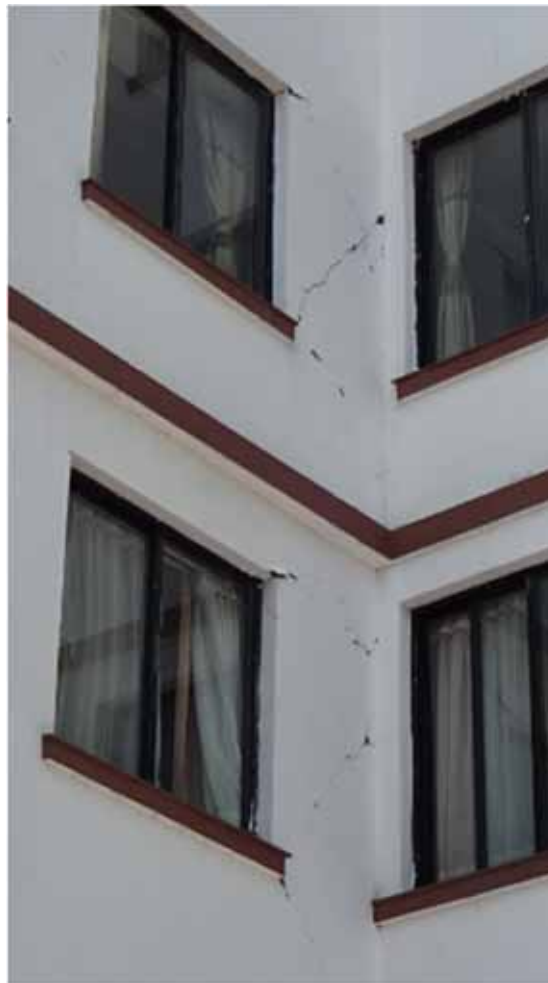
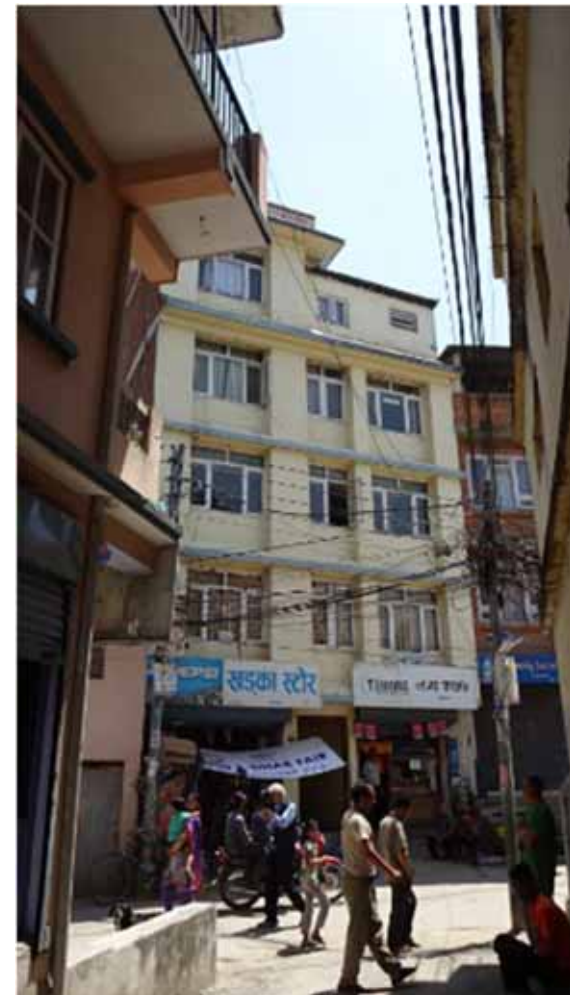
# 13 story high-rise building near Thamel in KTM

No structural damage, slight nonstructural damage (G1)

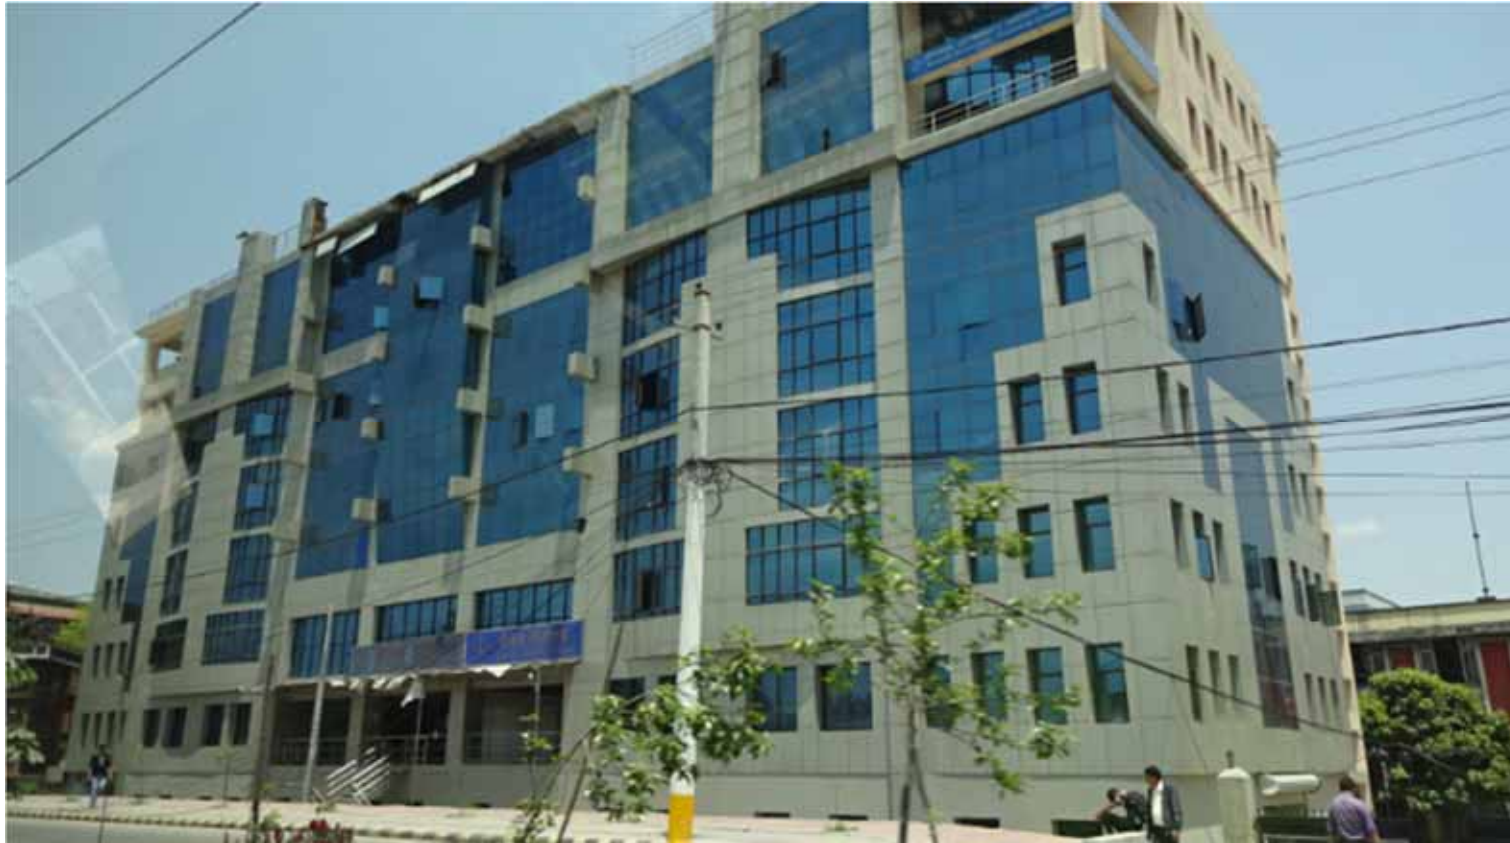
# No damage to engineered buildings in core of KTM

No structural damage, slight nonstructural damage (G0)

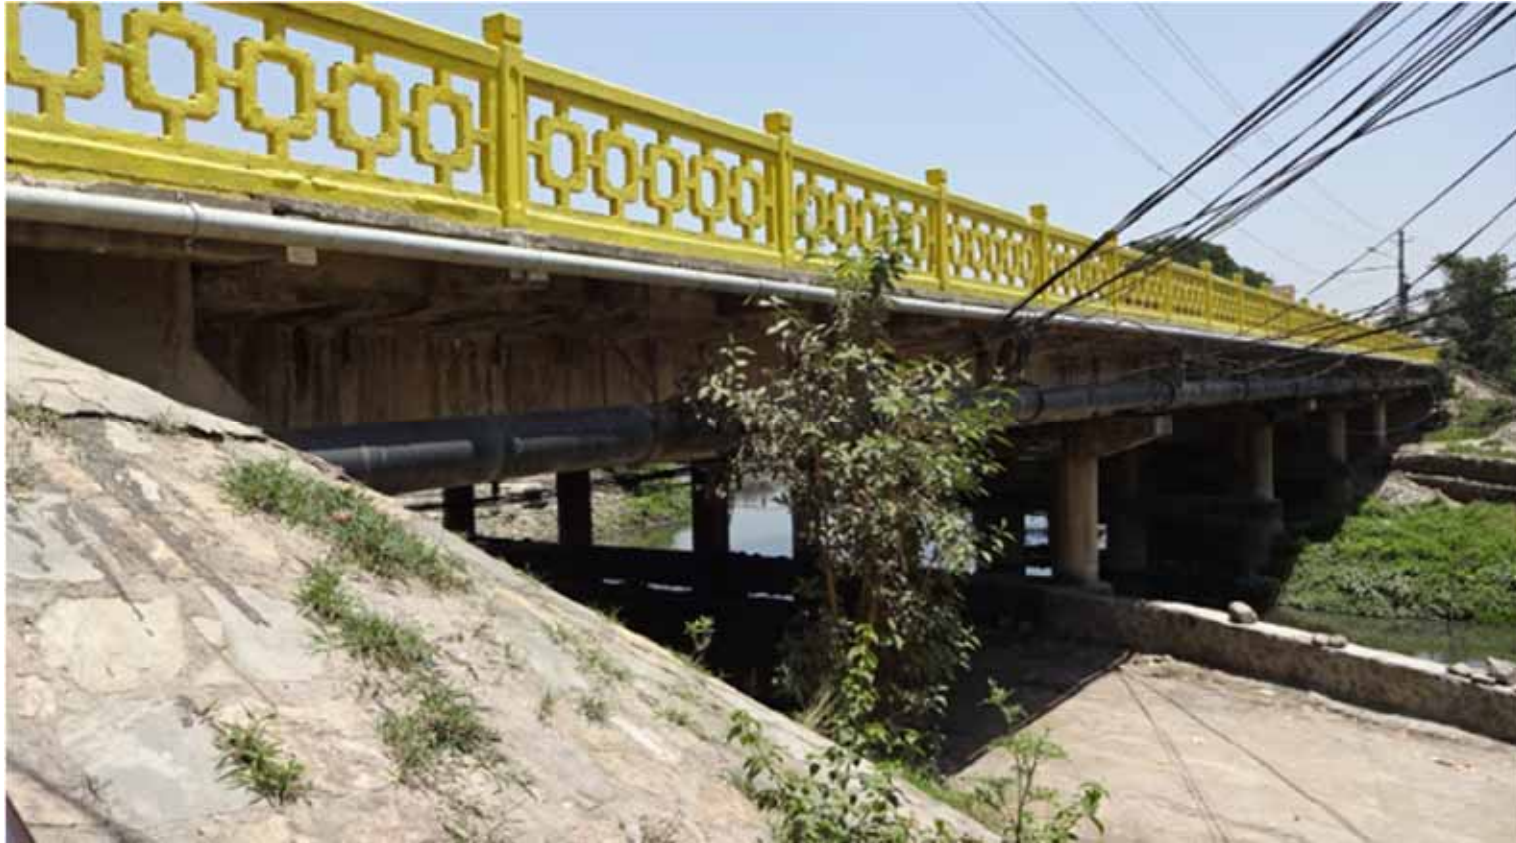
# No damage to bridges in KTM

No structural damage

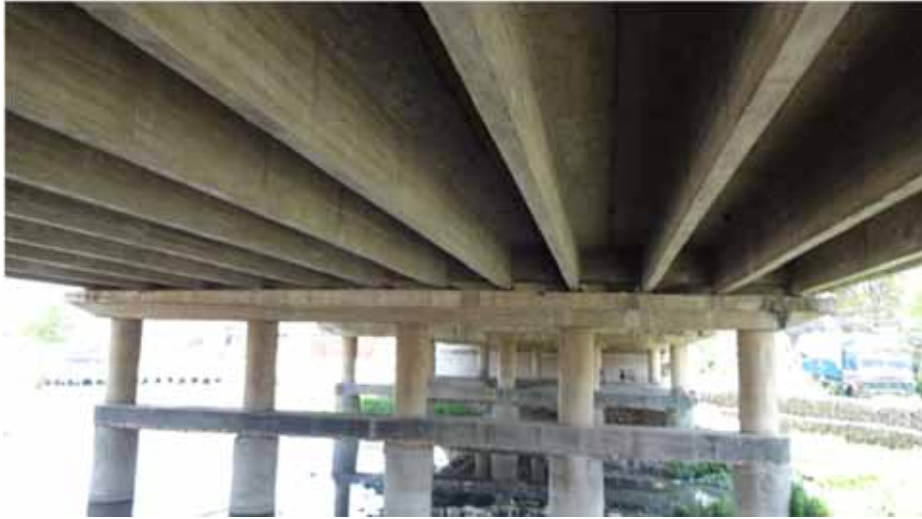
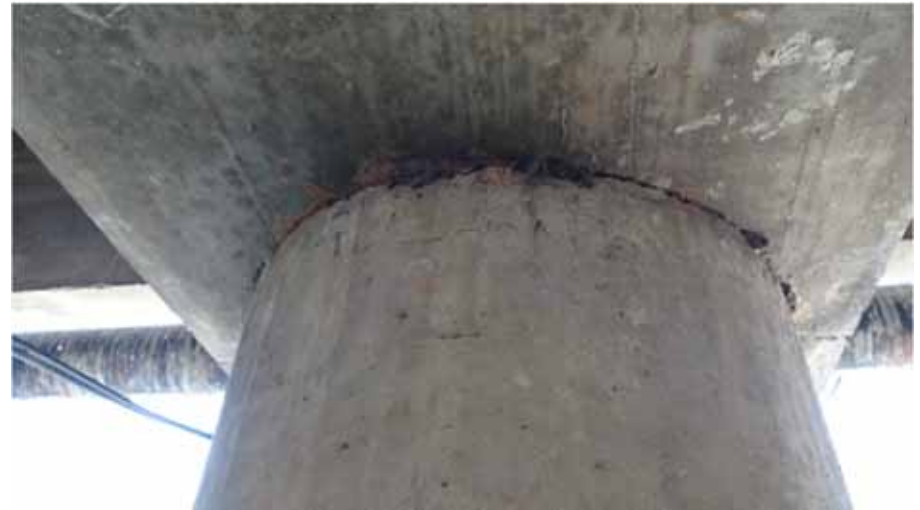
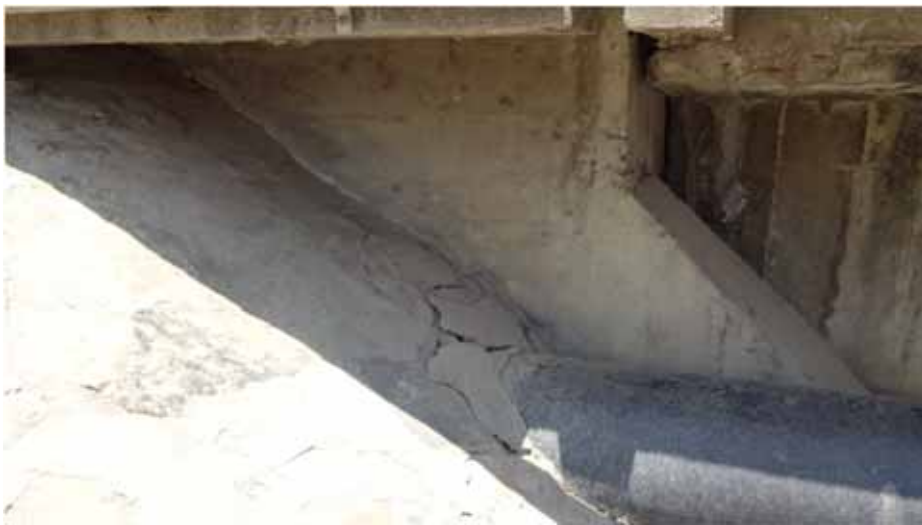
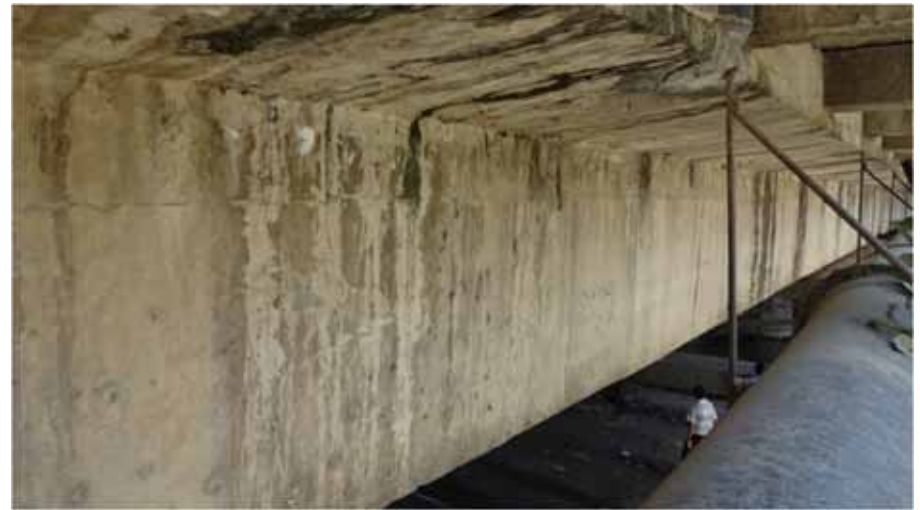
# No damage to bridges in KTM

No structural damage and affect to bridge abutment was observed.

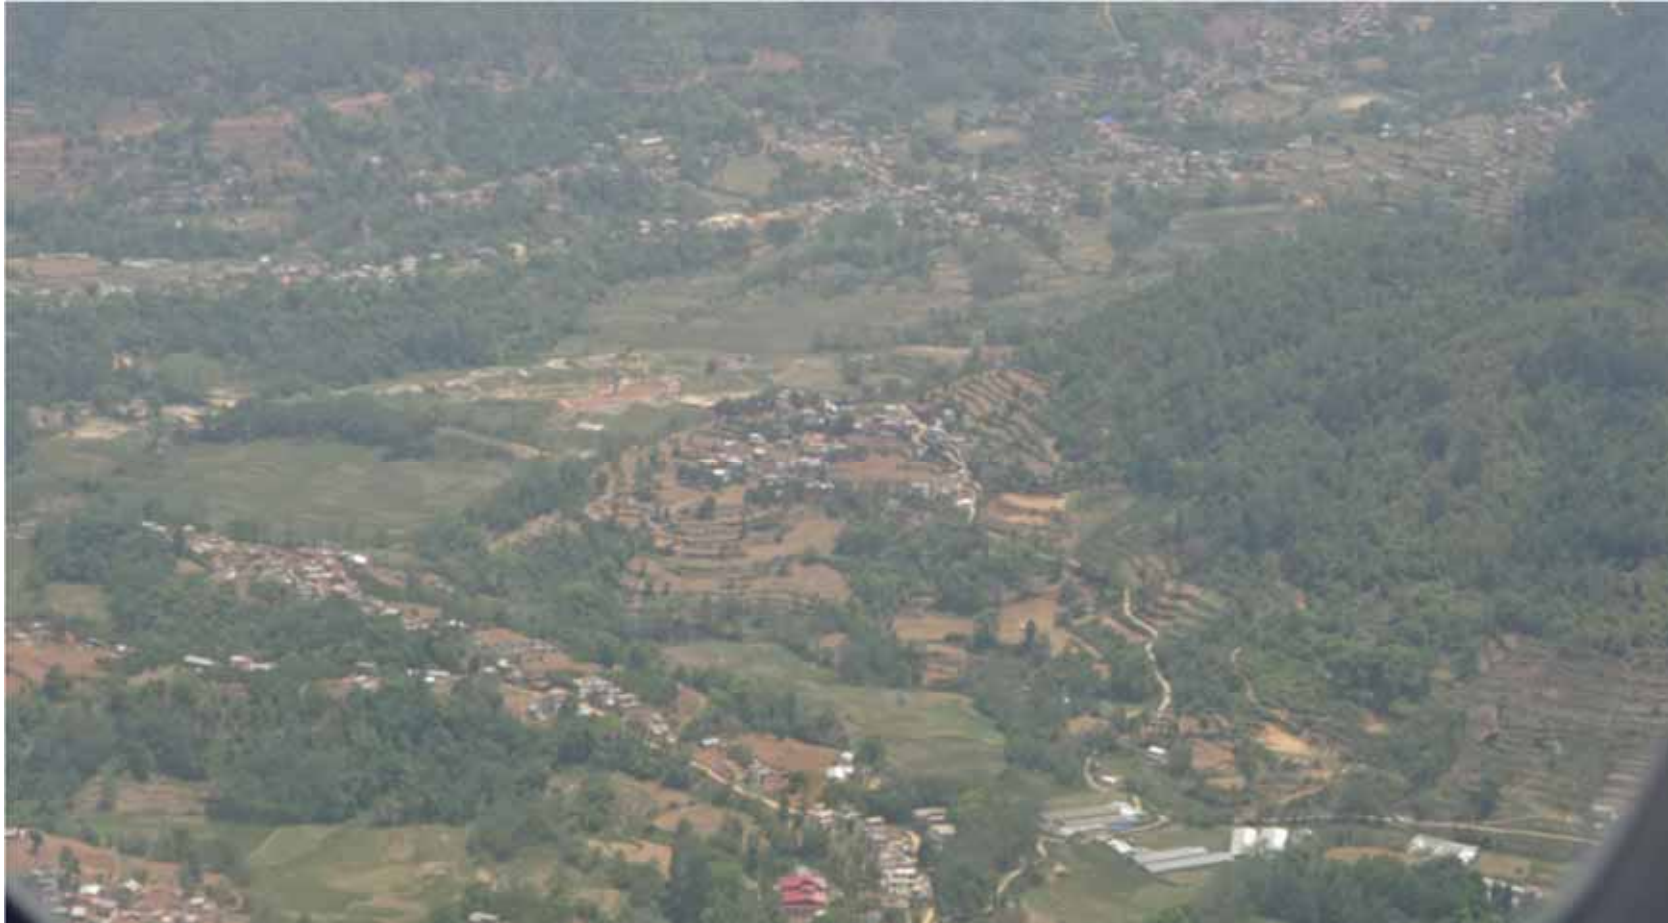
Few damage on the hill in the north of Tribuvan Airport were recognized

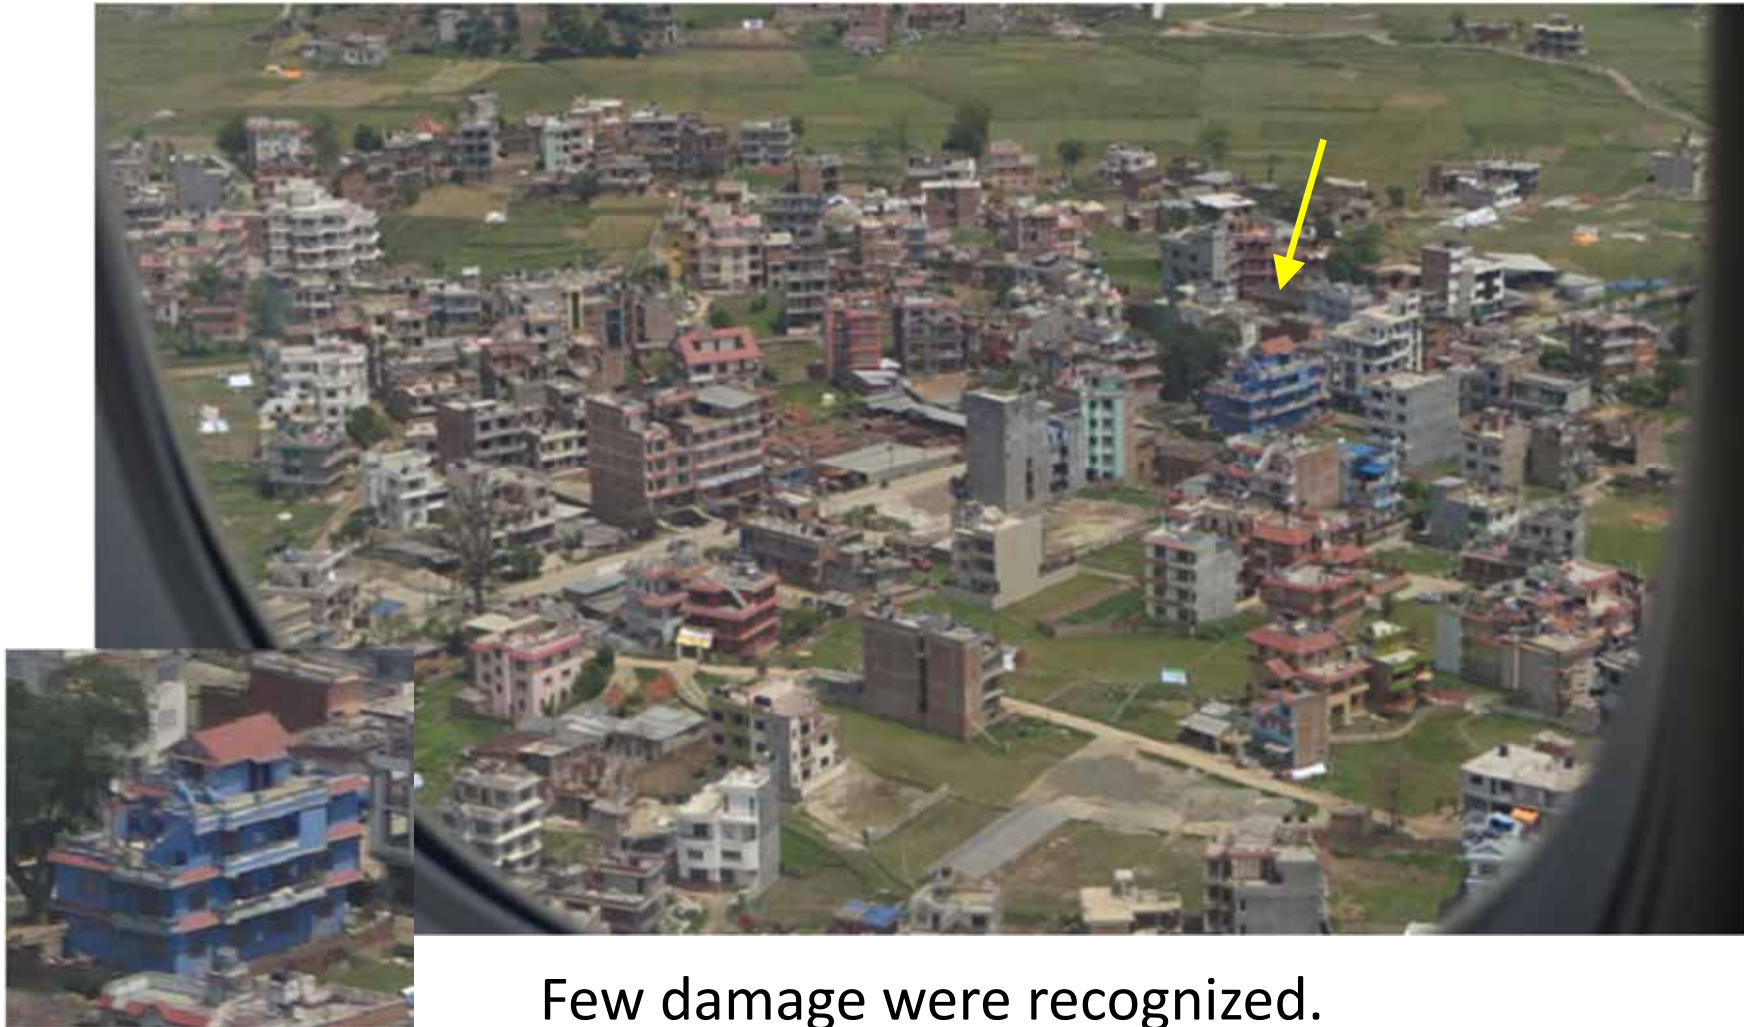
Few damage were recognized.

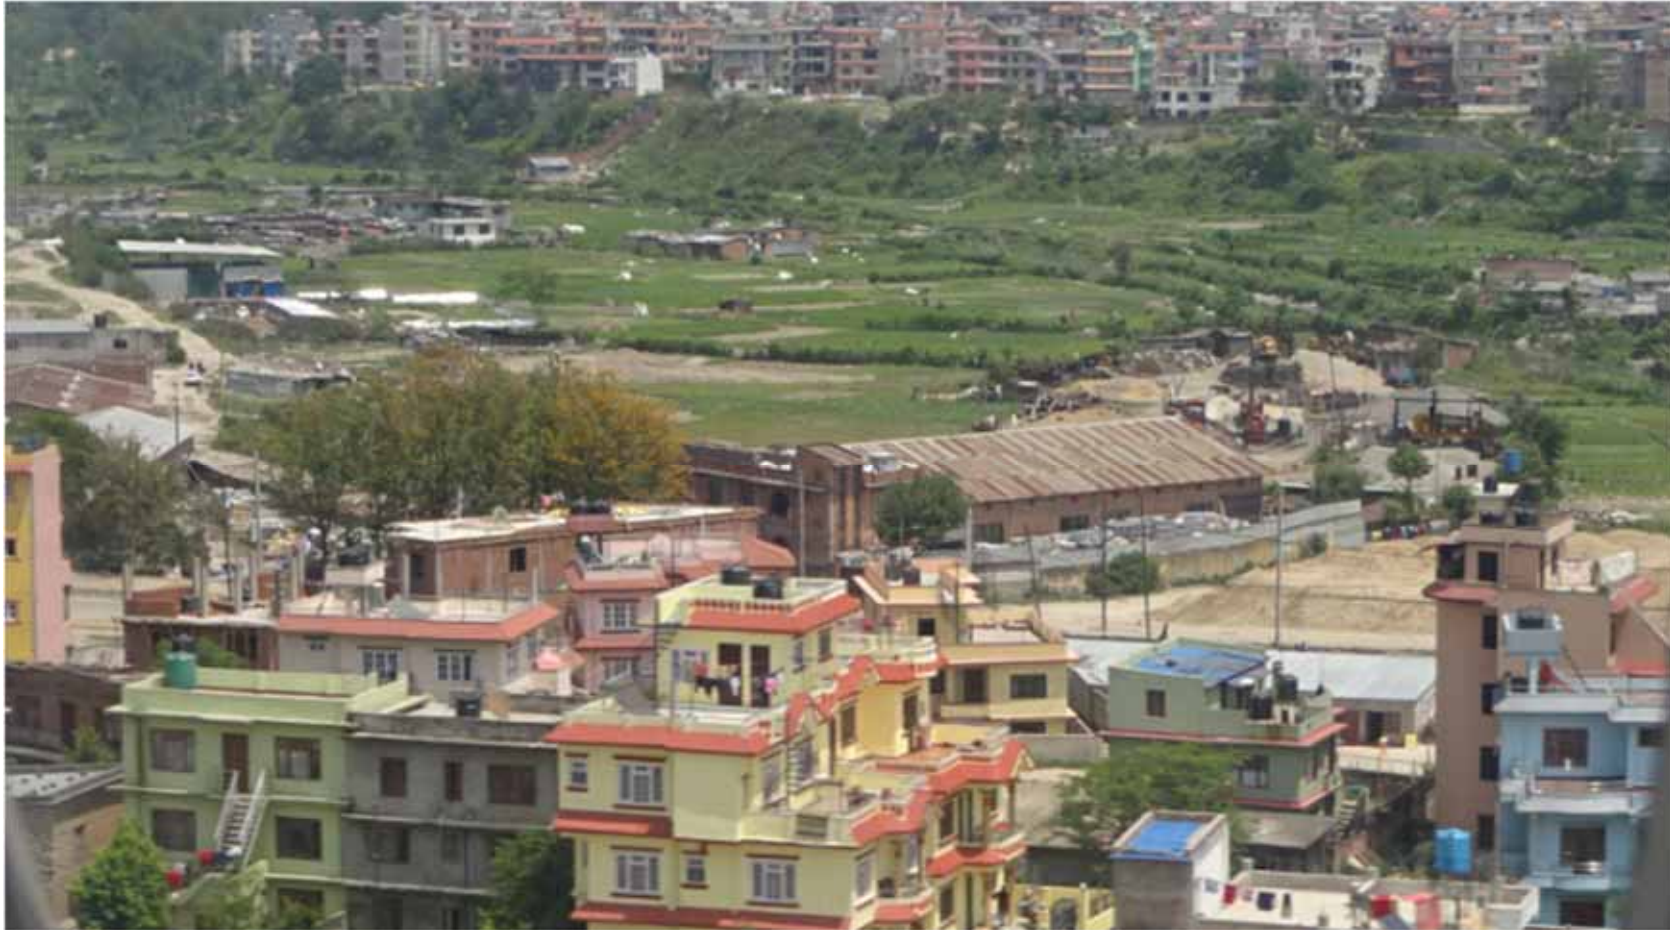
Water tanks on the roof, which is vulnerable in earthquake motion are not damaged.

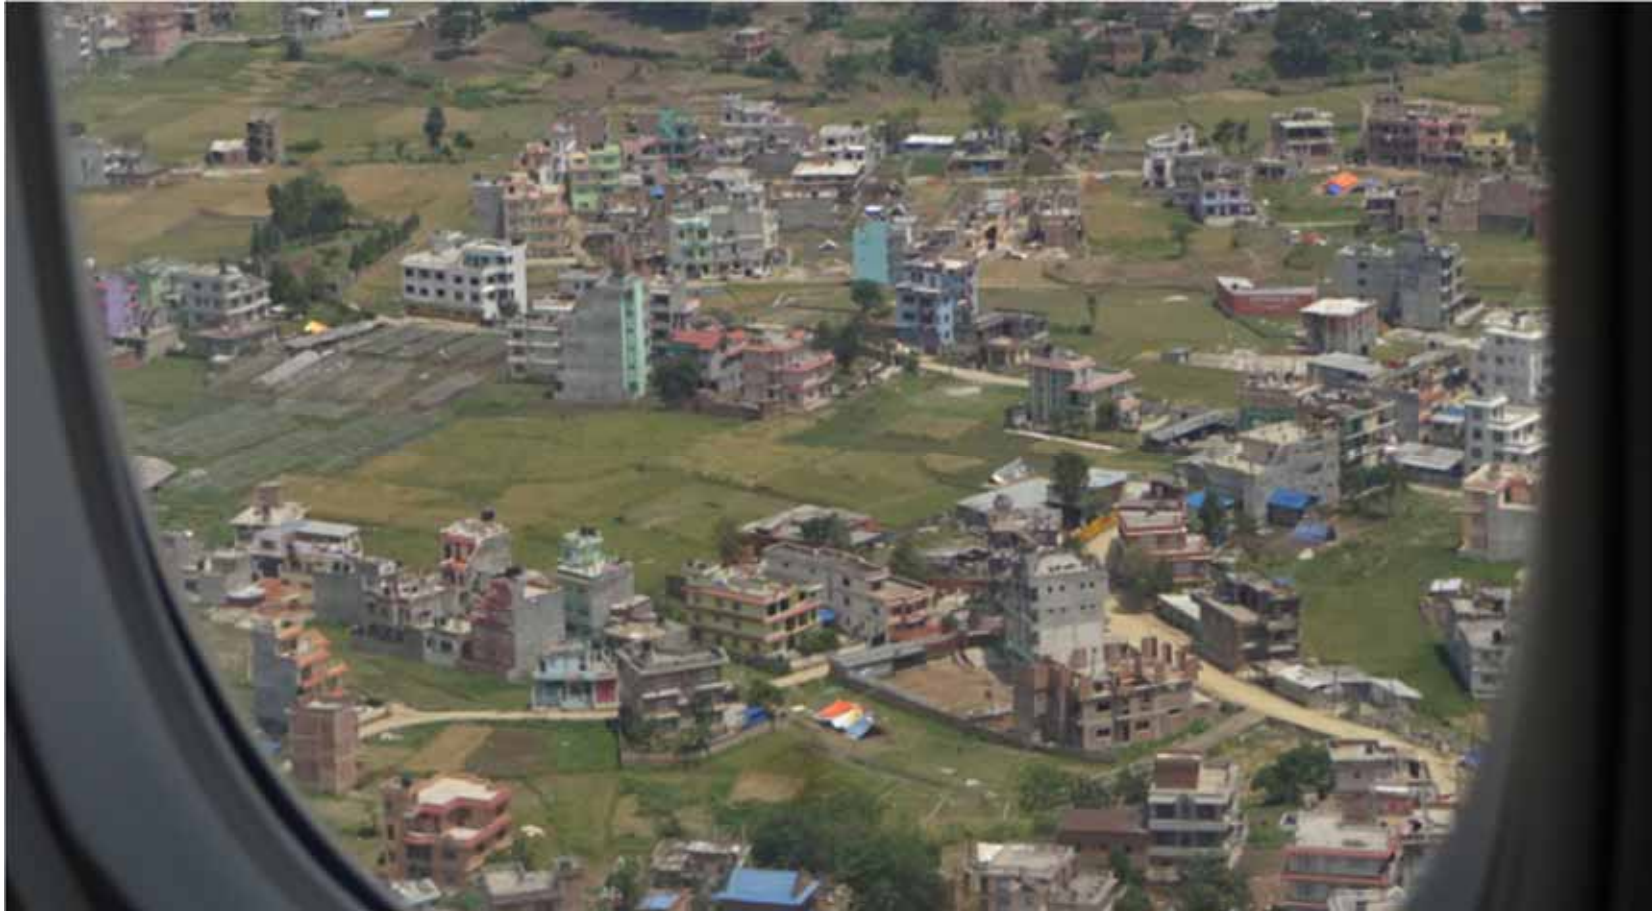
Few damage were recognized

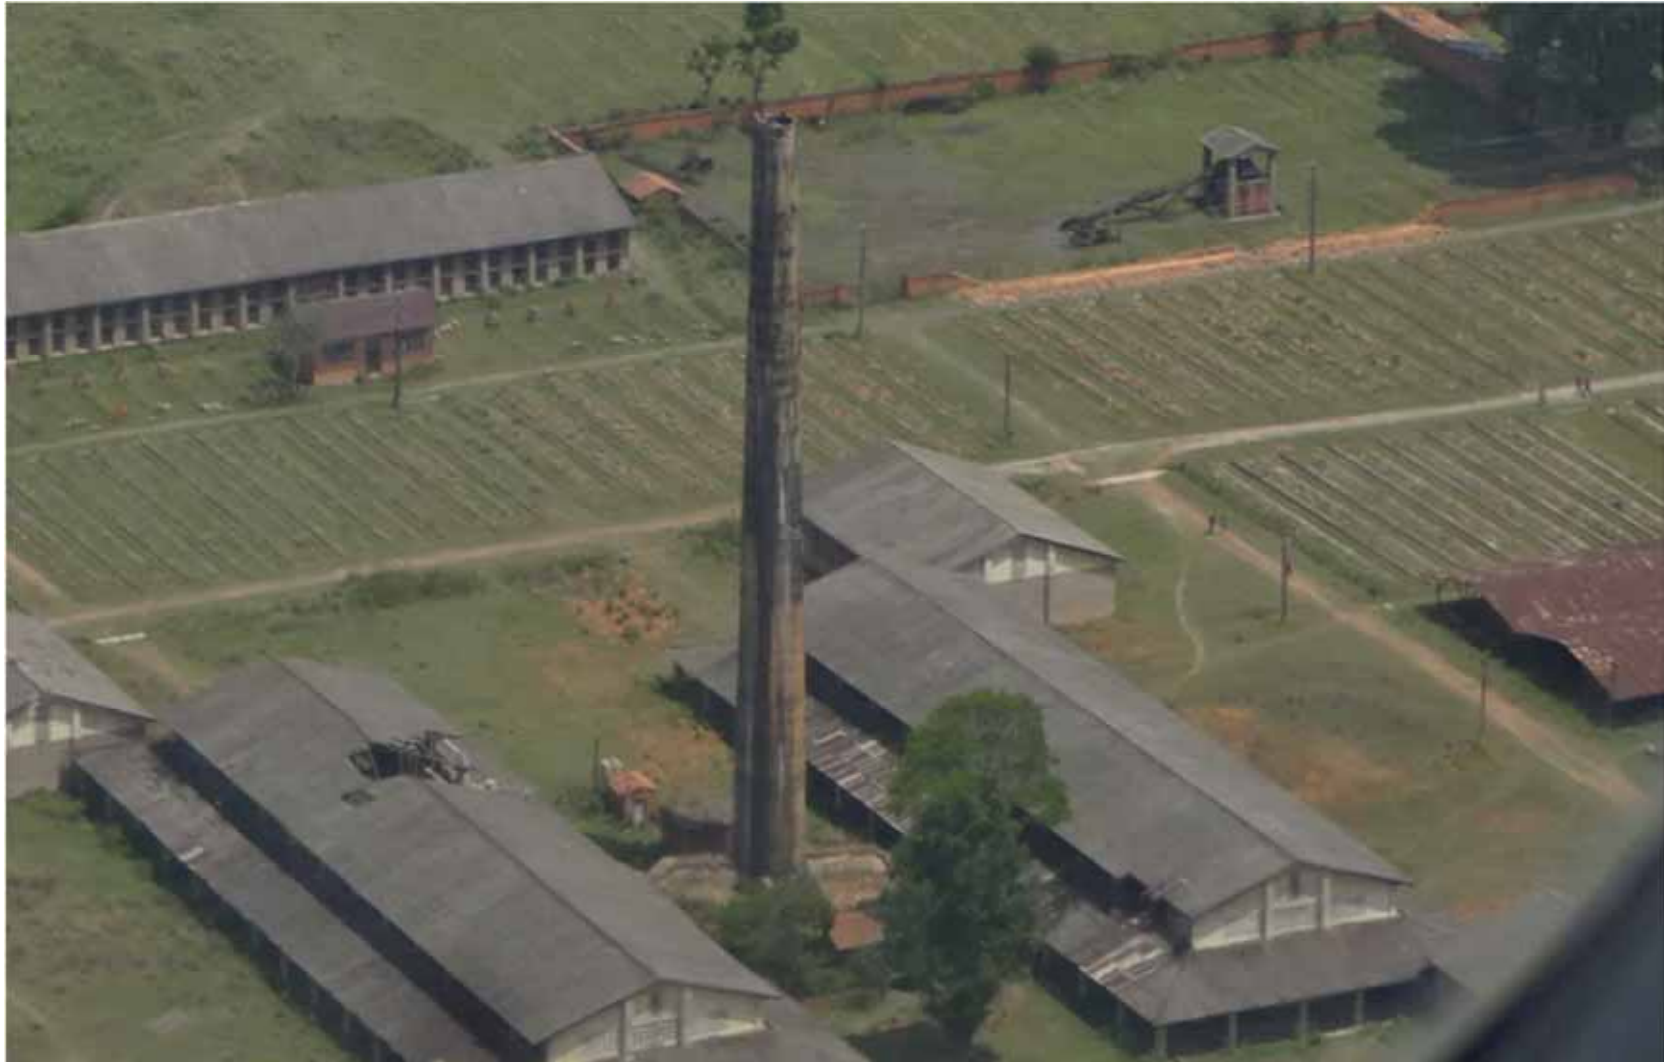
Slight damage to chimney was recognized.

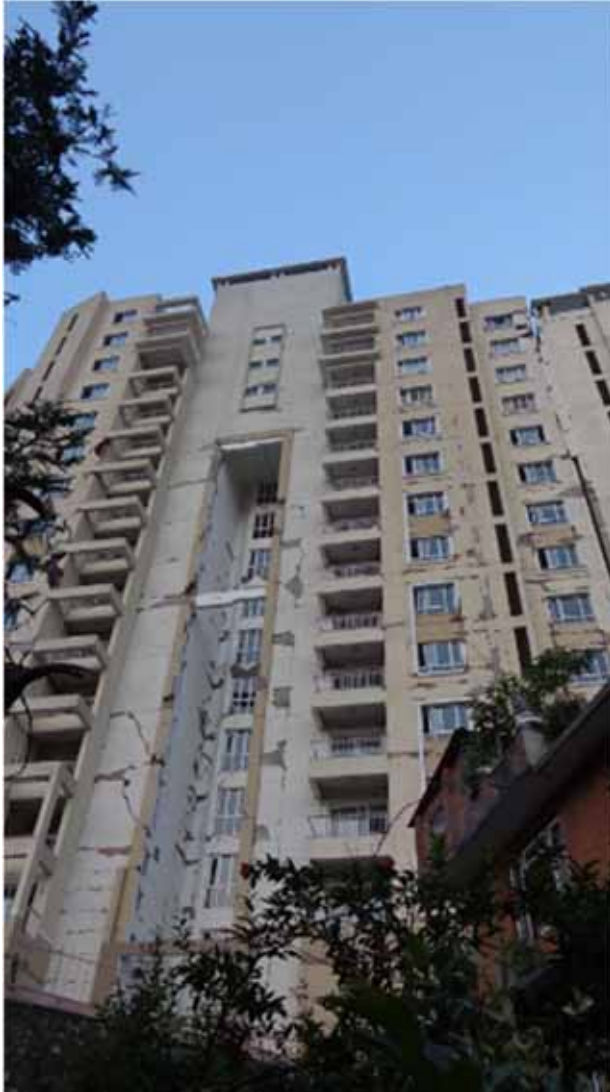
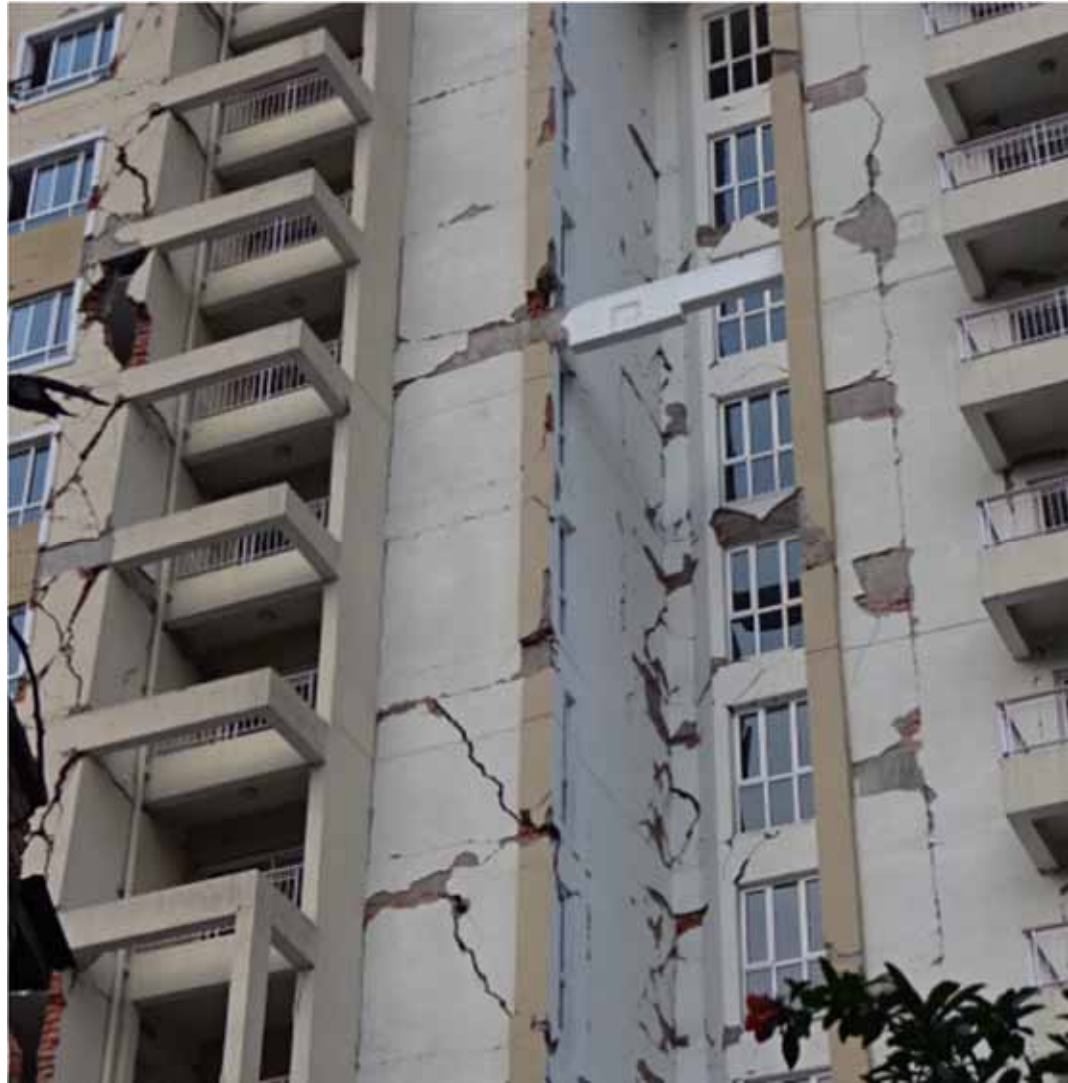
# Park Horizon, KTM

All the large cracks were on the walls, or non-structural elements. No visible cracks on the structural elements.

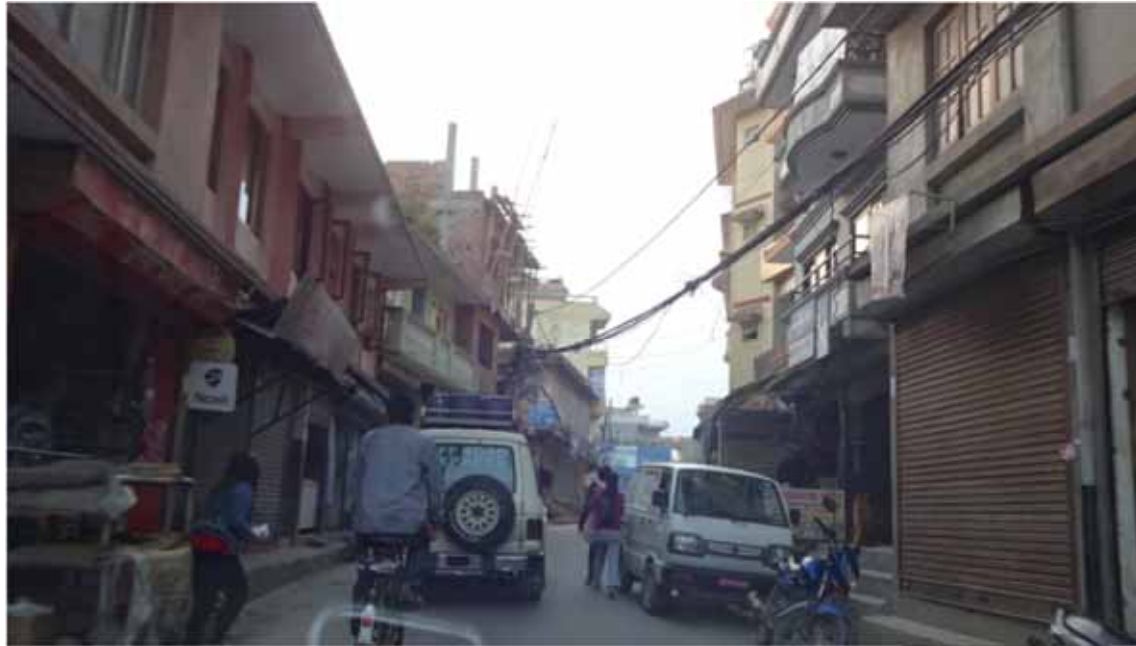
# Park Horizon, KTM

Normal buildings around the Park Horizon suffered no damage. According to our interview to local people regarding their behavior during the quake, seismic intensity there would have been 4 to 5- in JMA scale, or 7 in MMI scale.

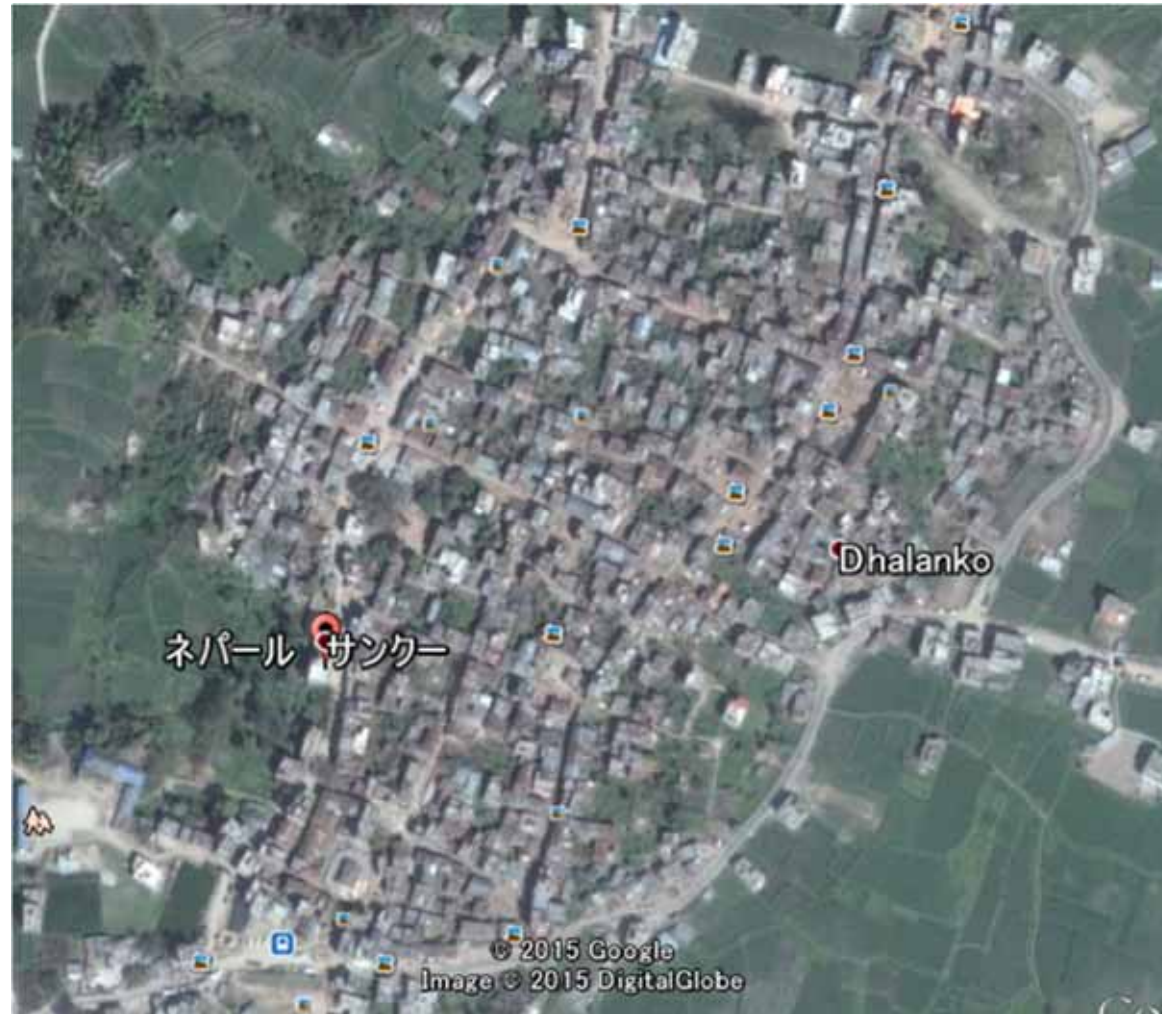
# Sankhu

80-90% buildings are reportedly destructed or heavily damaged.

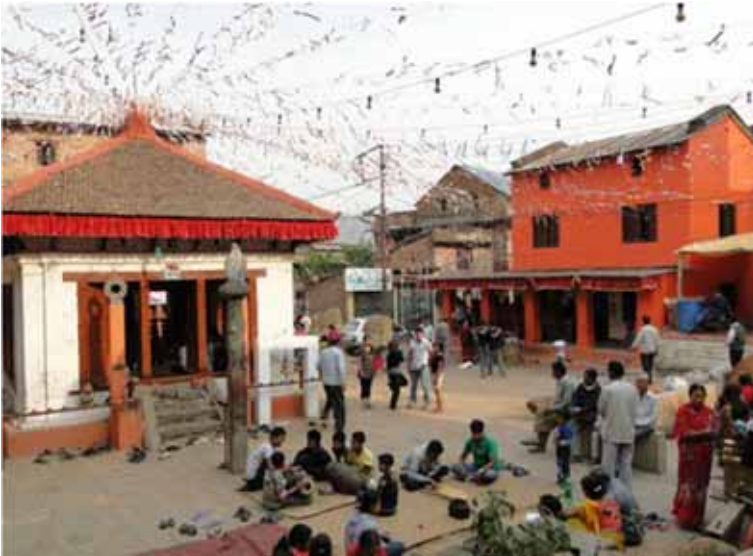
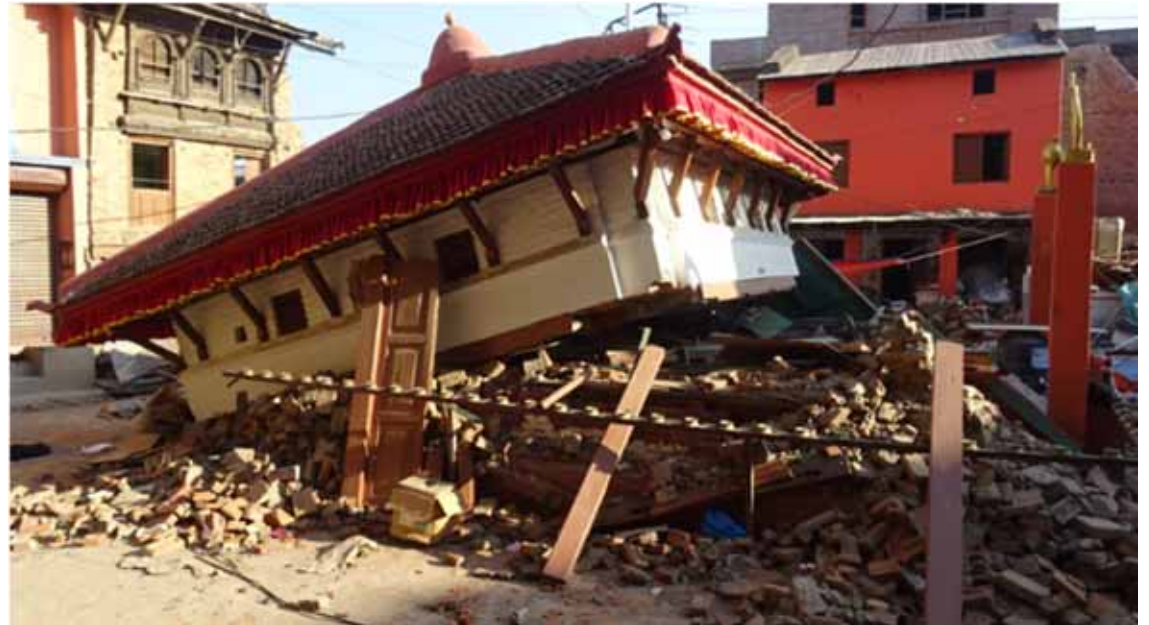
A temple before and after the quake.

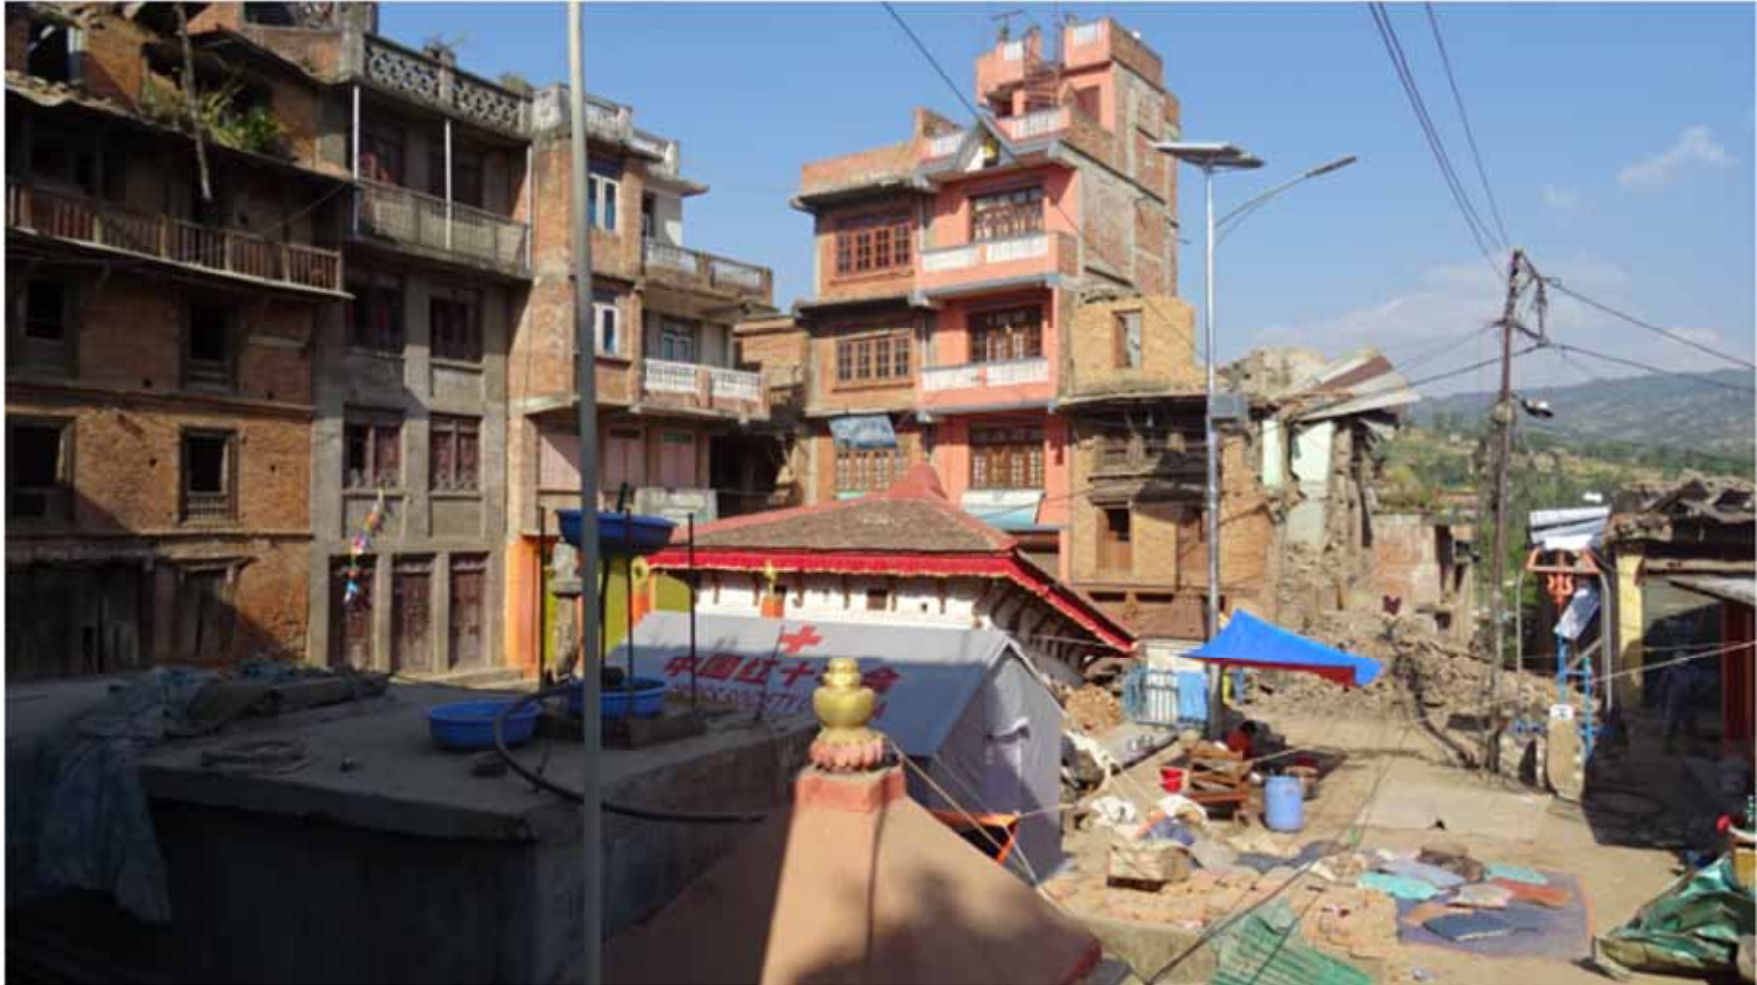
A RC build may have helped old masonry buildings against collapse.

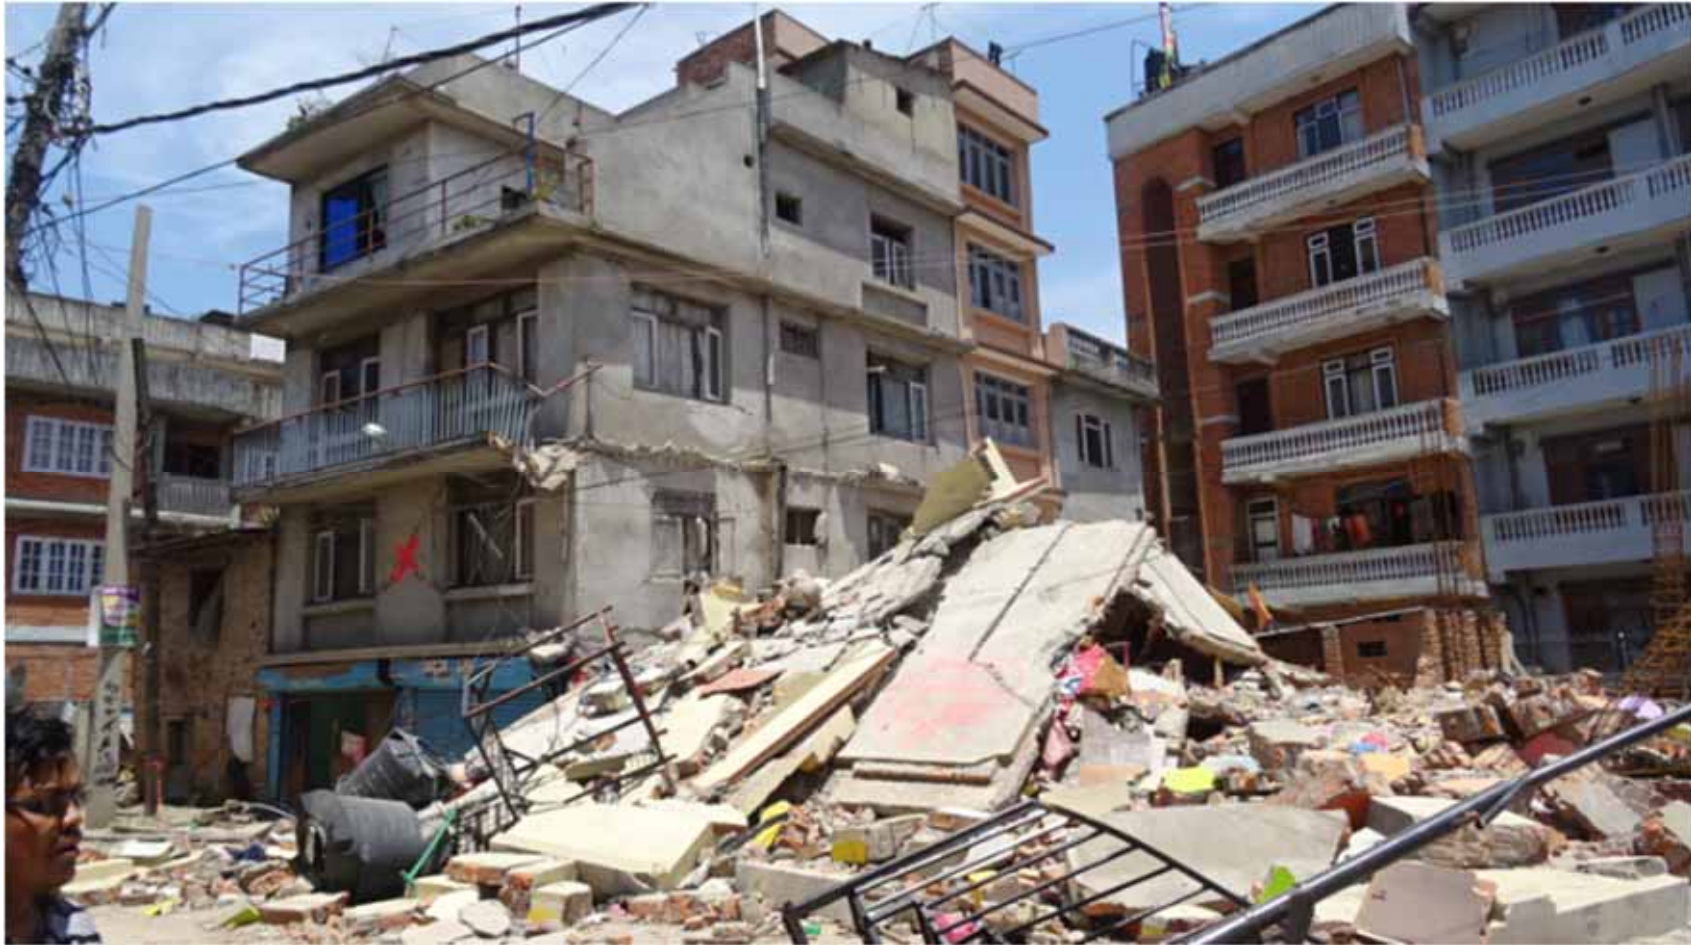
# Sobhabhagawati, KTM

A RC build may have helped old masonry buildings against collapse.
