# Preliminary Damage Survey Reporting Seminar of JSCE at University of Tokyo

## Nepal Gorkha Earthquake, 2015

Earthquake Engineering Group  
Ehime University Team  
JSCE, JGS, JAEE and ATC3 delegates

Shinichiro Mori, Prof., GPI

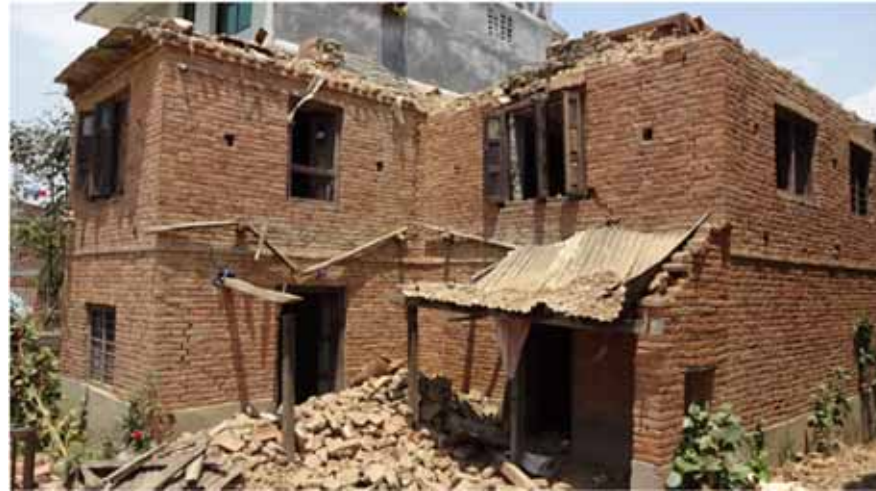
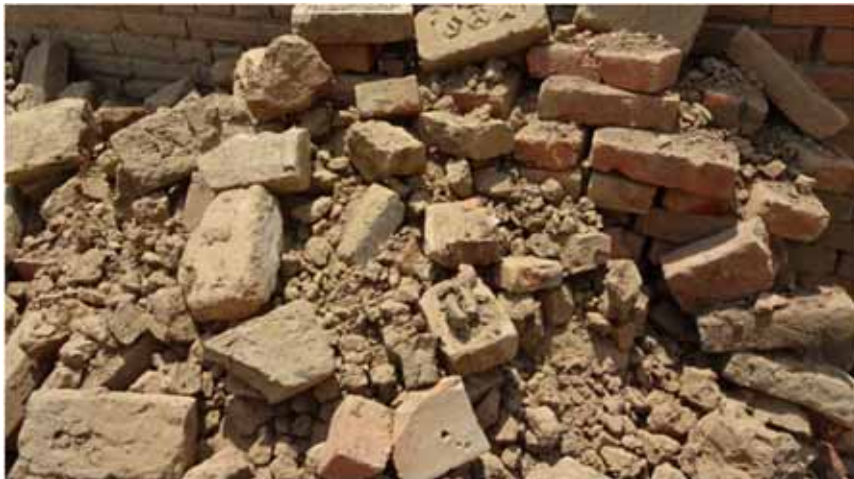
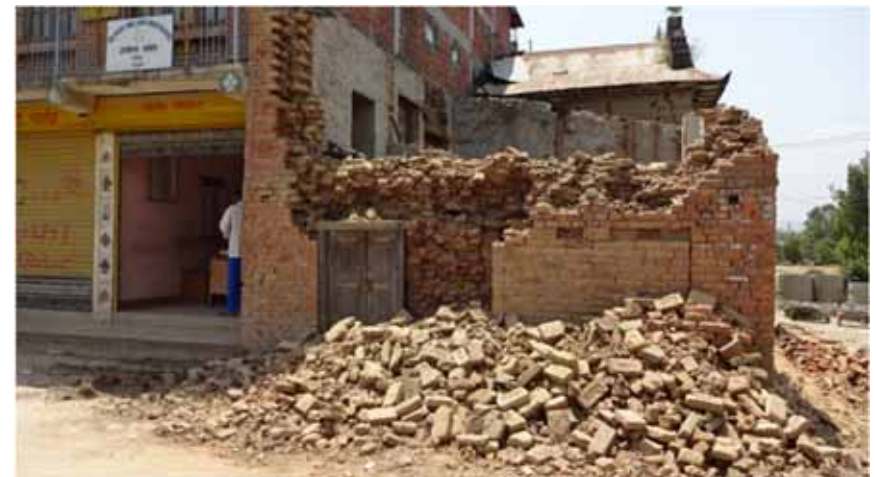
# Near Kakhutapur

A RC build may have helped old masonry buildings against collapse.

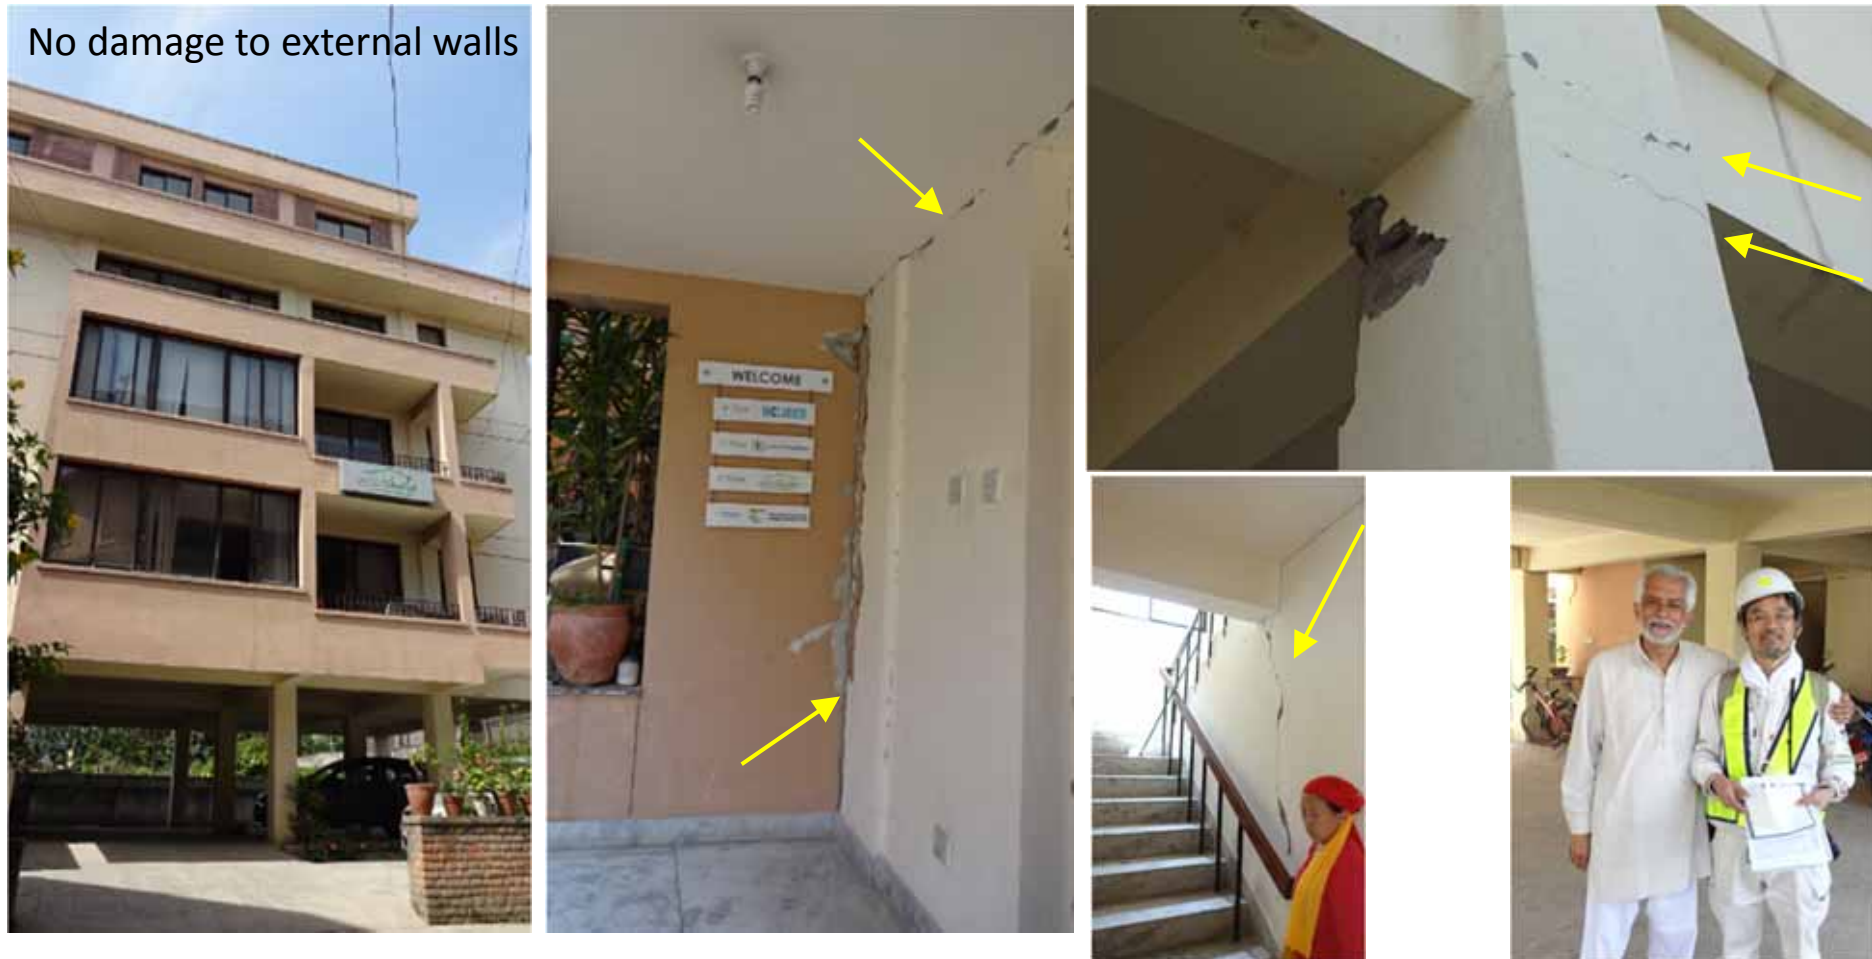
# A damaged 5F-building (G1) in Pulchowk, KTM

Damage: Cracks on the nonstructural internal brick walls. Bending cracks at the head of columns of the first story resulting delamination of plaster. **Slight damage.**

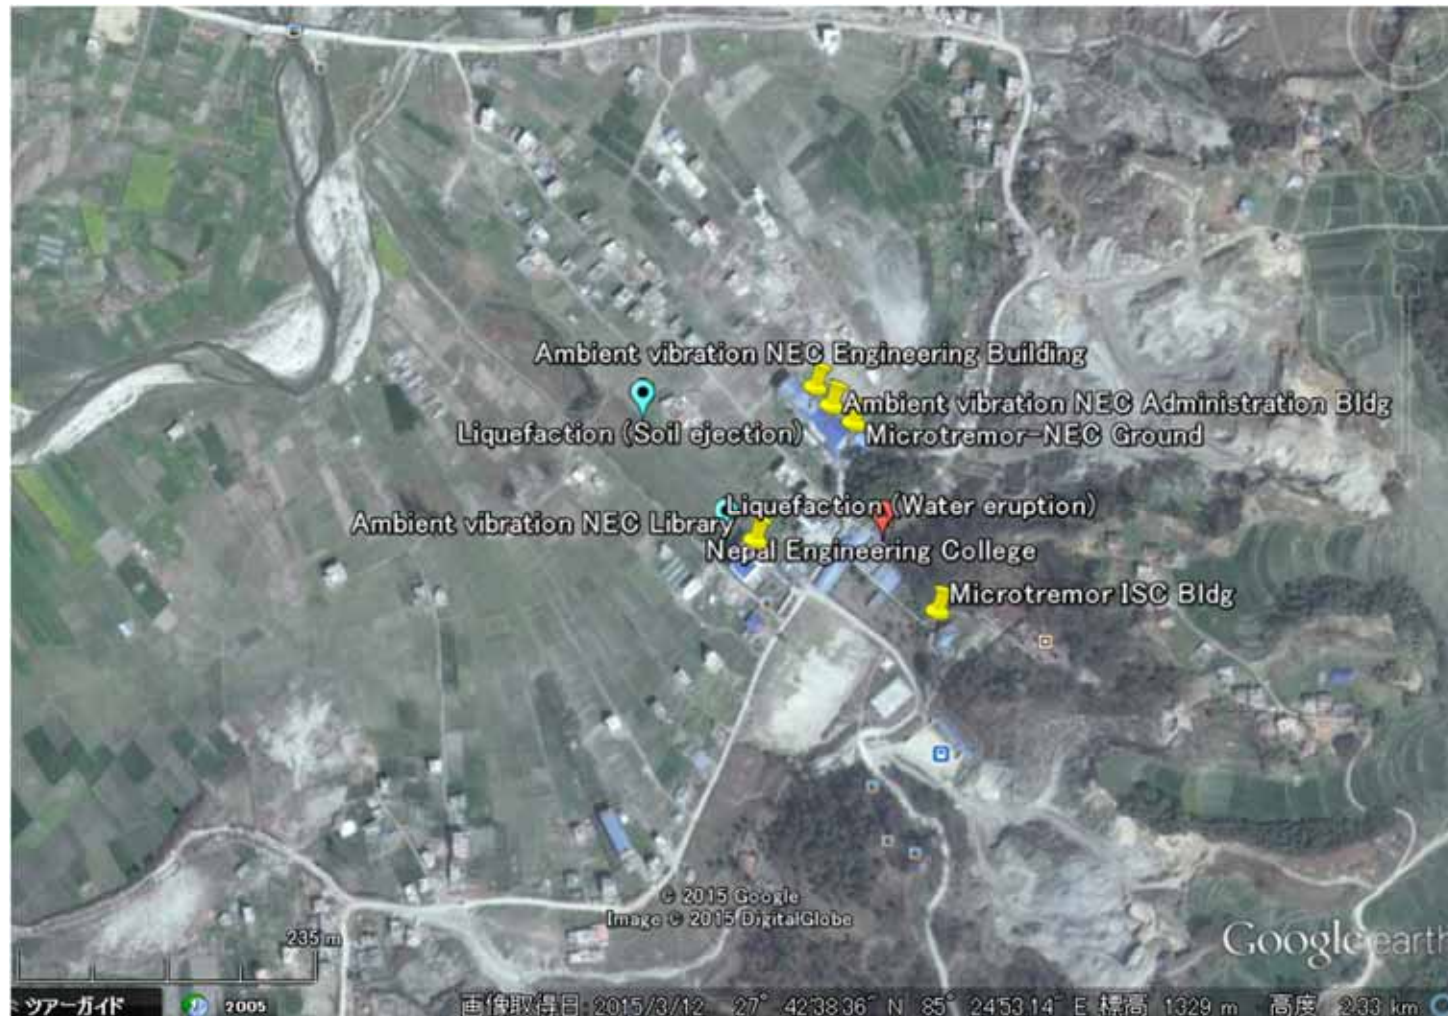
Nepal Engineering College buildings and surrounding houses damaged due to soil liquefaction: Settlement of buildings and houses observed.

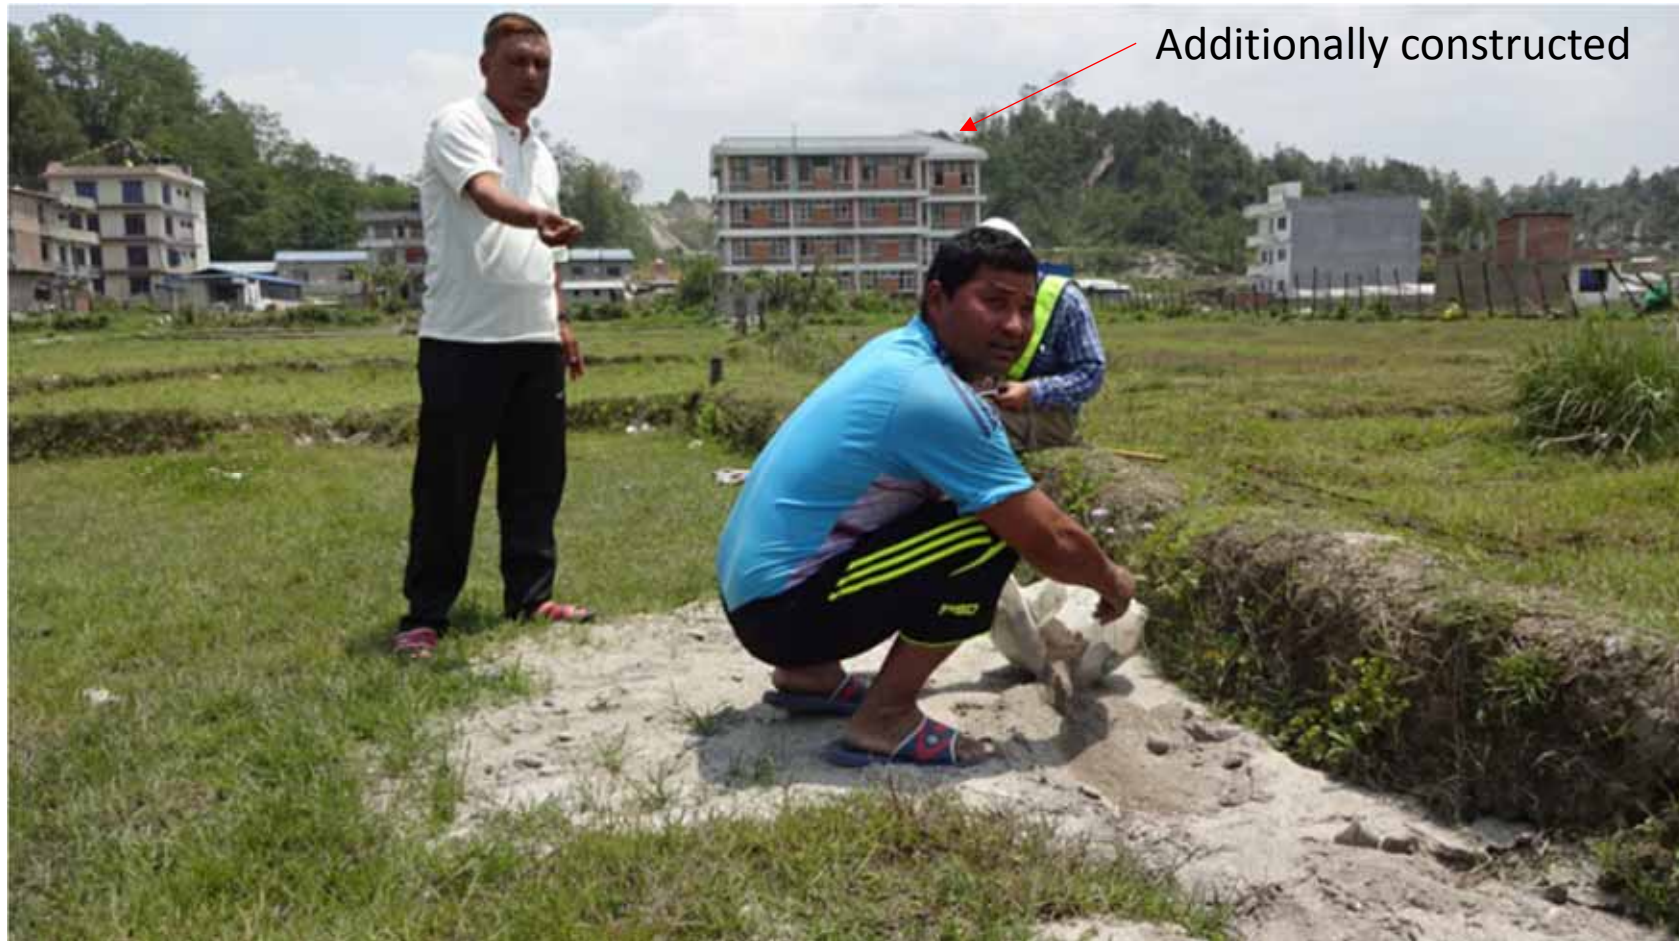
27 ° 42'40.01"N, 85 ° 24'50.63"E, Alt. 1326 m

Ejected sand during shaking of main shock from a fissure

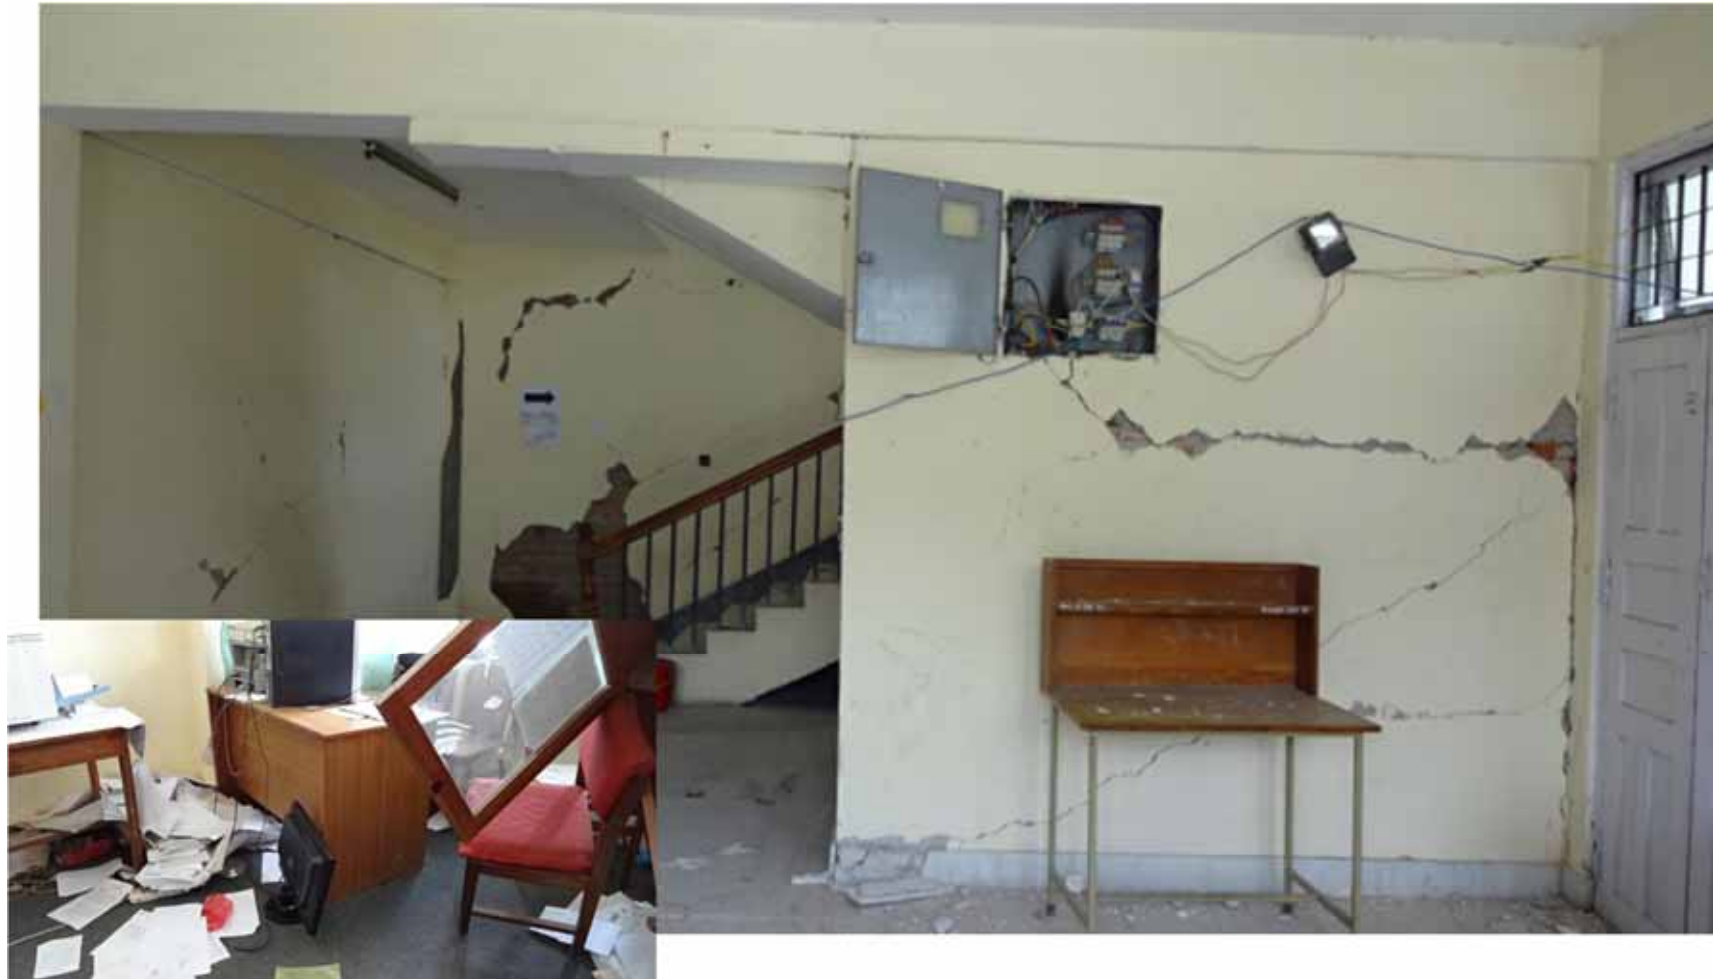
Brick shear walls suffered damage (G2). Subjects overturned (0.2g).

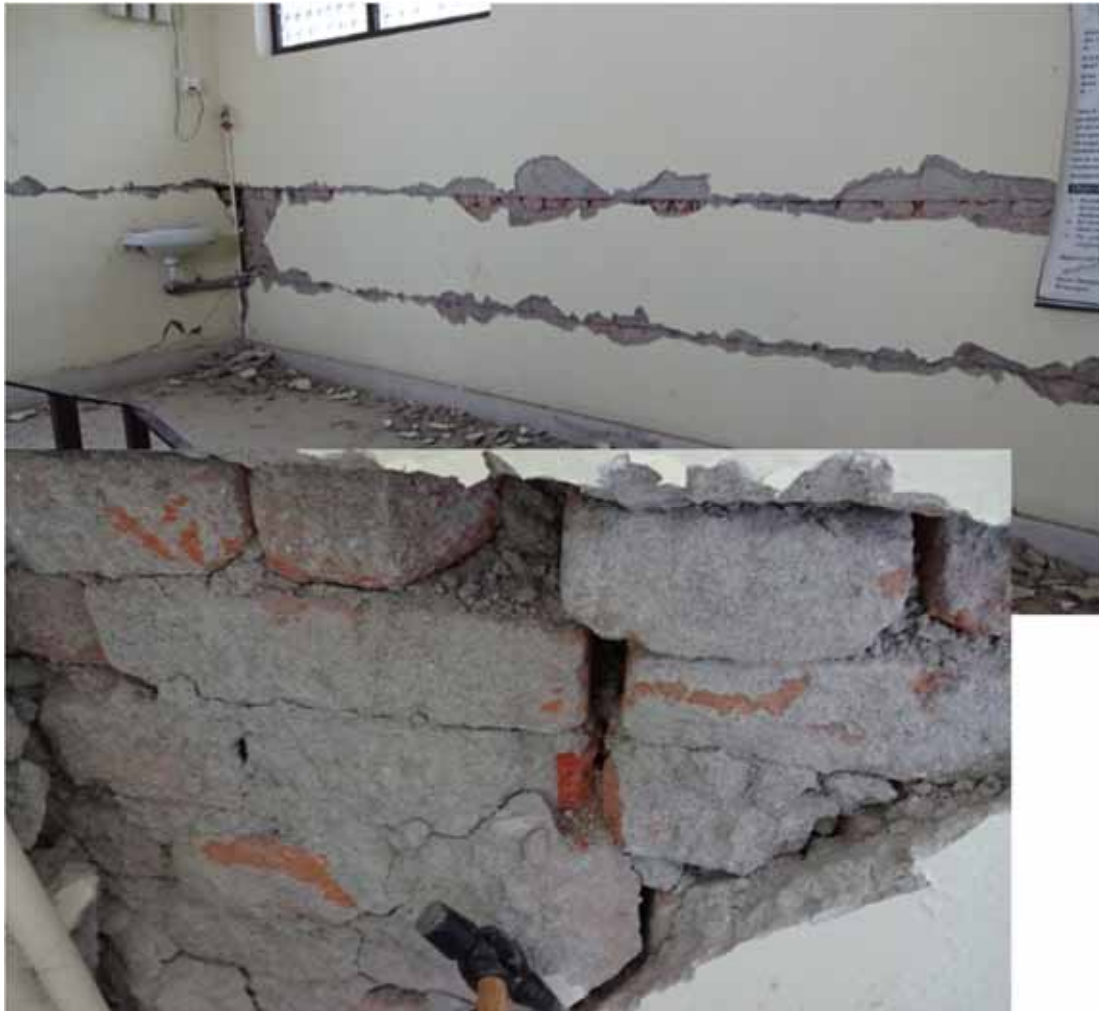
Mortar was not good

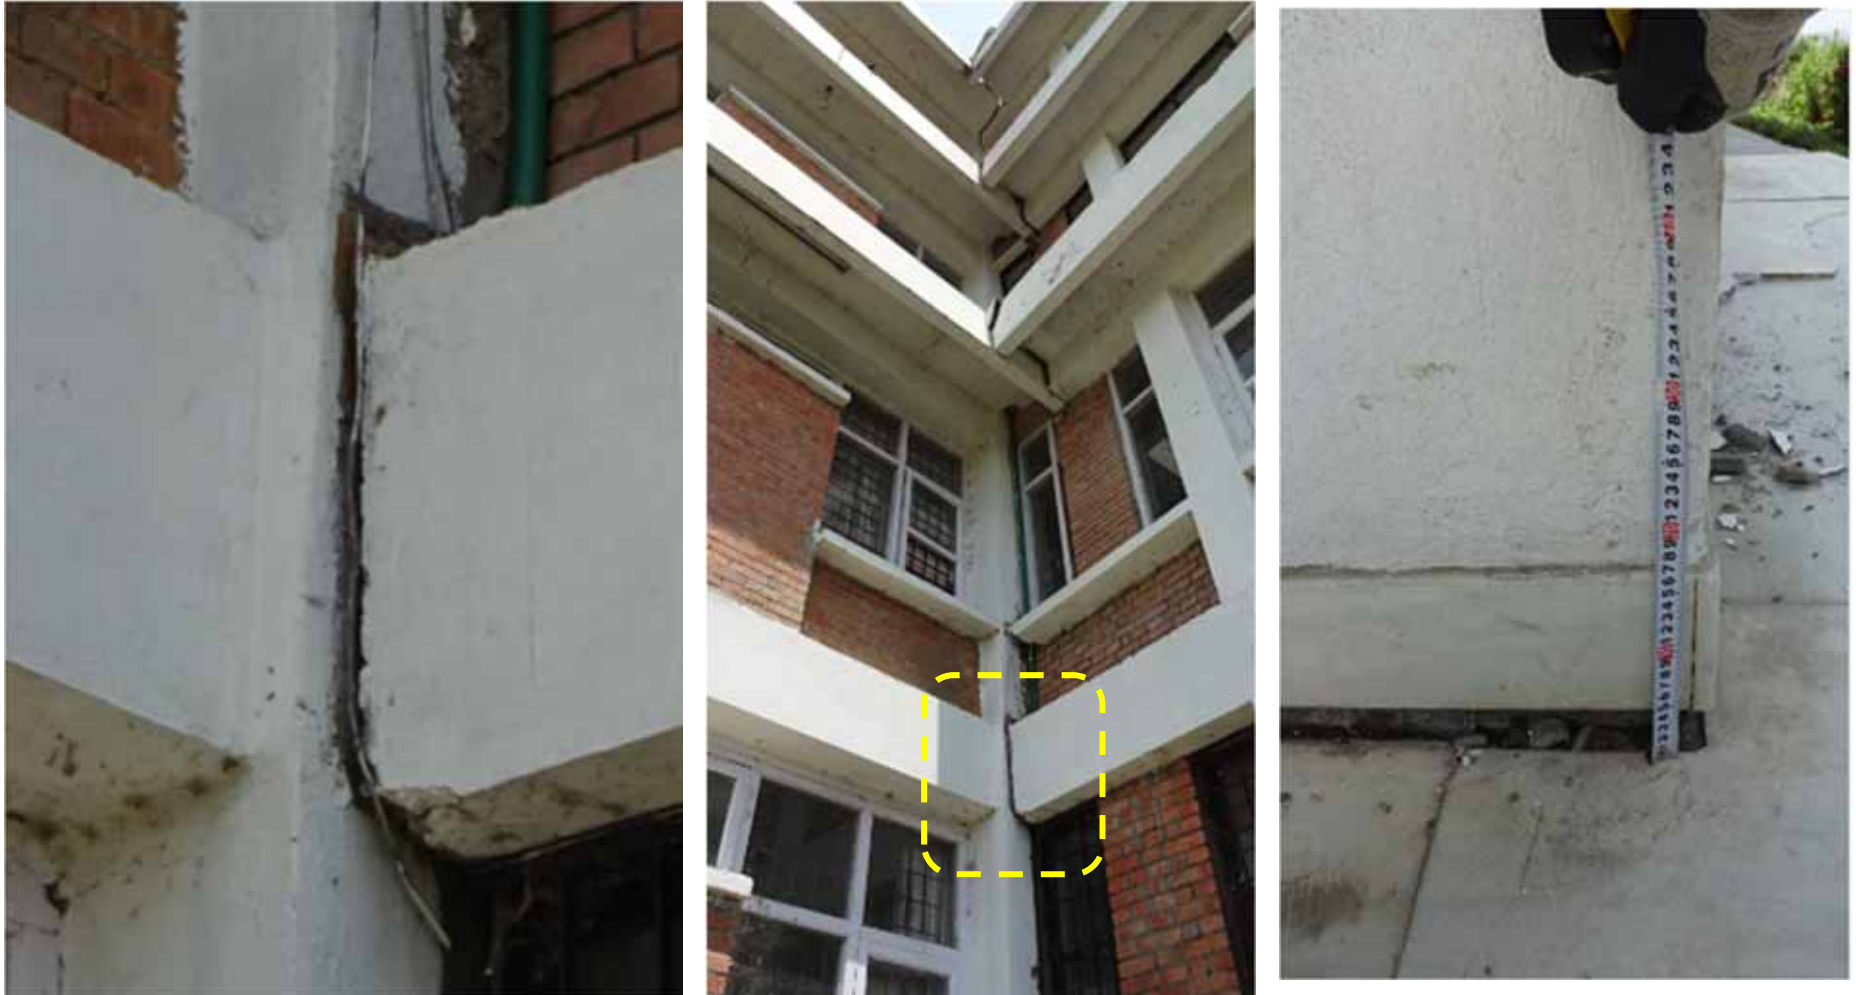
3 cm settlement relatively to ground and 6 cm another building

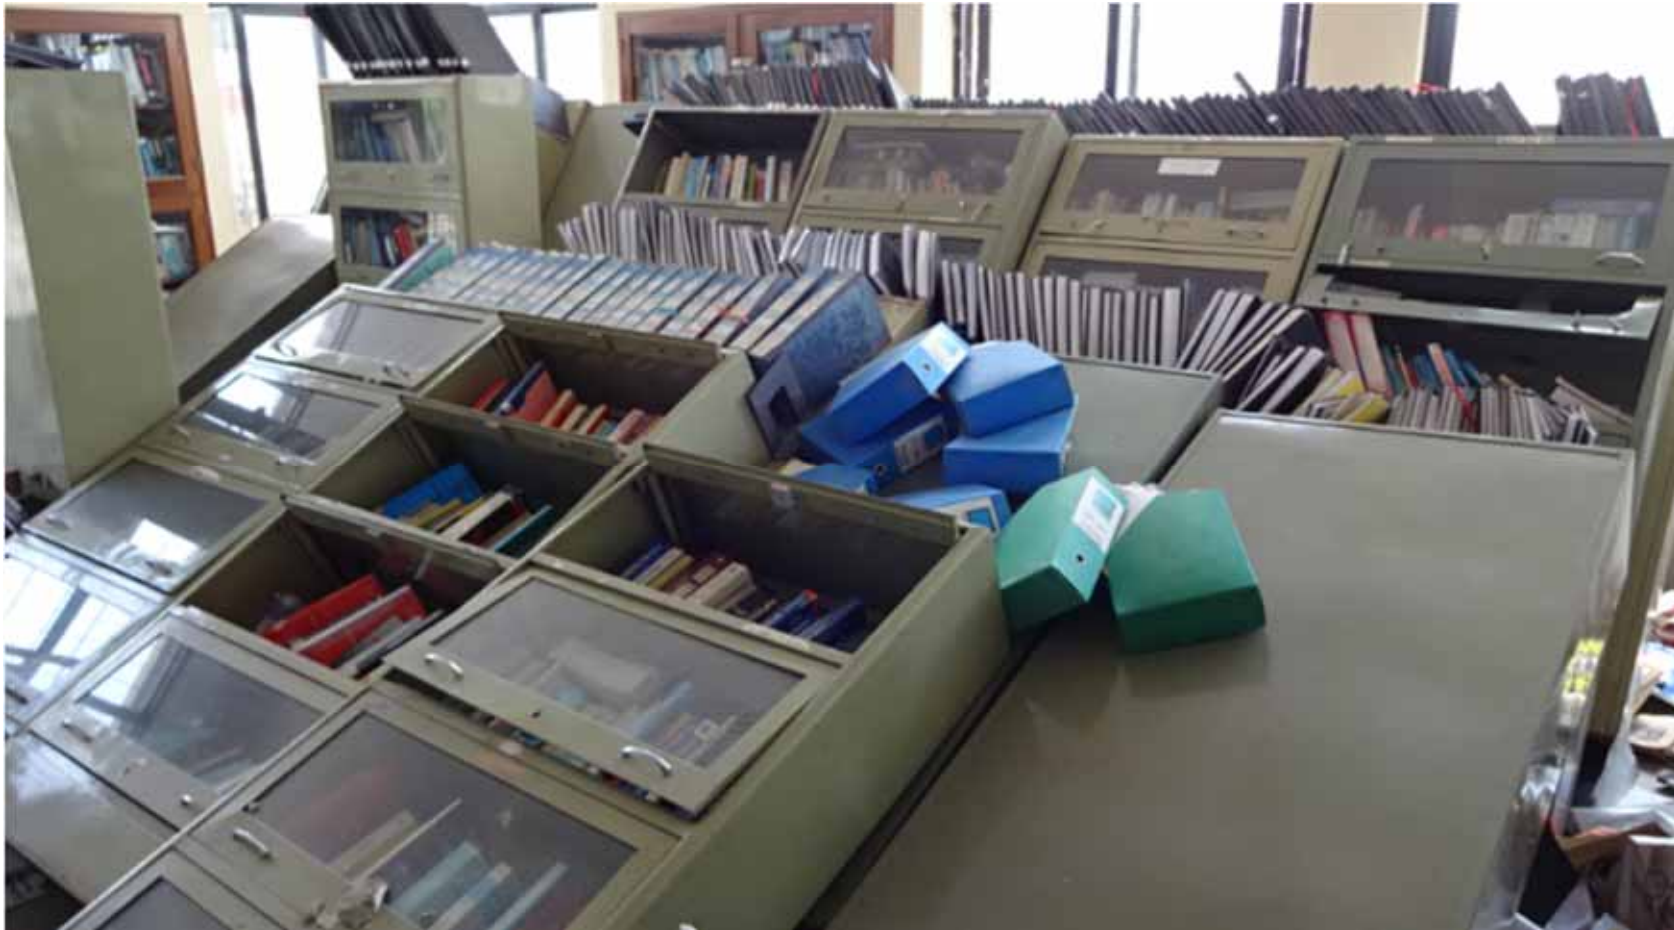
Seismic coefficient was estimated to be some 0.2 g.

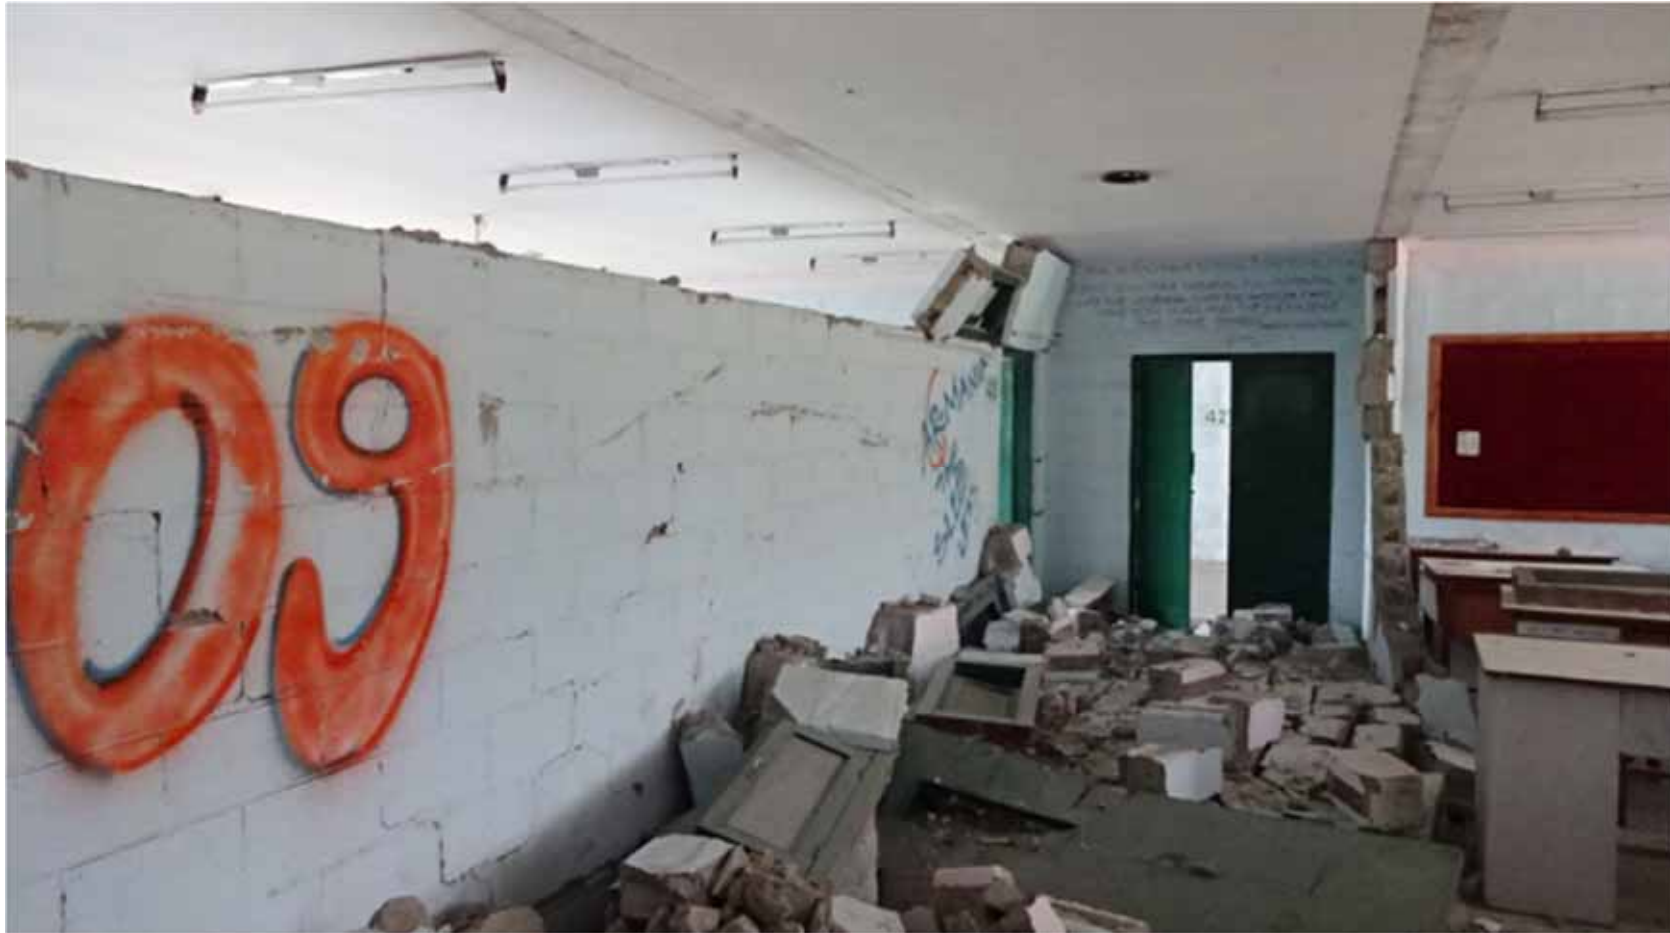
# Seismic damage at NEC

Concrete block wall was completely overturned. Saturday day time.

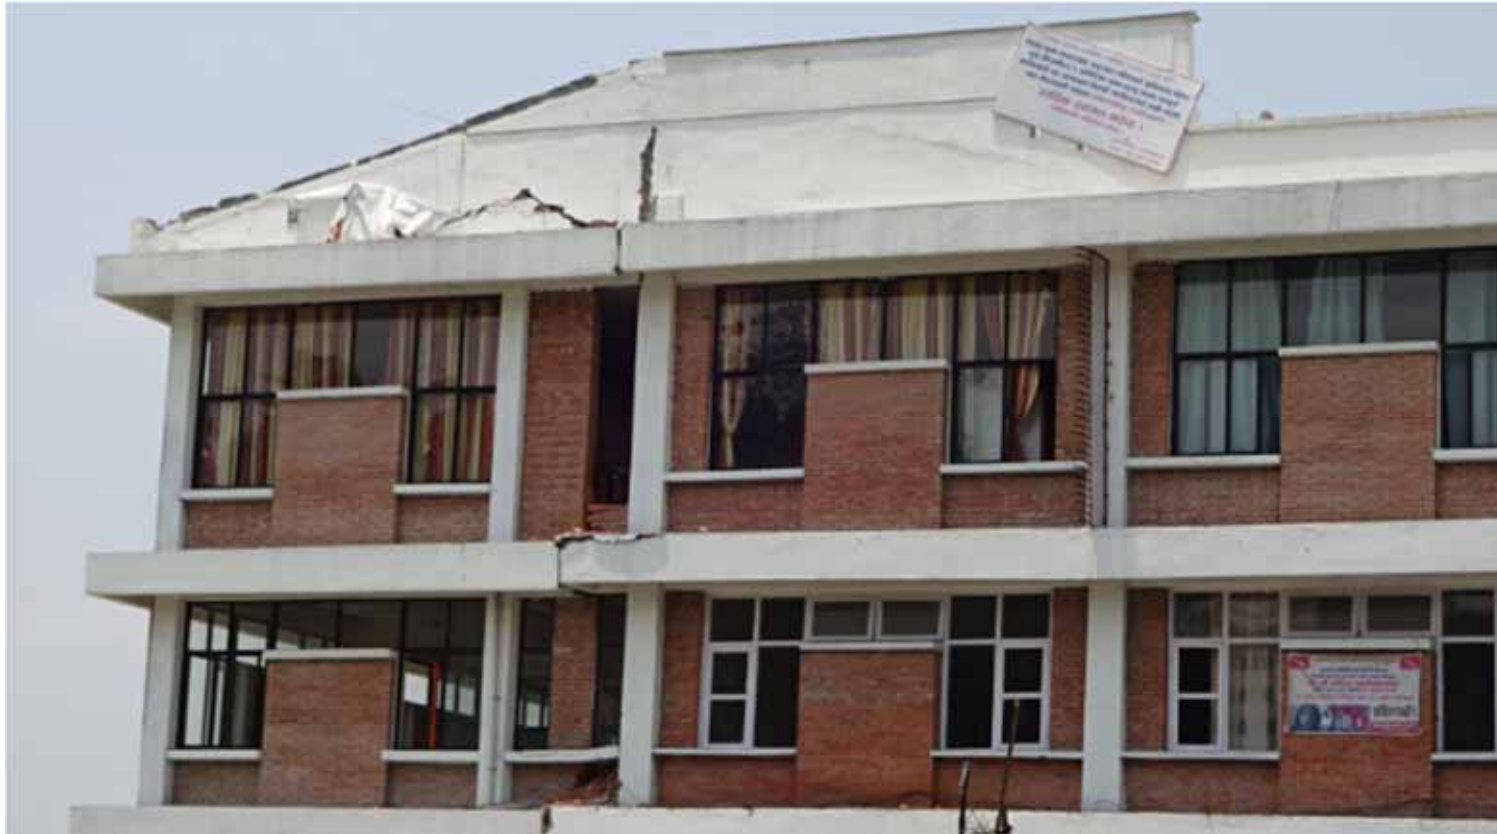
Parapet walls are damaged due to liquefaction-induced relative settlement.
