Geotechnical Damage caused by M7.5 Noto Peninsula Earthquake of January 1, 2024

(Updated version from EERI QQB presentation on Feb. 23, 2024)

Takashi KIYOTA¹, Jun KURIMA¹, Takaaki IKEDA², Masataka SHIGA²

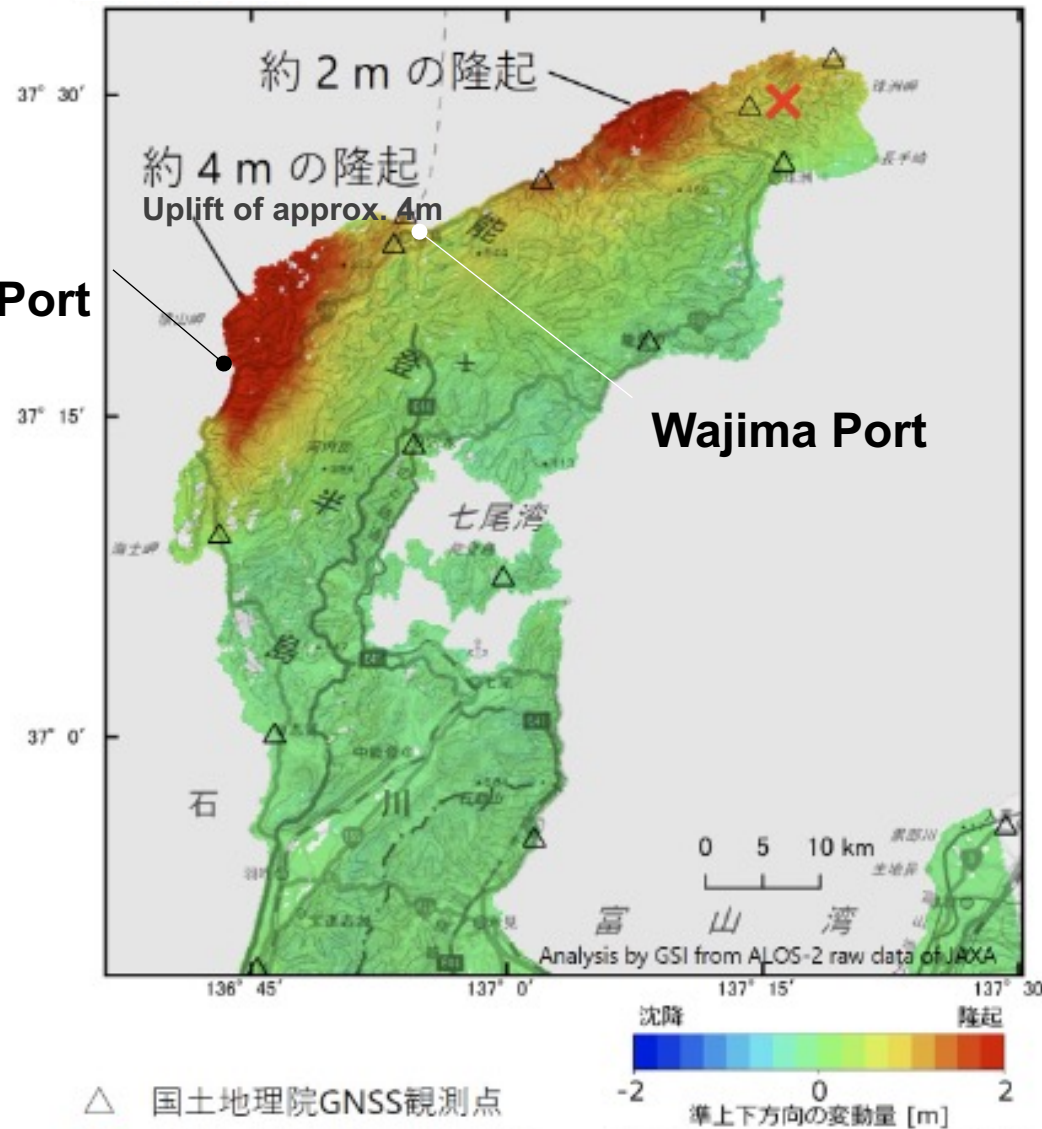
U-D Direction

InSAR analysis has detected ~4m vertical and ~3m horizontal displacements in the north-west of the peninsula

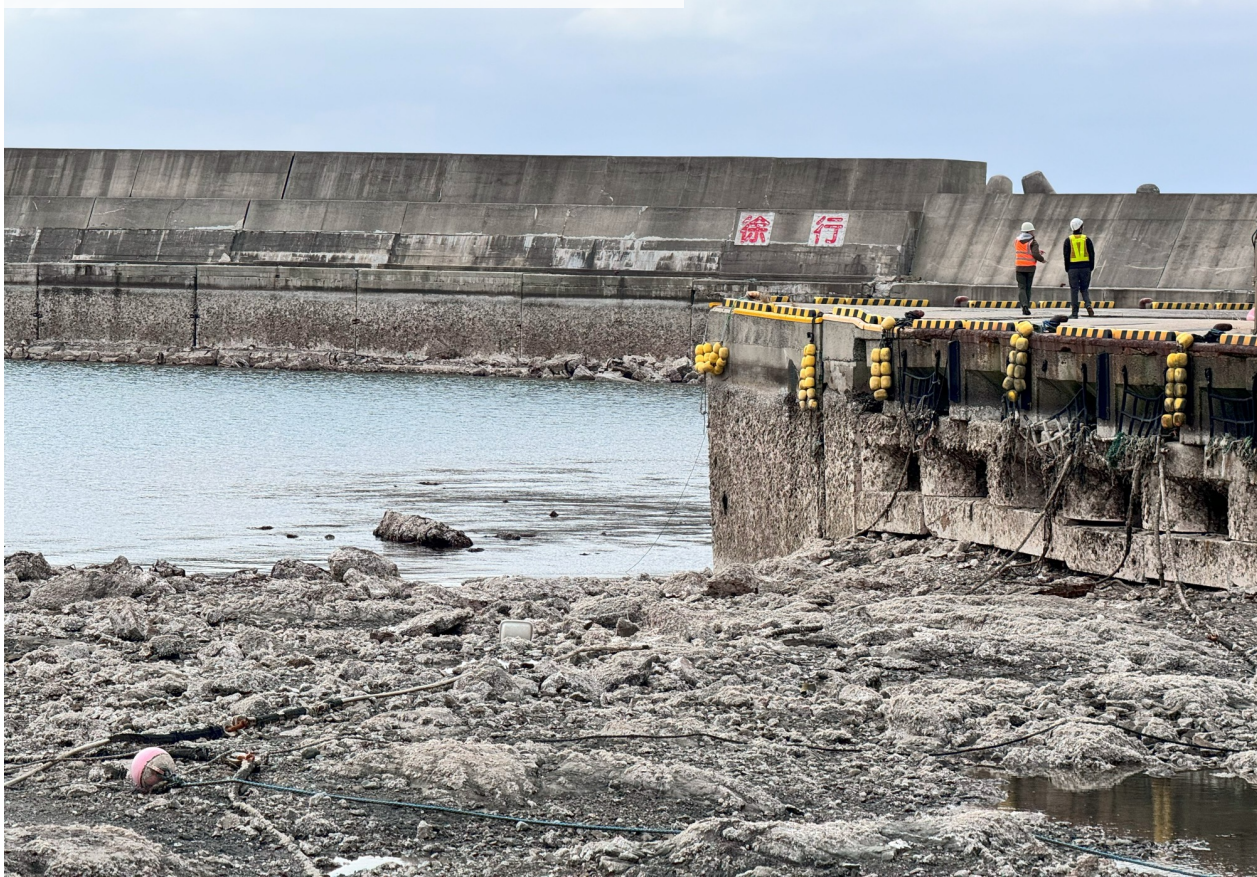
Kaiso Fishing Port, Shika, Ishikawa

- Uplift of approx. 4m resulted in the formation of a new marine terrace ([AIST](#) or [Shishikura et al., 2020](#))
- Some port facilities were rendered unusable by the uplift
 - Typical open cracks and uneven settlement were observed

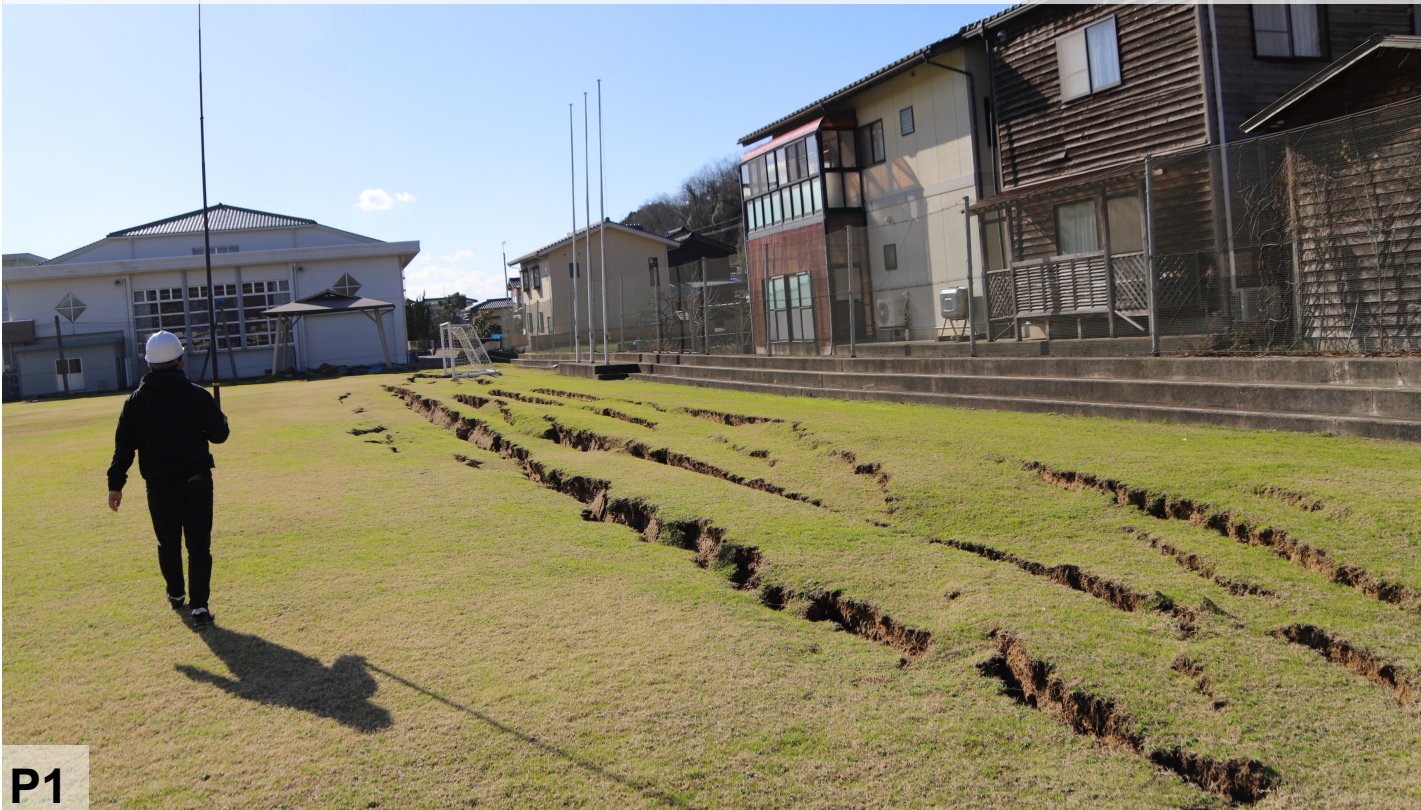
P1

- Tension cracks and vertical offset parallel to the dune axis in the closer area
- Road pavement was buckled or lifted up along Pref. Road No.8

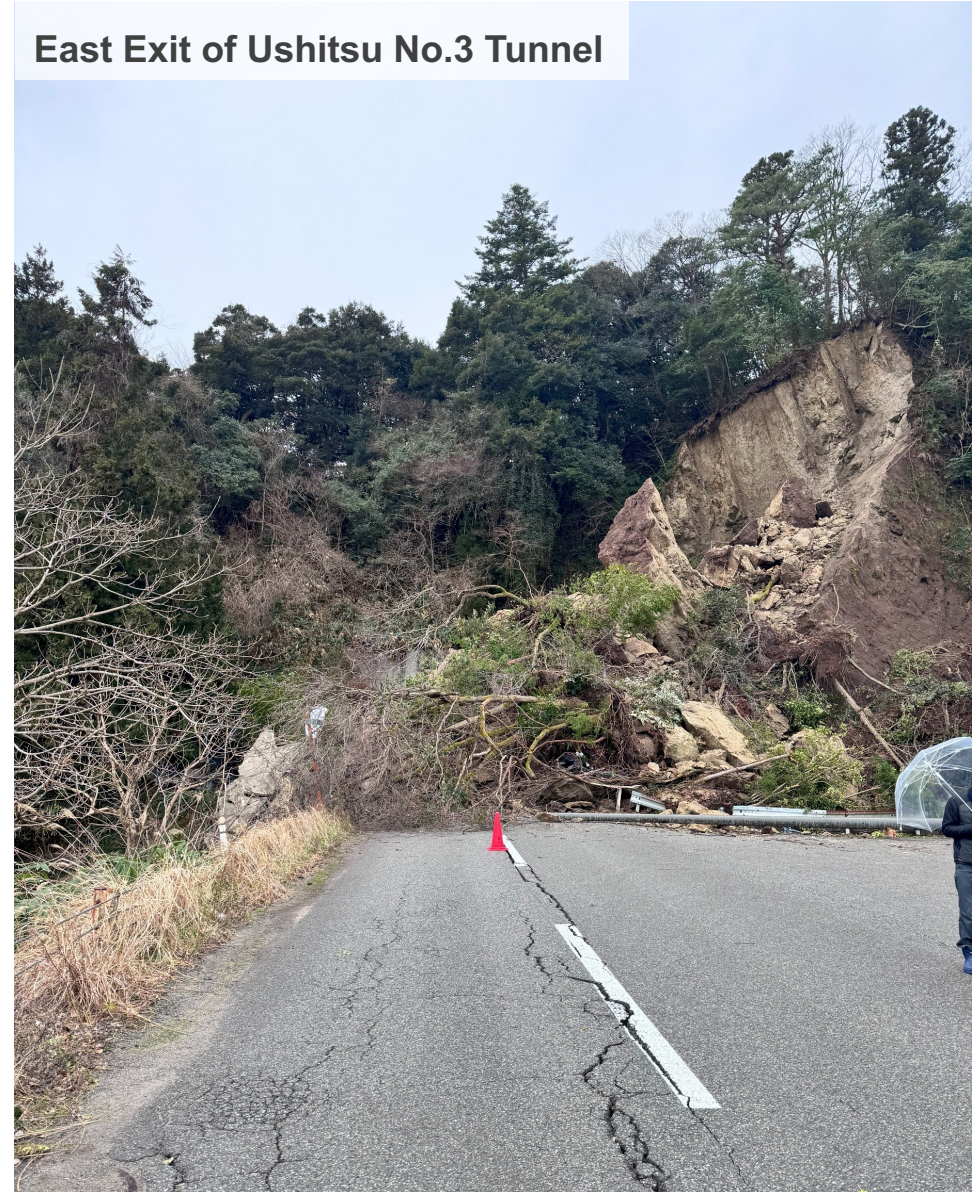
East Exit of Ushitsu No.3 Tunnel

Steep slopes of weathered rock collapsed even with shotcrete

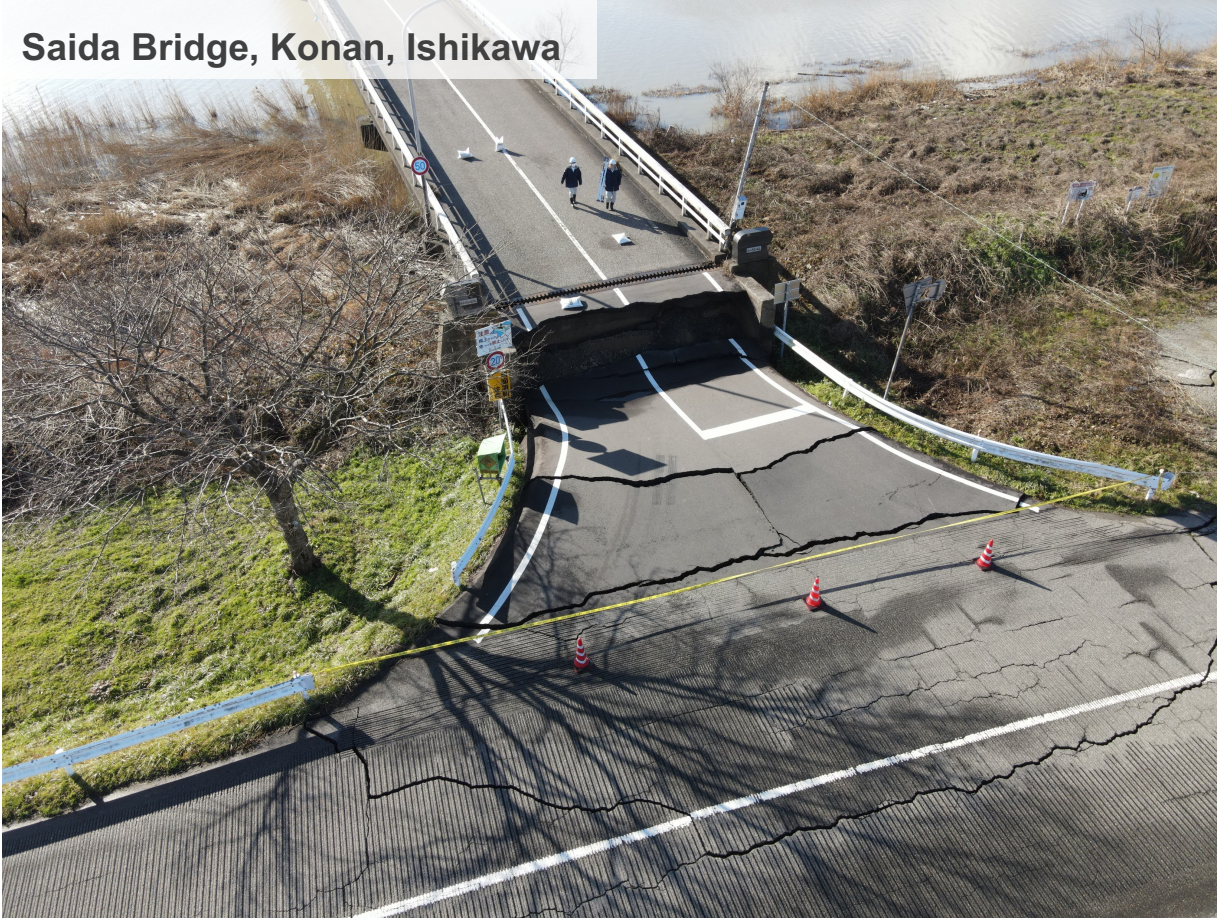
Saida Bridge, Konan, Ishikawa

- **Bridge approaches with embankments offset vertically over tens of centimeters**
 - Partially because of small bridges do not have approach slab
 - Another reason to make access to remote areas difficult in the early restoration stage

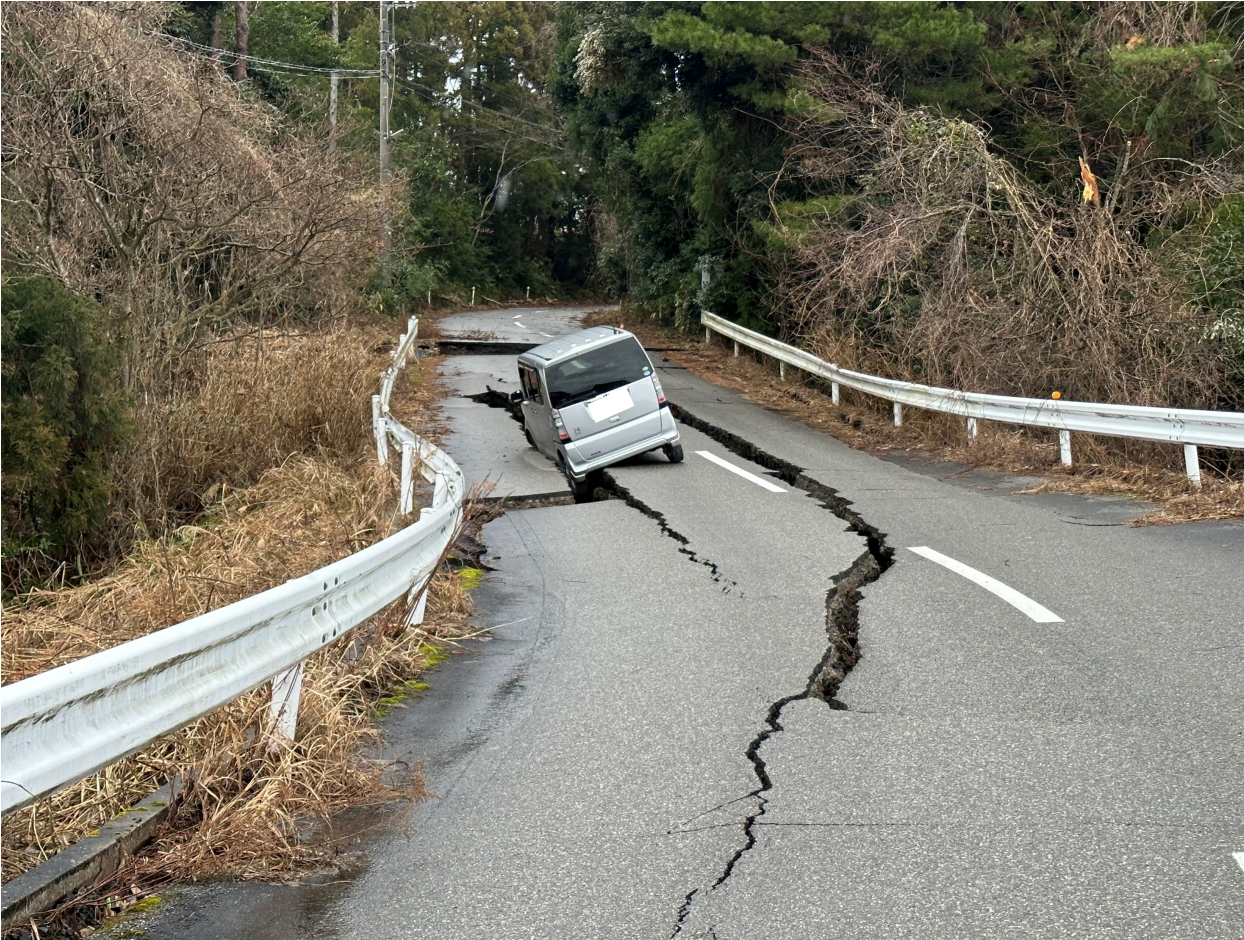
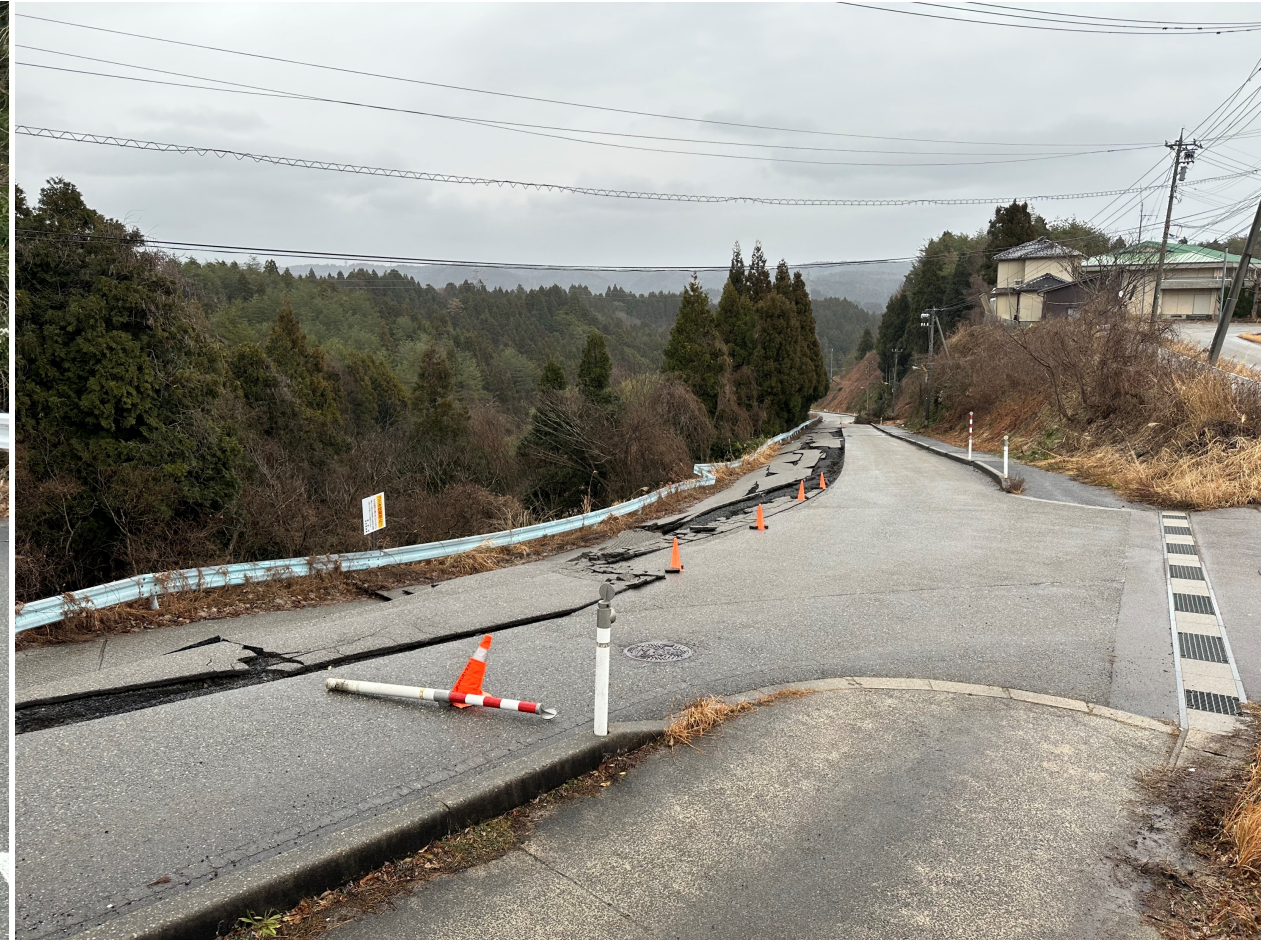
- Small filled had slid or settled towards the valley side

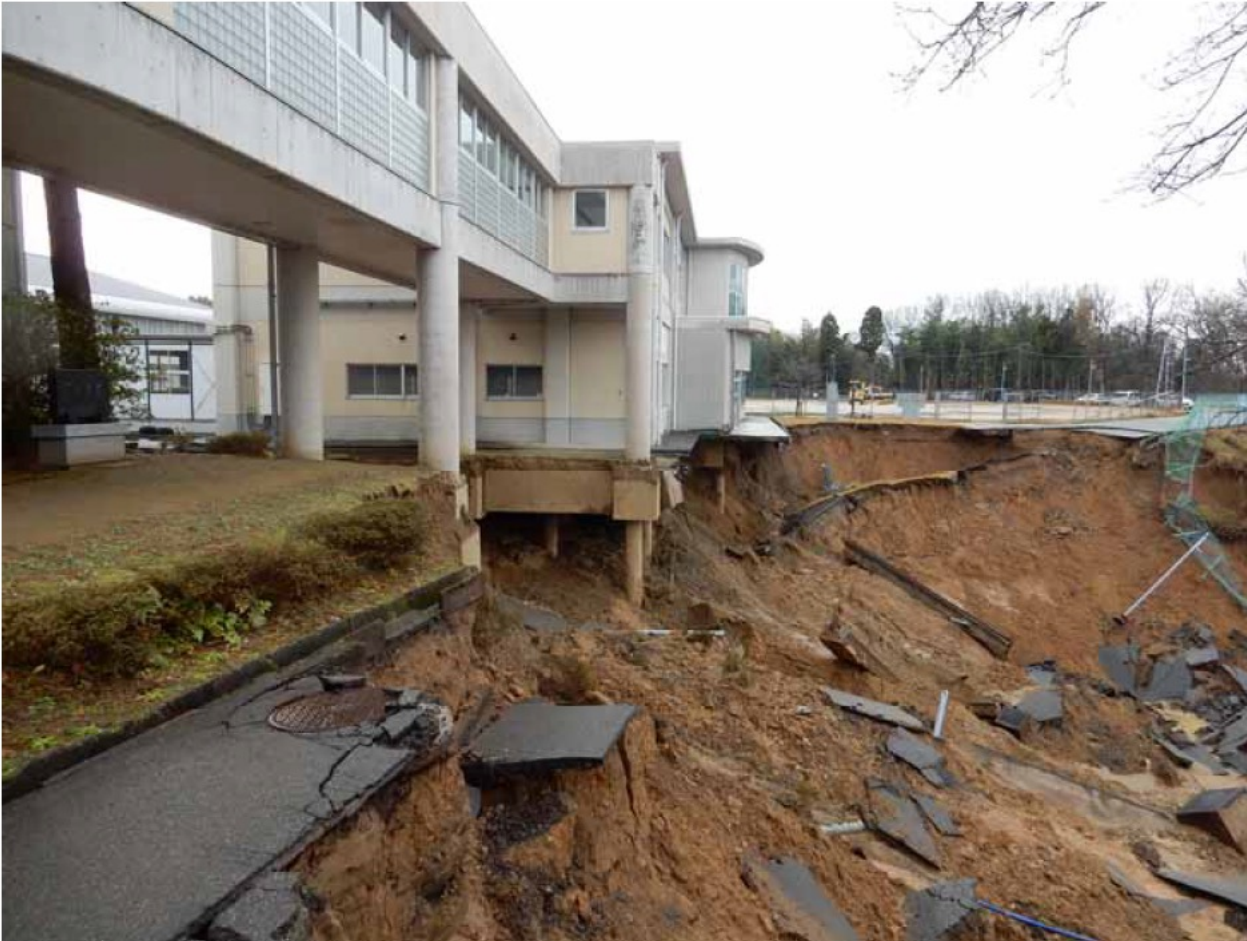
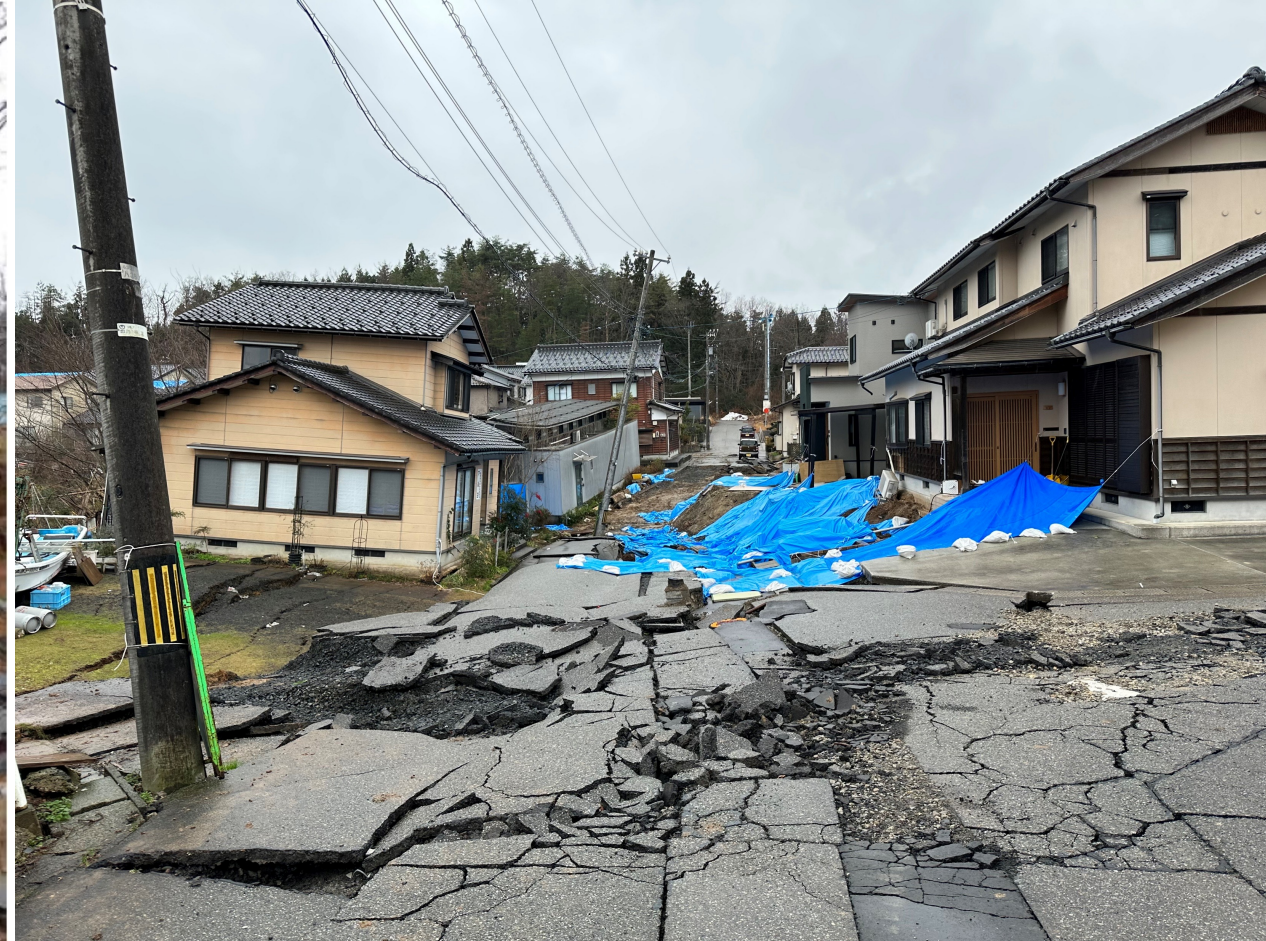
- **Filled valleys opened for school or residential houses slid downward**
 - Weathered filled material or poor compaction may cause these failure
 - Another reason for these slidings could be ~ 40 mm/day precipitation the day before the EQ occurred
