SITE INVESTIGATION OF THE AHAR-VARZEGHAN EARTHQUAKE IN NW IRAN OF AUGUST 11, 2012

Key facts:

- Hazard type: Earthquake
- Date of disaster: August 11, 2011
- Location of the survey: East Azerbaijan County, Iran
- Date of the field survey: August 26th - 31st, 2012

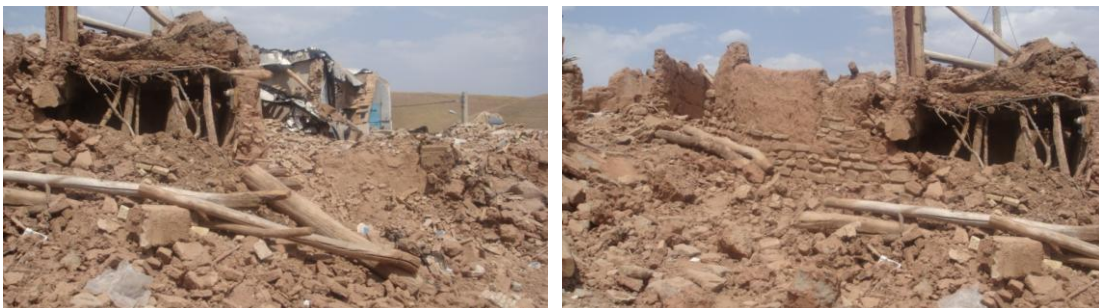
These types of buildings are very brittle and weak against earthquakes. And the significant amount of the death toll and structural damages are from these buildings. The mechanism of the damages that mostly in total is that the walls occurring across the earthquake waves are separated from the rest of the building and the roof that has lost its support collapses. The field observations showed that the main reasons of the collapse of these buildings are:

- 1- Lack of any kind of connection between cross walls.
- 2- Use of lumbers as the main beam in the roof without any effective connection between themselves and the supporting walls. The used lumbers are sometimes very heavy. And
- 3- Decay of the lumbers that are very potential for collapse even under the weight of the roof alone.

Photo 1 Damage to adobe buildings

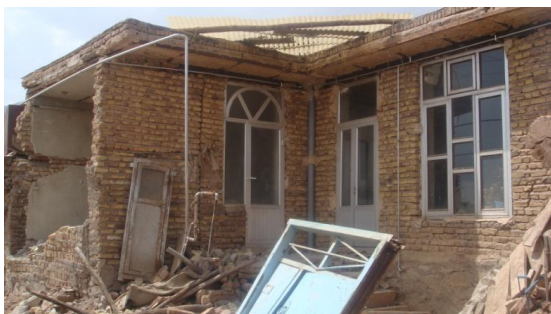
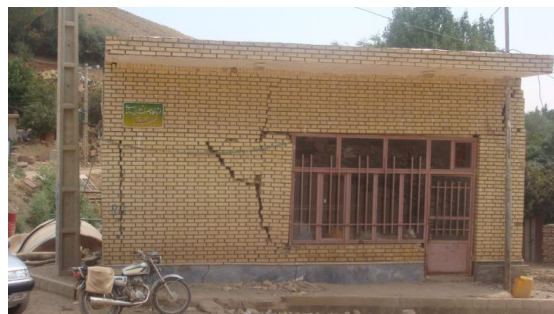
The observations showed that this type of building has not experienced total collapse. But the large amount of serious cracks in walls and wall and roof connections are apparent. The quality of bricks used in these buildings is very different. However, it was observed that this item has not effective parameter in the behavior of the building and rather the details of connections of walls to each other and to the roof or details around the openings are more important.

- a) Fall of some part of arches between the steel beams
- b) Break of arches near the supporting steel beams and
- c) Cracking of the roof and falling of covering gypsum.

There existed huge amount of shear cracks in this type of building. Wall collapse also was visible. Bending mode cracks were also observed, however, this type of crack was suppressed by falling off the walls.

Photo 2 Damage to brick buildings

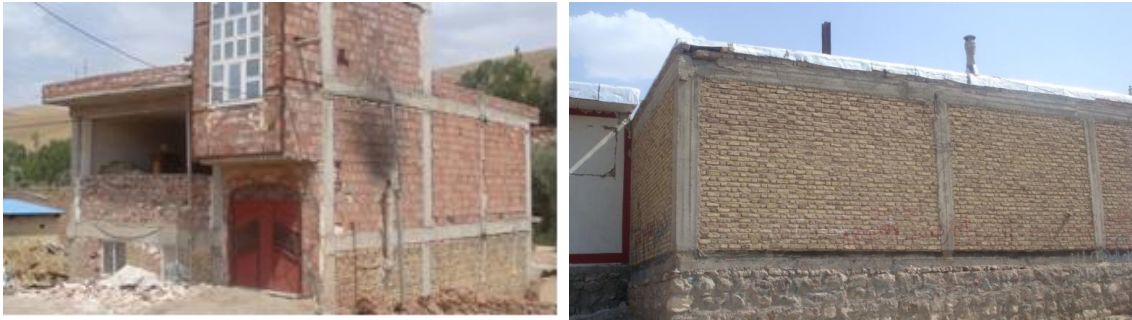
These buildings showed much better behavior in the course of the recent earthquake and there was not observed any total collapse in them. However, most of these buildings tolerated some minor damages and few of them even involved serious damages. The main reason for the damages can be mostly attributed to the following factors:

1. Lack of construction of suitable connection detail of tie columns and bond beams. Or missing some tie columns amid long walls.
2. Use of poor quality concrete and providing low diameter reinforcement. Also, compaction of concrete during construction is not done as appropriate.
3. Construction of a specified map required by the Housing Foundation for use of loan according to the code of practice of Iran (Code No 2800) and addition of some rooms without tie columns and bond beams later.
4. Lack of a proper connection of surrounding beam and columns to the filling walls. This factor is responsible for the utmost of the damages in these buildings.

Photo 3 Damage to half reinforced masonry buildings

Factors 2 and 4 are the major damages amount in the earthquake hit areas. However, it seems that if some more attention to be paid for the supervising the construction of these buildings and also a book of commented details are provided by the authorities for the connections, the future damage statistics would decrease significantly.

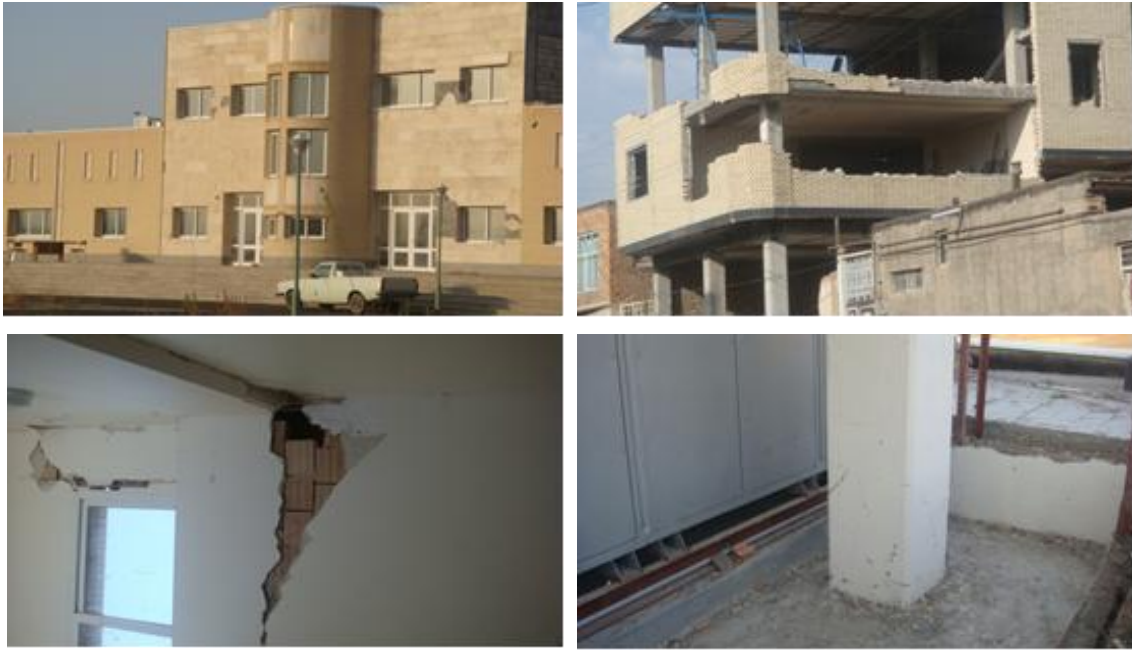
The other weakness of the concrete building is use of clay voided blocks which are very dense and brittle. These blocks do not provide proper bond with the poor quality mortar which is provided normally in construction of walls and therefore they crack or move during ground motion. The other factor is brittleness of the clay blocks which is not adaptable with the ductility of the concrete frames and with any draft of the frames the infilled clay walls. Eventually the walls crack or break and some time jump out in the transverse direction or tolerate serious diagonal shear cracks which cause spalling of gypsum in the walls.

The case of the Hospital of Varzegan was different. In addition to the aforementioned damages, there were signs of structural damage in the concrete columns of the last story of the building.

Photo 4 Damage to reinforced concrete buildings

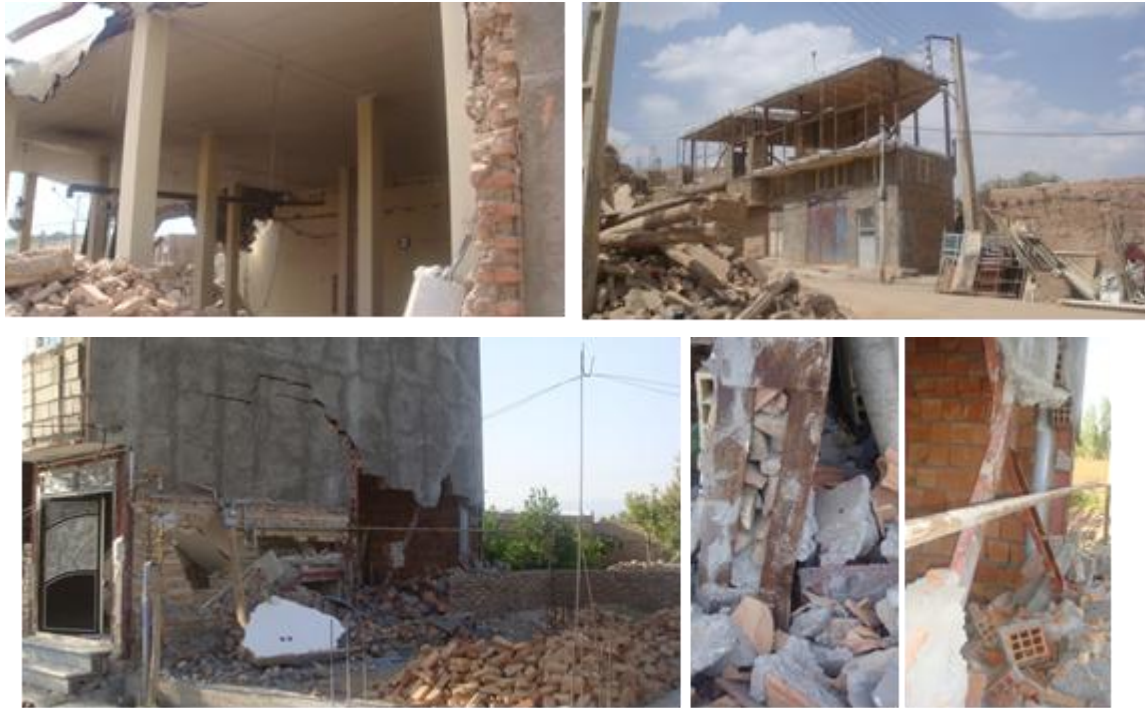
A case that worth of being considered specifically is a two story braced steel building. There was a buckling in one of the bracings of the building and also a rupture in the connection of the gusset plate to the web of the column. Also the main column had buckled because of pounding of a part of stair ramp connection to the column.

Photo 5 Damage to steel buildings

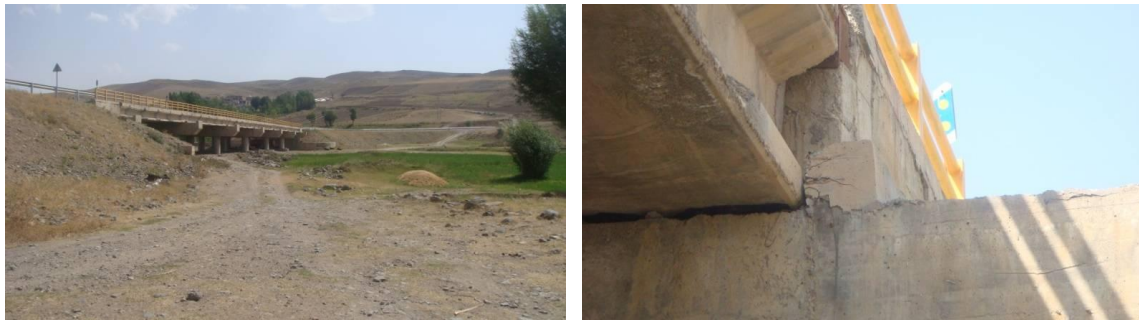
The masonry arch bridges also were safe and the reason is that they get low spans. From three major bridges that was investigated in the region on was in the road of Ahar to Varzegan. This bridge is a 5-span concrete bridge (No 1), the second was a old 6-span composite bridge in Varzegan and the last one was a new 3-span integral composite bridge. In all the above mentioned bridges the expansion joints have become active during the ground motion. And all the spans of the bridges adjacent to the joints have experienced some minor or moderate movements. In the case of the bridge No 1, some lateral movement was observed in the first span of the bridge. This movement was restricted by the shear block of the pier. However, some cracks have been induced in the shear block as a result.

Photo 6 Damage to 5-span concrete bridge (No.1)

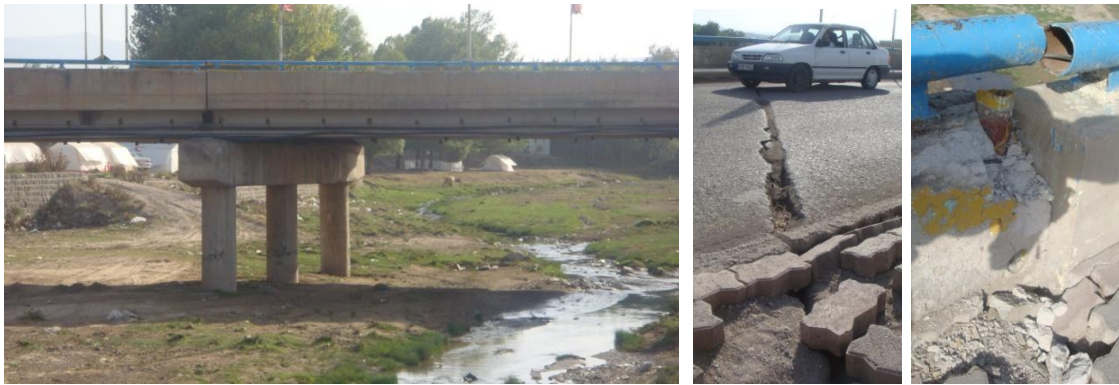
In bridge No 2, the movement was clear and almost all the spans had lateral movement. The main reason for this fact was no shear block was provided for the bridge and only the friction between the beams and pile has overcome the exceeding movement.

Photo 7 Damage to 6-span composite bridge (No.2)

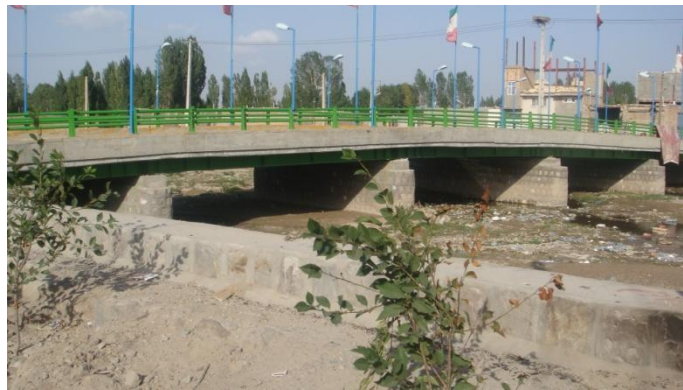
In bridge No 3, no lateral movement was observed. Since this bridge was integral and the main beams was continuous composite beams, there was not any lateral or transverse movement in the body of the bridge. However, there were apparent cracks both in the beginning and end of the bridge in the joint locations in the asphalt.

Photo 8 3-span integral composite bridge (No.3)
