# Quick report of preliminary reconnaissance of the 2024 Noto-hanto Earthquake in Japan —No.2—

Masakatsu Miyajima (Professor Emeritus, Kanazawa University)

Takao Hashimoto (Specially Appointed Professor, Kokushikan University)

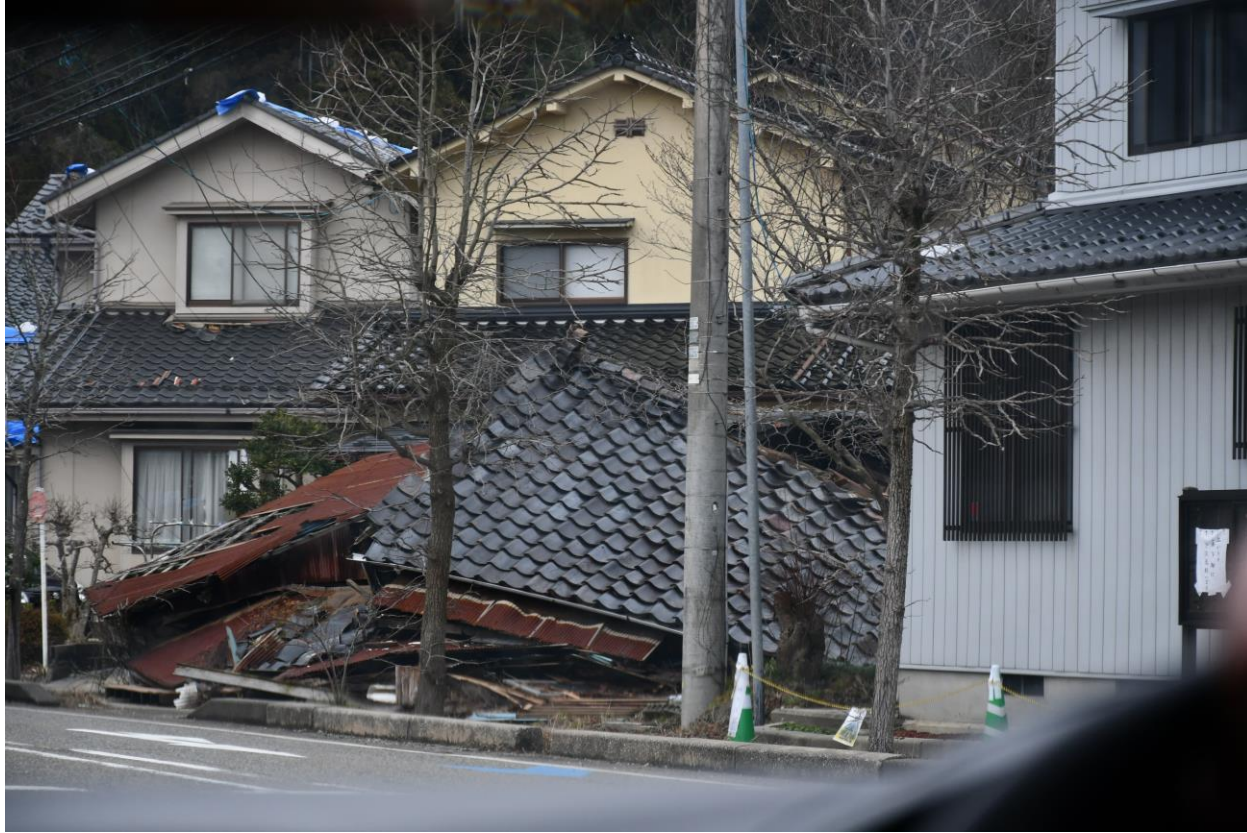
Collapse of wooden house (Map ①)

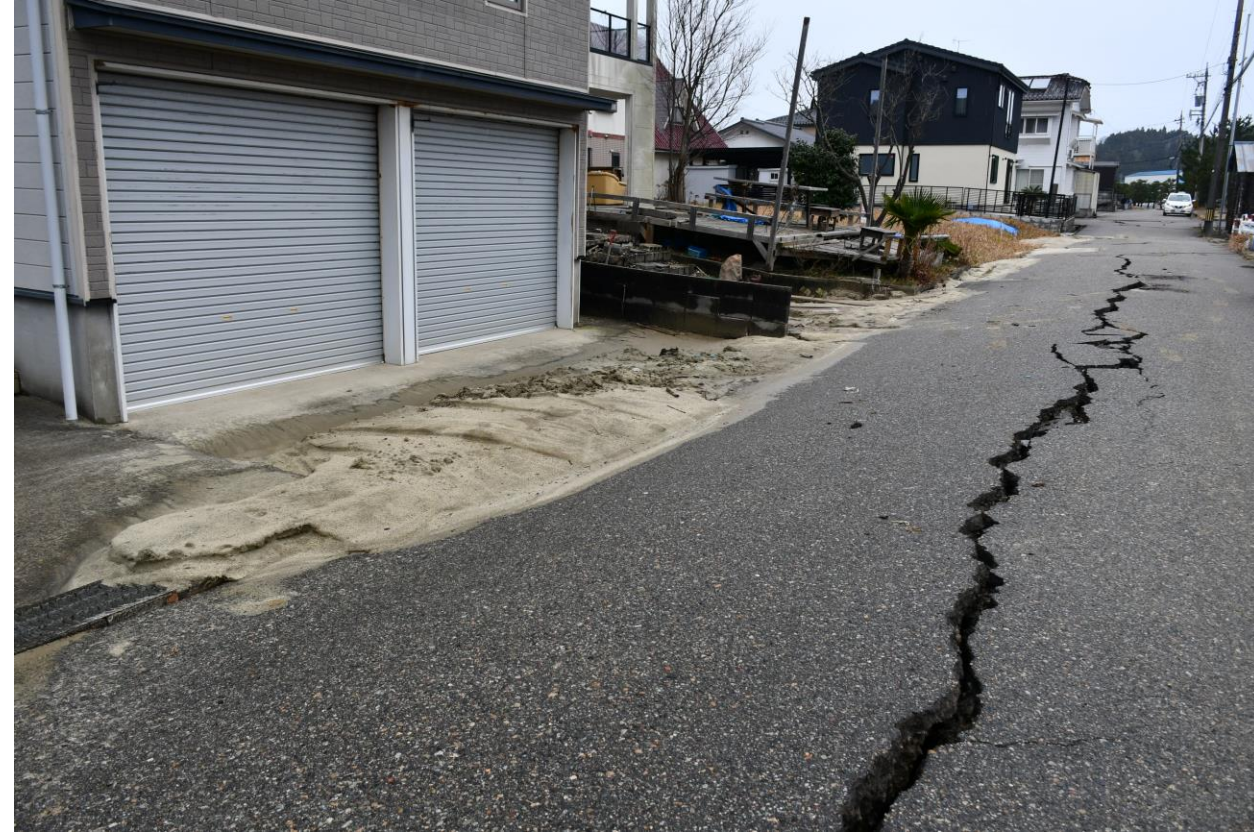
Road cracks and ejected sand due to liquefaction (Map②)

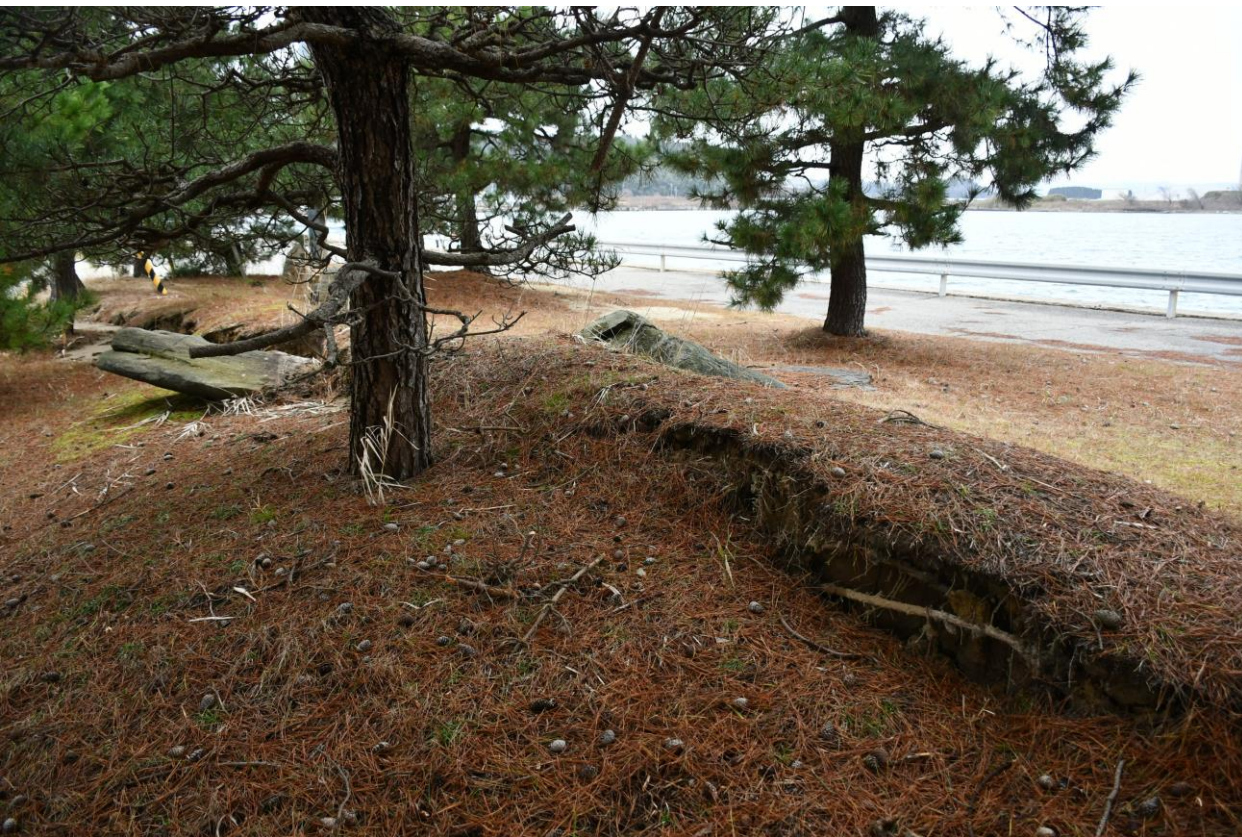
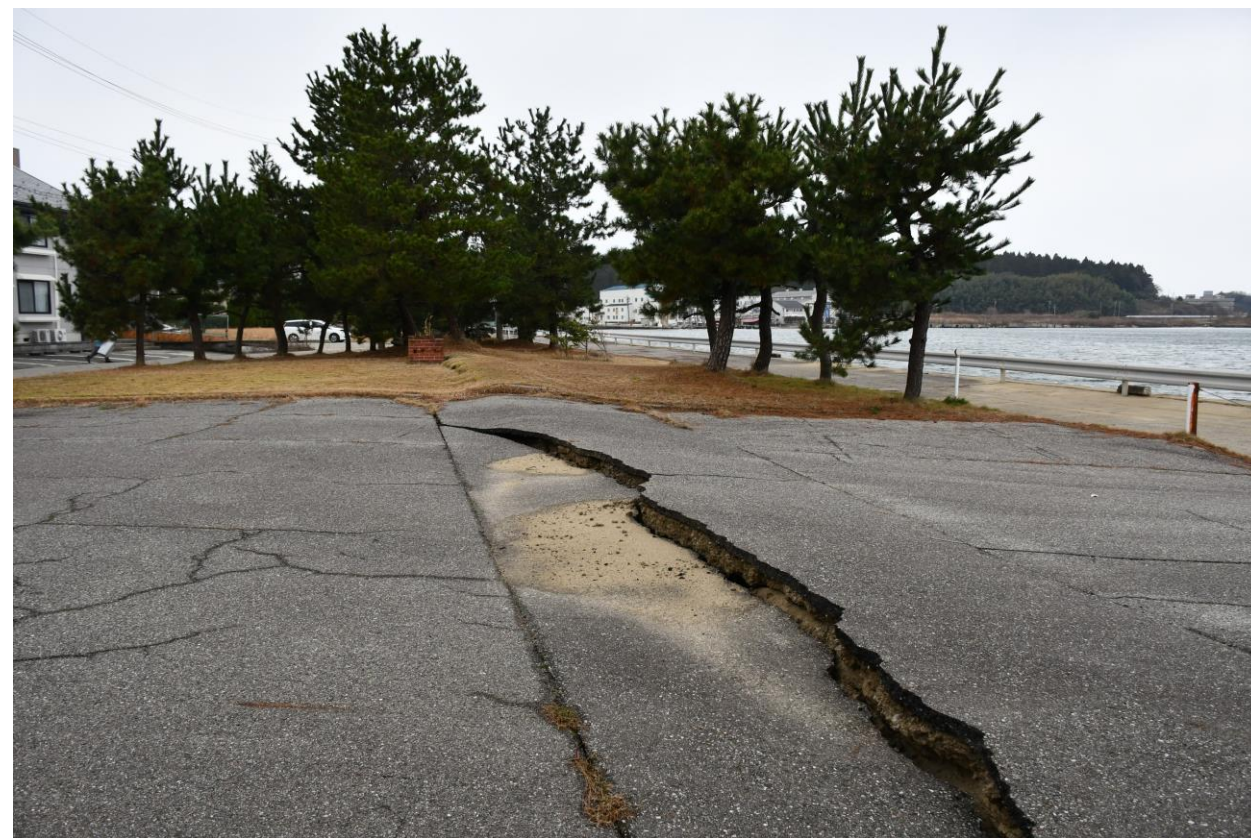
Uplift and depression of the ground due to lateral flow of liquefied ground (Map②)

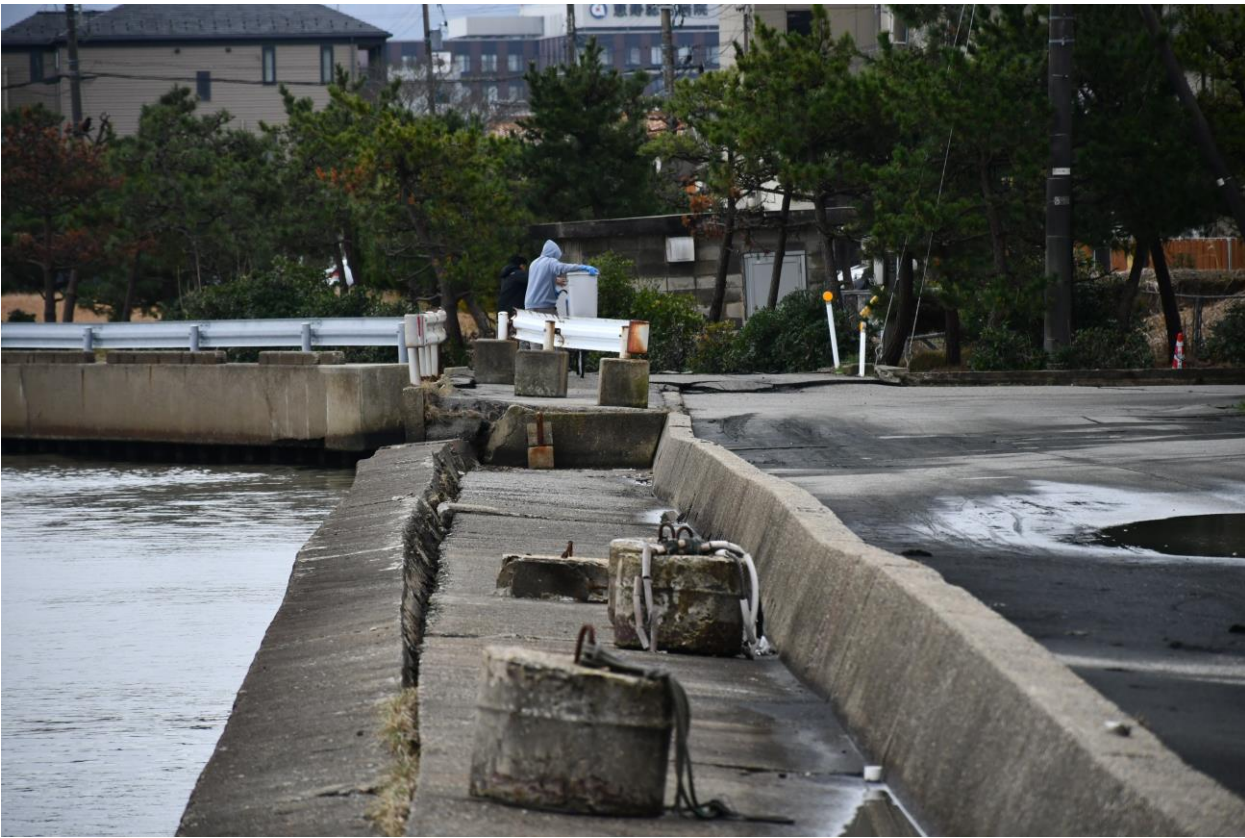
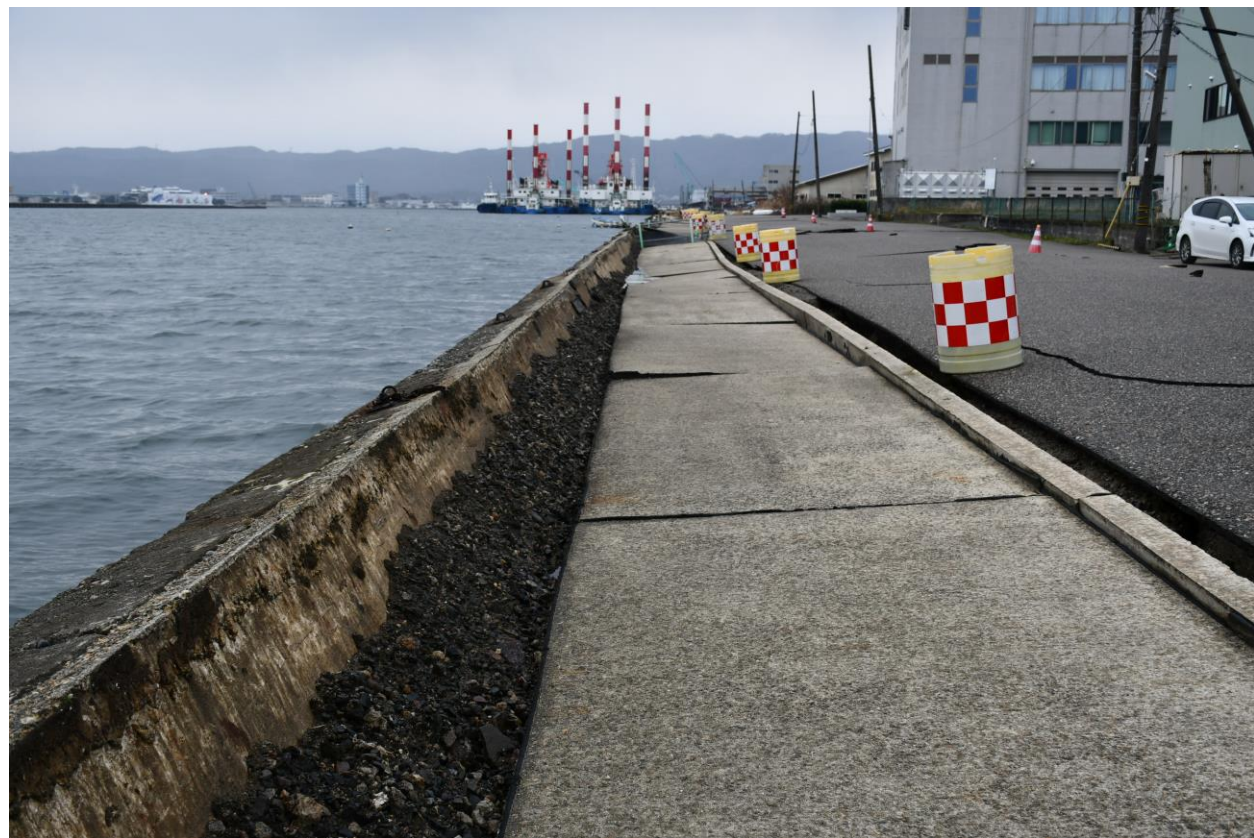
Curved quay (Map③)

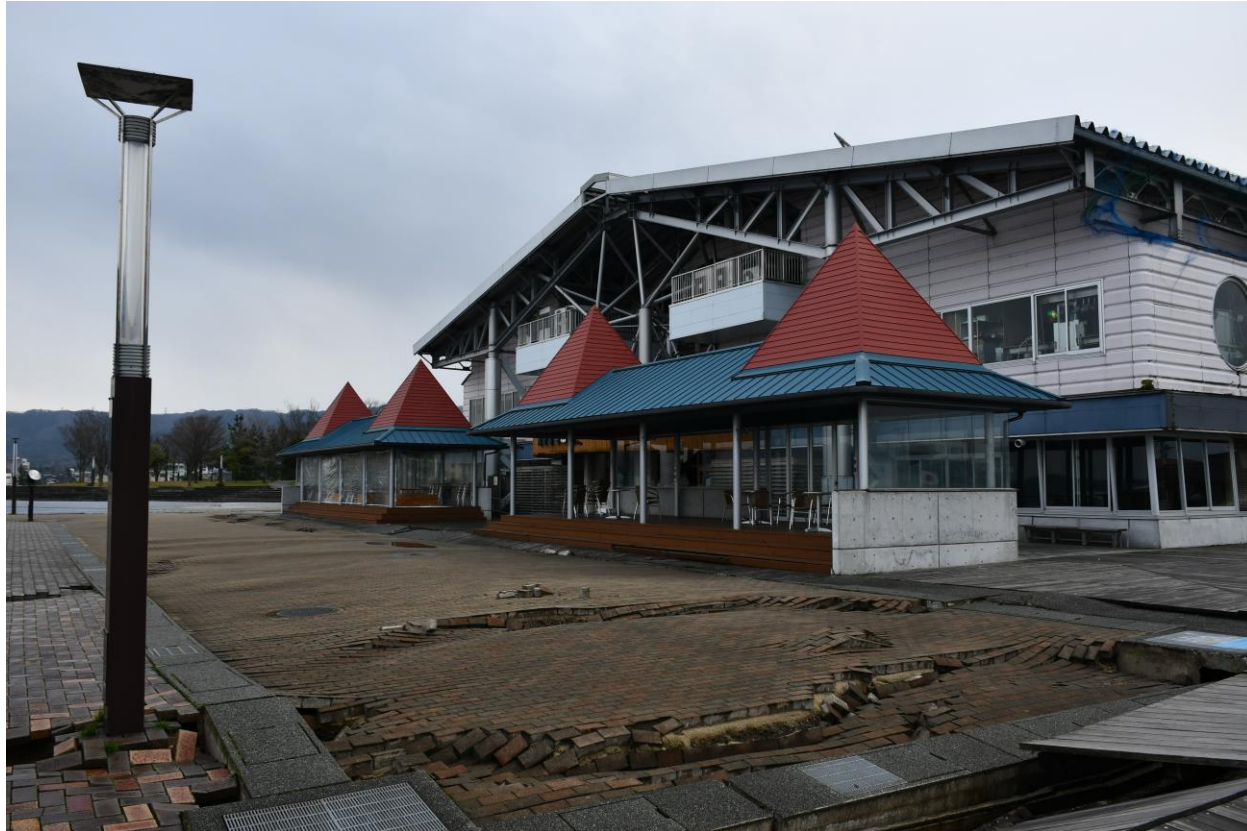
Damage of “ Food Festival Market”  
induced by liquefaction (Map④)

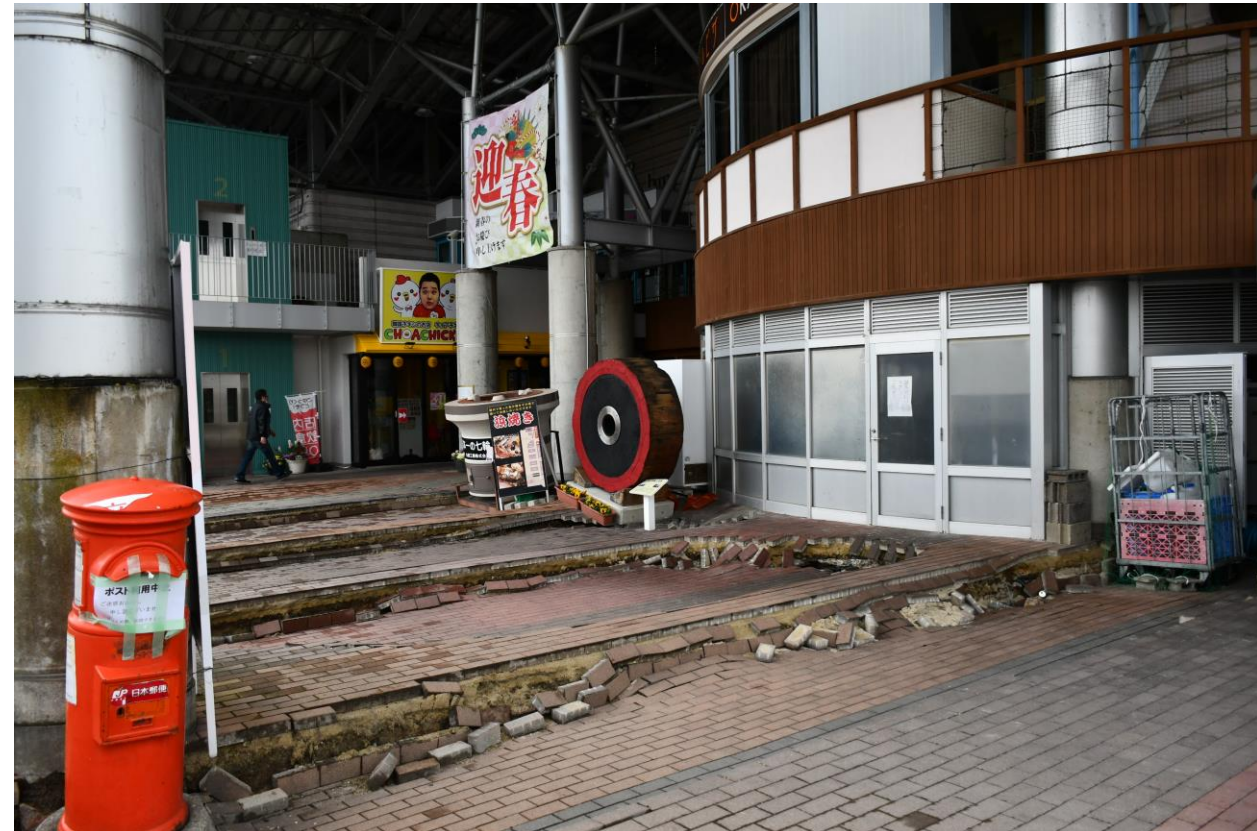
Subsidence of the entrance approach (Map④)

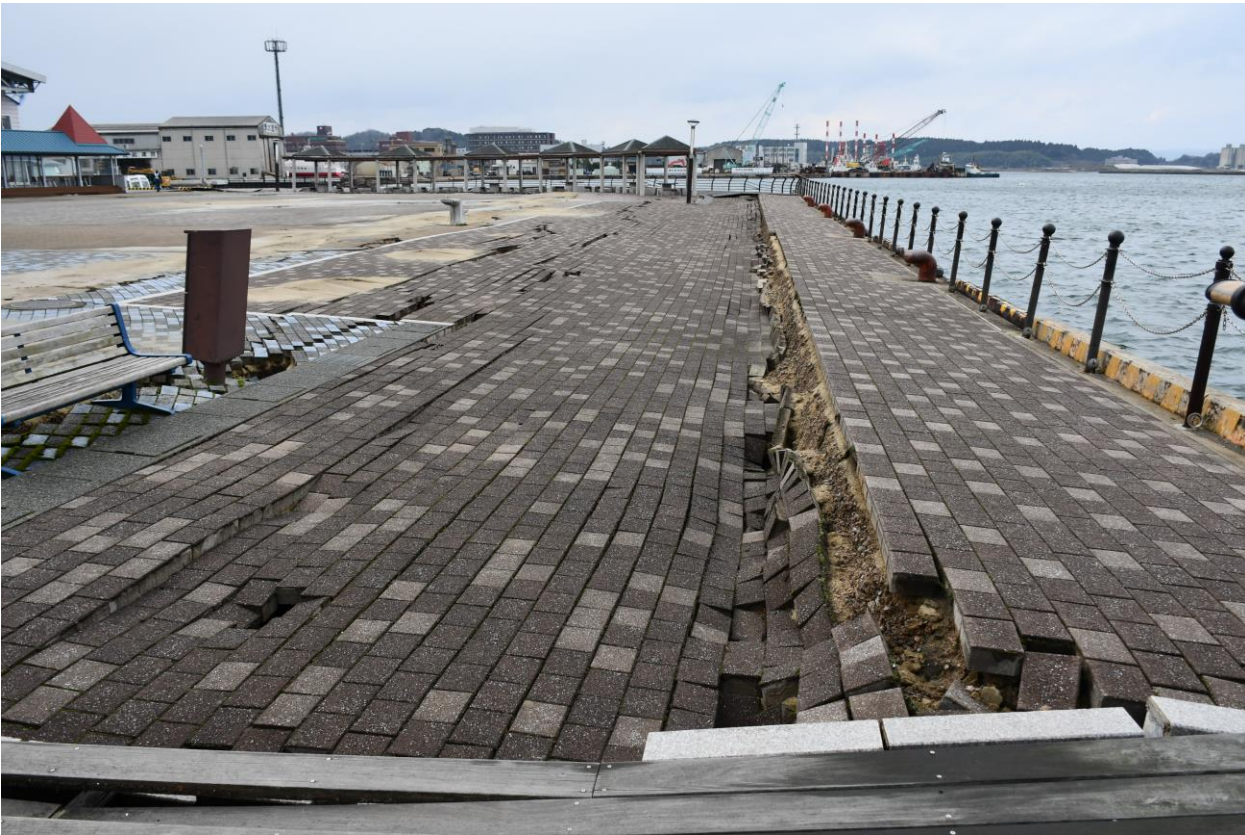
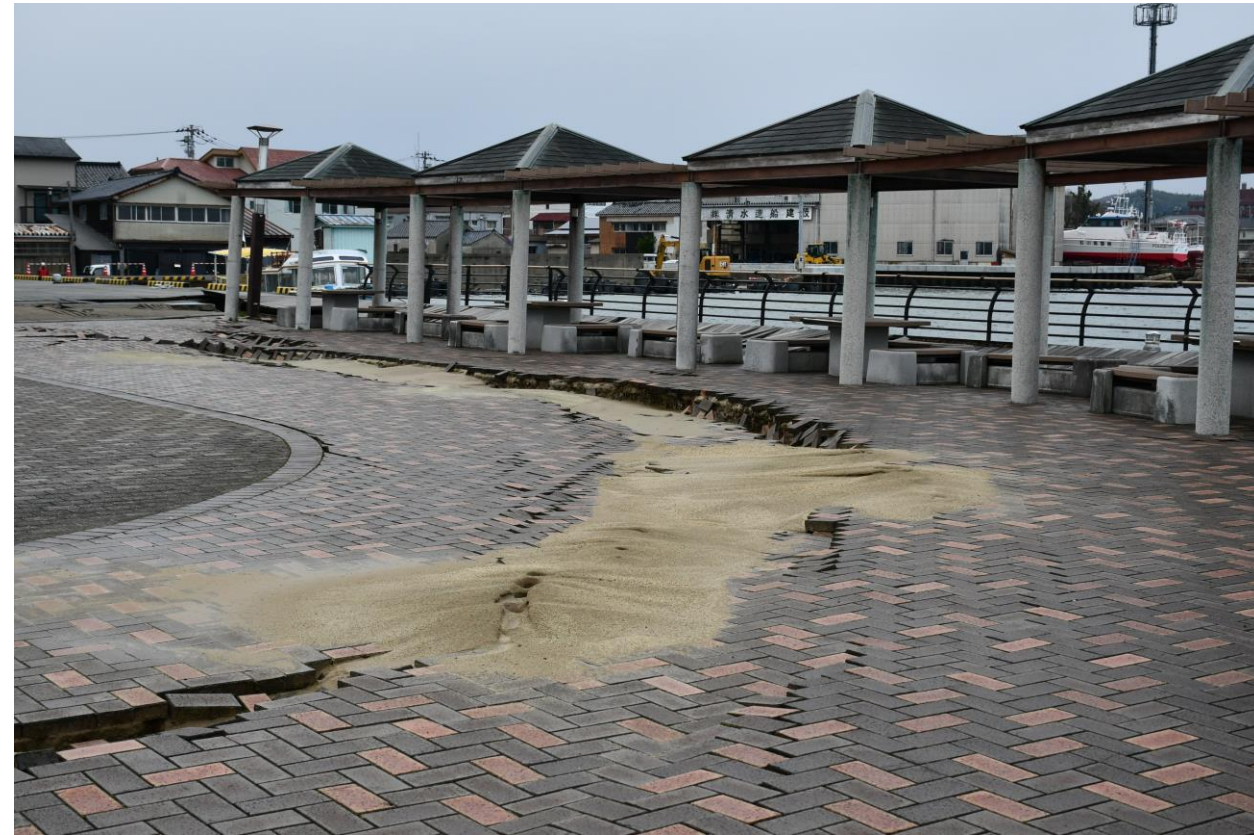
Subsidence and ejected sand due to liquefaction (Map④)

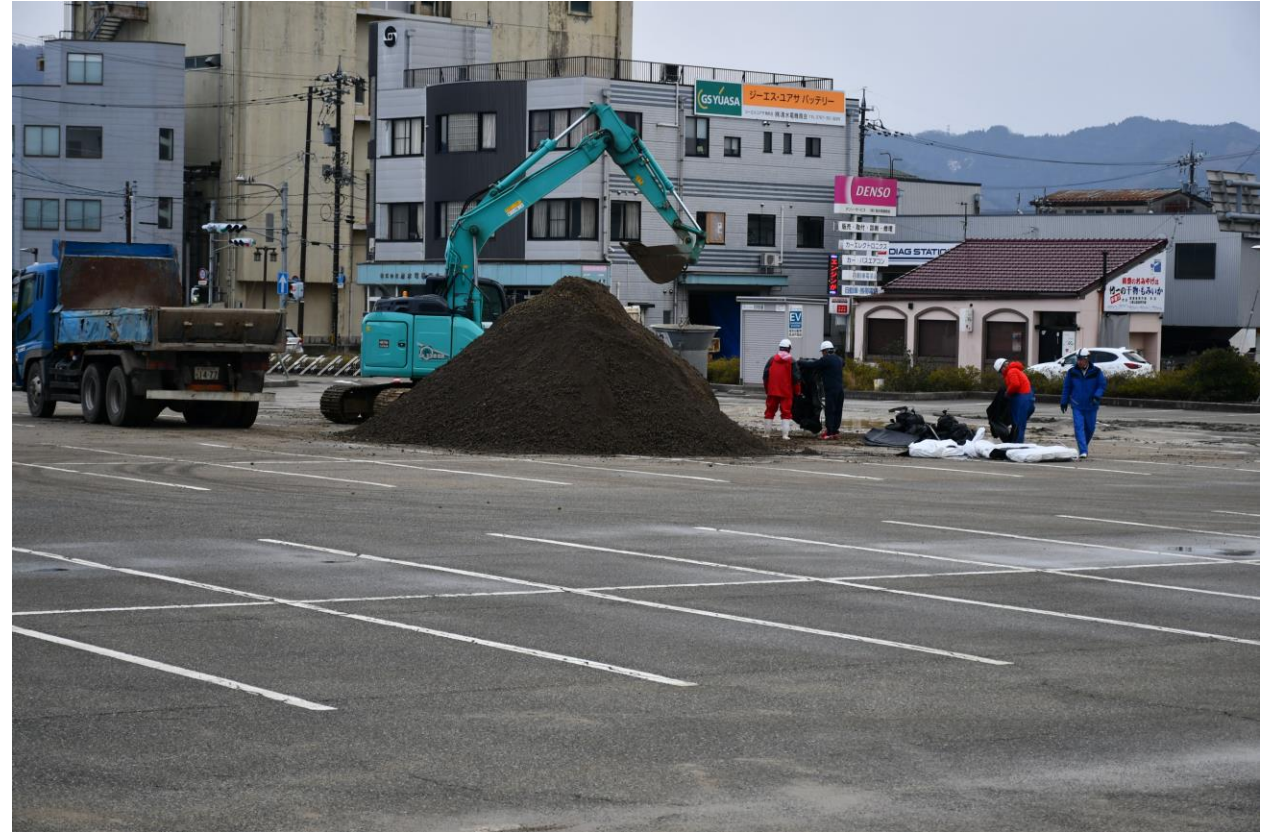
Removal of a large amount of ejected sand in the parking lot (Map④)

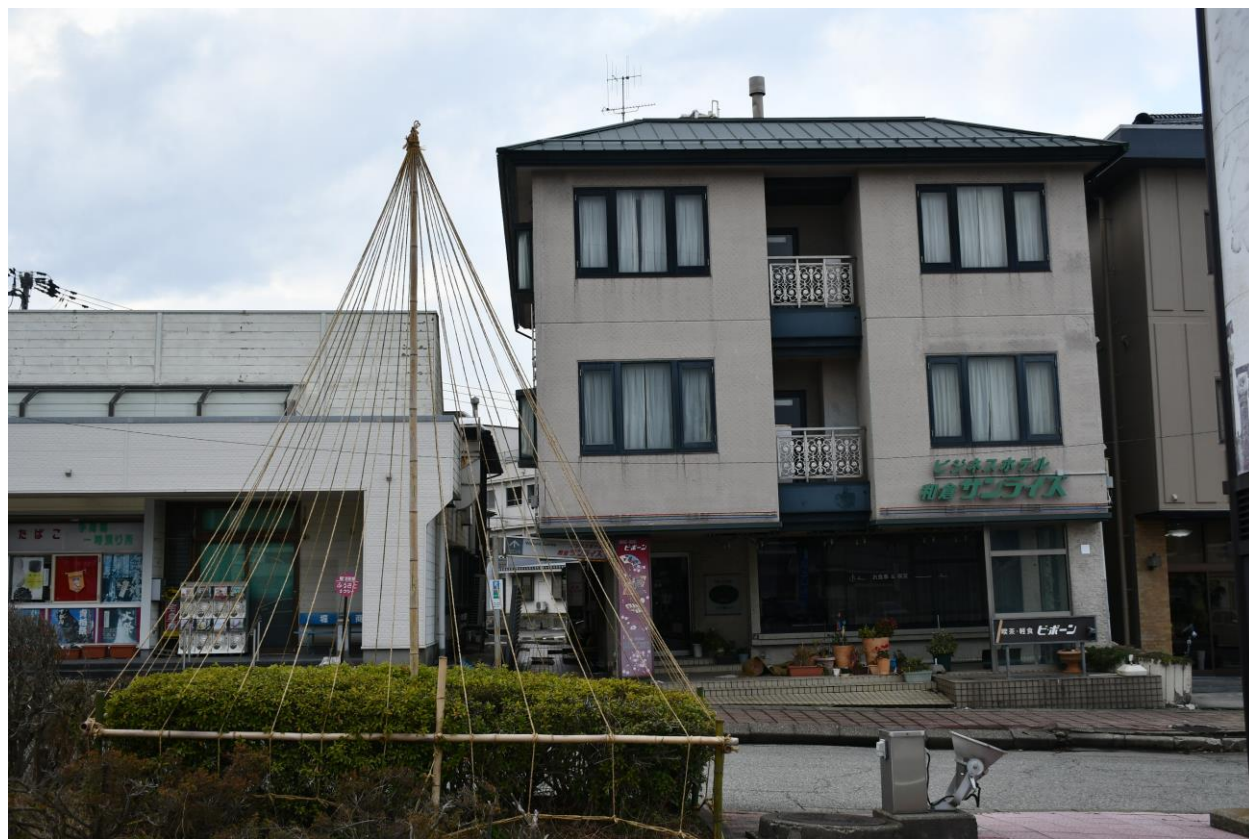
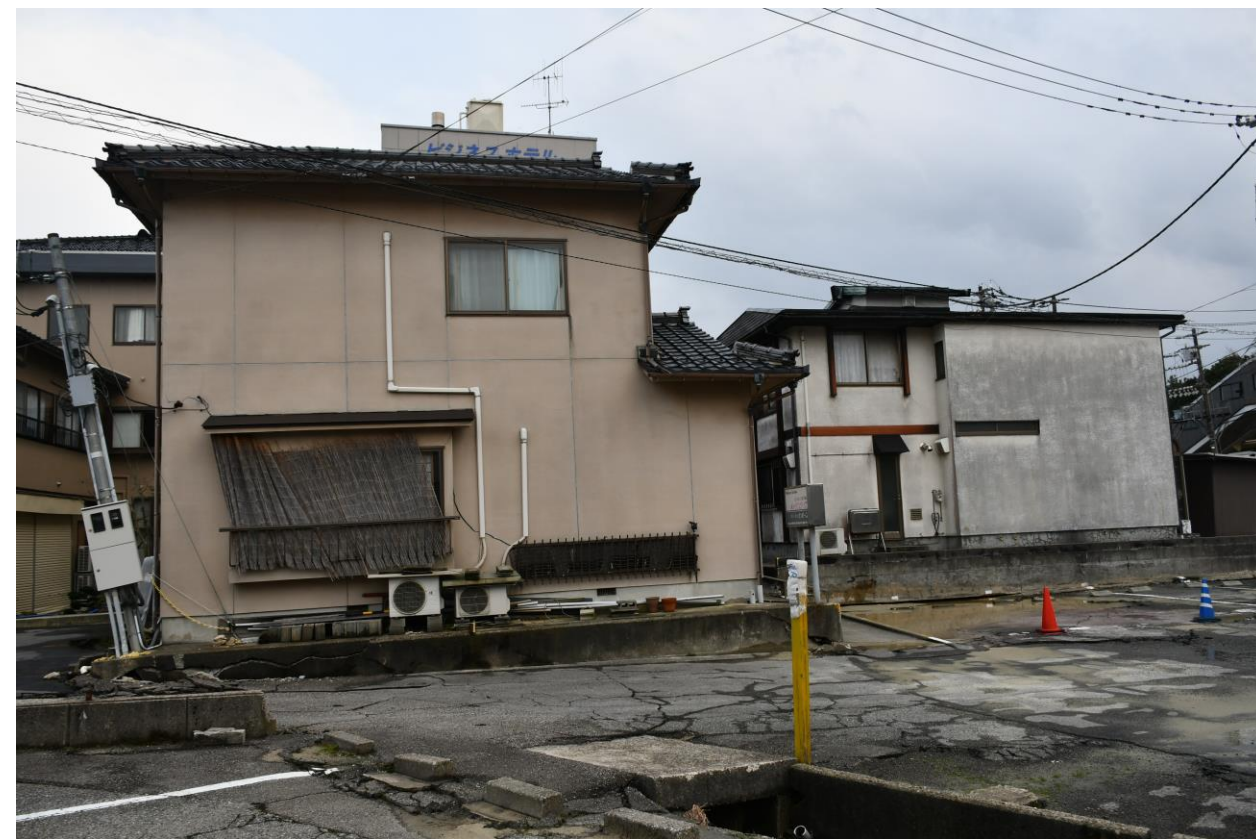
Inclination of the buildings in front of Wakura Onsen Station due to liquefaction (Map⑤)

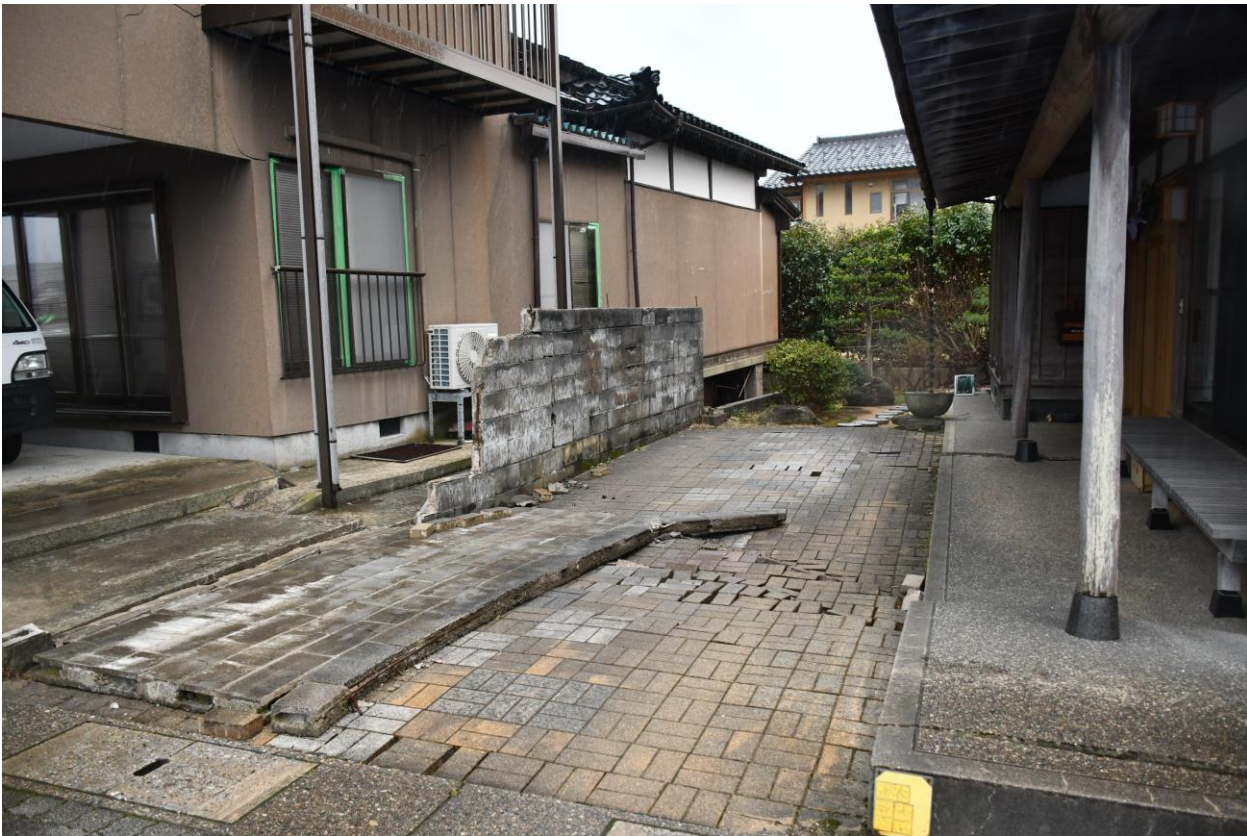
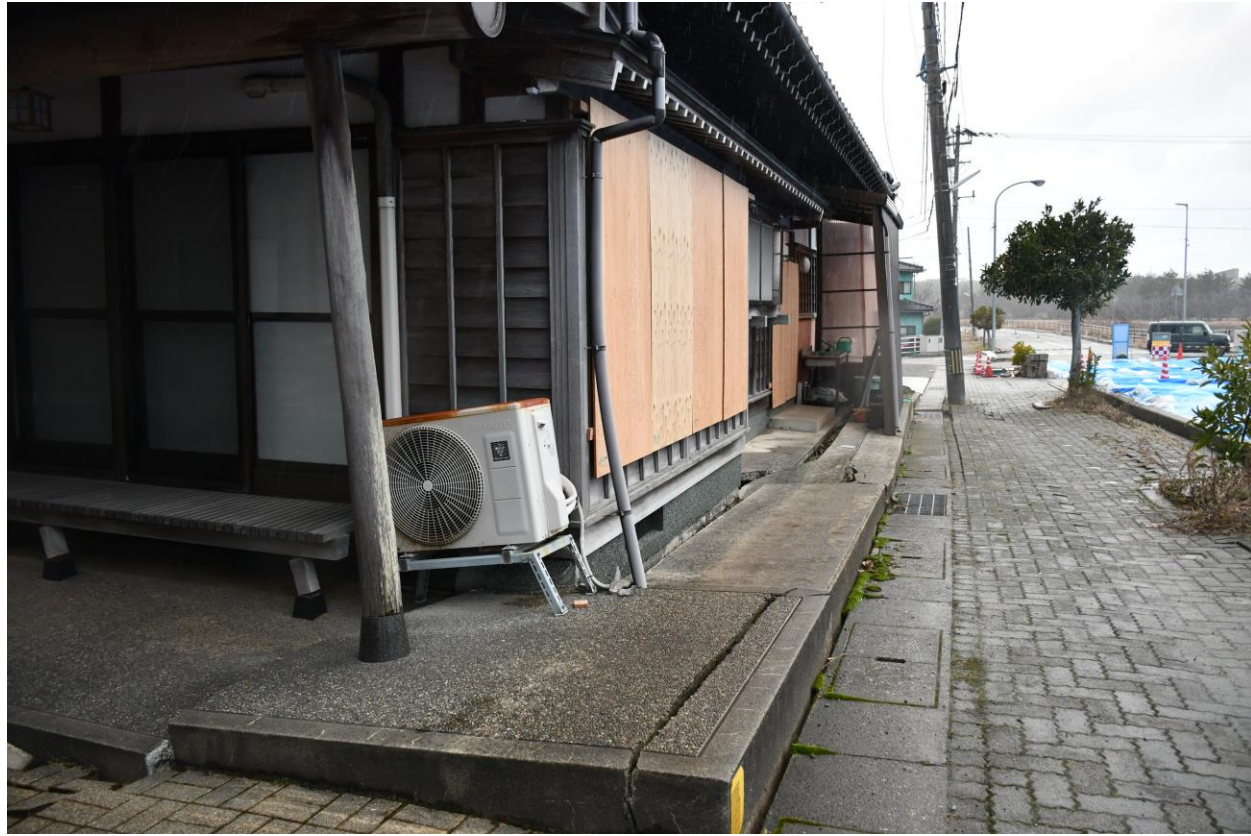
Subsidence and inclination of houses due to liquefaction (Map①)

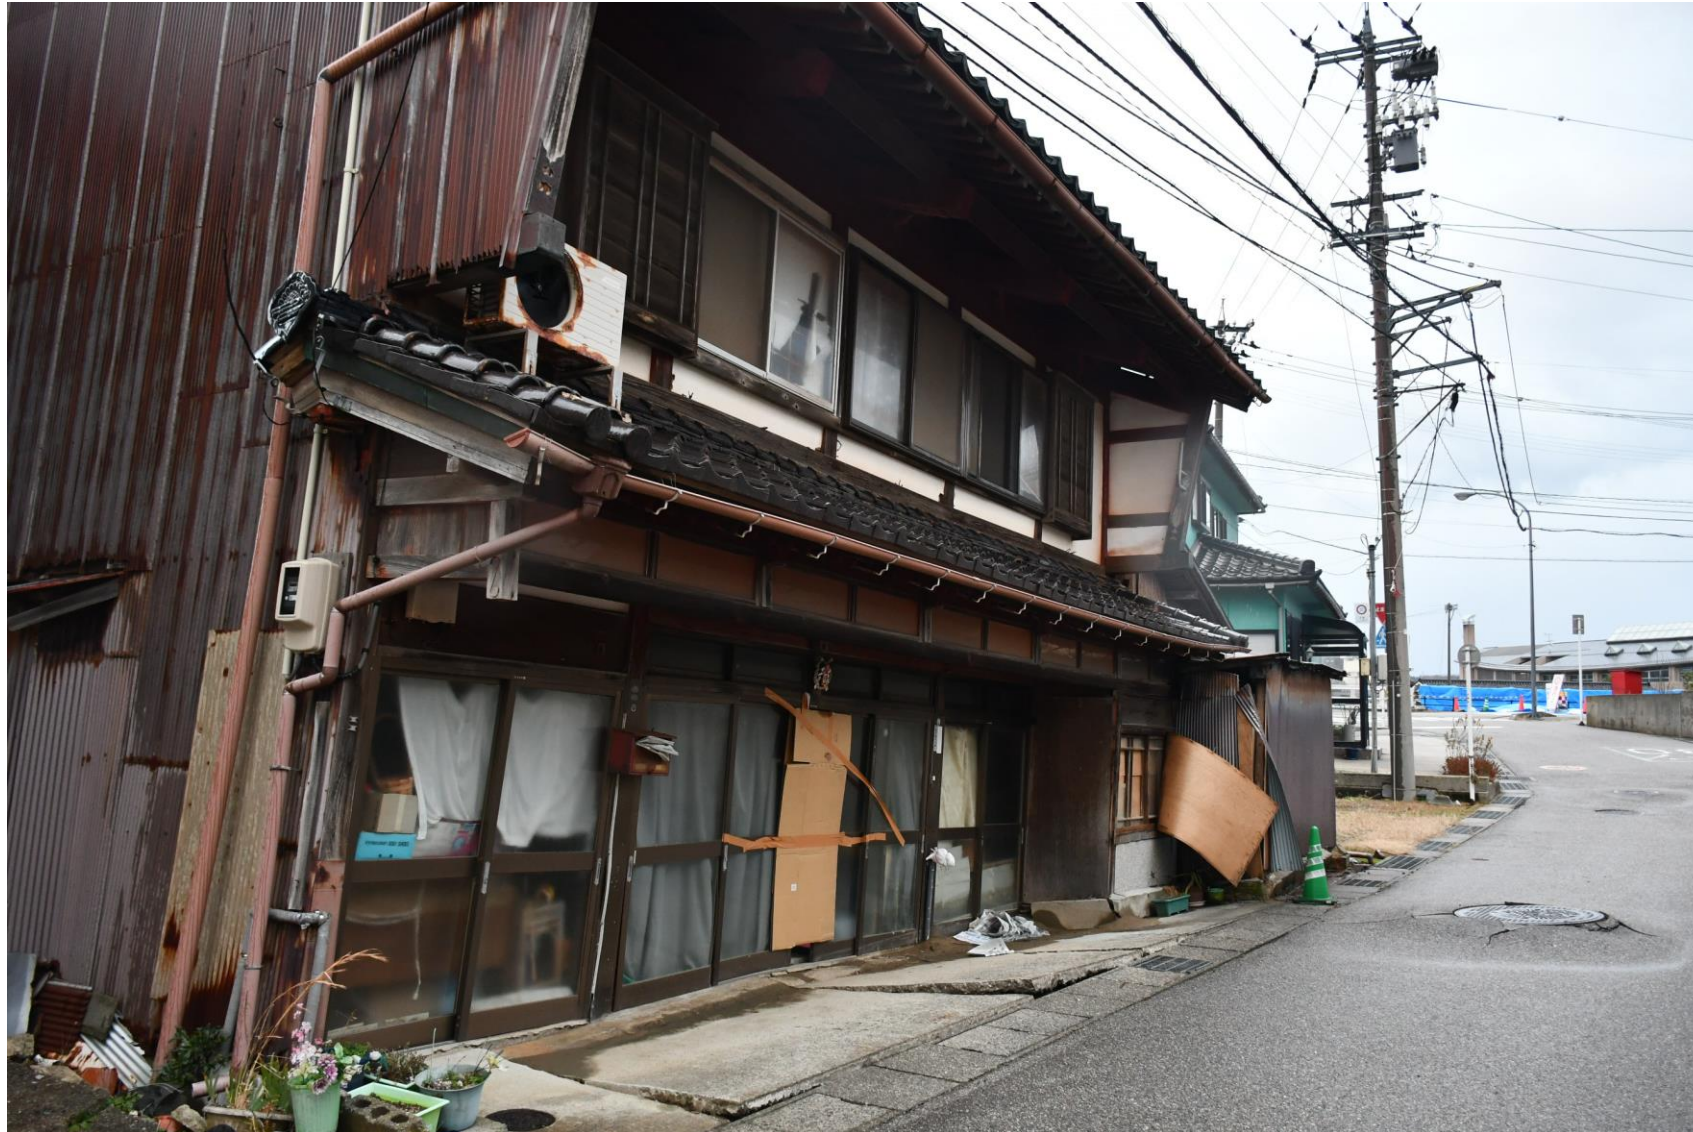
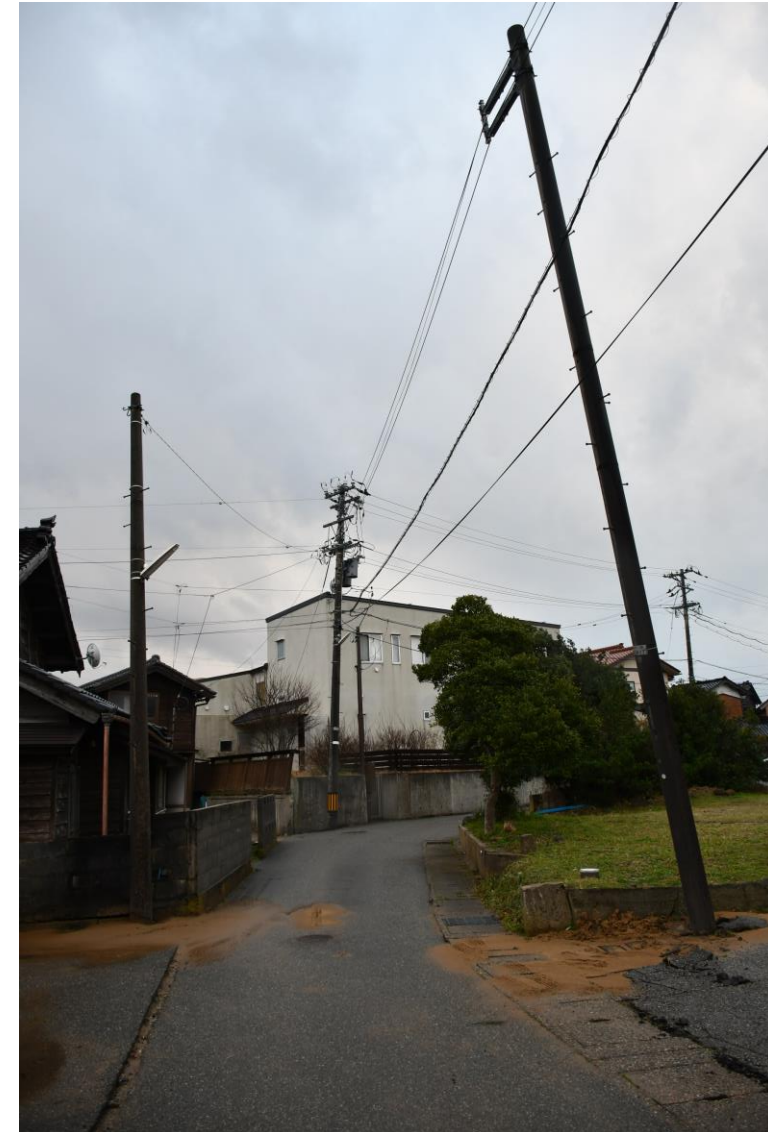
Subsidence of houses, utility poles due to liquefaction (Map①)

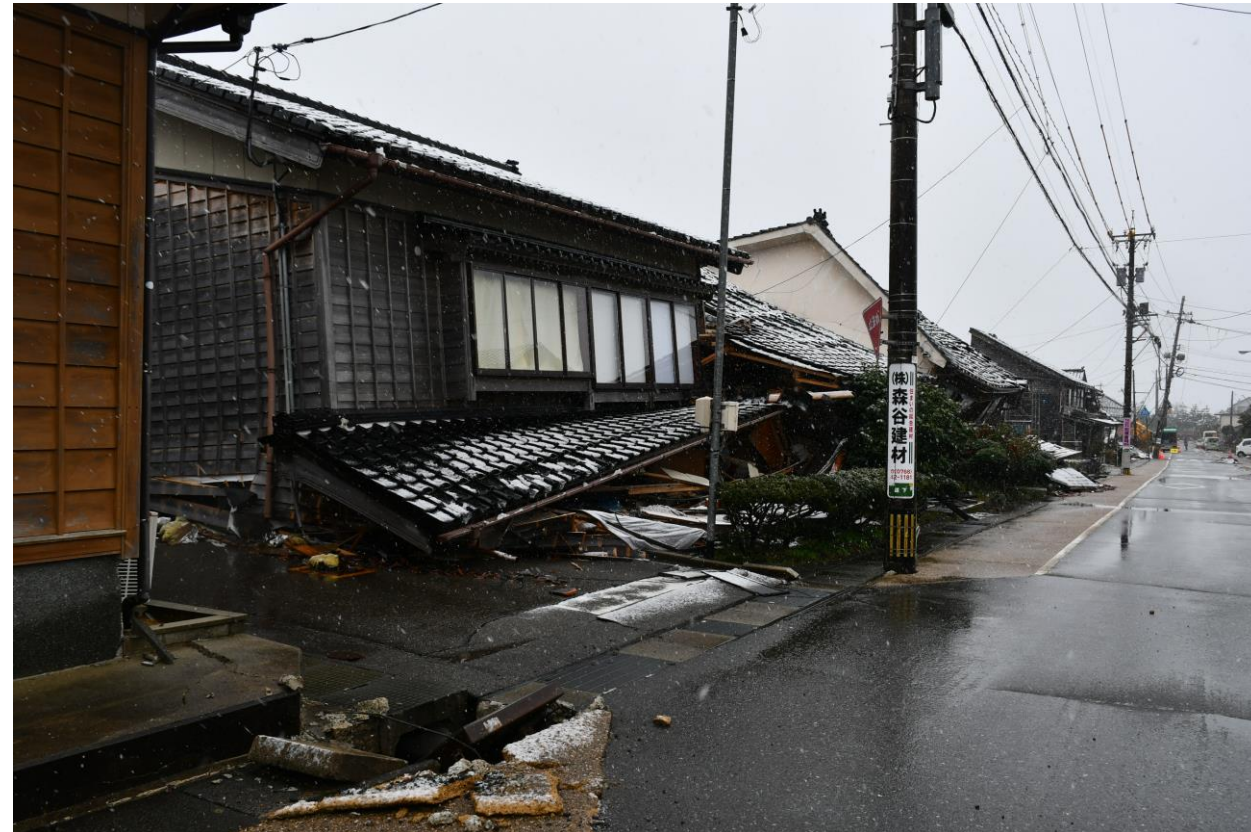
Collapse of wooden houses (Map①)

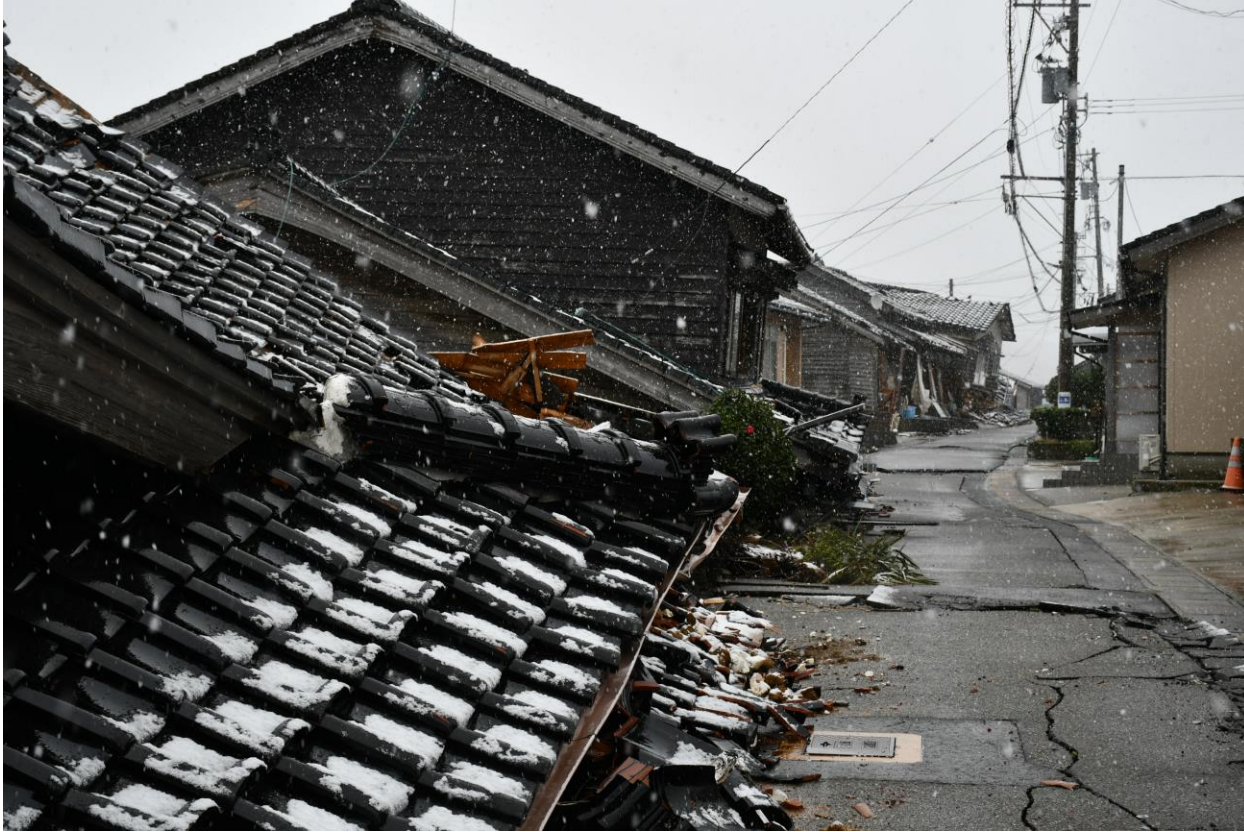
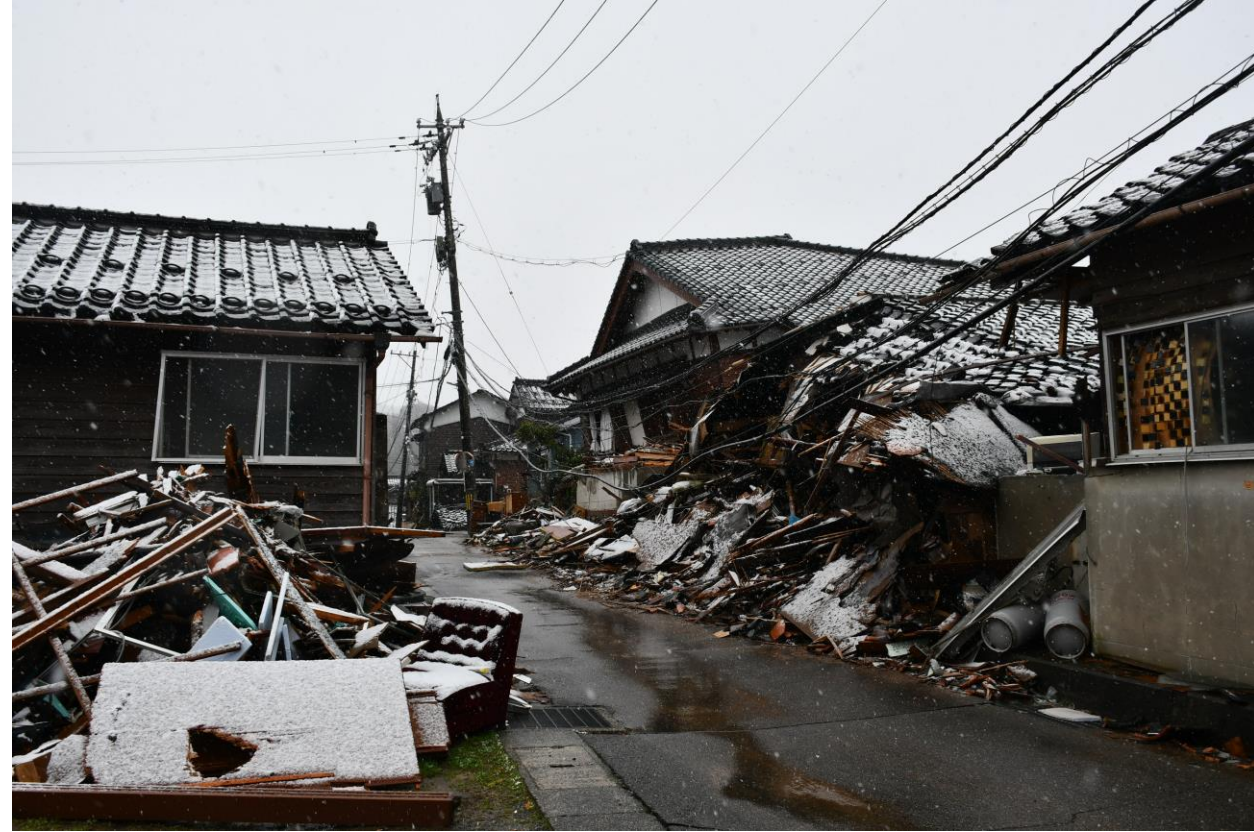
Collapse of wooden houses (Map①)
