# Quick report of preliminary reconnaissance of the 2024 Noto-hanto Earthquake in Japan —No.2—

Masakatsu Miyajima (Professor Emeritus, Kanazawa University)

Takao Hashimoto (Specially Appointed Professor, Kokushikan University)

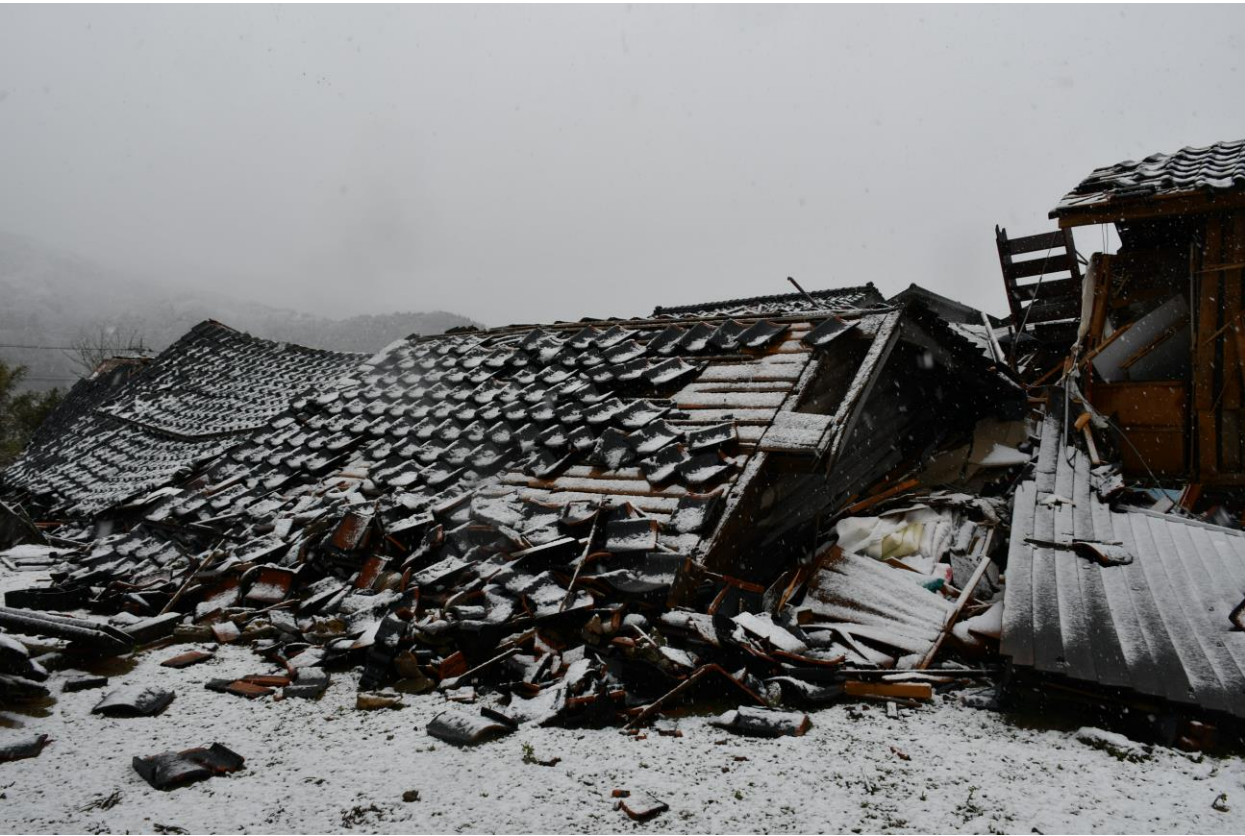
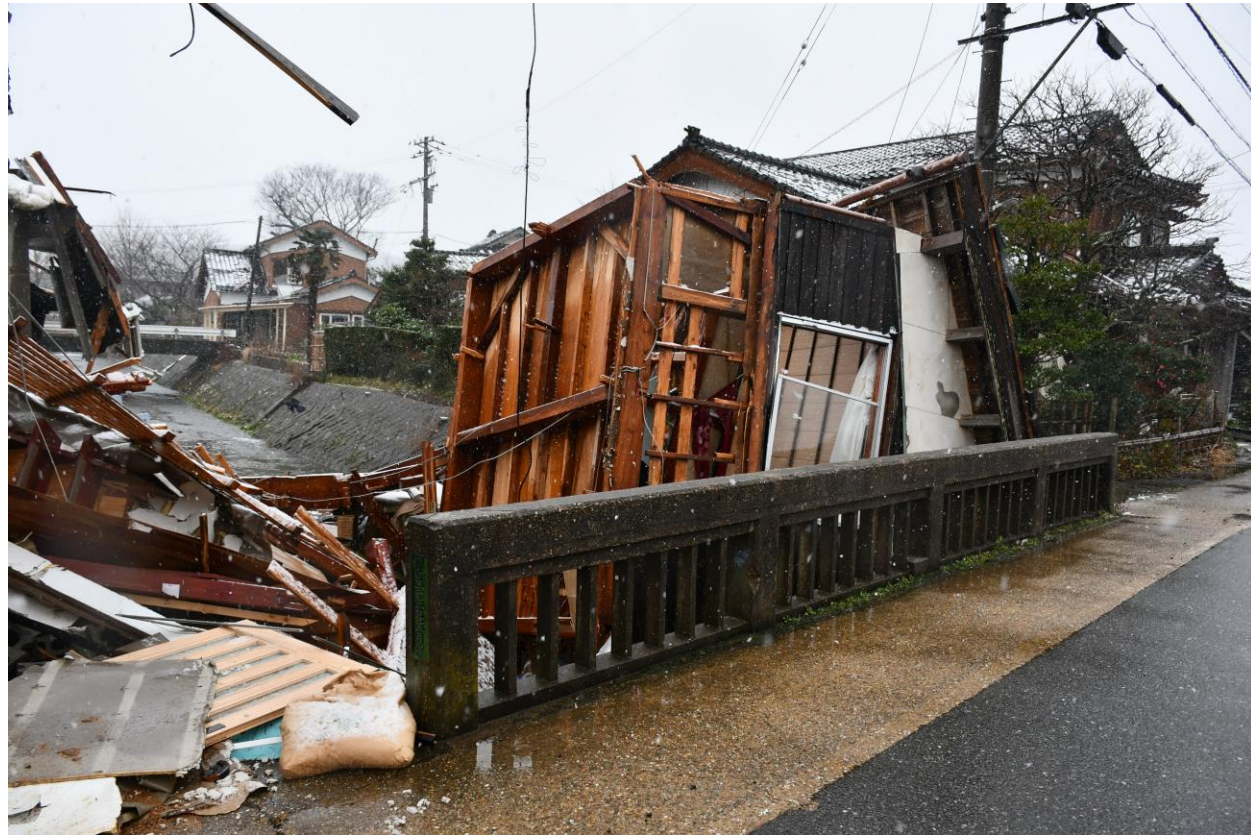
Collapse of wooden houses (Map①)

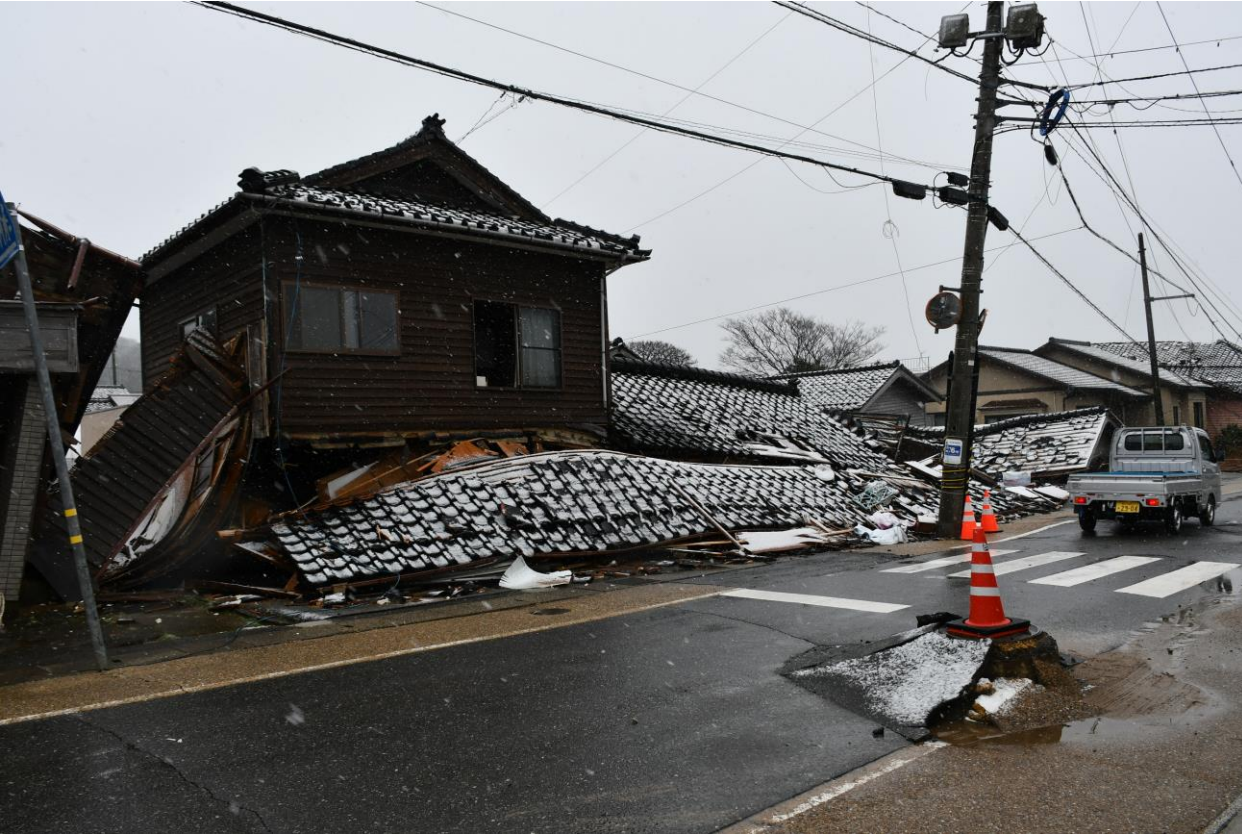
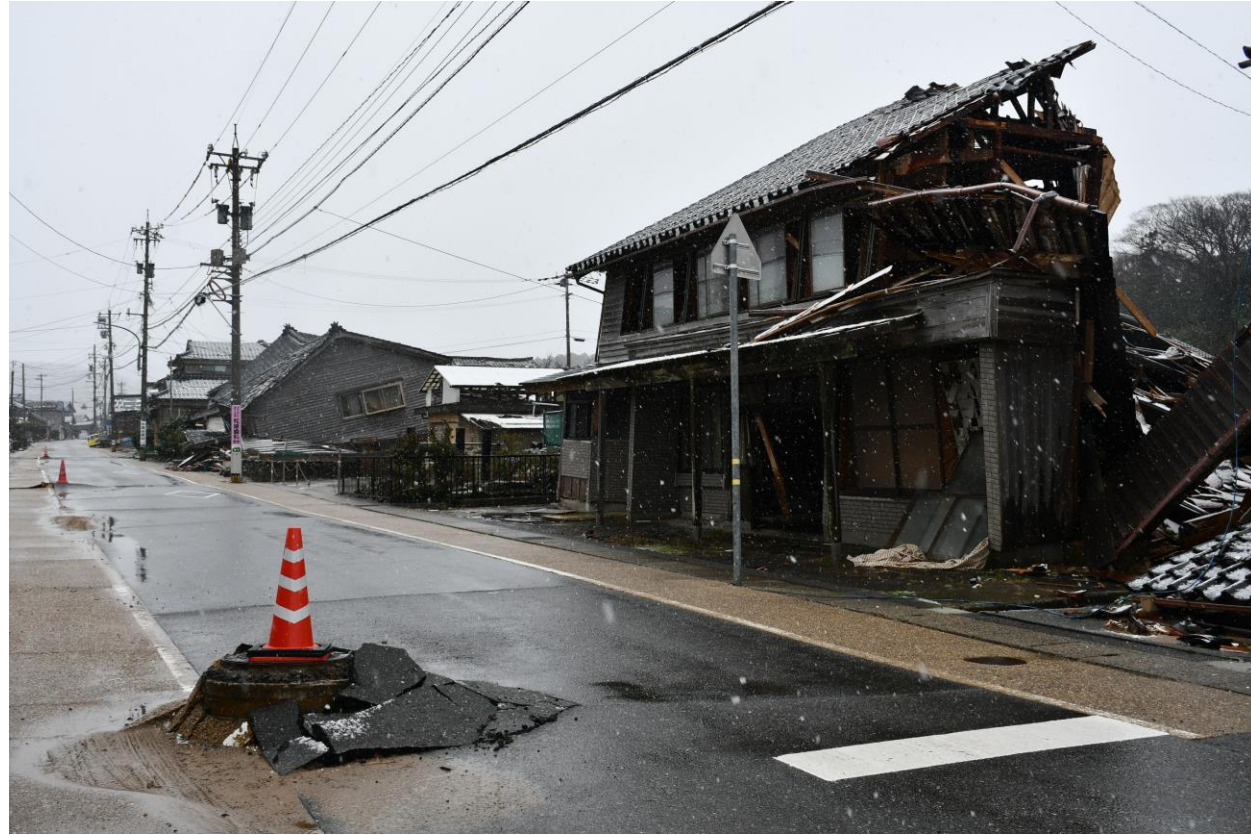
Uplift of manholes (Map②)

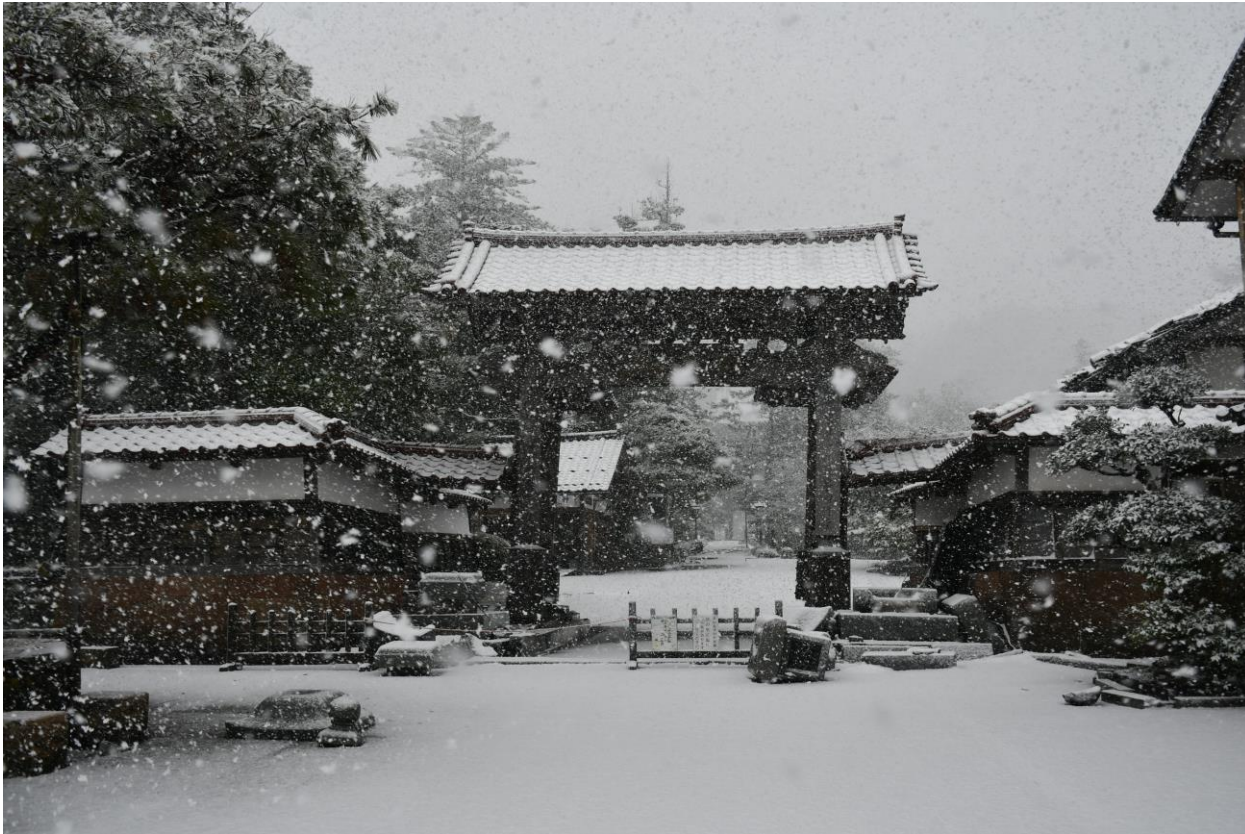
Extensive damage to Soujiji Temple (Map③)

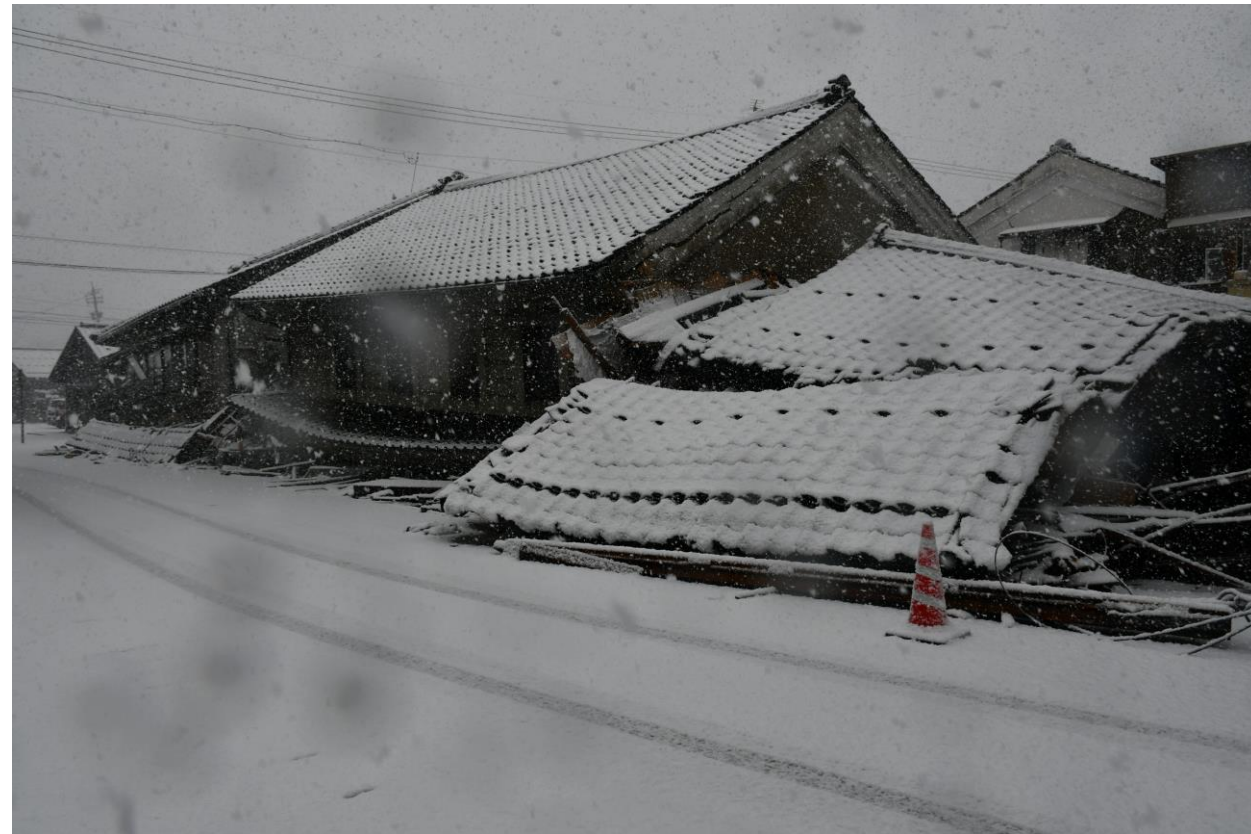
Collapse of wooden house (Map③)

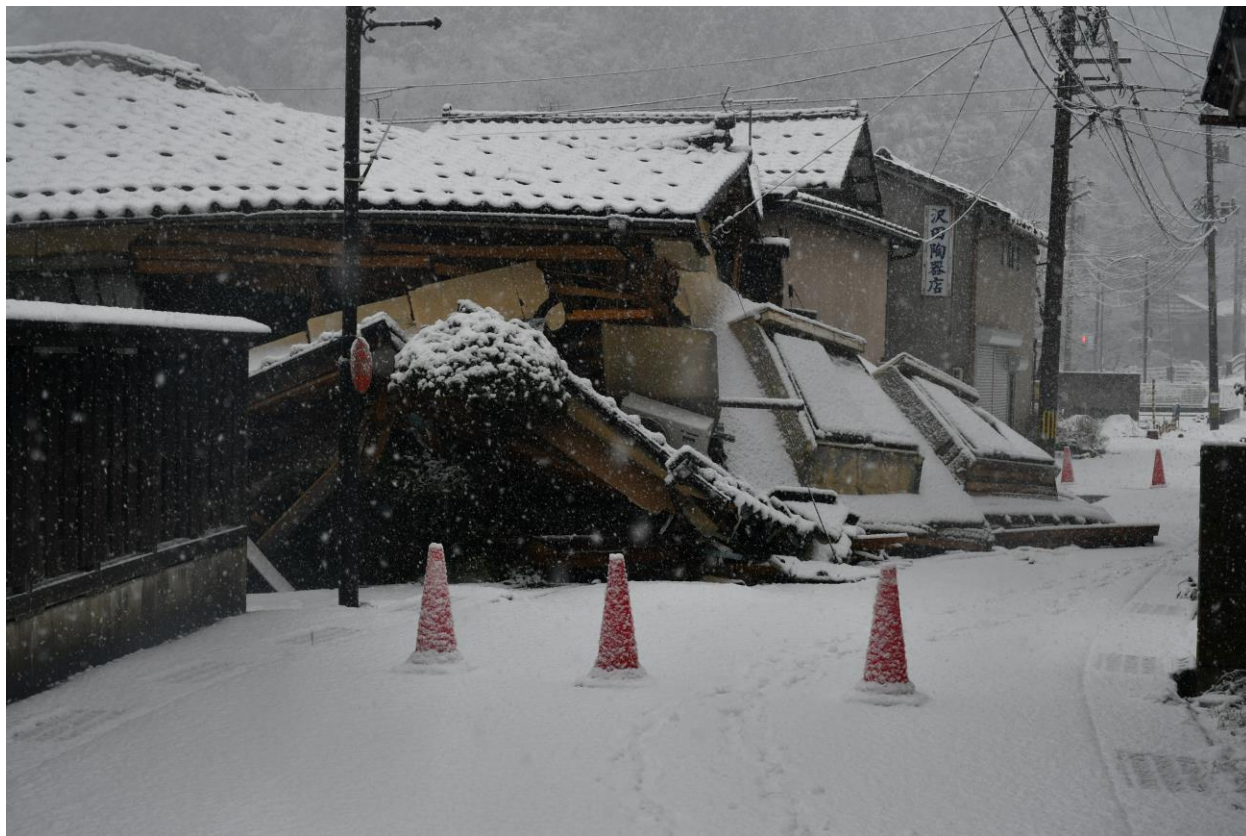
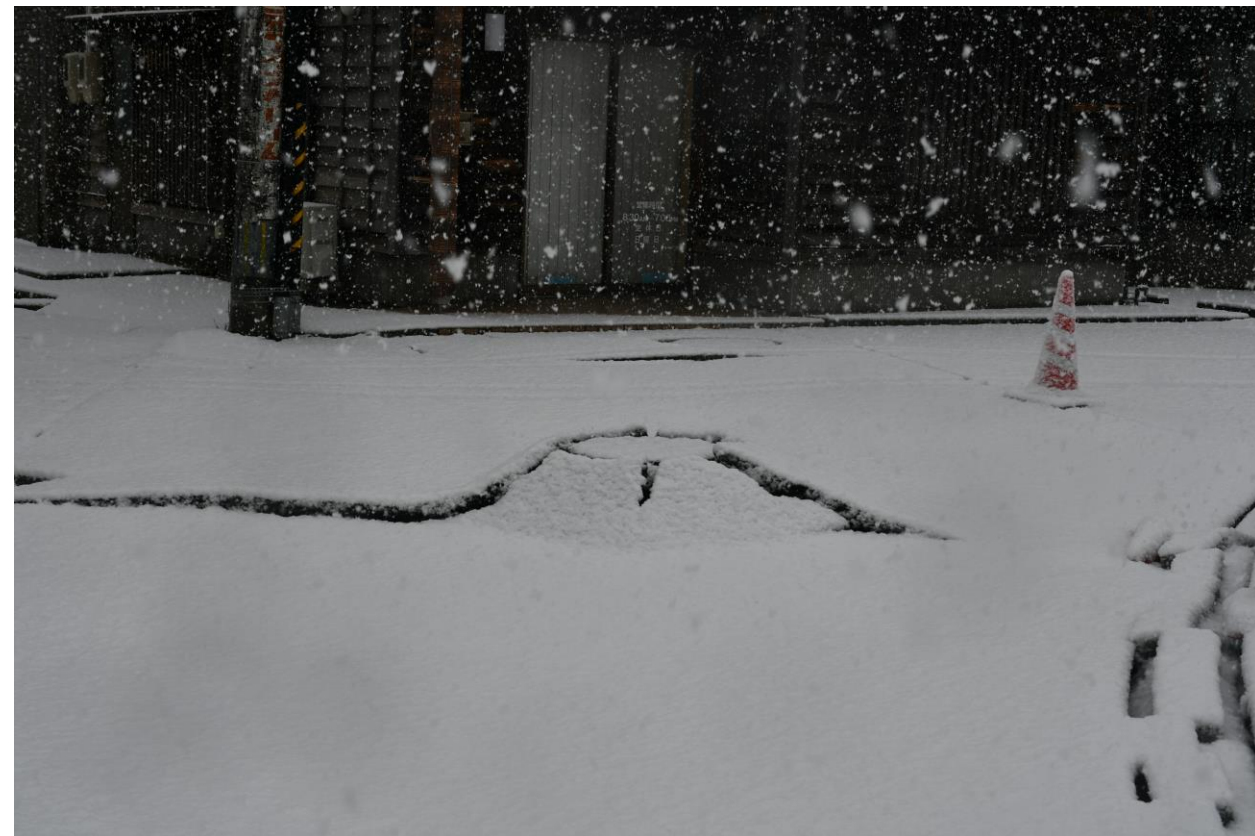
Traffic obstructions caused by collapsed houses and floating manholes (Map③)

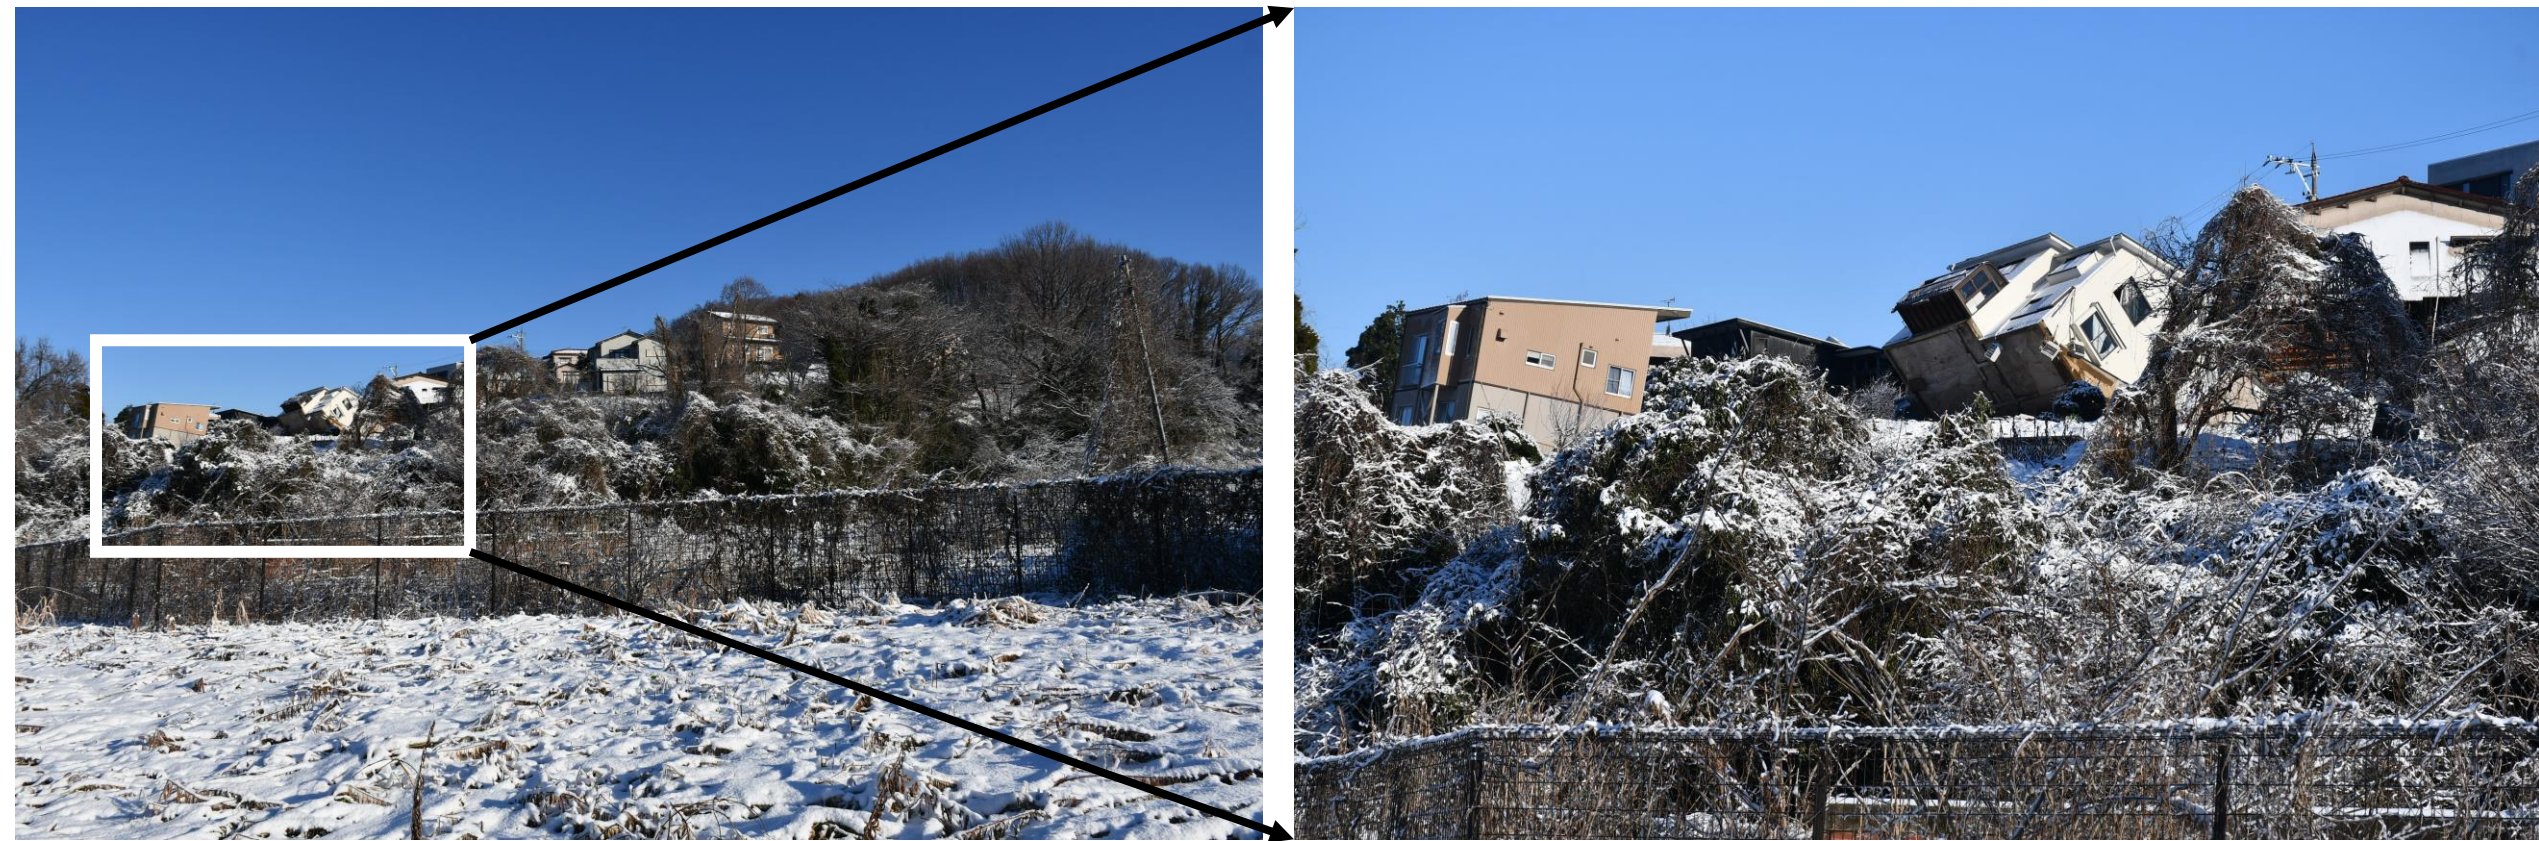
Damage to houses caused by landslides on embankment of developed residential areas (Map①)

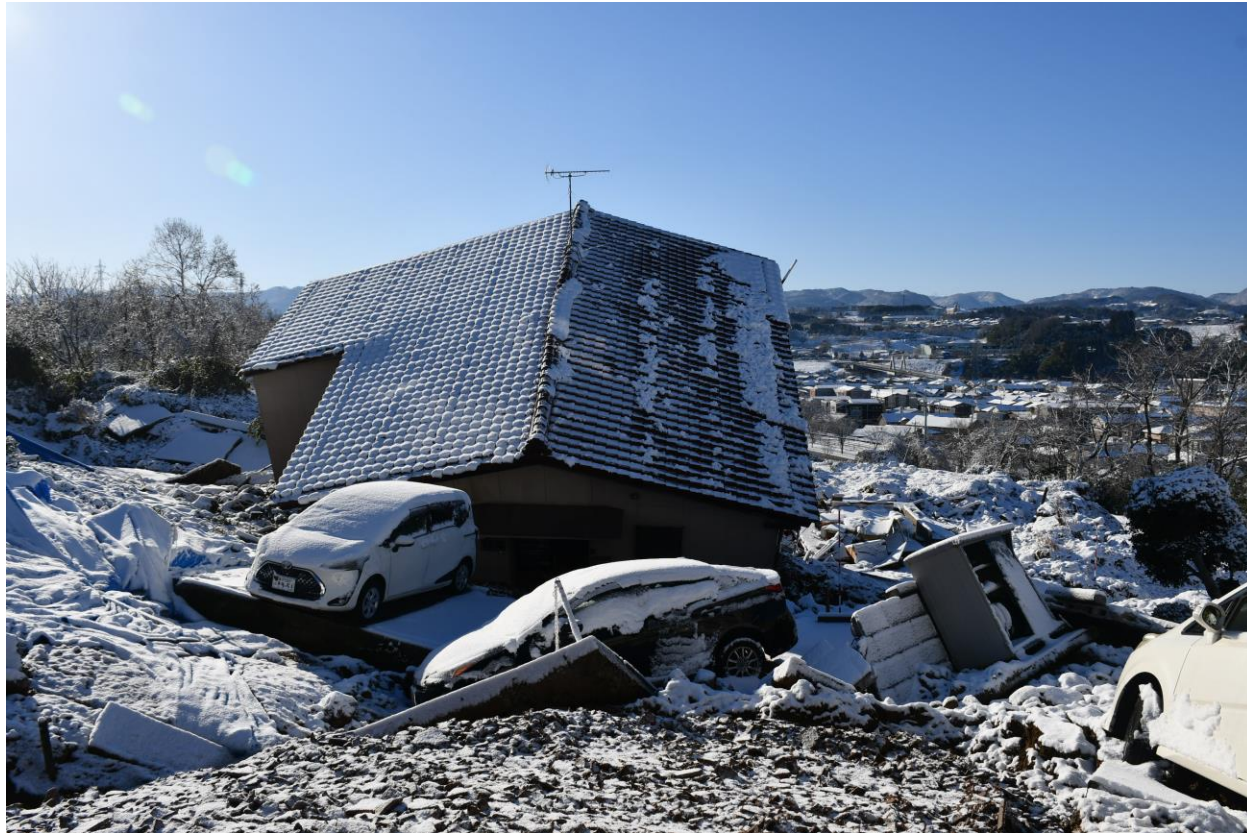
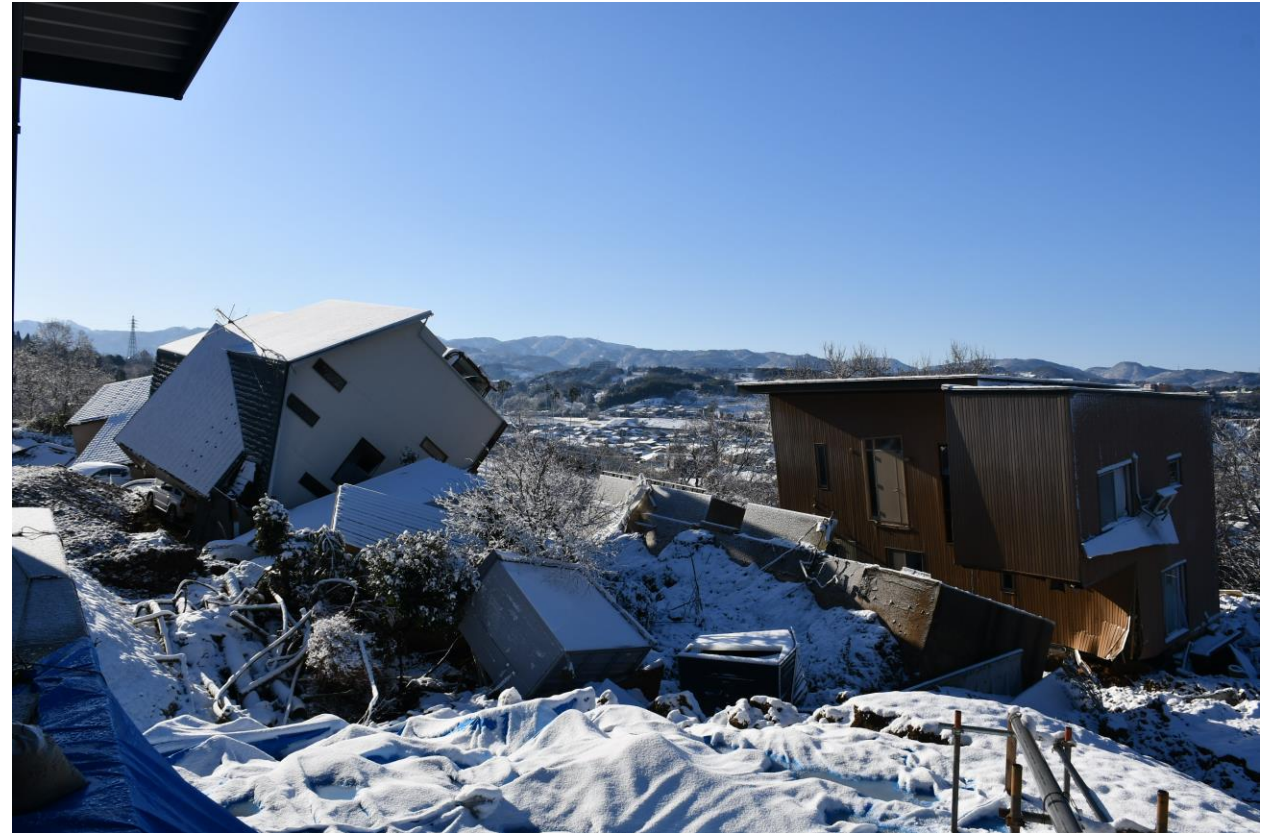
Damage to houses caused by landslides on embankment of developed residential areas (Map①)

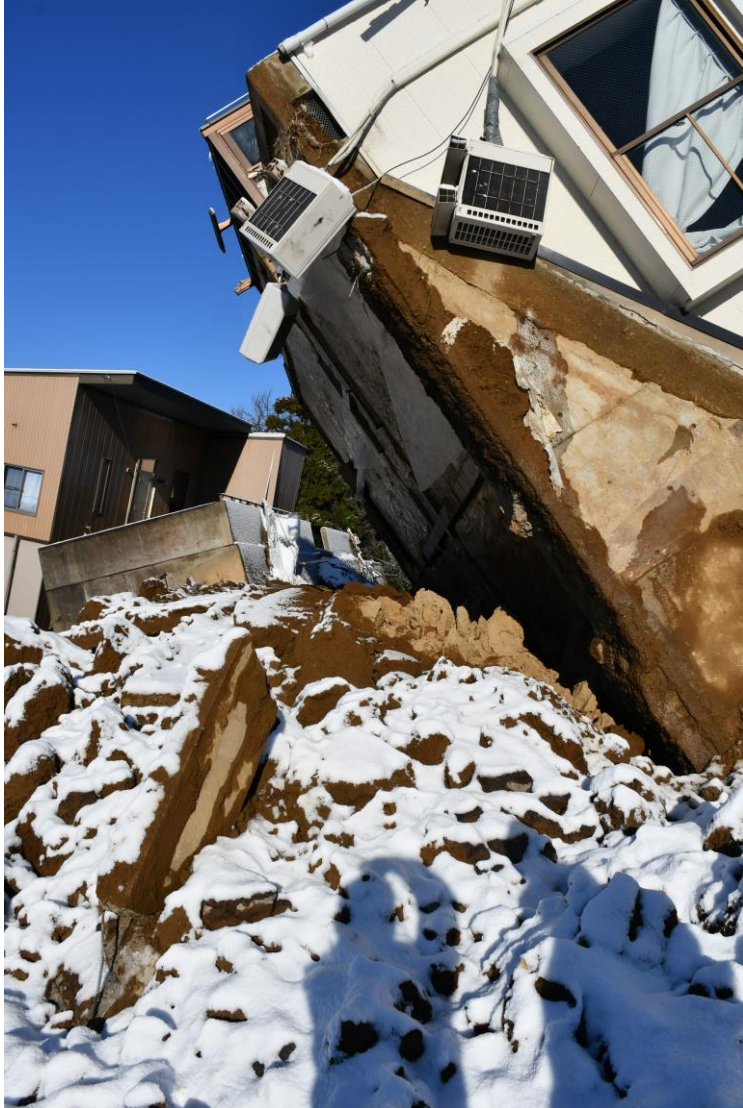
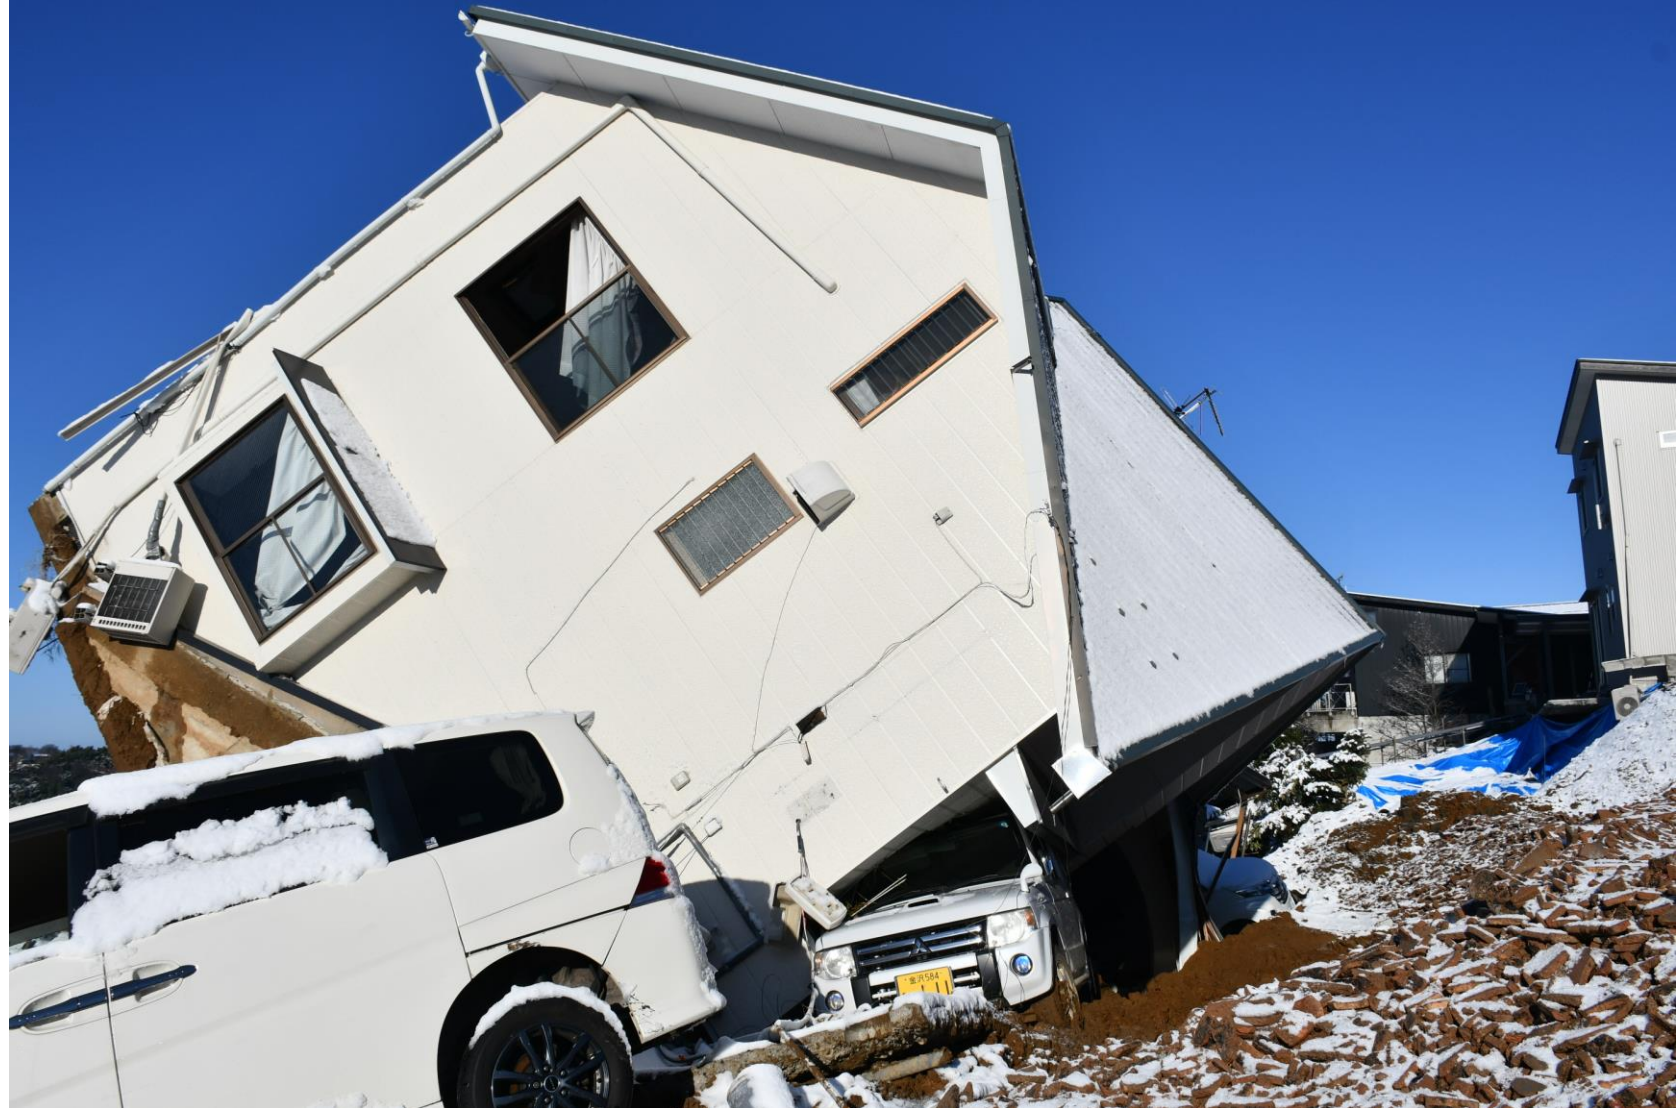
Damage to houses caused by landslides on embankment of developed residential areas (Map①)

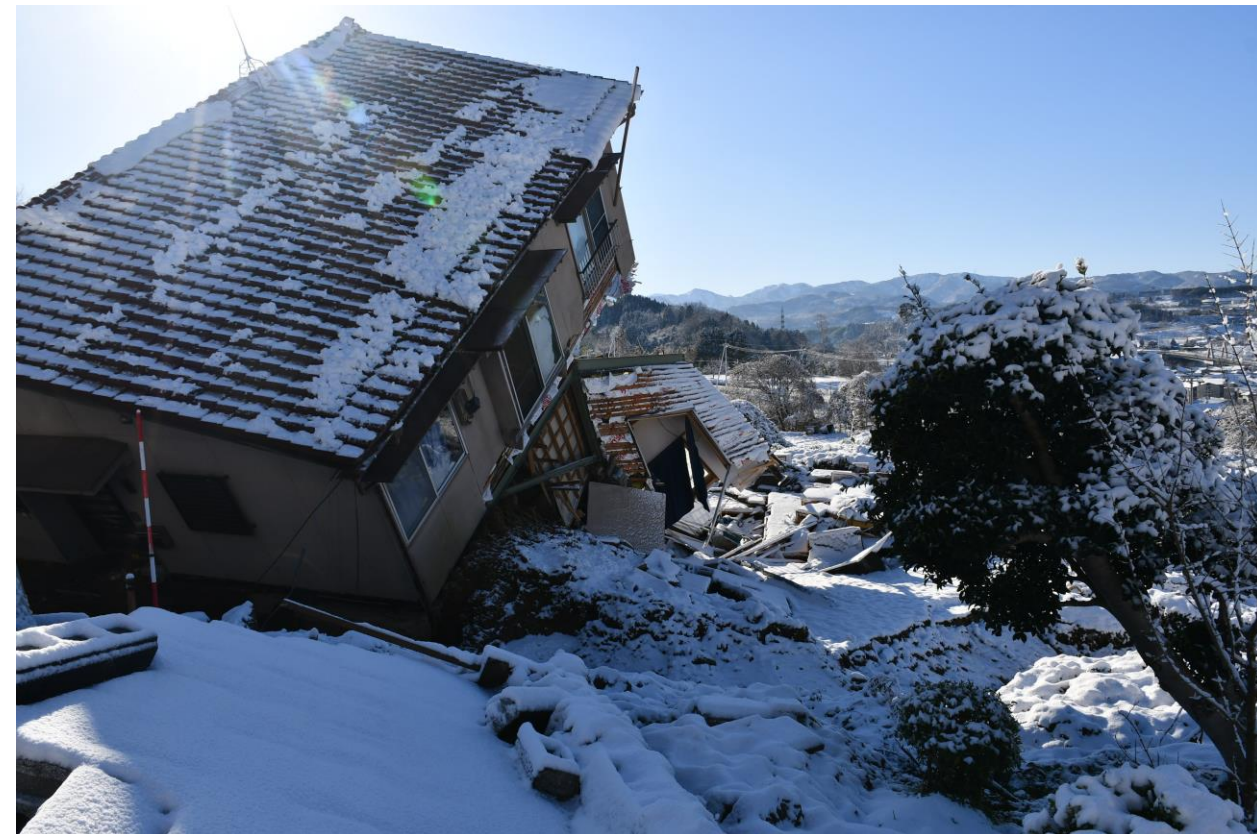
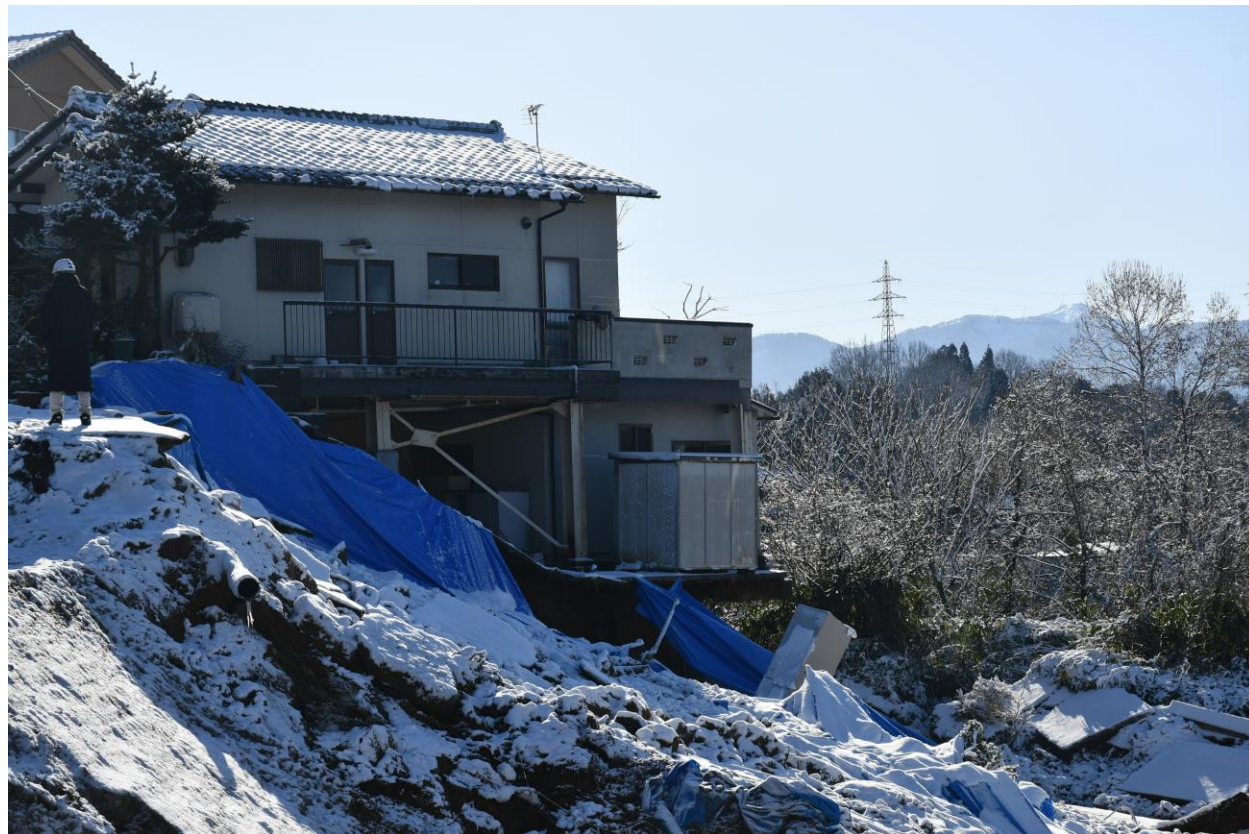
Damage to houses caused by landslides on embankment of developed residential areas (Map①)

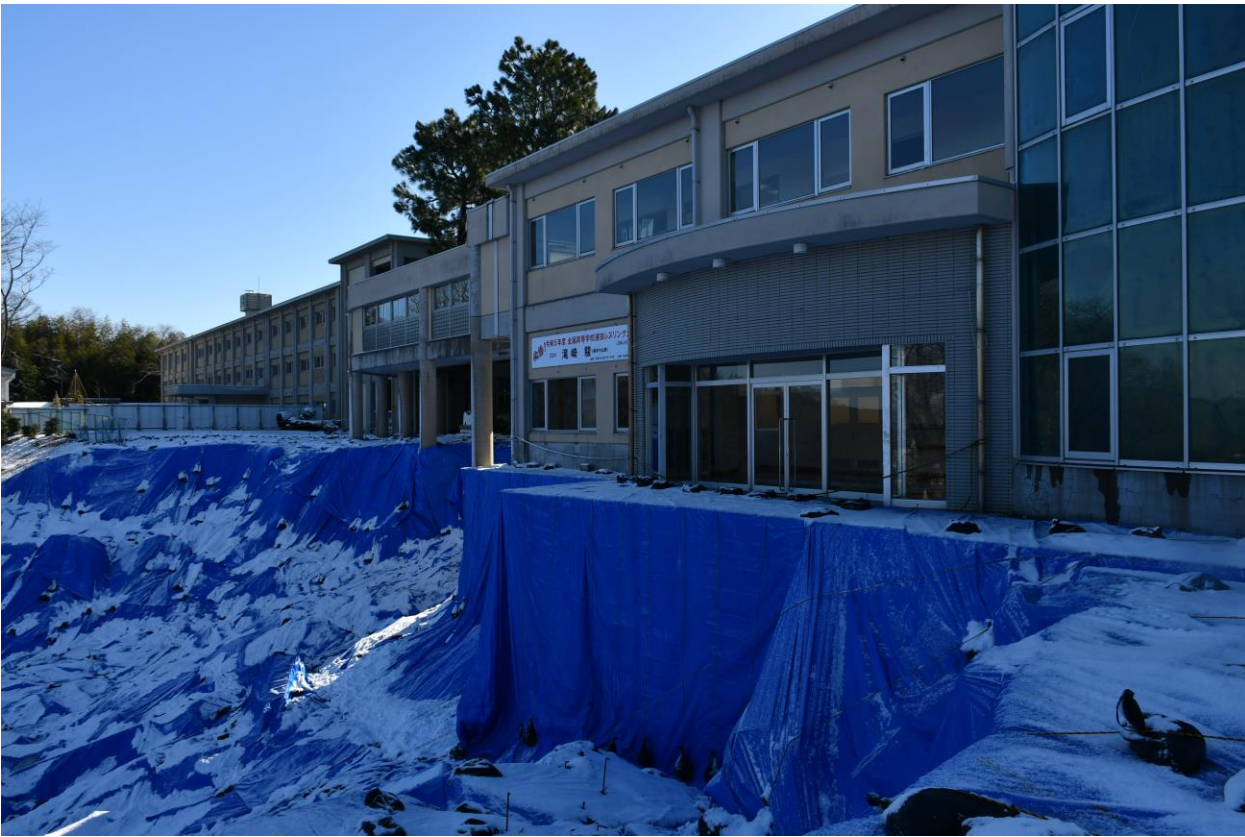
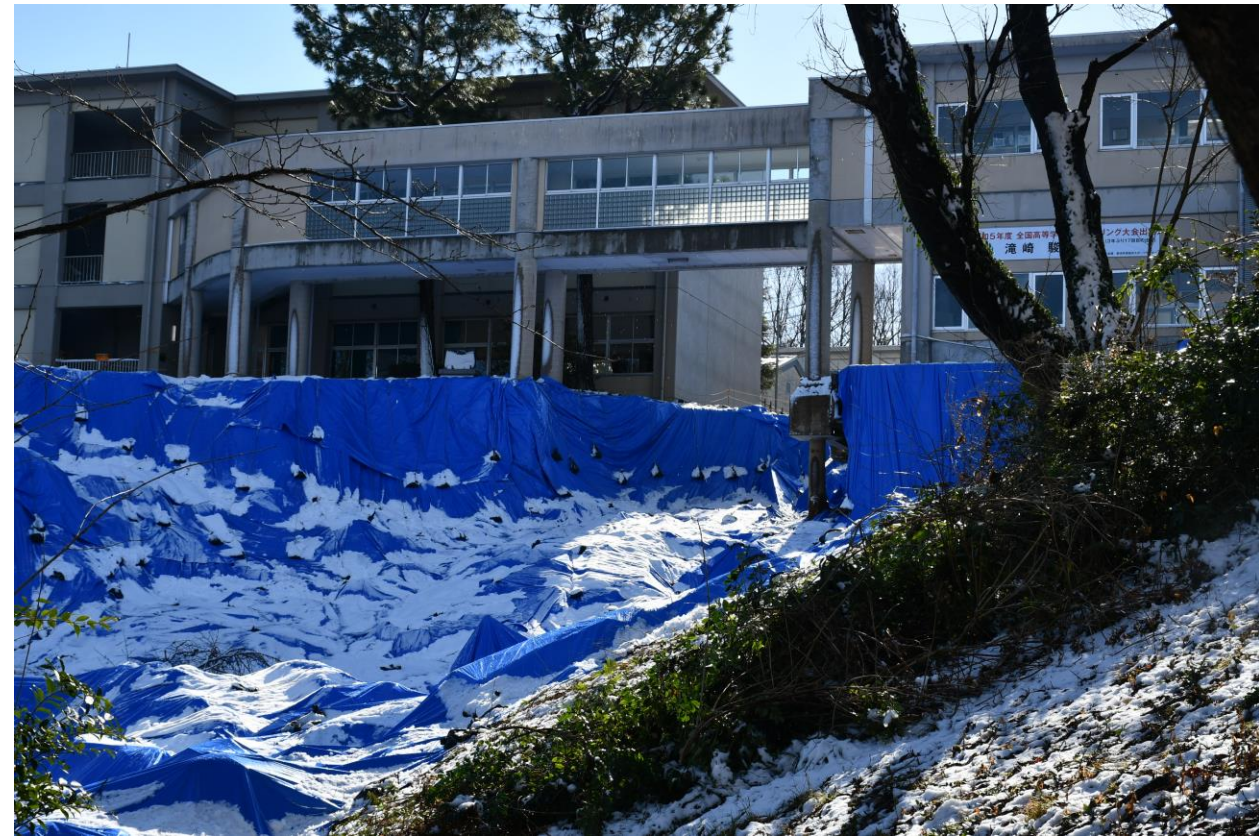
Slope failure on the high school grounds (Map②)

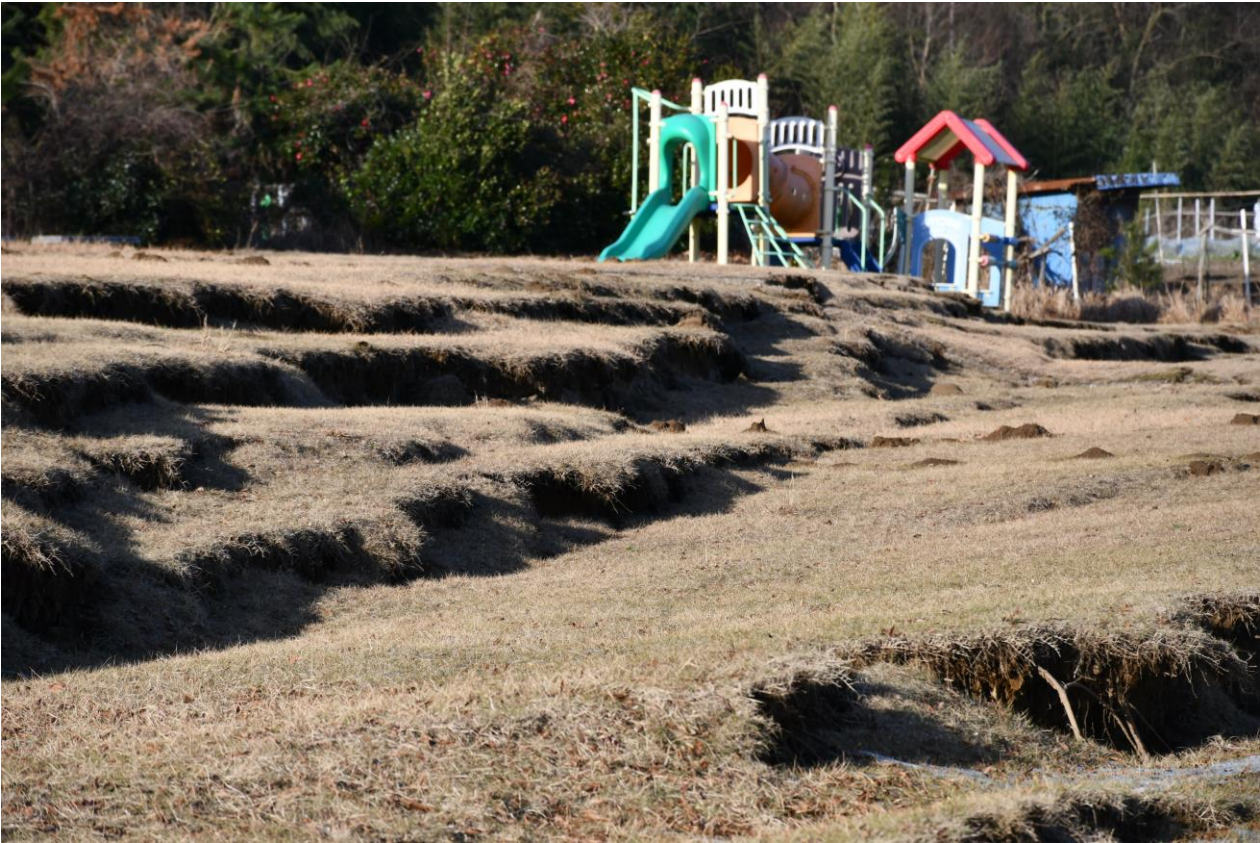
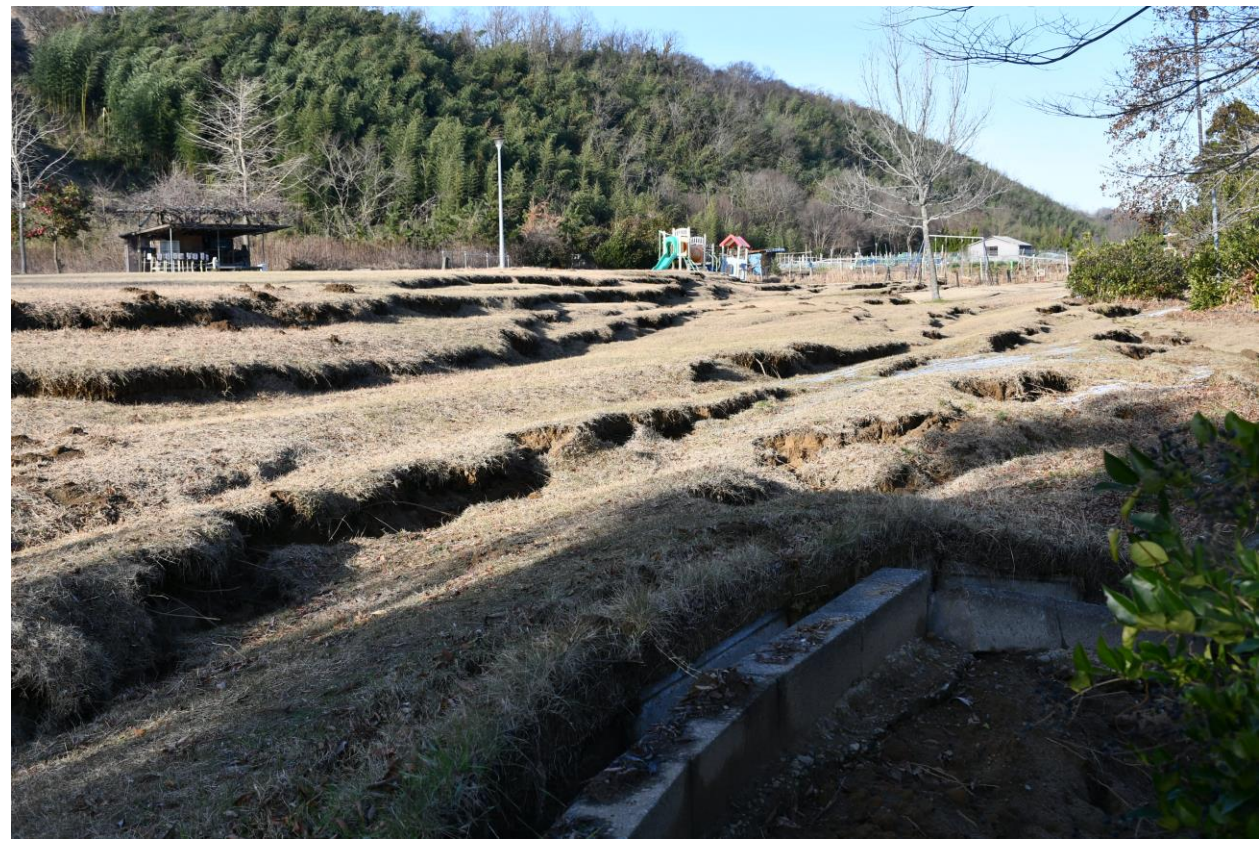
Ground deformation due to lateral flow (Map①)

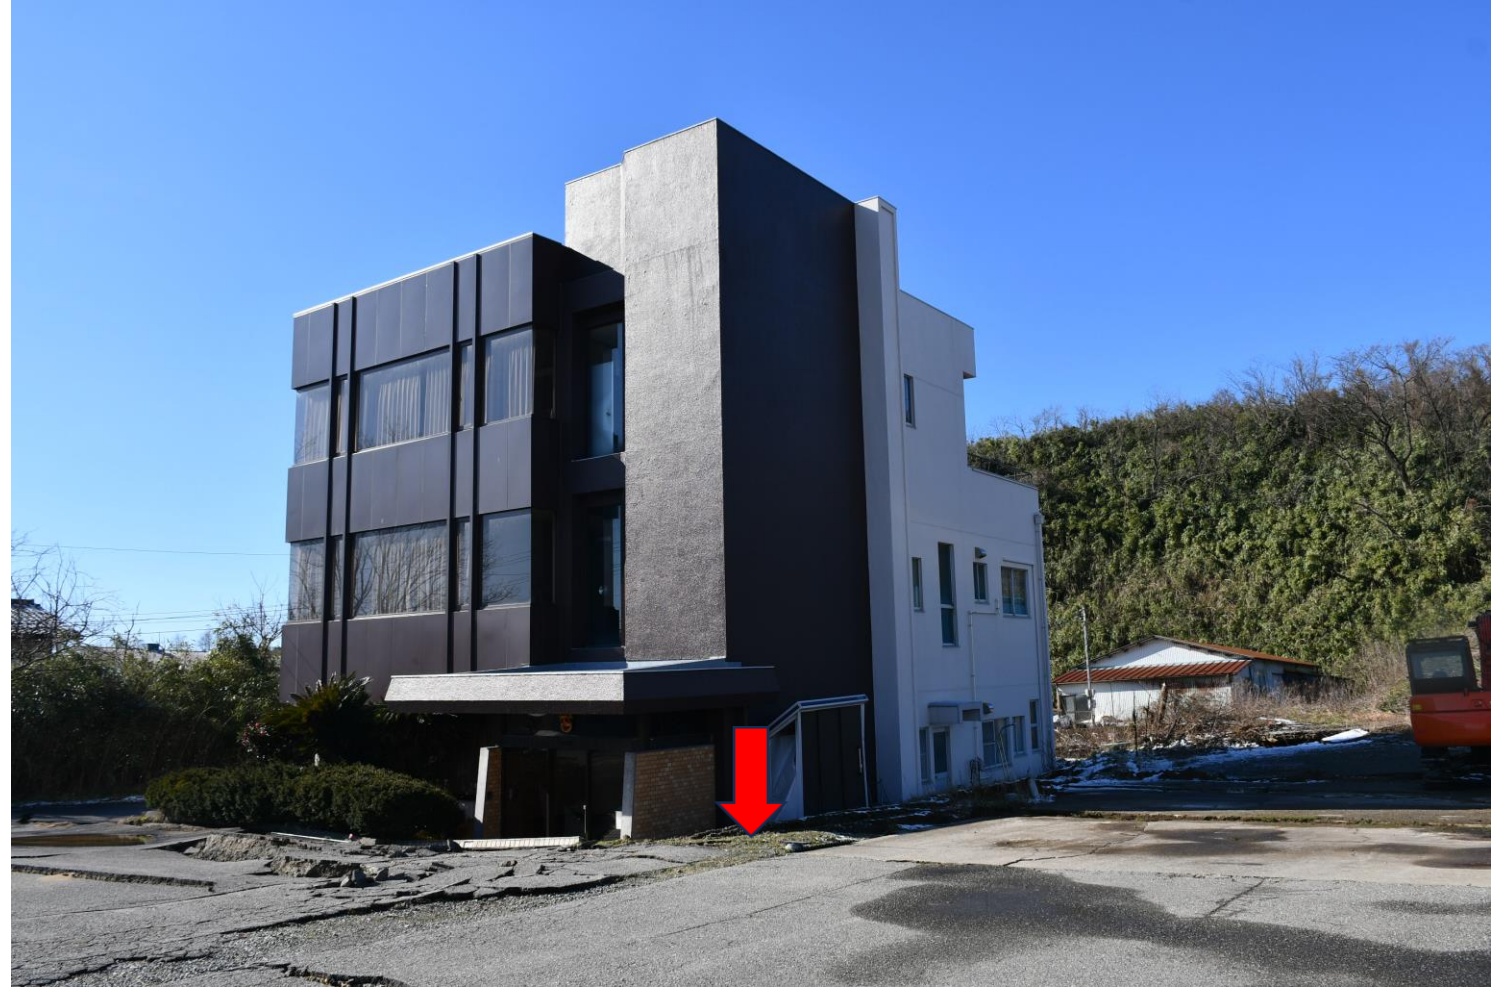
Subsidence of RC building due to liquefaction (Map②)
