# Quick report of preliminary reconnaissance of the 2024 Noto-hanto Earthquake in Japan —No.2—

Masakatsu Miyajima (Professor Emeritus, Kanazawa University)

Takao Hashimoto (Specially Appointed Professor, Kokushikan University)

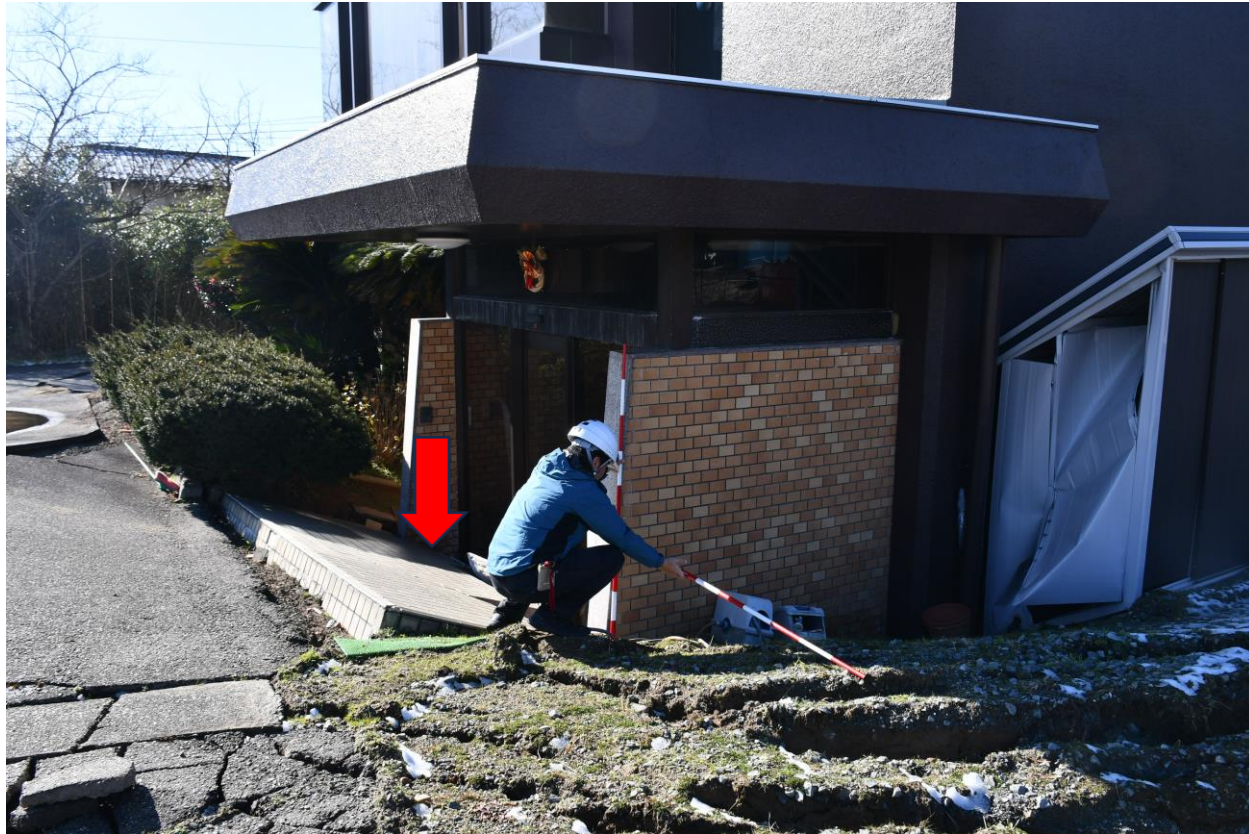
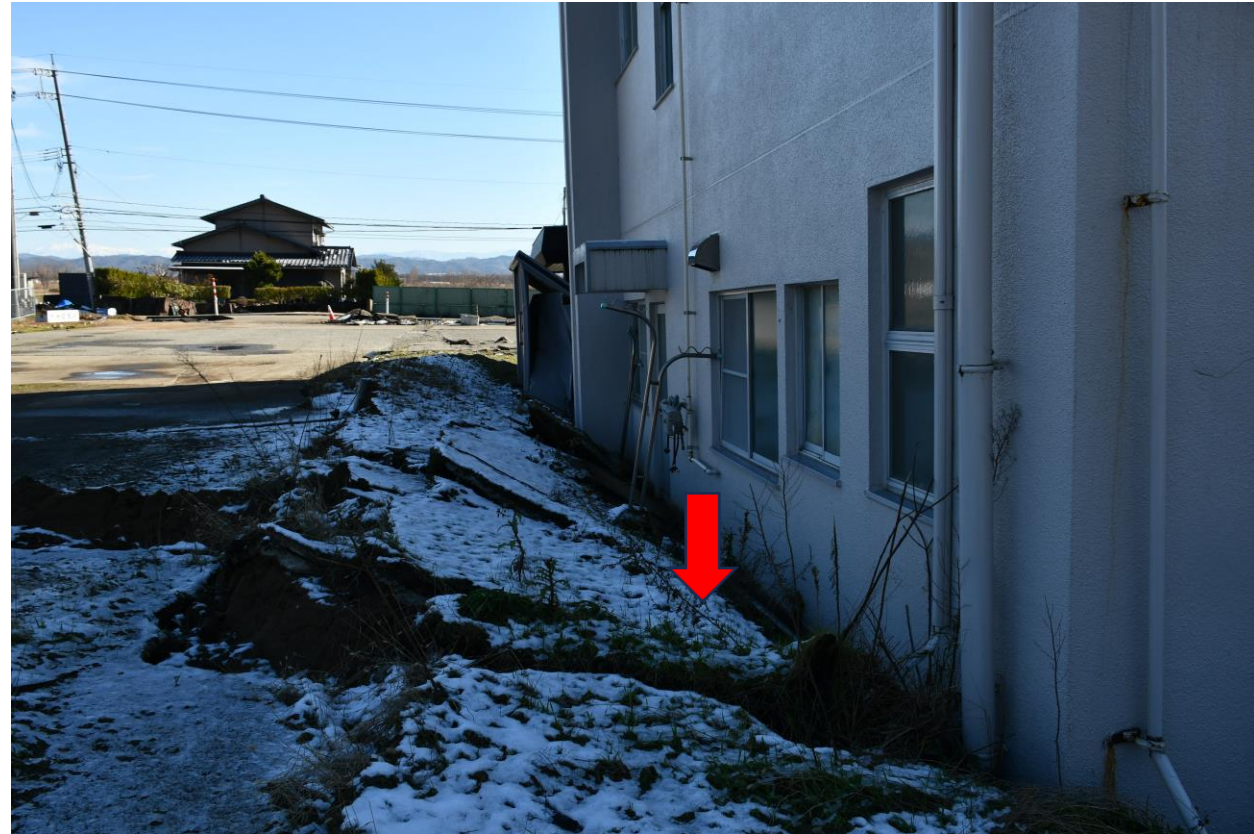
Subsidence of RC building due to liquefaction (Map②)

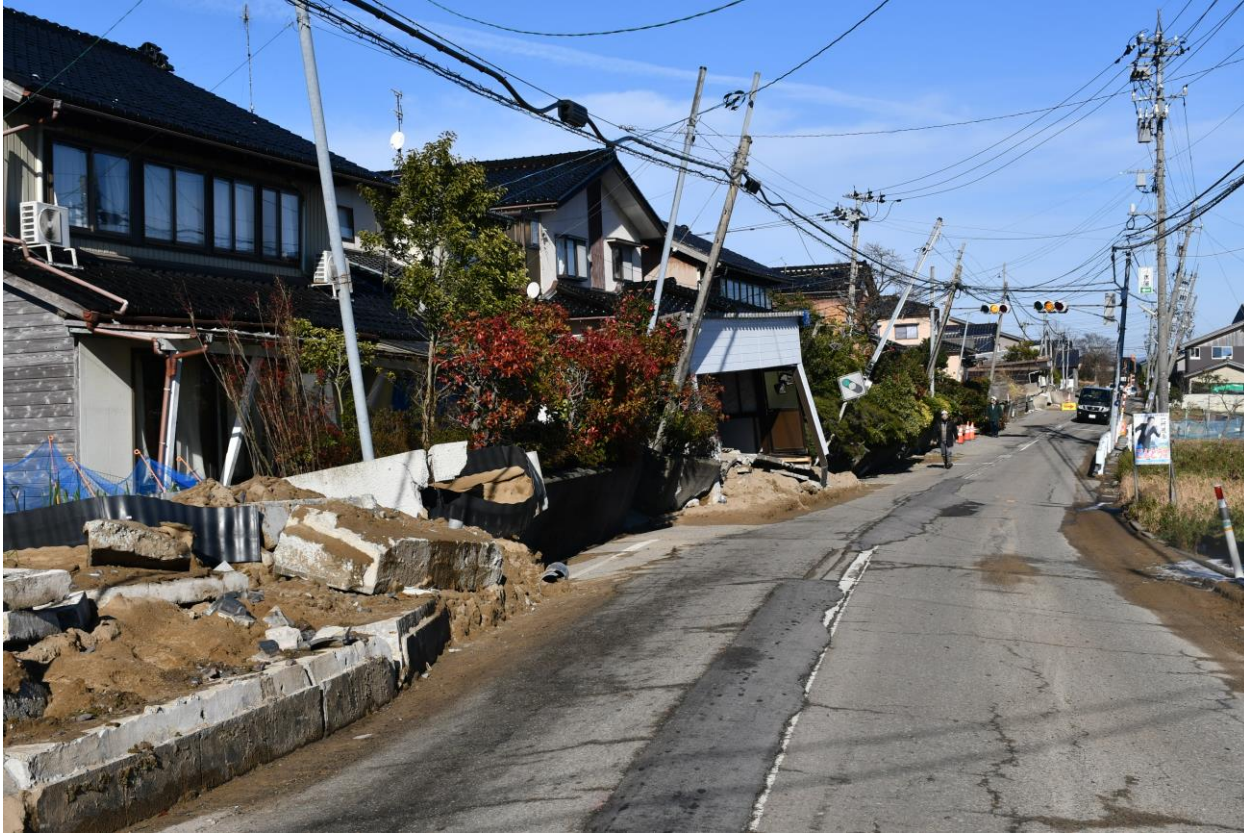
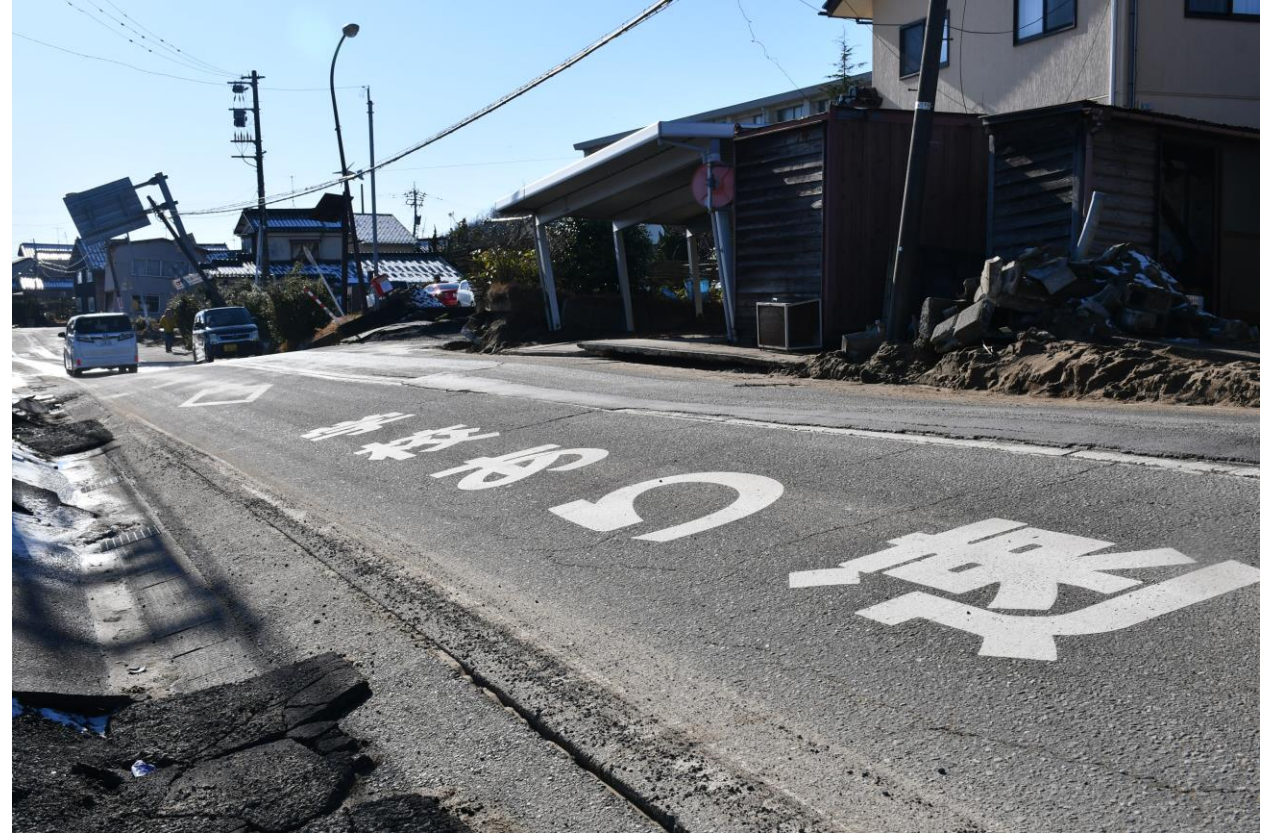
Meandering of the road due to lateral flow of liquefied ground (Map③)

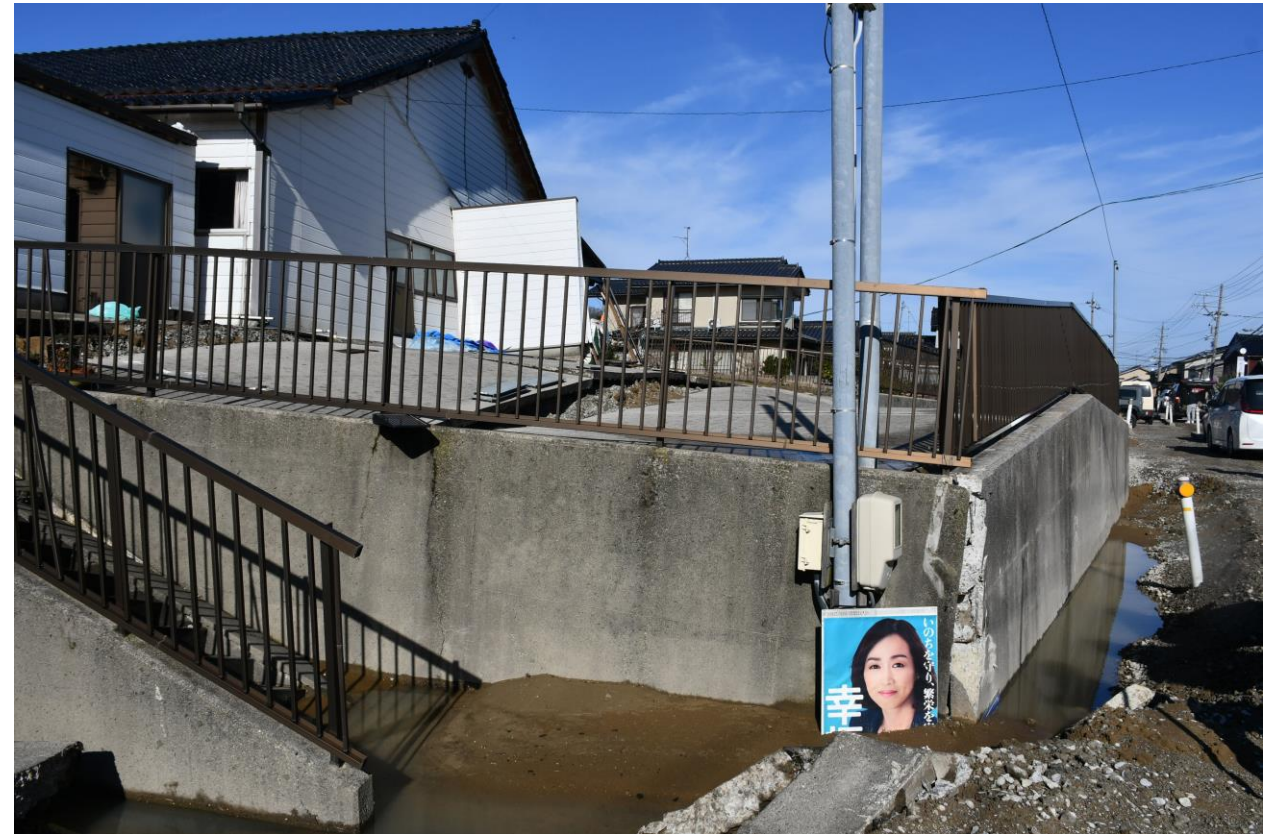
Lateral flow of liquefied ground in the dunes hinterland (Map③)

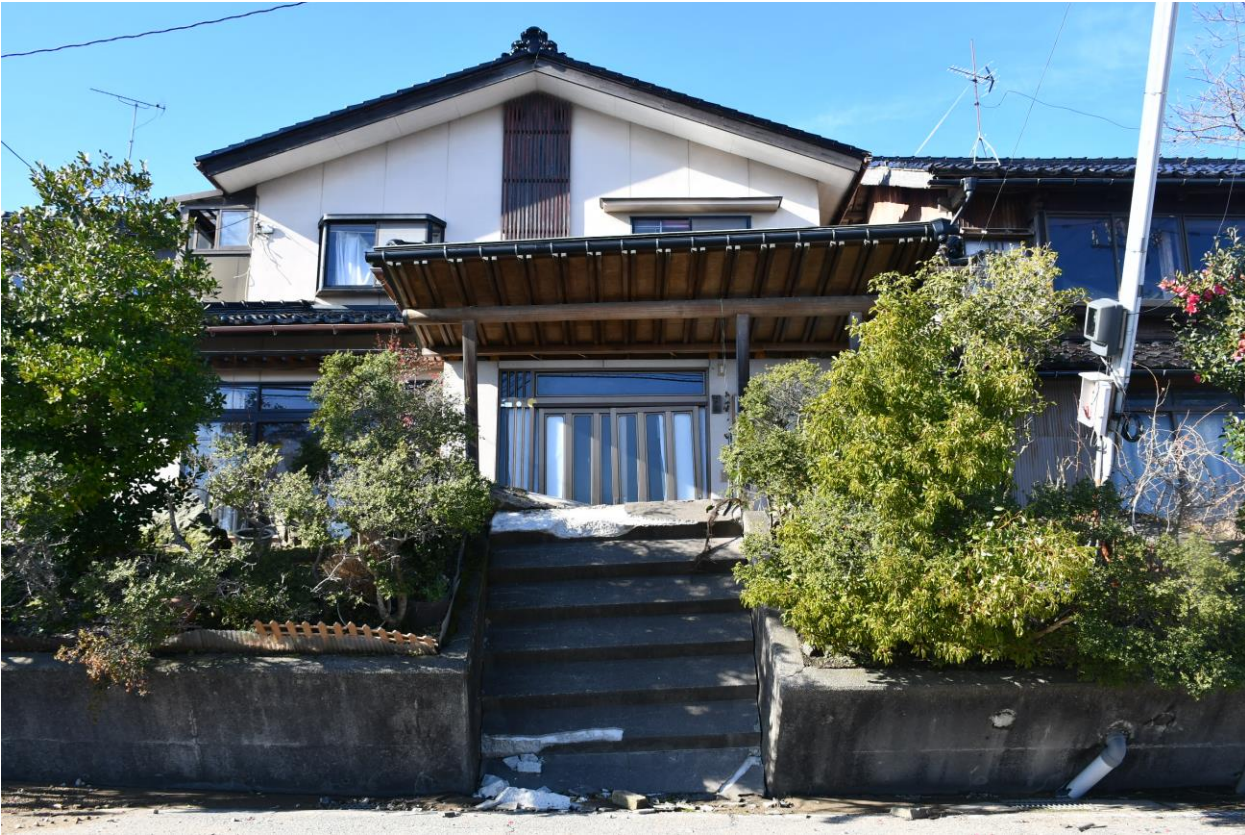
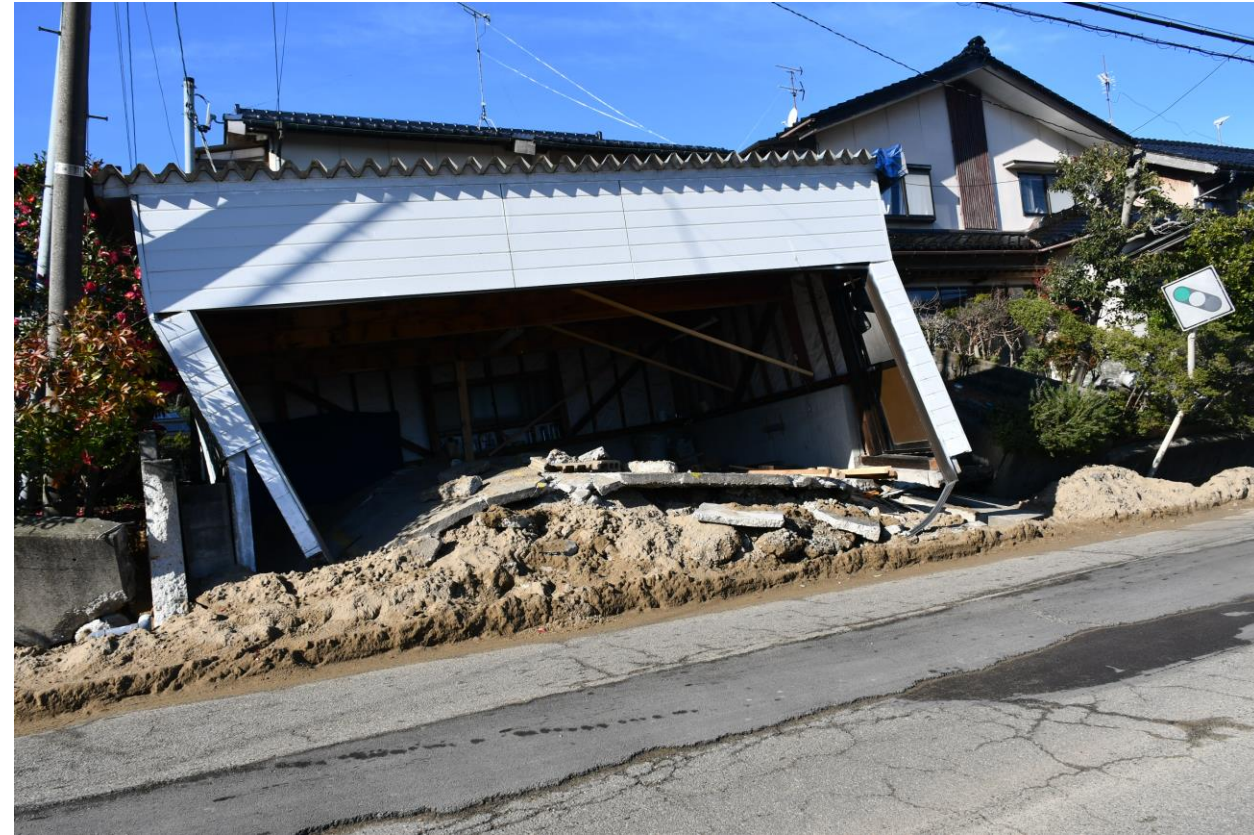
Lateral flow of liquefied ground in the dunes hinterland (Map③)

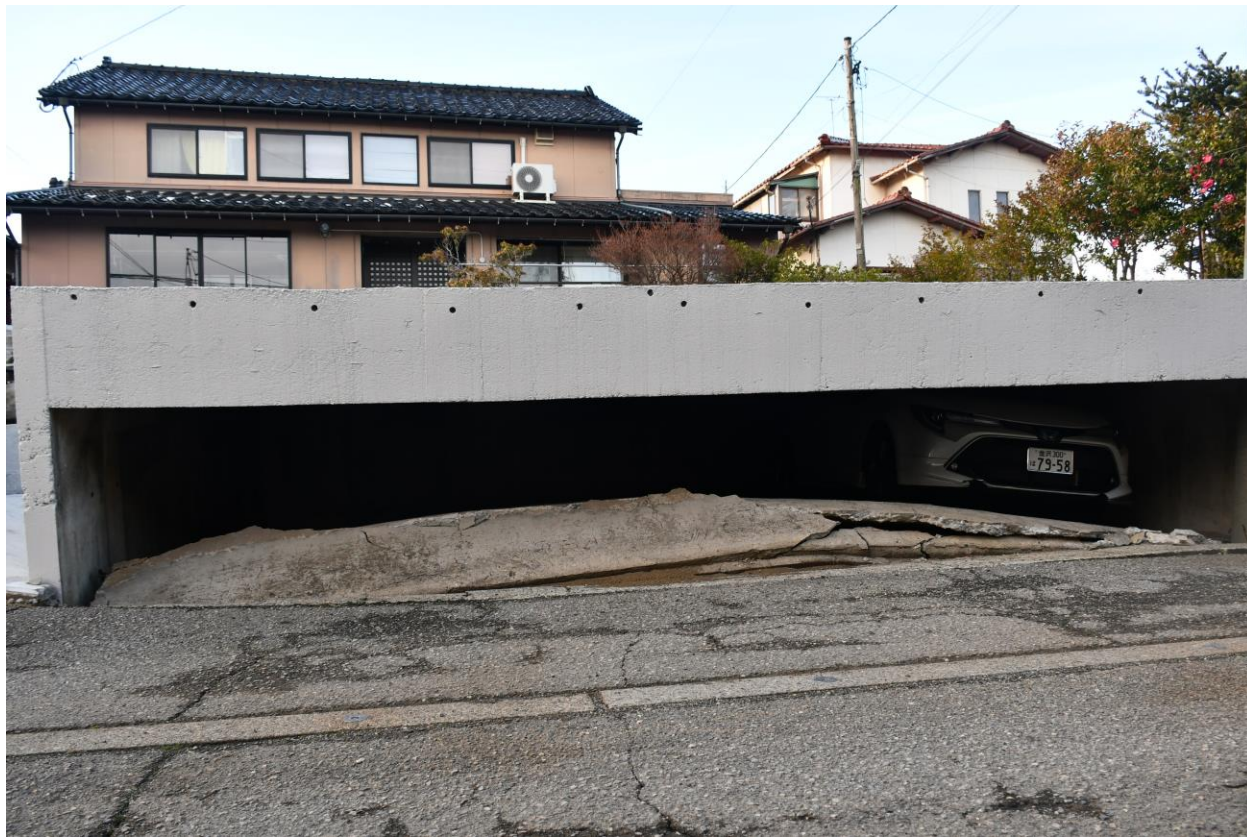
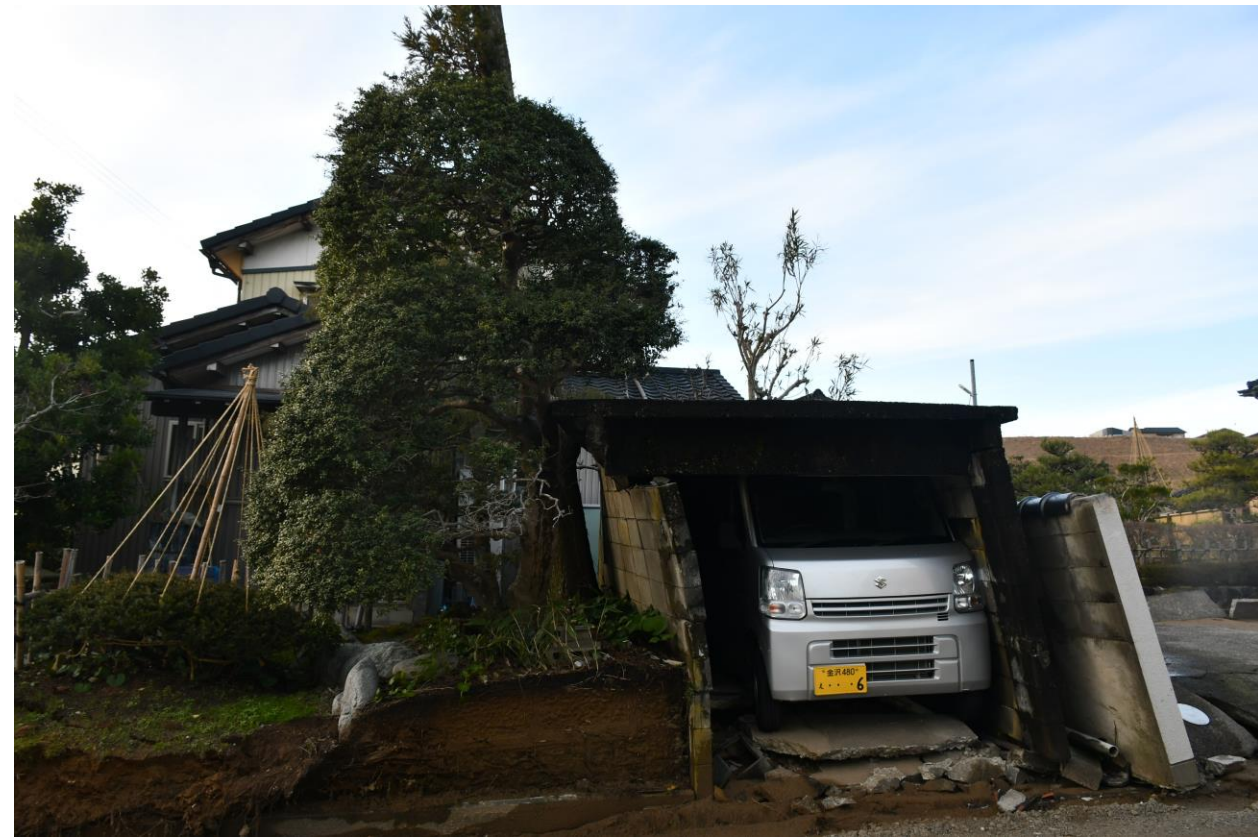
A car trapped in a deformed garage (Map③)

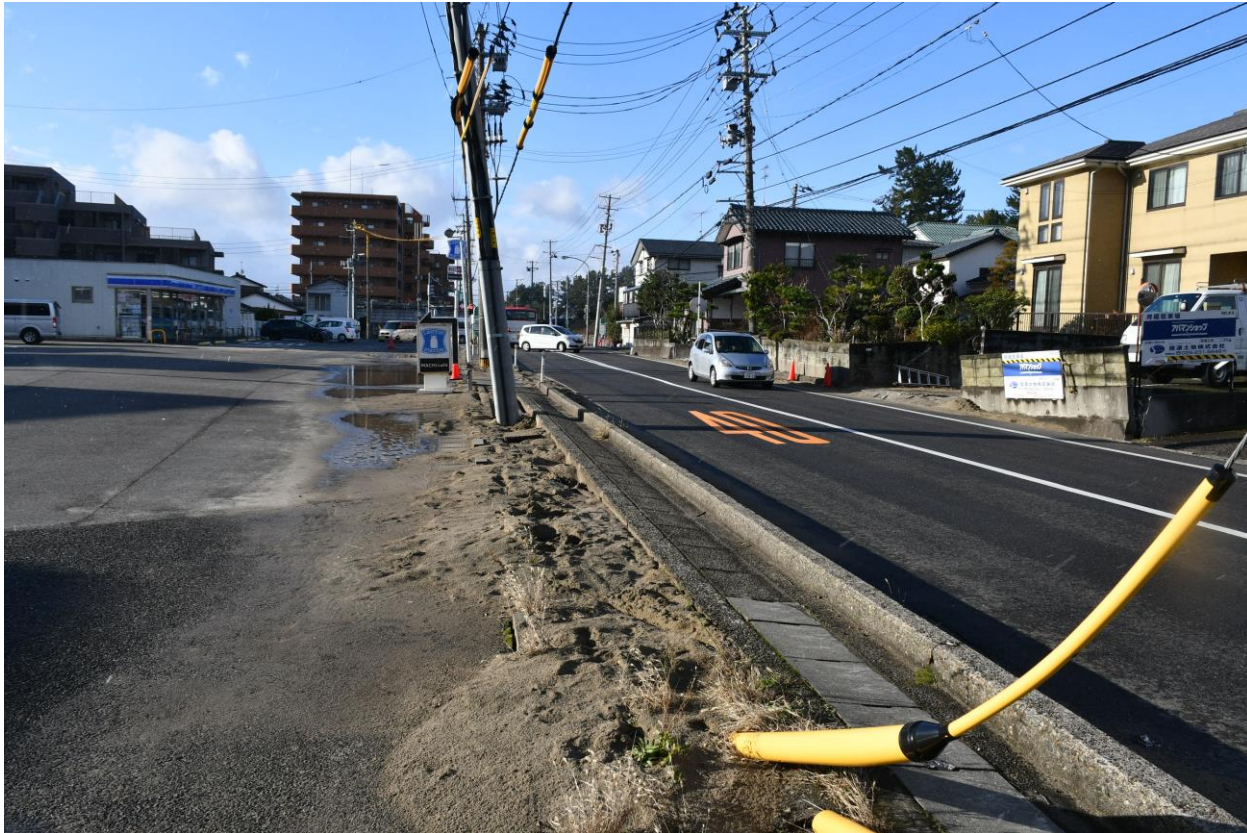
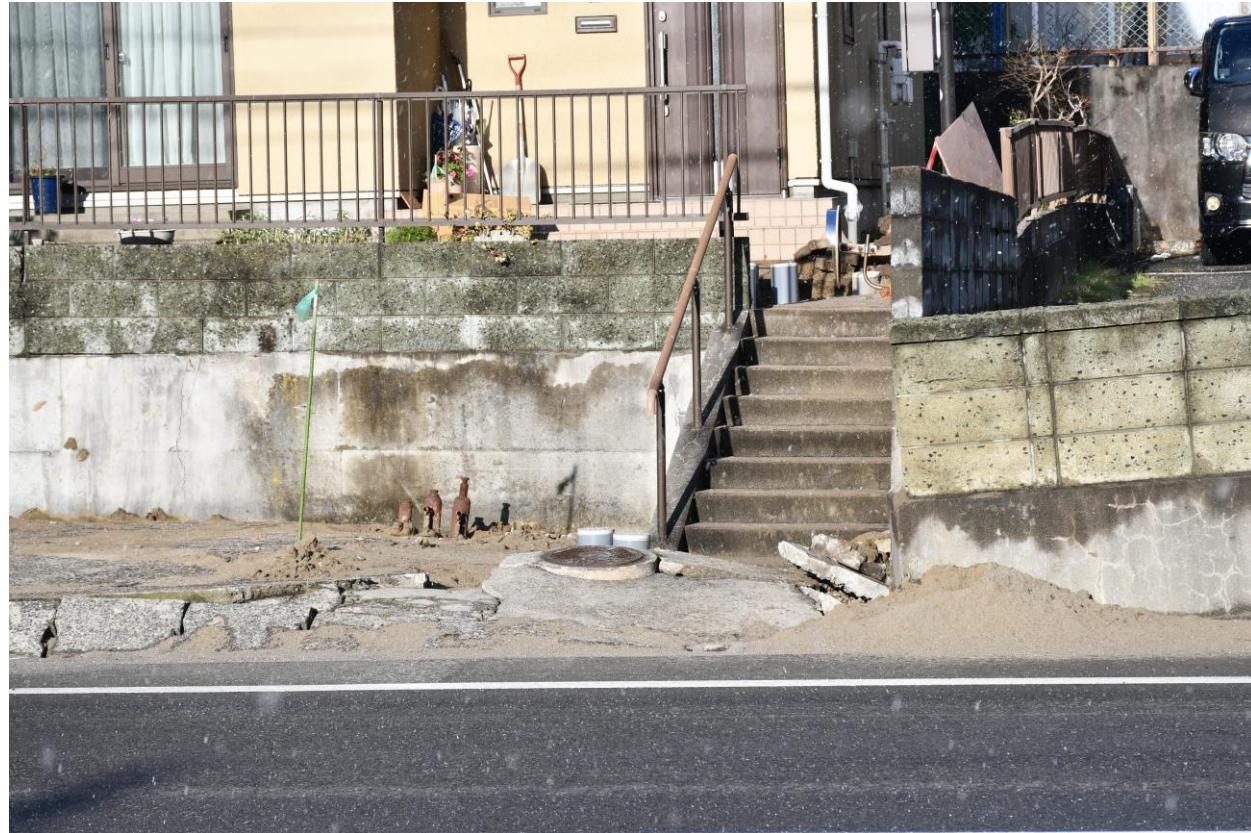
Lateral flow of liquefied ground in the dunes hinterland (Map①)

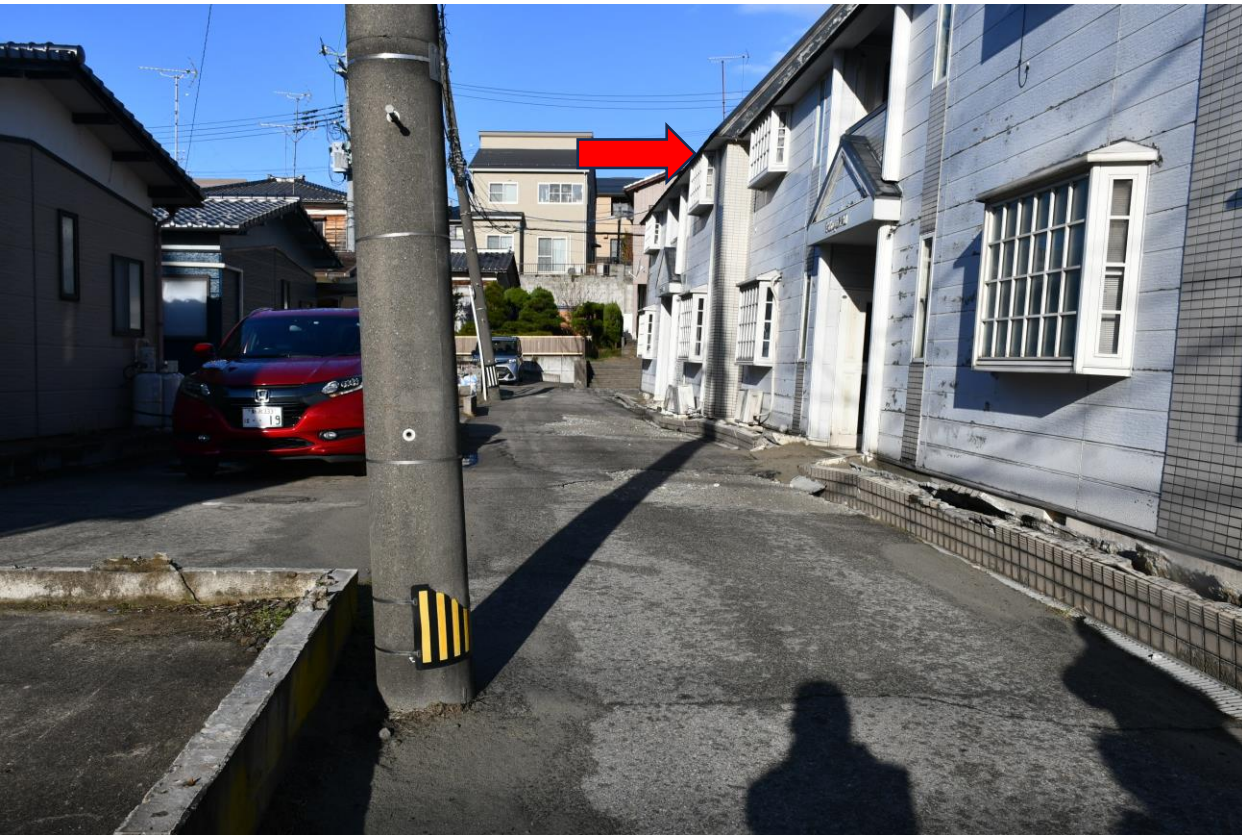
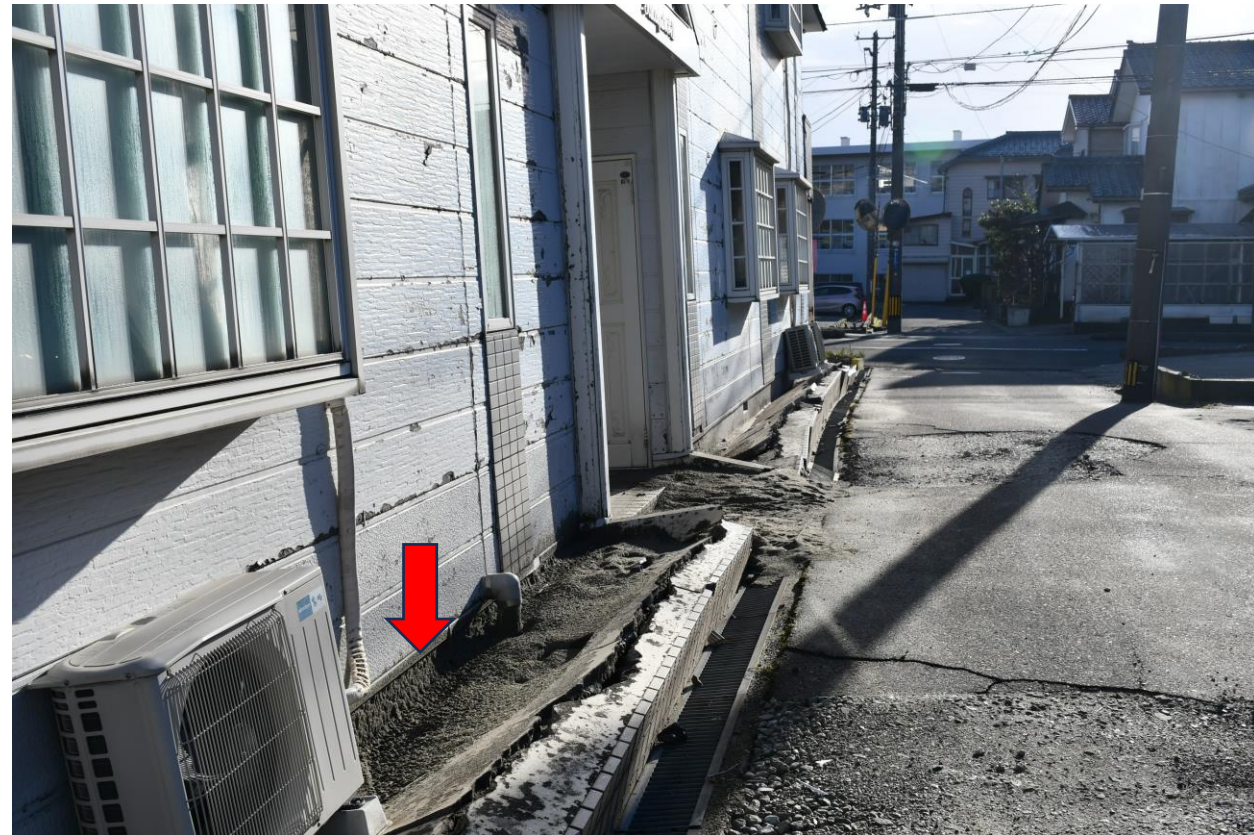
Subsidence and inclination of utility pole and apartments (Map①)

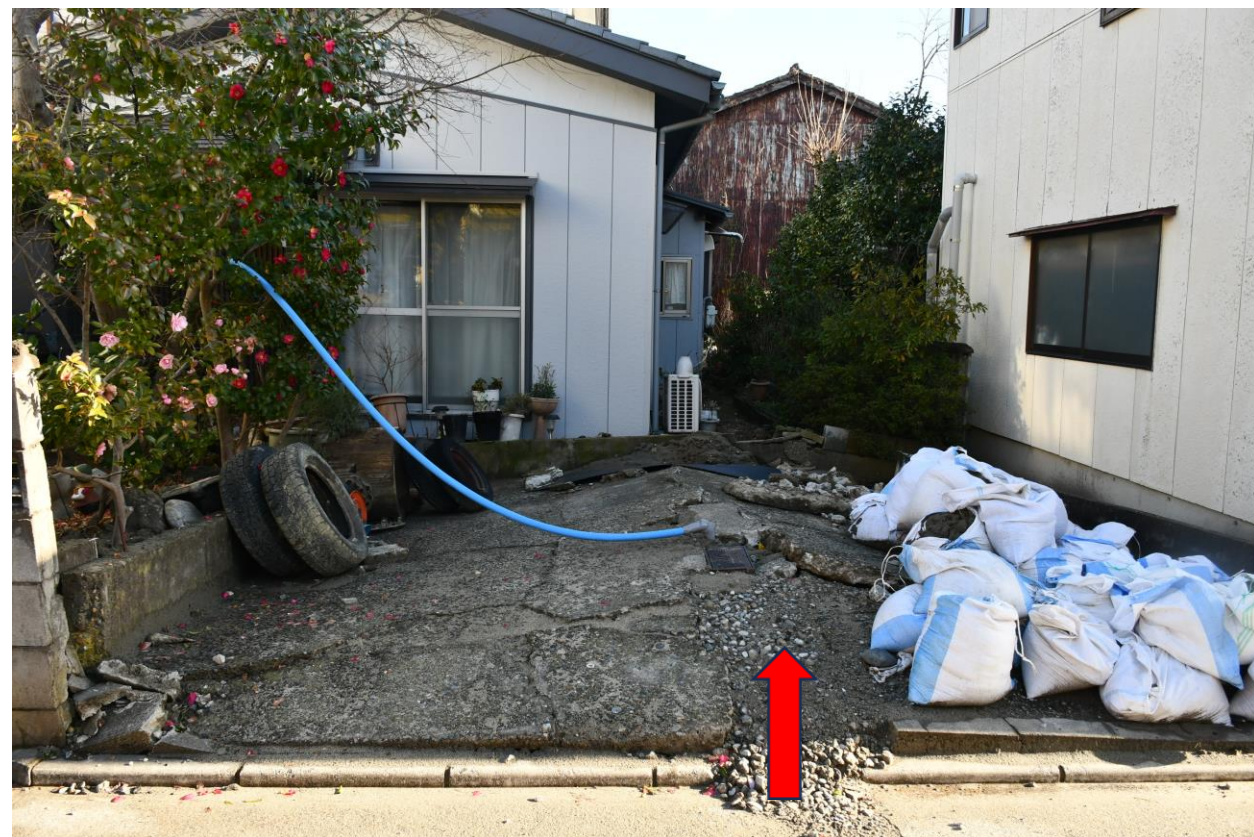
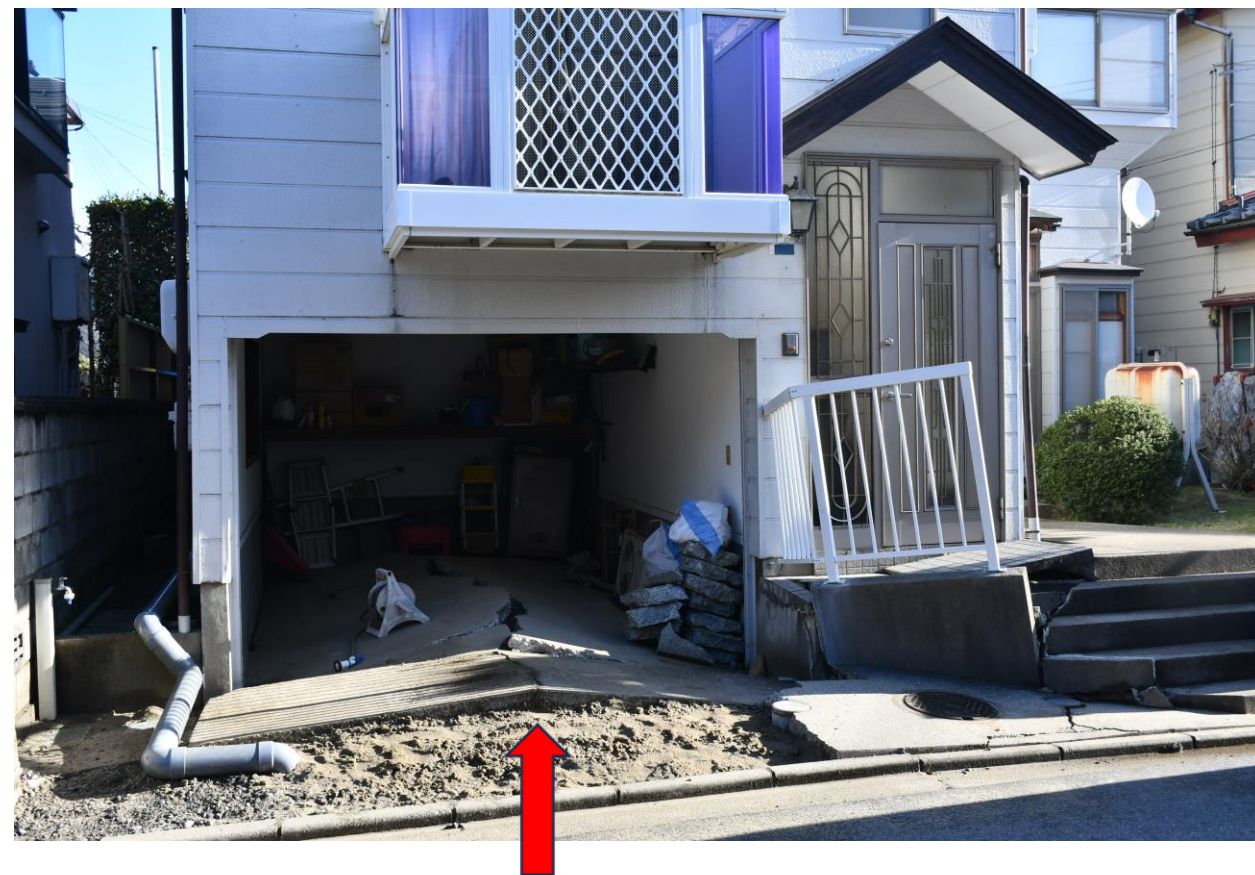
Uplift of the ground due to lateral flow (Map①)

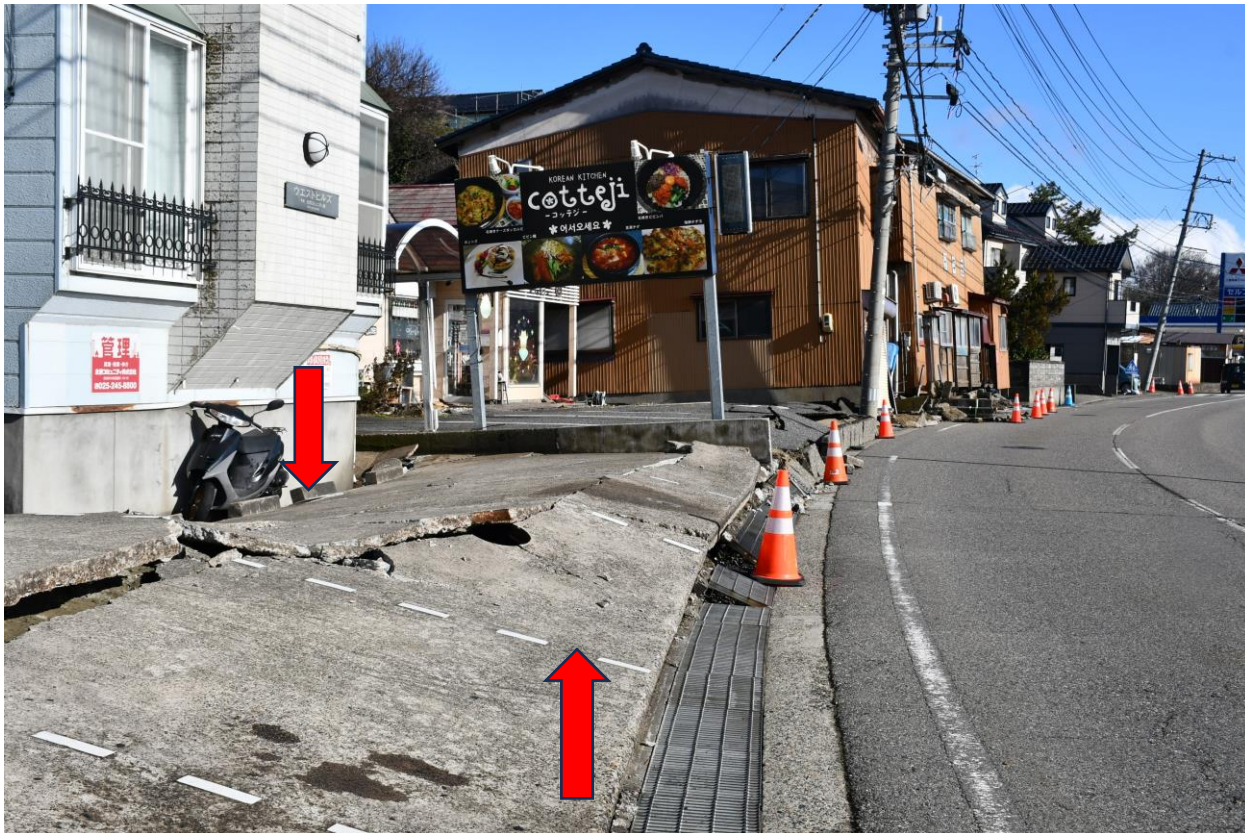
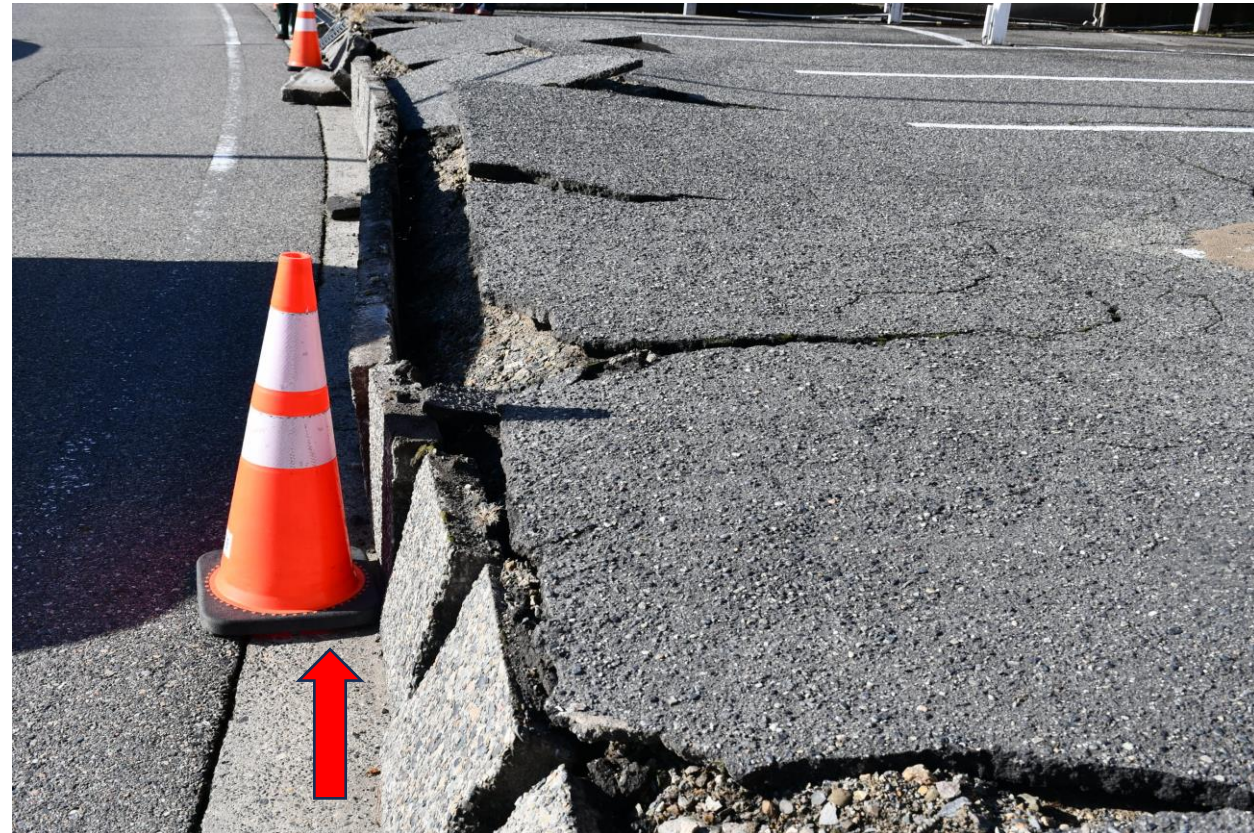
Uplift of the ground due to lateral flow (Map①)

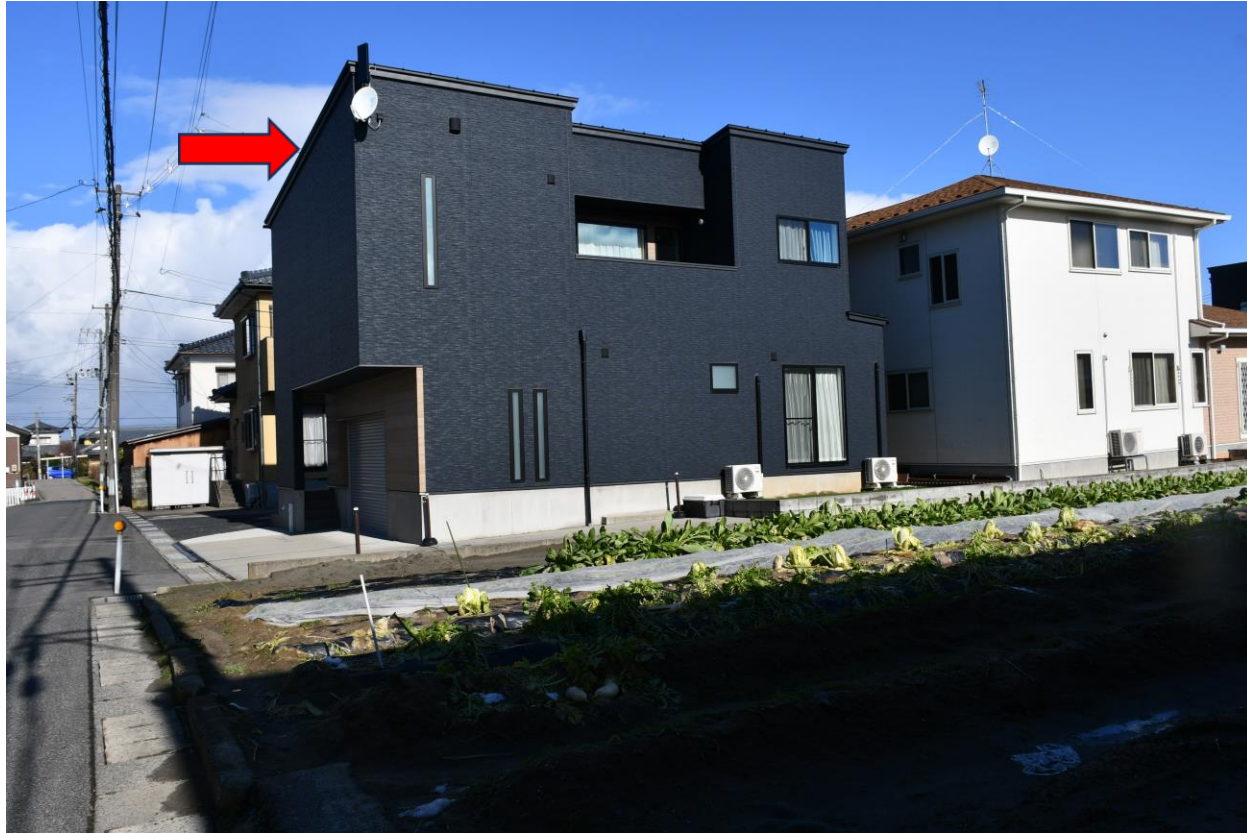
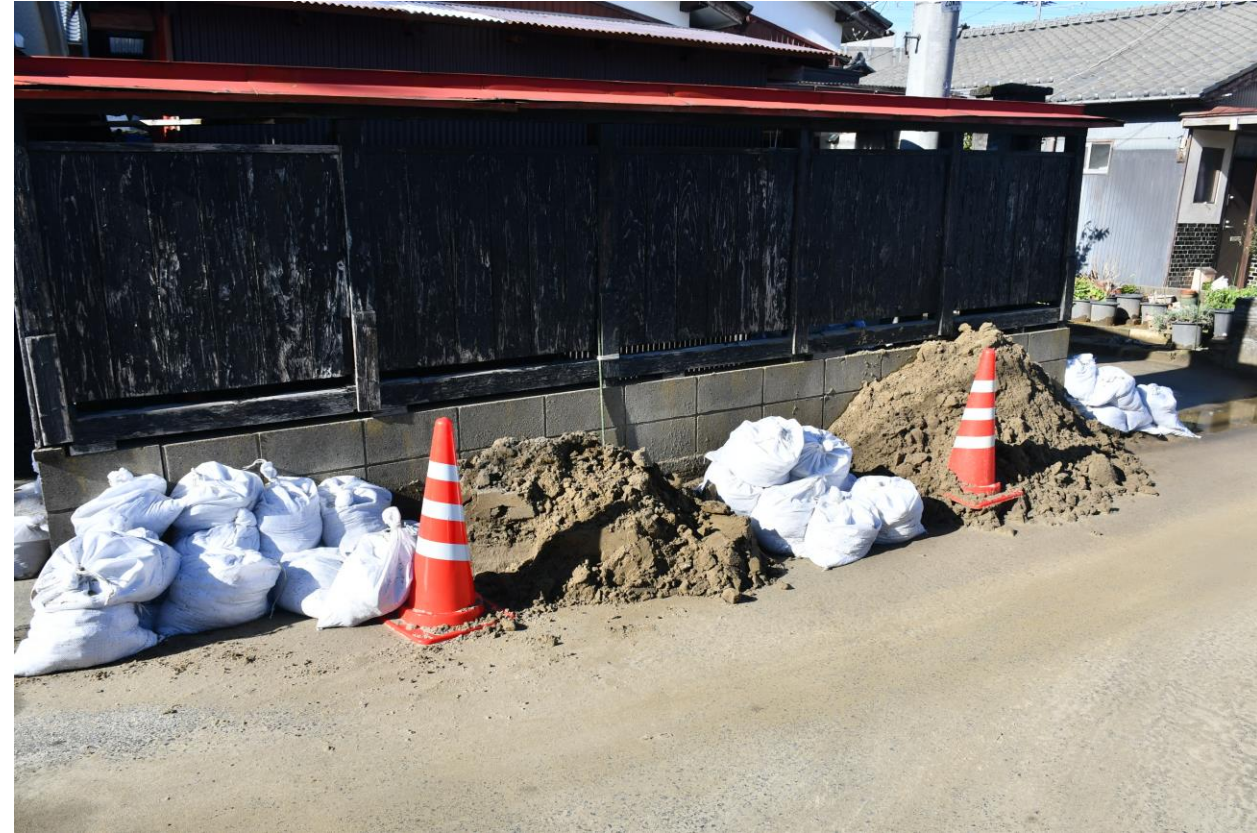
Inclination of houses and large amounts of ejected sand due to liquefaction on flat ground (Map②)
