A Quick Report  
on  
2025 Mandalay-Sagaing (Myanmar) Earthquake

Ömer Aydan

University of the Ryukyus, Okinawa, Japan

3<sup>rd</sup> Draft April 10

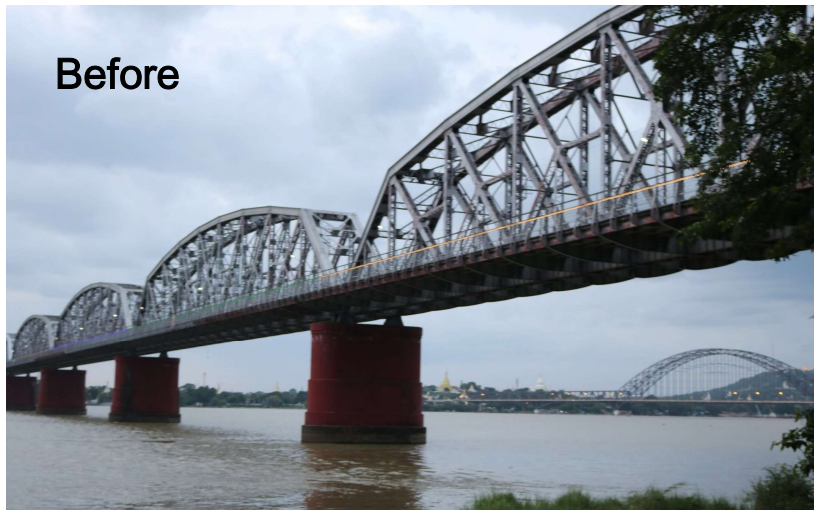
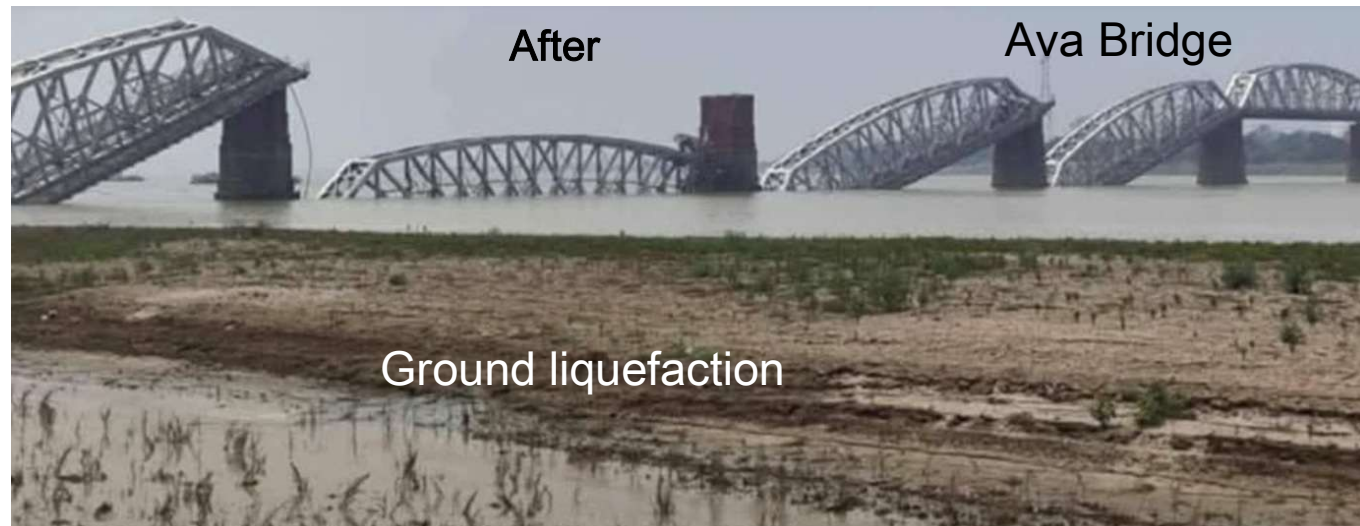
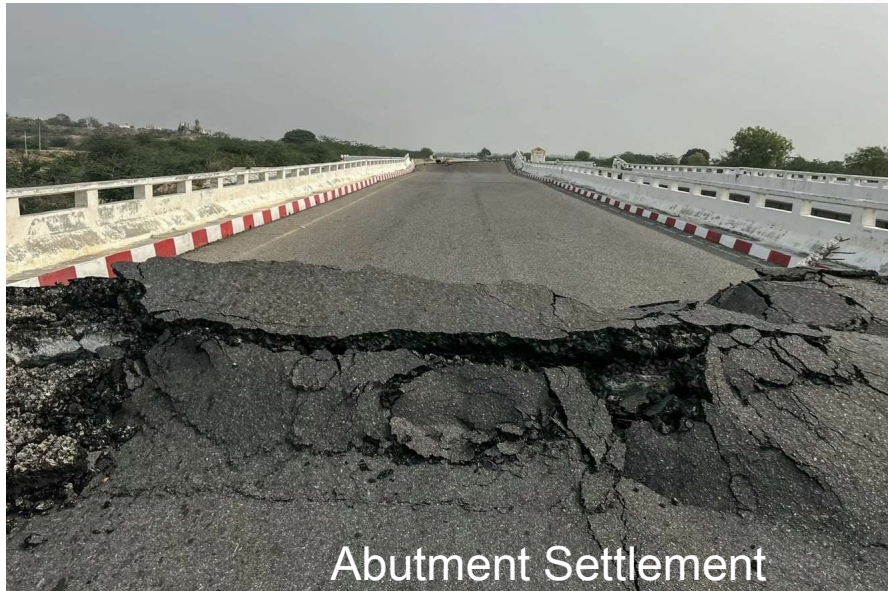
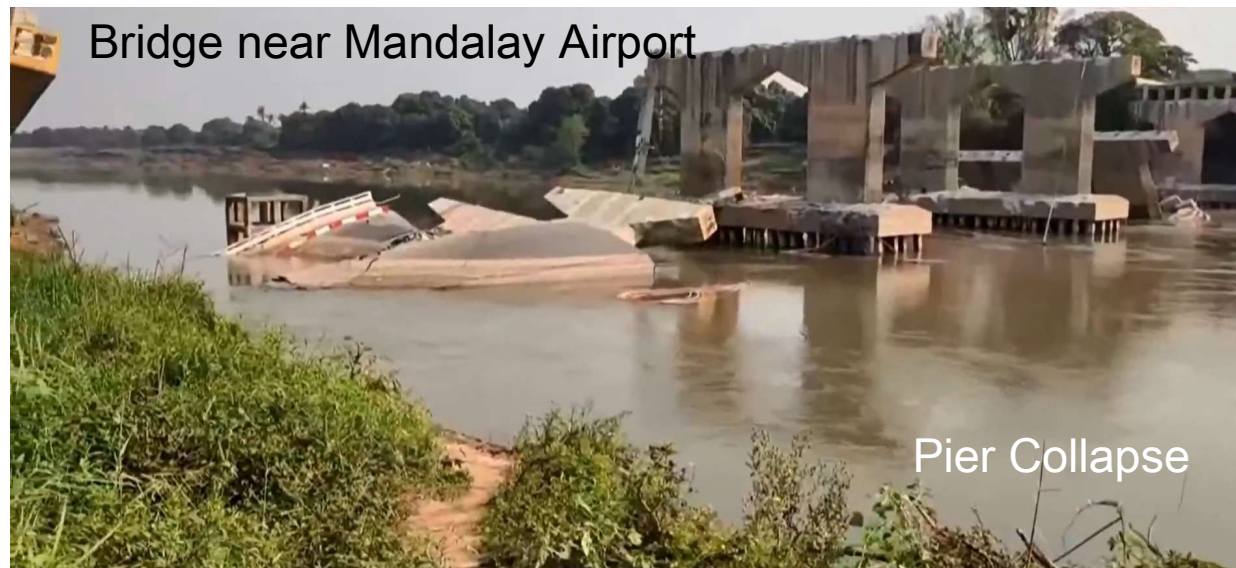
## Bridge Damage and possible causes

- 3) Widespread ground liquefaction occurred for a total length of 500 km. The ground liquefaction may be involved in the collapse of 91 years old colonial Ava Bridge in Mandalay

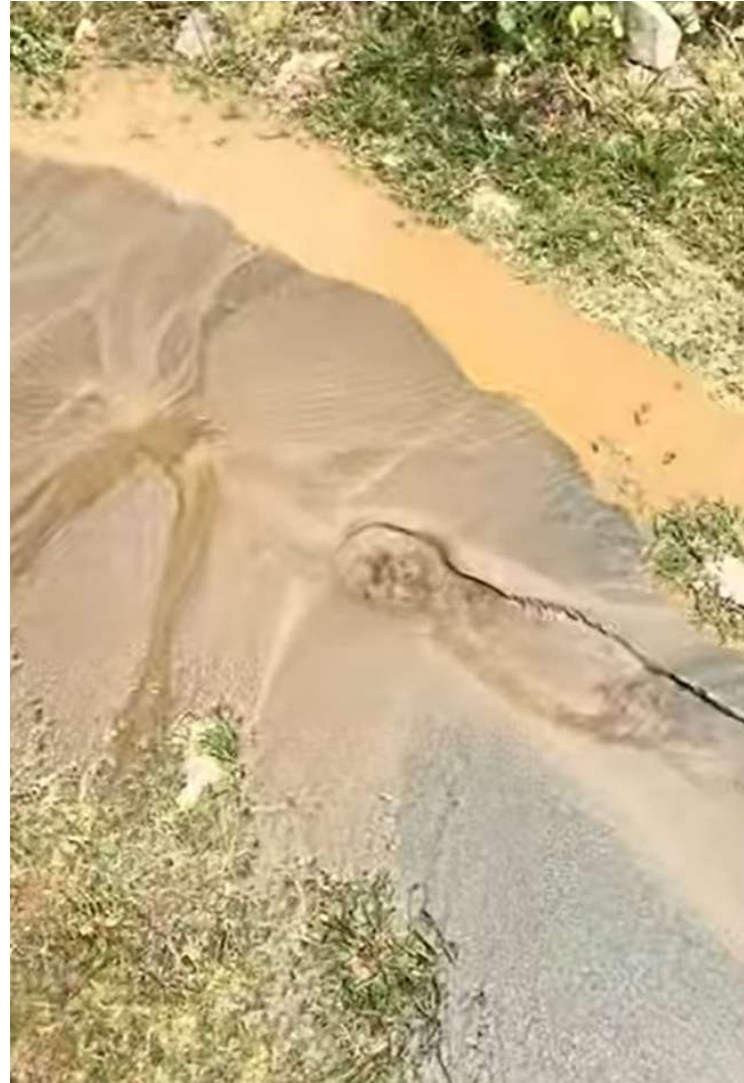
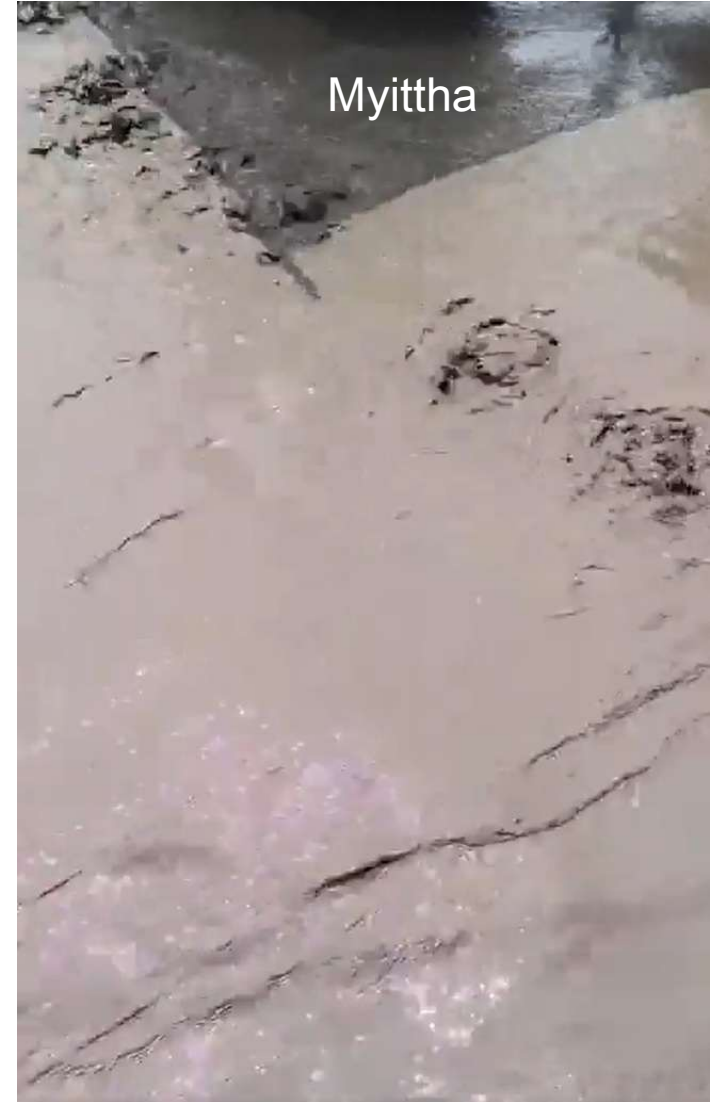
Pyay

Myittha

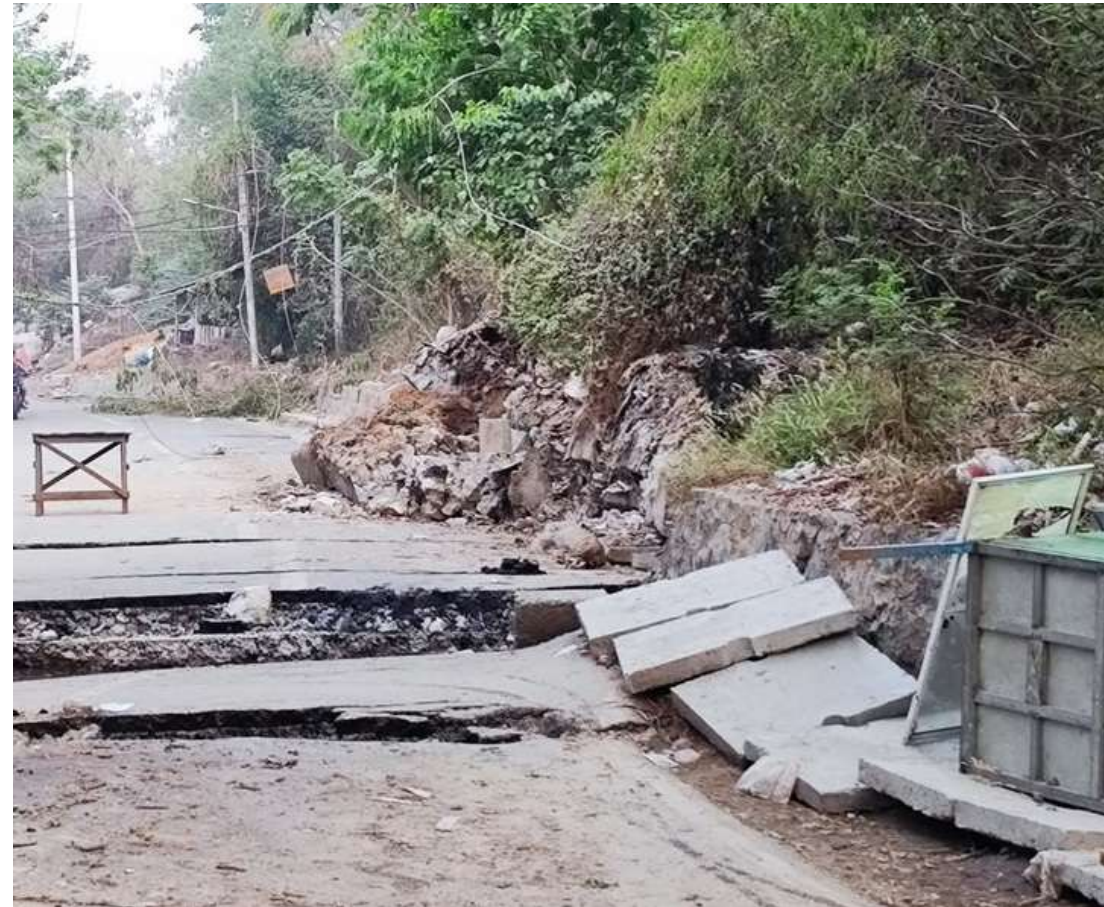
Slope and retaining-wall failures next to fault rupture

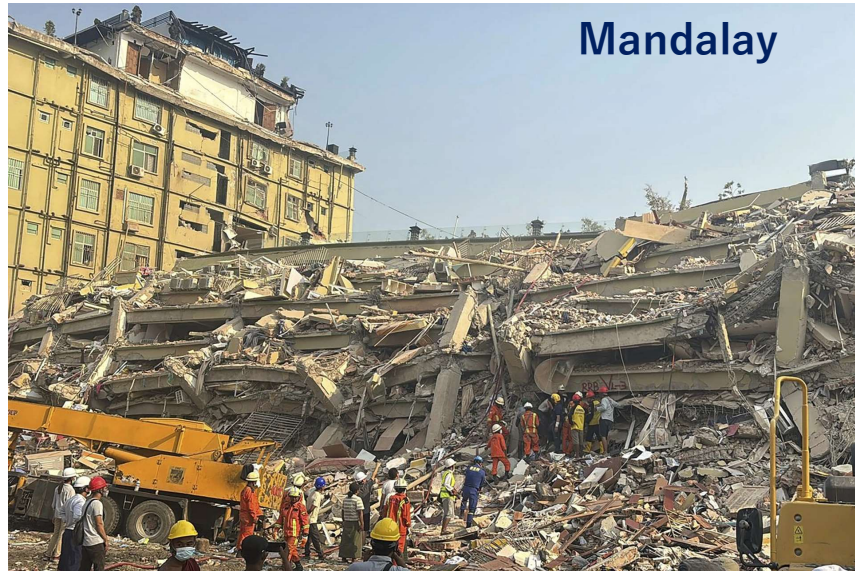
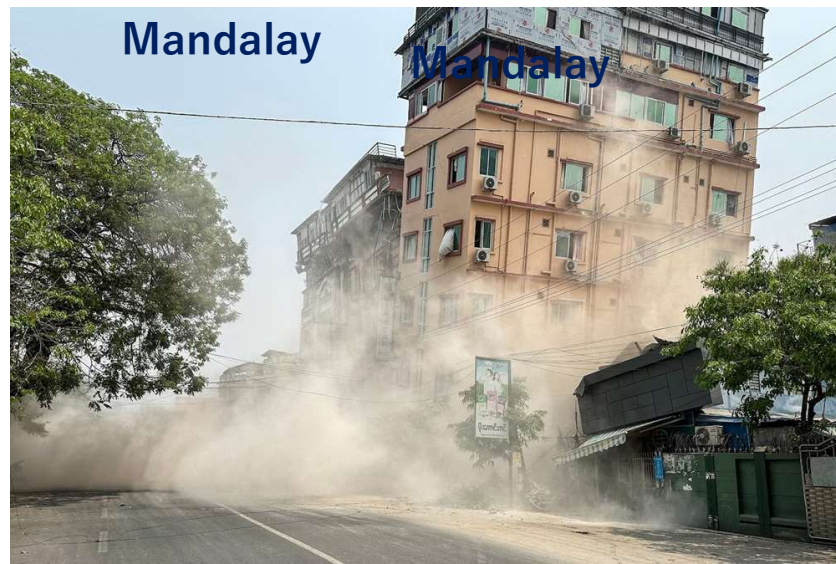
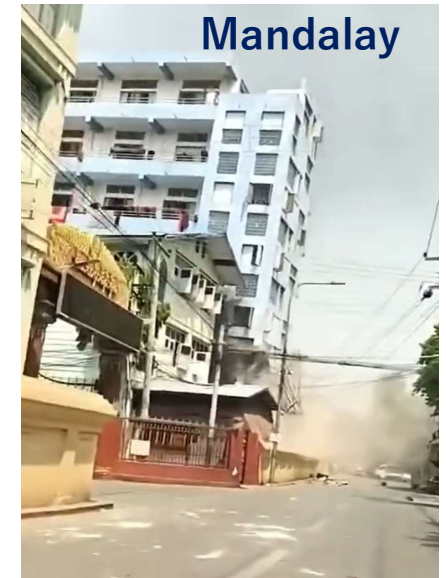
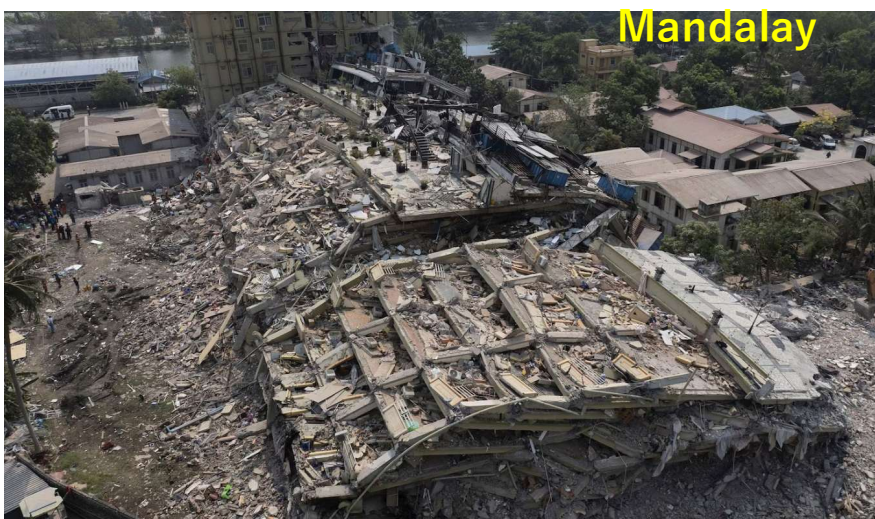
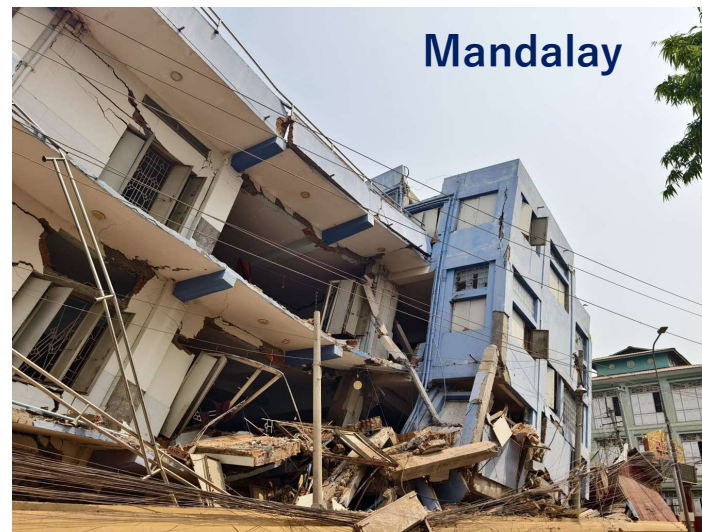
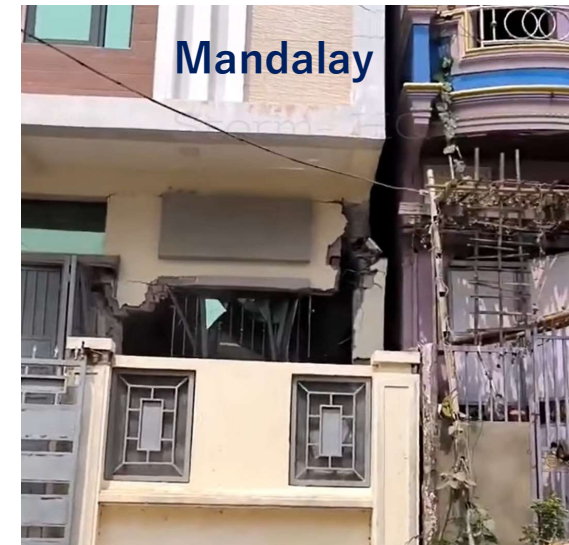
## Building Damage (RC structures)

Soft-floor and pancake modes

- 5) The crustal stress direction is similar to those obtained from the inference from focal plane solutions.
- 6) Many RC structures collapsed due to soft-floor effect at the ground level and poor construction of beam-column connections.

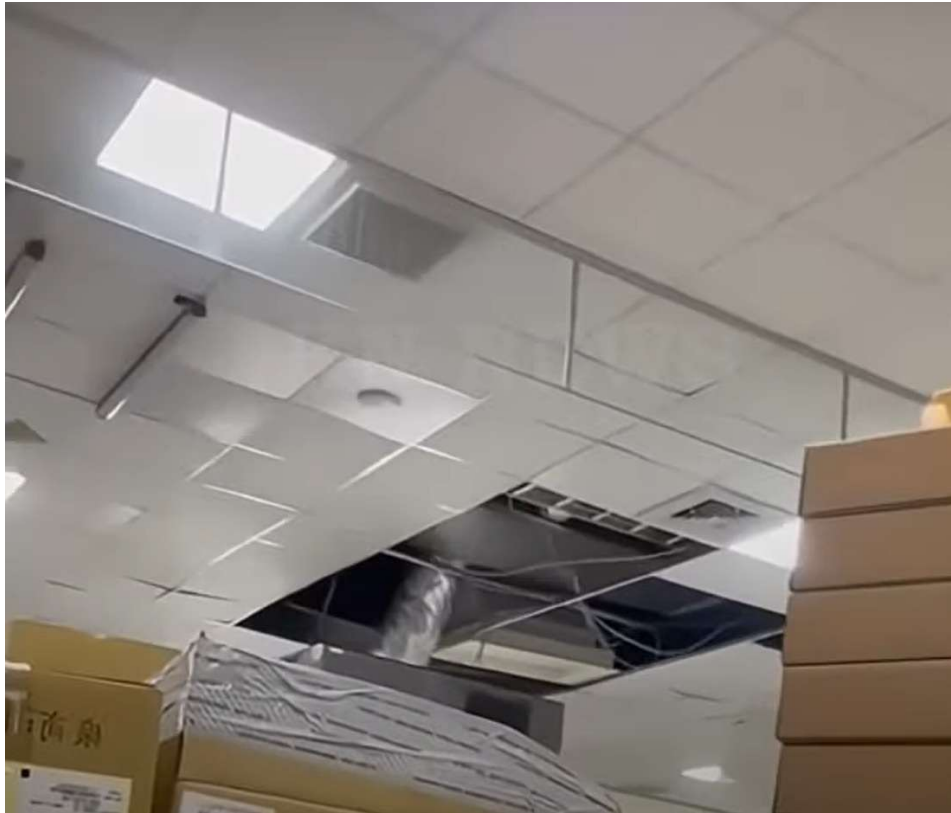
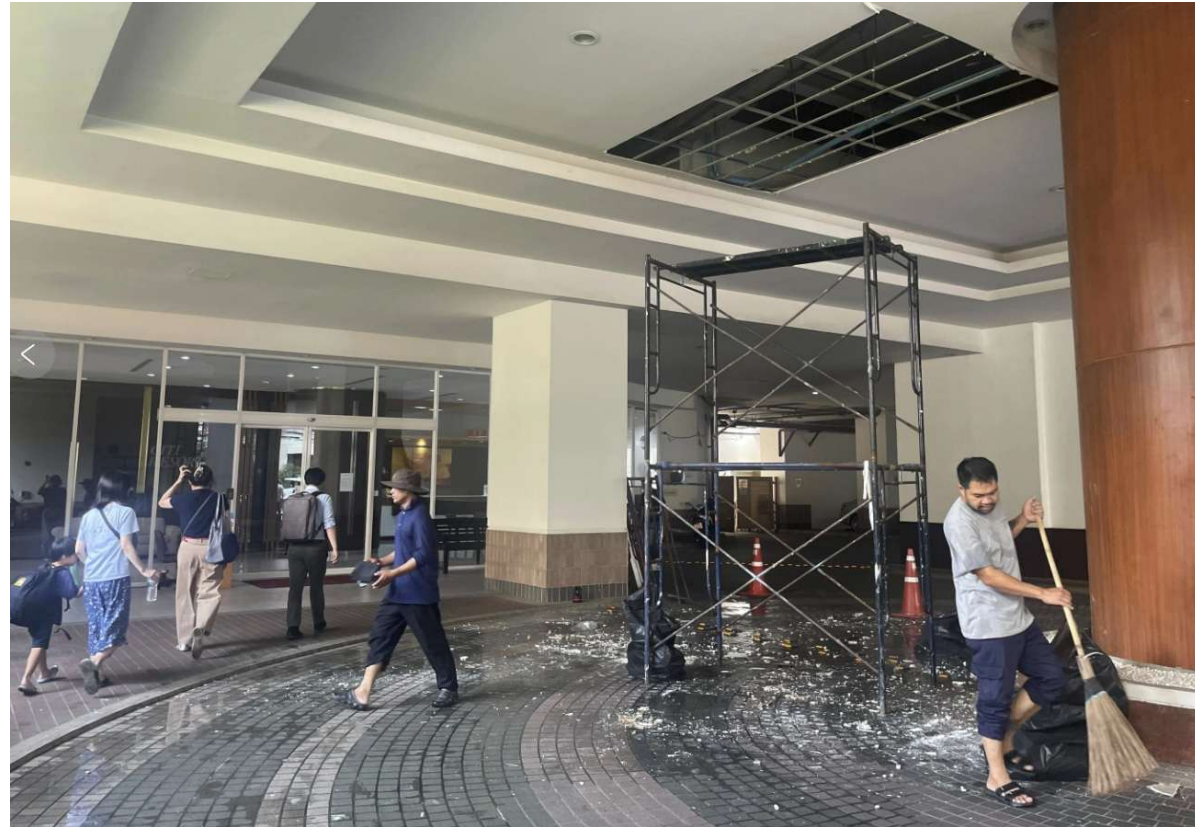
## Interior Damage

Suspended ceiling panles are easily fallen and and it was even observed in 2007 Kameyama earthquake (Mw<6)

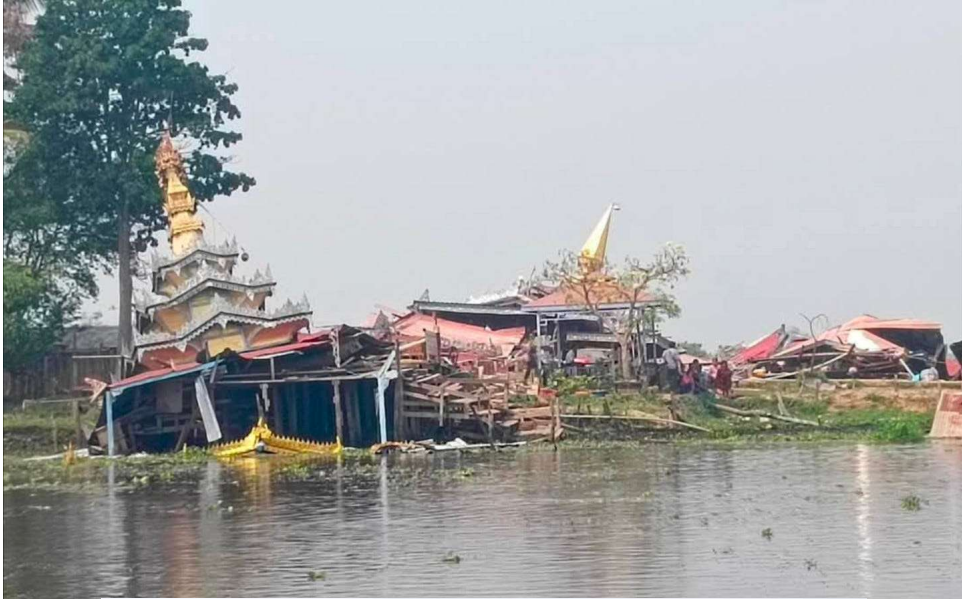
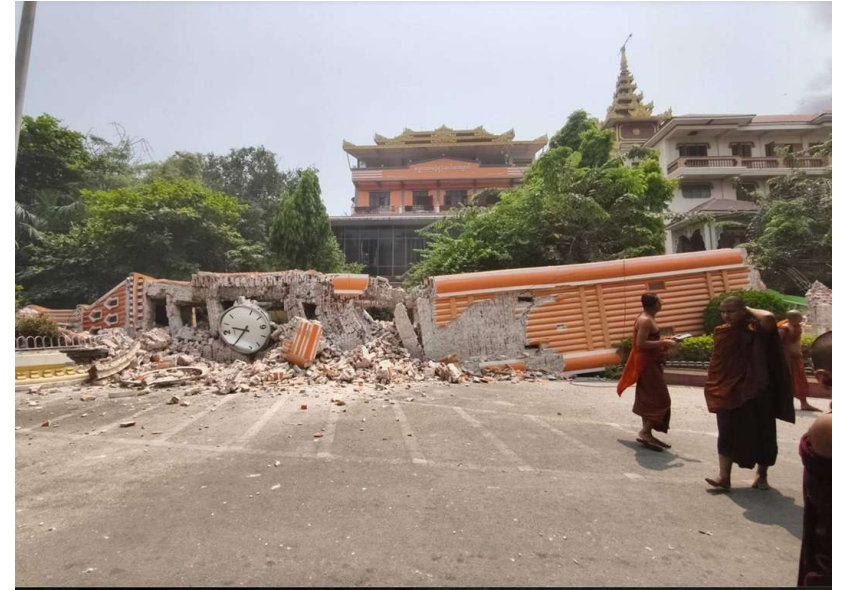
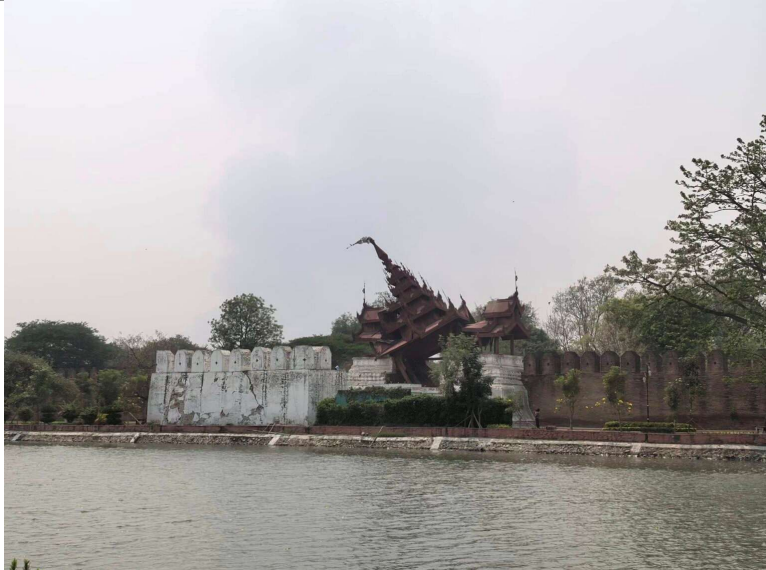
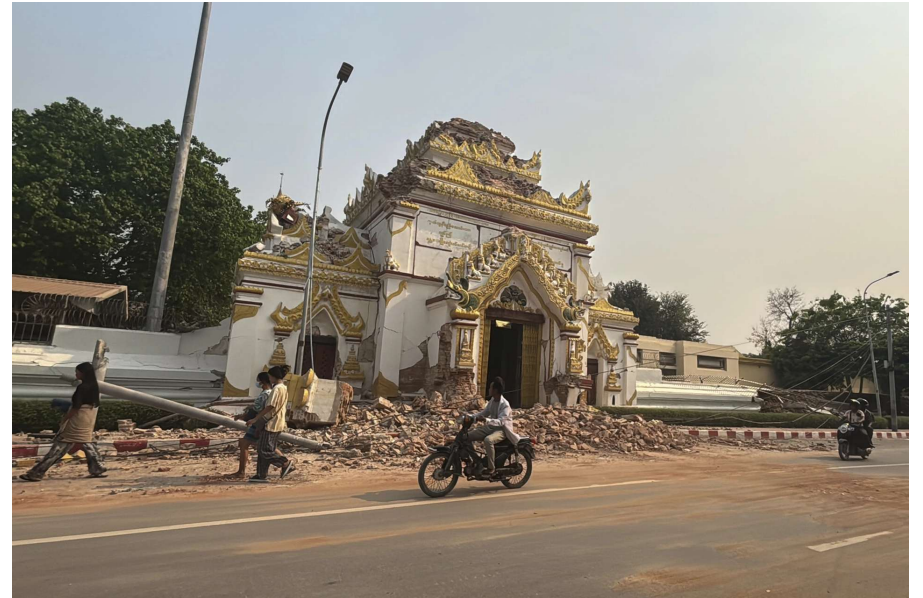
Interblock sliding and toppling failure

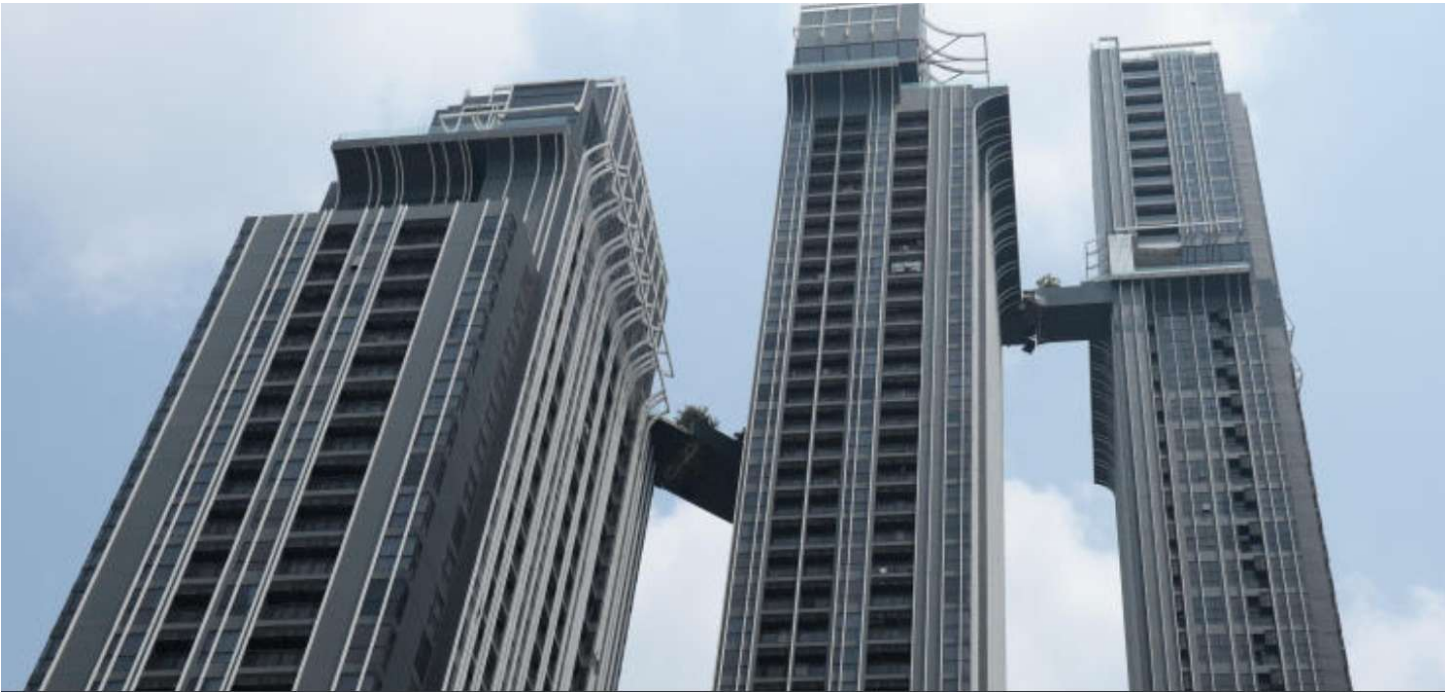
High-rise buildings with connection bridges damaged

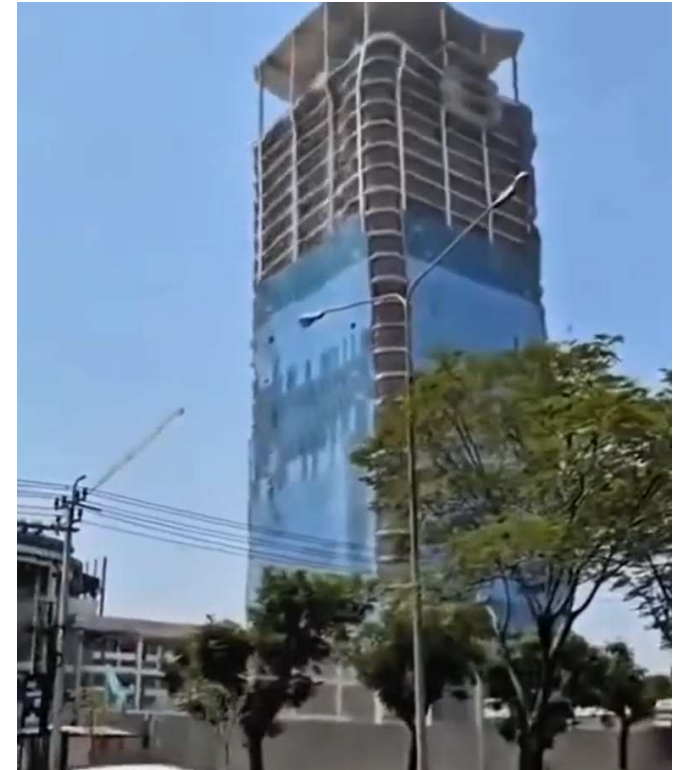
Collapsing 30 floor high-rise building in Bangkok

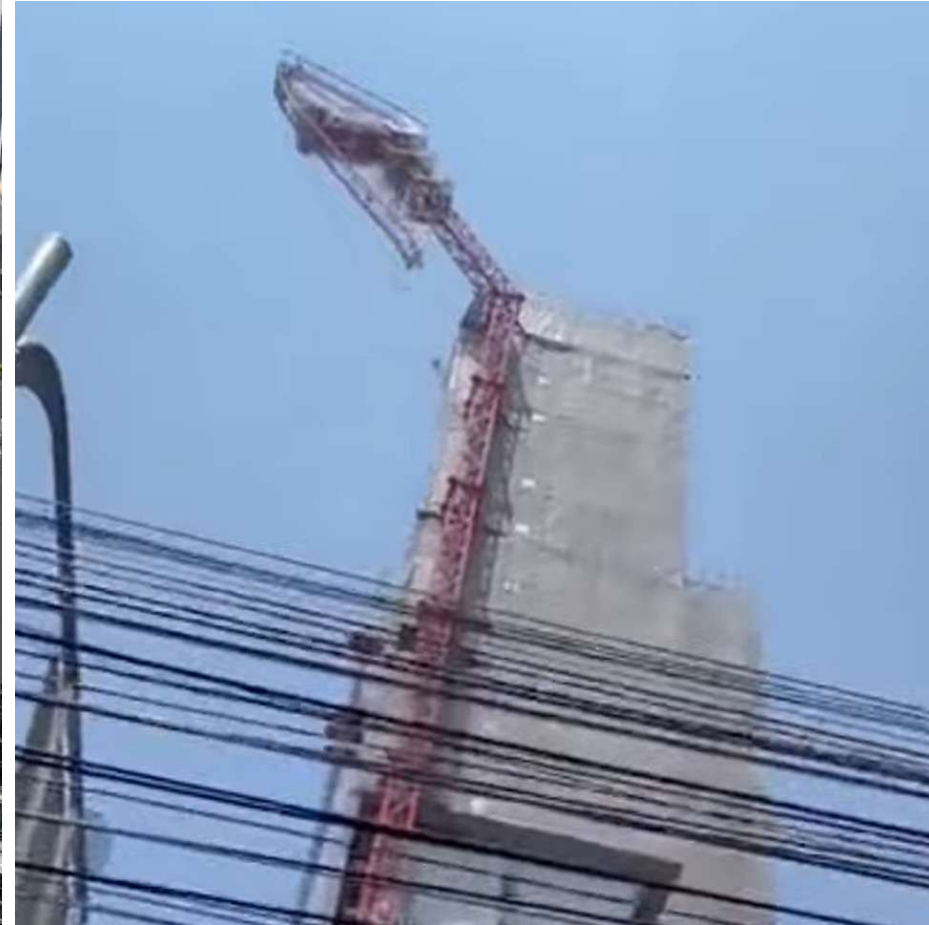
Collapsing construction Crain, Bangkok

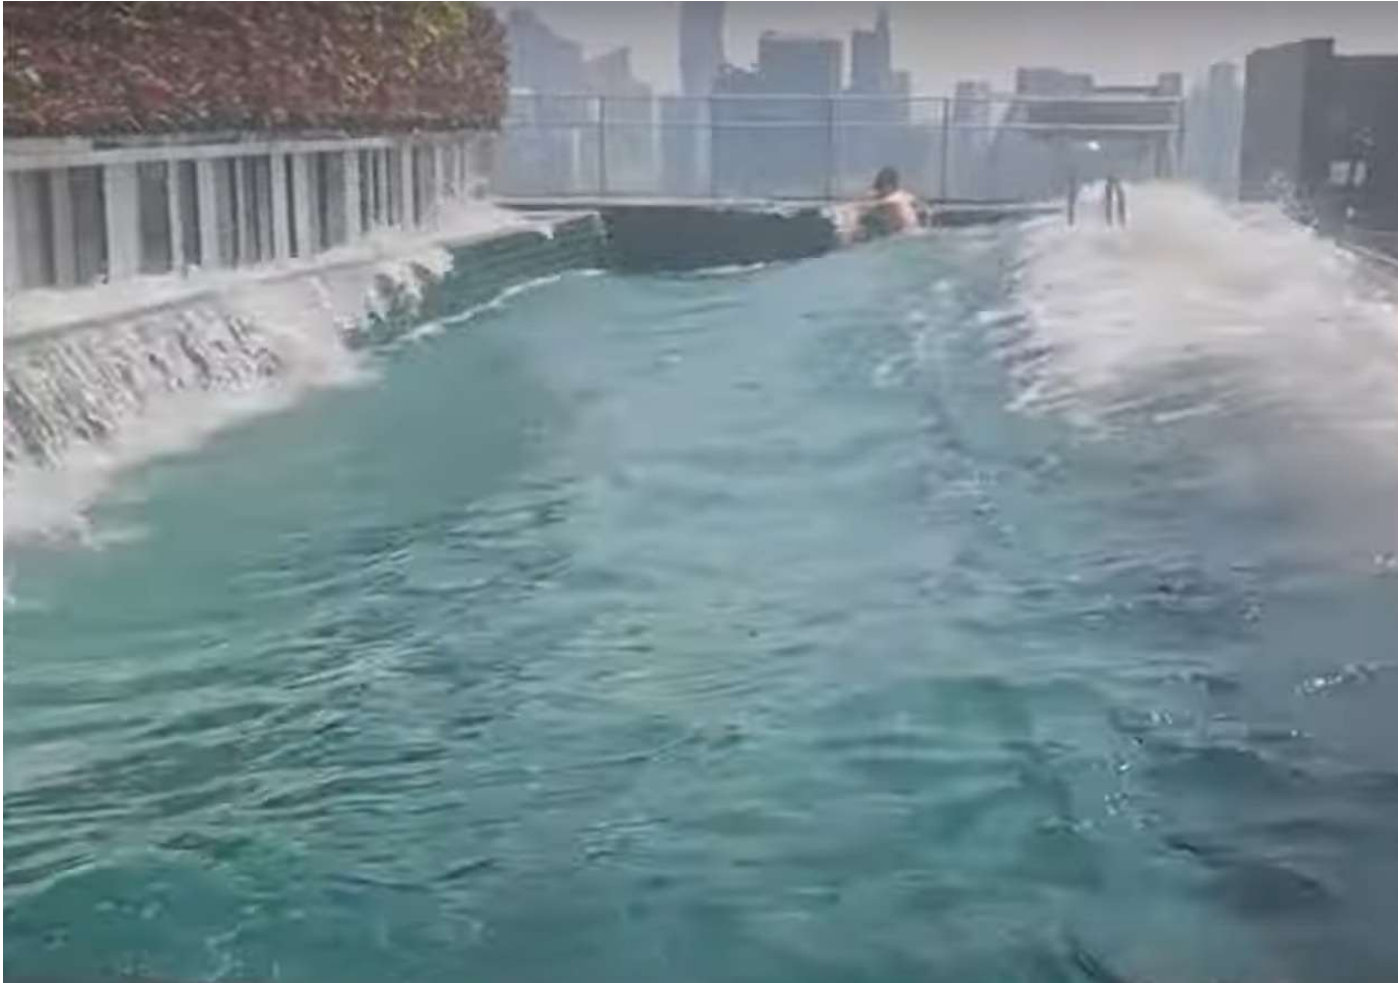
Bangkok

## Sloshing in pools on top of the high-rise hotels

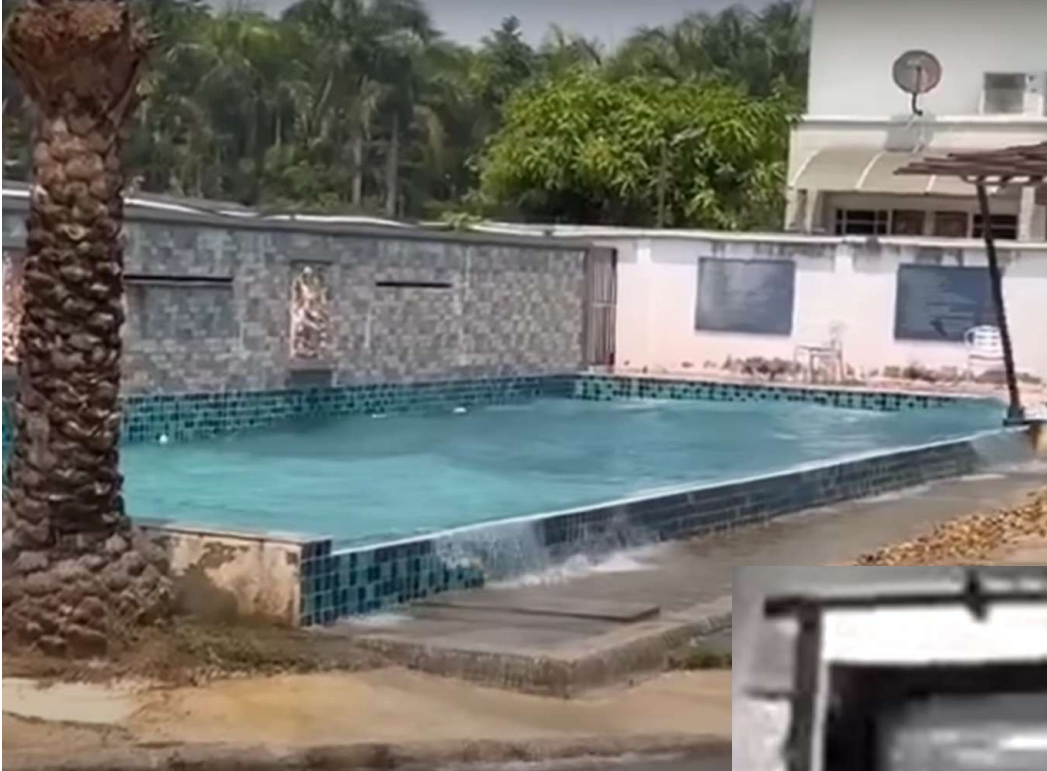
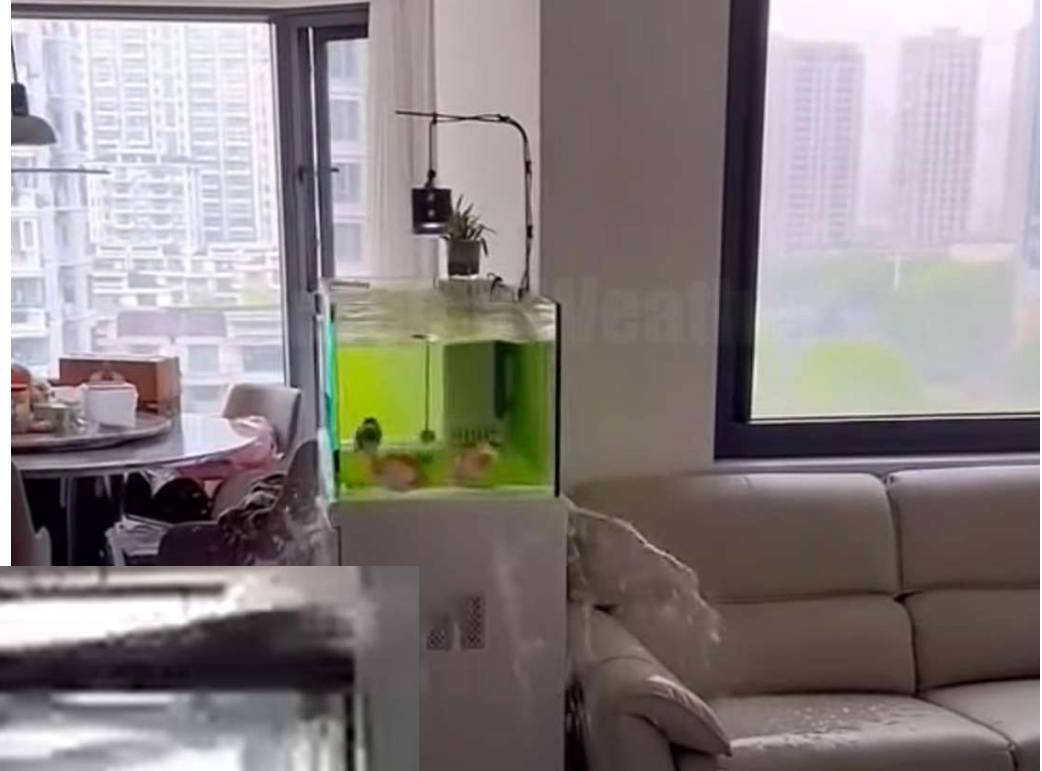
## Sloshing in pools and aquarium, Bangkok

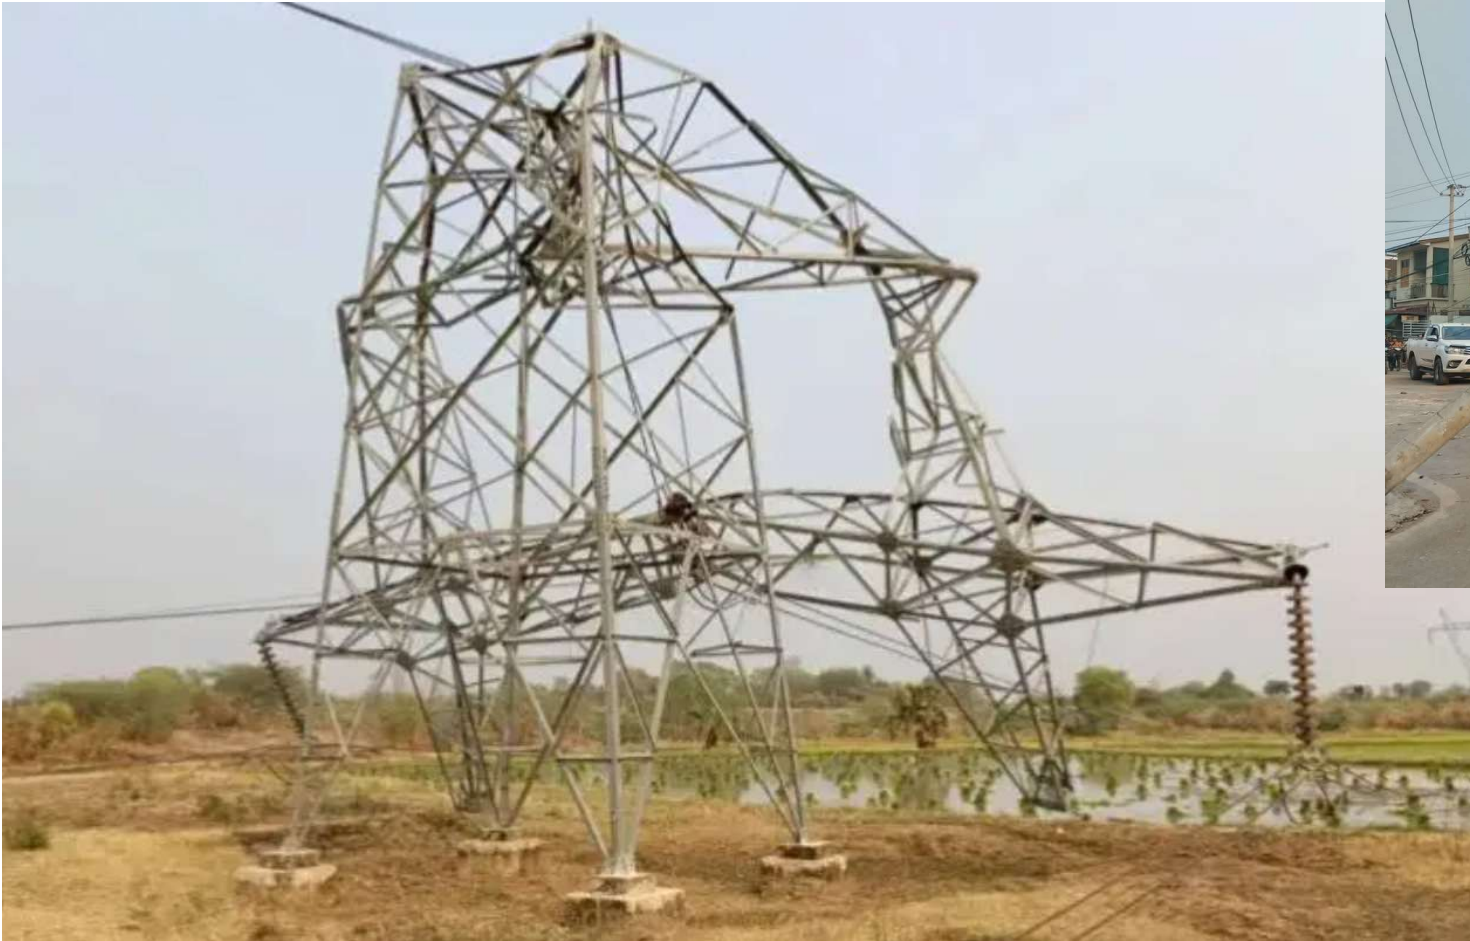
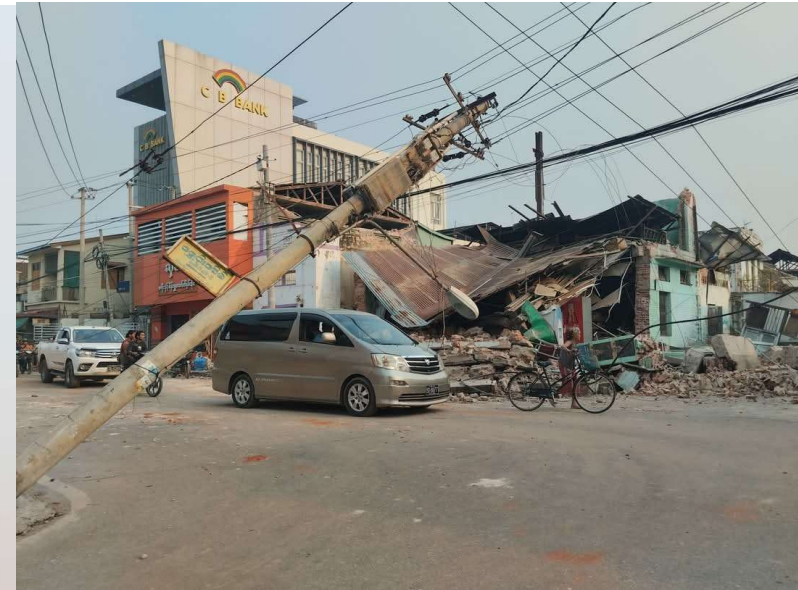
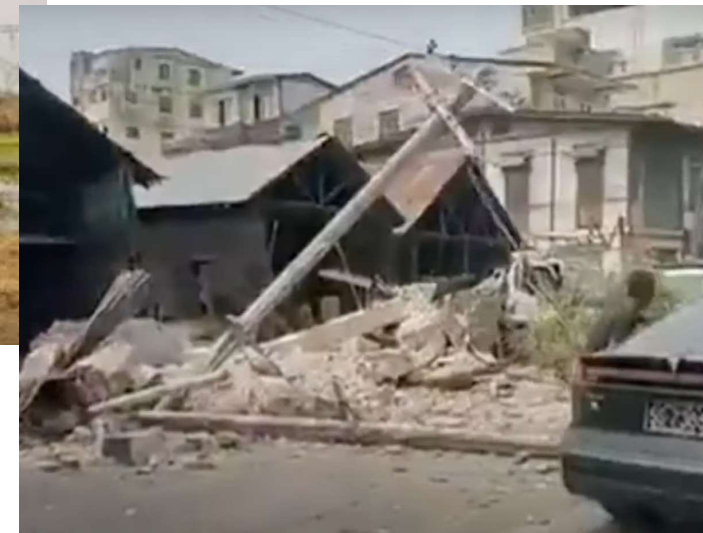
## Damage at Energy Transformation Lines and Utility Poles
