SINKING OF HILL ROAD DUE TO GRAVITATIONAL DEFORMATION AND RATE OF SINKING AT PAGLAJHORA SINKING ZONE IN DARJEELING HIMALAYA IN INDIA

Yoshinori KAWAMURA ¹and Takayuki MAYUMI ²

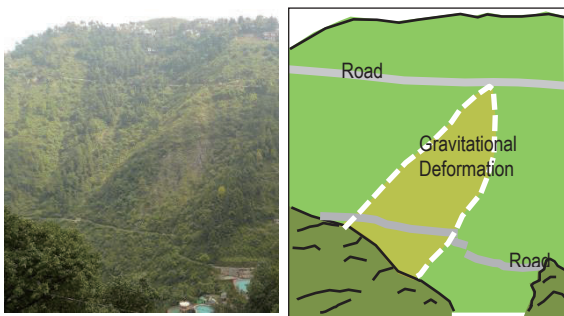
Figure 1 Gravitational Deformation and Sinking of Hill Road in Uttarkhand, India²

In a technical cooperation project in India funded by JICA, Capacity Development Project on Highways in Mountainous Regions, we proposed gravitational deformation be blamed for many sinking sections in the Himalayas², as shown in Figure 1. Gravitational deformation often involves slope failures and rock fall at its toe and flanks as the deformation proceeds.

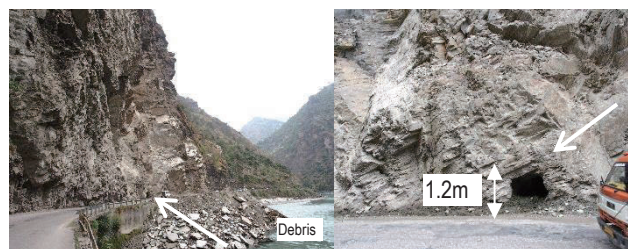
Figure 4 Peculiar Hole with Groundwater at the toe of slope

In India, along hill roads in the Himalayas, deep-seated landslides / collapse involving bed rock are often observed with devastating damage to roads. A massive rock collapse in 2015 at a section of Kulu - Manali Highway (NH21) supports the proposed process in Figure 3. As shown in Figure 4, a large peculiar hole with ground water spring was observed

at the toe of the rock slope, which corresponds to the plane of rupture of the rock collapse. The large hole at the toe is thought to be made by the strong water pressure triggered by the connection of the upper and lower water tables behind the slope when the collapse occurred.

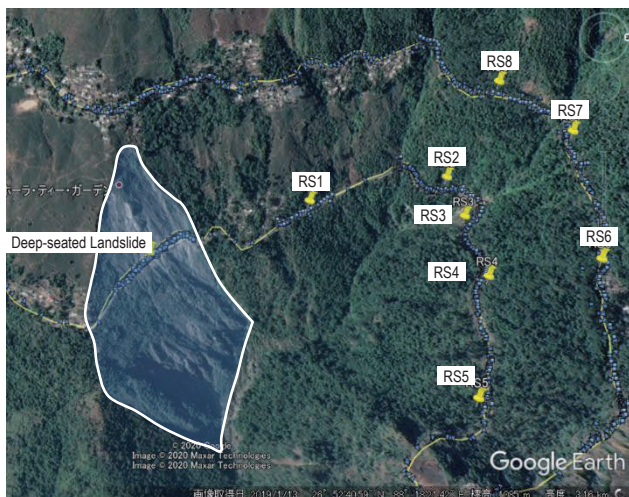
Figure 5 Deep-seated Landslide and Road Sinking in Paglajhora

Paglajhora Sinking Zone includes a trace of a massive catastrophic deep-seated landslide and road sinking sections. Through a study in February 2020, 8 road sinking sections were confirmed as shown in Figure 5.

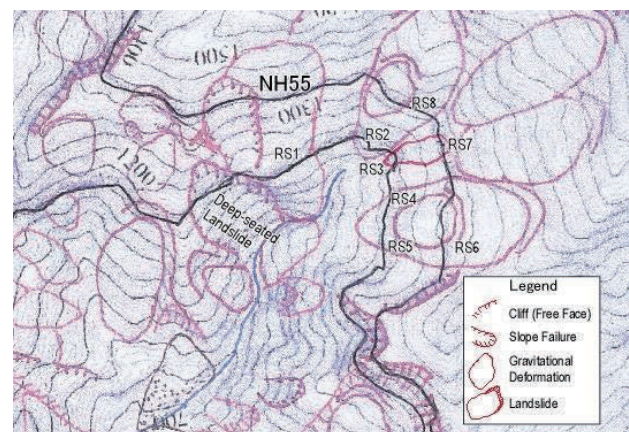
Through map reading, blocks of gravitational deformation are interpreted by extracting topographic features of the deformation²⁾. Figure 6 shows a result of map reading for the site. The 8 road sinking sections in Figure 5 correspond to the gravitational deformation blocks interpreted through map reading.

Figure 6 Map Reading of Paglajhora Sinking Zone

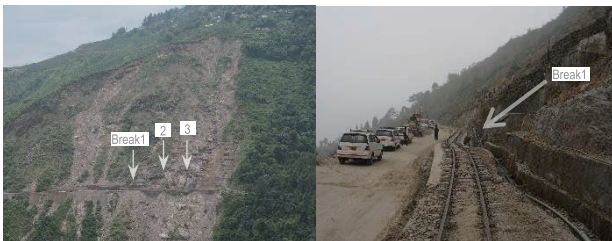
Figure 7²⁾ explains the deformation in three layers. Bending and sinking of NH55 and the railway track of DHR have been observed as shown in Figure 8²⁾.

Figure 8 Deep-seated Landslide (Left) and Bending and Sinking of Highway and Railway Track (Right) in 2017²⁾

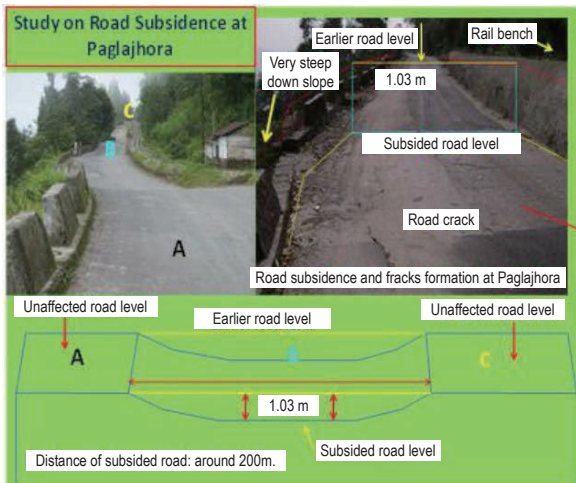
Figure 9 Road Sinking at RS1 in 2009⁹⁾

Before the deep-seated landslide in 2010, the road sinking at RS1 was recorded as 1.03 meters in 2009, as shown in Figure 9⁹⁾. Sujit Mandal reported other records of sinking as 6 ~ 8 meters, 1.42 meters, and 0.95 meters/year, the exact locations of which are, however, unclear⁹⁾.

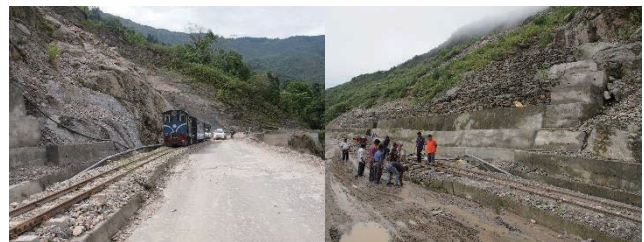
Figure 11 Photos in May (Left) and August (Right) in 2016

The photo in May 2016 in Figure 11 is right after the reopening of NH55 and DHR and that in August 2016 is during the first monsoon after the reopening.

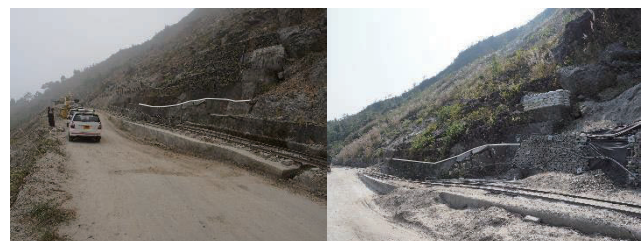
Figure 12 February 2018 (Left) and February 2020 (Right)

On the other hand, by comparing the photos in 2018 and 2020 in Figure 12, focusing on the top lines of the retaining wall indicated by the white lines, the rate of sinking in two years is roughly estimated as around 10 cm / year or more. Thus rough rates of sinking at Paglajhora deep-seated landslide may be around 10 cm / year or more.

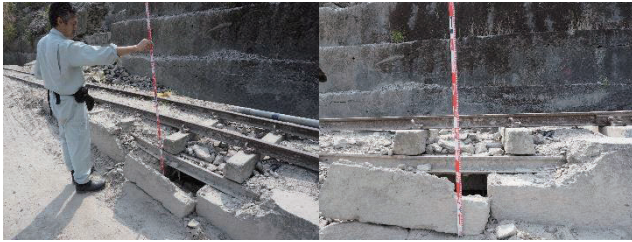
Figure 13 Raised Railway Track of DHR (H=20cm)

As shown in Figure 13, the foundation of the railway track was found partially broken in February 2020, through which abandoned railway track was found. The raised height is 20cm. From the situation, the abandoned track should be the one in the reopening in 2016 and the raised one should be laid before February 2018. The minimum rate of sinking is, therefore, estimated as 10 cm / year or more.

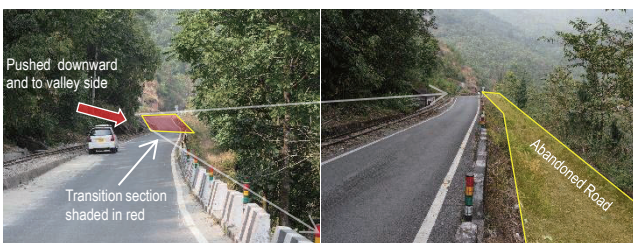
Figure 14 Transition Section of RS1 (2020)

At the transition section, as the downward movement of gravitational deformation proceeds, horizontal alignment of NH55 is also pushed to valley side, as shown in Figure 14.

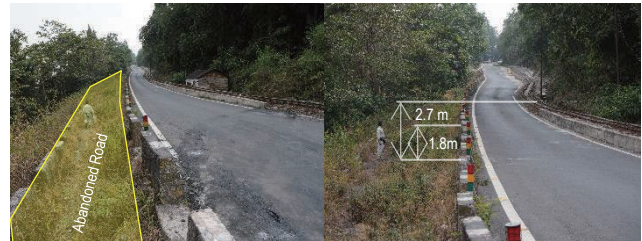
At RS1, as shown in Figure 15, an abandoned road was found on the valley side, which connects to the current NH55 at the boundary with the stable section, as shown in Figure 14 on the right.

road sinking is possible. From Figure 15, the height between the railway track of DHR and old NH55 is estimated to be around 2.7 meters. (The man in the photo is 180cm tall). The difference between the stable and sinking section in Figure 9 is roughly 1.0 meters. Thus the amount of sinking from 2009 to 2020 is around 1.7 m, which leads an estimated sinking rate of around 15 cm / year.

Figure 15 Height Difference between Old and New NH55 (2020)

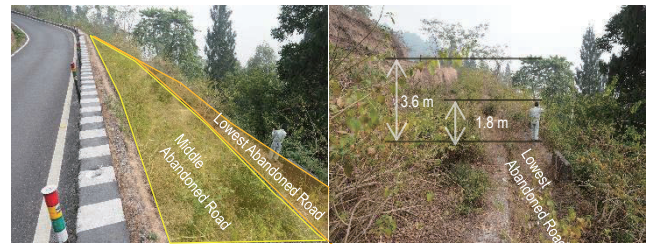
At RS4, at least 2 layers of abandoned roads were found along the current NH55 as shown in Figure 16.

Figure 16 Abandoned Road of NH55 at RS4

The height from the lowest abandoned road to the current NH55 is around 3.6 meters. Unfortunately, we have no certain data when the lowest road started sinking. The volume of sinking estimated from the abandoned road is of noteworthy, however.

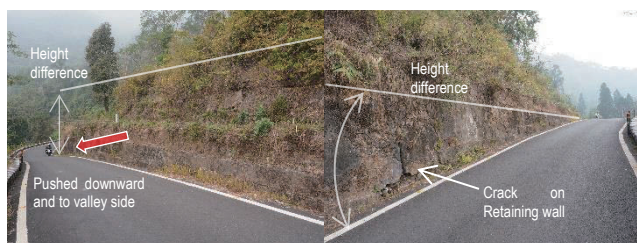
Figure 17 Transition Section on East End of RS4

Similar to the volume of sinking, as shown in Figure 17, the height difference at the transition section on the east end is also large. Cracks on the retaining wall along the road are often observed, along with horizontal deformation toward valley side.
