SHAKING-INDUCED DAMAGE TO BUILDINGS BY M 9.0 EAST JAPAN MEGA EARTHQUAKE ON MARCH 11, 2011

April 17, 2011

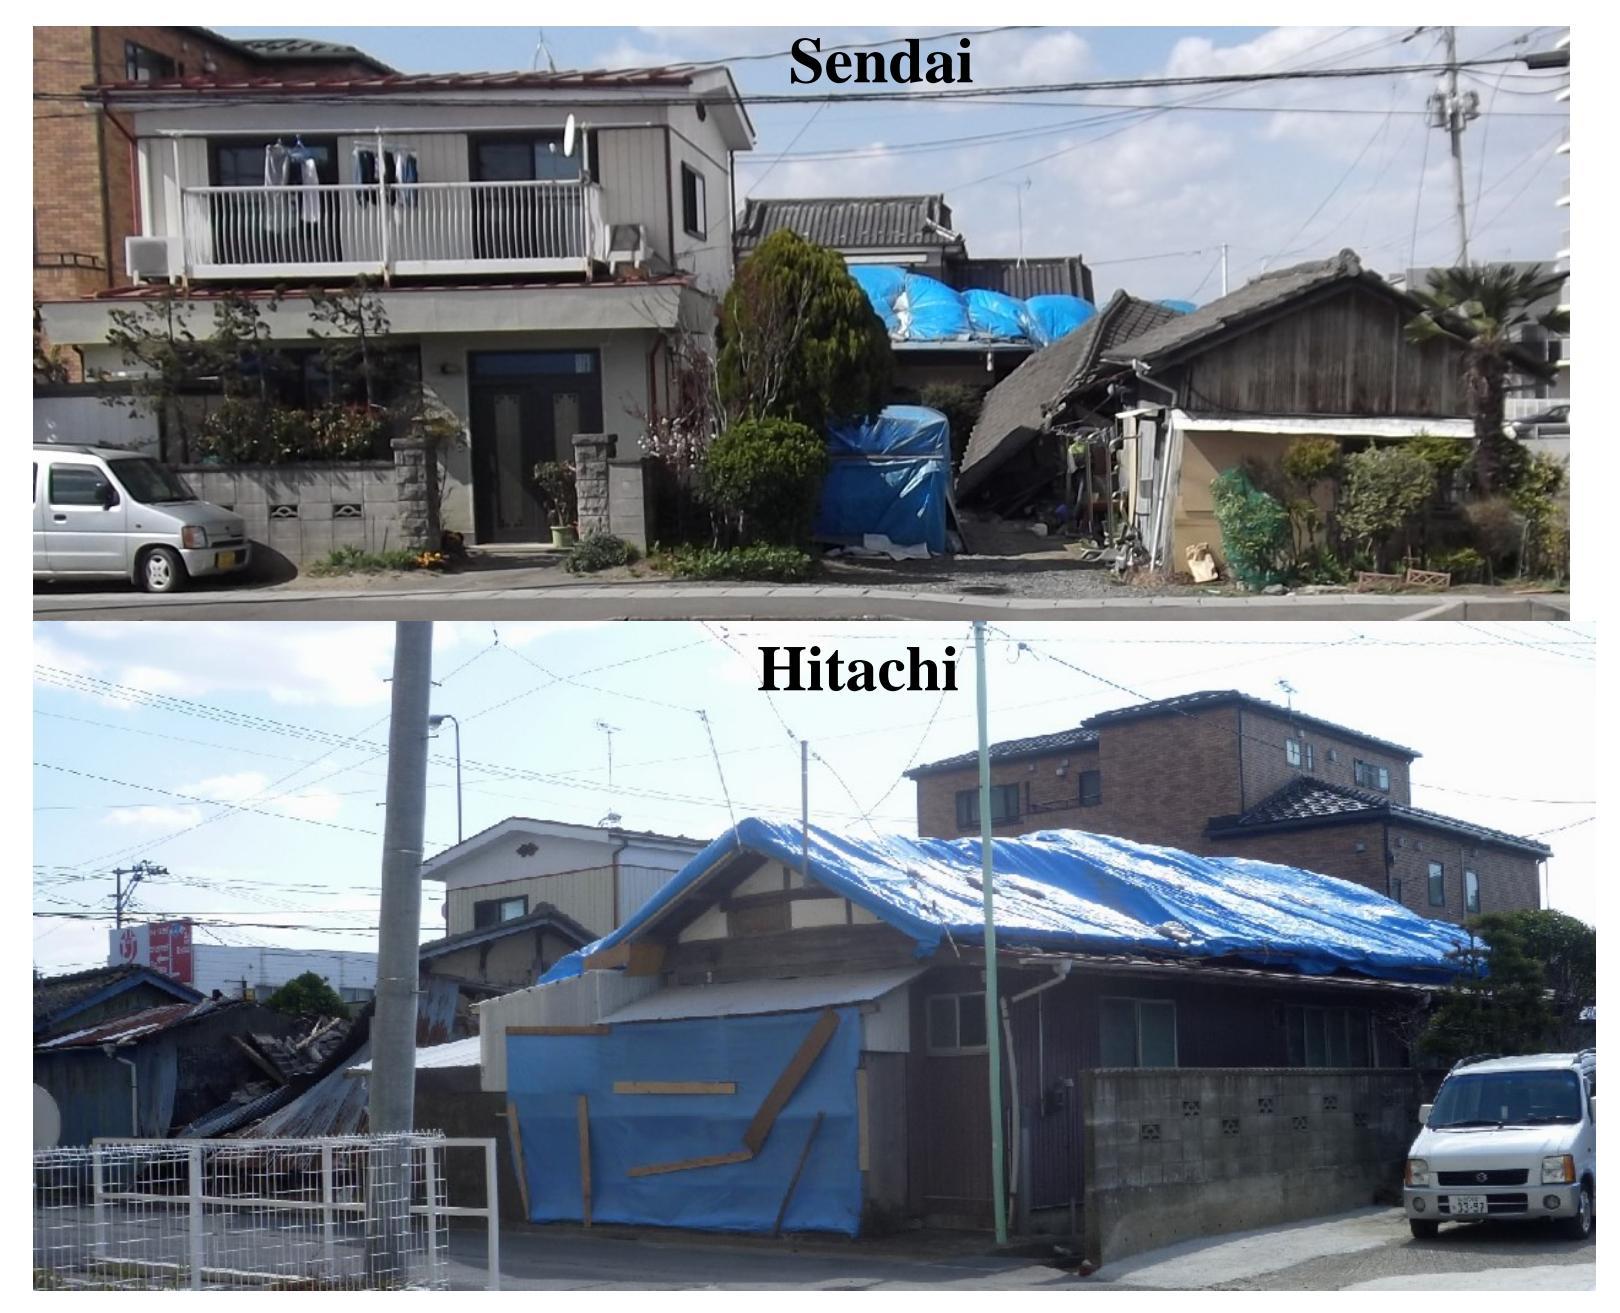
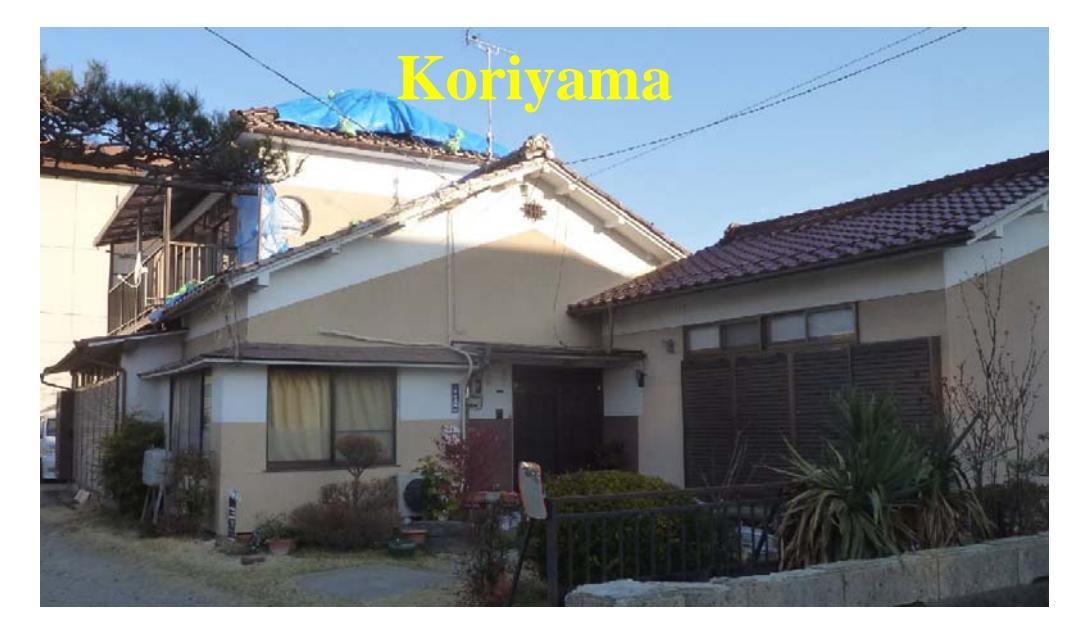
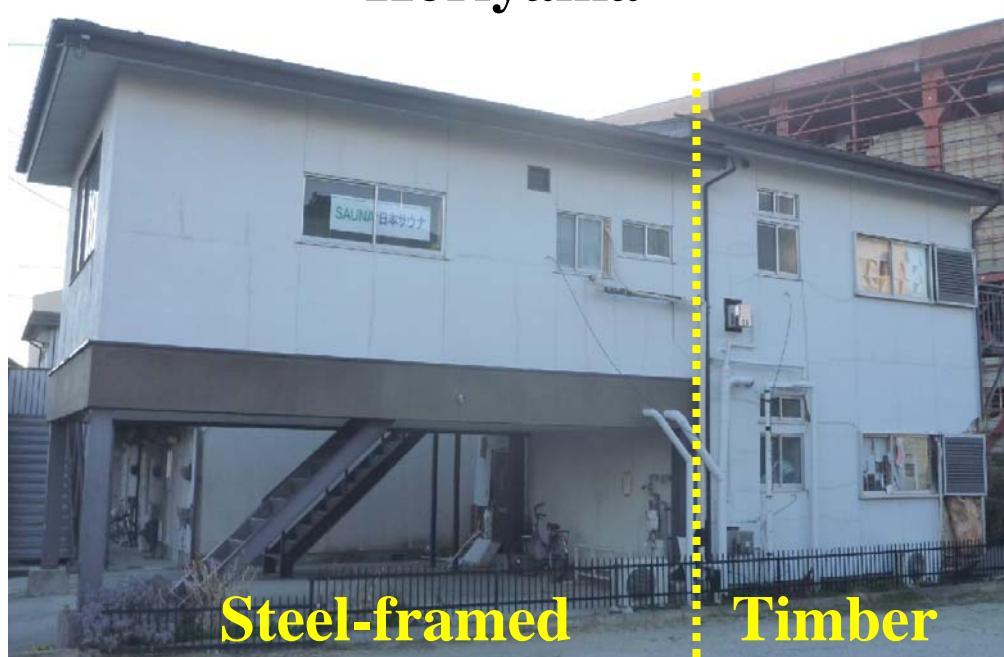
Koriyama

Very old timber houses are generally collapsed.

Damage is generally limited to roof with tiles (kawara).

Timber residential houses performed well against ground shaking.

Damage to timber houses occurred built on a soft ground or nearby creeks or rivers.

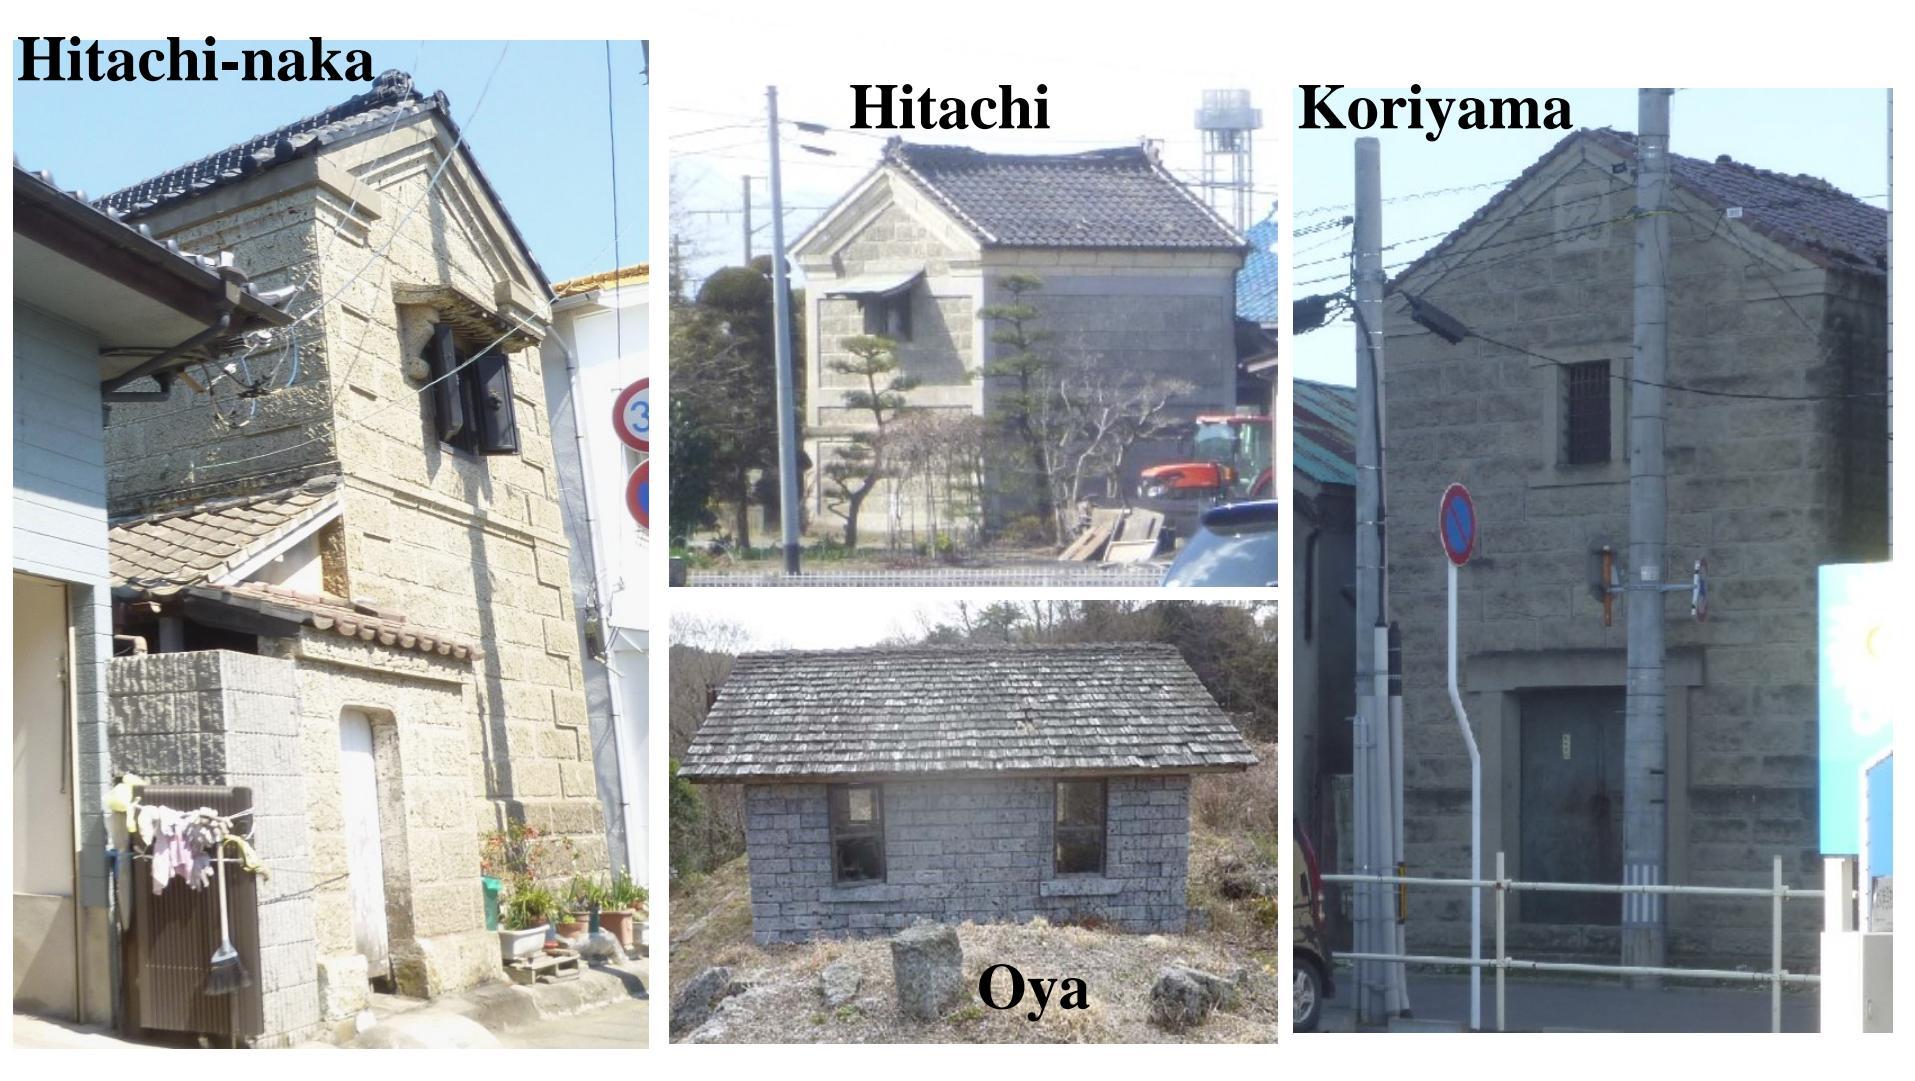
Damage is generally limited to roof with tiles. As the number of masonry buildings are few, no major collapses were observed

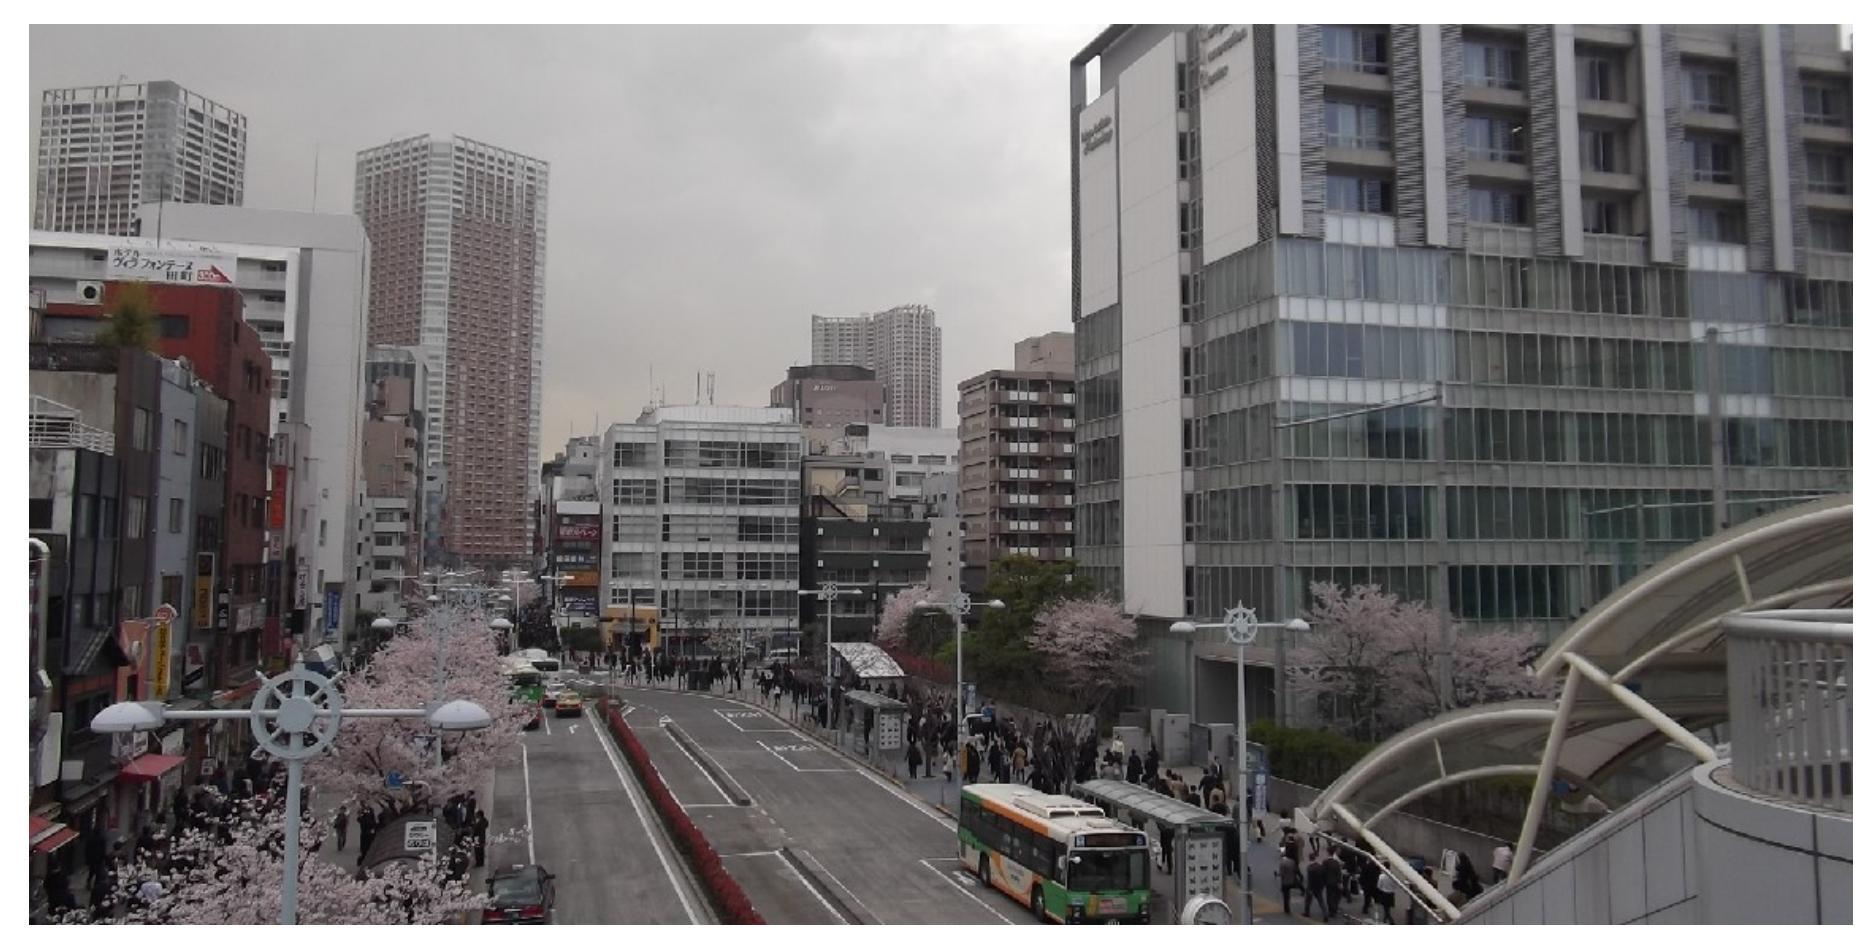
The damage to buildings due to ground shaking is quite limited. There are some completely collapsed RC buildings constructed before 1978 code revision. Some damage to buildings is also due to ground liquefaction in alluvial ground. These buildings are only limited to Sendai City and a few in Sukagawa and Fukushima Cities.

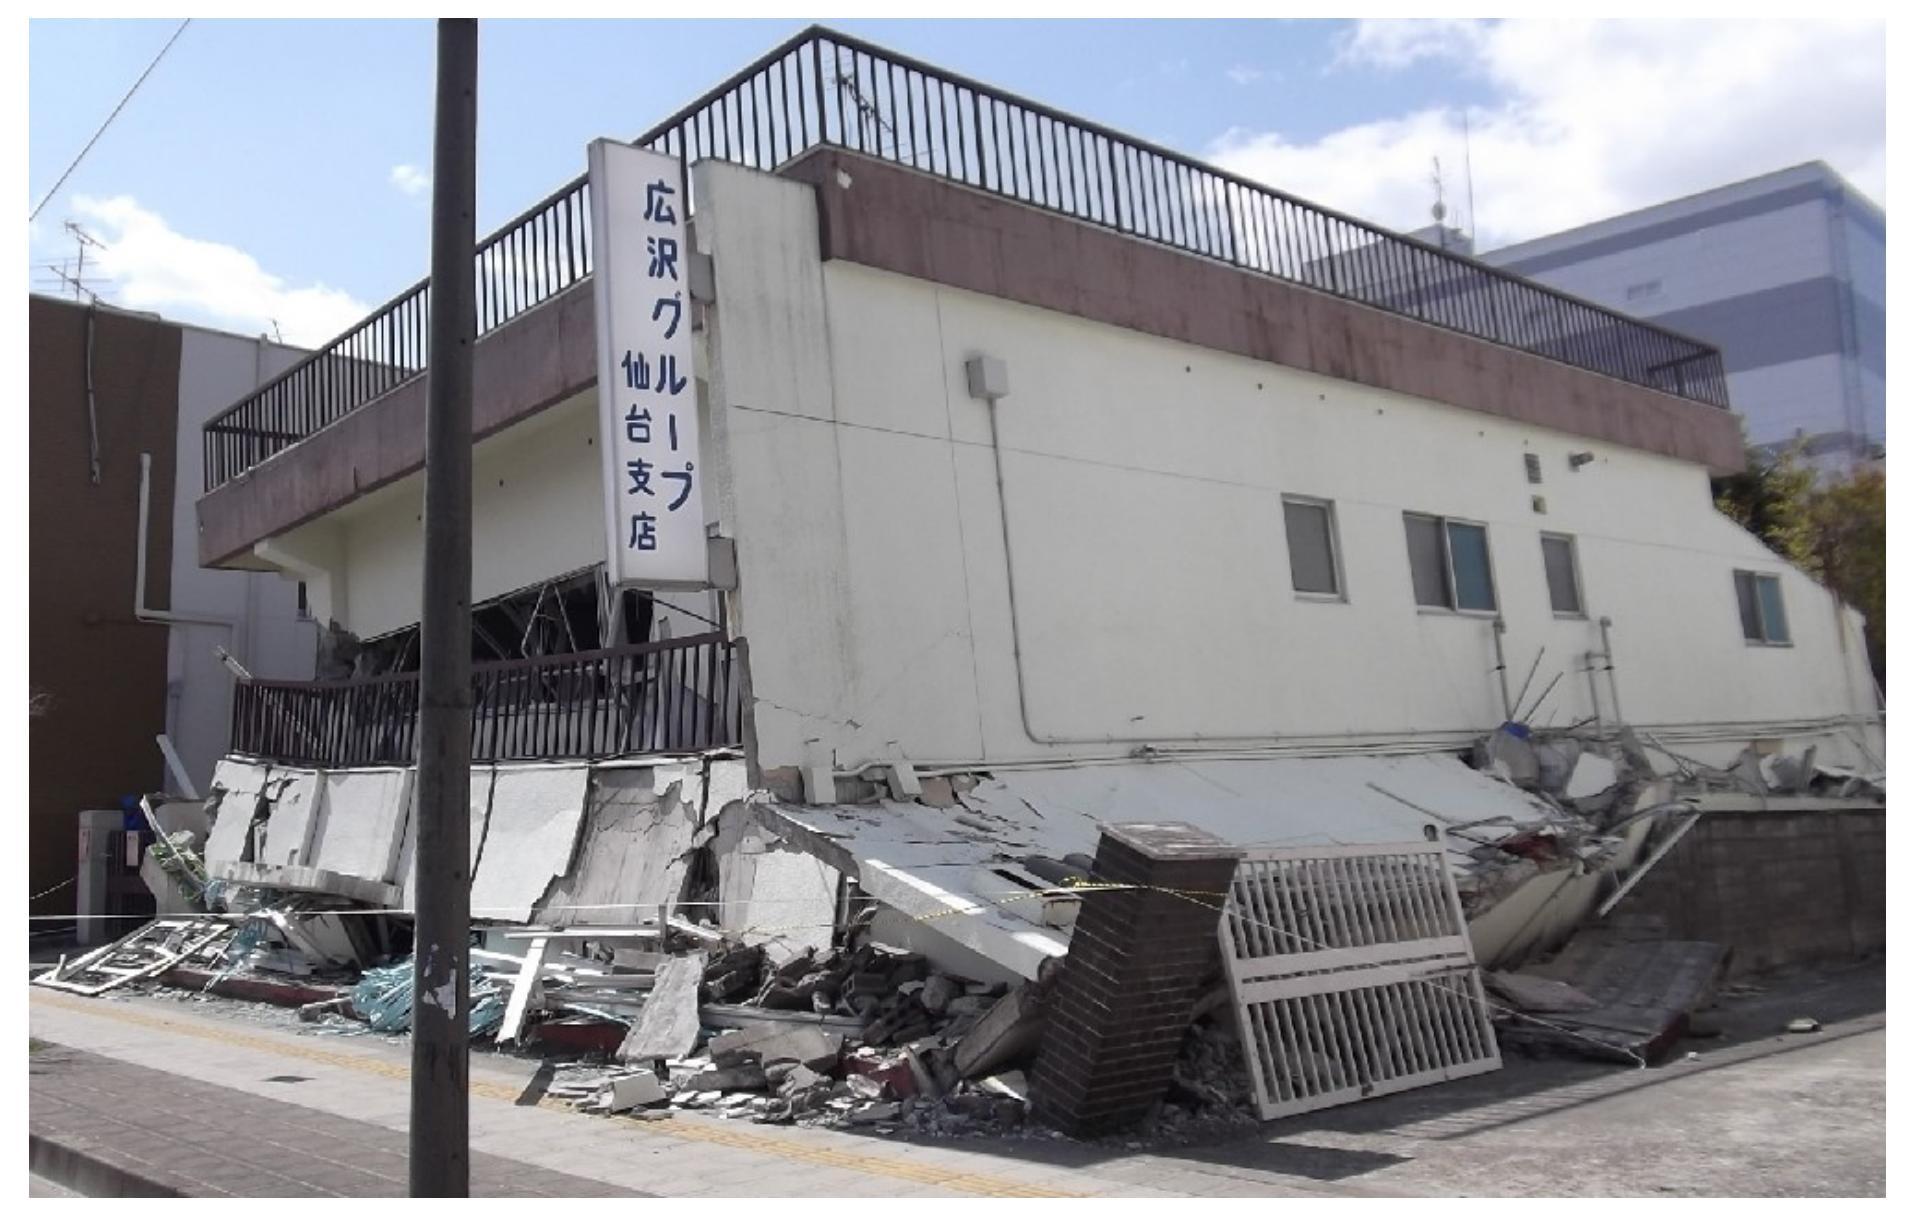
Completely collapsed RC building

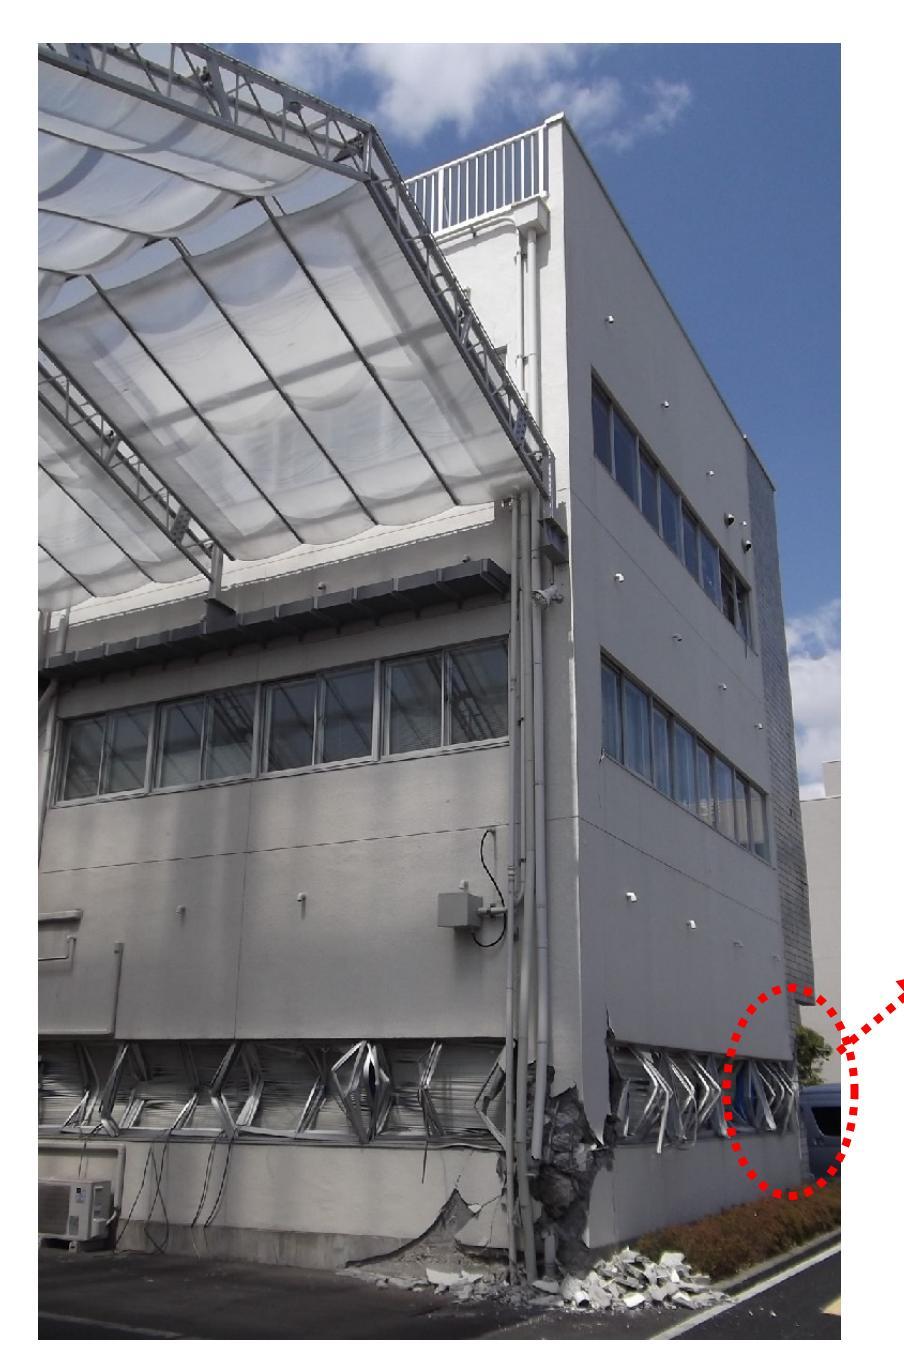
Heavily damaged RC building in Sendai

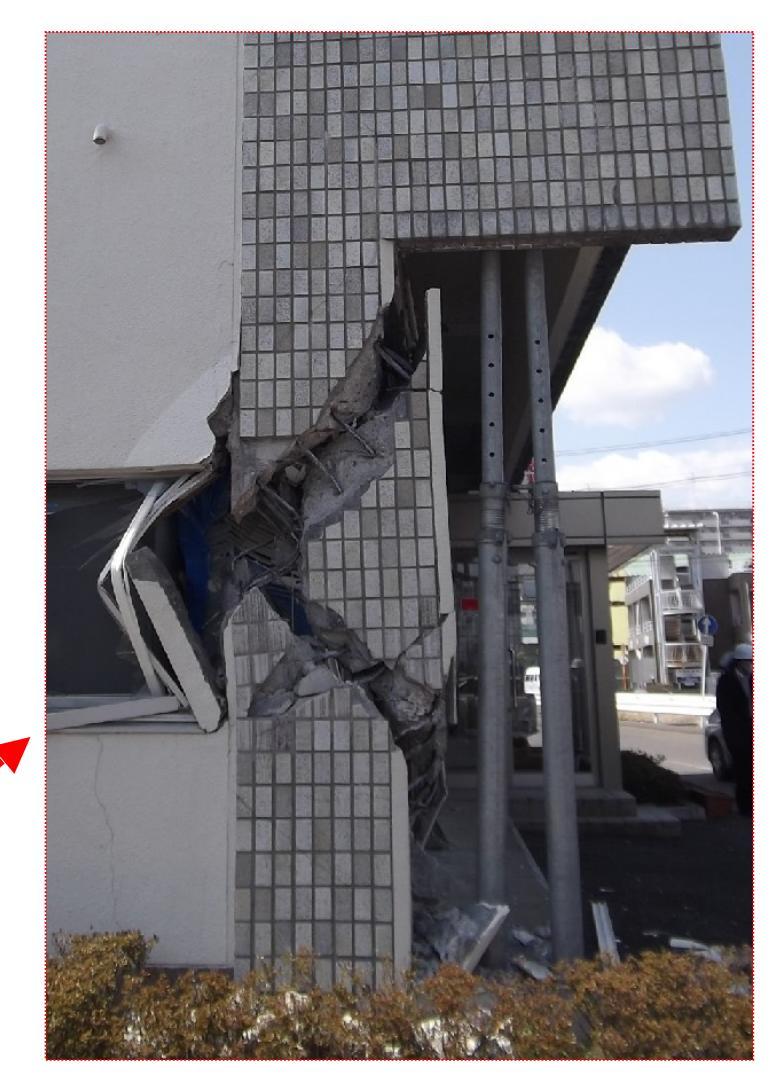
Damage to Retrofitted RC Building of Tohoku University for Civil and Architectural Departments

Damage is concentrated at the interface between 2nd and 3rd Floor

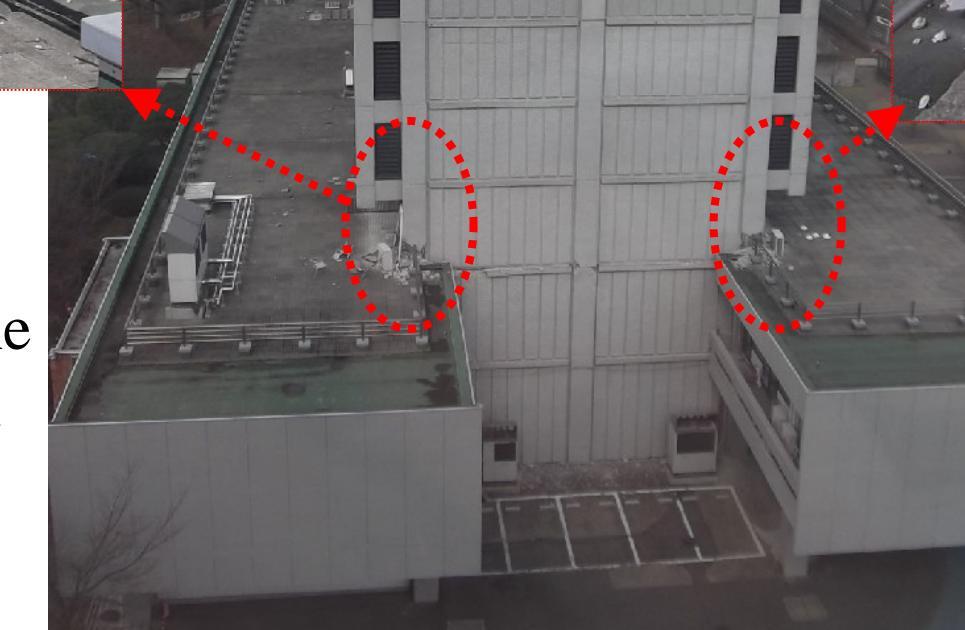
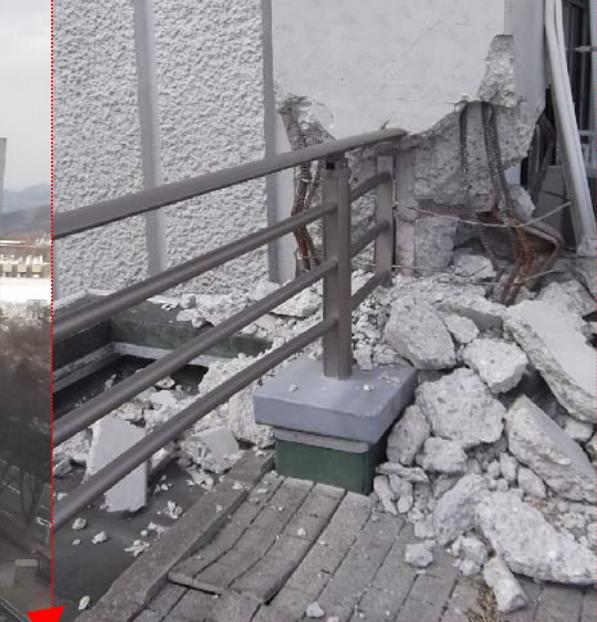
Slightly damaged RC building (Sendai)

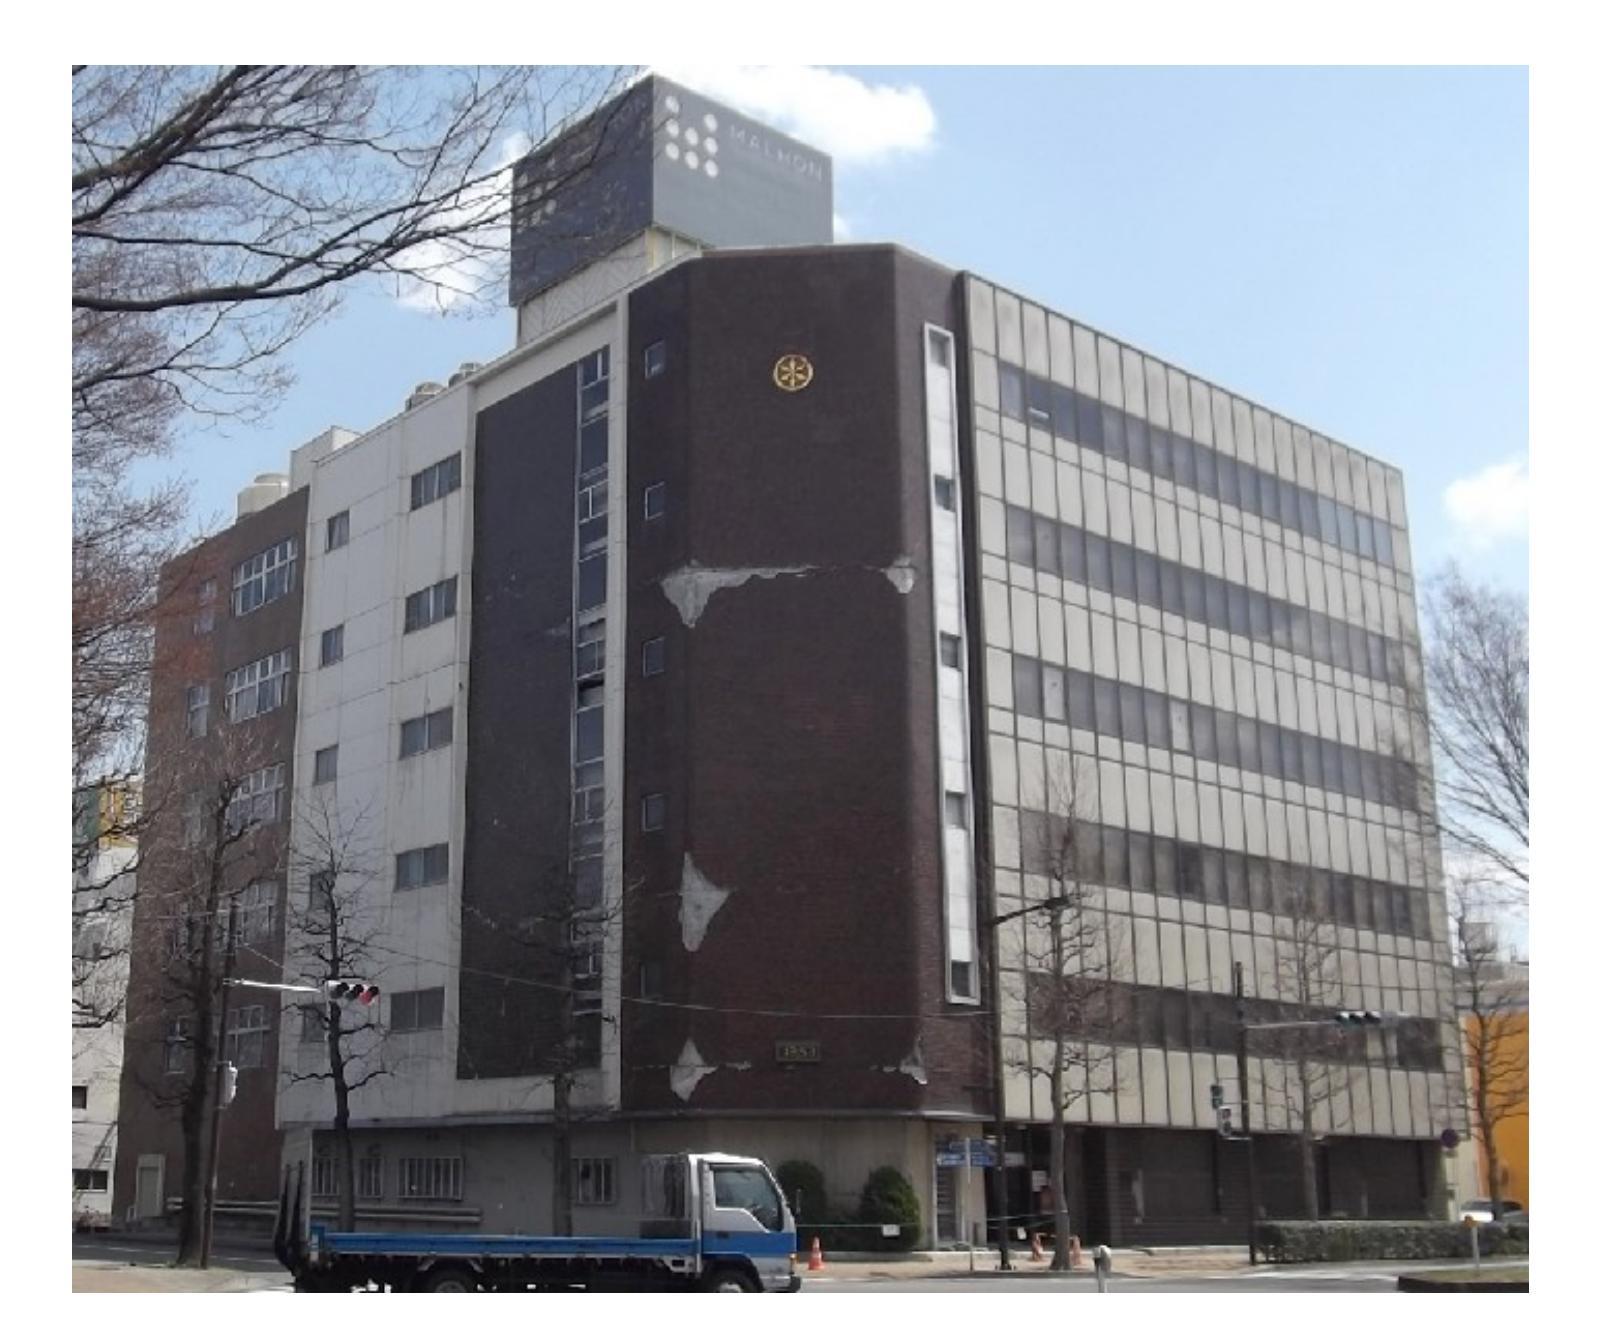
Slightly damaged RC buildings (Koriyama)

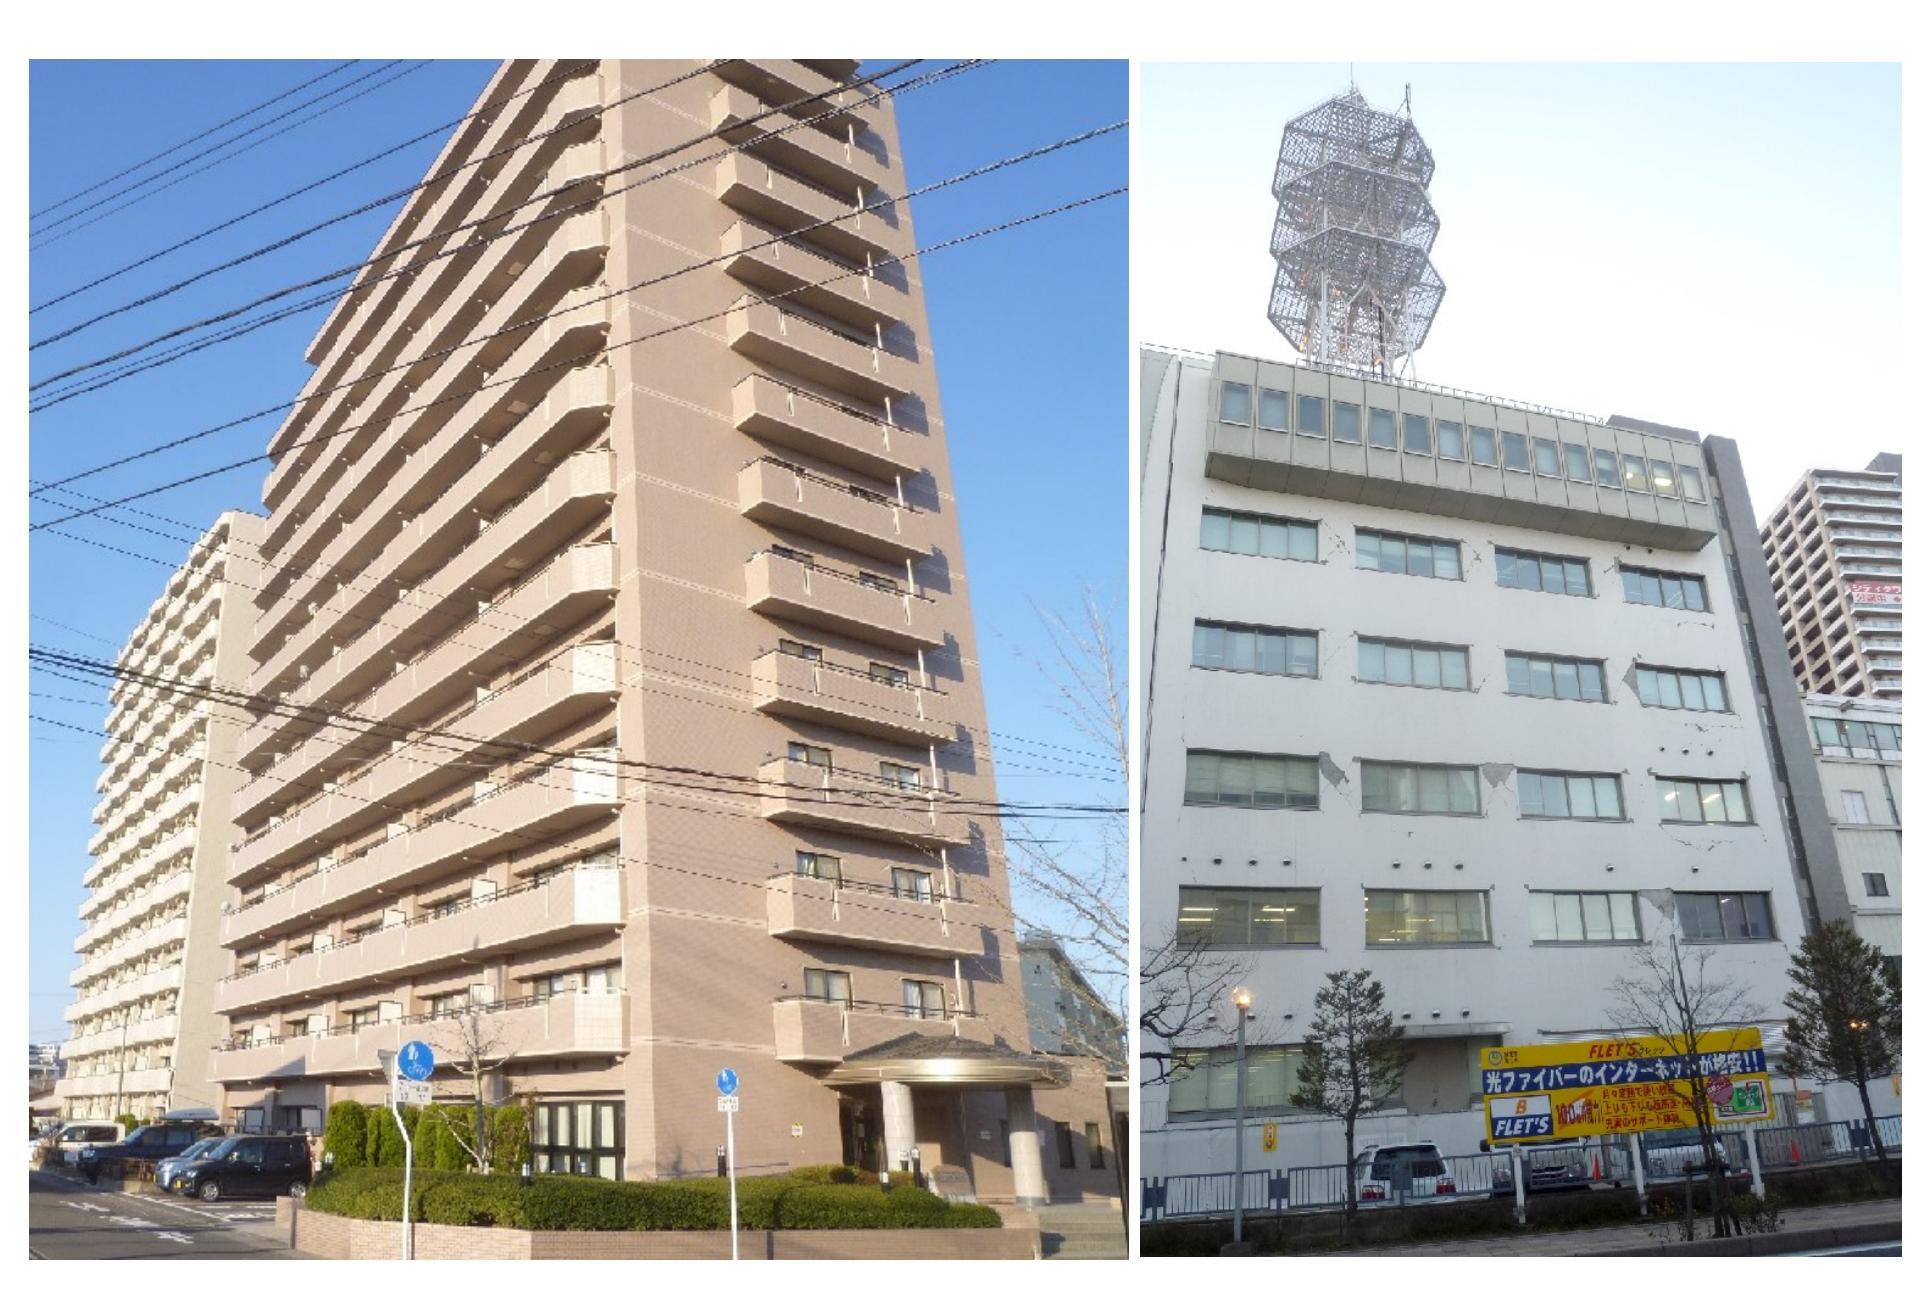
Tilted RC building due to heavy ground liquefaction in Sendai

Tilting is about 2 degrees

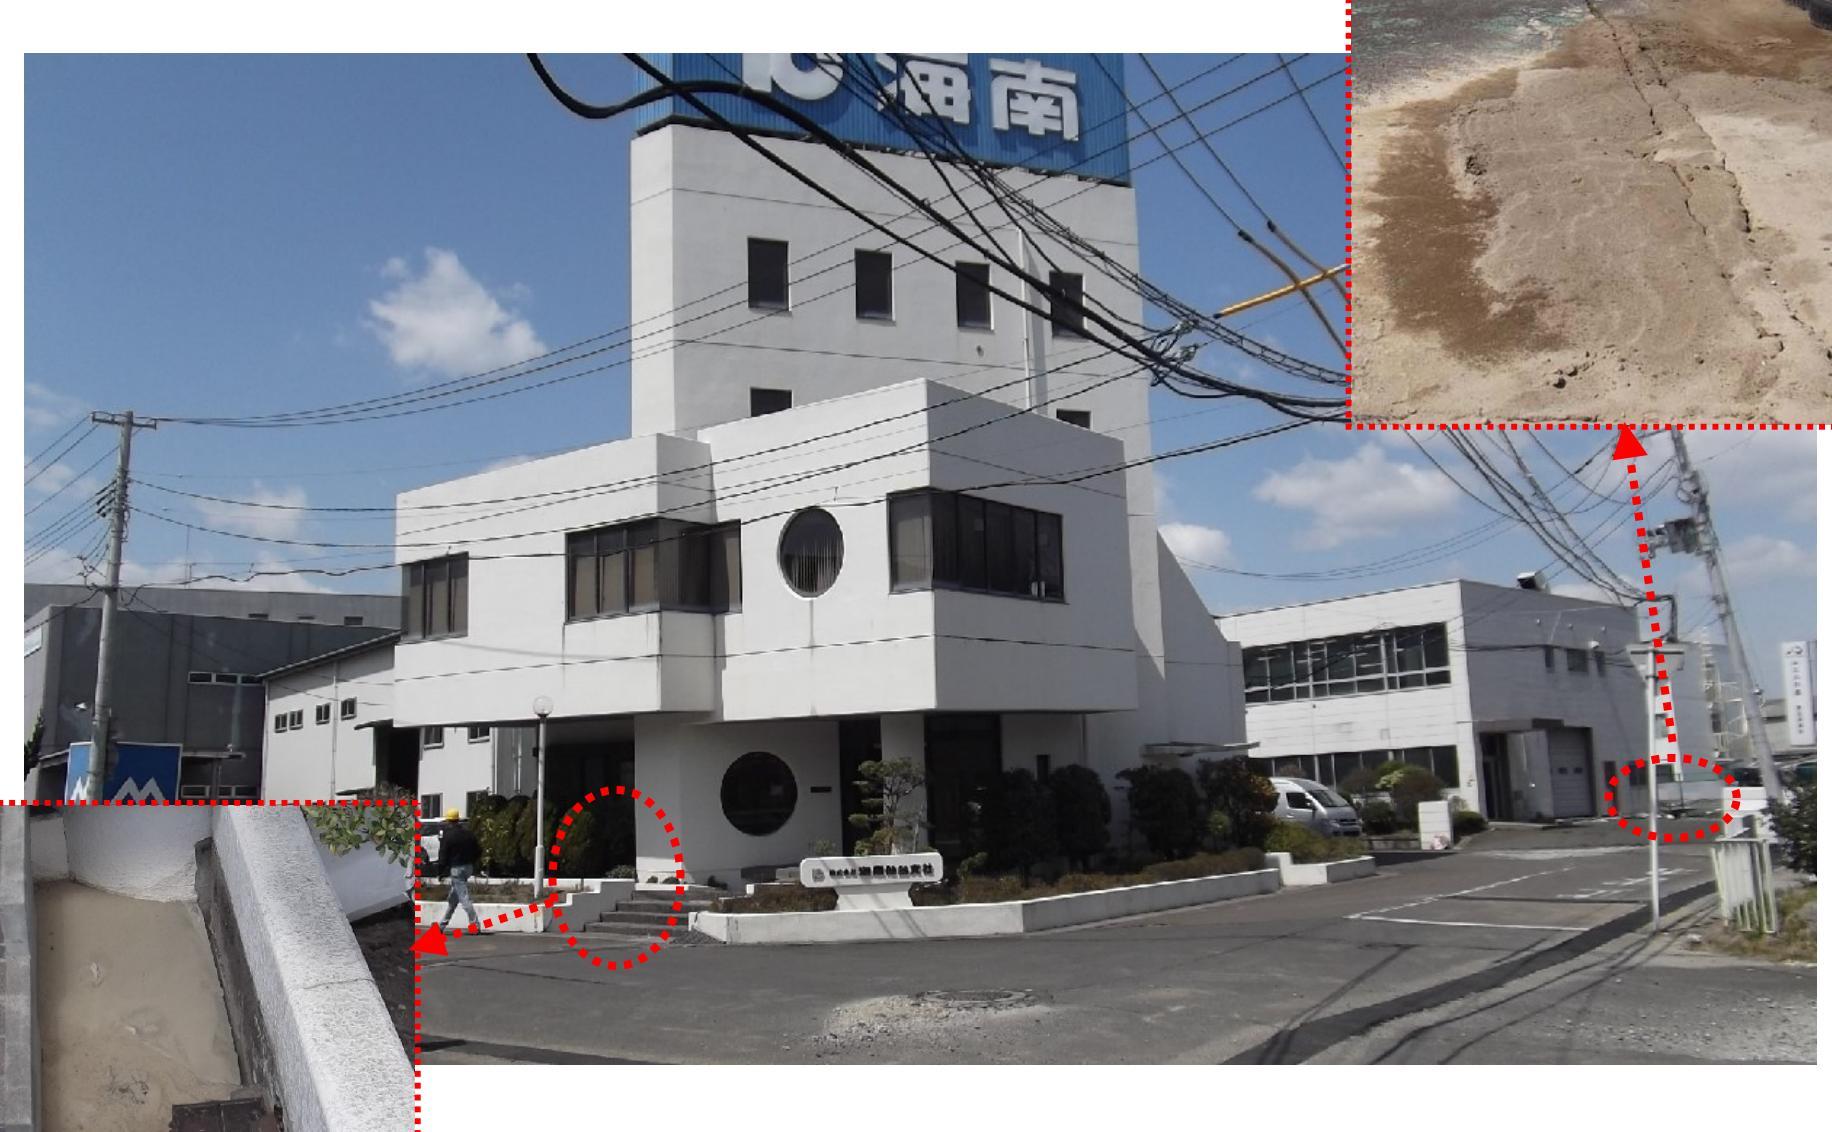
RC buildings damaged due to ground shaking and ground liquefaction in Sendai City

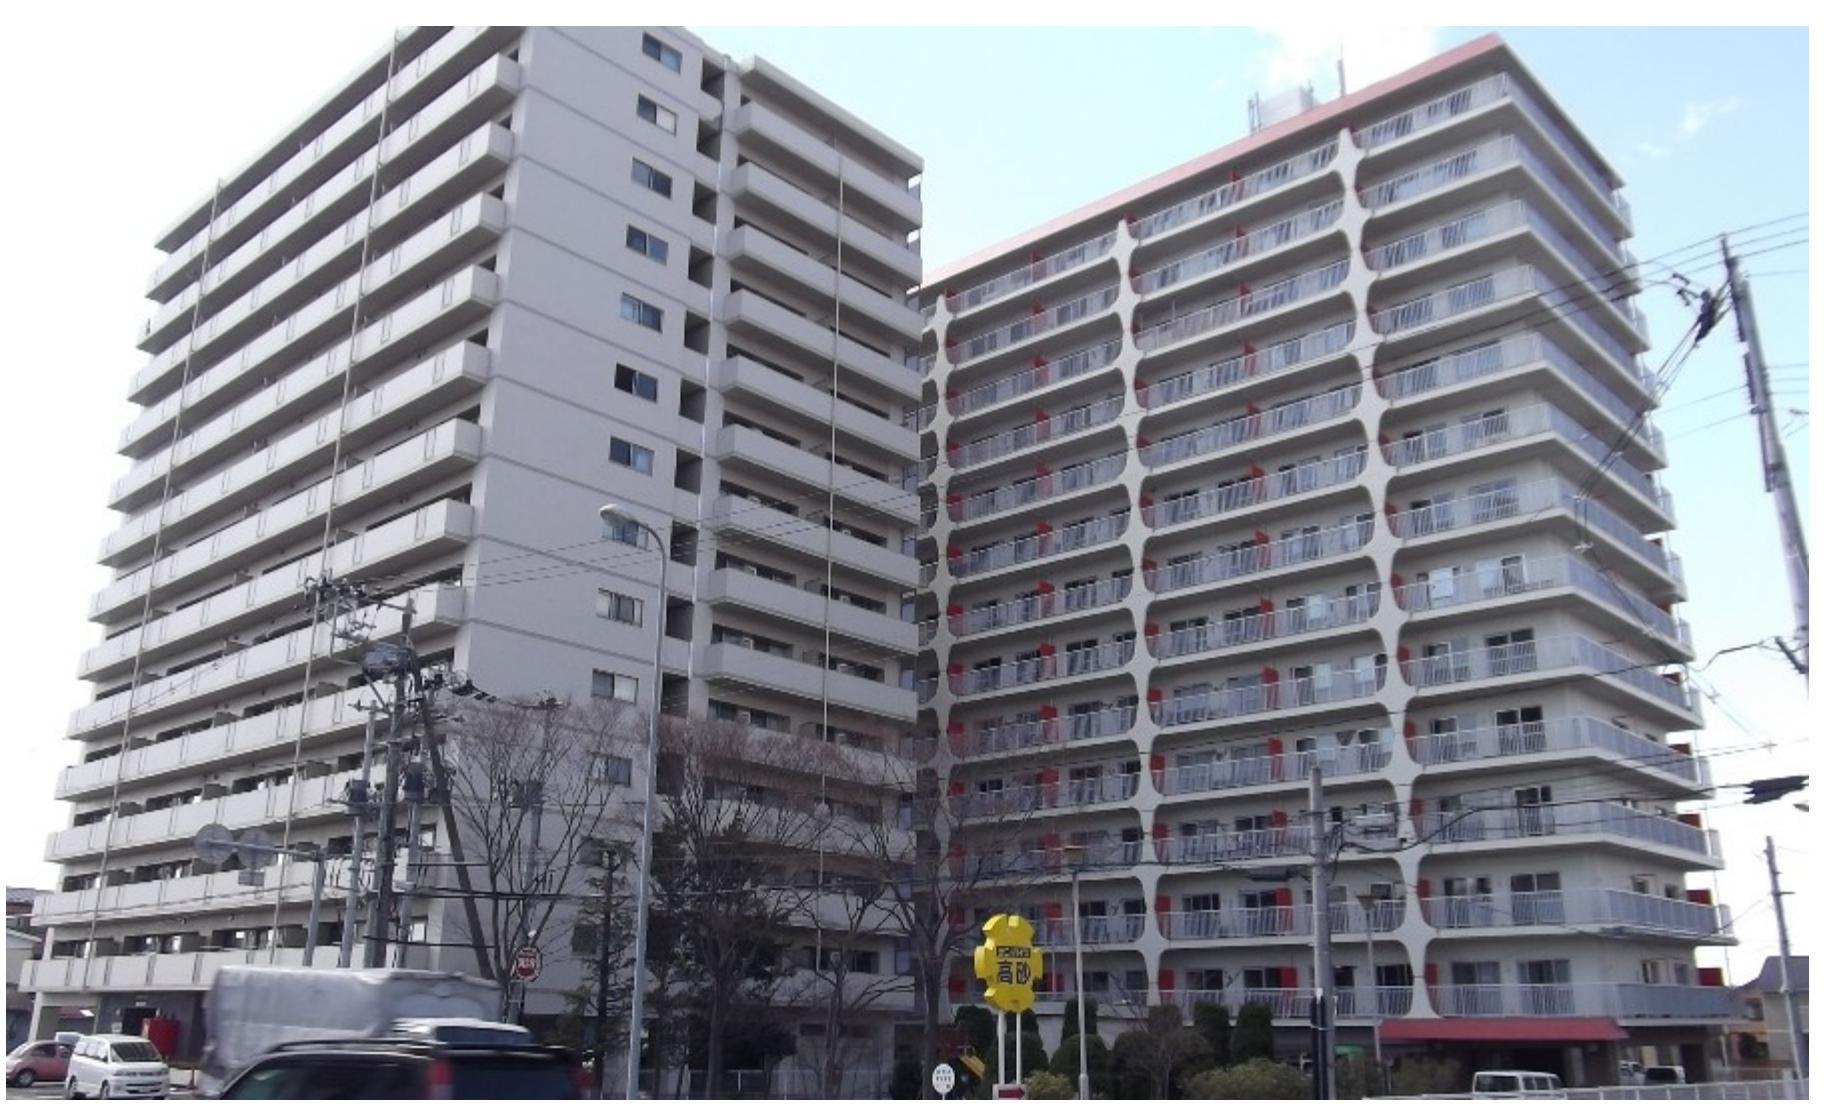
Buildings tilted due to pile damage in liquefied ground
