SHAKING-INDUCED DAMAGE TO BUILDINGS BY M 9.0 EAST JAPAN MEGA EARTHQUAKE ON MARCH 11, 2011

April 17, 2011

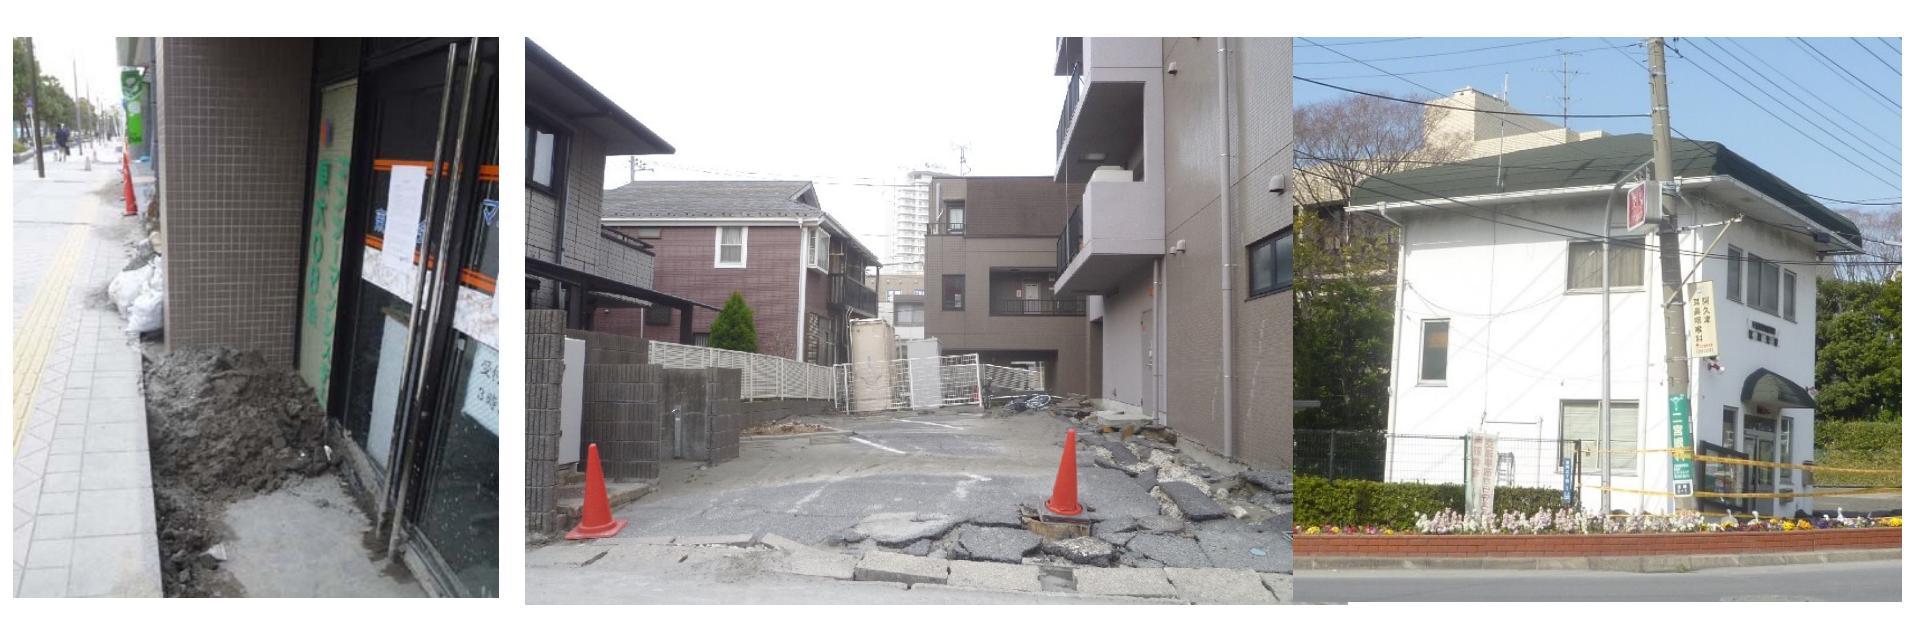
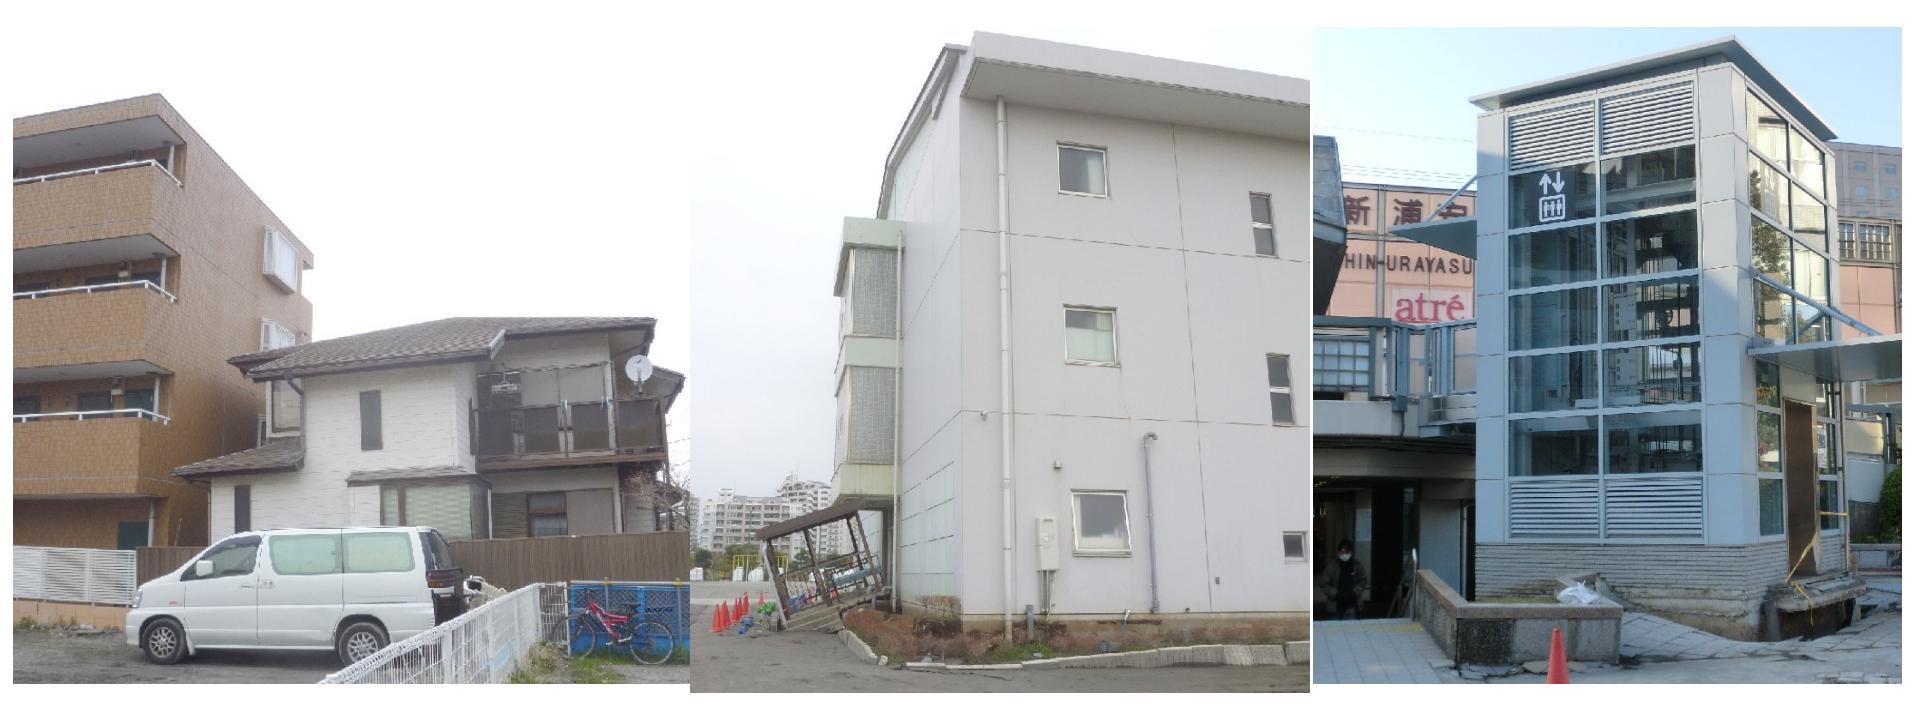
Tilting and settlement damage to RC buildings in Shin-Urayasu

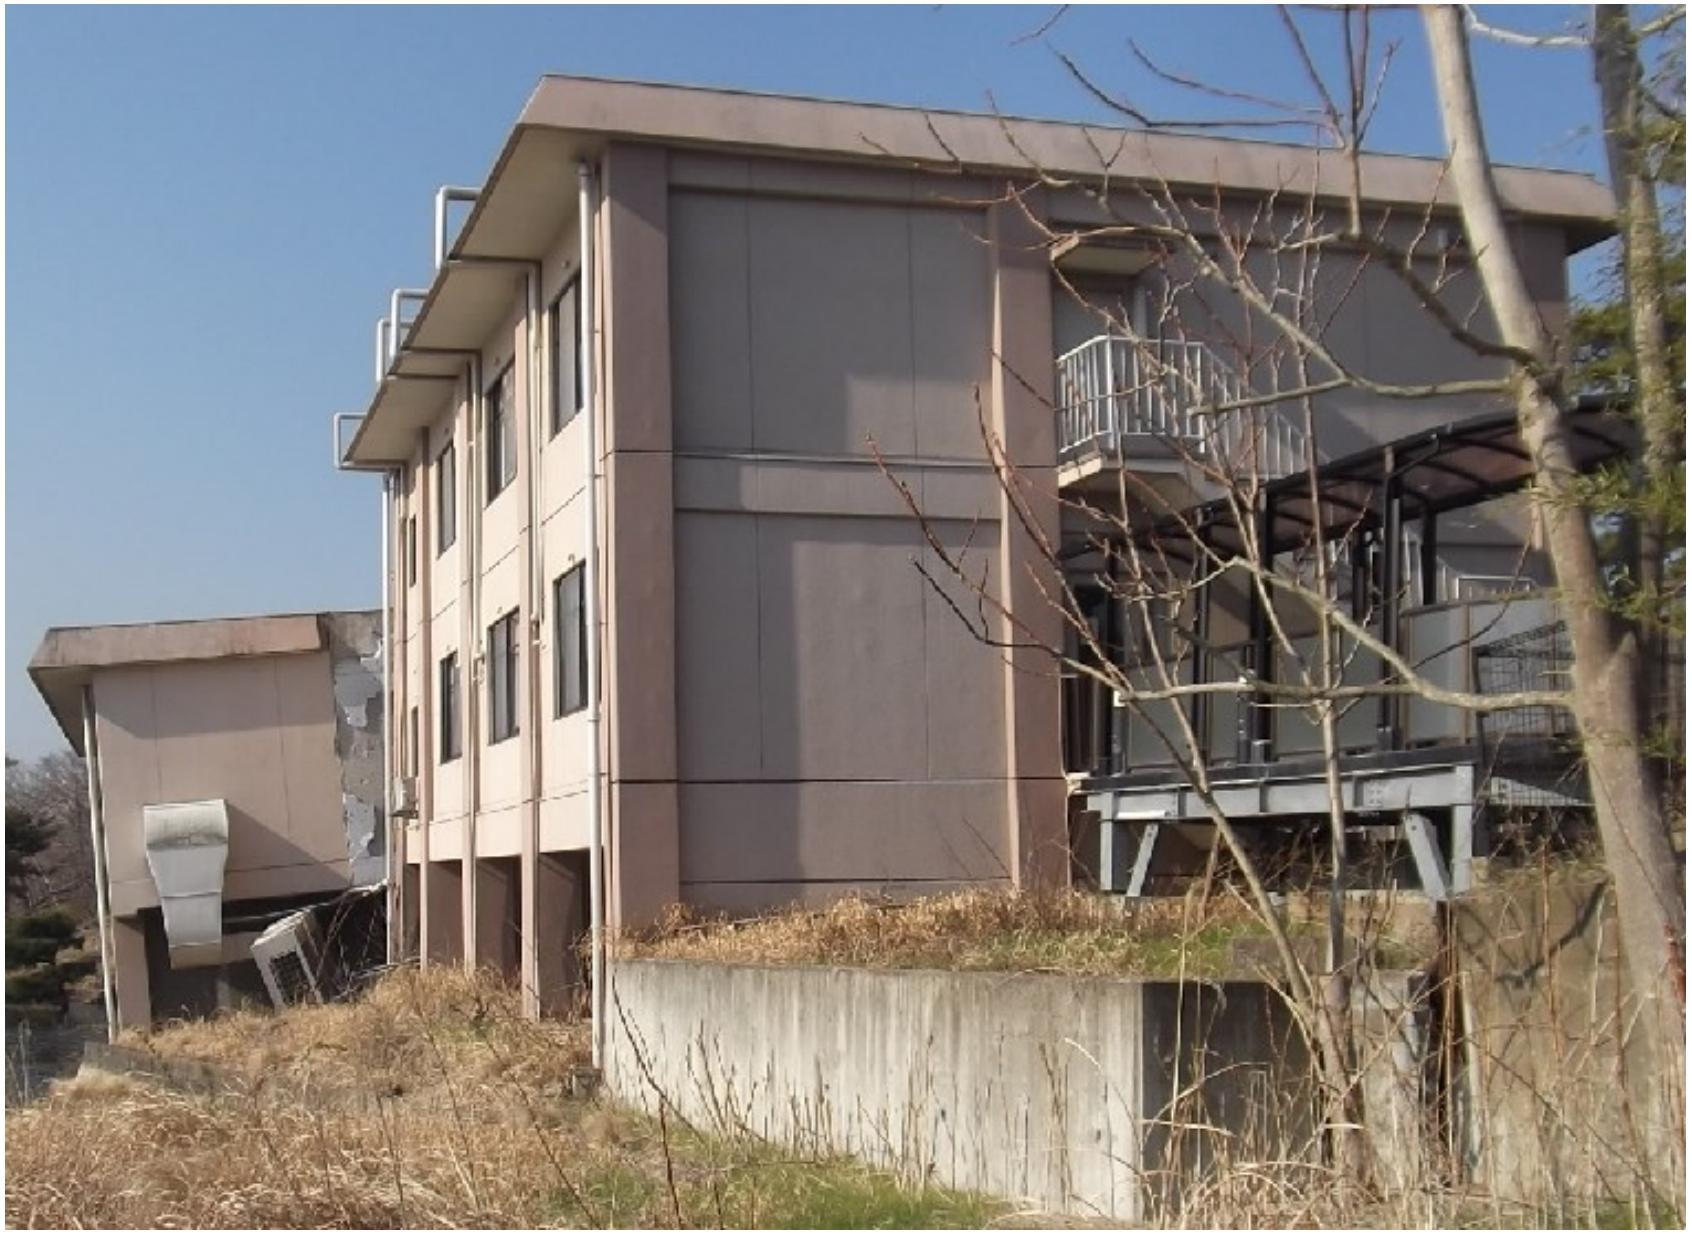
Tilted and displaced RC building due to lateral spreading in Tokai Mura

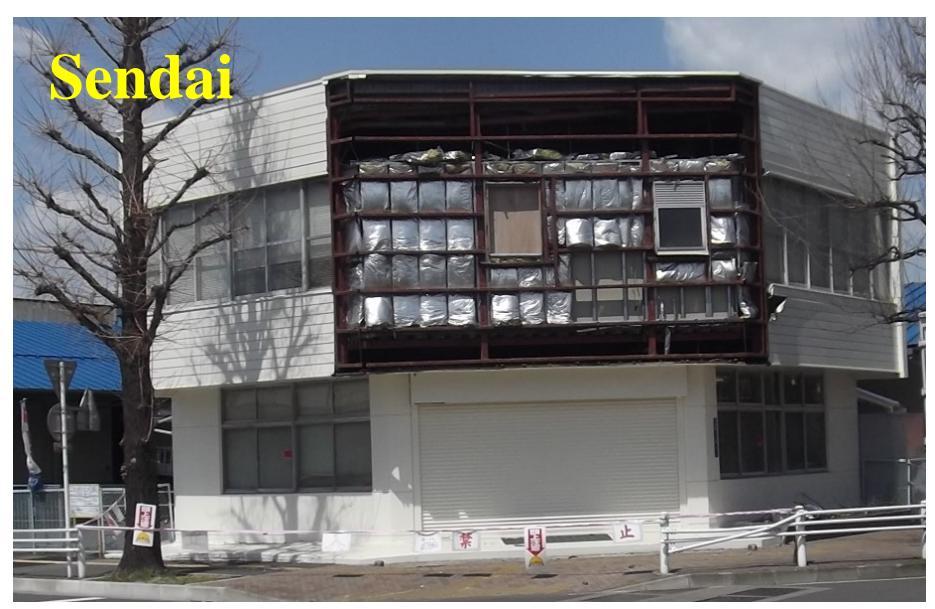
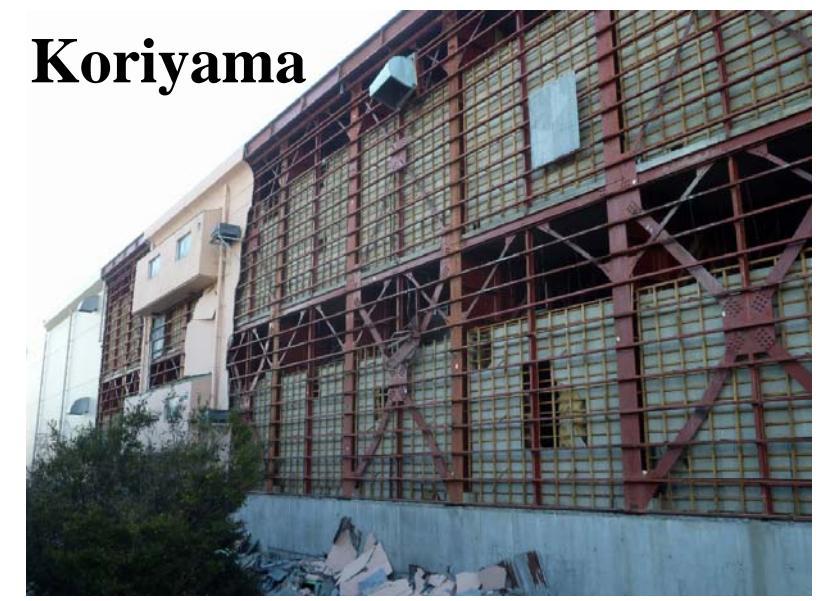
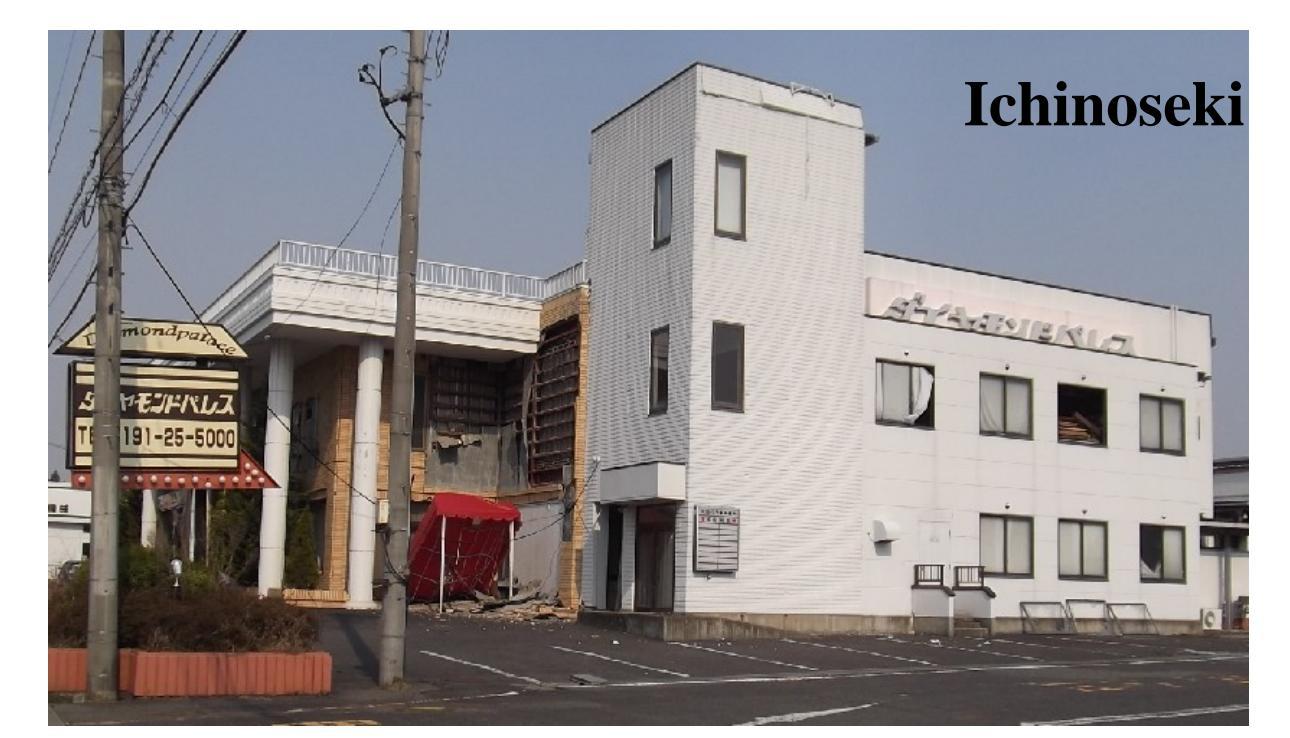
Damage is generally caused by the fall of wall infill panels due to ground shaking
