Preliminary damage survey report on 2015 Nepal Gorkha Earthquake

Advance Party of Japanese Investigation Team for the 2015 Nepal Earthquake Disaster

Damage survey in Kathmandu City

Damage survey near Epicenter Area and Pokhara

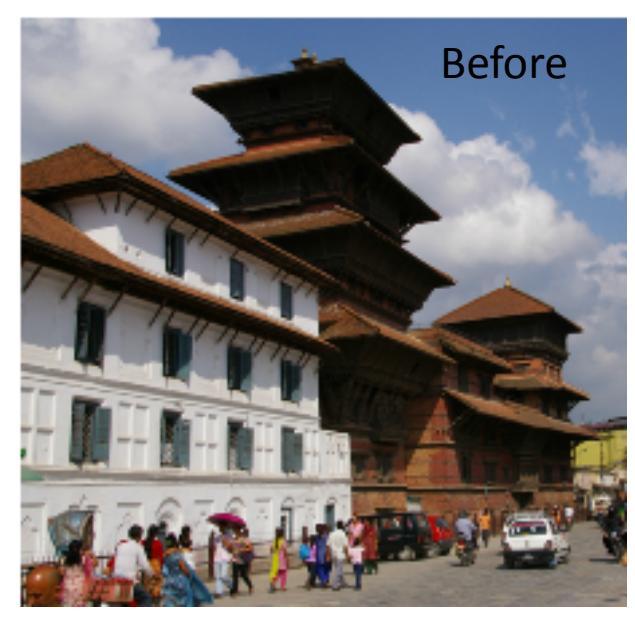
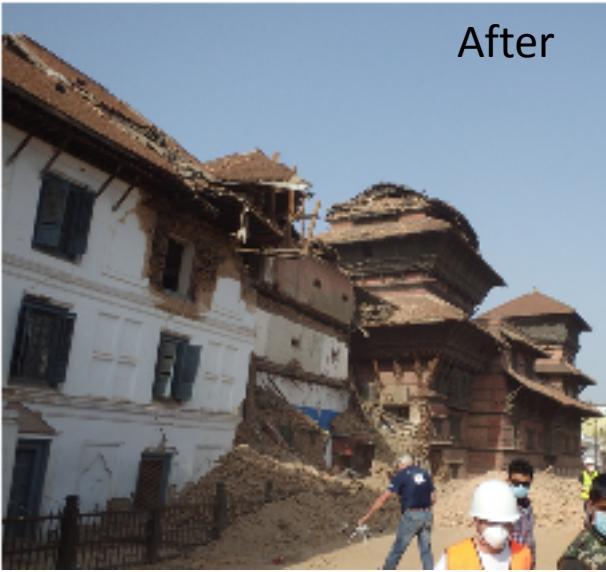
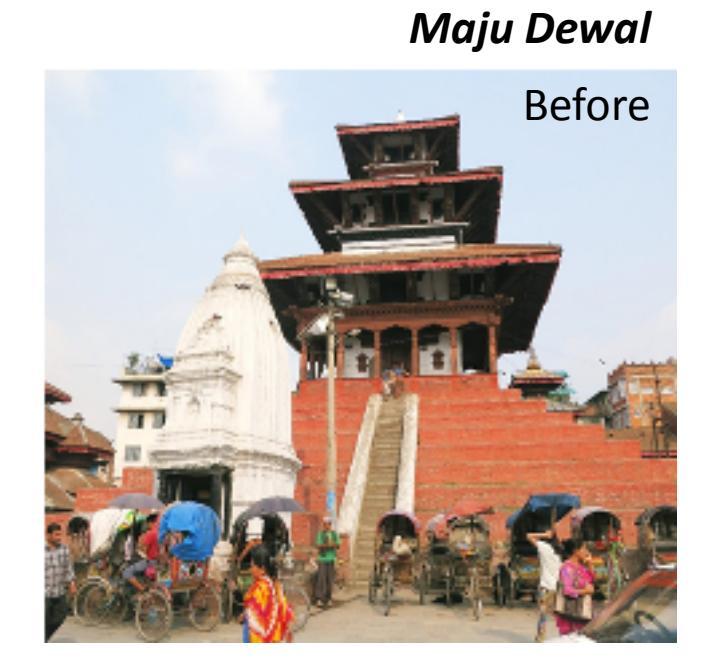
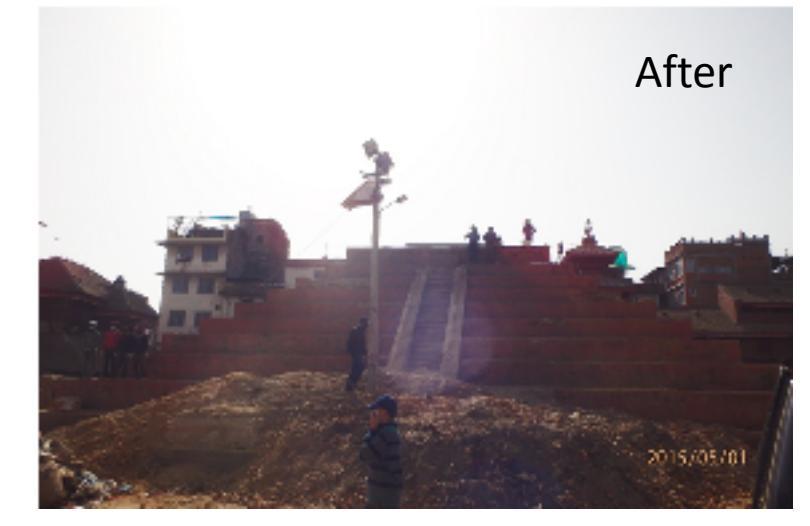
2.1. Heritage buildings collapse (location A)

Most of the temples are more than 500 years old

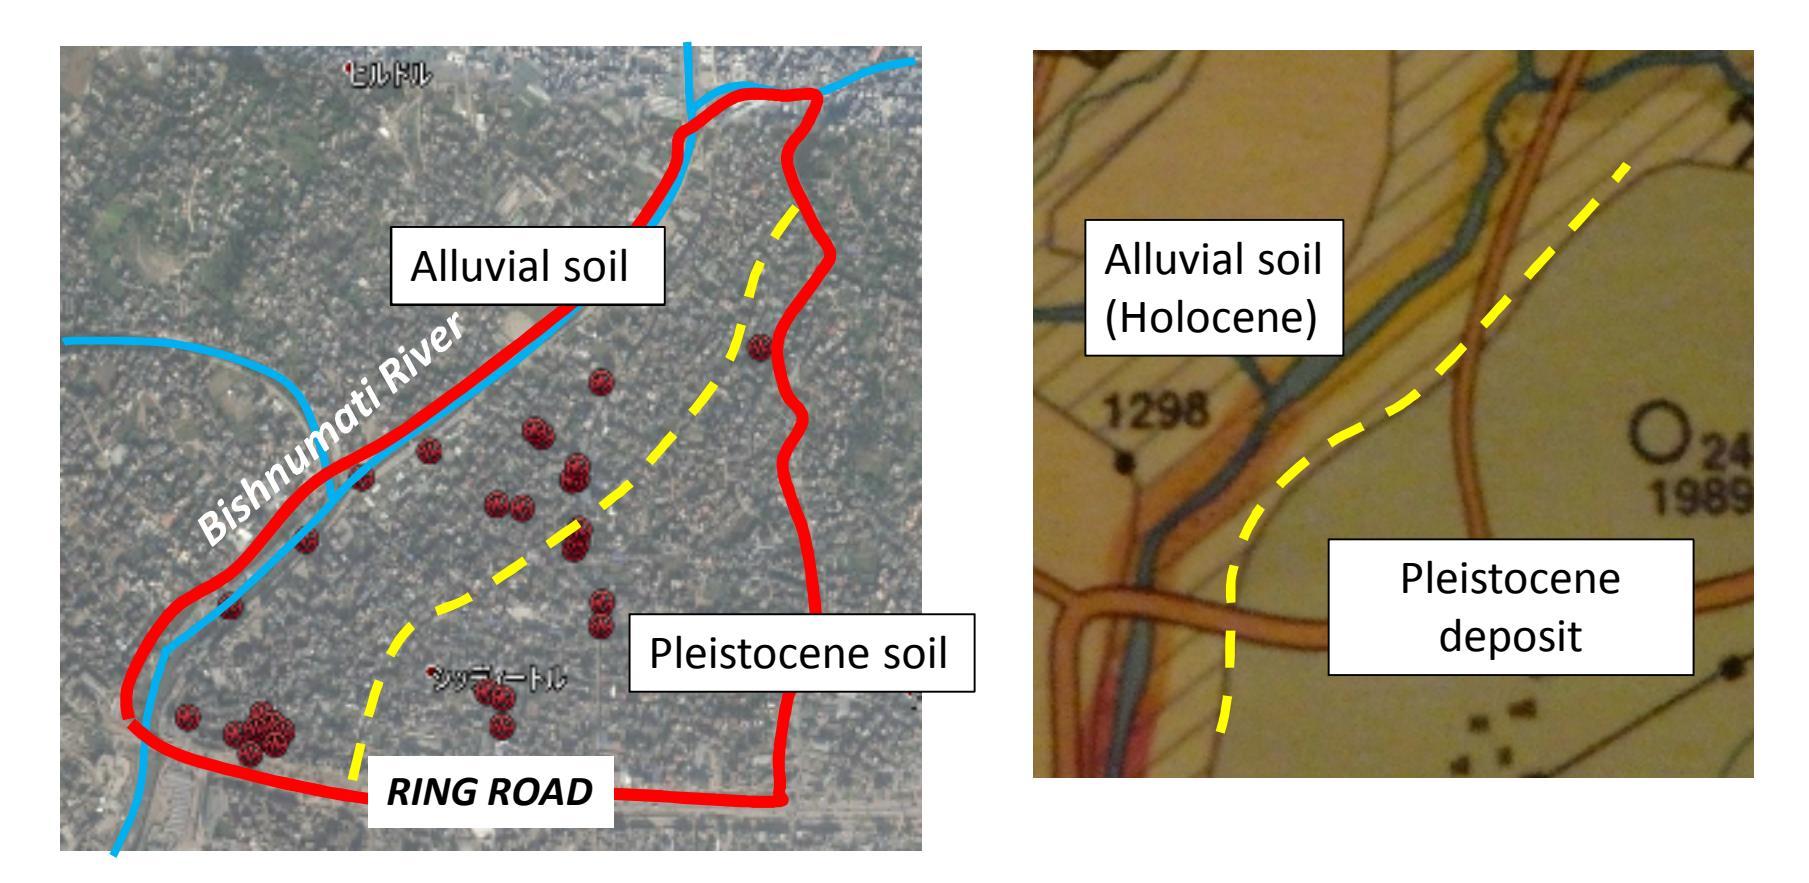
Study area (location E)

At least 28 buildings totally collapsed or should be demolished Most heavily damaged buildings are located on the *alluvial soil deposit*

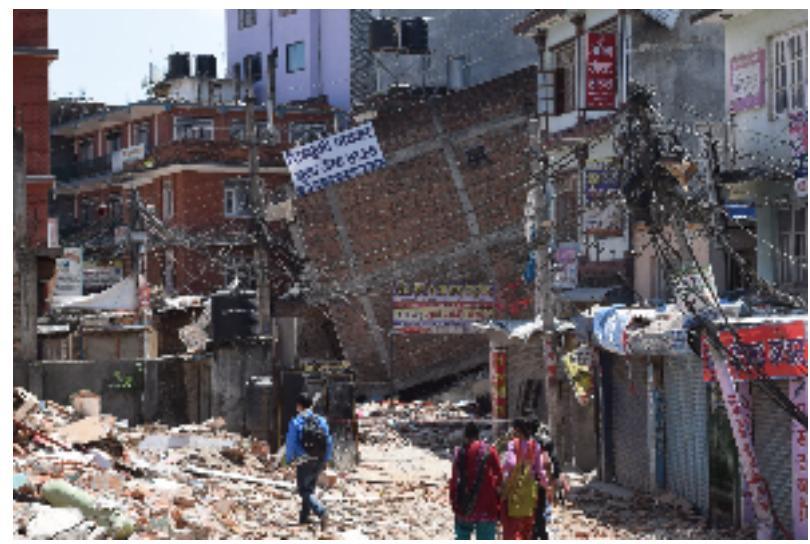
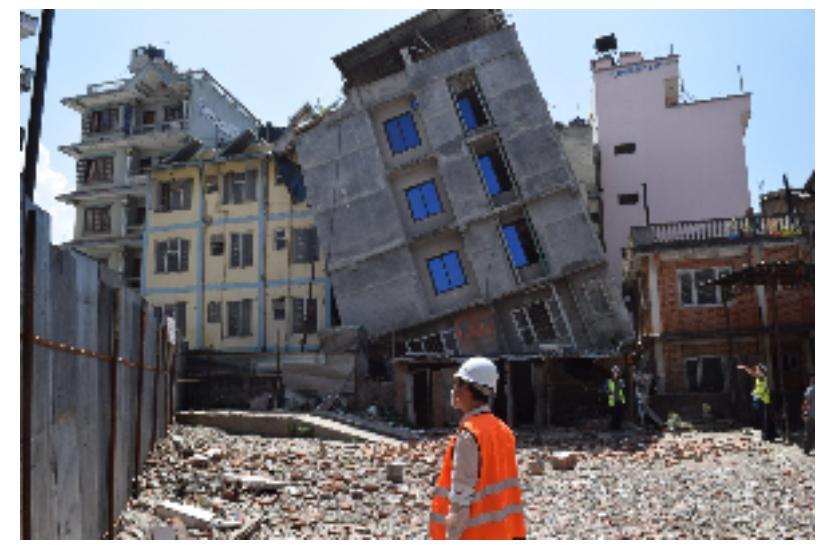
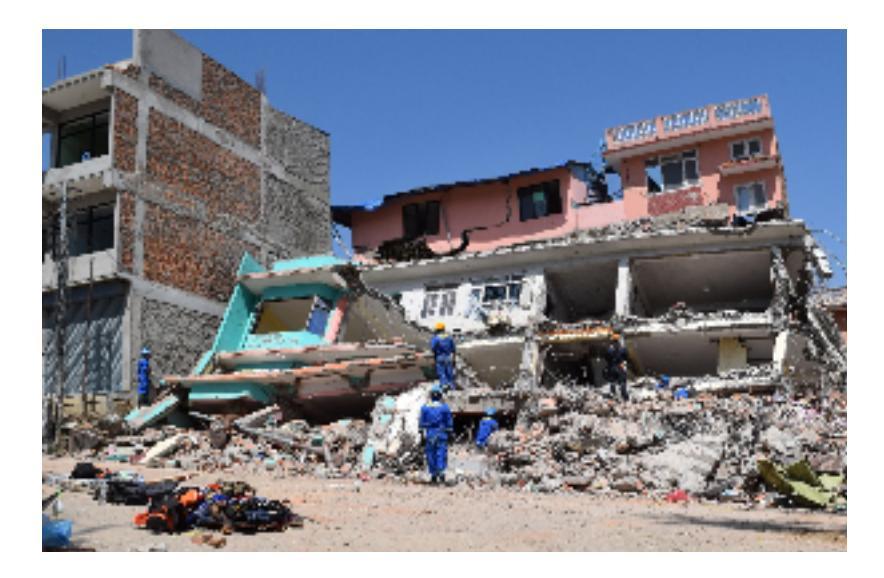
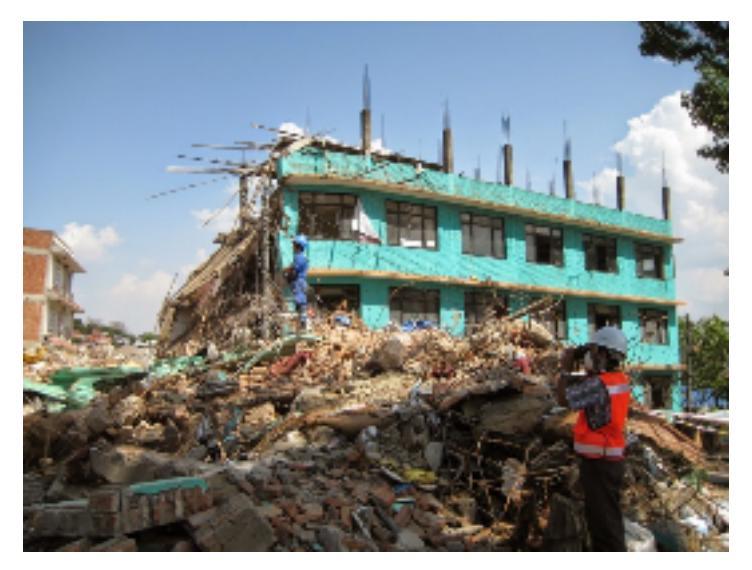
Along the Ring Road (location F)

Local ground motion amplification and/or loss of bearing capacity, poor quality of non-engineered RC buildings

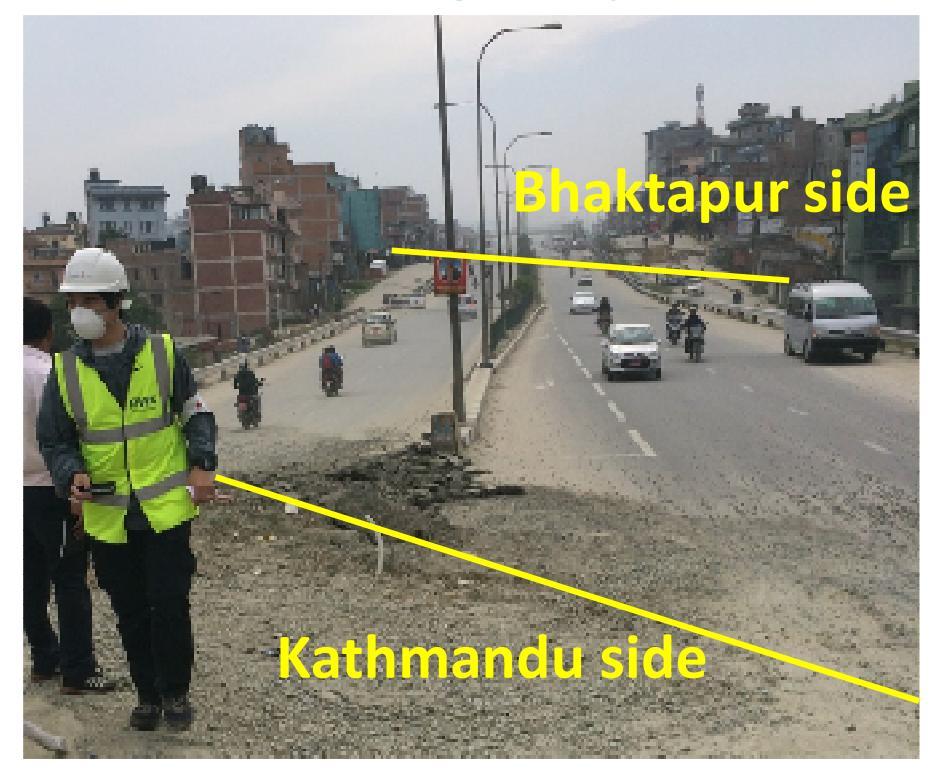
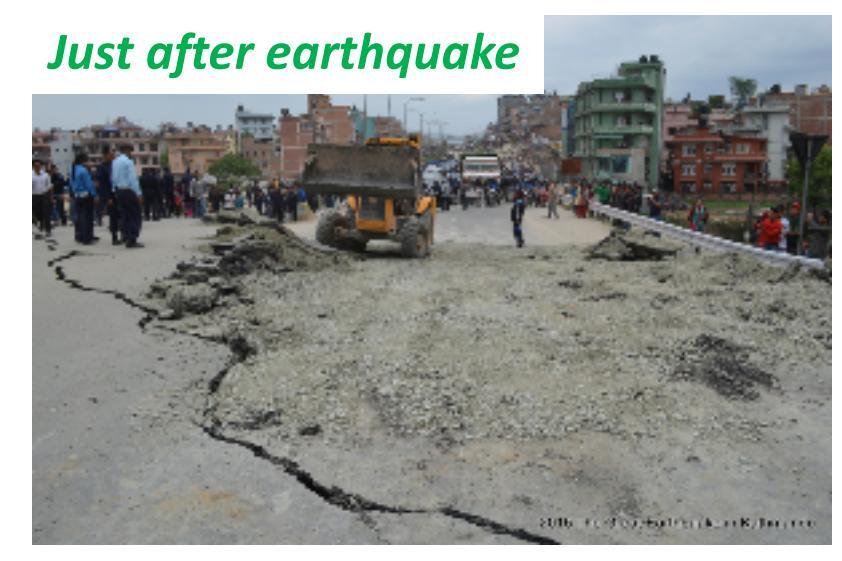
During survey

Embankment settlement

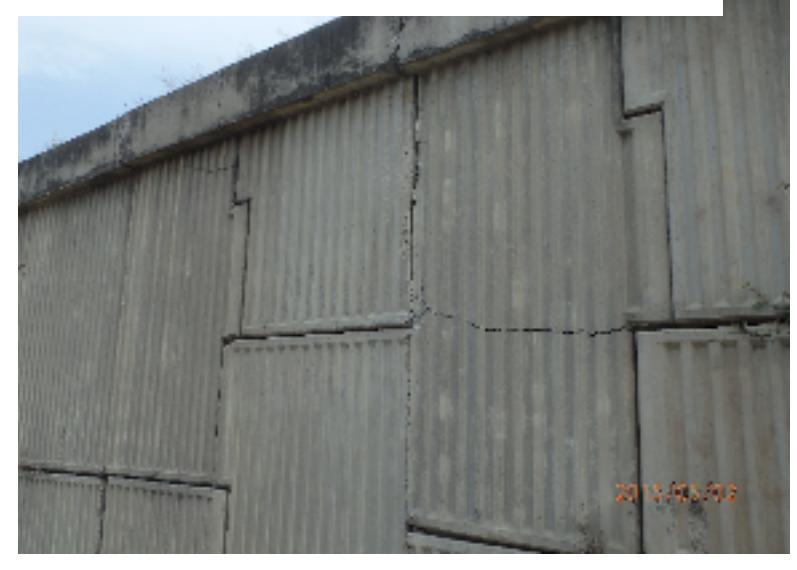
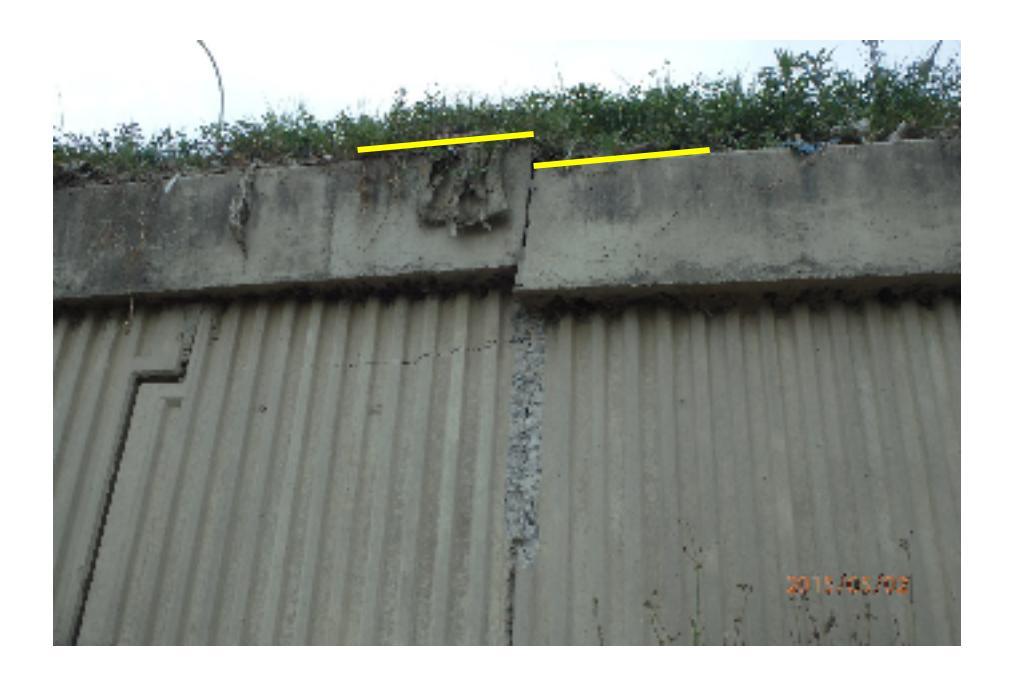
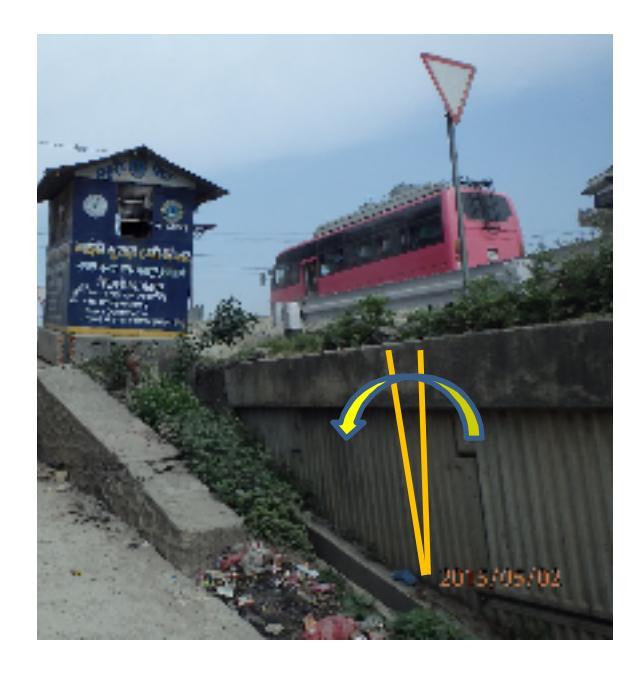
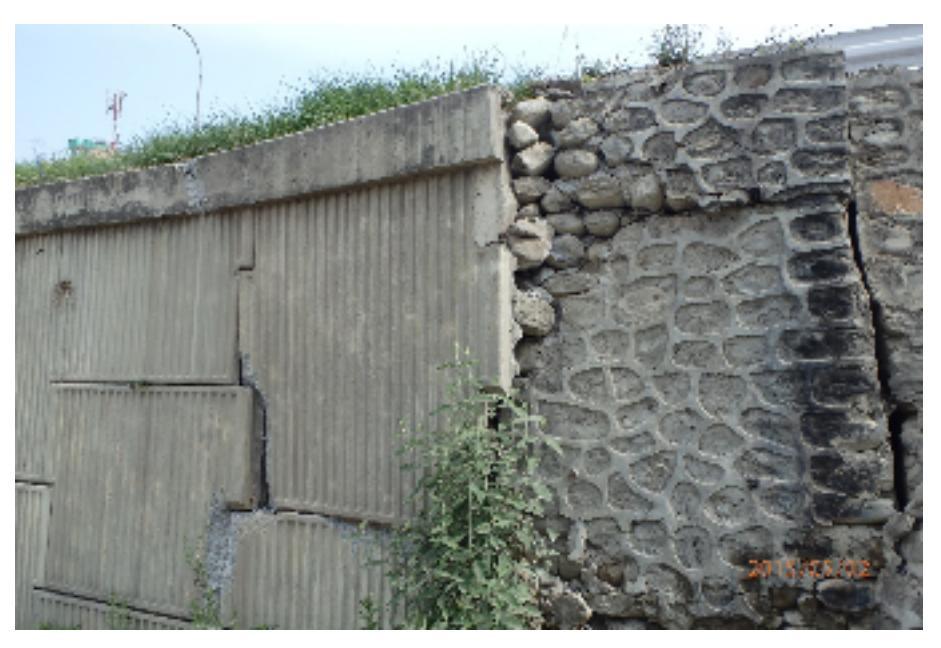
Retaining walls cracks

• Damage due to poor compaction of the filling soil

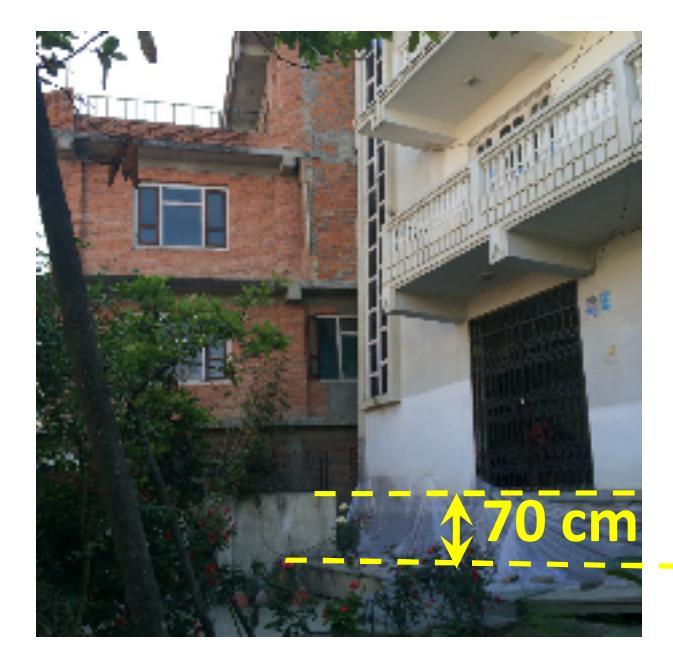
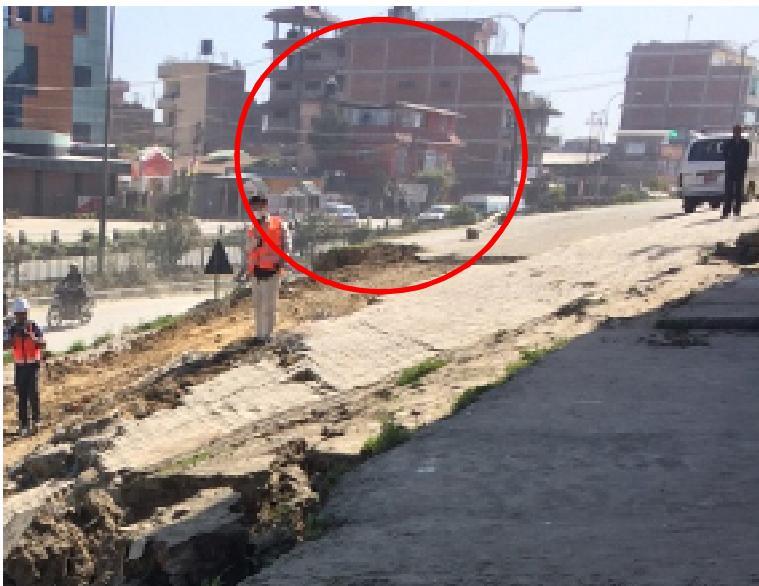
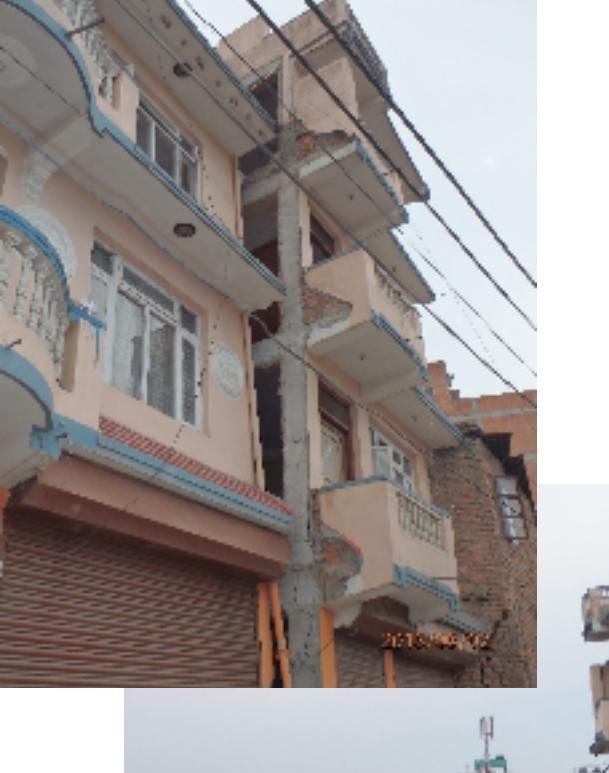
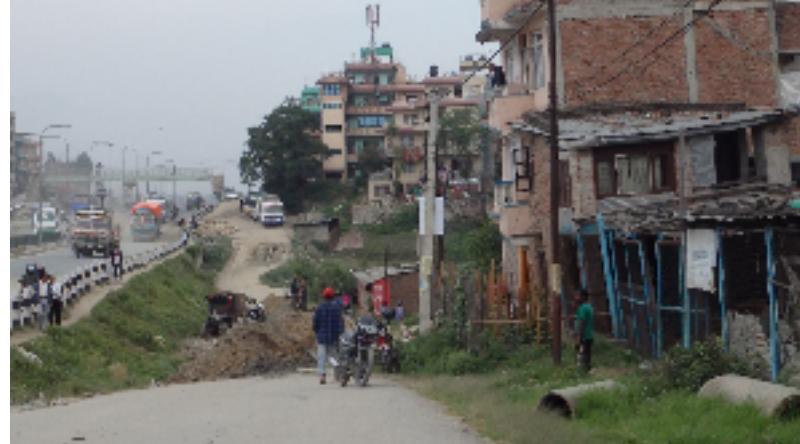
Ground-failure-induced tilting and subsidence of buildings

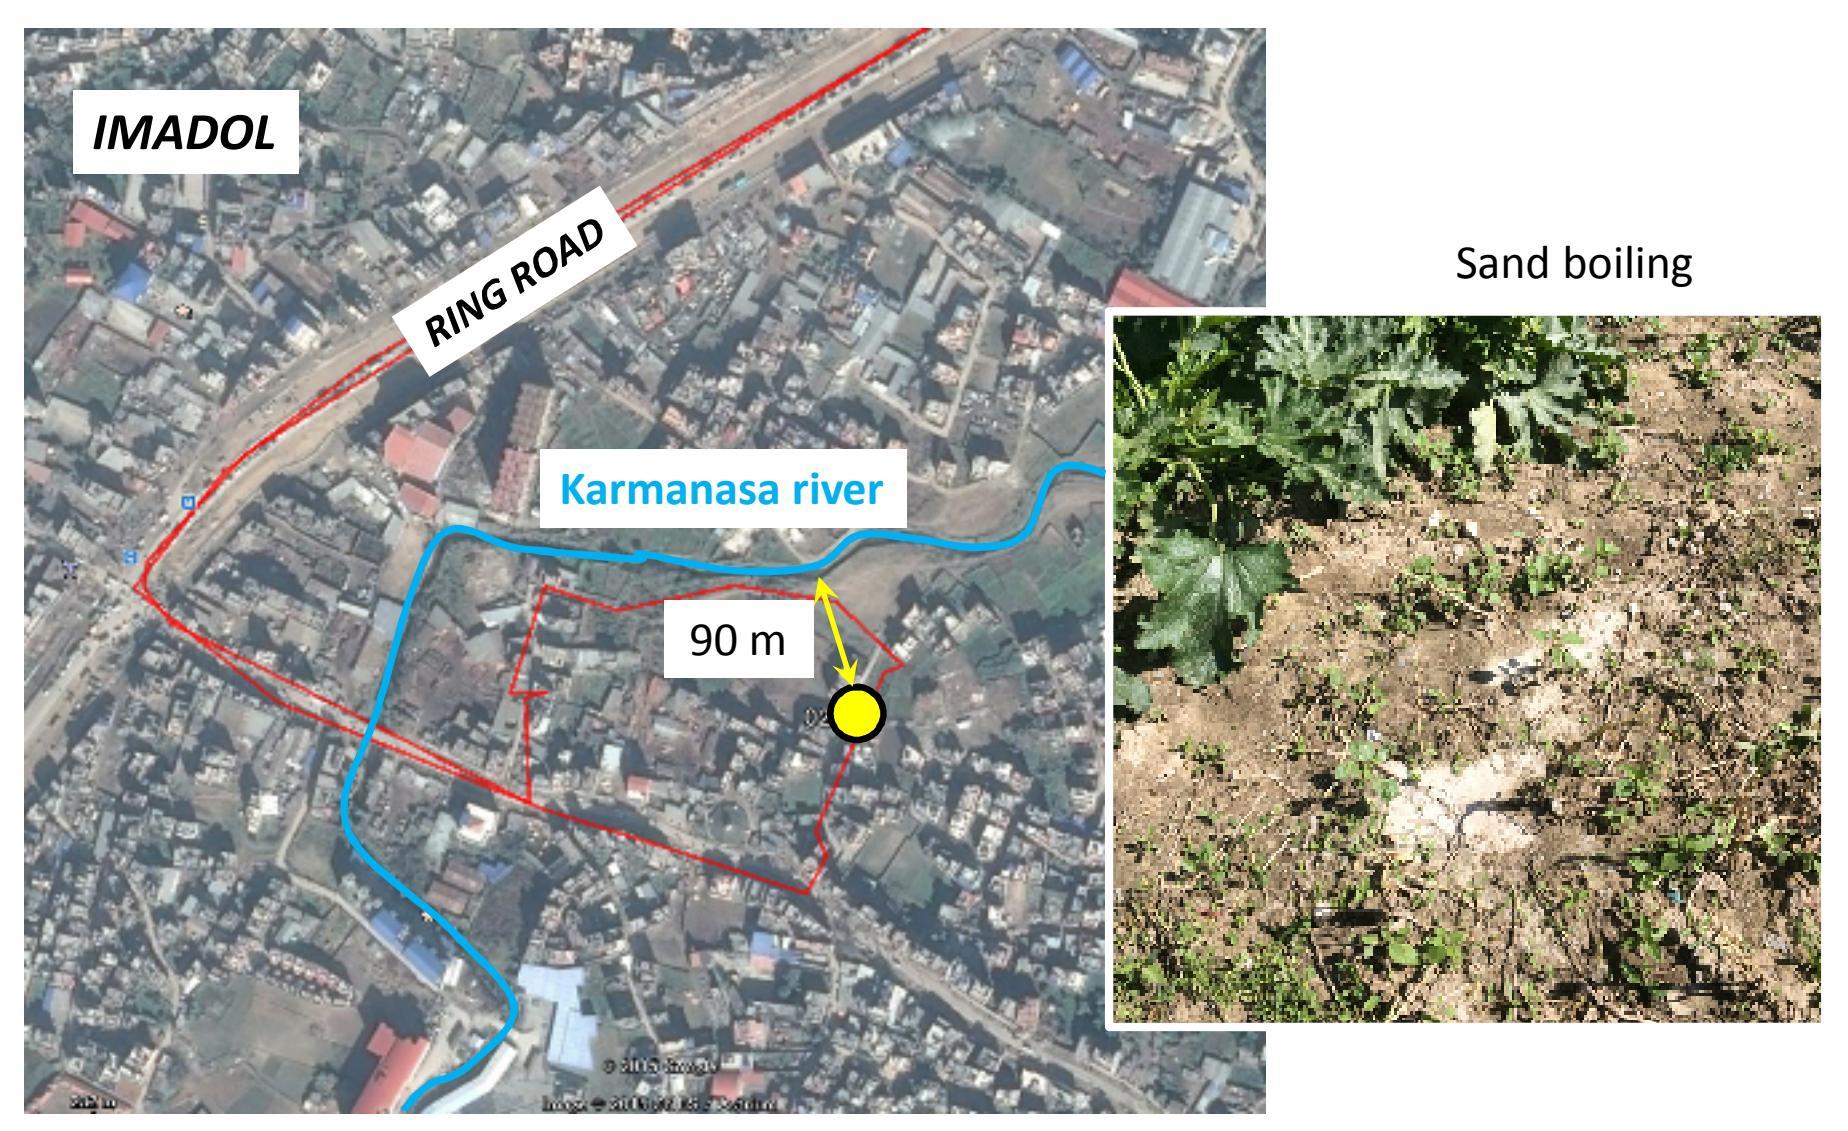
2.5. Soil liquefaction (location C)

- No damage induced to surrounding buildings
- Water table very low during dry season

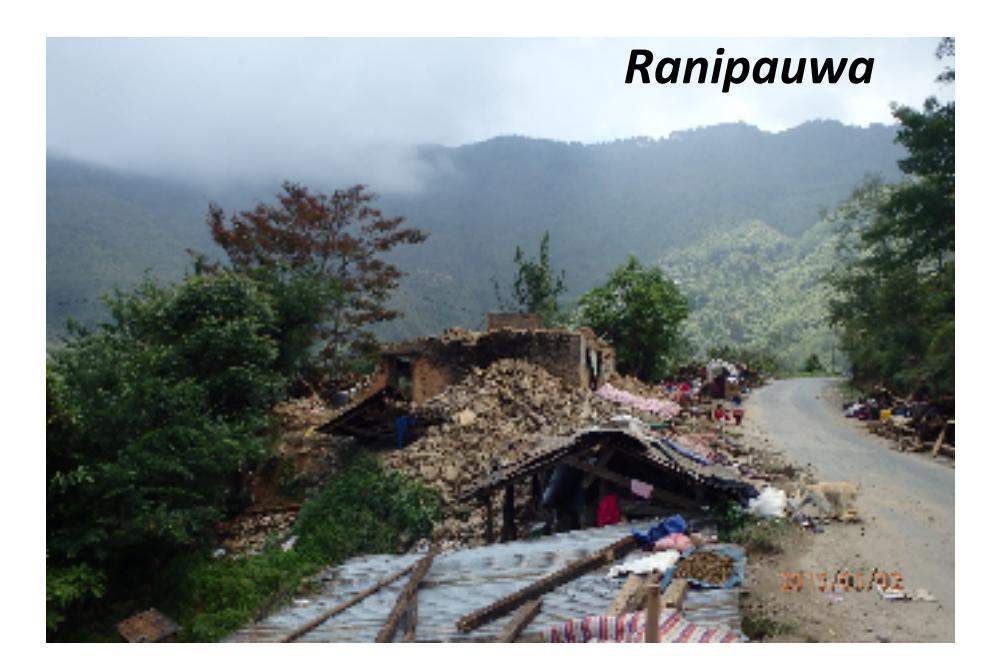
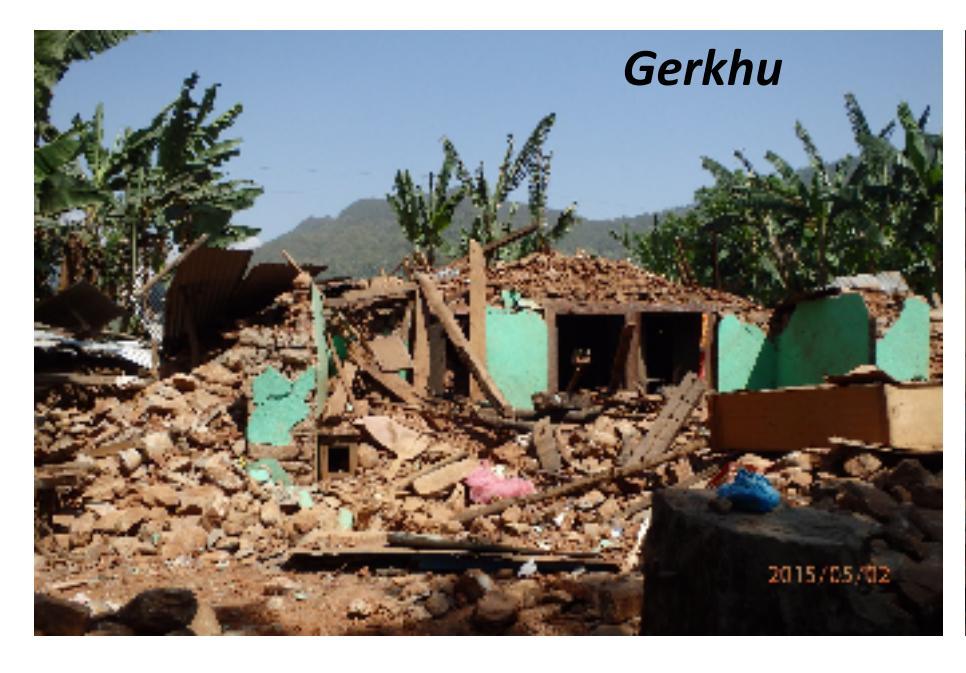
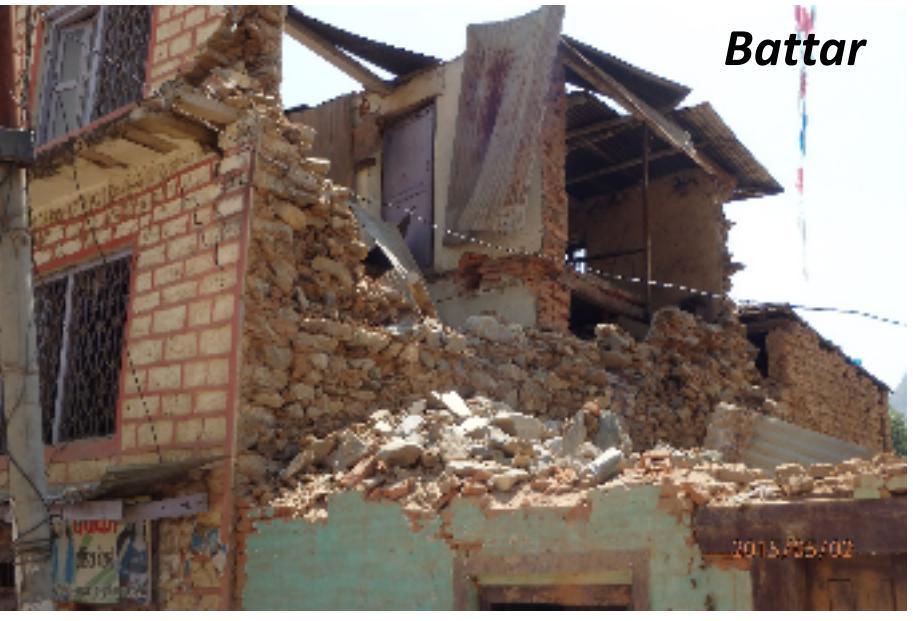
- Ranipauwa
- Nipala
- Battar (Bidur)
- Gerkhu
- > 80% houses damaged

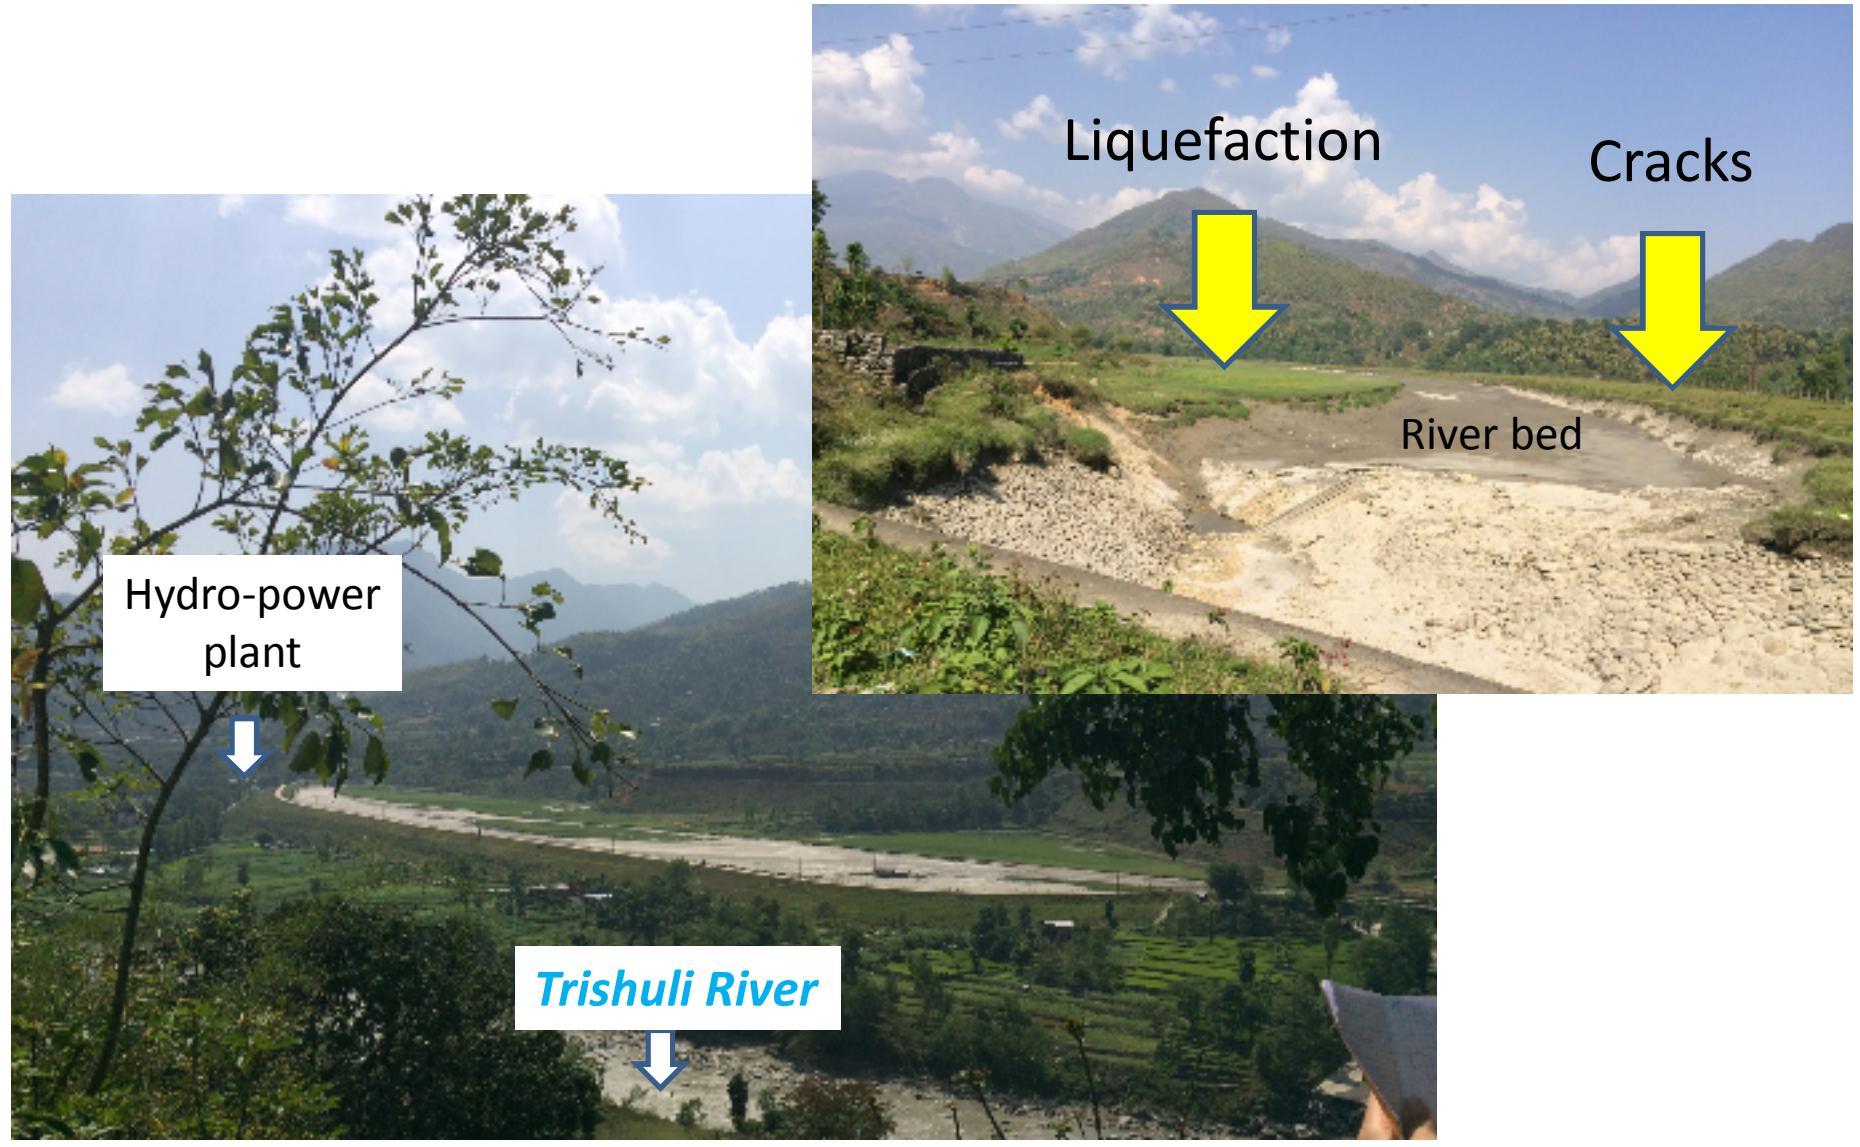
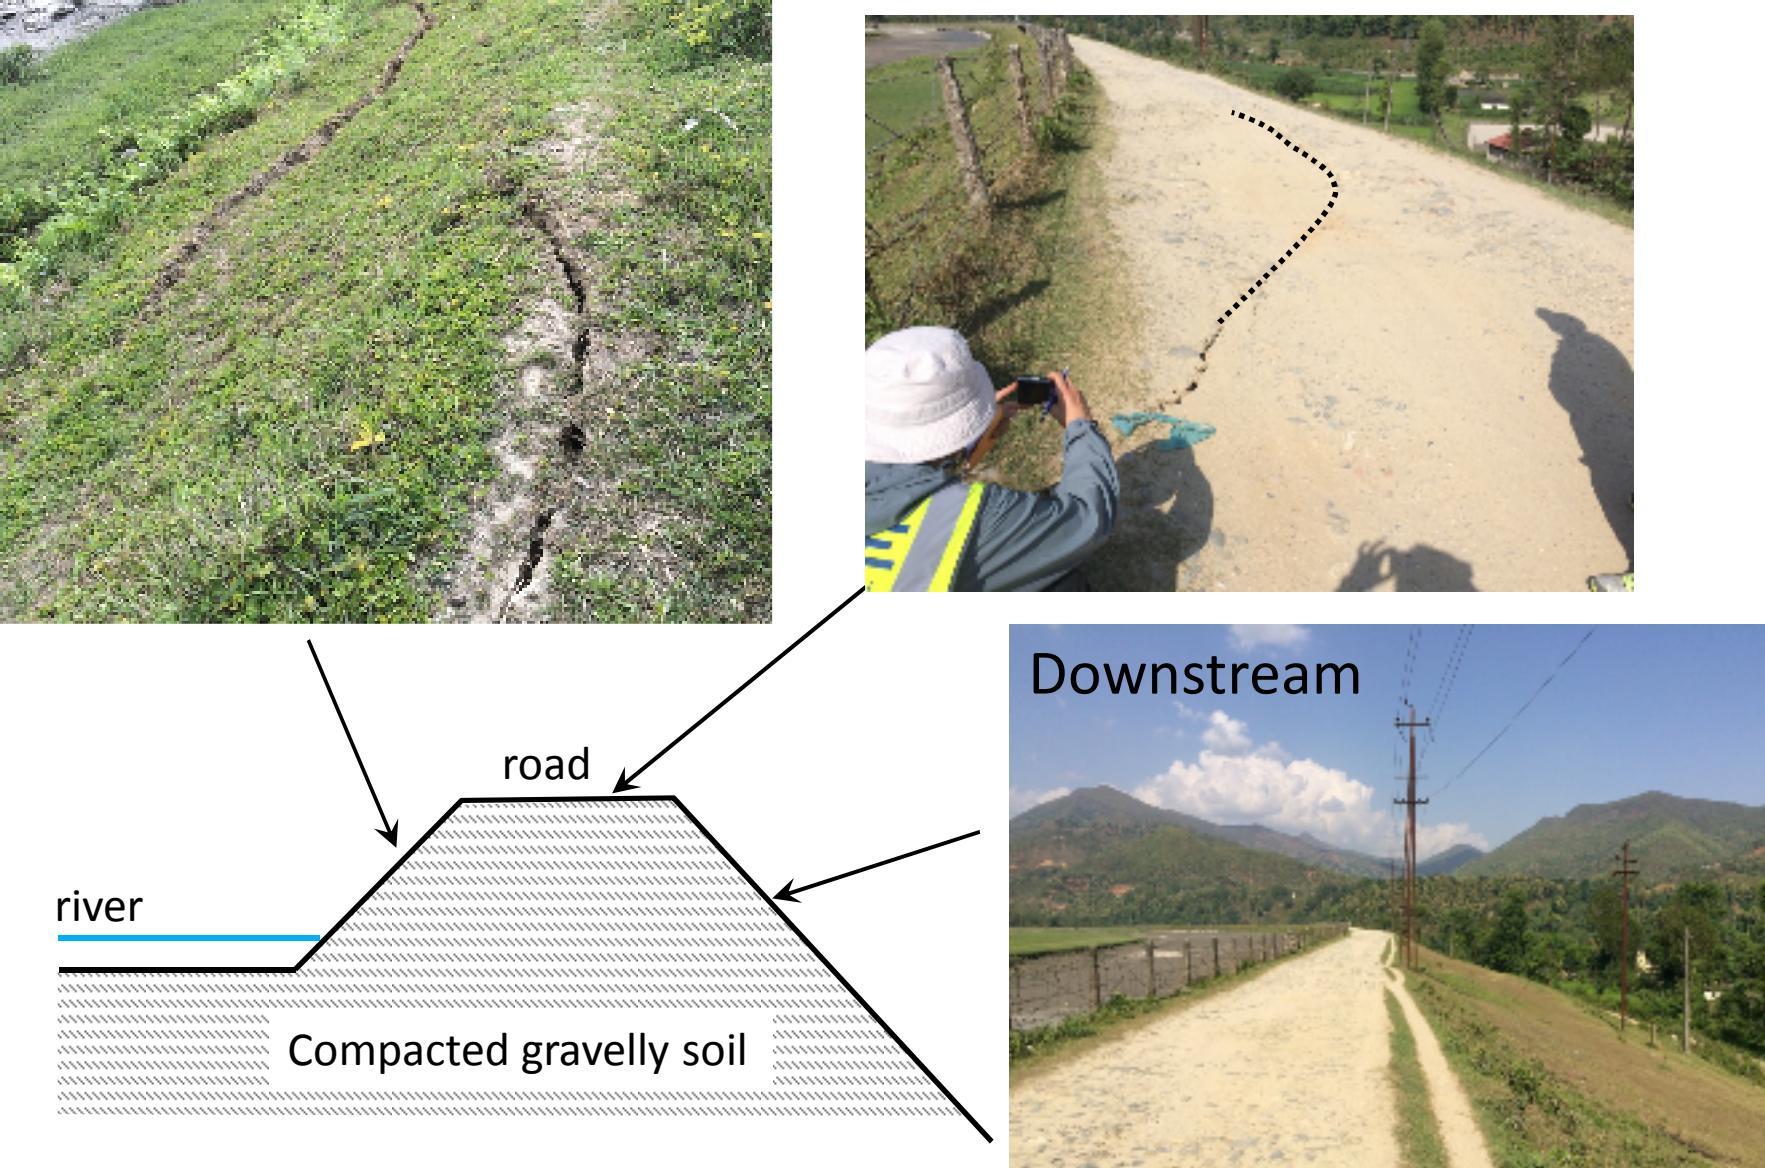
Damage to Trishuli earth dam

- In Trishuli, liquefaction was observed. However, most significantly, cracks along the upstream side of the earth dam are of concern
- In Melamchi, damage to houses and landslides were widely observed (close to Mw=6.7 epicenter of 4/26)
- In the epicenter area, many villages were completely devastated and a number of landslides could be observed
- In Pokhara valley, only minor damage to houses were observed. In Armala area, no new sinkholes were formed
- No damage to bridges was observed during the survey

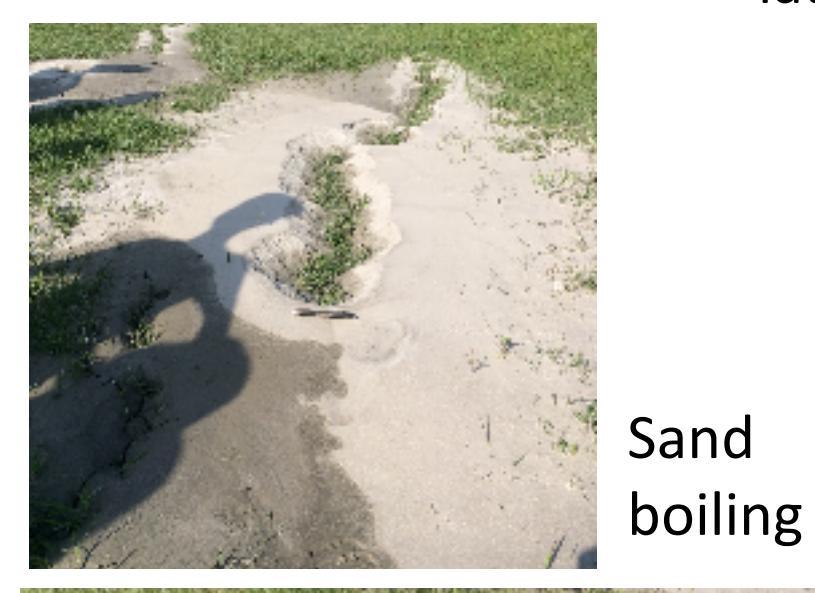
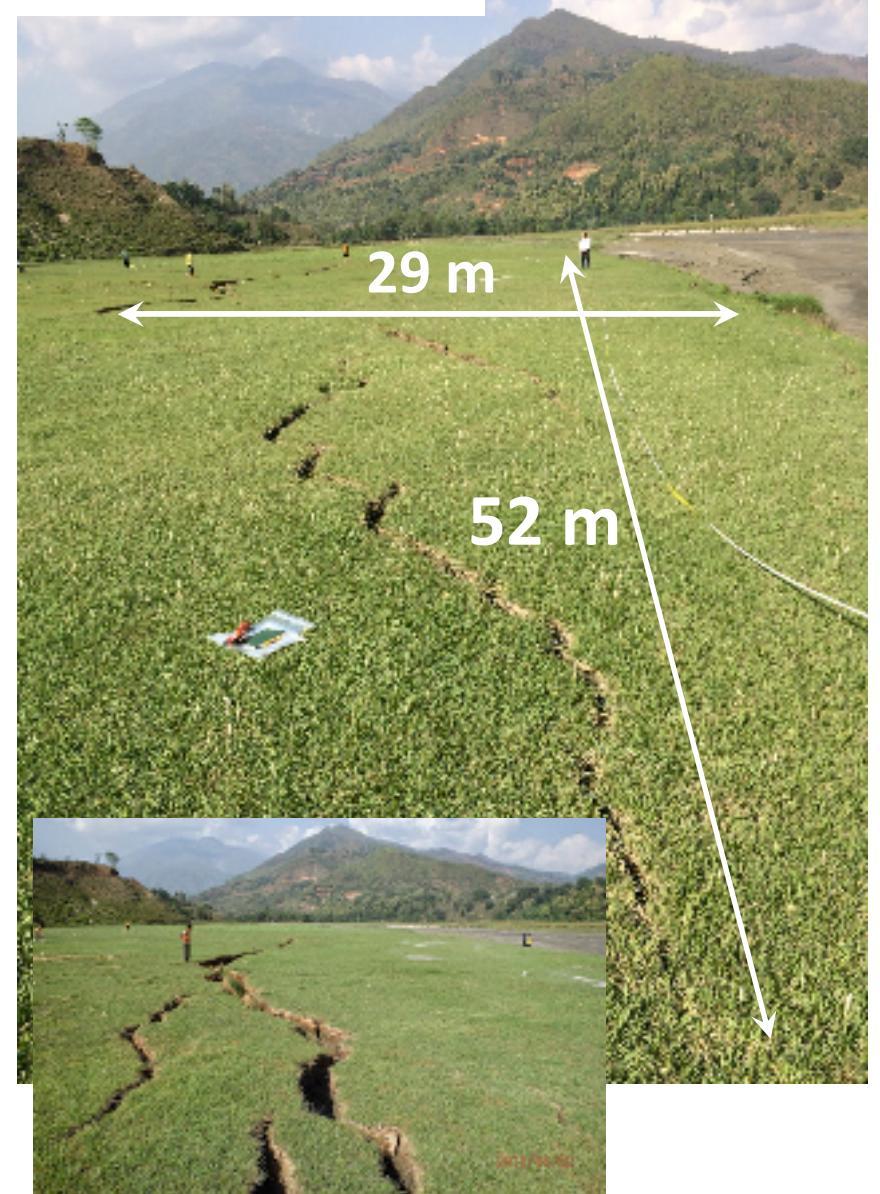
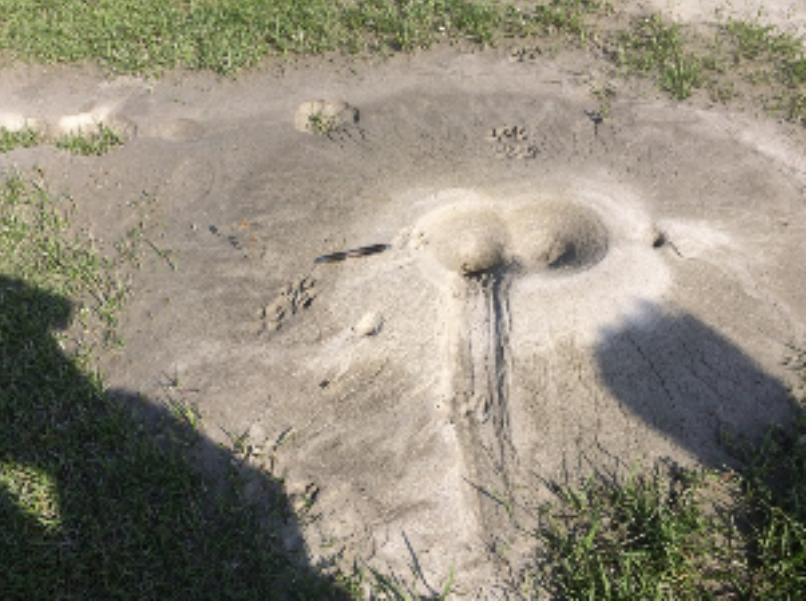
Soil liquefaction

Liquefaction-induced lateral spreading

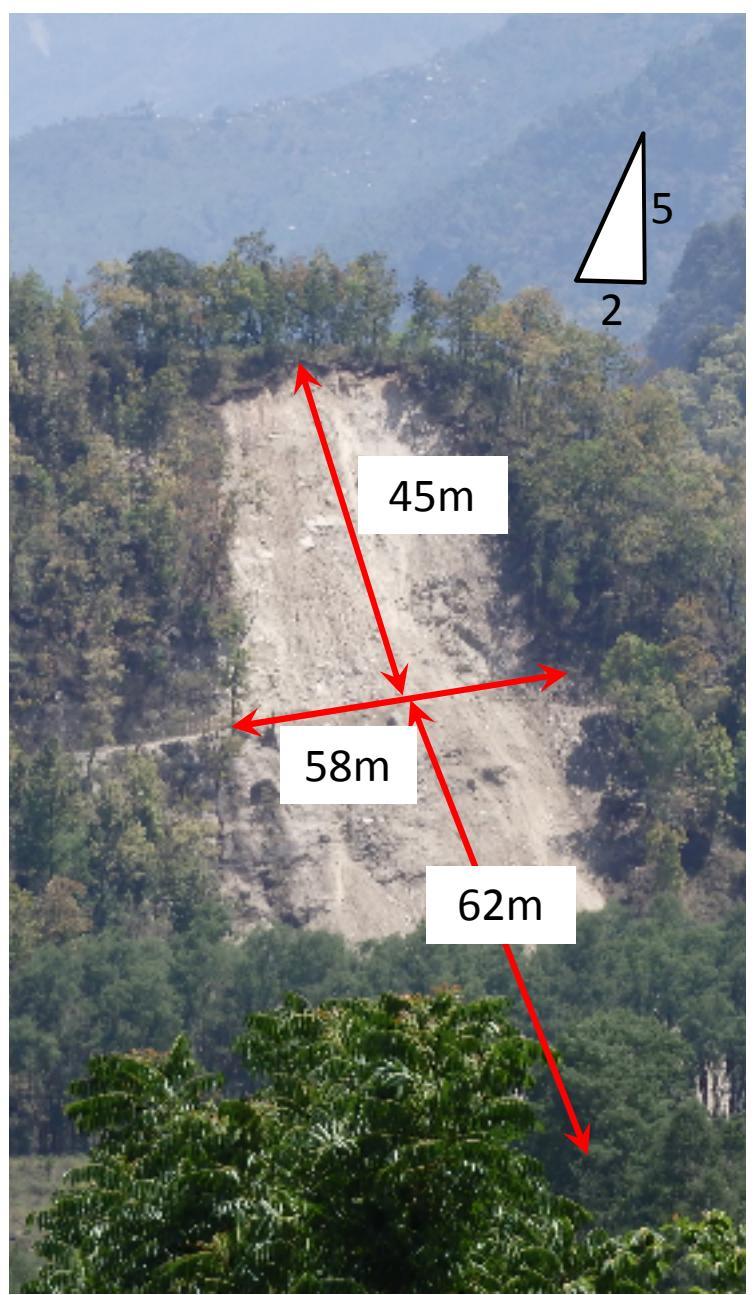
Landslide #2

Looking from the road down to the river
