Piles for RC/Steel-frame buildings pulled up by tsunami at Onagawa Town, in the March 11th 2011 East Japan Earthquake

Key Facts

- Hazard Type: Uplift of piles in tsunami engulfed area
- Date of the disaster: March 11th, 2011
- Location of the survey (Lat. Lon., name or address): Onagawa Town, Miyagi Prefecture
- Date of the field survey (if any): April 20th, 2011
- Survey tools (if any): GPS
- Key findings: Details of uprooted pile-supported buildings

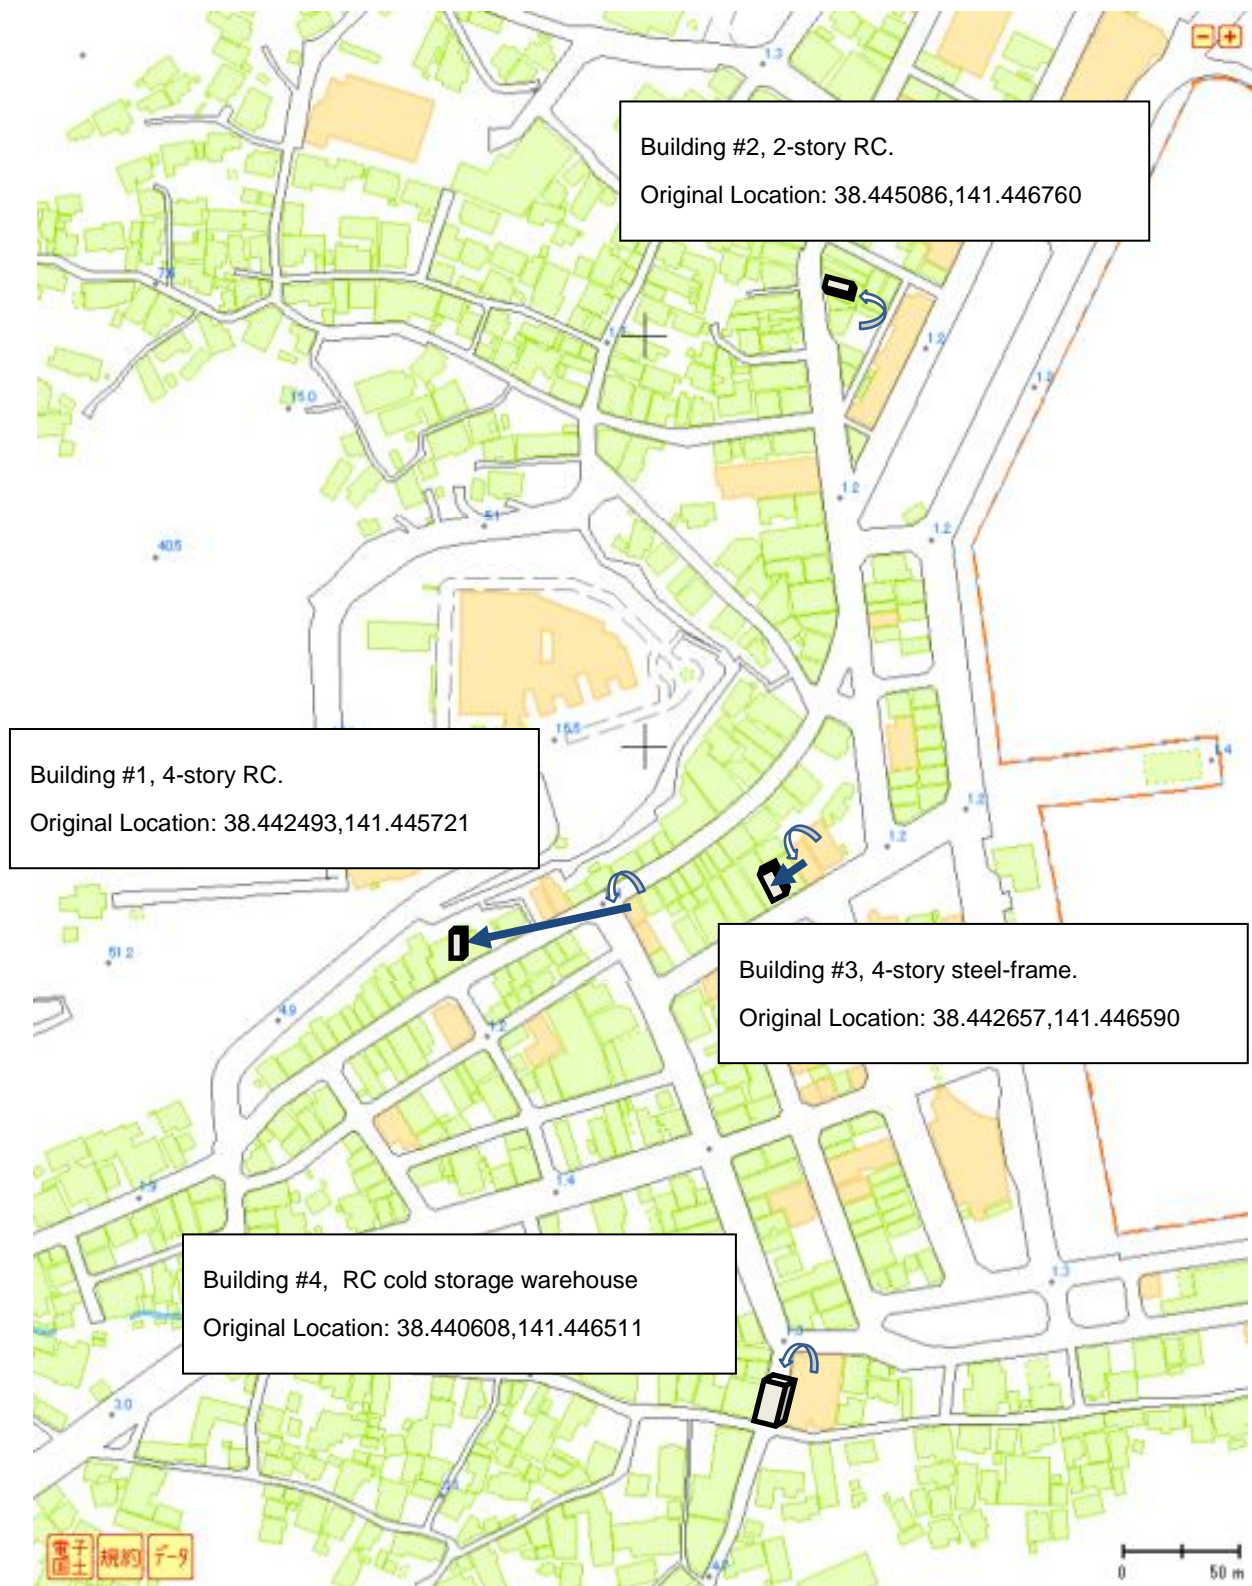
Fig. 2 Locations of uprooted pile-supported buildings in Onagawa (after Cyber-Japan²).

Fig. 2 shows the downtown center of Onagawa, facing Onagawa Bay. There were at least four pile-supported buildings found toppled and /or carried over some distances. Piles are all of PC (Pre-tension type centrifugal pre-stressed Concrete) type.

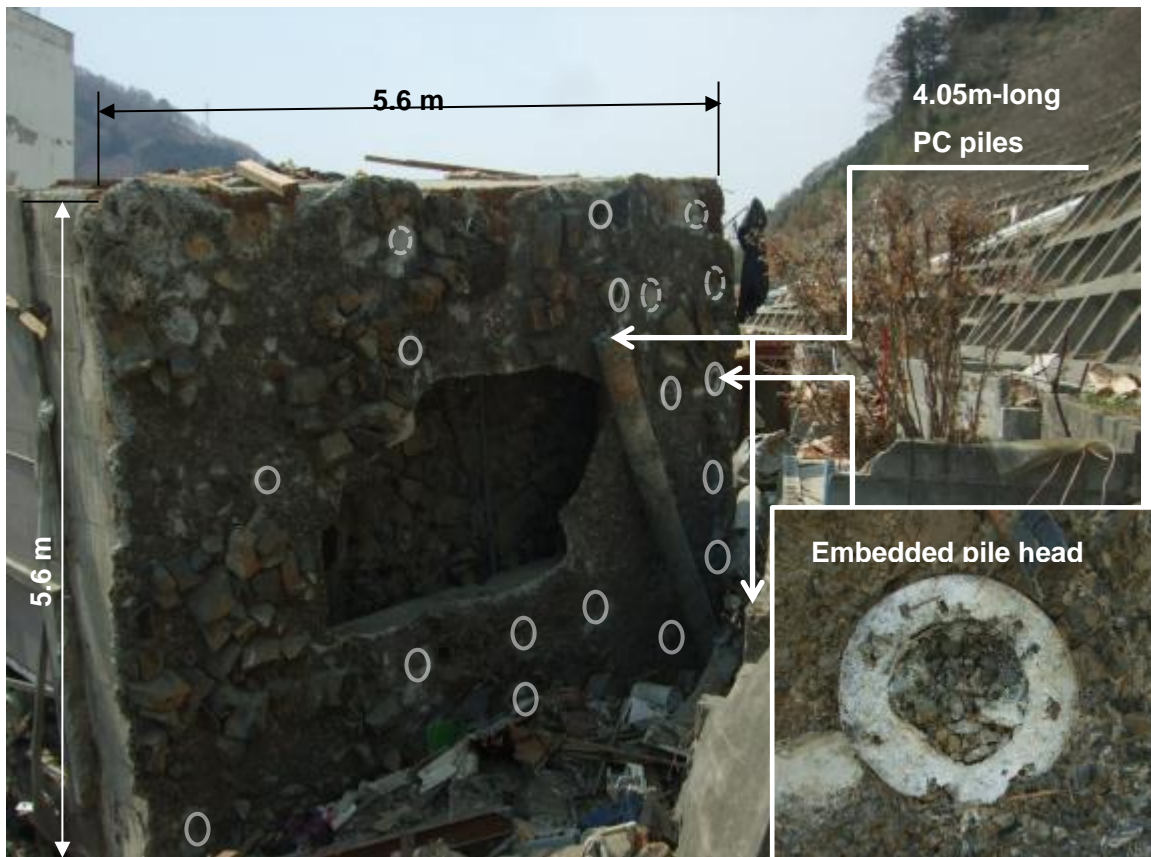
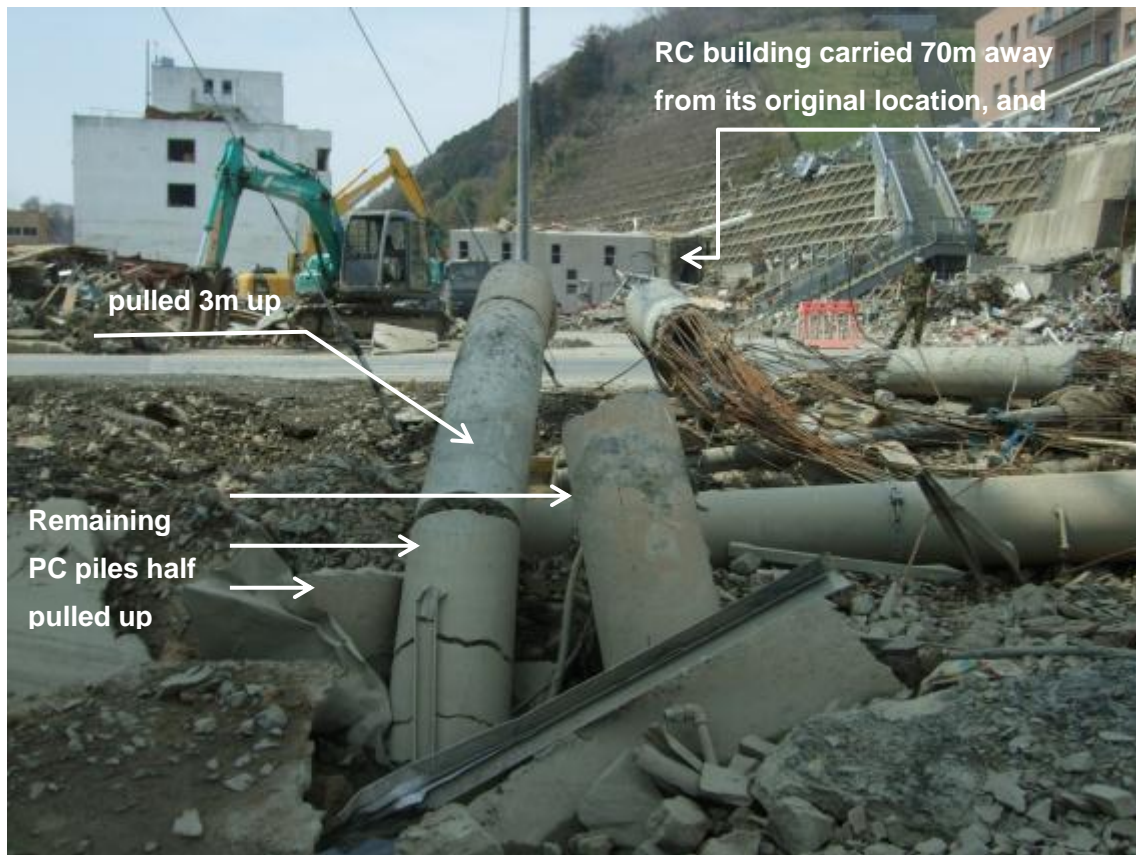
Building #1 was a thin and tall 4-story RC building (5.6m wide, 5.6m deep and 14.5m high) at N38.442482, E141.445728, which was carried over a 70m distance and lying west-face down with its bottom pushed against the cut-hillside of Onagawa Hospital (see Fig. 3).

Fig. 3 Bottom of foundation for Building #1 and piles left half-embedded in soil

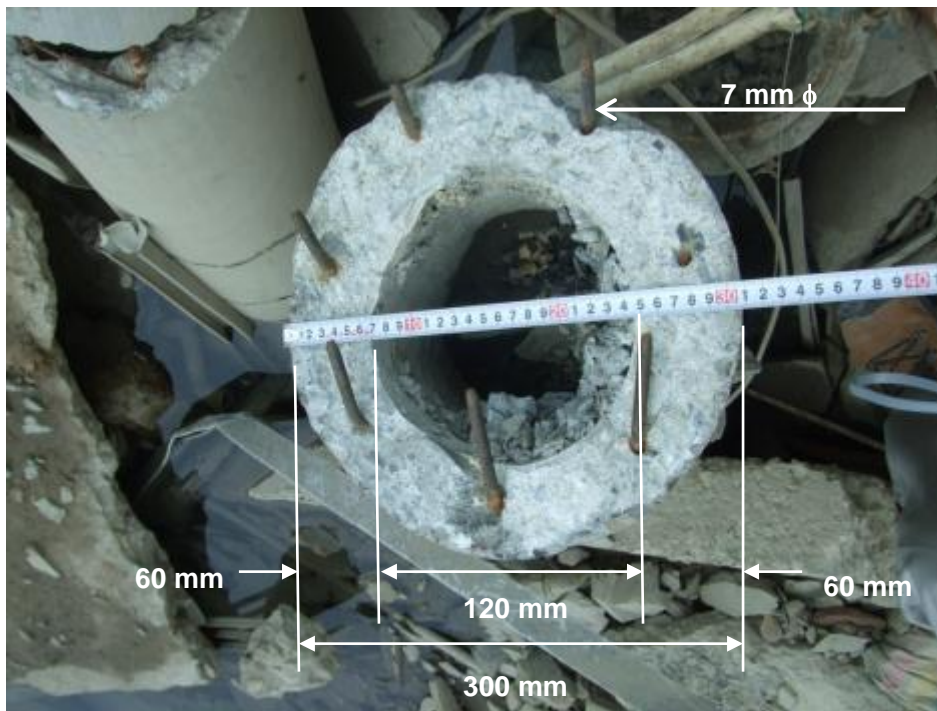
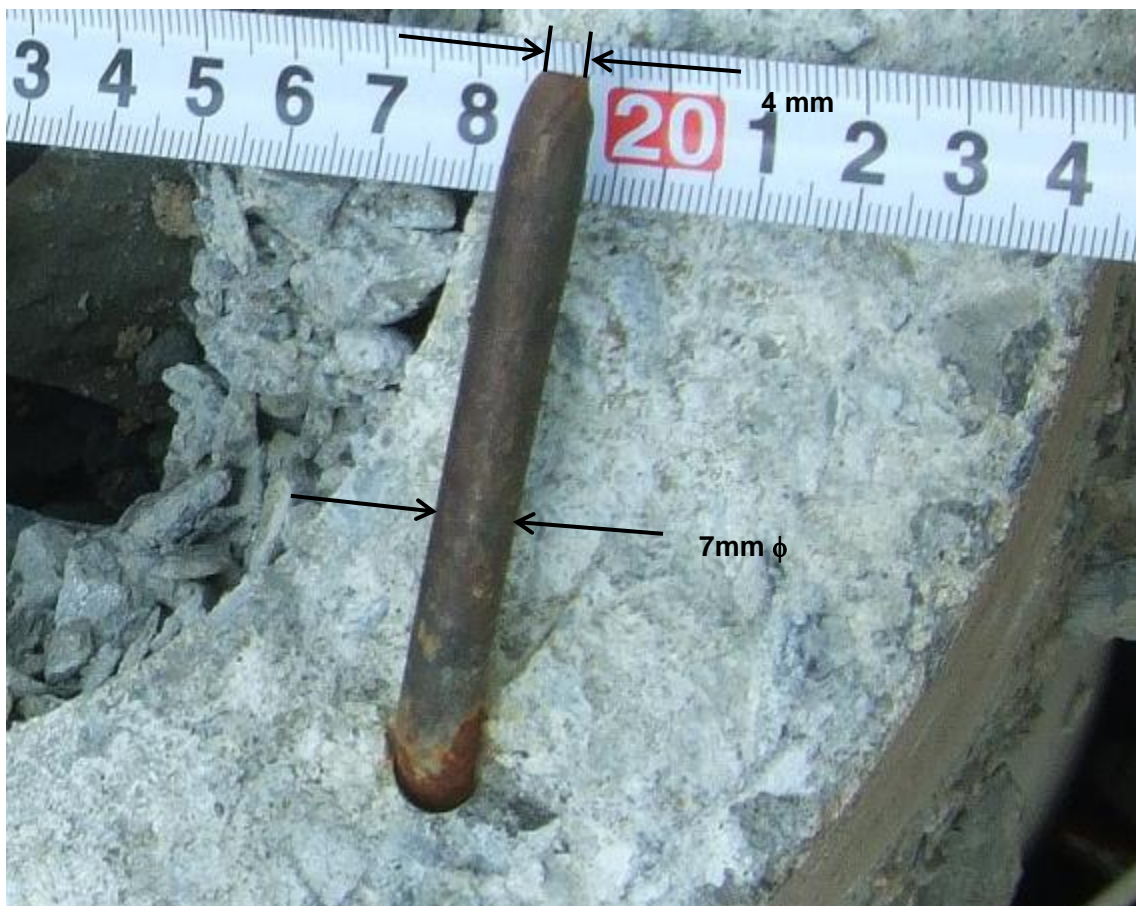
Fig. 4 Fracture surface of PC pile for Building #1: A fracture cross-section of PC (Pretension type centrifugal pre-stressed concrete) pile used for Building #1, 300mm and 120mm in outer and inner diameters respectively, has 7 PC wires exposed with cut ends thinning to about 4mm diameter.

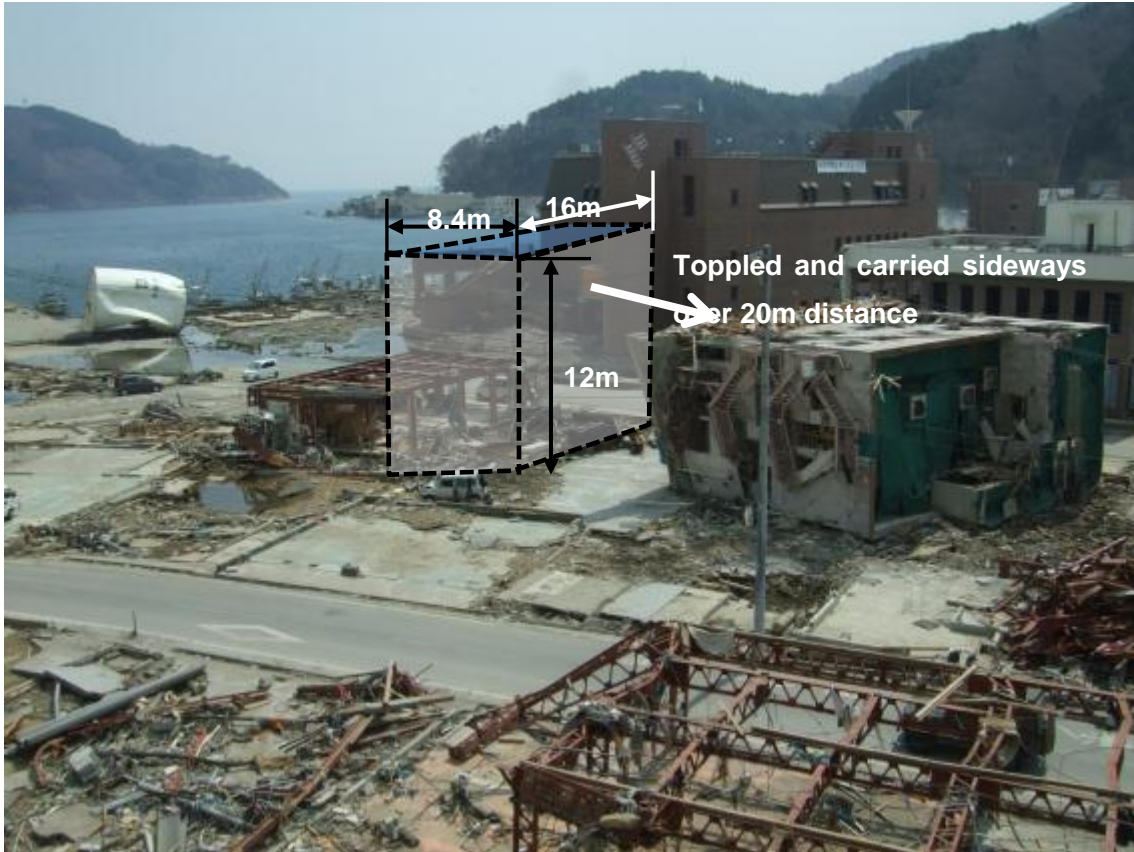
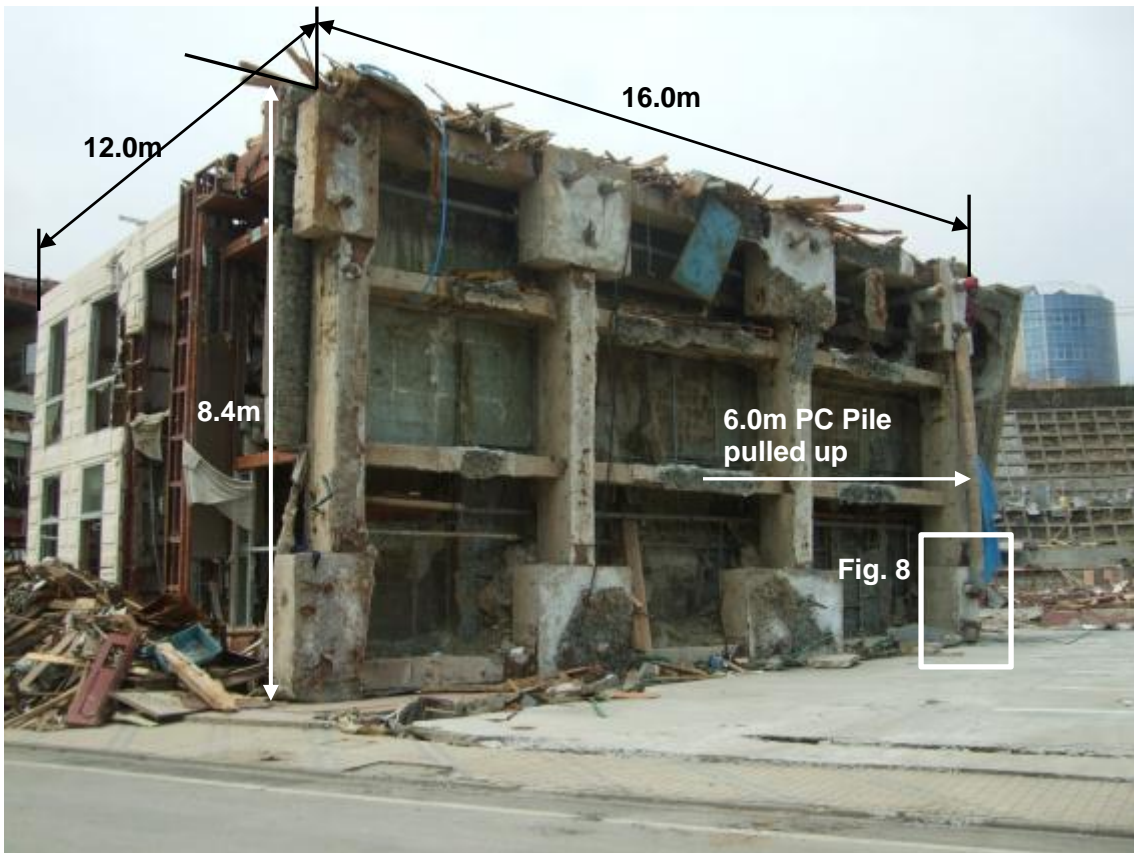
Fig. 5 Building #3 (Original location at Original Location: 38.442657,141.446590), A steel frame 4-story building was toppled and carried sideways over about 20m distance. A PC pile of about 6m long is found hanging down from the upper right corner.

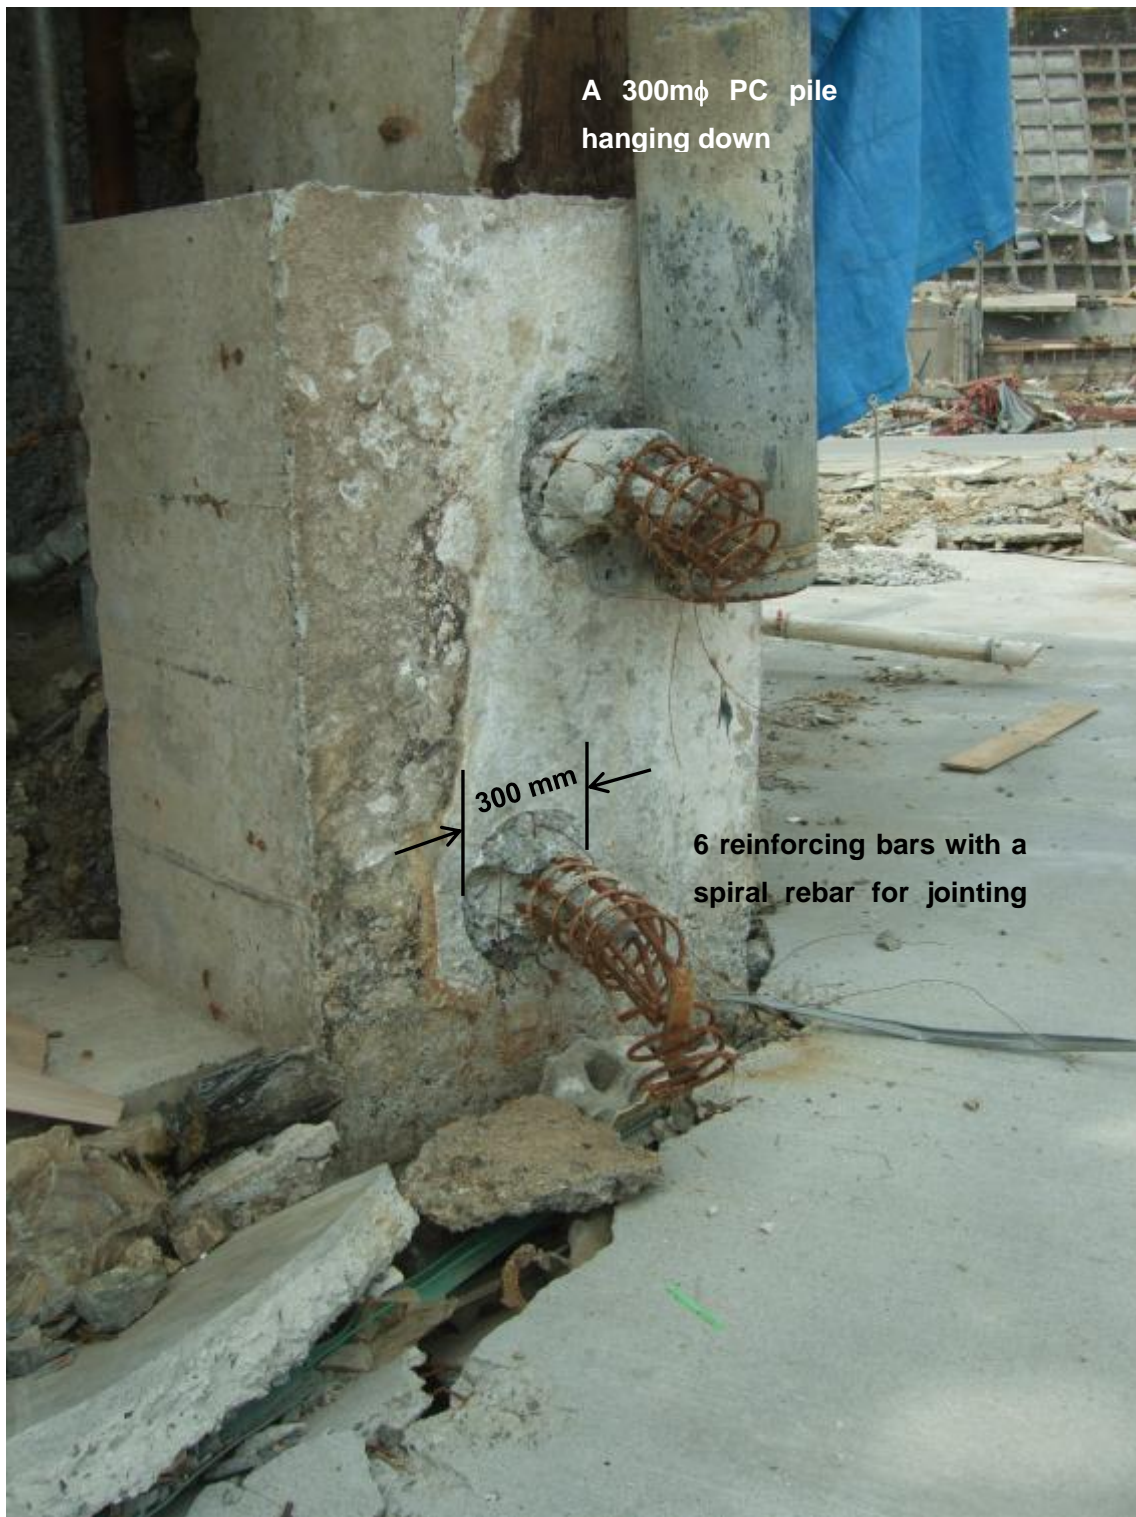
Fig. 6 Detail for jointing pile heads for Building #3: Detail of rebars for jointing a pile head was exposed. There are 6 rebars coiled in a spiral bar for each pile head.

There were at least four pile-supported buildings toppled and /or carried over some distances in Onagawa. They were mostly supported by PC piles of 300mm diameter. Jointing details of the PC pile heads differed from building to building. Some were identified as fixed ends (Buildings #1, #2), and others were more likely moment-free ends (Buildings #3, #4). Building #1 took the longest drift over 70m distance dragging at least two piles. According to the geological map, the town center spreads over late Pleistocene to Holocene marine and non-marine deposits. However, detail soil profiles for the original

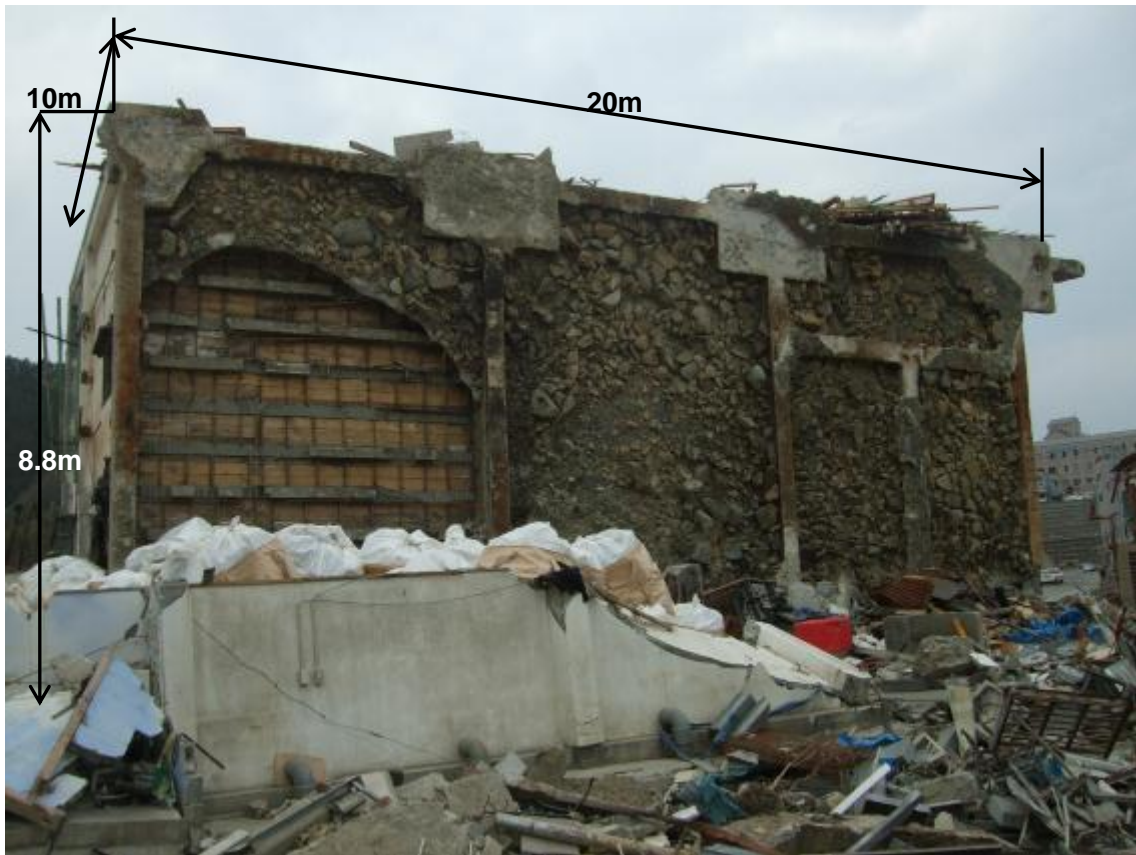
Fig. 7 Building #4: toppled west from its original Location at N38.440608, E141.446511. This was a steel-frame cold storage warehouse for fishes and seafood products. Dim marks of pile head are seen indicating the building was just resting on piles. This warehouse had a small door/window aperture.
