# Tsunami-induced Debris of Freight Containers due to the 2011 off the Pacific Coast of Tohoku Earthquake

Kentaro KUMAGAI<sup>1</sup>

## Key Facts

**Key Words:** The 2011 off the coast of Tohoku earthquake, tsunami-induced debris, freight container

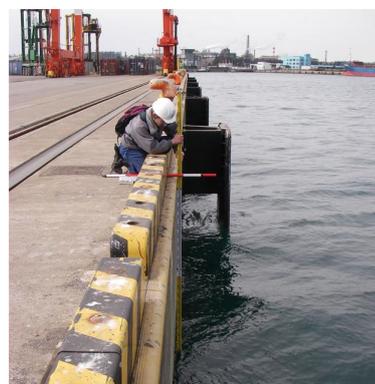
Fig. 13 Ground elevation measurement

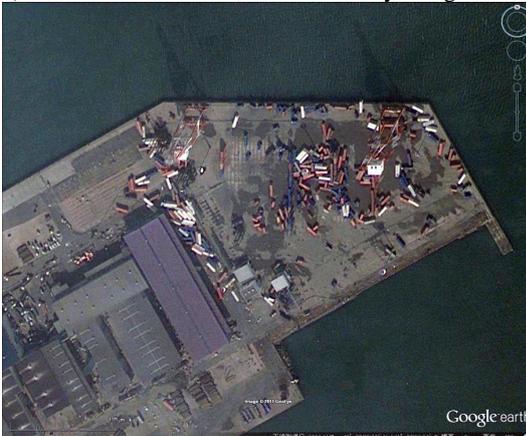
a) Pre-tsunami at June 6, 2010. Photo by Google Earth

b) Post-tsunami at March 13, 2011. Photo by Google Earth  
**Photo 2** Satellite View of Container terminal

Photos 2 a) and b) show satellite views of the terminal on June 6, 2010 and March 13, 2011, respectively. Many containers were scattered over a wide area of the terminal because of the repeated inflow and backflow of the tsunami. Some containers were concentrated around a warehouse. According to the hearing, 458 containers were located at the terminal after the tsunami, and 701 containers were lost from the terminal. Photo 3 shows that wire fences were also damaged and broken.

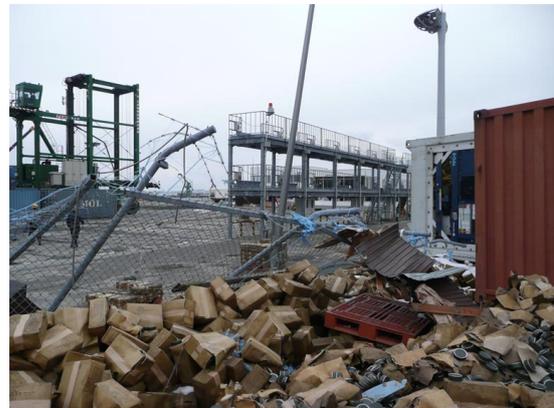
**Photo 3** Damaged wire fence on March 16, 2011.  
Photo courtesy of Mr. Yuji WATANABE

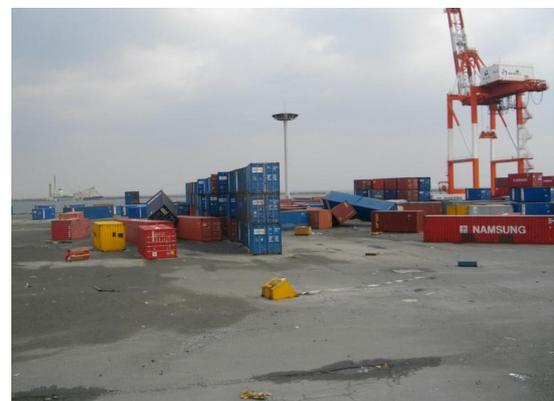
**Photo 4** Container terminal of the Hachinohe Port.  
Photo courtesy of Hachinohe Kowan Unso Kaisha, Ltd.

Although many containers were lost from the terminal, some triple stack containers remained. Photo 4 shows the terminal immediately after the tsunami. Some 20 foot triple stacked containers are in

their original positions. The cargo of these containers was ferronickel with a mass of approximately 20 t for each container. According to the hearing survey, it was observed that the bottom and middle containers in the triple stack were wet due to the tsunami. The container at the top remained dry. Although the triple stacked containers remained at their original posi-

t. On the other hand, the mass of double stacked 20 foot container with ferronickel is only 44 t. Therefore, the buoyant force is enough to drift these containers. This result agrees with the observed fact through Photo 4.

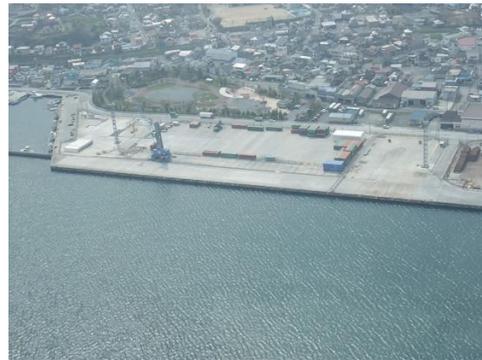
Photo 6 Aerial view of container terminal in May 2010, Photo courtesy of Iwate Prefecture

Fig. 19 shows a plain view of the Ofunato Port. The container terminal is located at the Nonoda area. Photo 6 shows an aerial view of the area in May 2010. 73 containers were stored in double stacks at the time of the earthquake. 35 containers are with cargo, and the other 38 were empty containers. No information was available on container size in length.

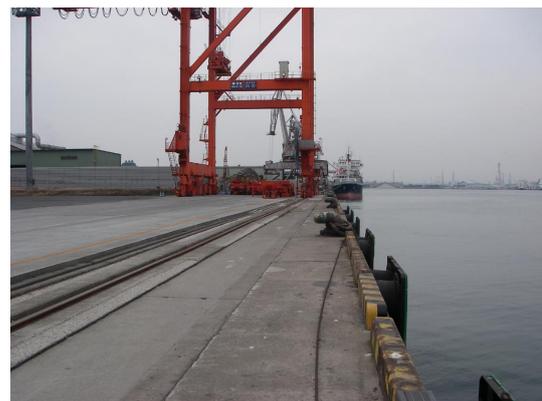
Fig. 25 Ground elevation of Sendai-Shiogama Port

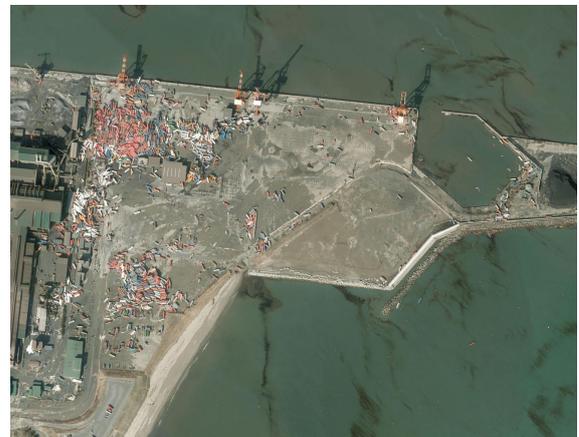
a) Pre-tsunami conditions on March 31, 2009.  
Photo by Google Earth

b) Post-tsunami conditions on March 12, 2011.  
Photo by GSI

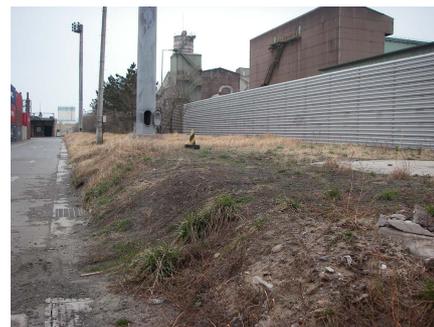
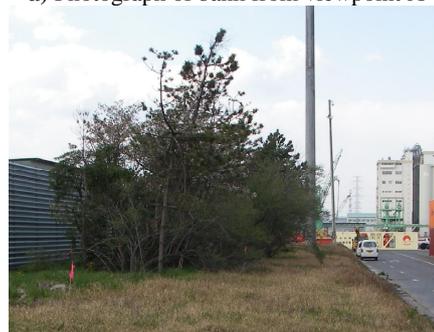
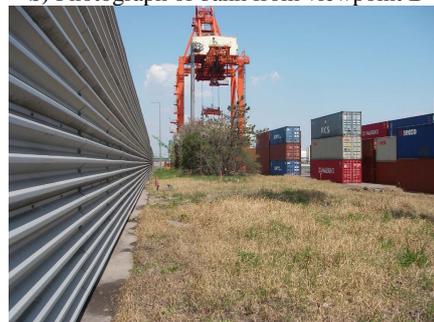
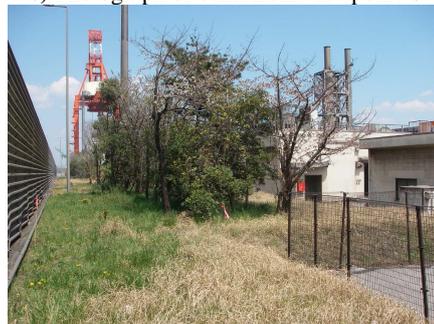
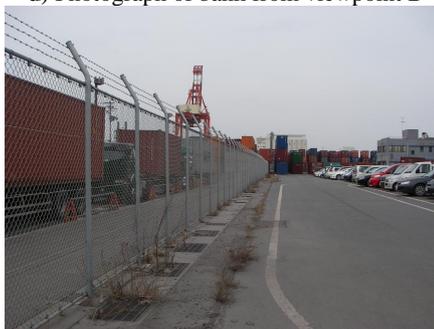
e) Photograph of wire fence from viewpoint E  
**Photo 9** West end of the terminal

**Photo 8 c)** shows that, in zones I and III, the steel board wall on the boundary had broken, and containers drifted westward beyond the boundary and to reach to the outside area of the terminal. **Photos 9 a)** and **c)** show zones I and III in April 2013. The wall had been restored already at that time. Both zones are in a treeless area, and containers were driven beyond the bank without interruption of vegetation. The wall was previously broken by the tsunami flow or by collision with containers.

In zone II, in contrast, the wall remained in its original condition despite the tsunami inundation. **Photo 8 c)** shows that the vegetations on the bank dammed the tsunami debris and prevented the wall from collapsing. **Photo 9 b)** shows the vegetation in the zone. The differences between zone II and zones I and III imply that the bank and trees on the bank have some effect for blocking the containers in this terminal.

There is no bank in zone V. A wire fence separates the terminal area from the outside of the terminal, as shown in **Photo 9 e)**. Containers drifted to westward beyond the boundary and reached the outside area of the terminal. The wire fence was broken due to the tsunami.

a) Photograph of bank from viewpoint A

b) Photograph of bank from viewpoint B

c) Photograph of bank from viewpoint C

d) Photograph of bank from viewpoint D

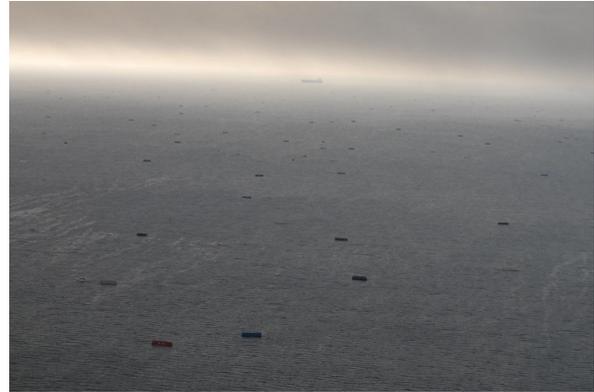
**Photo 10** Aerial view of containers on sea surface of Sendai Bay, Photo courtesy of the Japan Coast Guard

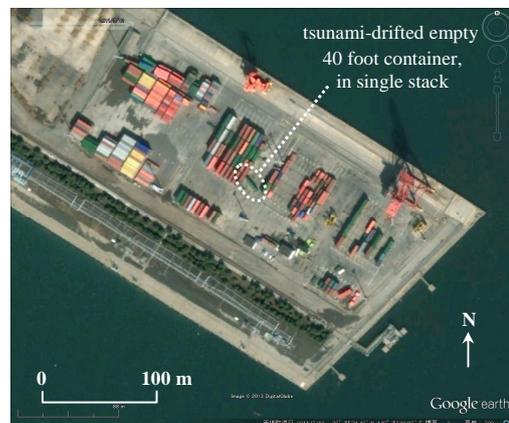
**Photo 13** Container terminal of Onahama Port on March 13, 2011. Photo by Google Earth

According to hearing, no container was driven to the outside of the terminal, and no containers were lost from the container terminal. **Photo 13** shows an aerial view of the container terminal on March 13, 2011, following the tsunami. All containers remained inside the terminal. However, one empty 40 foot container in a single stack was moved by the tsunami and remained at the center of the terminal.

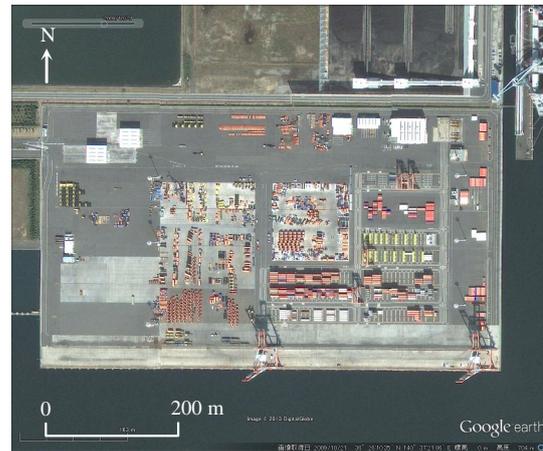
a) Pre-tsunami conditions on Oct. 21, 2009.  
Photo by Google Earth

b) Post-tsunami conditions on March 12, 2011.  
Photo by GSI

**Photo 14** Aerial view of container terminal of Ibaraki–Hitachinaka Port

The tsunami entered the inner harbor through the north and south openings of the breakwater. According to a worker at the terminal, containers were swept by the tsunami, which entered the inner harbor through the south opening. **Photo 14 b)** and **Fig. 36** show an aerial view and a sketch of the terminal after the tsunami, respectively. Many containers were swept and were concentrated at the northern end of the terminal. If the movement was caused by the tsunami through the south opening of the breakwater, the containers should have been swept from the south to the north. This fact coincides with the eyewitness report from the worker.

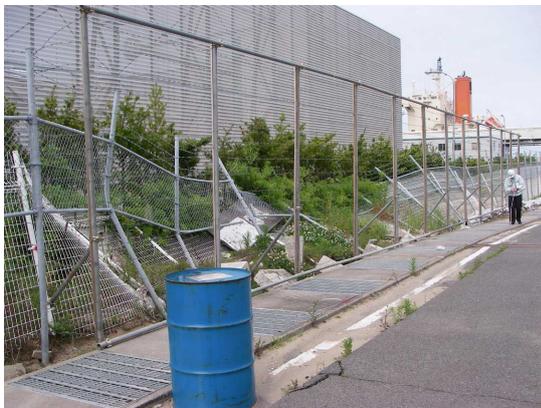
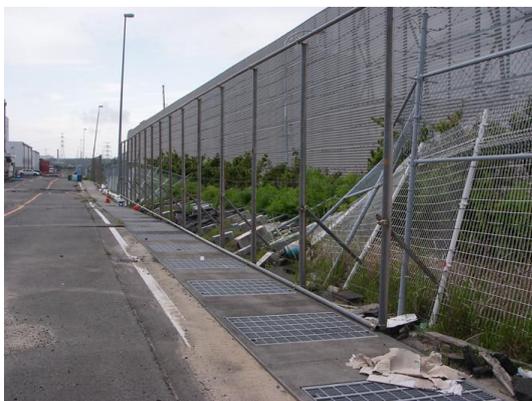
a) Snapshot from view point A

b) Snapshot from view point B

**Photo 15** Snapshots of wire fence

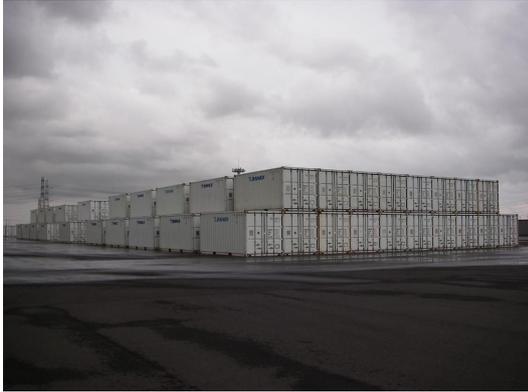
**Photo 17** 20 foot containers with cargo in area G on September 25, 2012

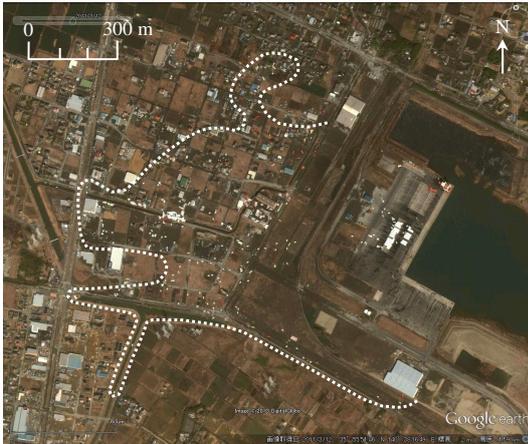
**Photo 18** Aerial view of area around the container terminal on March 12, 2011, Photo by Google Earth

**Photo 18** shows an aerial view of container scattered area behind the terminal. It can be seen that containers were scattered in a wide area behind the terminal. Koyama (2011) developed a distribution map of the scattered containers on the basis of his field survey and photo image analysis research<sup>12)</sup>. According to Koyama's research and an additional photo image analysis conducted by the author, the area in which containers arrived from the terminal due to the tsunami was determined, as indicated by the dotted line in **Photo 18**. The size of the area is approximately 1.2 km in an east-west direction, and approximately 1.1 km in a north-south direction.

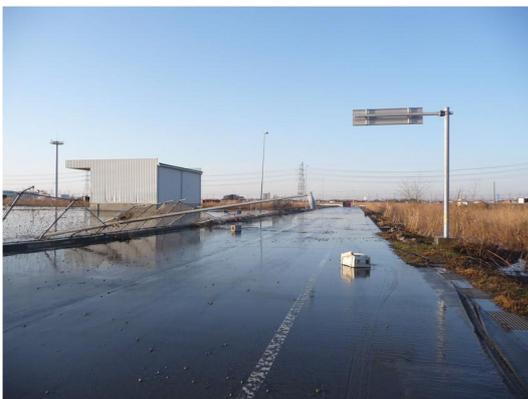
**Photo 19** Broken wire fence of container terminal in Kashima Port, Photo courtesy of Ibaraki Prefectural Office

**Photo 19** shows the wire fence at the container

terminal, which was broken by the tsunami, from the viewpoint of X in **Fig. 40**. According to the photo, the wire fence was severely damaged and fell toward the outside of the container terminal.
