Follow-up report of damage caused by the Gorkha Earthquake, Nepal, of April 25th, 2015

- Hazard Type: Earthquake
- Date of disaster: April 25th, 2015
- Location of Survey: Kathmandu, Dhunche, Nepal
- Date of the field survey: July 11th to July 16th and October 31st to November 3rd, 2015
- Survey tools: Dynamic dual-frequency positioning system, Microtremor sensor, Surface wave survey measurement tool
- Key findings:
 - 1) Surface Wave Surveys near the damaged section of Araniko Highway identified the presence of a shallow soft soil layer, which is considered to be an organic soil deposit.
 - 2) Creeping nature of a landslide mass was clearly observed along Pasang Lhamu Highway at the southern limb of the Kuncha-Gorkha anticlinorium.

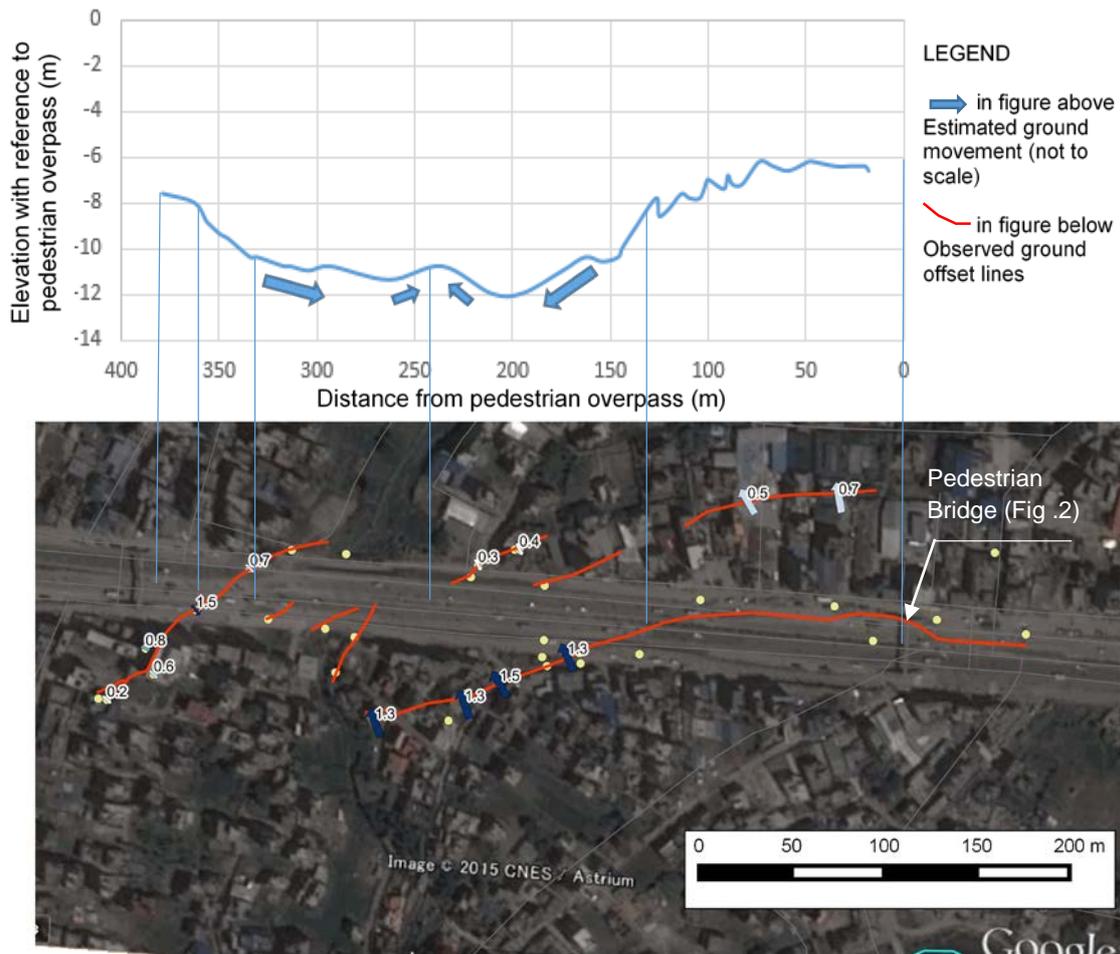
Fig. 1 Depressed section of Araniko Highway and ground offsets³⁾ (Photo from Google Earth)

A section of the Araniko highway crosses a small valley at Kausaltar with an embankment. This section has sunken seriously in the Gorkha Earthquake. The location is about 2 km southeast of the Tribhuvan International Airport, Kathmandu. Several lines of vertical ground offsets appeared diagonally across this road making up a swath of ground offset lines (Fig. 1³⁾).

The offset lines that appeared on the ground are about parallel to each other trending in ENE to WSW direction. These offset lines disappear beyond their eastern and western ends, and were about 300 to 400 m long at the most, indicating that the failure was just localized within this short extent of the swath. While the maximum vertical offset of about 2m was reached near boundaries between the terrace and the valley, the sagging part of the highway embankment has been slightly pushed up as shown in Fig. 1³⁾. This ground deformation was responsible for the damage to a two-span continuous pedestrian overpass (Fig. 2), whose north pier rests exactly on the northeasternmost line of ground offset while the other two are on the relatively intact hill terrace. As the result, the

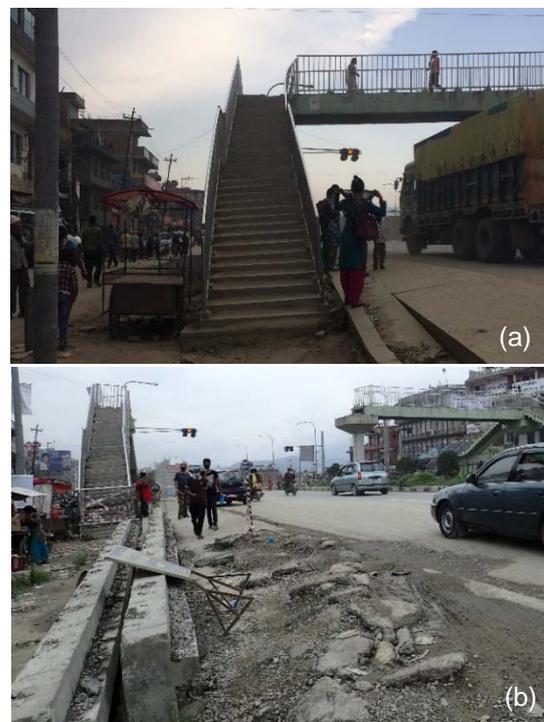
Fig.2 Pedestrian overpass over Araniko highway at Kausaltar (27°40.475' N 85° 21.865' E) :
 (a) dislocated bridge photo on May 3rd 2015 and
 (b) demolished northern deck of the overpass on July 15,

northern pier was on an outward tilt, causing the joint between the pier and the deck to open up by about 40 to 45 cm. The opening was found to have been a little expanded during the two months of period between the surveys by the advanced and main teams. There could have been a good chance for any single supported deck of overpass to fall upon the highway with its spans expanded. Though it was a two-span continuous overpass, the northern half of the deck was demolished in view of the authors' previous report³⁾ (Fig. 2(b)).

The above sequence of events can be an indication that the ground may have moved a little even after the earthquake. Soil samples from boreholes drilled after the earthquake for reconstructing the highway reportedly had an inclusion of shallow organic soil as

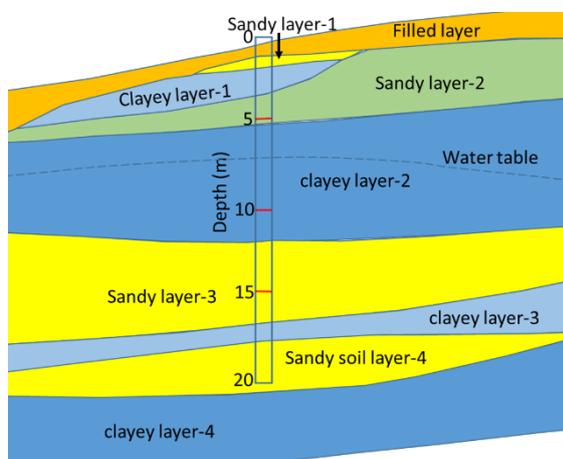
Fig. 3 Soil profile estimated from borehole data (provided by JICA⁴⁾)

shown in Fig. 3 (JICA⁴⁾); organic soil is particularly susceptible to instability conditions with a marked loss of shear strength in an intense shake.

Borehole B⁴) (Figs. 4 and 6), showing the likelihood that the organic soil layer reaches Line 1. A line of vertical ground offset crosses Line 1 at its 48m distance, and immediately below this point, there spreads one more soft soil layer underlying the softest soil layer. Similar soil profile was estimated for Line 2 (Fig. 6(b)). Below the capping soil with shear wave velocity ranging from 160 m/s to 180 m/s, a soft soil layer spreads across the entire stretch of Line 2. This soft soil layer is thickest near the vertical offset line and Borehole B, reaching 4 to 5 m below the ground surface. It is also noted that below both the line of ground offset and the buckled highway pavement, there spreads one more soft soil layer immediately beneath the softest soil layer.

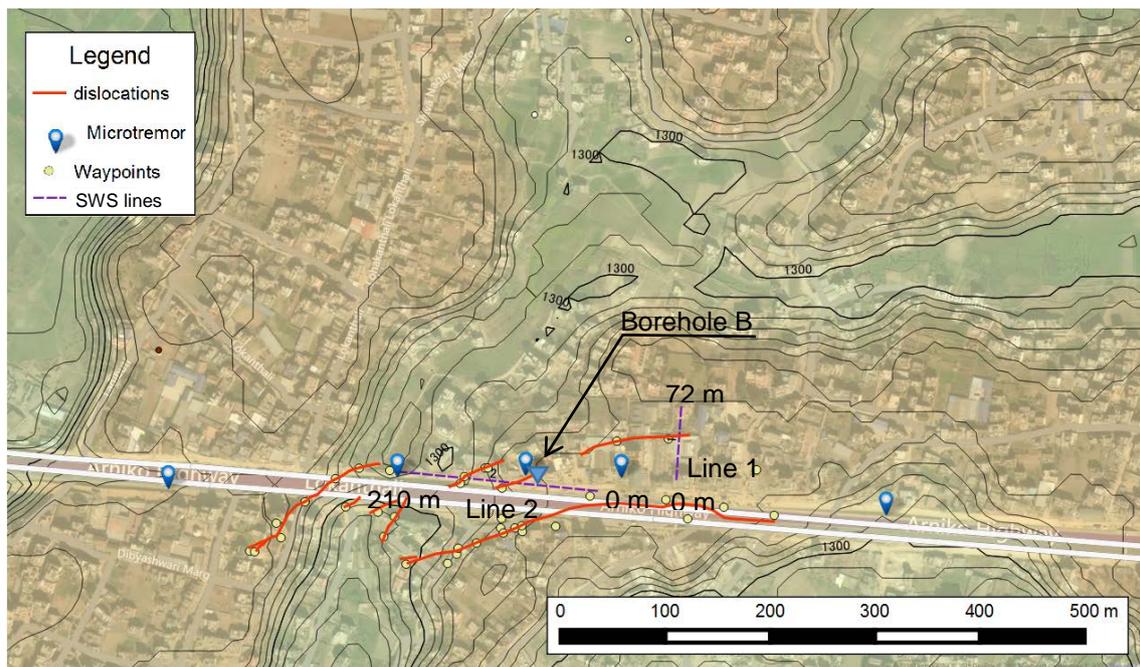
A Surface Wave Survey (SWS) test was conducted along two lines shown in Fig. 4. Line 1 extends 72 m in the transverse direction of the highway, while Line 2 covers 210m stretch along the highway, both crossing some major lines of ground offset.

Fig. 4 Surface wave Survey test profile lines 1 and 2

Microtremor observation is conducted at five points along the highway (Fig. 4). Points 1 and 5 are located on the intact terrace, while Points 2, 3 and 4 are along the damaged section of the highway. As these points are lined along the busiest highway in Kathmandu, main source of ambient tremor can be predominantly vehicular movements and/or human activities. A portable device called Network Sensor (CV374-AV, Tokyo Sokushin Co. Ltd.) consists of three servo type accelerometers (VSE-14C, Tokyo Sokushin Co. Ltd.) for two horizontal (X, Y) and one vertical (Z) components, each having the velocity cover-range of 2 cm/s over the frequency range of 0.2 to 100 Hz.

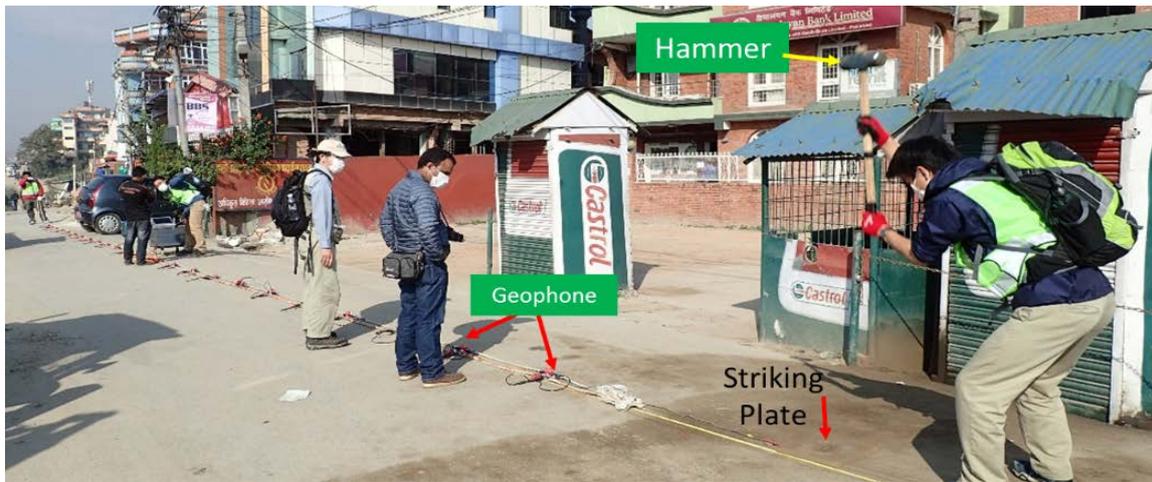
SWS test is a nondestructive geophysical method widely used to investigate sub-surface structures. Penetration depth of a surface wave that propagates along the free surface depends upon its wavelength such that the longer wave-length influences the deeper portion of the ground, thus reflecting mechanical nature of deeper soils. Given this nature of surface waves, both the number of geophones and the geophone interval are very important. The entire stretch of the line of geophones is to be at least two times the depth of interest, while the geophone interval determines the spatial resolution of the analysed 2D soil profile. In the authors' survey, total 24 geophones are lined up at every 1 m interval, and this fixed spread of geophones (land streamer hereafter) is towed along the ground surface. A 5 kgf hammer is used to generate surface waves by hitting vertically a rubber plate, maintaining the source and the end receiver offset of 1m. After acquisition of the data from every impact, the land stemmer is towed 1 m forward simultaneously. This process is repeated for the entire stretch of the measuring line. Fig. 5 shows the typical SWS test arrangement in this investigation.

Fig. 5 Land streamer of geophones

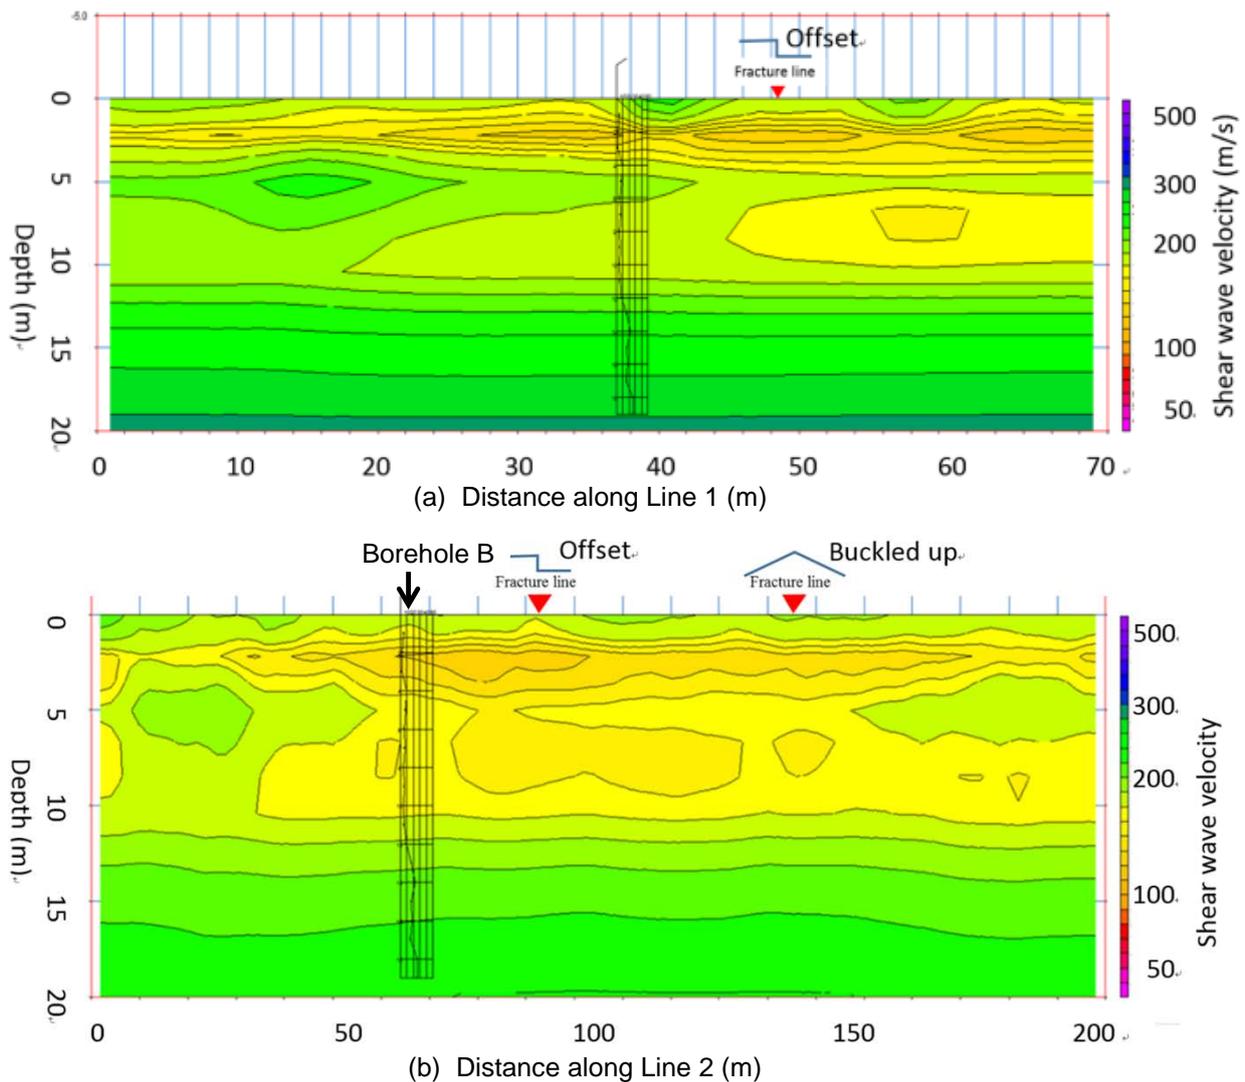
Fig. 6 Estimated soil profiles along Lines 1 and 2

The result of SWS test along Line 1 is shown in Fig. 6(a). The back-analysed shear wave velocities for the uppermost surface layer of about 1 to 2 m thickness range from 160 to 180 m/s, indicating the presence of compacted gravel and/or filling materials. This uppermost layer caps a softer soil

layer with its estimated shear wave velocity below 150 m/s. The thickness of this soft soil layer varies from location to location, but generally gets thicker as we go away from the highway and reaches around 4m at the very end of the line. The average depth of this layer corresponds to the organic soil taken from

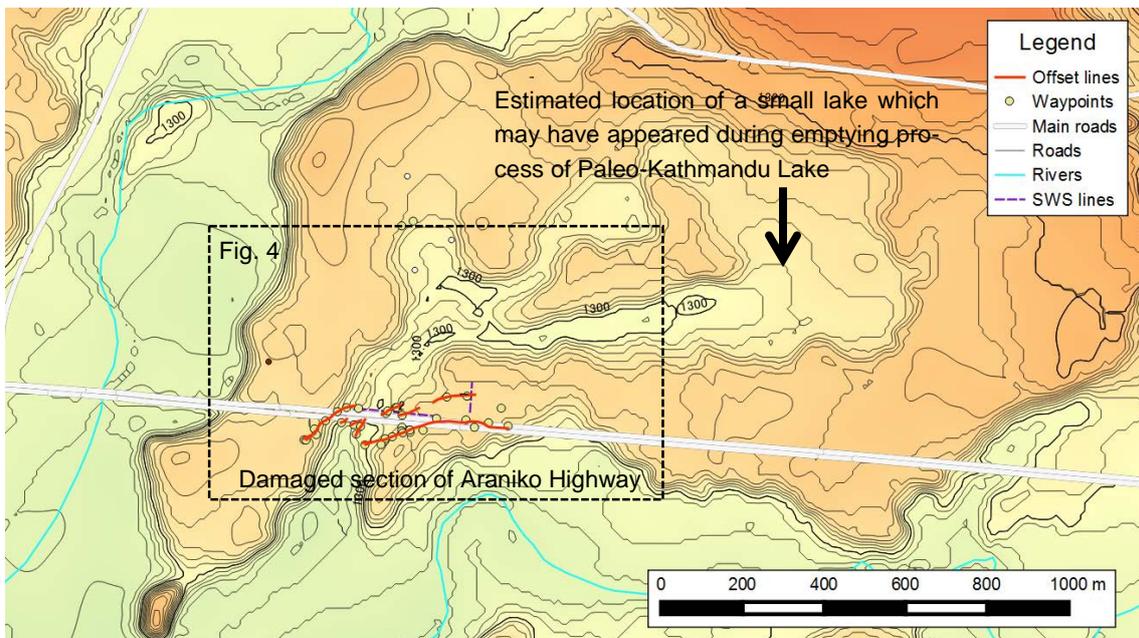
Fig. 7 Estimated location of a small lake which may have appeared during emptying process of Paleo-Kathmandu Lake

is all organic soil to be sure, but at least the fact that there was an organic soil at Borehole B clearly indicates that there was a paleo-lake whose water was covering this area. Morphological feature of this area suggests the presence of the small paleo-lake basin just north of the damaged section of the highway as shown in Fig. 7. Though the Paleo-Kathmandu lake was formed over one million years ago with the tectonic uplift, the organic soil here may be much newer than the other surficial deposits covering the entire Kathmandu basin. When the Paleo-Katumandu lake was almost emptying, there yet remained a little amount of waters of small lakes and ponds which included the one that covered the northern part of the damaged highway section. Fig. 8 is a birds eye view map of the damage section together with SWS results. As we go towards the estimated small paleo-

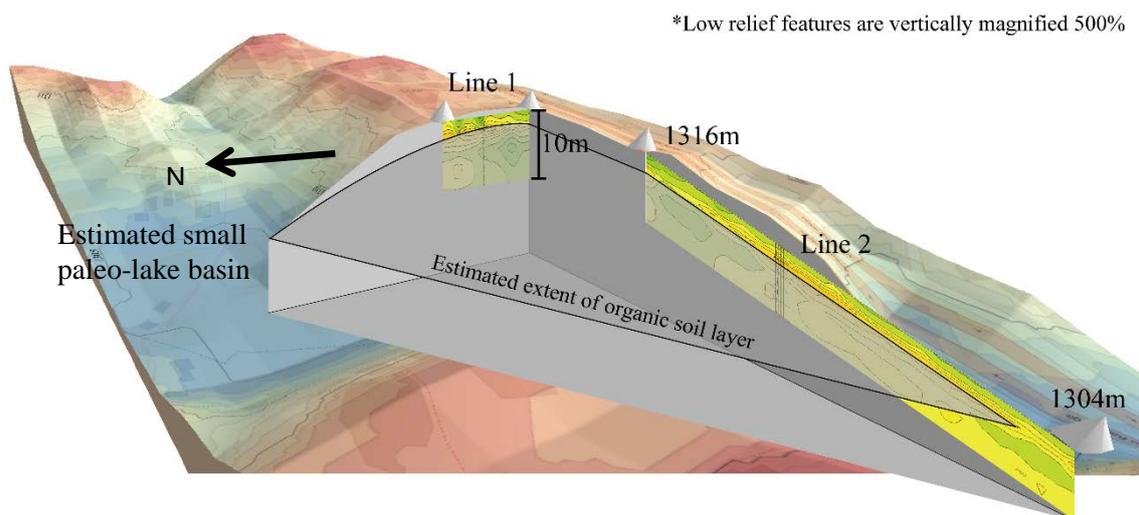
Fig. 8 Birds eye view of the damage section with observation points and SWS test profile

lake basin, the softest soil layer is getting thicker. Carbon 14 dating of the sampled organic soil, SWS and just a small number of borehole drilling may help us to estimate the presence of organic soils from micro-terrain features, which information is very necessary in mapping out plans for rehabilitating urbanized areas of Kathmandu.

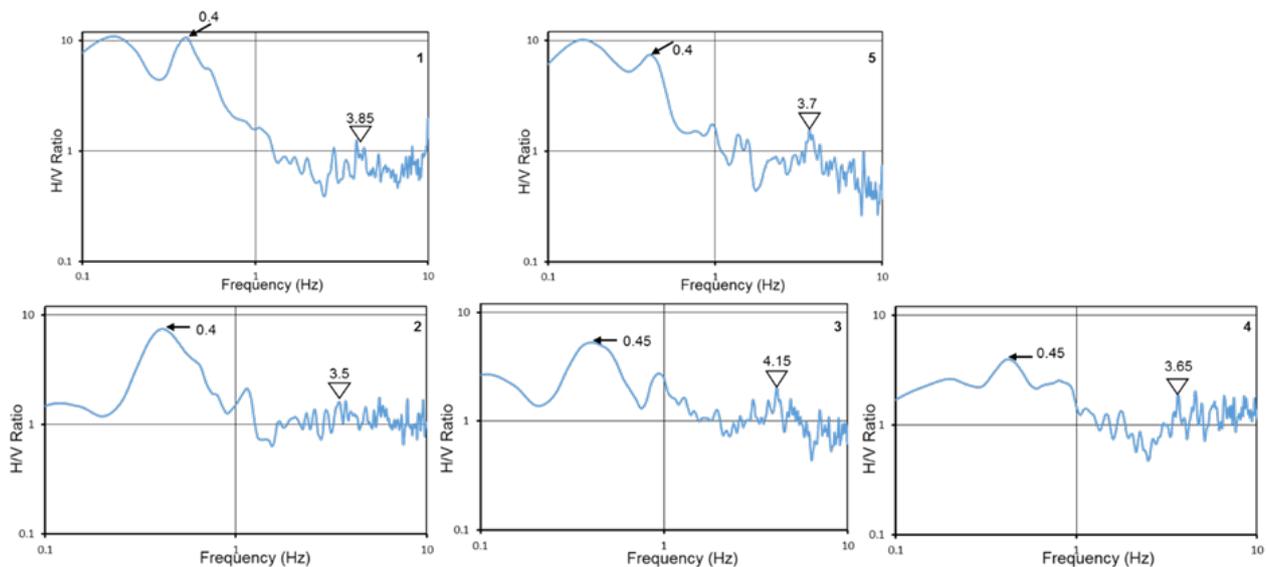
Fig. 9 H/V spectral ratios at five locations

Horizontal-to-vertical (H/V) spectral ratios, which can provide relevant information concerning site conditions and/or site amplification, were obtained at these five points as shown in Fig. 9. It is noted that in all H/V spectra, a common predominant frequency of 0.4 to 0.45 Hz appears. Though the graphs are smoothed by Parzen window with band width of 0.05 Hz for a higher frequency range from 1 to 10Hz, multiple peaks appear probably reflecting rather local soil profiles. H/V ratios for these peaks are rather small scattering around 1.0, and they alone do not seem to provide any clear clue to identify the subsurface structure. However it is noted that the subsurface organic soil layer together with the underlying soft soil layer may have a resonance frequency of around 3.5 Hz given their average shear wave velocity of 100 to 150 m/s and thickness of about 10 to 12 m.

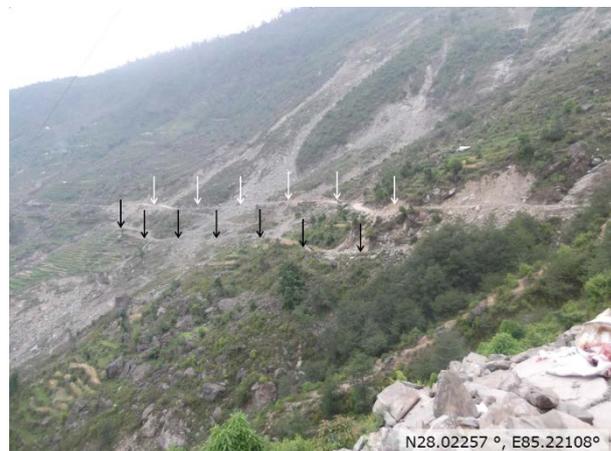
Fig. 10 Creeping section of Pasang Lhamu Highway: Black and white arrows show that the road constructed in 2003 (black arrows) has carried over about 30m horizontal distance from its original location (white arrows).

Pasang Lhamu Highway, a twisty mountain road, is one of the important highways of Nepal that connects Kathmandu to China via Dhunche. Many landslides have been observed along Pasang Lhamu Highway. Among them, a landslide at Ramche is found crucial for maintaining this road (Fig. 10). This massive landslide mass was detached from the hill slope of about 2100m above sea level in a rainy season of 2003. A temporary road was quickly constructed across this zone for the important traffic of this highway not to be suspended long. However the detached mass has been moving inch by inch towards the Trishuli River around 1300m below this road. The satellite images taken at different times show that this temporary road has been carried down

the slope over about 30m horizontal distance³).

Geologically, the landslide is at the southern limb of the Kuncha-Gorkha anticlinorium formed by alternating bands of metasandstones and chlorite-phyllite⁵). Thick loosely packed colluvium with huge boulders are situated on the rocky slope.

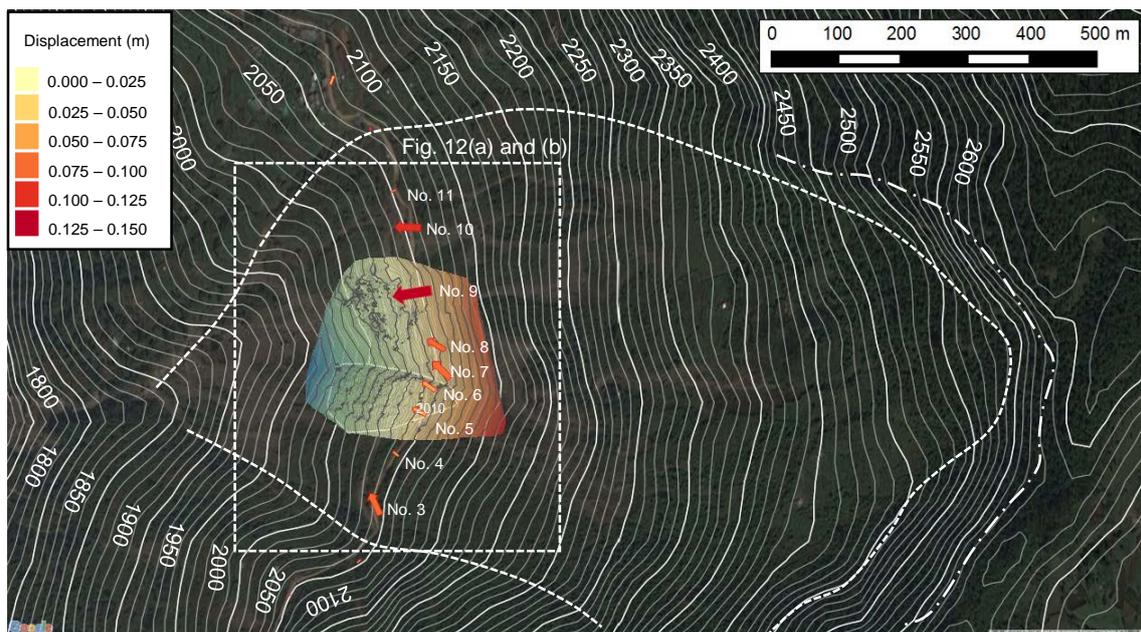
Fig. 11 Vectors of creeping displacements over 4 months period from July 2015 to Nov. 2015. (Photo from Google Earth)

months period (July 14th, and November 1st, 2015, Table 1) along the creeping section of this highway. A reference station was taken at a N28.01564°, E85.21363 ° on an outcrop of sandstone on a stable mountain ridge. Then survey nails were driven at 13 locations along the highway. The movements of three orthogonal displacement components (X, Y and Z) for each of these 13 points were measured twice on mid-July 2015 and 1st November 2015 (Table 1 and

Fig. 11). Given GDOP values ranging from 2.3 to 4.7 for these two surveys, the expected errors are at most 0.009 m and 0.007 m at Points 3 and 13, respectively. The largest lateral displacement of 0.15 m was reached at Point 9 with an expected maximum error of 0.003 m. Therefore, at least the observed displacement for Point 9 is considered to have statistical significance indicating clear creeping nature of this landslide mass. The vertical displacement component of Point 9 is 0.11 m, indicating that the displacement vector here dips $0.11/0.15$ radian towards the Trishuli River, which inclination is a little larger than the average slope inclination of about $1/2$. It is empirically known that vectors of creeping displacement observed on the surface of a coherent landslide mass can be about parallel to the slip surface lying below. This empirical knowledge suggests the possibility that the highway crosses a little higher part of one of coherent landslide masses making up the entire slope.

The micro-terrain shown in Fig. 12 can be a reflection of local surficial soil movements to be sure, but by no means, does it show the entire picture of the creeping landslide masses. Fig. 11 also shows contour lines of the slope extracted from 30m by 30m resolution digital terrain model from JAXA⁶⁾. As can be seen from a set of these contour lines, major lines of convex and concave breaks of the mountain slope, shown by white dot-and-dash and broken lines, respectively, immediately below the mountain ridge indicate that the entire landslide mass can be rather deep seated. If drone flights were not limited, we would be able to obtain significant information for mapping out necessary tactics for either stabilizing the slope or rerouting the highway. Moreover if we had more GPS survey points covering the whole landslide mass, a least-squares minimization of the difference between the measured slip vectors and dips of the hidden slip surface would enable a rational estimation of the entire geometric features of the slip surface⁷⁾. Water of a gorge was found flowing across the highway indicating the subsurface soil of the landslide mass at this elevation is soaked up. Seasonal change in groundwater flows here is to be investigated.

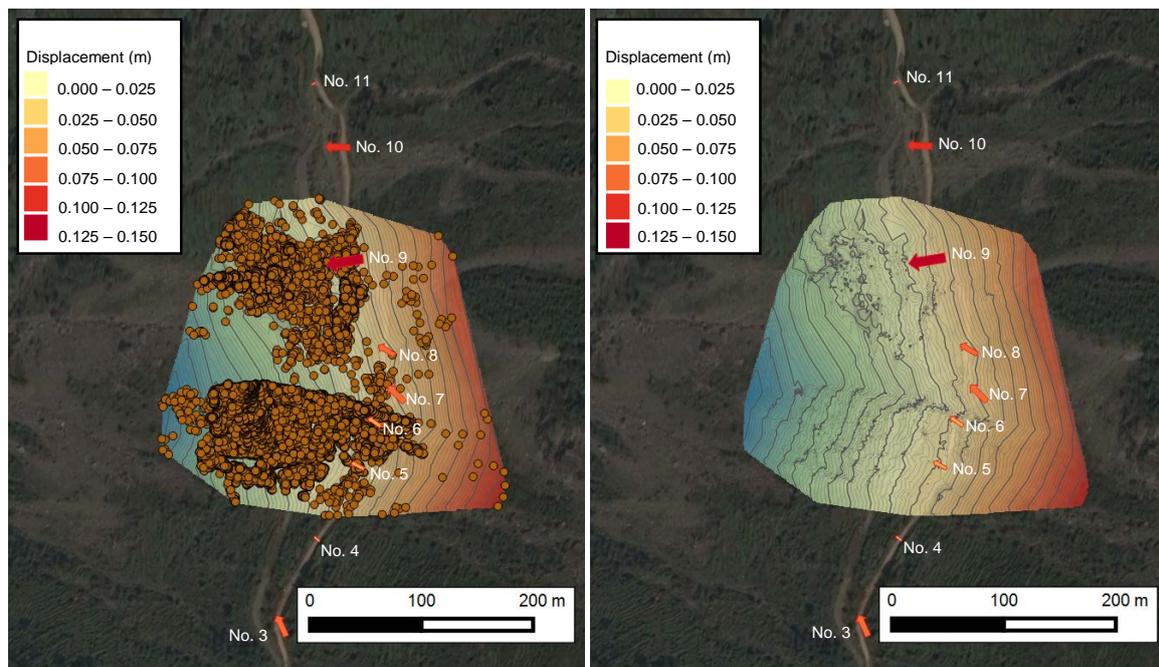
Fig. 12 Micro terrain model (right) for a fraction of the creeping slope extracted from photos: Stereo-photogrammetry software allows to detect dots on the left figure automatically/ manually from photos for creating the 3D image shown on the right figure. (Photos from Google Earth)

To see detail morphological features of the coherent landslide masses, it was originally planned to fly a drone to take aerial photos for stereo-photogrammetry. However Nepal moved to limit drone flights after the earthquake, and only photos from available ground photo spots were used. Due to this limitation, the extracted image-based 3D terrain model covers only a small fraction of the entire creeping slope as shown in Figs. 11 and 12. However the extracted 3D image shows small scarps in the middle of these landslide masses suggesting that they are not a single coherent mass but multiple.
