Provisional report of the geotechnical risks caused by the Mw=7.8 Nepal earthquake of April 25, 2015¹

JSCE Landslide survey group, JSCE/JGS/JAEE joint Investigation Team for the 2015 Nepal Earthquake Disaster

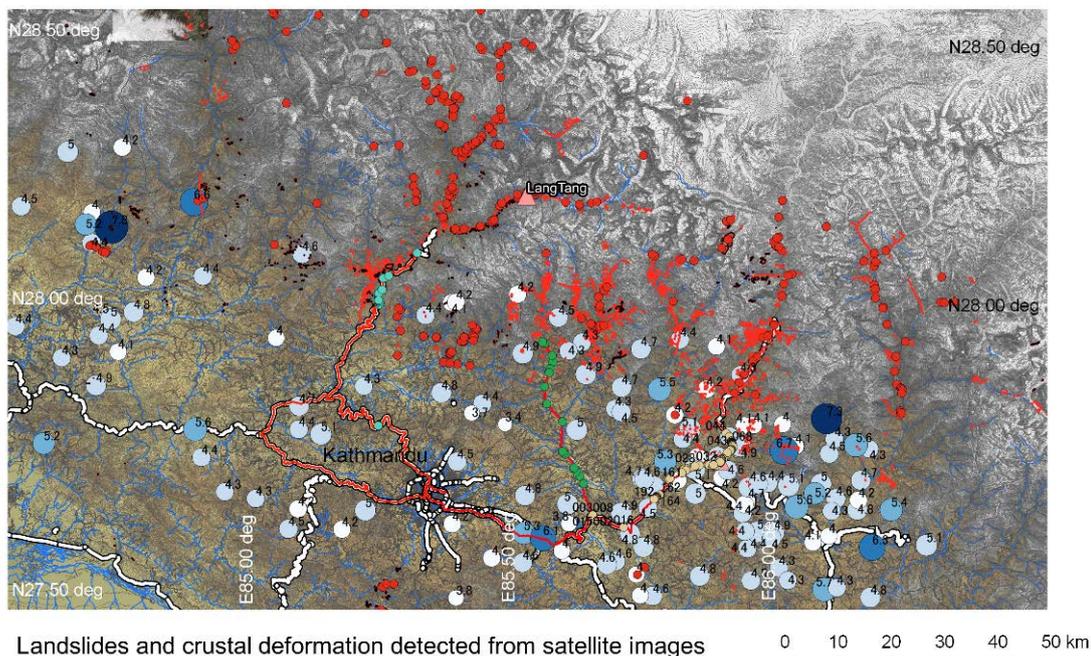
Fig. 1 Prepared map of landslides and aftershocks

Satellite data used to prepare this data set include those from the International Charter Space and Major Disasters, as well as freely-available online viewers. Maps for our survey were prepared given this set of digital data (Fig. 1). Note that the dataset was last updated on May 8th, 4 days before the largest Mw=7.3 aftershock of May 12.

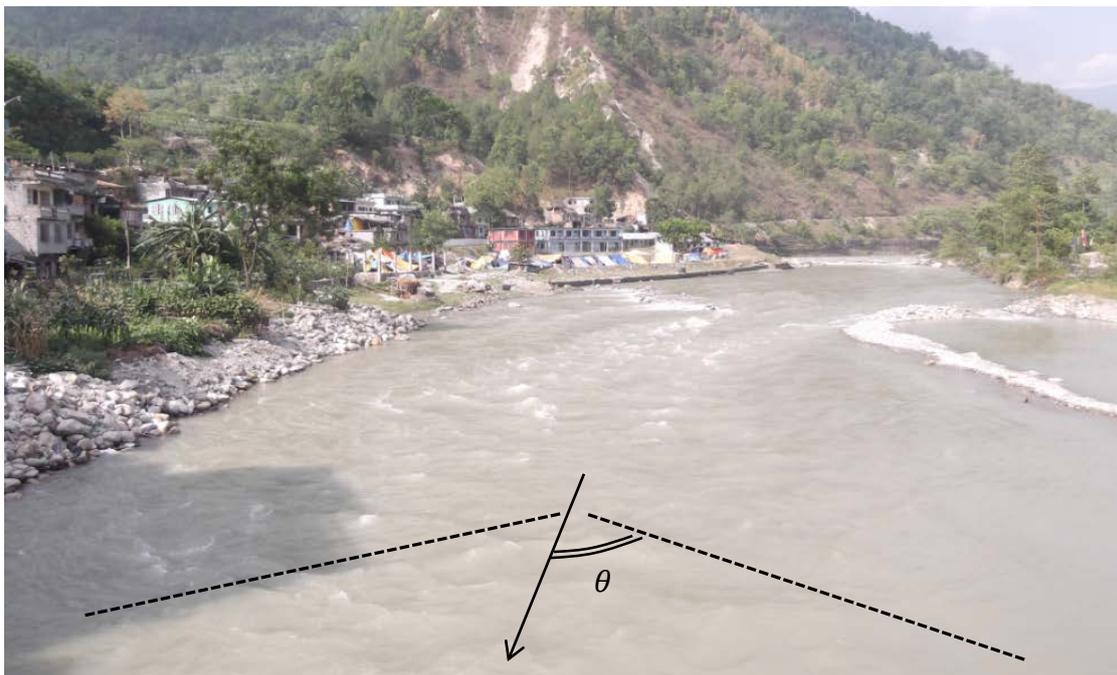
Fig. 2 Hydraulic jump propagating across flow at an angle θ at Point 2 (N27.75387°, E85.82750°)

River water depth h is first estimated by observing hydraulic disturbances transmitted downstream within a steady cone of apex angle θ (Fig. 2)

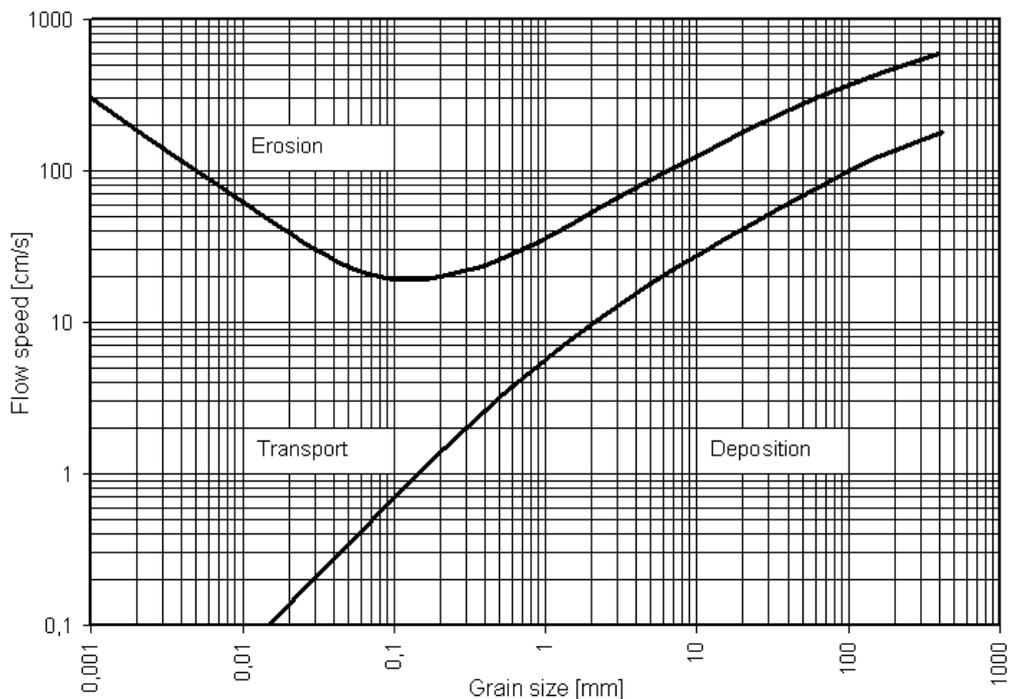
Fig. 3 Hjulström curve showing the critical current velocity required to move grains on a plane bed

Peak average velocities of 7.7 to 5.6 m/s associated with the estimated peak discharges of 500 to 700 m³/s may occur in the rainy season, which velocities can be substantially large for the river-bed load including large boulders to be eroded as can be predicted by the curve shown in Fig. 3².

Peak discharge and associated riverbed load transportation rate are to be estimated based upon much more reliable information. This estimation is particularly important to deal with potential risks for intake facilities of hydropower stations, etc.

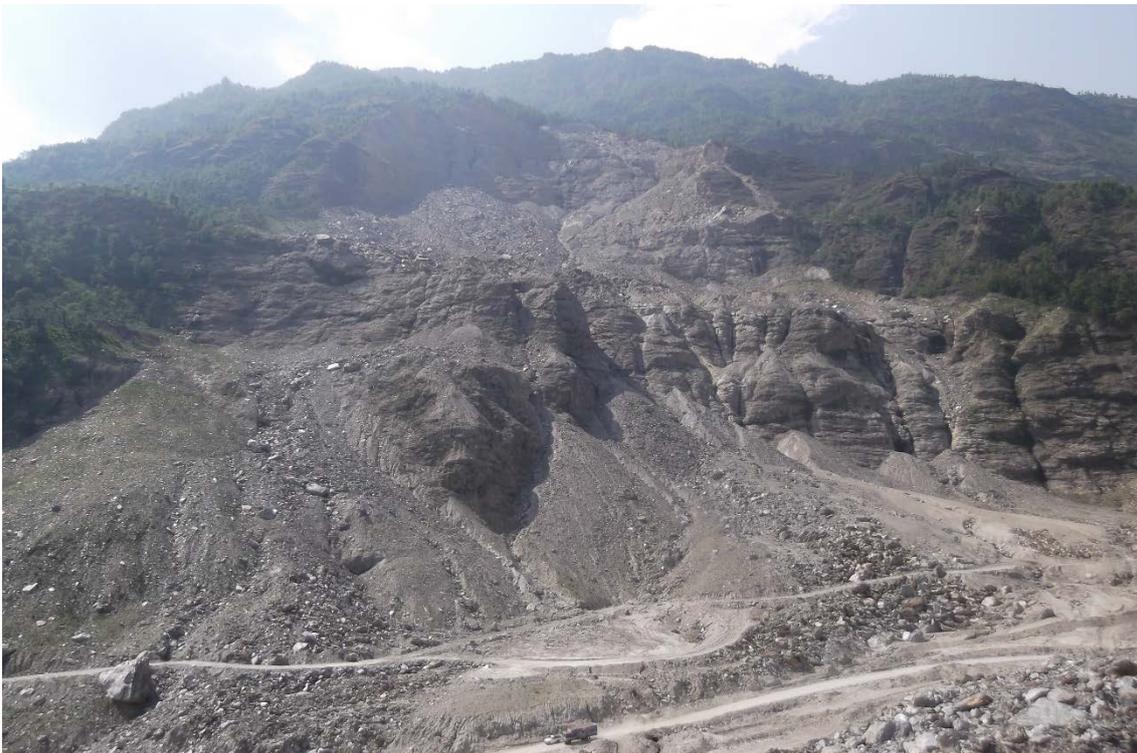
Fig. 4 Sunkoshi Landslide

Heavy rainfall on August 2, 2014 triggered a landslide on a steep valley wall of metamorphic rock of Sunkoshi river. The landslide mass reportedly killed 156 people and blocked the river to form a lake behind it. Though the landslide was not caused by the earthquake, the presence of the landslide mass that has fallen in the river will certainly have an important and serious effect on the riverbed load transport and thus important facilities such as intake gates for hydropower stations. It is reported by the Earth Observatory, NASA that some 5.5 million cubic meters of rock and debris tumbled down into the Sunkoshi River valley^[3]. A 3D image of the exposed slip surface was made to see more details of detached and deposited rock and debris using Epipolar geometry^[4], which geometry allows a 3D image from photos taken from different locations to be reconstructed. Though three photos were taken from three different Points 1, 2 and 3 (Table 3), Points 2 and 3 are very close to each other. Therefore one more reference point (Point 4) was taken for much better control of positioning at an exposed rock on the intact mountain slope, which can be seen from all the camera locations. The longitude, latitude and elevation of this point were tentatively obtained from a Landsat imagery and the 30m SRTM DEM^[5].

Volumes and dimensions of large landslide masses clogging major streams are also to be estimated.

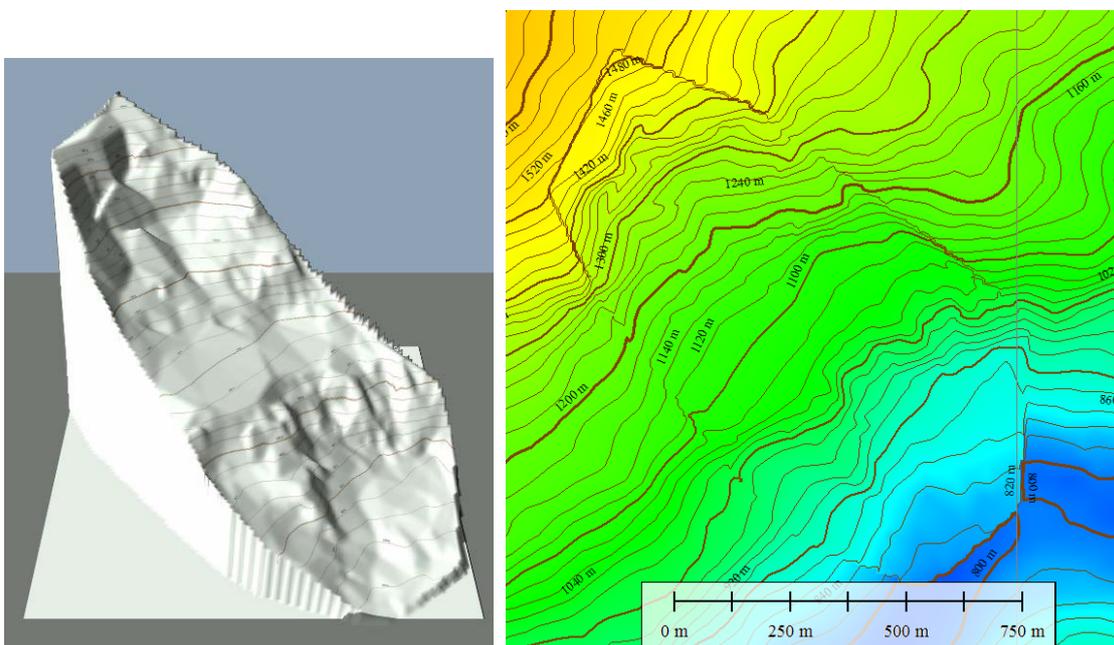
Fig. 5 DEM of slip surface of Sunkoshi Landslide

The obtained digital elevation model for the exposed slip surface of Sunkoshi is shown in Fig. 5. Though the entire stretch of the exposed surface was not completely covered, there are a clear hollow of the top source region, major triple-terraced cliffs on the top, halfway up and near the toe of the exposed surface with conic talus deposits (collections of broken rock fragments) rimming along the bases of these cliffs. The angle of repose for these talus deposits varies from 15 for low-lying coarse rock deposits to 30 degrees for high-lying finer granular deposits.

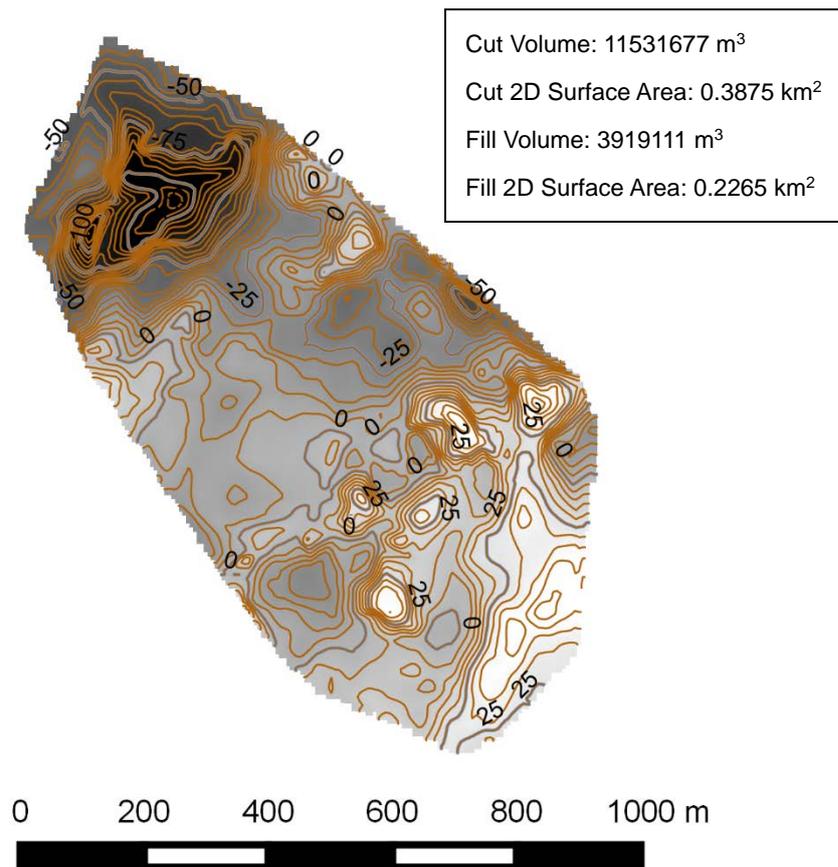
Fig. 6 Change in elevations within the exposed slip surface

A 30m SRTM digital elevation model^[5] was used herein as the terrain model before the landslide event, and compared with the obtained digital elevation model of the exposed slip surface. Fig. 6 shows the change in elevation within the measured slip surface area.

The volumes of the detached and deposited masses are estimated to be 11.6 million m³ and 3.9 million m³ respectively. The observed area is not covering the major part of the soil mass that has fallen into the river, and the remaining mass of 7.7 million m³ may be as much as the rock/debris volume of 5.5 million m³ estimated by NASA^[31]. However, the estimated volumes are sensitive to points taken for geo-referencing (Table 3), and revised values will be reported in the updated version of our report.

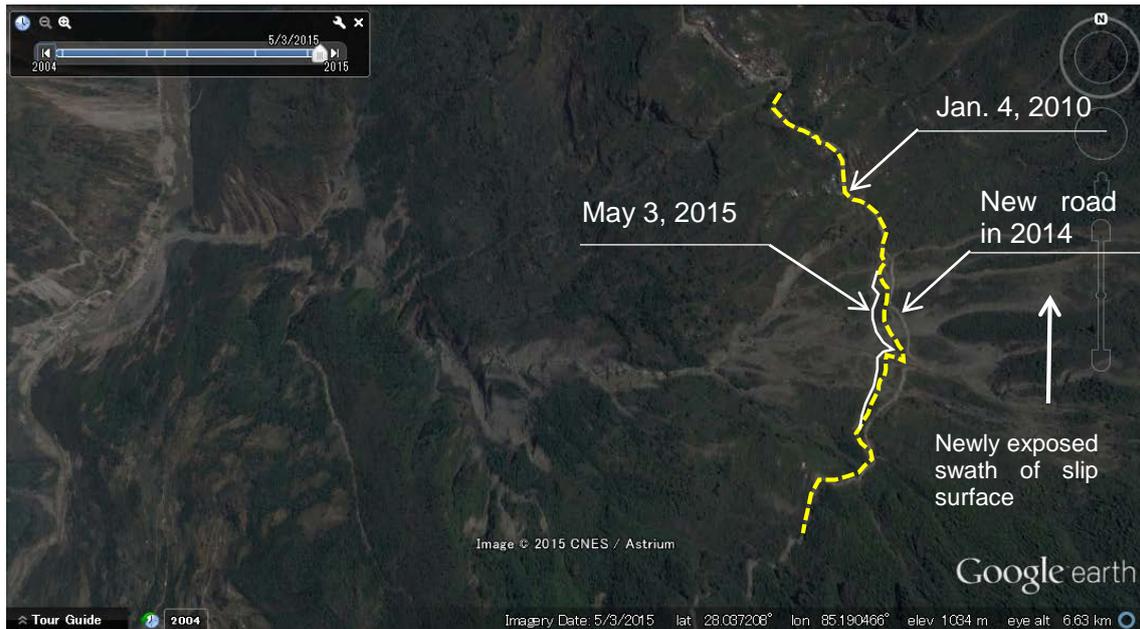
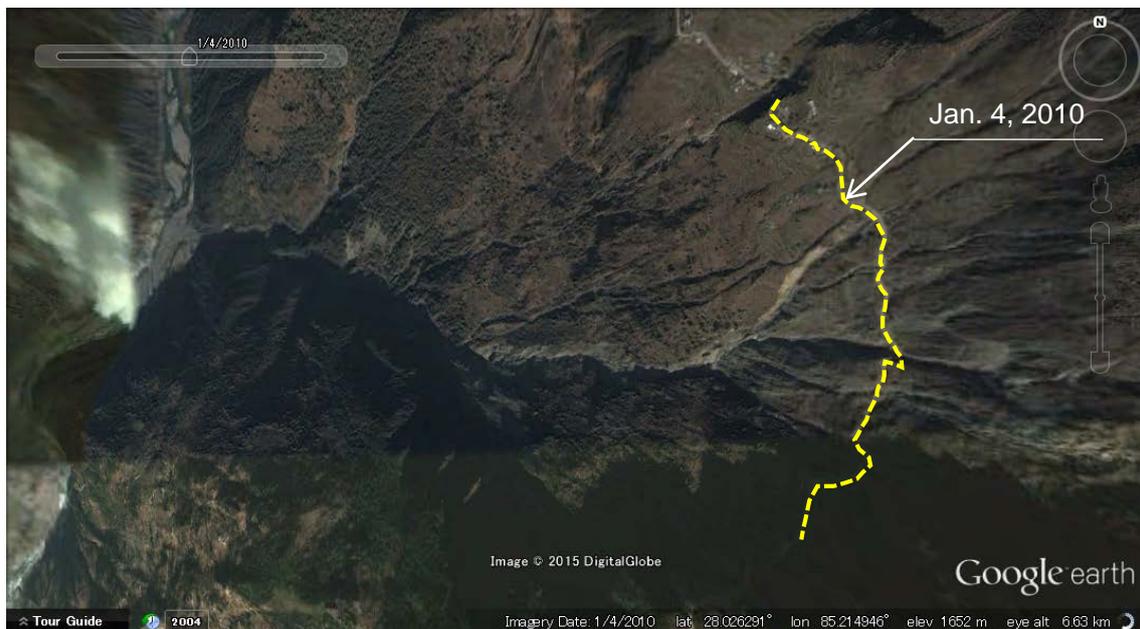
Fig. 7 Landslide zone (Satellite images taken from Google Earth)

However, the road started moving inch by inch towards the toe. Fig. 7 shows two satellite images of the zone from different times, the upper and lower ones from May 3, 2015 and January 4, 2010, respectively. It is noted in the latest 2015 photo that the temporary road section crossing the landslide

zone is currently west of the location where this section used to be in 2010, indicating that this section has been carried down the slope over about 30m horizontal distance. Moreover swaths of bare slip surfaces above the temporary road, which swaths were not visible in the 2010 photo, are appearing and becoming thicker year by year. Though the earthquake had reportedly invisible and indirect effect upon the remaining landslide mass, the movement of the mass can be further accelerated in the upcoming rainy season of 2015.

Continuous monitoring of creeping slopes from satellites is important. Once early signs of accelerated movements are found, pin-point countermeasures for villages and roads can be taken in a quick and rational manner.

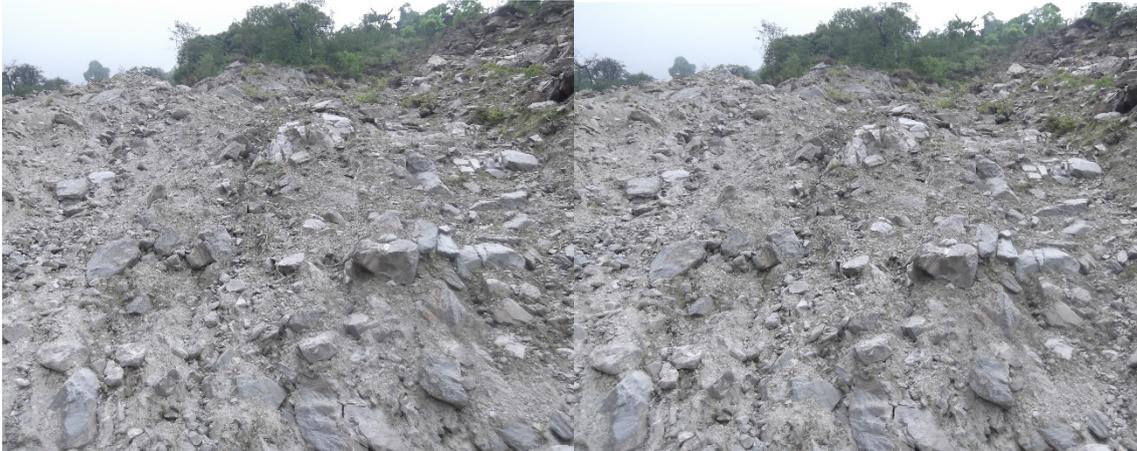
Fig. 8 Sign of dilating debris mass halfway up on a landslide mass, which was cut at this elevation for the temporary road construction at N28.067959°, E85.228808°

All along the Trishuli road from this point of continuous creeping to Dhunche, clear indications of dilating landslide masses can be seen from place to place. Fig. 8 shows a pair of photographs of a dilating debris mass halfway up on a landslide mass, which was cut at this elevation for the temporary road construction. These photos, arranged side by side can be perceived as a single image in terms of depth, and one notices that the matrix of fine sand filling up the voids of sub-angular rocks/ boulders

exhibits fresh open cracks, an indication that the fabric of these embedded large rocks are slowly dilating. An anaglyph 3D image of this debris mass is shown in Fig. 9.

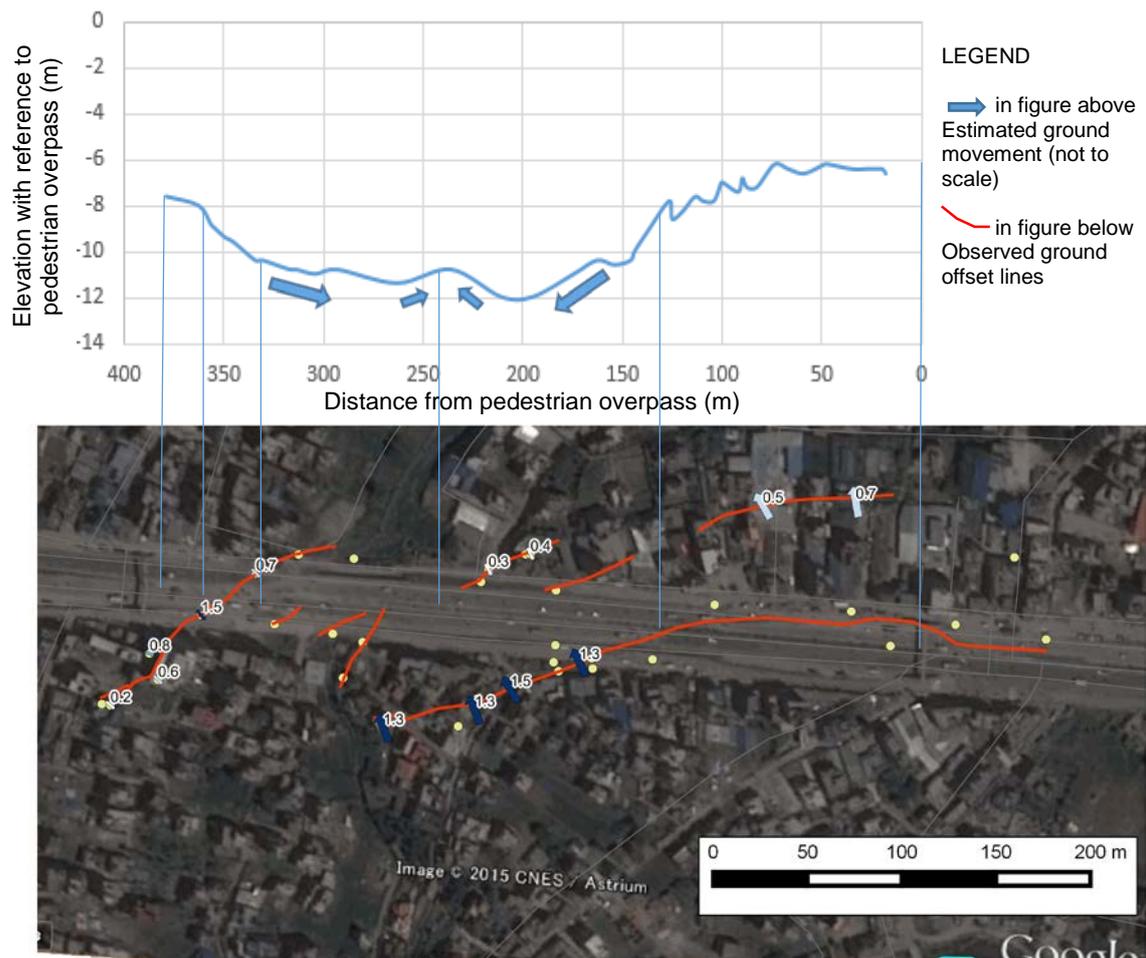
Fig. 10 Depressed section of Araniko Highway and ground offsets (Photo from Google Earth)

Several lines of vertical ground dislocations appeared diagonally across Araniko highway making up a 200m wide swath of ground failure. Way points are marked along visible dislocation lines by a GPS receiver as shown in Fig. 10. The observed ground dislocation lines are about parallel to each other trending in NEE to SWW direction curved slightly north. These lines die out beyond their eastern and western ends, and about 300 to 400 m long at the most, indicating that the failure was just localized within this short extent of the swath. Two outermost lines of relatively large dislocation indicates that the area between these two major dislocation lines has sunken by about 2m.

However the inner-most lines suggest that the lowest wet zone may have been pushed slightly up. To highlight this feature of mass movement, a longitudinal section of the highway was measured by using a handy laser-ranger (Fig. 10).

Though the cause of this ground depression is yet controversial, the authors think that a local lateral spread of sandy hill slopes towards the low-lying wet ground was responsible for this failure. The wet and slightly depressed area along a small canal may have been liquefied and/or weakened enough to allow the sandy hillsides on both sides of the canal to move a little sideways against each other, and bulged. This ground depression was responsible for the deformation of a two-span continuous pedestrian overpasses, whose north pier rests exactly on the south-easternmost line of dislocation while the other two are on the relatively intact hill terrace. As the result, the northern pier was on an outward tilt, causing the joint between the pier and the deck to open up by about 40 to 45 cm. It was lucky that the deck of the overpass did not fall onto the highway probably because it was a two-span continuous beam. However there could have been a good chance for any single supported deck of overpass to fall upon the highway with its spans expanded. According to one of our members who have been there on May 2nd, the joint may have been opened a little wider (Fig. 11), indicating that the tilt of the pier has been increasing gradually and/or in a step-wise manner over a month's period since the earthquake hit.

Something that should not be forgotten in discussing rehabilitation strategies is that a large earthquake often causes long lasting geotechnical problems. Once liquefied, soil can remain soft for months. Locations with similar land deformations to the depressed section of Araniko Highway are to be identified and their causes are to be thoroughly studied to reflect the natures of weak soils upon rehabilitation/ reconstruction plans.

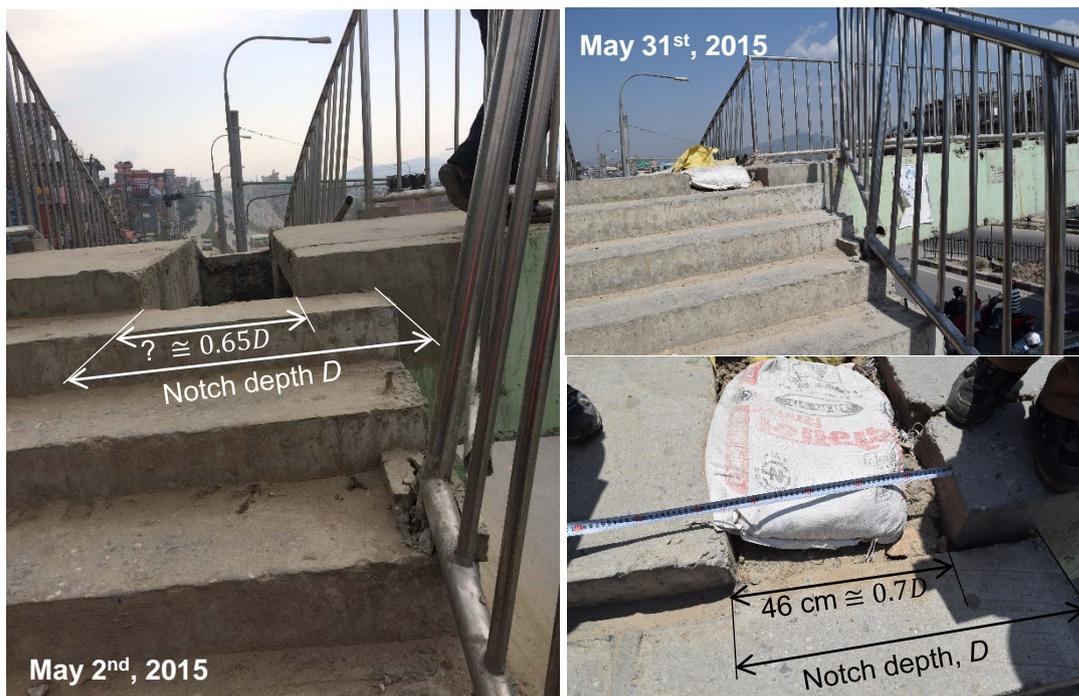
Fig. 11 Joint opened between deck and pier of the pedestrian overpass. Photos left and right by R. Pokhrel on May 2nd and 31st, 2015, respectively, at N27.674601°, E85.364705°:

Assuming that the notch depth D of the pier-top landing for the bridge-girder seating is the same for both photos of May 2nd and May 31st, these photos are suggestive that the joint has opened a little wider over a month's period.

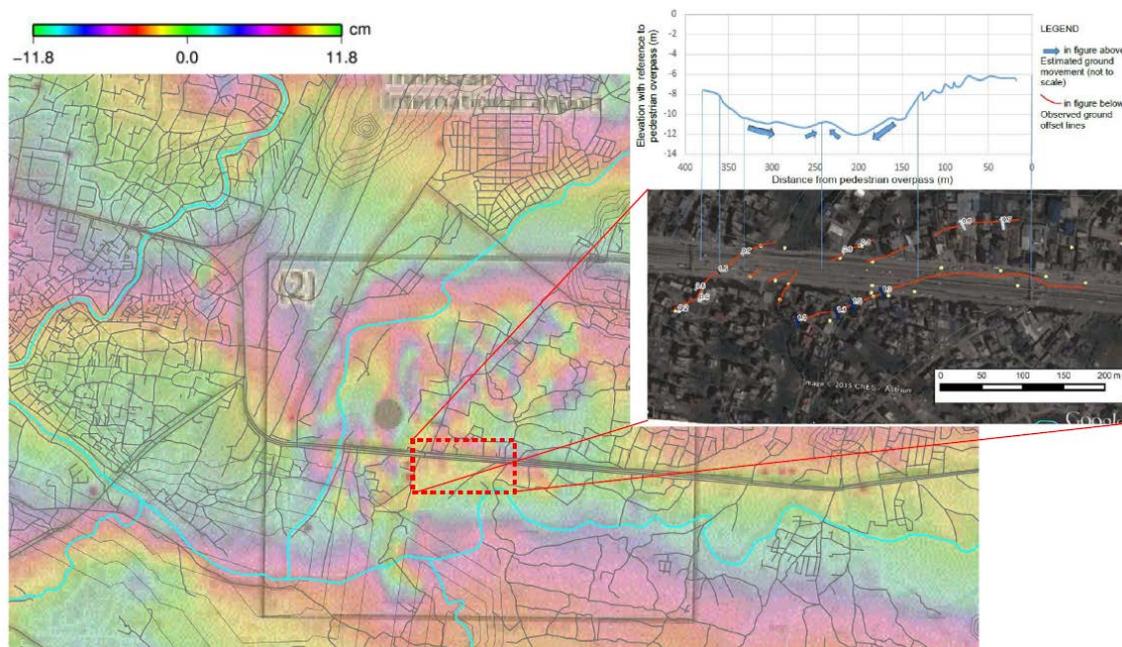
Fig. 12 Disturbance of InSAR fringe pattern near sagging section of Araniko Highway
(PALSAR-2 InSAR from [6])

Given the above findings, local soil conditions are to be carefully reflected upon rehabilitation plans in a rational manner, because as has been frequently seen in the past earthquakes, it can take months for liquefied/weakened soil to regain its initial strength, and even after it regains the strength, the soil can remain susceptible to re-liquefaction in a next big earthquake. To pinpointing locations of weak soils, InSAR imageries may be useful as shown in Fig. 12 which figure exhibits disturbance of enlarged PALSAR-2 InSAR fringe pattern near the depressed section of the highway.
