# Damage to Urban Gas Industry after the 2011 off the Pacific Coast of Tohoku Earthquake

Yoshihisa Maruyama

## Seismic Safety Measure in Urban Gas Industry

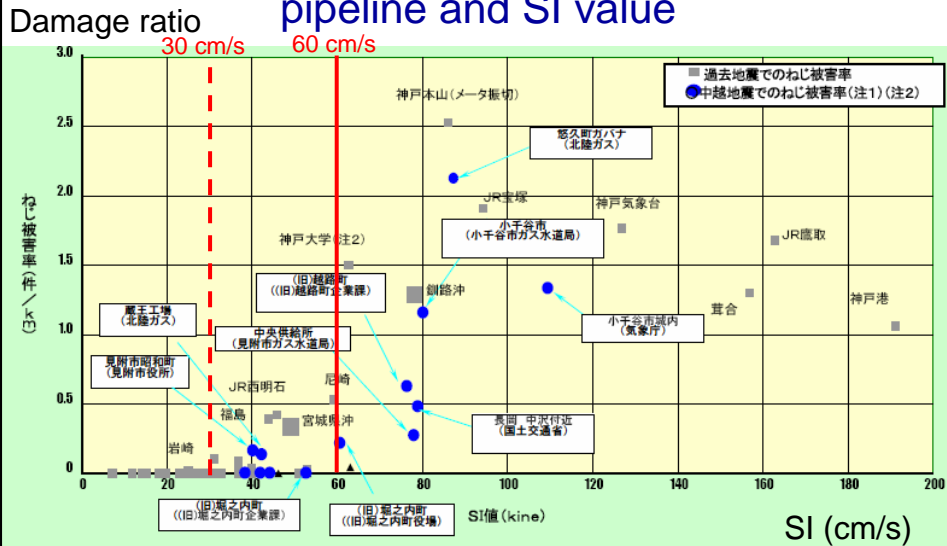
## Relationship between damage ratio of gas pipeline and SI value

- (注1) 今回データは、地震計を中心とした1km~2km四方のエリア内のねじの被害率を集計。なお、兵庫県南部地震のデータは、2.4km×1.8kmのメッシュ内のねじ被害率を集計。
- (注2) 川口町についてはSI値が計測不能のためプロットしていない。
- (注3) 神戸大学の地震計は地下10mのトンネル内に設置されており、地表面より小さい地震動を観測している可能性が高い。

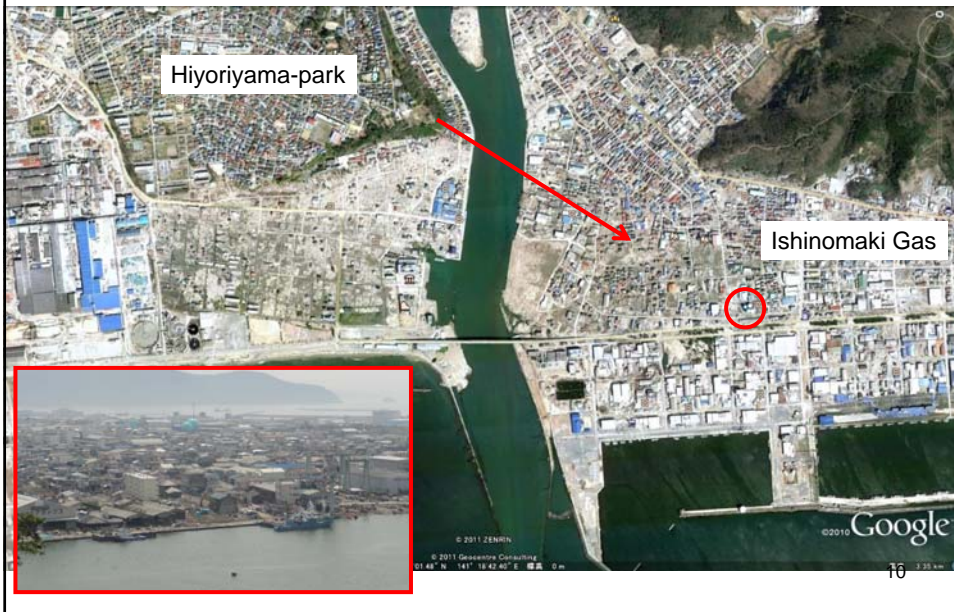
# Field Survey in Ishinomaki

June 7, 2011

## Recovery Process of Ishinomaki Gas

**March 23:** Gas supply to Japanese Red Cross Ishinomaki Hospital was restarted operating the on-site gas generator

**April 9:** Gas-making plant was reopened using temporary facilities

**April 12 – May 3:** Gas supply was recovered except for the severely tsunami-inundated areas

**May 18:** Restoration work was almost over except for the completely washed-away areas

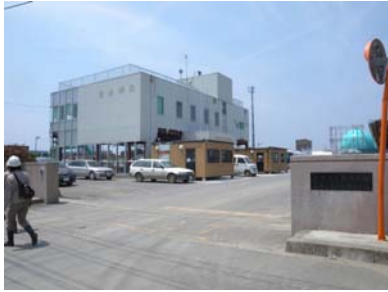
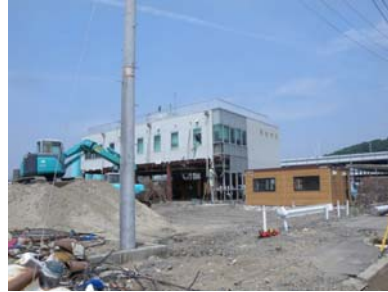
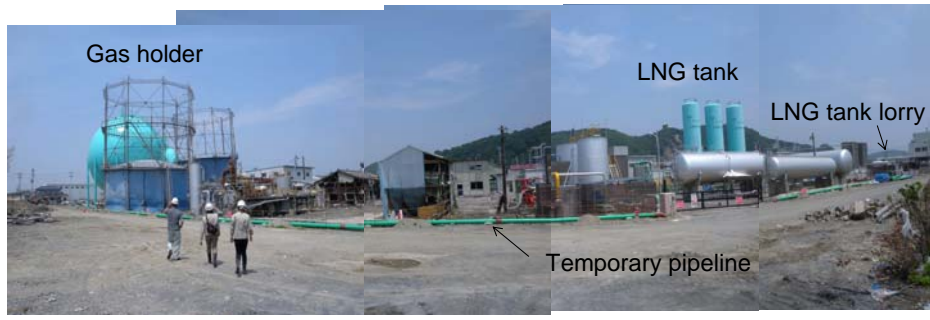
## Field Survey in Ishinomaki

June 7, 2011

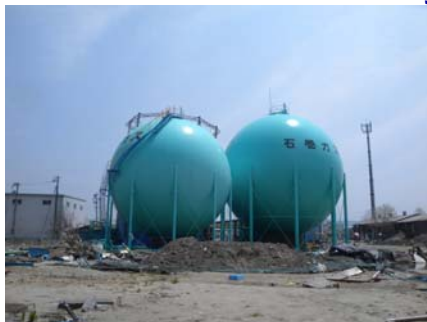
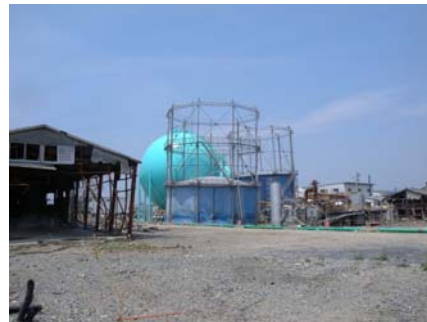
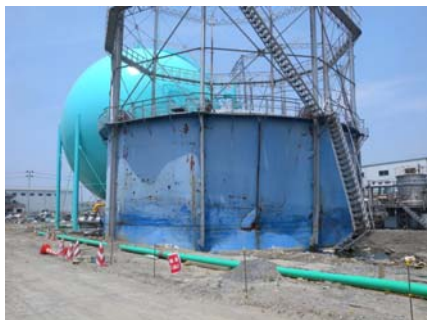
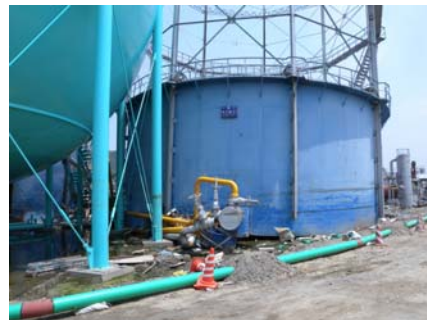
## Field Survey in Ishinomaki

June 7, 2011

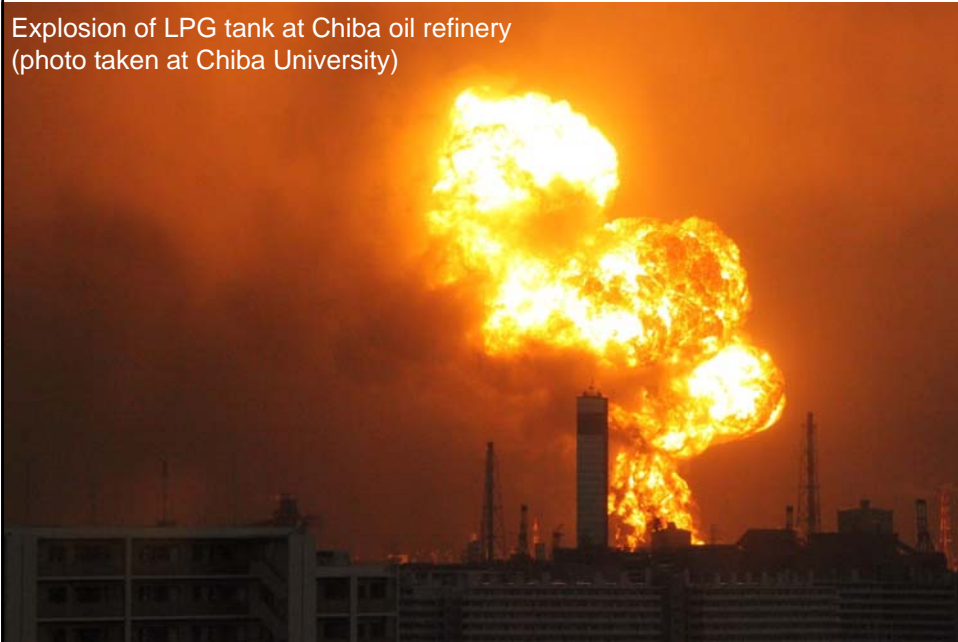
Explosion of LPG tank at Chiba oil refinery  
(photo taken at Chiba University)
