# Geotechnical damage caused by the recent gigantic earthquake in Japan

Ikuo Towhata  
University of Tokyo

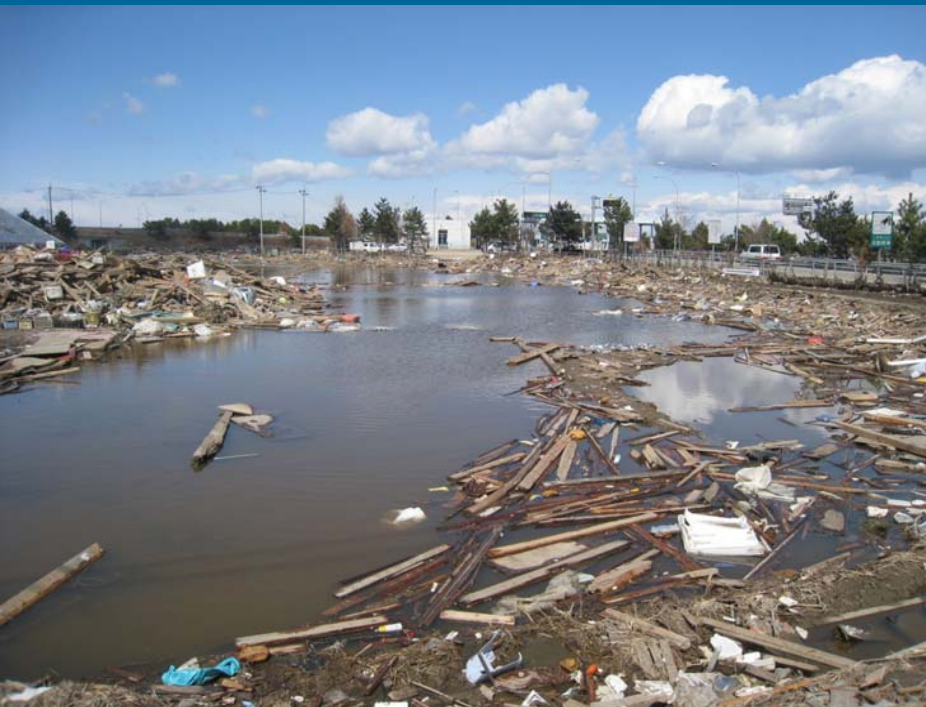
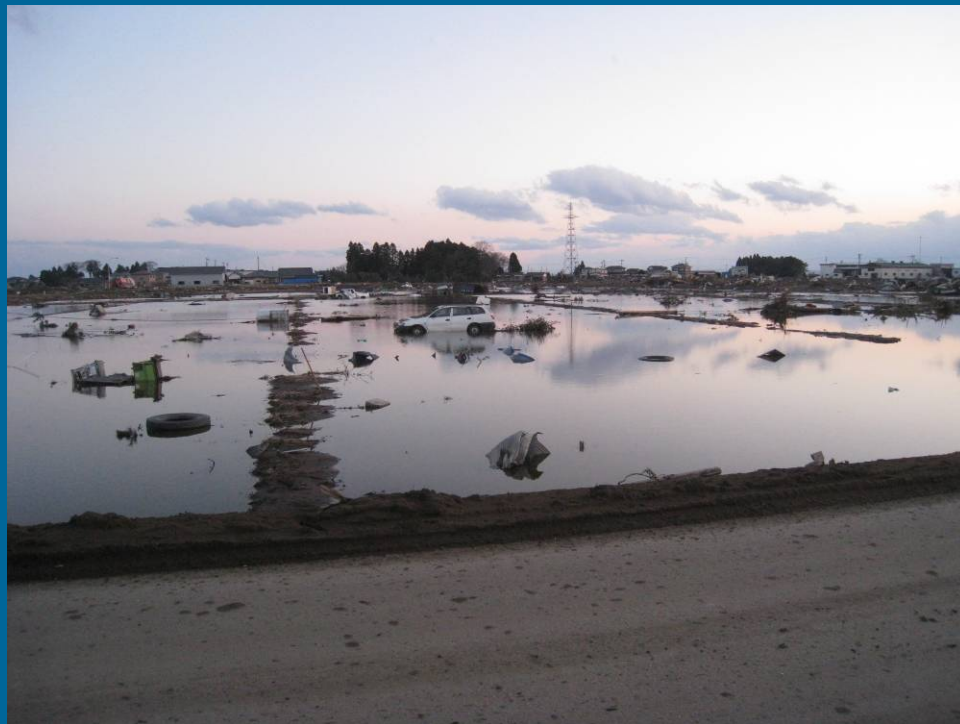
# Coseismic subsidence in coastal area

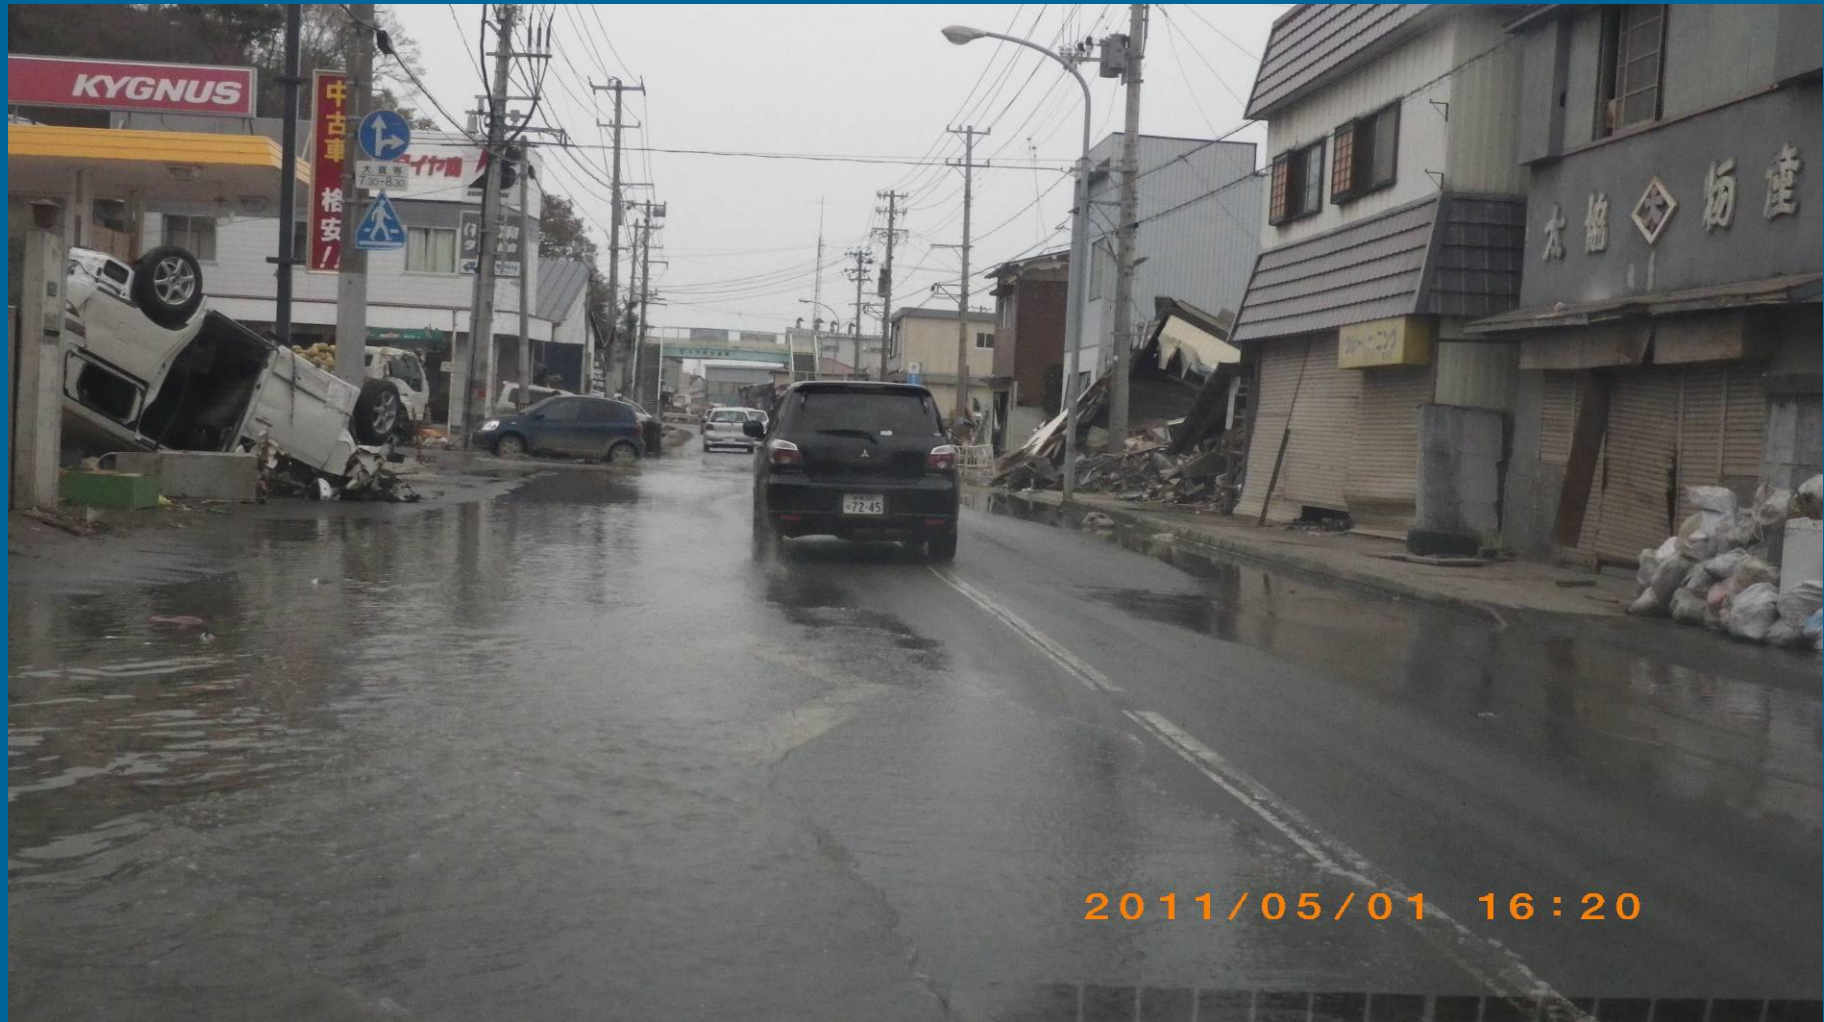
2011/05/01 16:20

# Ground level is lower than before; Difficulty in drainage Risk of flooding in typhoon season

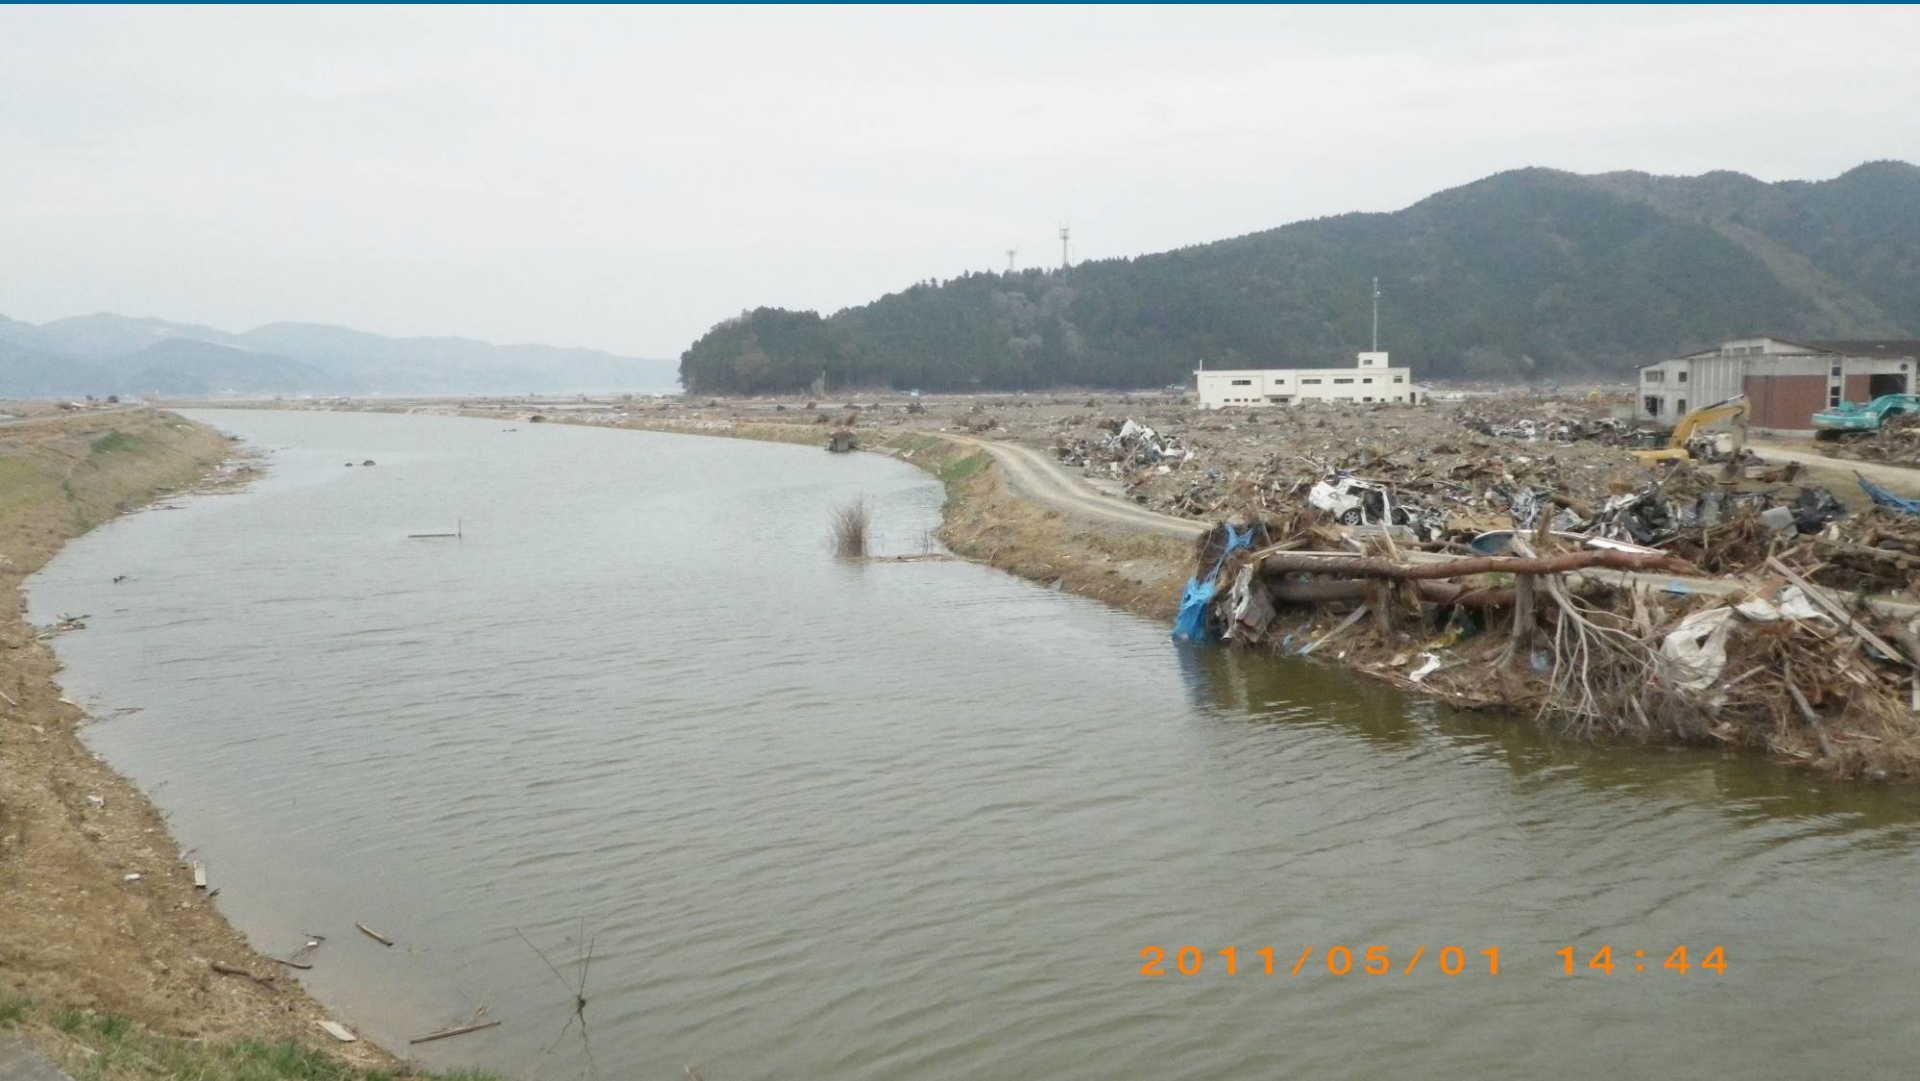
2011/05/01 14:44

# Situation was made worse by tectonic subsidence: insufficient levee height

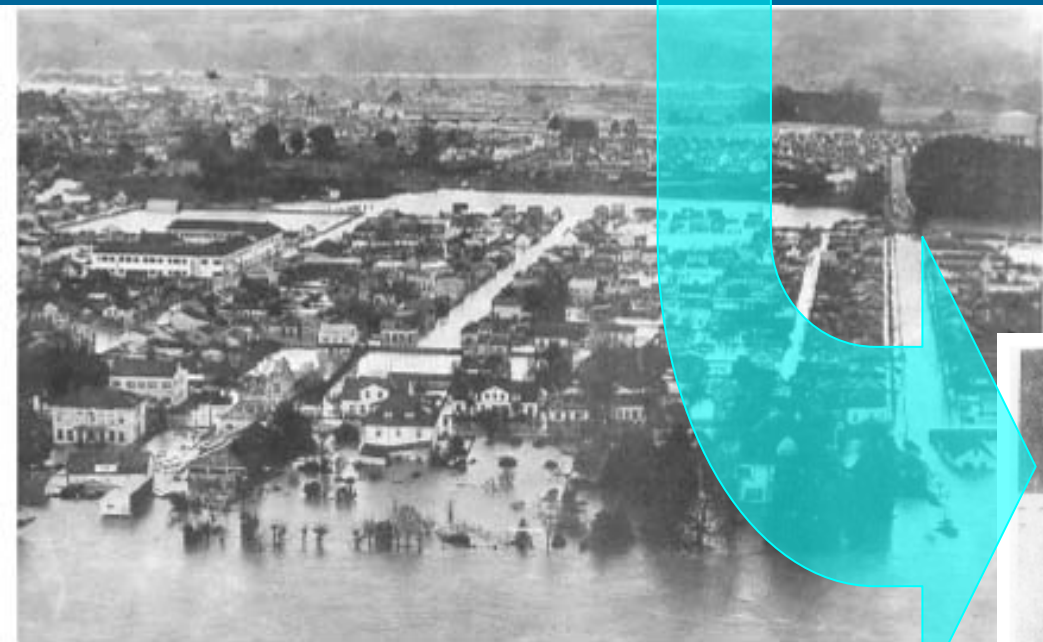
Fig. 16.55 Inundation of Valdivia City (Soto Melo)

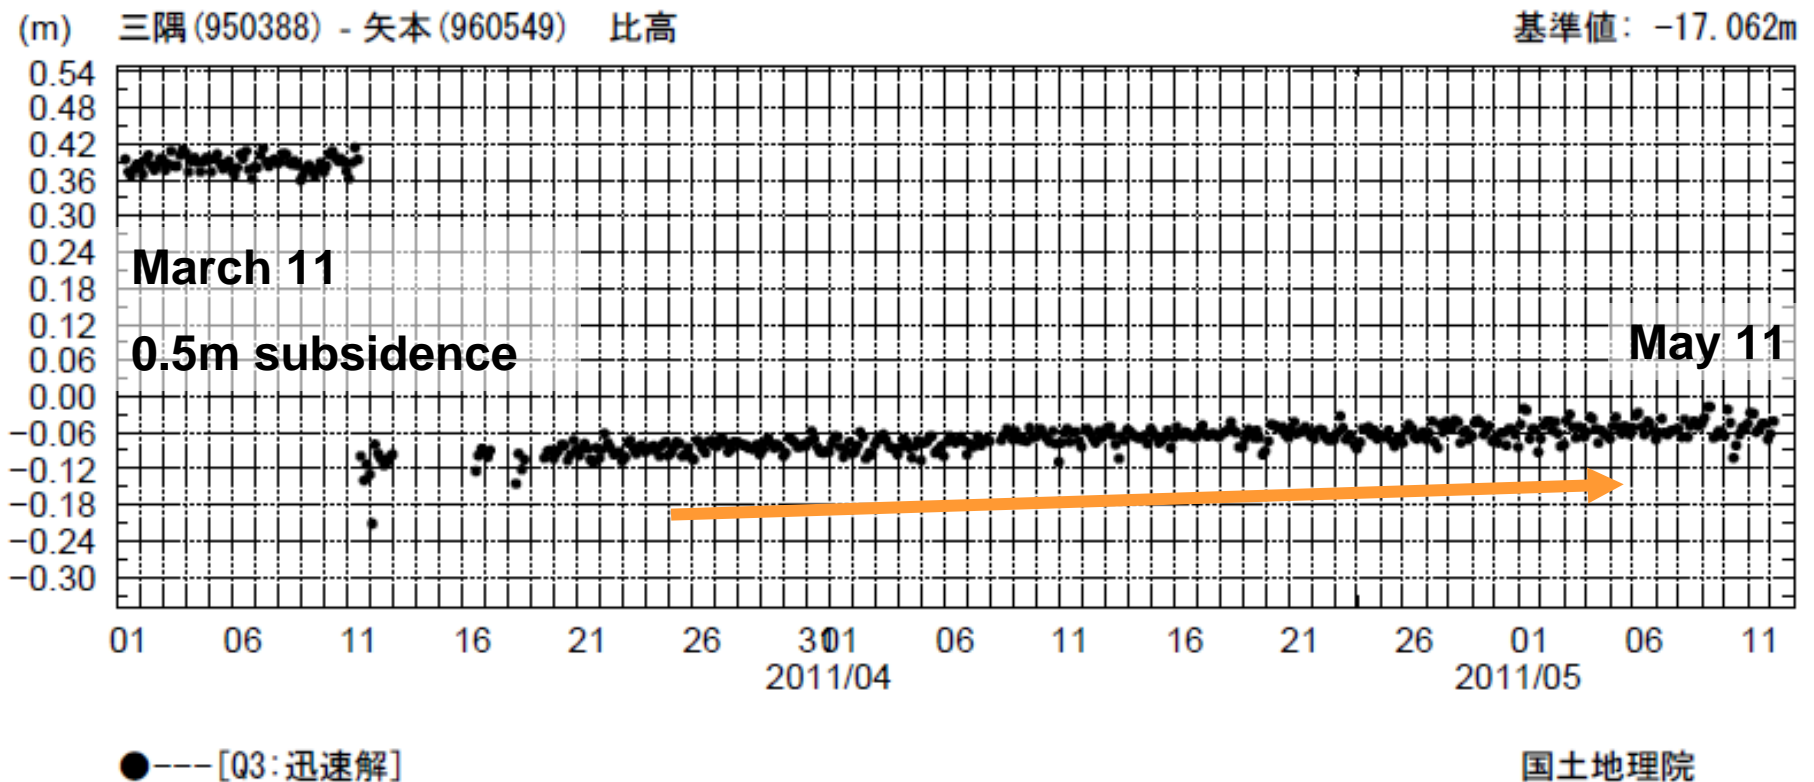
Near Sendai City, ground is coming up  
but **very slowly**

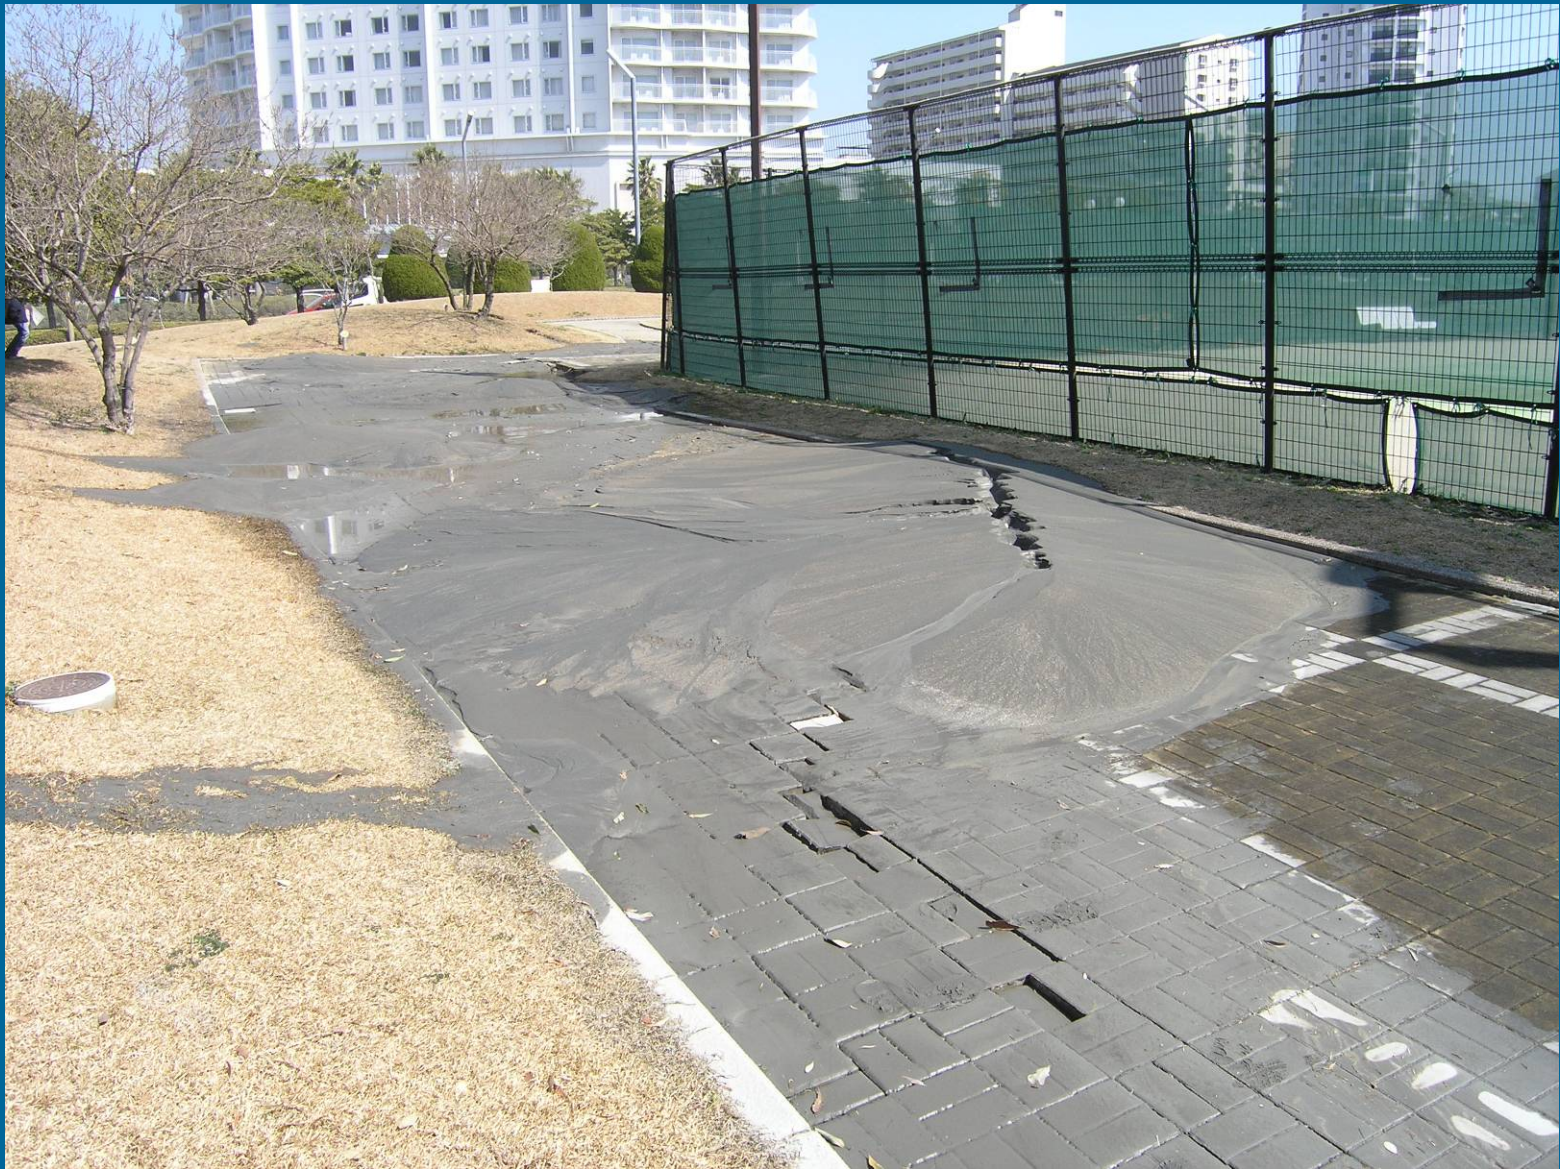
# Liquefaction in young sandy deposit (Urayasu City near Tokyo)

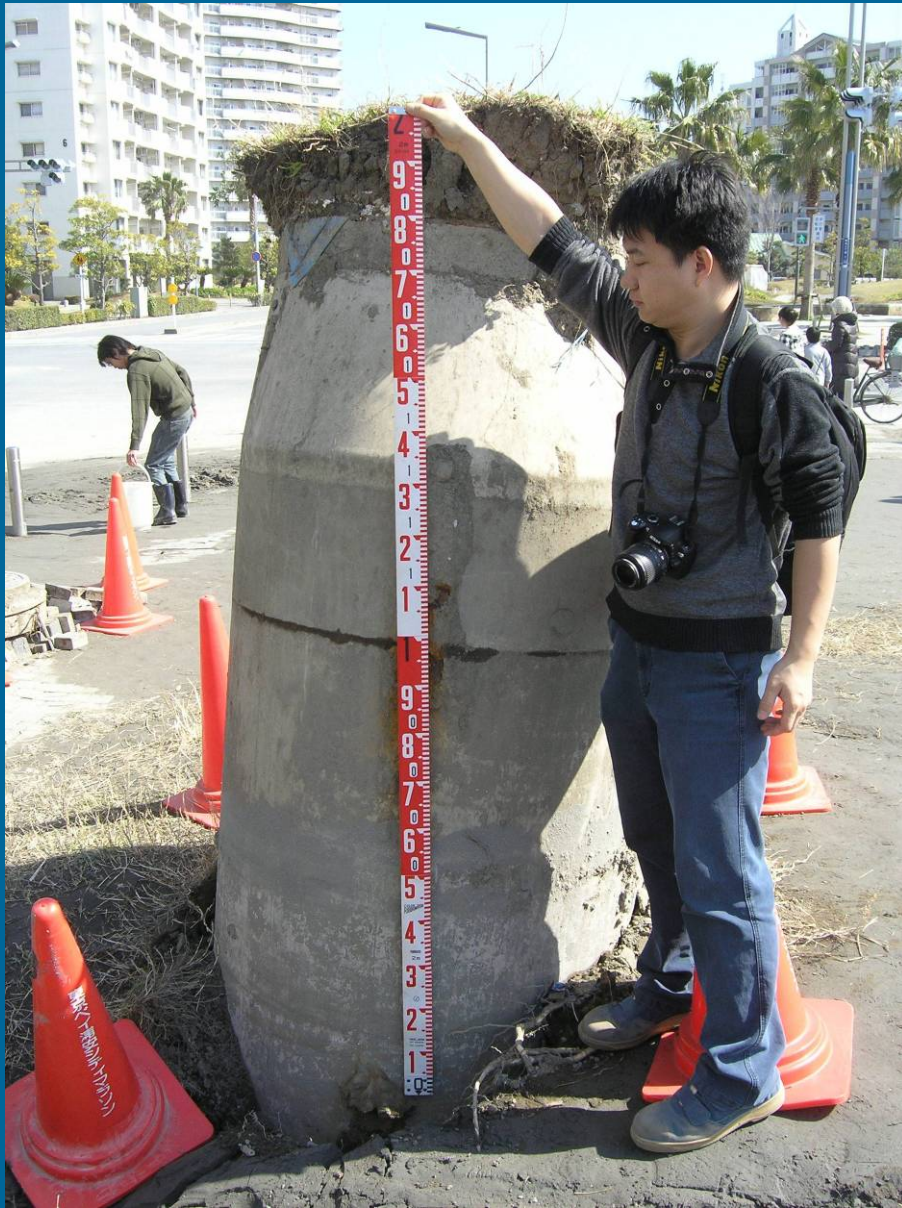
Floating of sewage manhole caused by liquefaction of ground and backfill

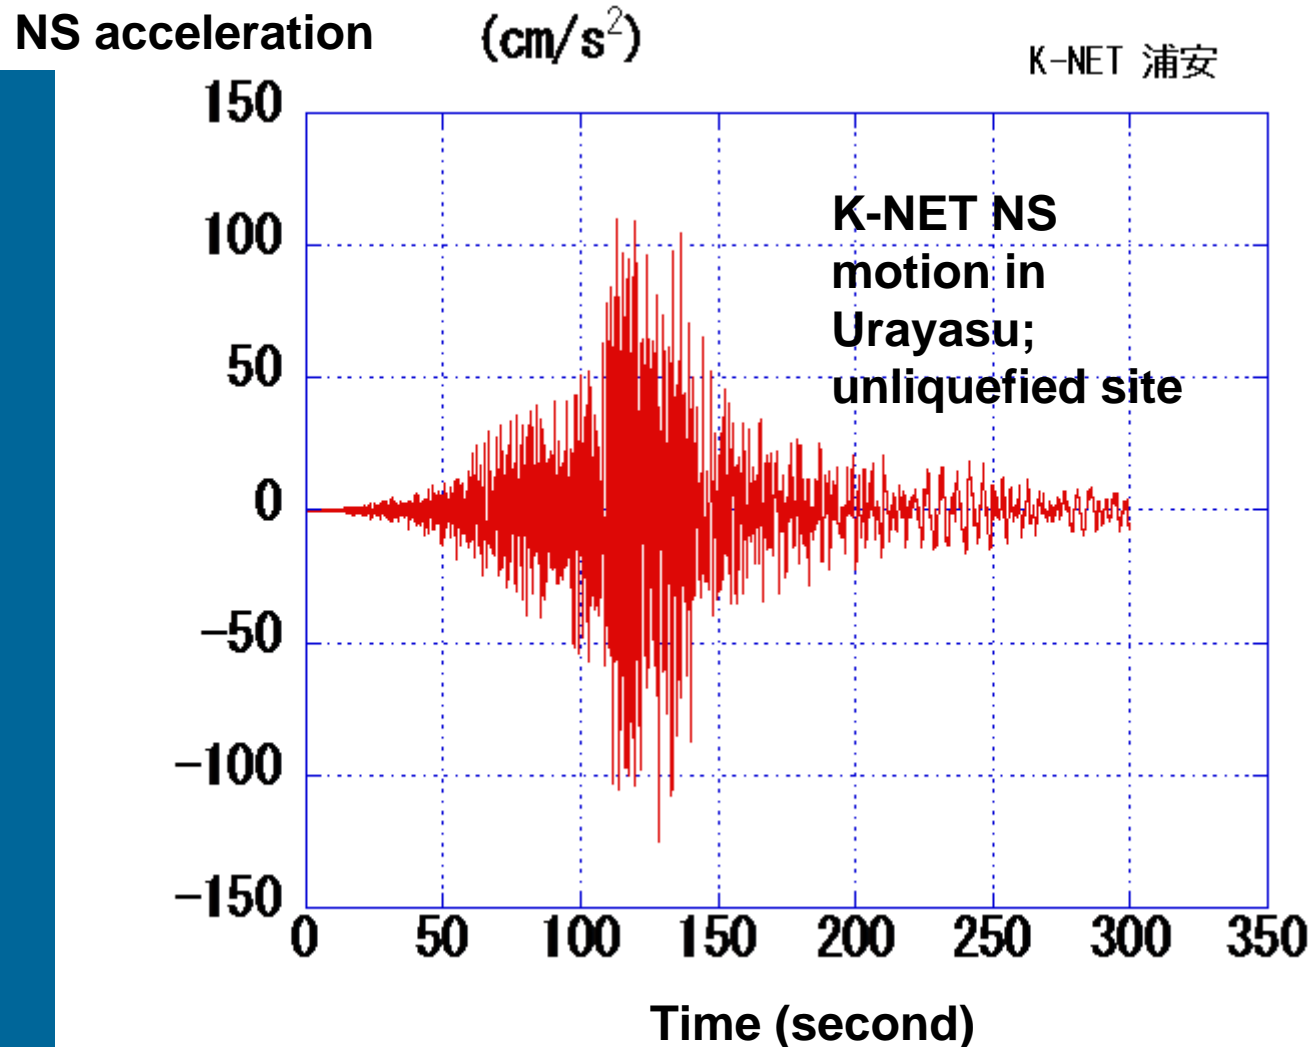
Magnitude = 9.0; Long duration of shaking and many number of cyclic shear; liquefaction easy to occur.

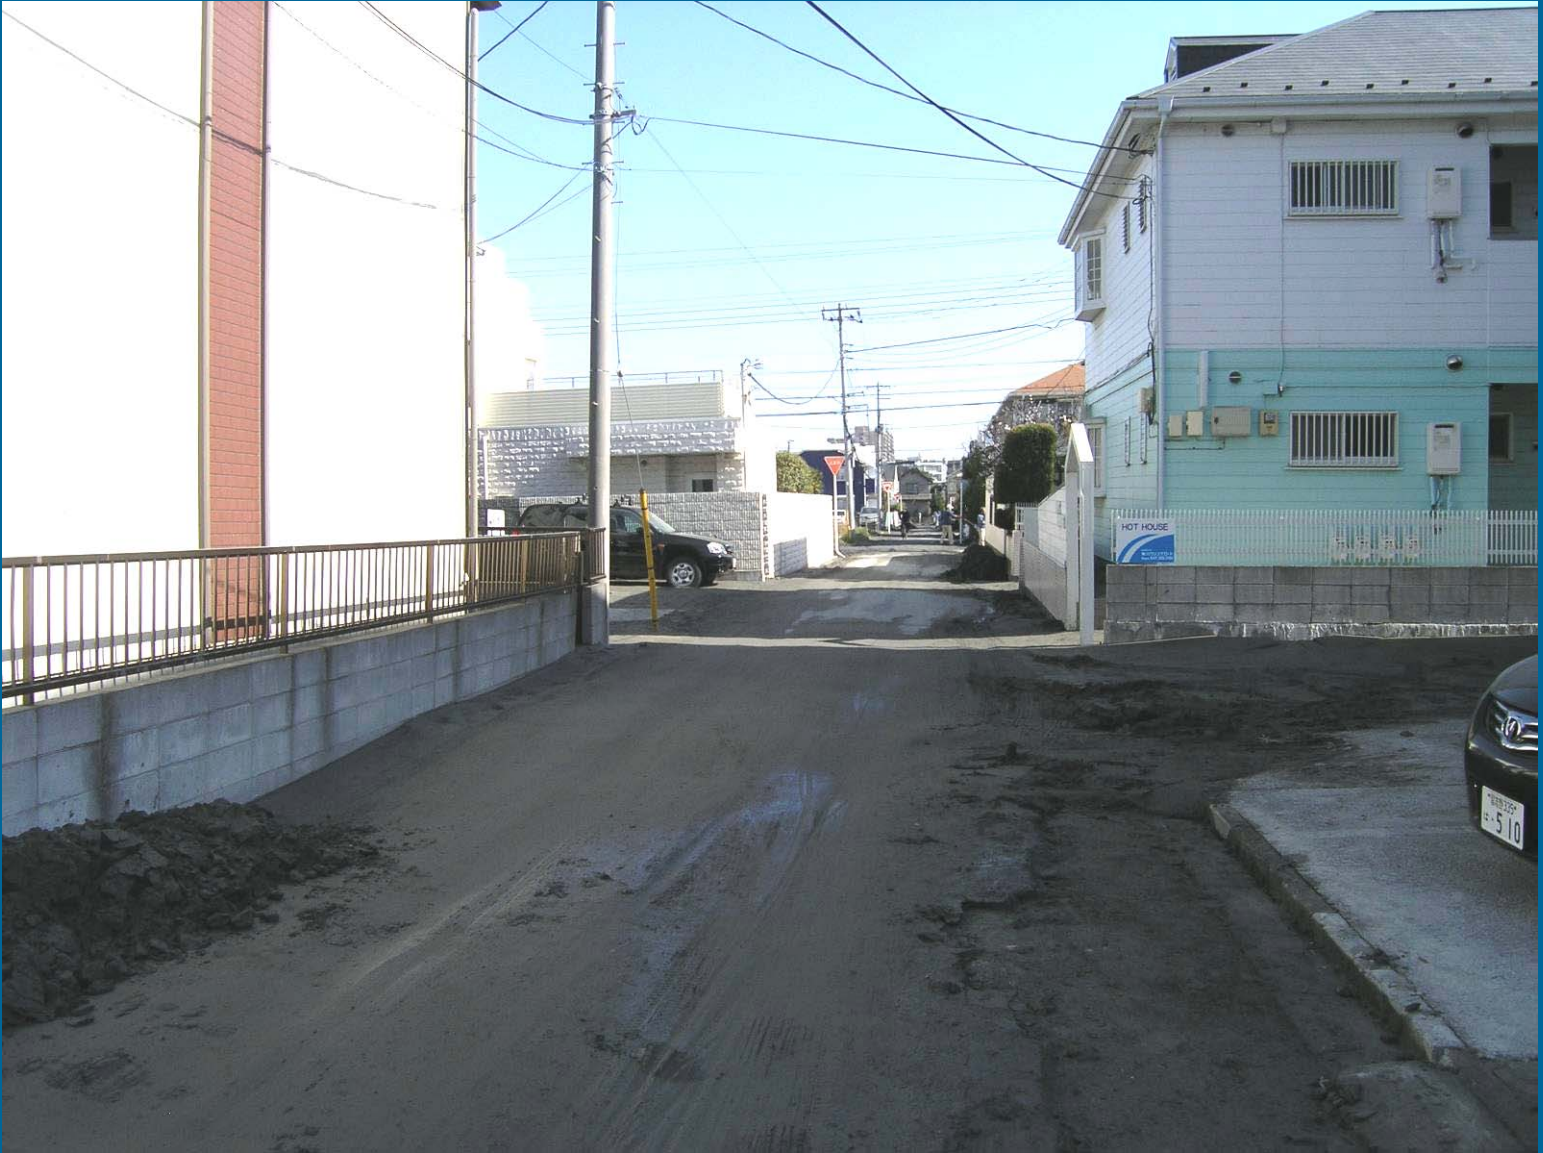
# Liquefaction in residential area (Urayasu City)

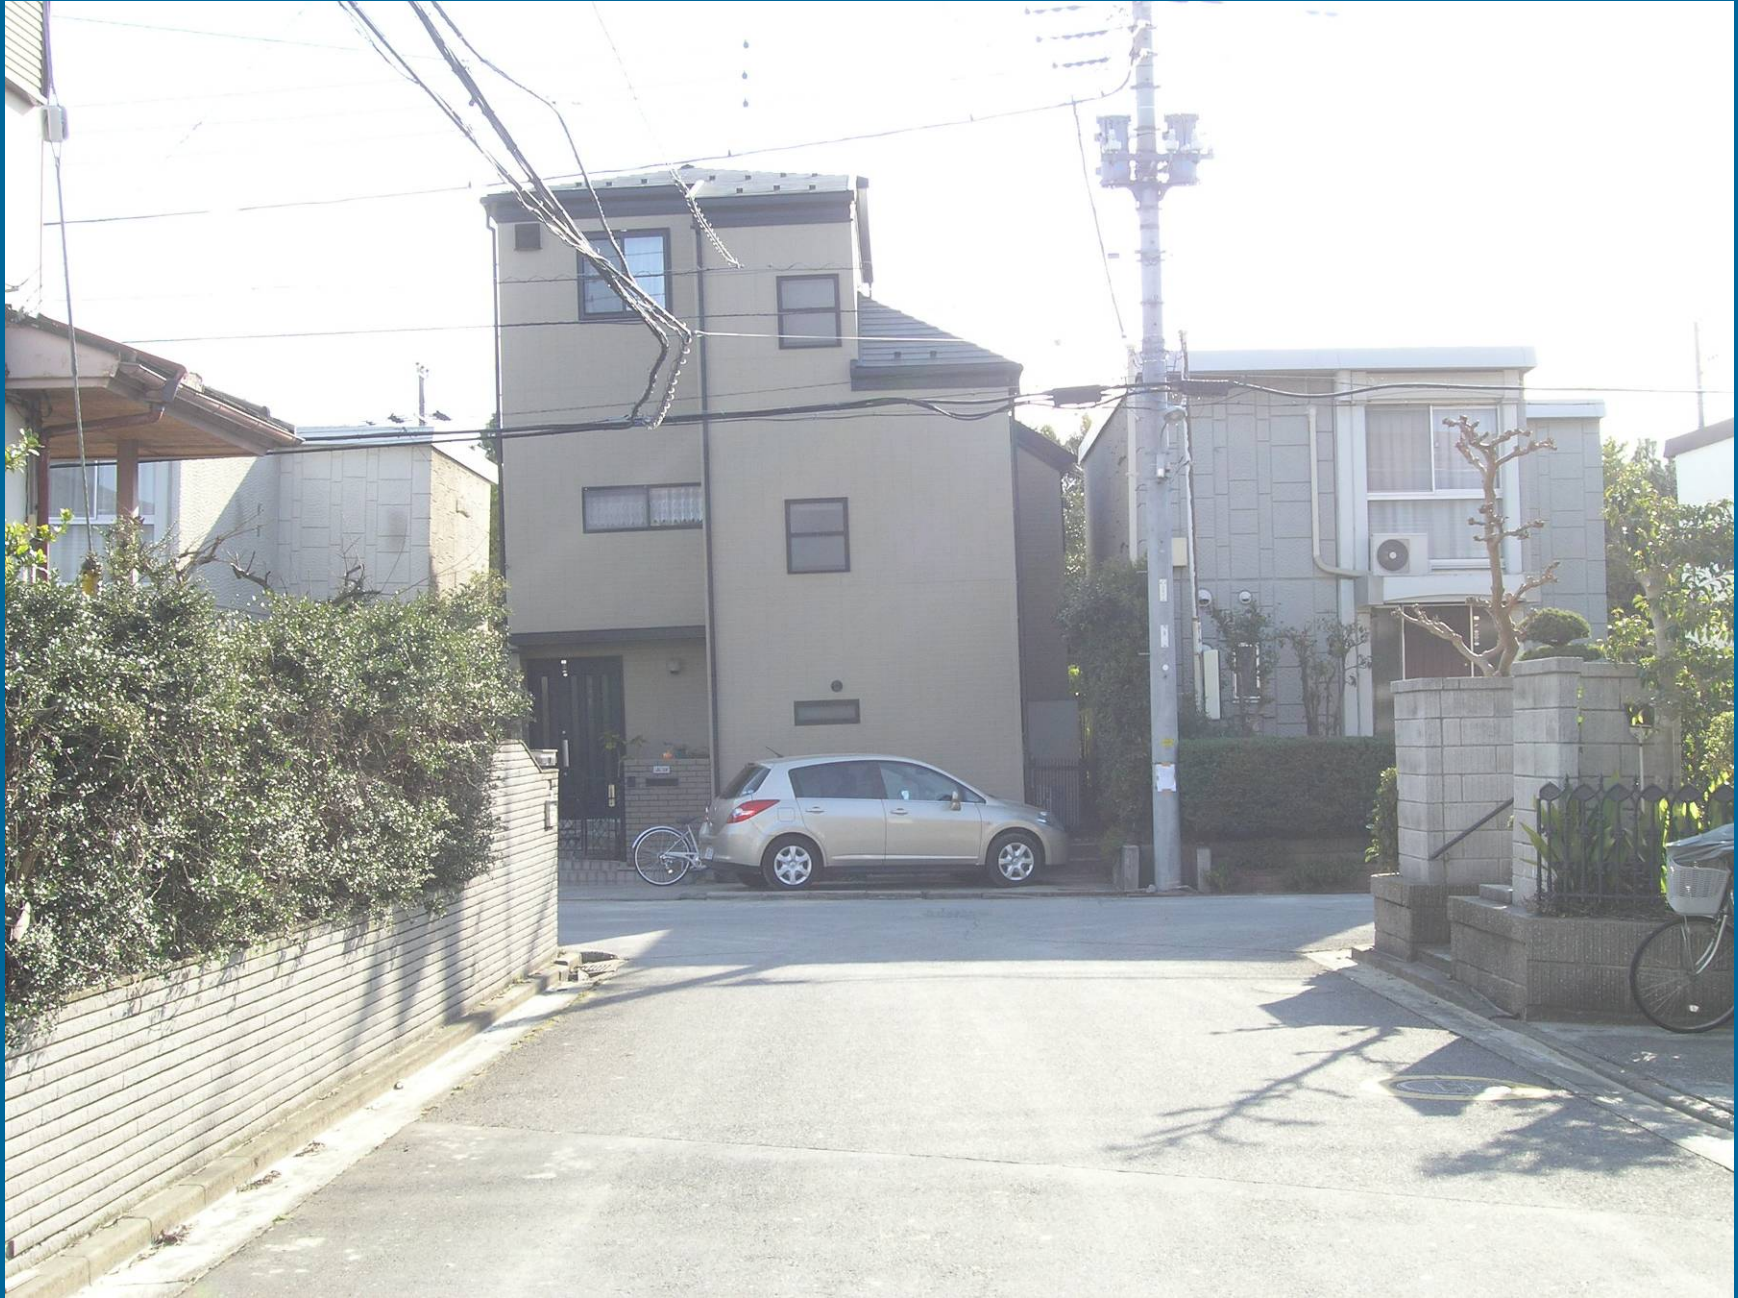
# House tilting in Chiba City

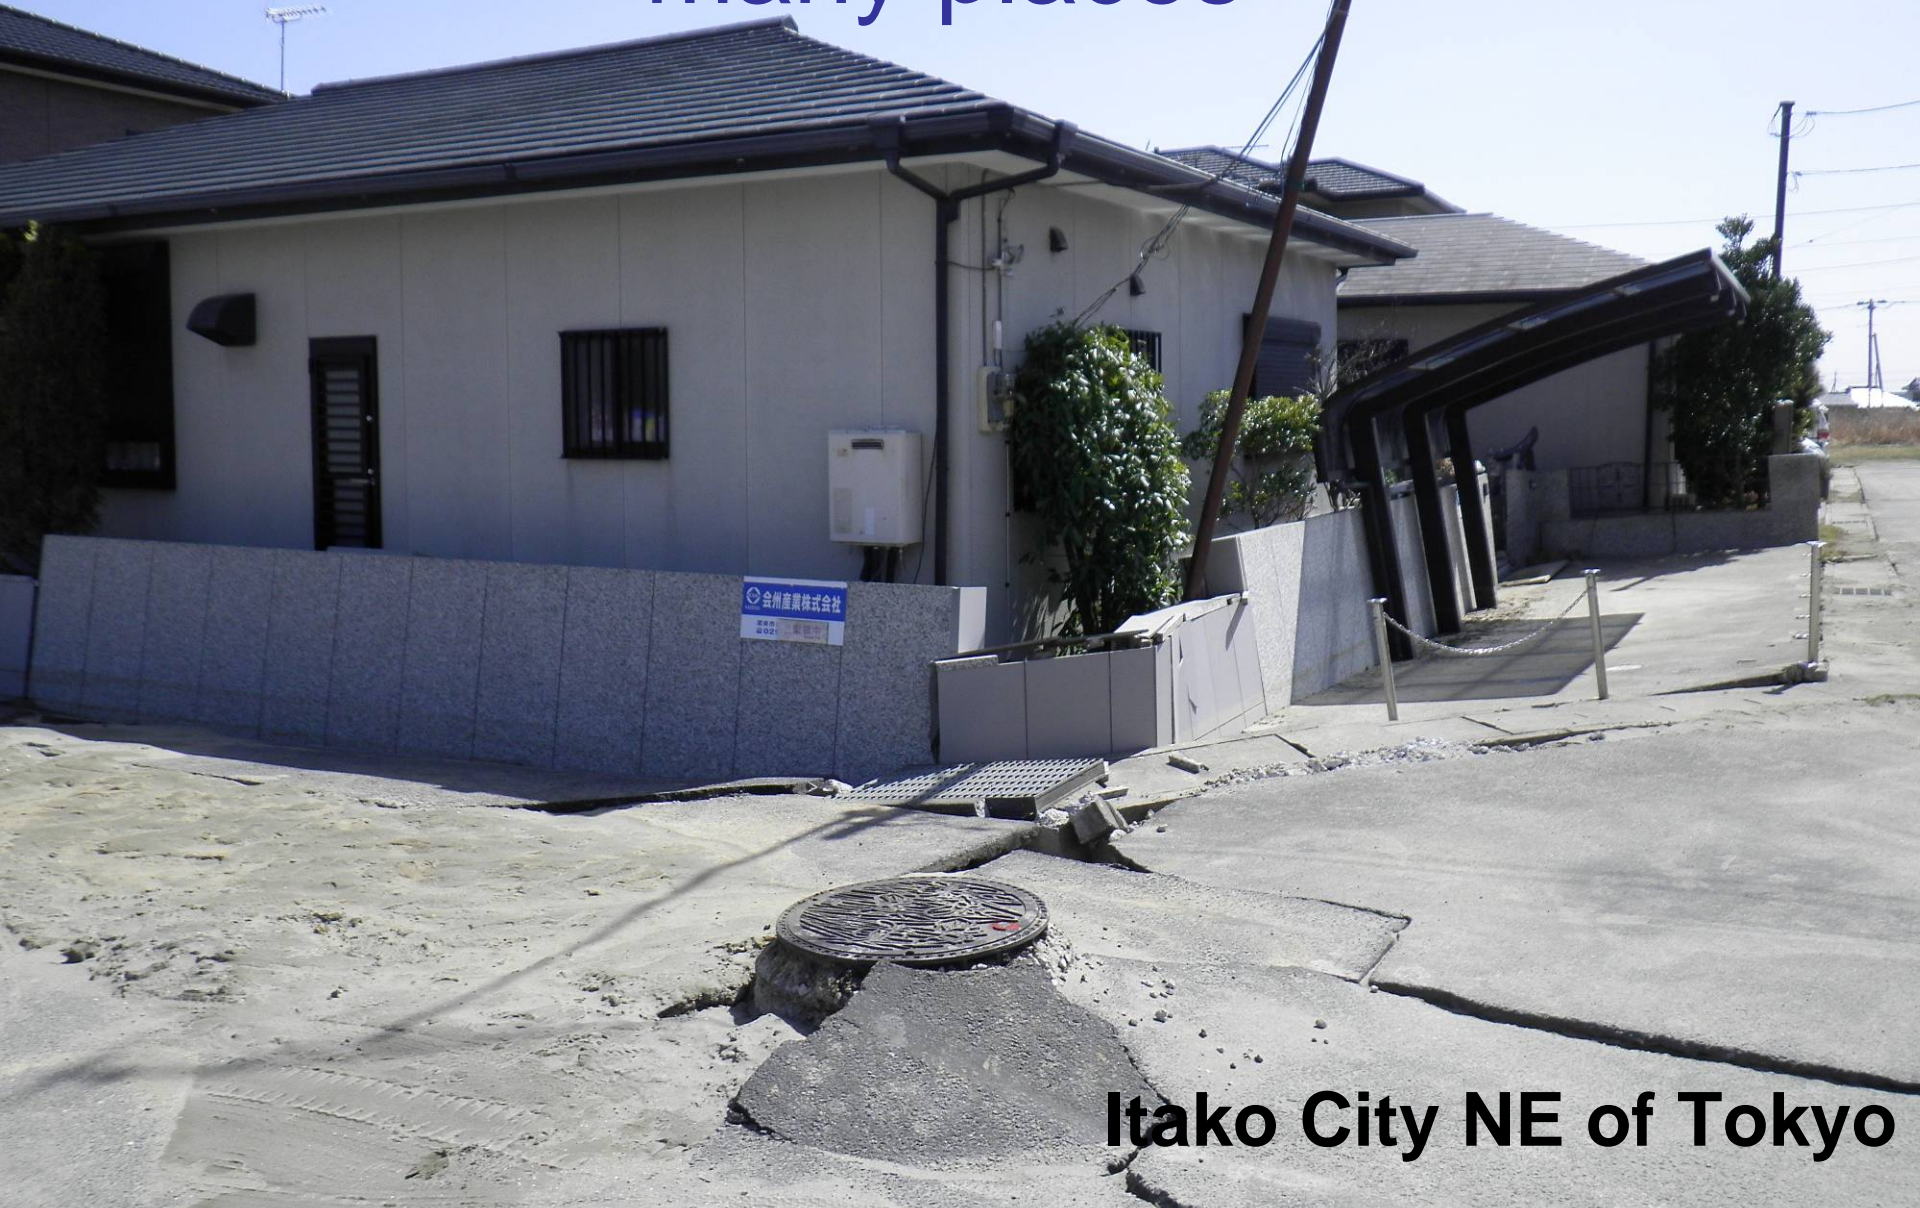
**Itako City NE of Tokyo**

# Liquefaction affected houses at many places

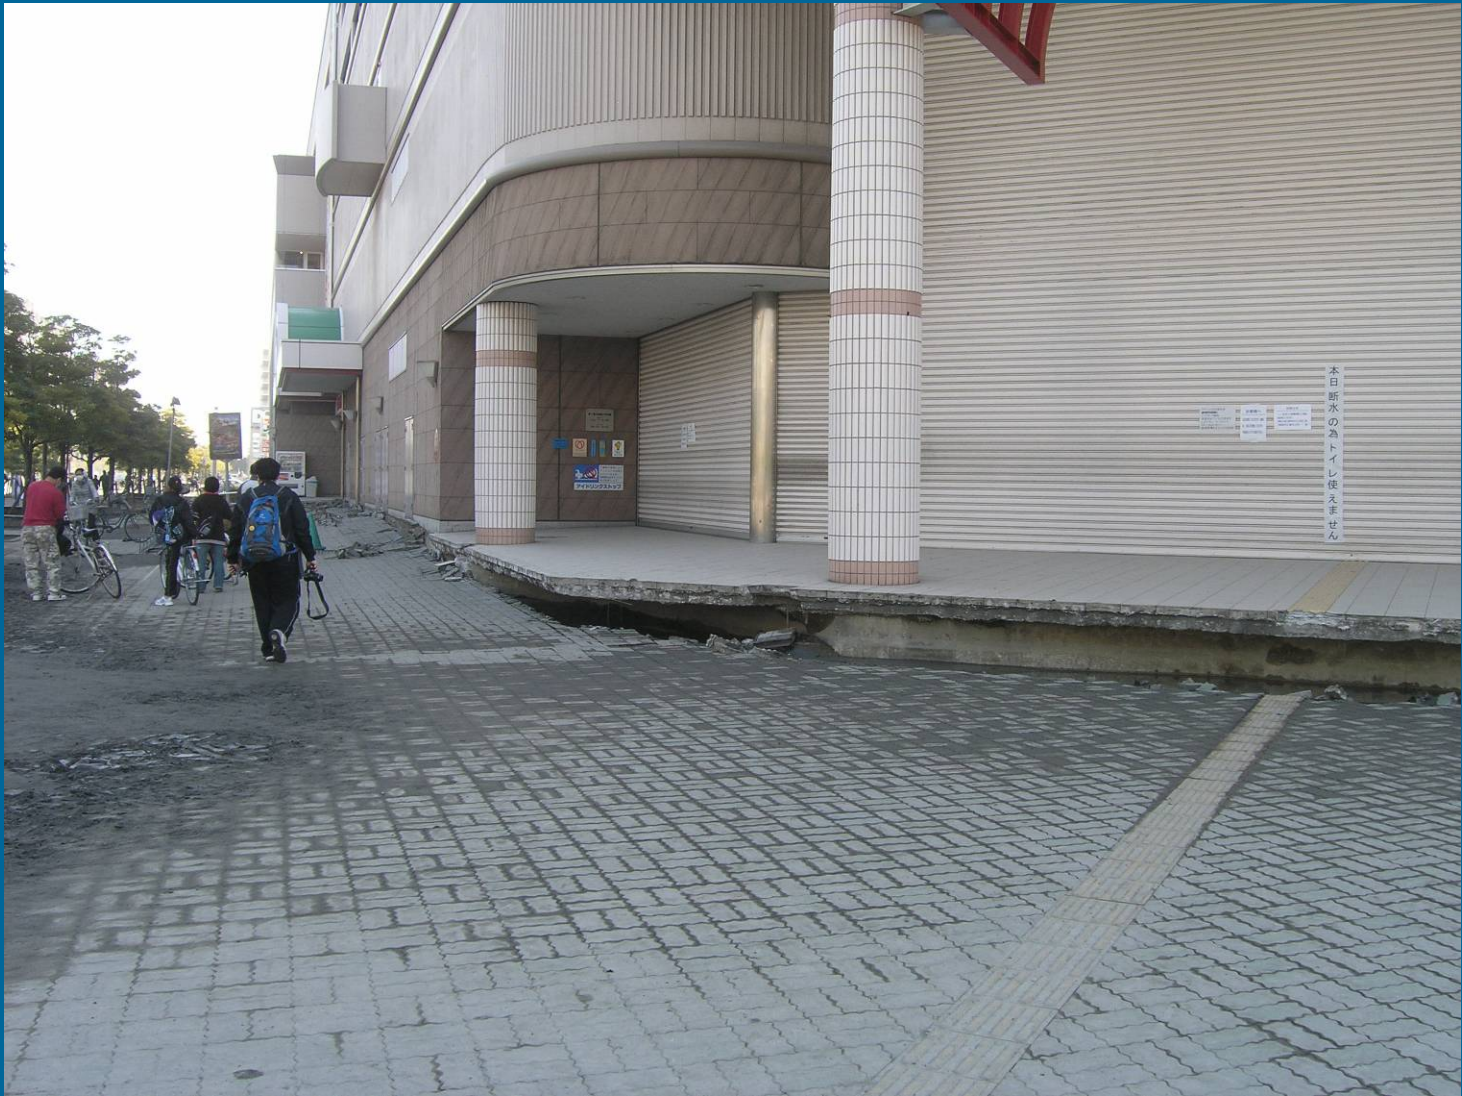
# Differential subsidence around pile-supported building and disconnection of lifeline (Urayasu City)

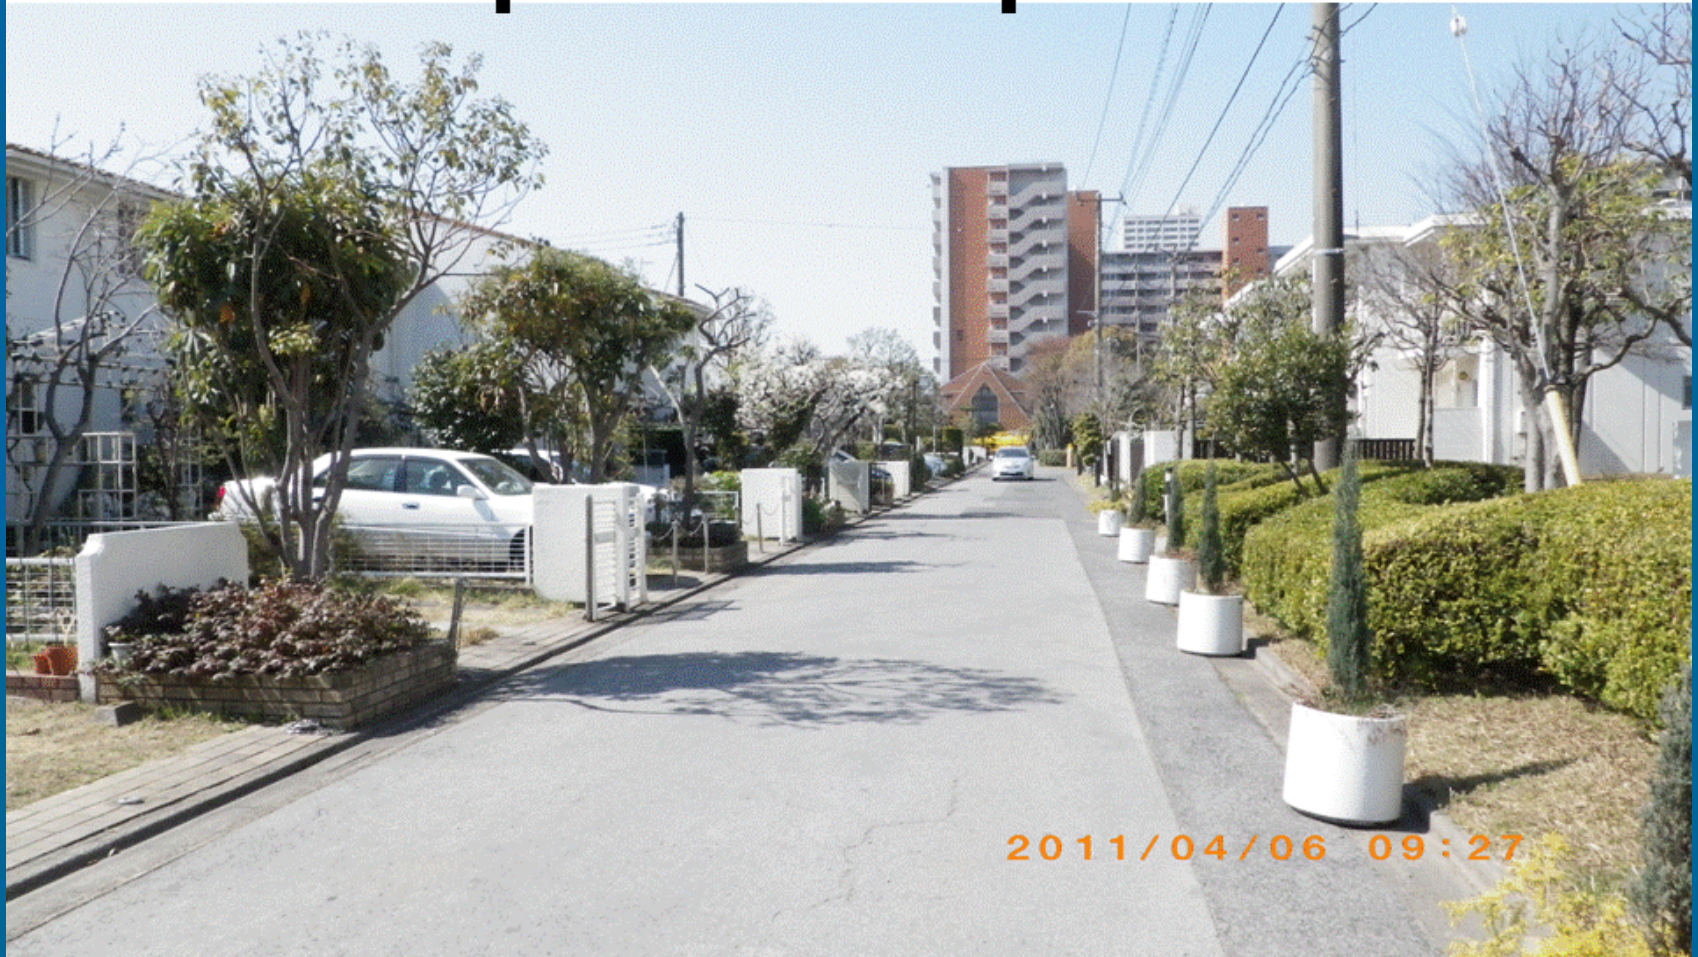
2011/04/06 09:27

# Successful soil improvement; Sand compaction piles and gravel drains

Gravel drain

Sand compaction pile

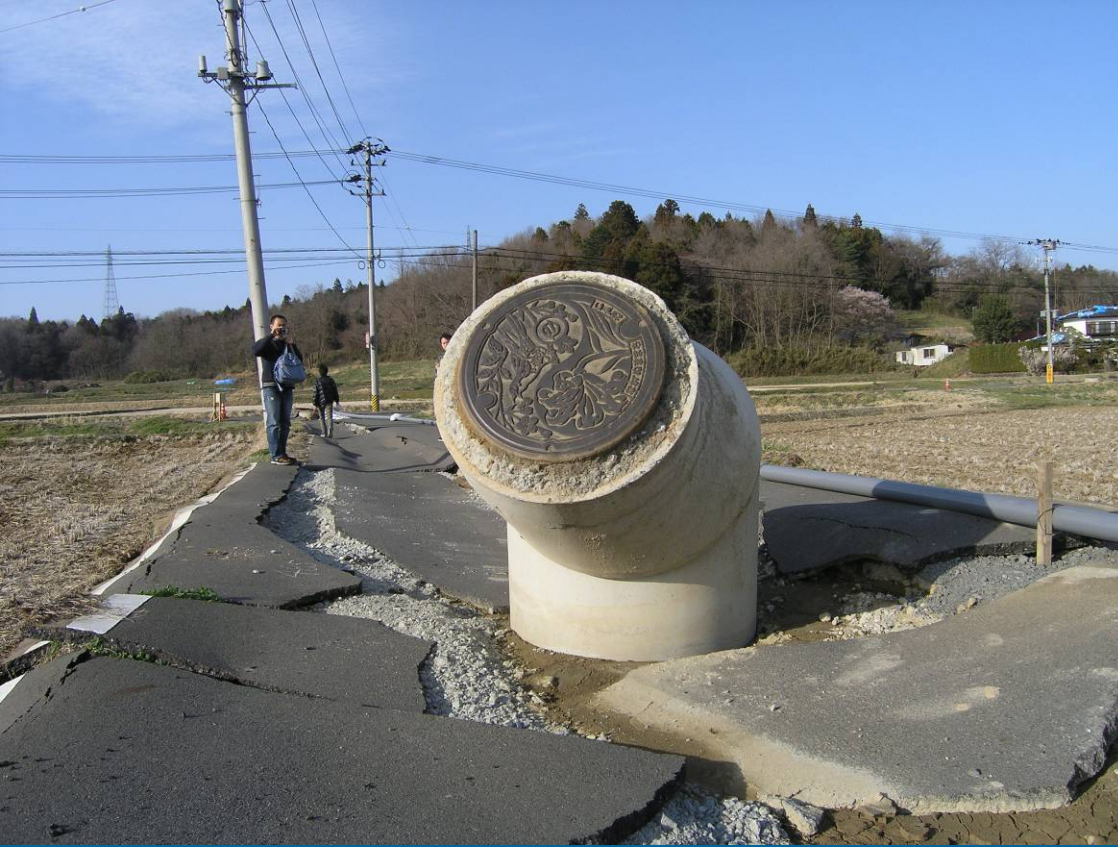
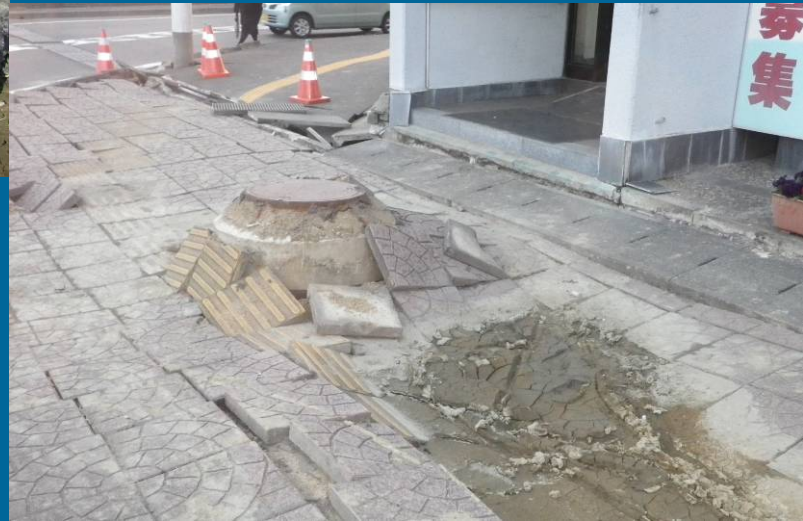
# Sewage pipelines were destroyed at extremely many places
