# Geotechnical damage caused by the recent gigantic earthquake in Japan

Ikuo Towhata  
University of Tokyo

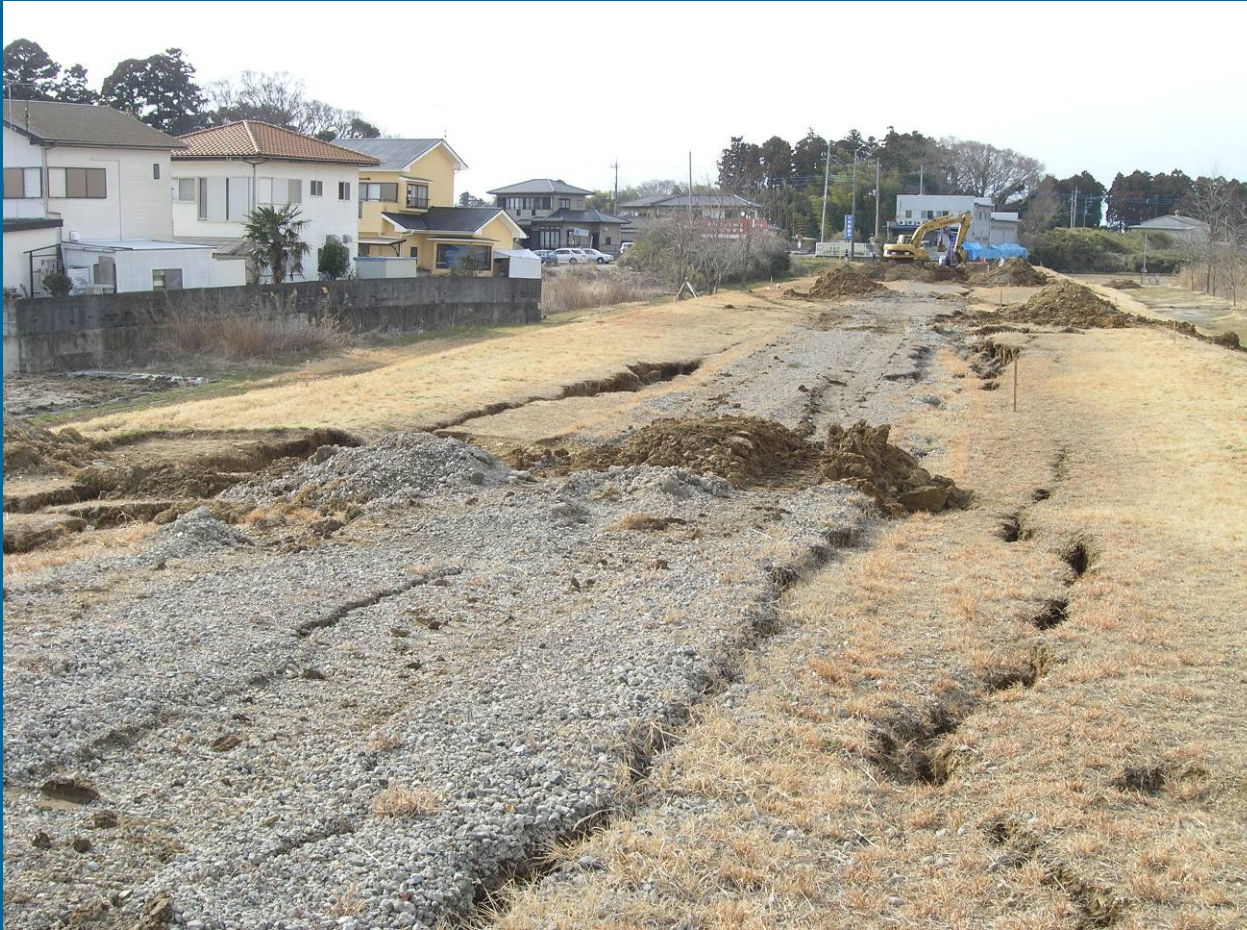
## Nearly 2000 sites of damage

Liquefaction in foundation, subsidence, and lateral spread

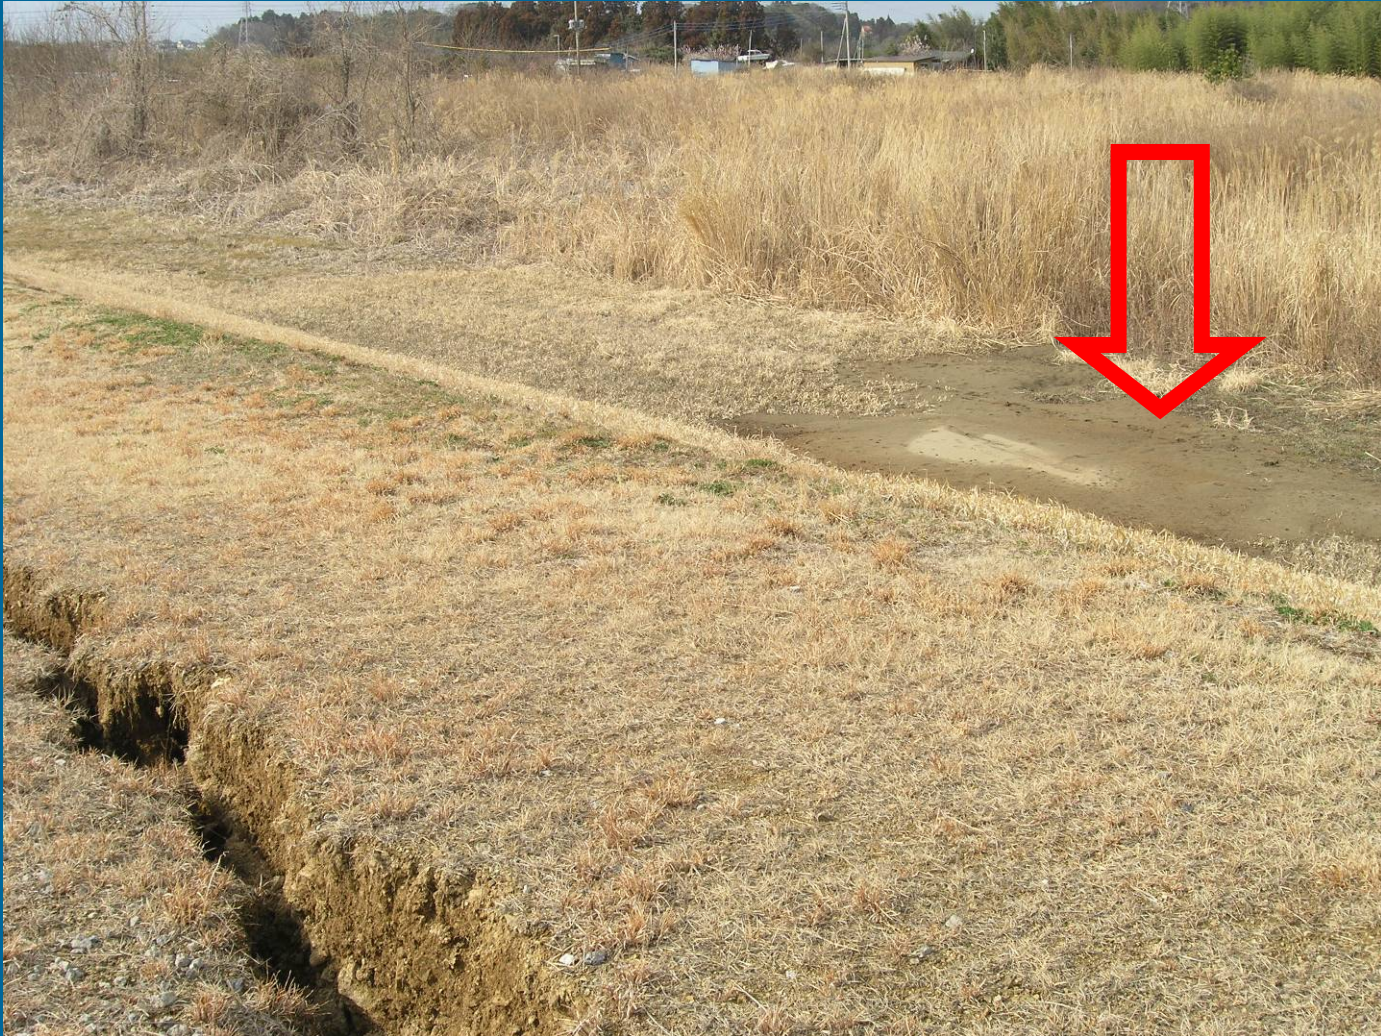
# Sand boiling on river side

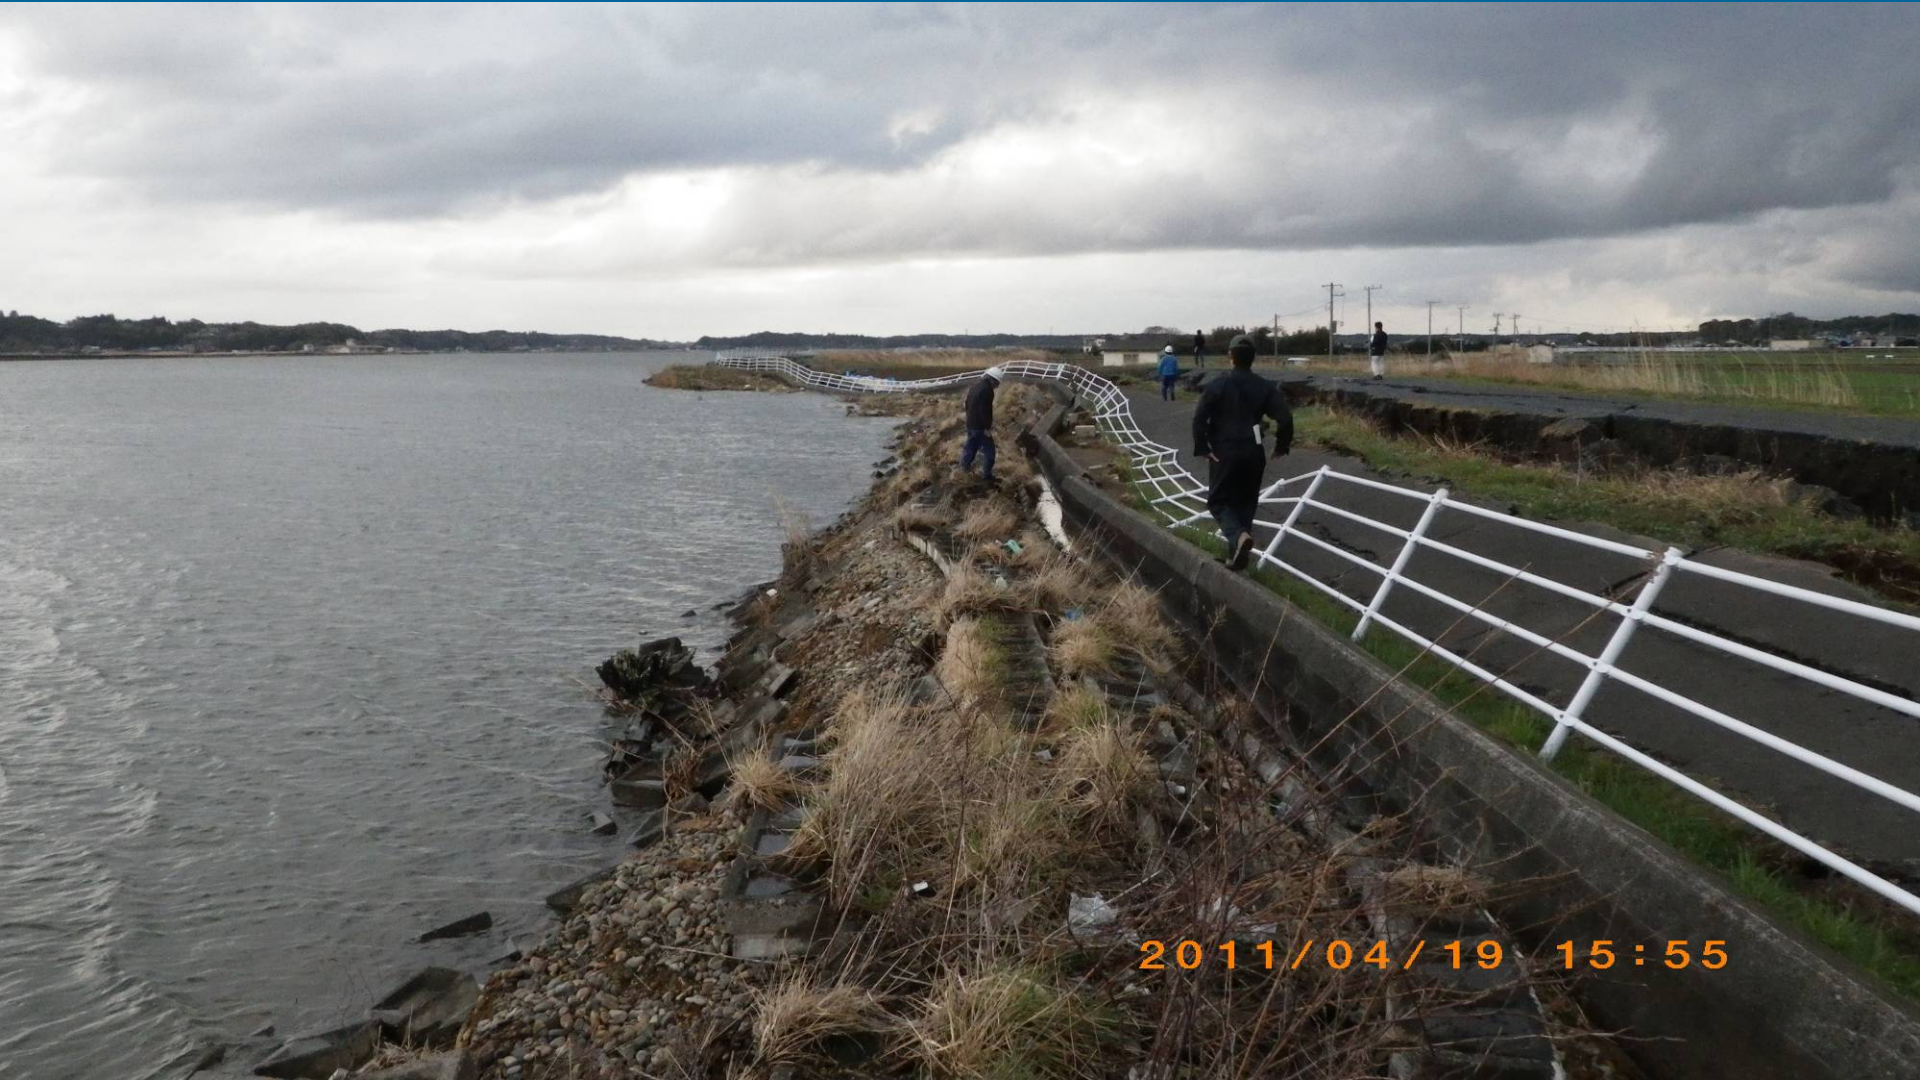
2011/04/19 15:55

# Liquefaction in foundation

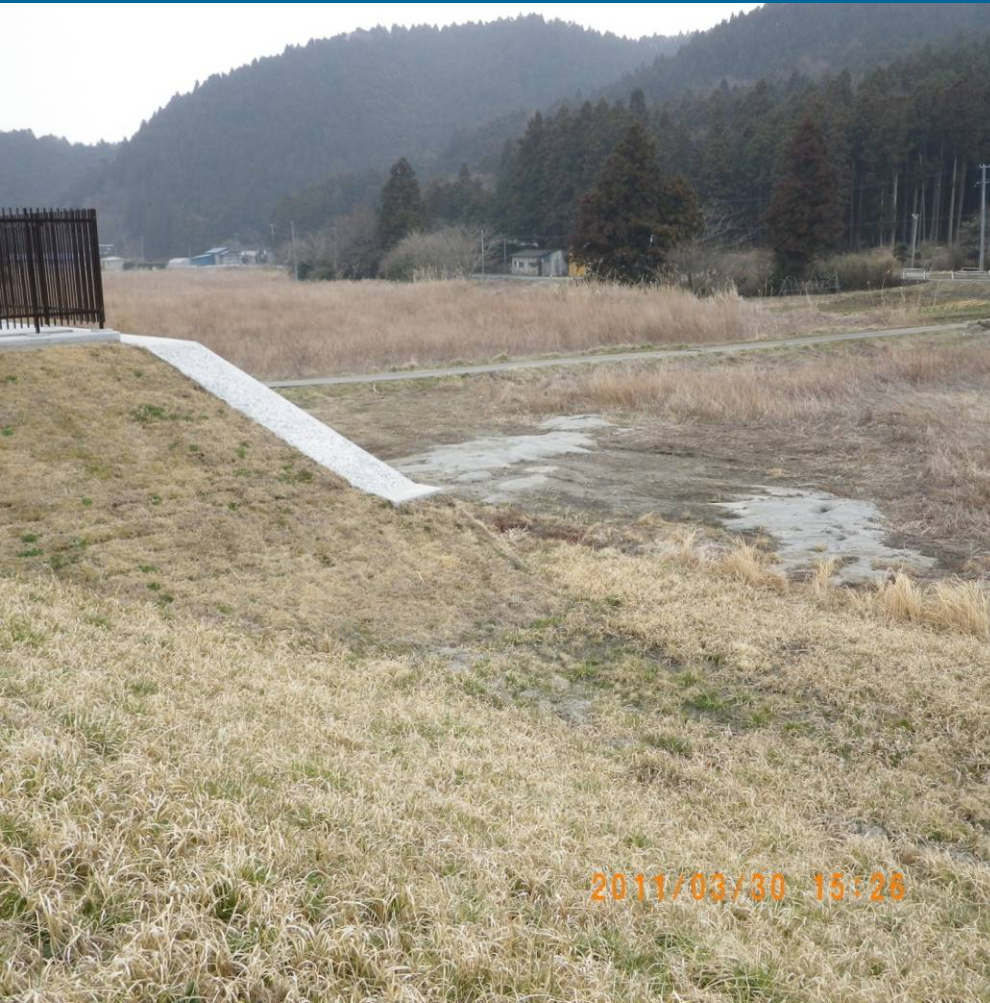
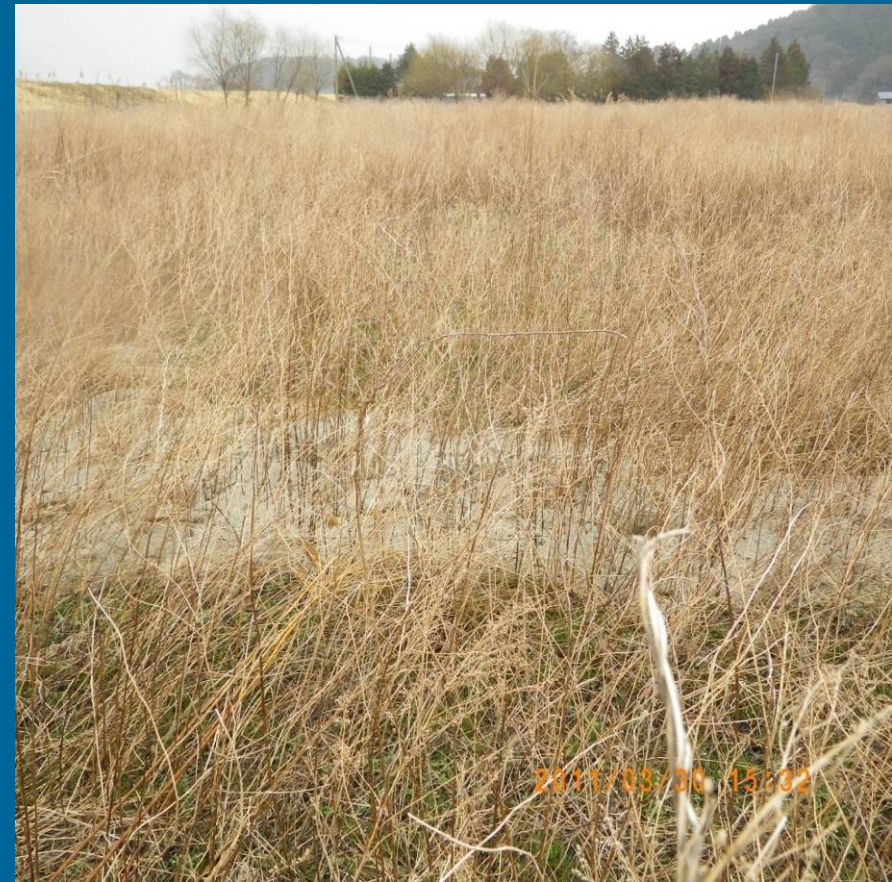
# Repeated liquefaction; 4<sup>th</sup> time

1978 main and after-shocks, 2003 and 2011

Most damages in river levees were associated with liquefaction in foundation or inside the levee.

Liquefaction is repeatable.

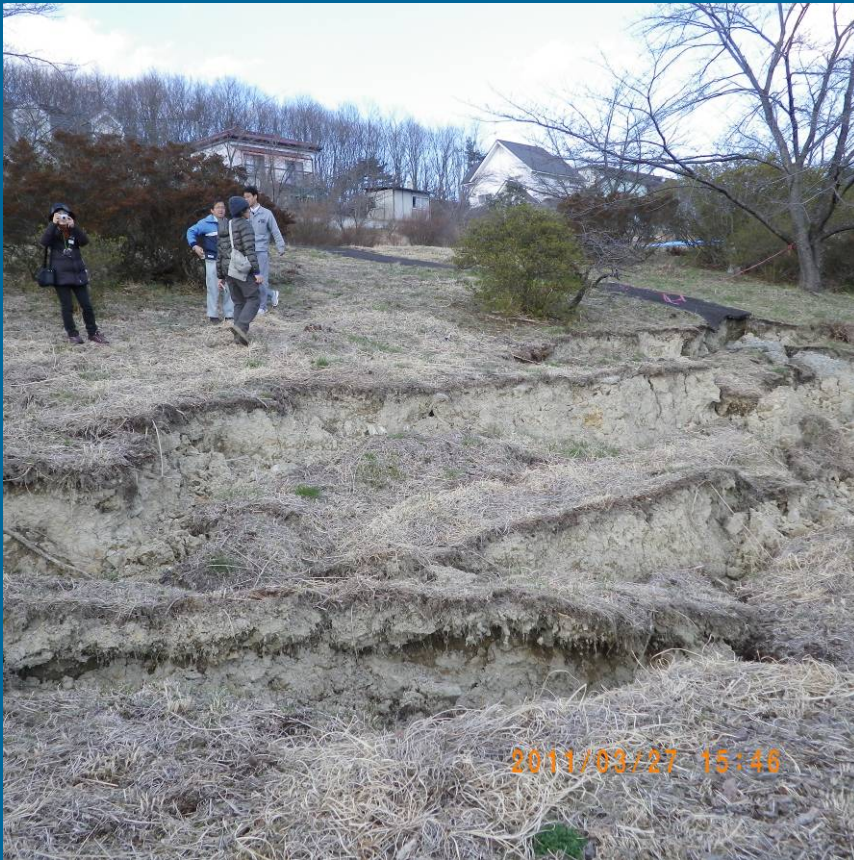
# Damage in residential development in hilly area: cut and **fill** construction

Site of previous slope failure in 1978

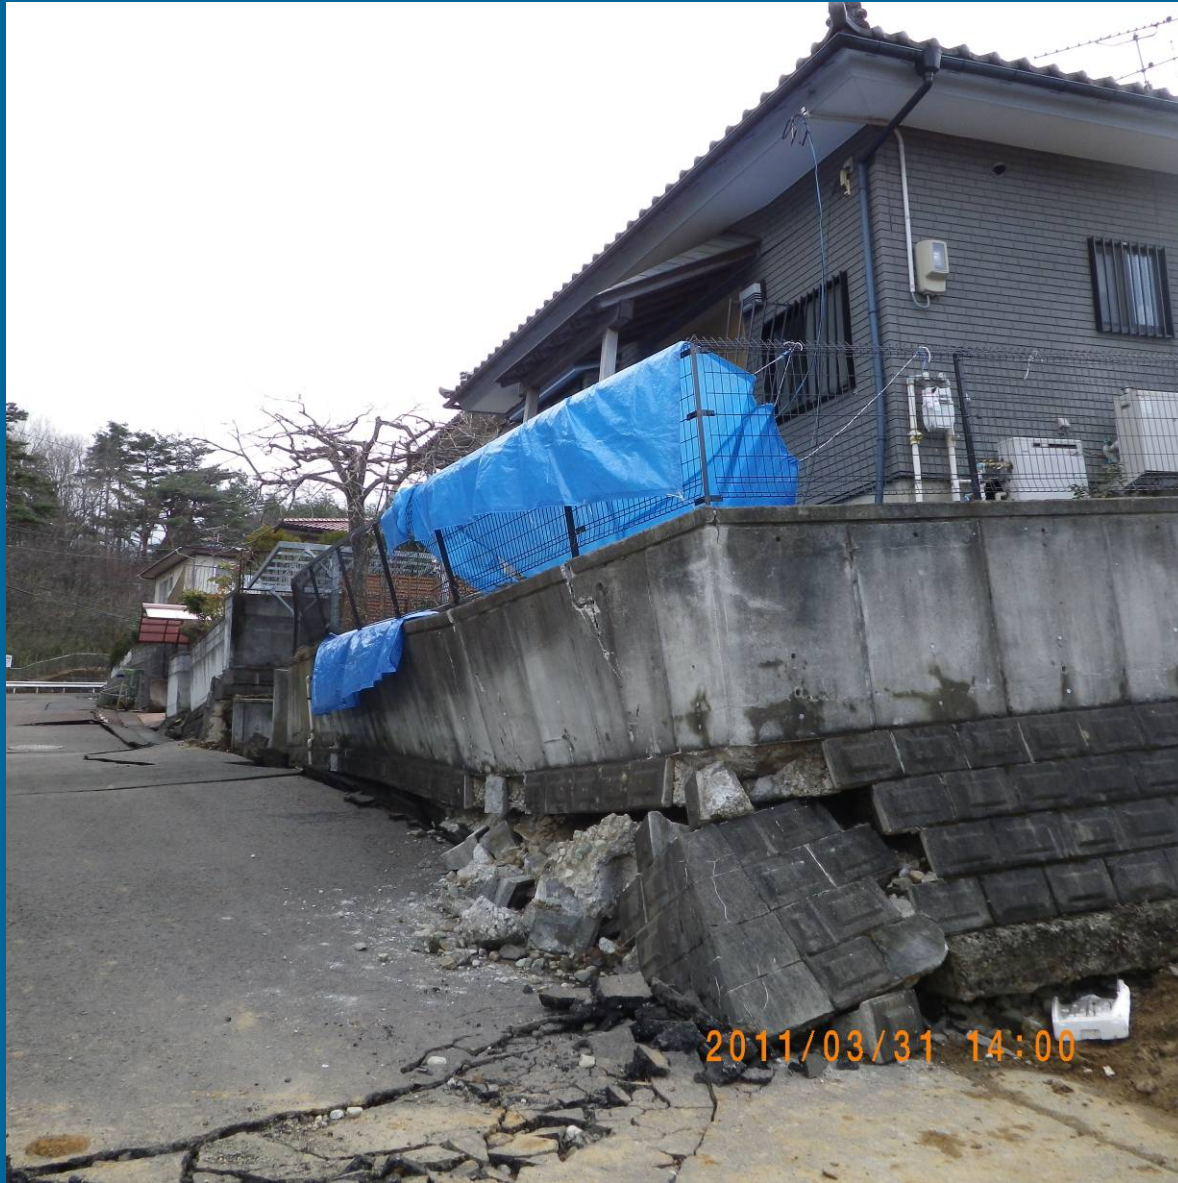
# In Sendai City: On Fill,

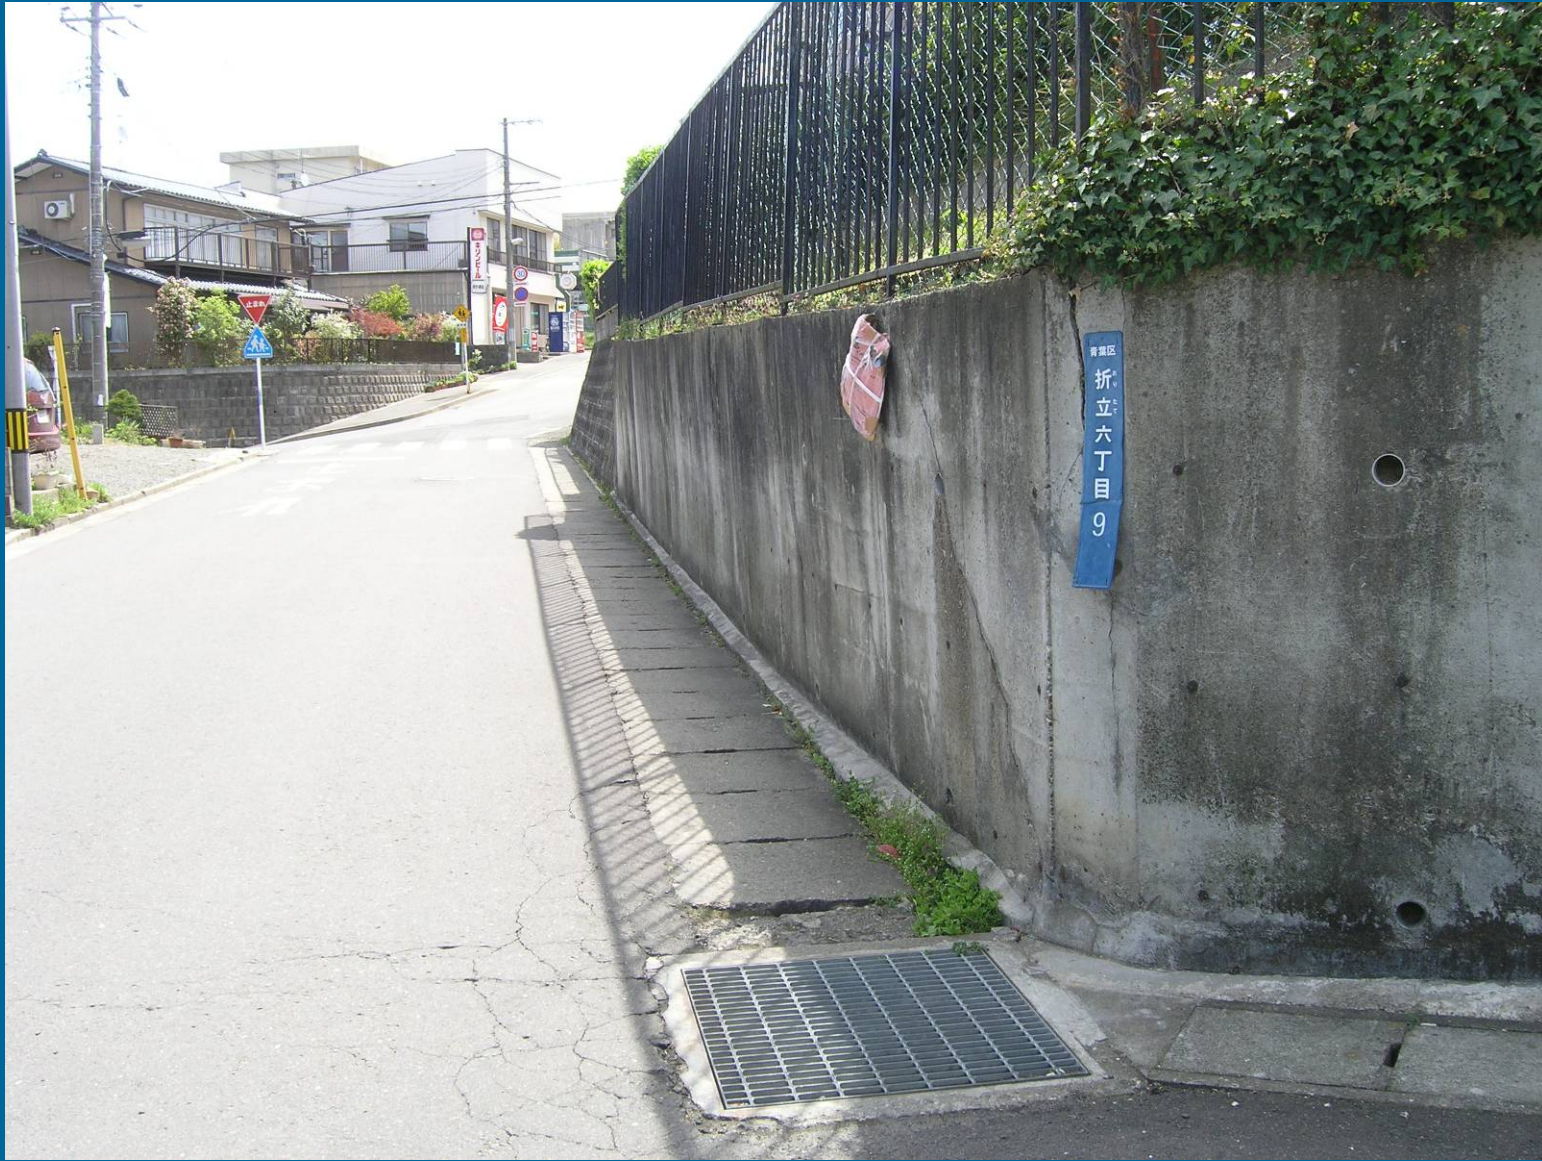
On cut part, *in contrast*, damage is *much less*

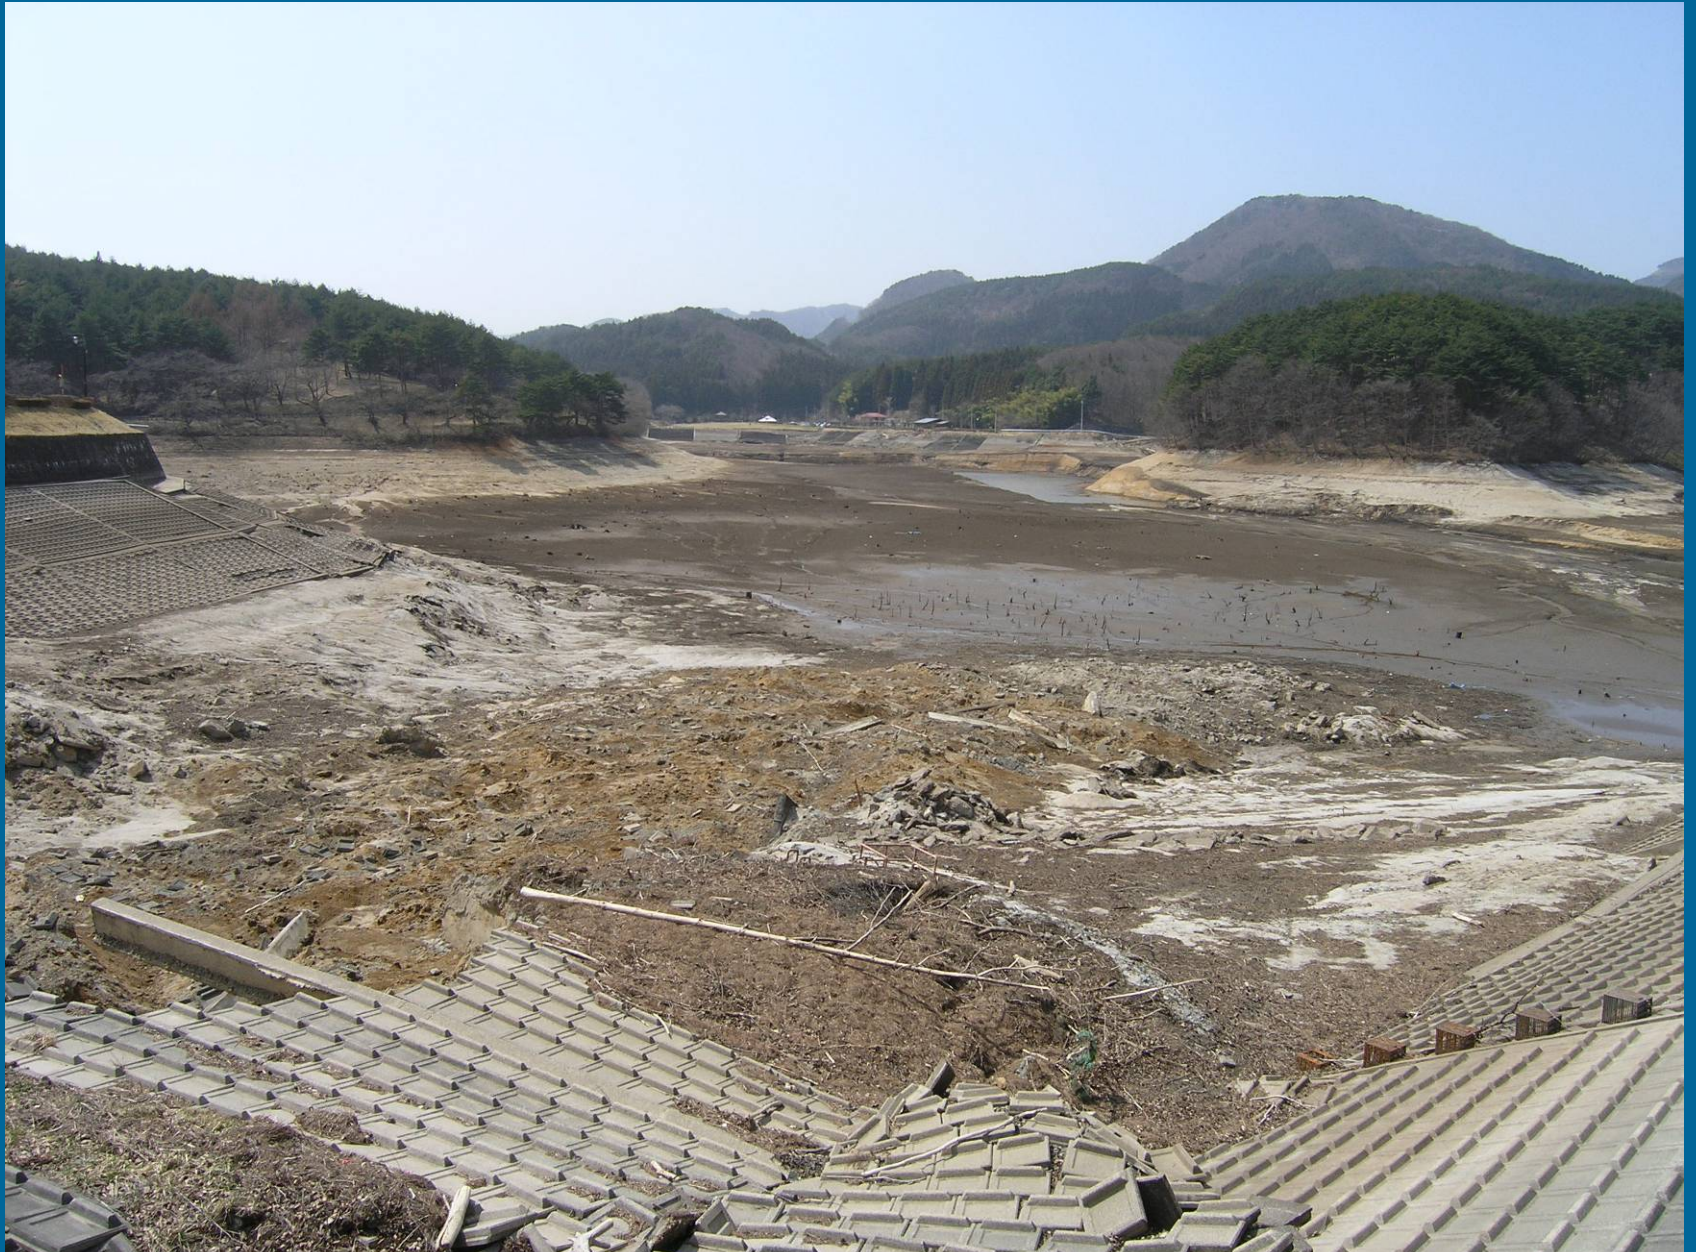
# Breaching of Fujinuma (irrigation) Dam

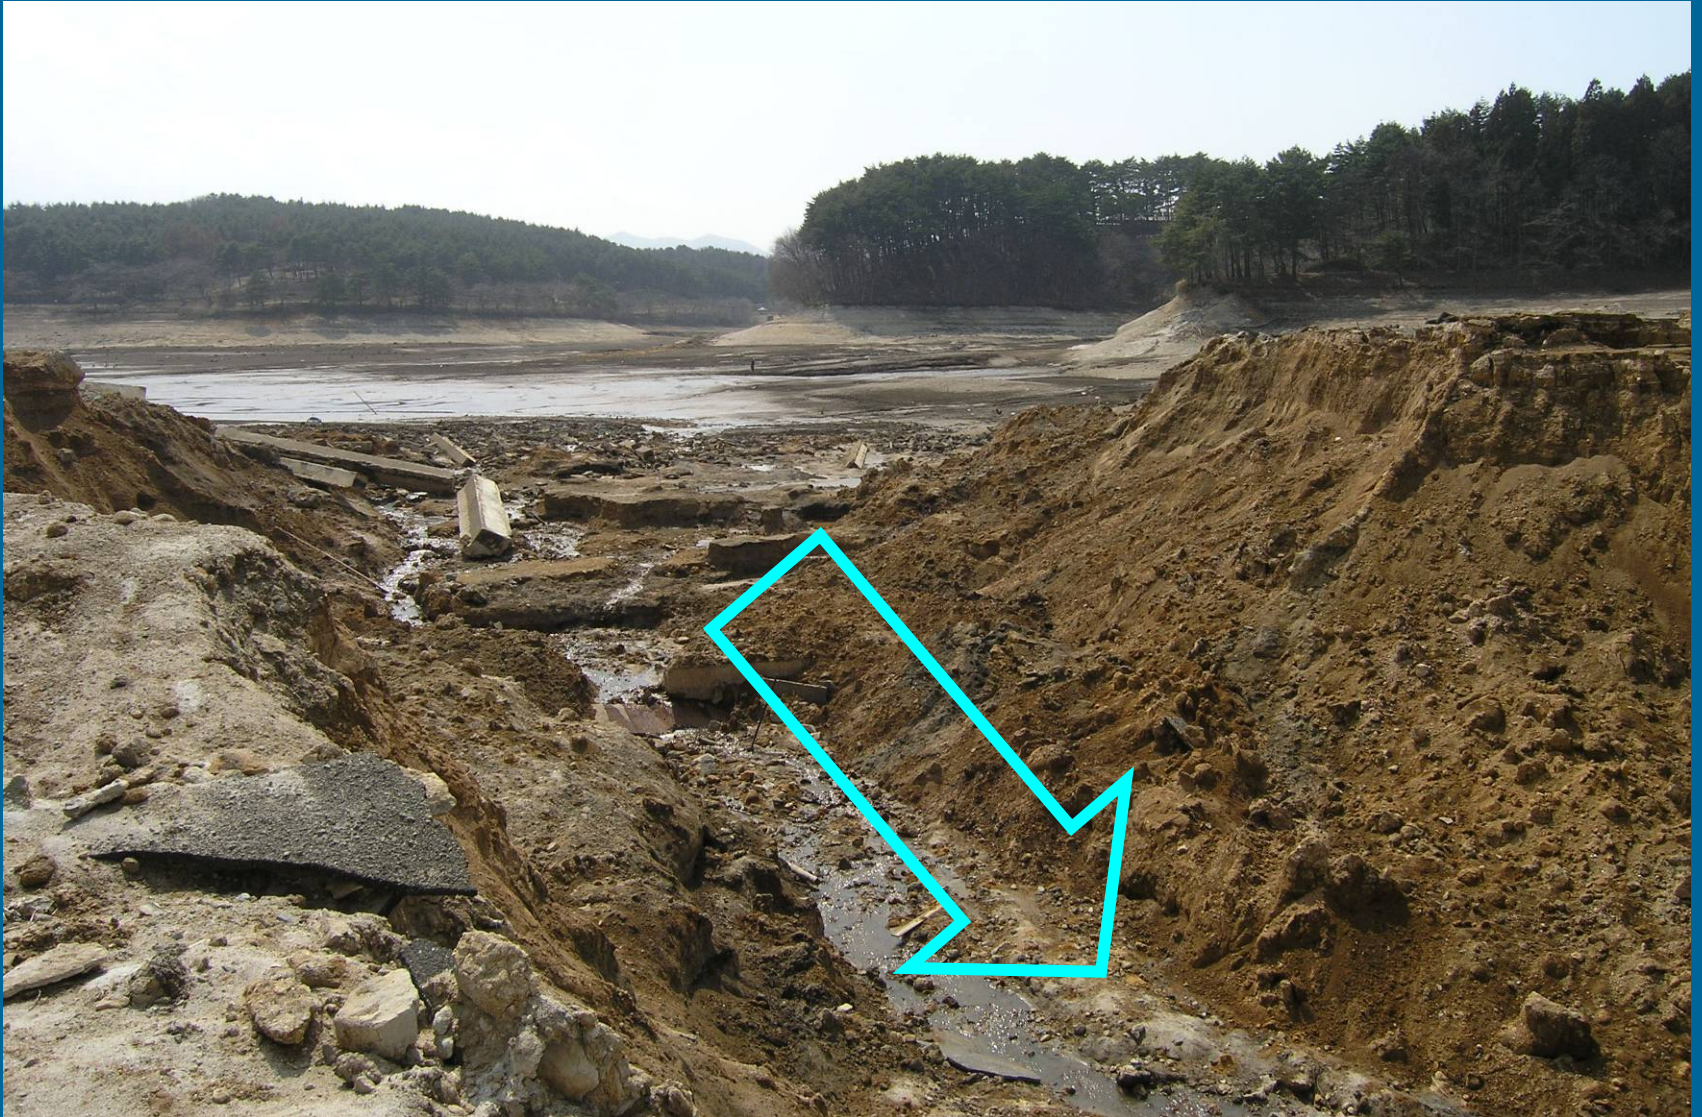
First dam was eroded and 150万m<sup>3</sup> of water attacked a downstream village

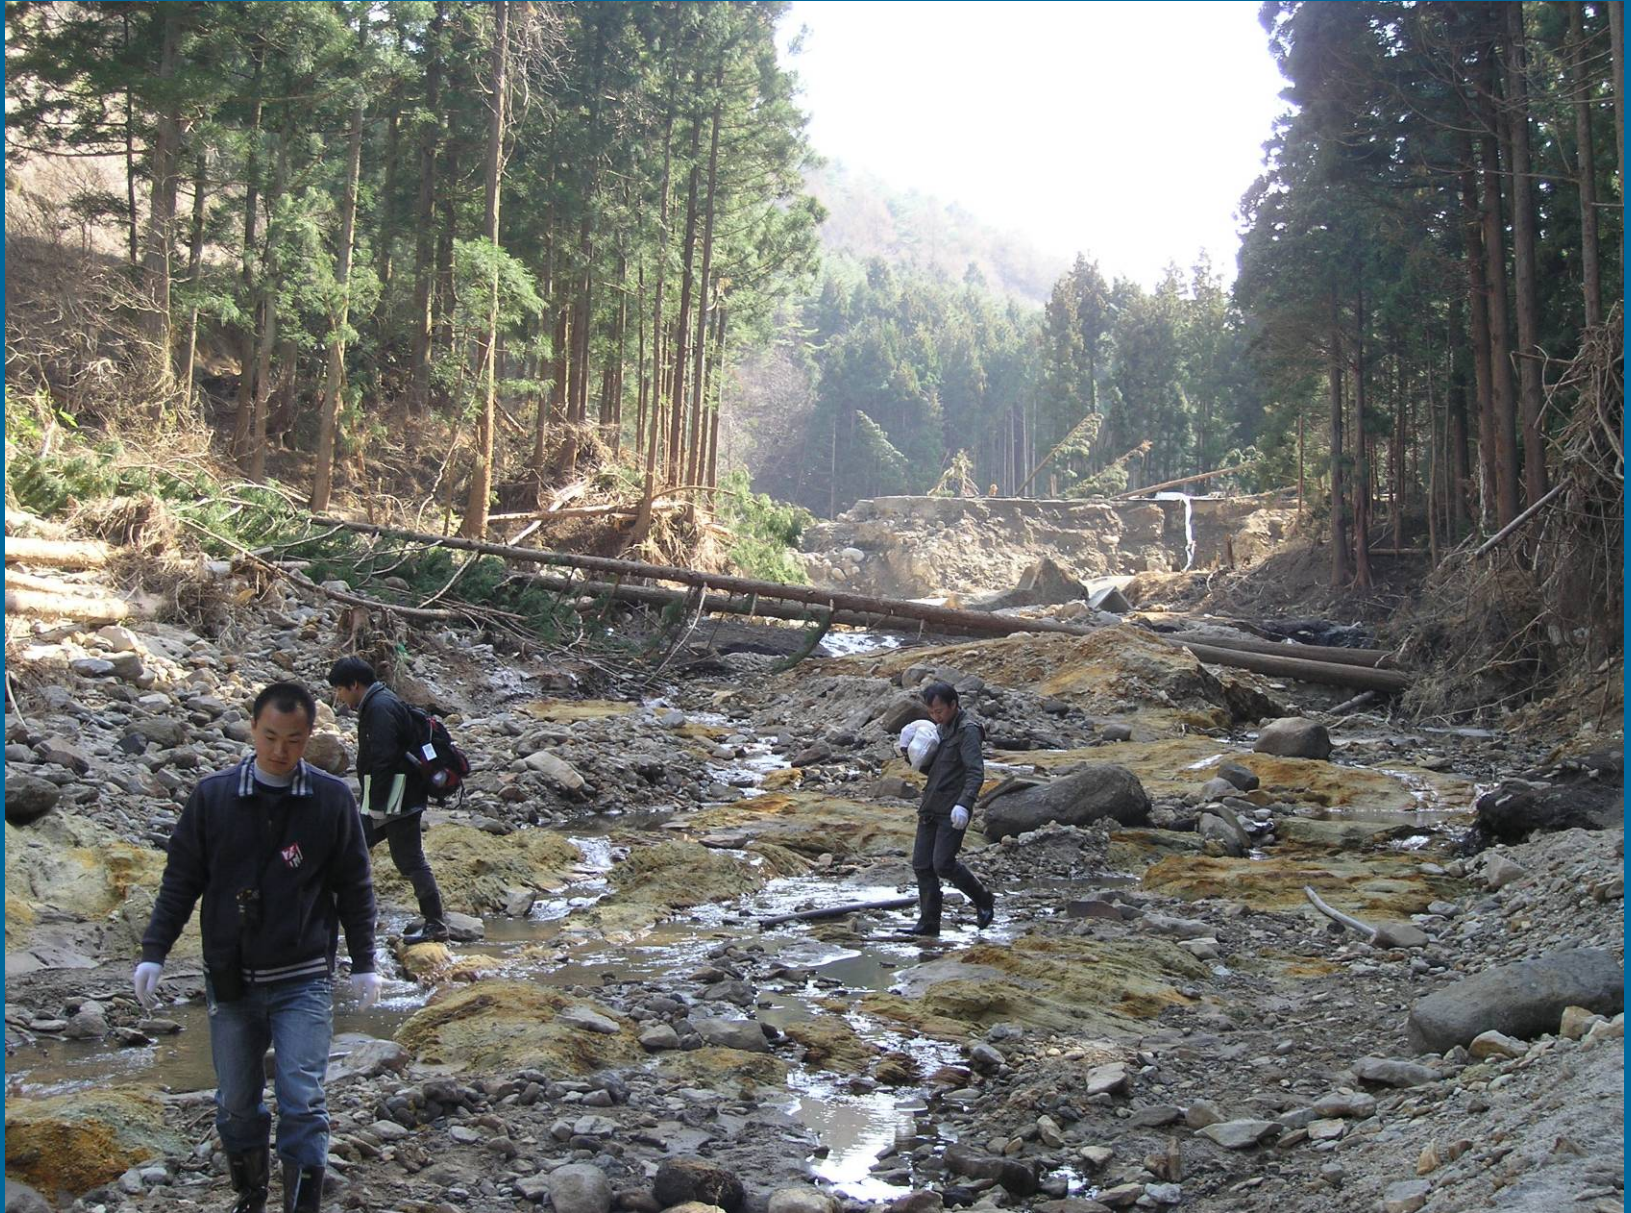
# Flooded channel
