Investigation Report on Earthquake near Awajishima on April 13, 2013

Key Words : Earthquake near Awajishima, strong ground motion, damage to houses, soil liquefaction

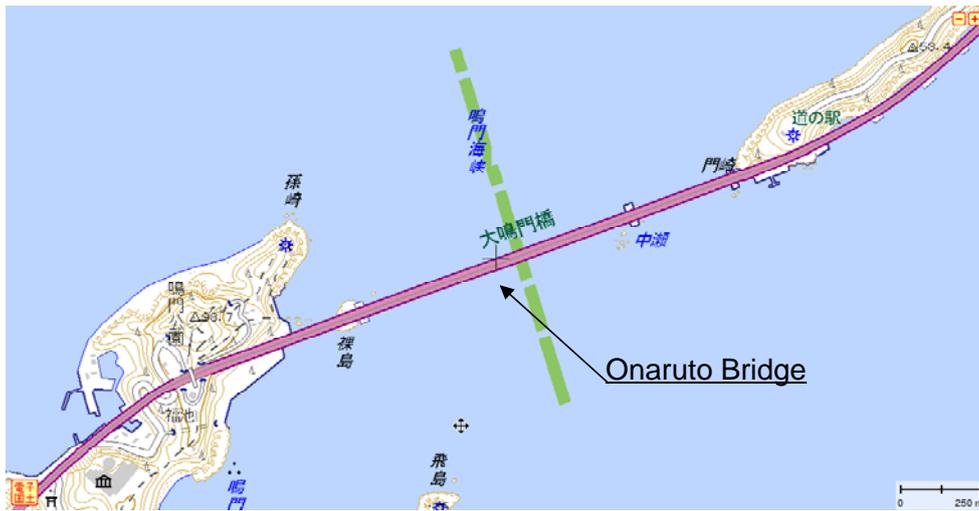
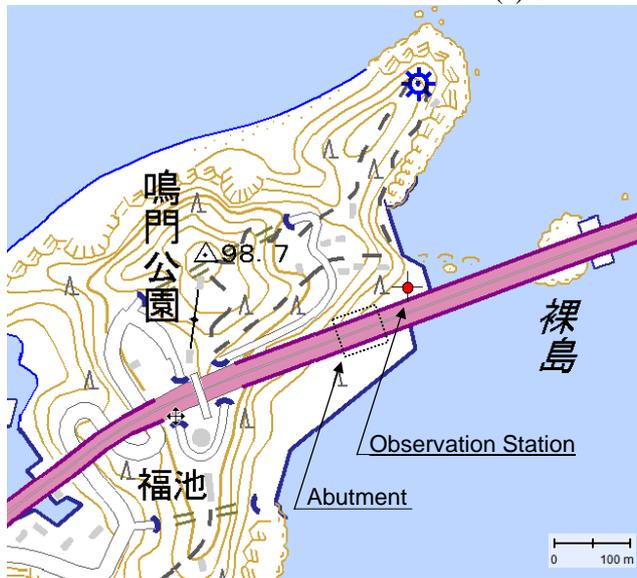
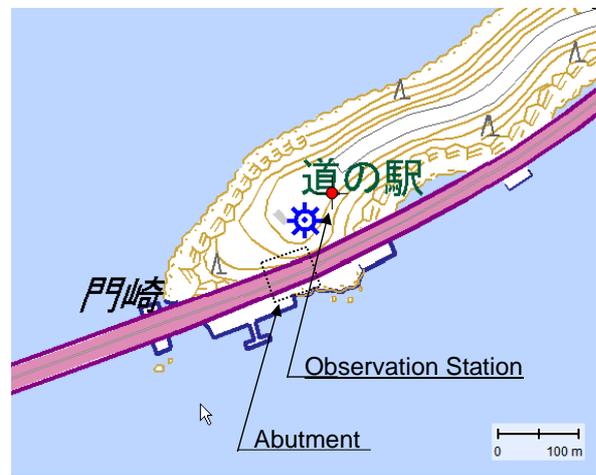
Fig.7 Observation station at the Onaruto Bridge site

As the seismometers on the Onaruto bridge sites were installed on rock outcrops only 50 to 100 m away from the bridge abutments on Awaji and Naruto sides of the strait as shown in Fig.7, the obtained seismometer records (Figs 8(a) and 8(b)) are considered to clearly reflect the basic features of the input ground motions to the bridge abutments. Given GPS signals as a very accurate time reference for both the seismometers, it is noted that the record on Awaji side started about half a second earlier than that on Naruto side indicating that the primary wave took about half a second to cross the 2 km wide Naruto Strait.

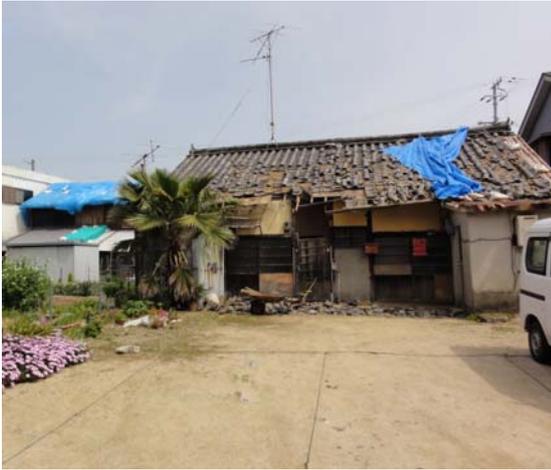
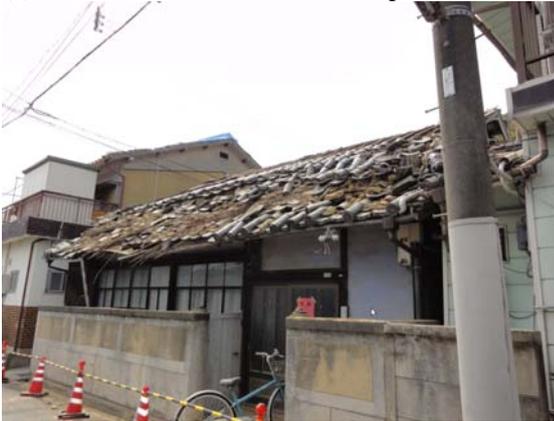
Photo 1 Damage to houses in Takenokuchi area, Sumoto city

One of the common and typical features of damage to Japanese traditional houses was that roof tiles arranged over fine mud were shaken off in the intense

shake. In Sumoto city, damage to houses was concentrated in the Takenokuchi area which spreads over an alluvial soil deposit of the estuary delta of Sumoto river (**Fig.12, Photo.1**). No clear trace of liquefaction was found by the first author during his first survey. In a nearby cemetery of a Buddhist temple, approximately 150 tombstones toppled over in the earthquake, according to the chief priest of the temple. The total number of the tombstones in this cemetery is roughly estimated to be about 500.

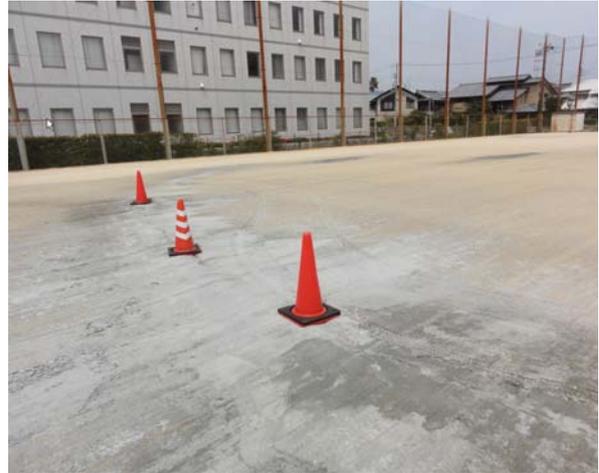
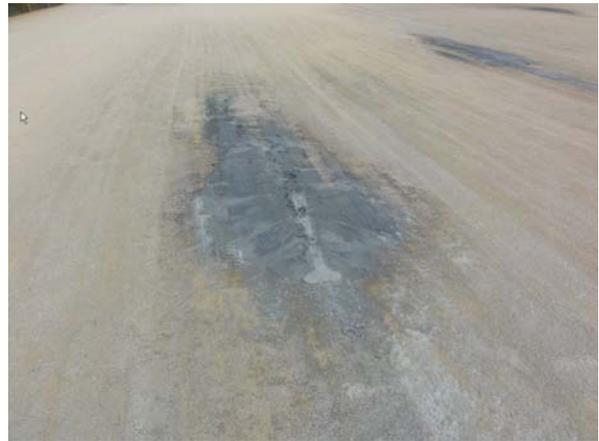
Photo 2 Liquefaction seen at Tsuna seaside sports park (N34.424707, E134.900878, April 14, 2013)

Moderate liquefaction traces were found at some areas on a reclaimed land in Awaji city (**Fig.13**). **Photo.2** shows one of the liquefied sites (Tsuna seaside sports park). Different features of damage to houses from those of Takenokuchi area were observed in a residential area near the park (**Photo.3**). There were liquefied soils from place to place. Ac-

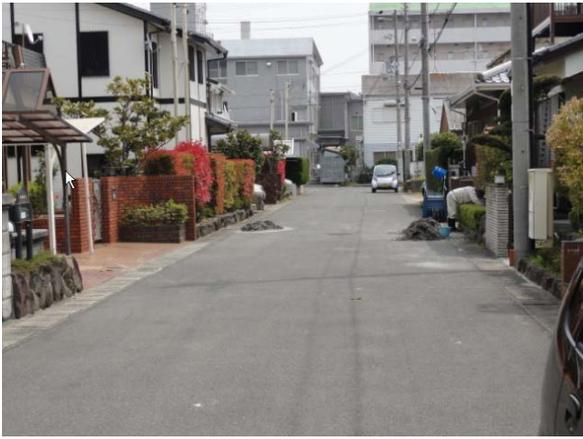
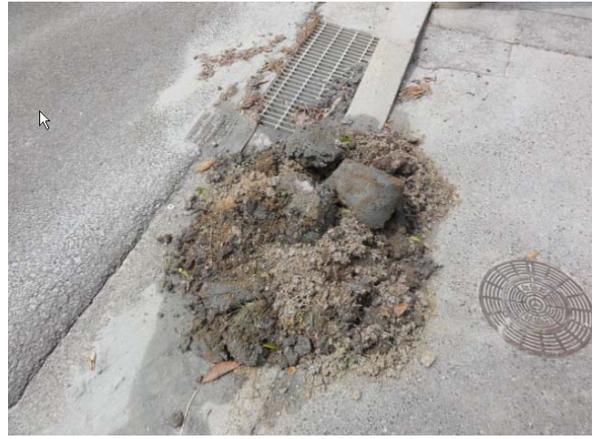
Photo 3 Liquefied residential area
(N34.425987, E134.901113, April 14, 2013)

ording to a person who was clearing sand-covered roads, his house has slightly-tilted in the earthquake. No roof tile seems to have been damaged in this area probably because the liquefied subsoil reduced ground acceleration remarkably.

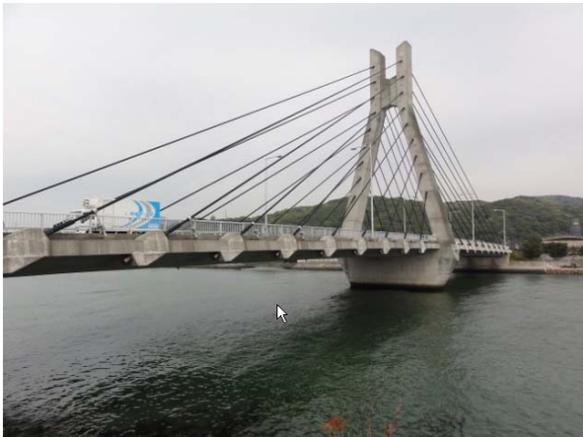
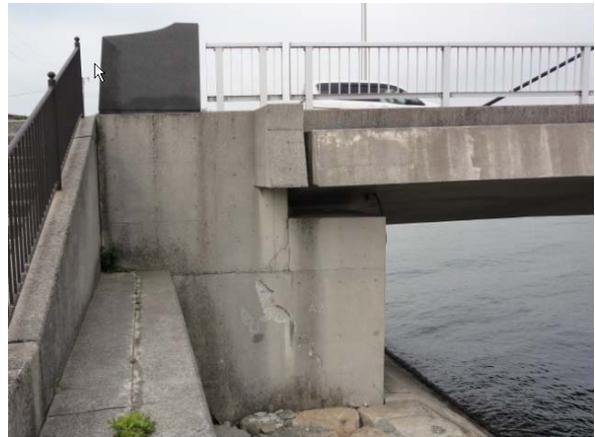
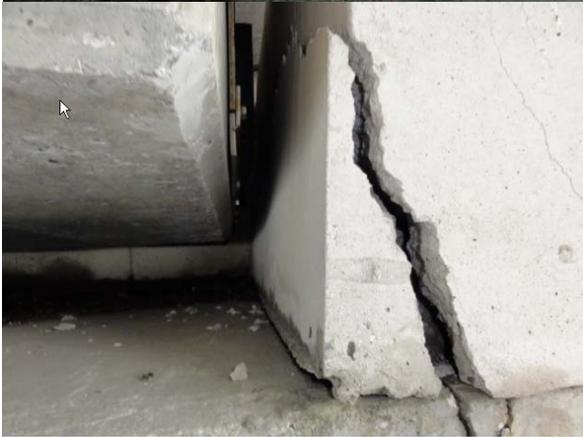
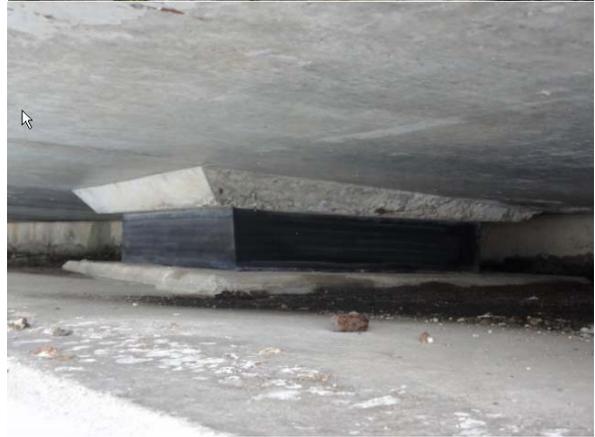
Photo 4 Damage to Suhama Bridge
(N34.347940, E134.896113, April 23, 2013)

Only Suhama Bridge, the lowermost cable-stayed bridge across Sumoto River, suffered some marked damage to its abutments (**Photo.4**). Both abutments were cracked probably due to collision(s) with the bridge girders. Permanent deformation of its rubber bearing remained on the south side of the river (**Photo.4**). More details can be found in the report by Mori¹⁰.

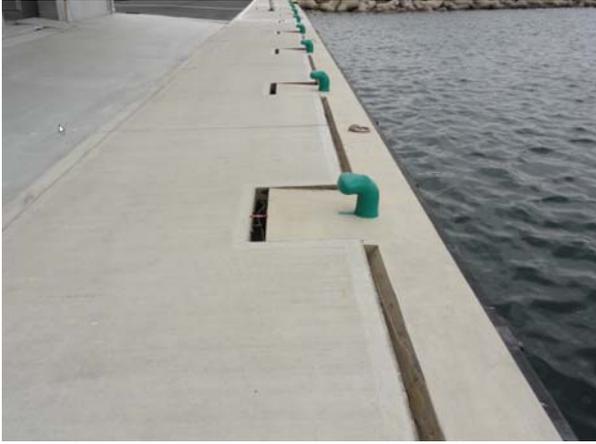
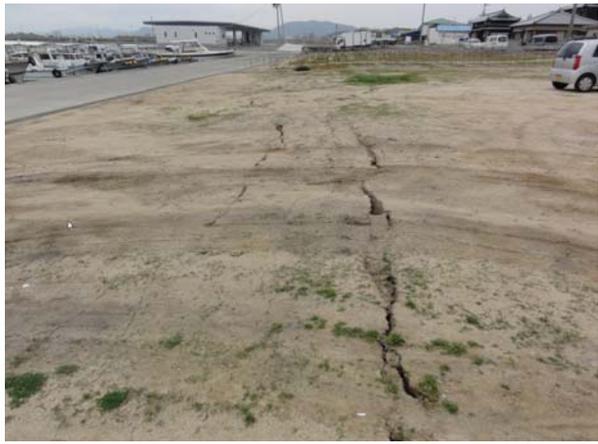
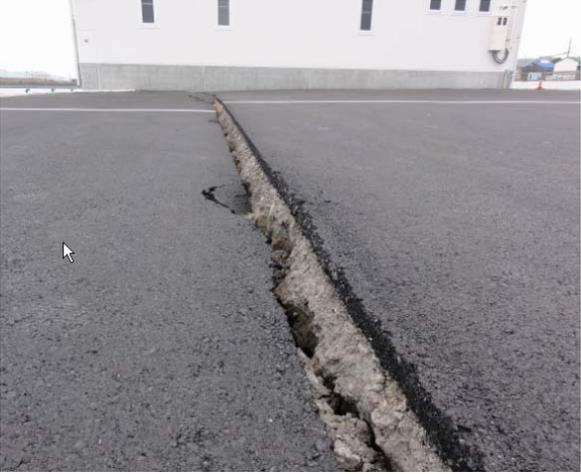
Photo 5 Damage to Ikuho fishing port in Awaji city (N34.446263, E134.918498)

Most significant failures of port and harbor facilities were reported at Ikuho fishing port of Awaji city (**Photo.5**). Quay walls have thrust forward by approximately 20 - 30 cm. Ground fissures appeared about 10 m inland parallel to the coast line. No clear trace of liquefaction was seen when the authors vis-

ited the site.
