Rock slope failures, liquefaction and permanent deformation in 2015 Gorkha earthquake, Nepal

Key Facts

- Hazard Type: Earthquake
- Date of the disaster: April 25th, 2015
- Location of the survey: Kathmandu, Sunkoshi, Melamchi, Dhunche, Bungamati
- Date of the field survey: May 27th to June 2nd, 2015
- Survey tools: GPS receiver
- Key findings: Failure modes of rock slopes, In-situ initial stress state, Ground liquefaction, Spectrum of aftershock

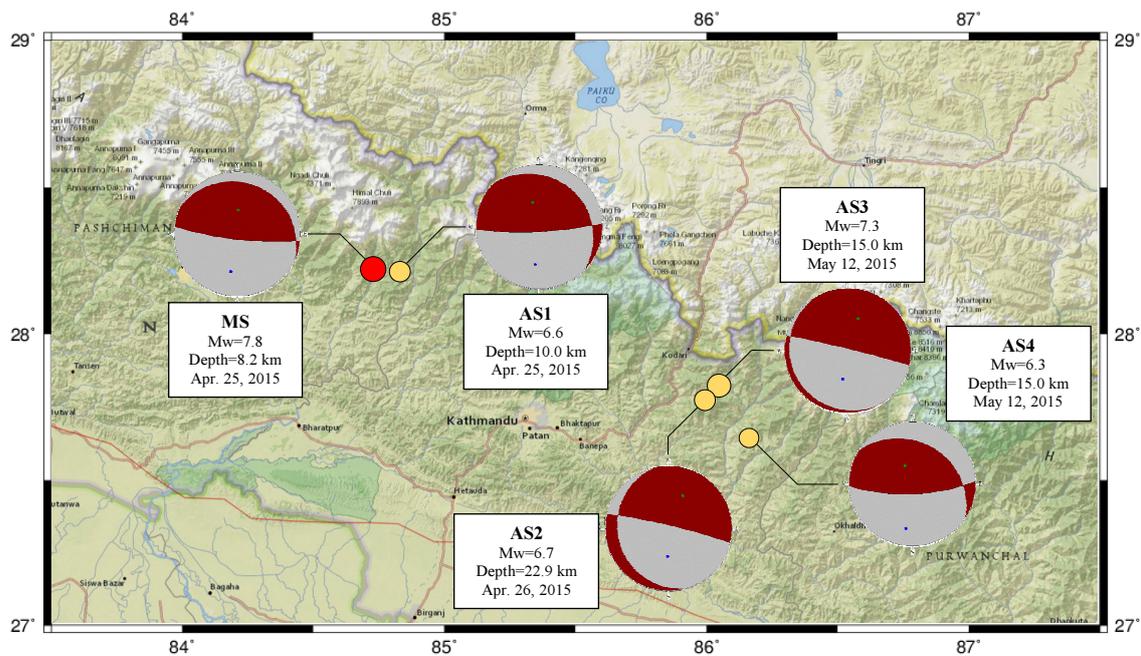
Fig.1 Illustration of focal plane solutions for the mainshock and aftershocks (Mw > 6.3). MS: Mainshock, AS: Aftershocks

An extensive in-situ full stress tensor inferences were carried out at the epicenter of mainshock and aftershocks shown in Fig. 1 by using Aydan's method^{22), 23)} based on the USGS database⁵⁾. In these measurements, the friction angle of the fault was set to 30° for the stress inference computations. Fig. 7 shows examples of the computer-output diagrams for the mainshock on April 25th, 2015 (MS in Fig. 1) and the aftershock on May 12th, 2015 (AS3 in Fig. 1). Table 1 summarized the inferred results together (MS, AS1-4). As a result, the largest horizontal stress will act in the direction of NNE-SSW ($d_{\sigma_H} = 6.8$), which is nearly perpendicular of the Himalayan frontal thrust fault. Note that the horizontal stress of the aftershock are larger than that of the mainshock. Additionally, we computed the stress state of four major earthquakes in the Himalayan area from their focal plane solutions based on USGS data base. Computation results are also given in Table 1. The

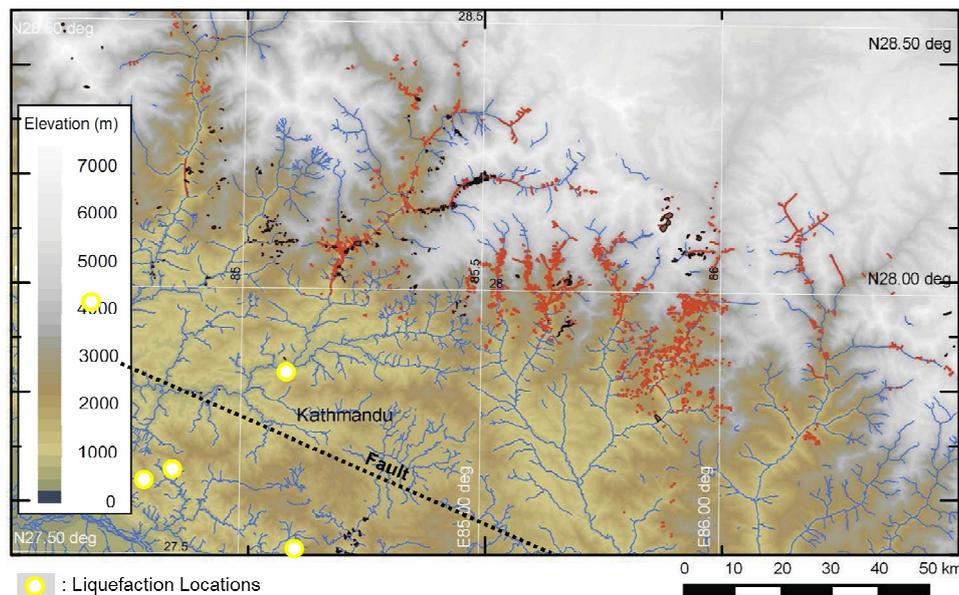
Fig.2 Landslides extracted from satellite imageries⁶⁾⁻⁸⁾ and liquefaction locations.

weathering due to intense freezing-thawing cycles as well as water-content variations. The 2015 Gorkha earthquake caused the widespread slope failures over the mountainous areas with such geological formations, which is also one of the most distinct characteristics of this earthquake. According to the analyses of satellite imagery by Durham University^{6), 7)}, the slope failures by the earthquake were concentrated in areas north to the epicenter as shown in Fig. 2⁸⁾. Specifically, there were numerous slope failures

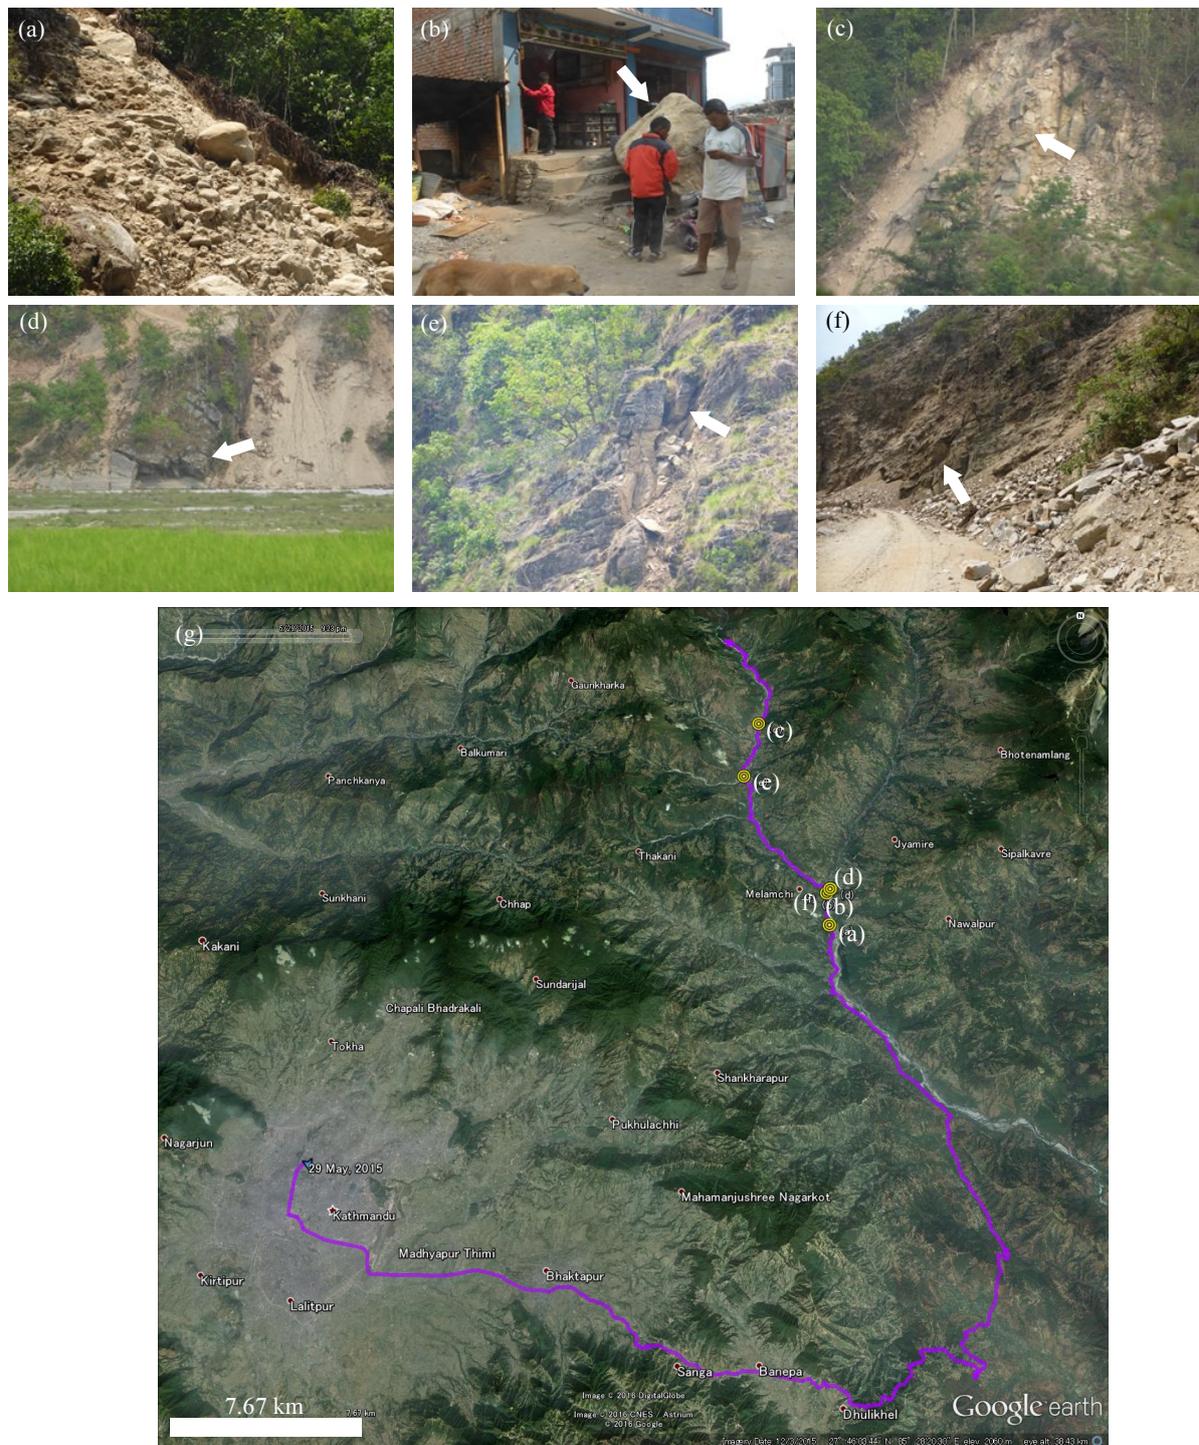
Fig. 3 Slope failures induced by the Gorkha earthquake. (a) Soil Slope failure having large spheroidal boulders; (b) A rock fall, which hit a house; (c), (d) Planar and wedge sliding failures; (e), (f) flexural and block toppling failure; (g) location map.

observations on the 2005 Kashmir Earthquake¹⁾ and some information from the world wide web network, the common forms of slope failures by this earthquake may be categorized as (i) surficial plastic deformations and flow of top soil or weathered zone, (ii) planar and wedge sliding and (iii) flexural or block toppling as shown in Fig. 3. Some soil slopes failures consisting of spheroidal boulders deposits were also observed (Fig. 3(a)). These type ground conditions were mainly observed in valleys carved by fast-flowing rivers. Many large granitic or gneissic boulders in a heavily weathered rocks become loose due to intense shaking and damaged living environment as shown in Fig. 3(b). These rock falls were observed along rivers with steep slopes. Planar and wedge sliding failures were observed

mainly in Schist, Phyllite, and Shale (Fig. 3(c), (d)). The flexural or block toppling failure caused by strong shaking induced by the earthquake were also observed in the slopes consisting of weathered metamorphosed rocks, whose schistosity plane dipping into mountain (Fig. 3(e), (f)). The planar failure of rock slopes was mainly due to sliding on schistosity planes of metamorphic rocks or bedding planes of sedimentary rocks mainly at the slopes facing the causative fault plane. For references, Fig. 4 shows some rock samples, which were collected through this investigation from the sites large slope failures.

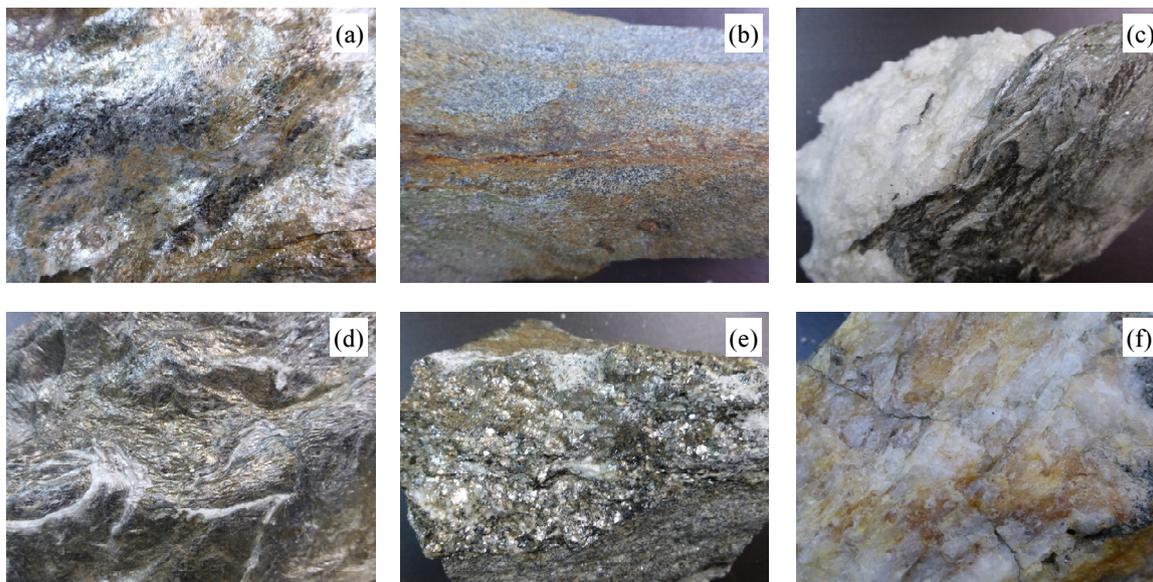
Fig.4 Rock samples. (a) phyllite at Sunkoshi, (b) quartzitic schist at Melamchi, (c) schist with quartzite nodule at Sunkoshi, (d) schist at Dhumche, (e) gneiss at Melamchi, (f) quartzite at Sunkoshi

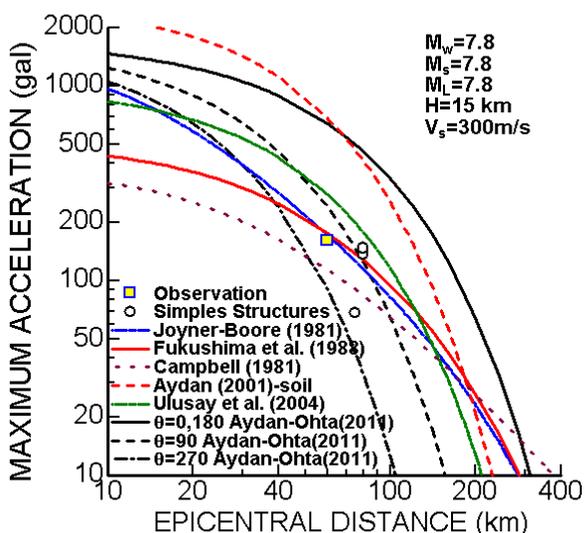
Fig.5 Comparison of various empirical relations for attenuation of maximum ground acceleration with observed and inferred data.

Although the available data are quite limited, an attempt was made on the attenuation of strong motion together with observed and inferred data from the collapsed or toppled structures in Fig. 5. In the figure, ‘Simple Structures’ imply block models¹⁰⁾⁻¹²⁾, through which we may infer the acceleration levels of earthquake for different failure modes in areas without some recording devices. The data is generally consistent with available empirical relations proposed by various researchers¹³⁾⁻¹⁸⁾.

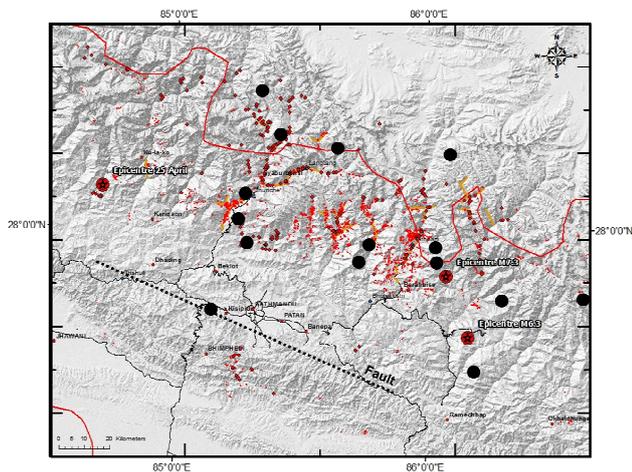
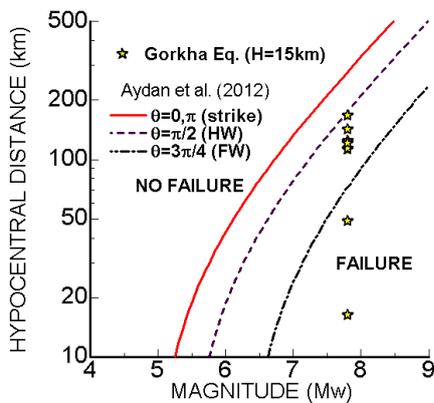
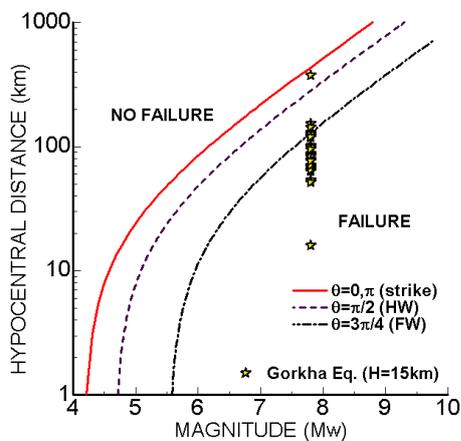
Fig.6 Comparison of empirical relations with observations.

(a) Mapped landslides

(b) Coherent slopes

(c) Disrupted

Fig. 6 compares the relationship between the earthquake magnitude and the hypocentral distance of failed slopes according to the relation of Aydan et al¹⁹⁾⁻²¹⁾. This relationship is given by the following form.

(FW) conditions, respectively. A, B and C are empirical constants, and their values differ depending upon the characteristics of the earthquake¹⁹⁾. The values of A, B and C in coherent condition are 0.2, 0.8, 30, respectively. Whereas, in disrupted condition, A, B and C are 0.3, 0.8 and 25, respectively. From Fig. 6, The plotted case histories are quite consistent with estimations from this empirical relation.

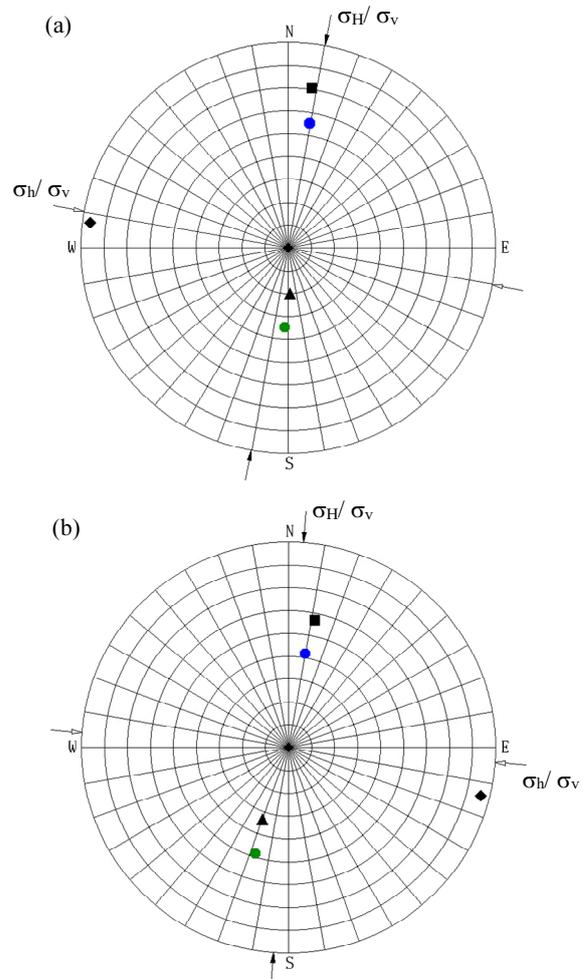
Fig.7 Examples of inferred initial stress state for the Gorkha earthquake: Upper hemisphere equal angle projection. (a) Mainshock on April 25th, 2015, (b) Aftershock on May 12th, 2015. (■: σ_1 / σ_v , ◆: σ_2 / σ_v , ▲: σ_3 / σ_v , ●: Compression, ●: Tension)

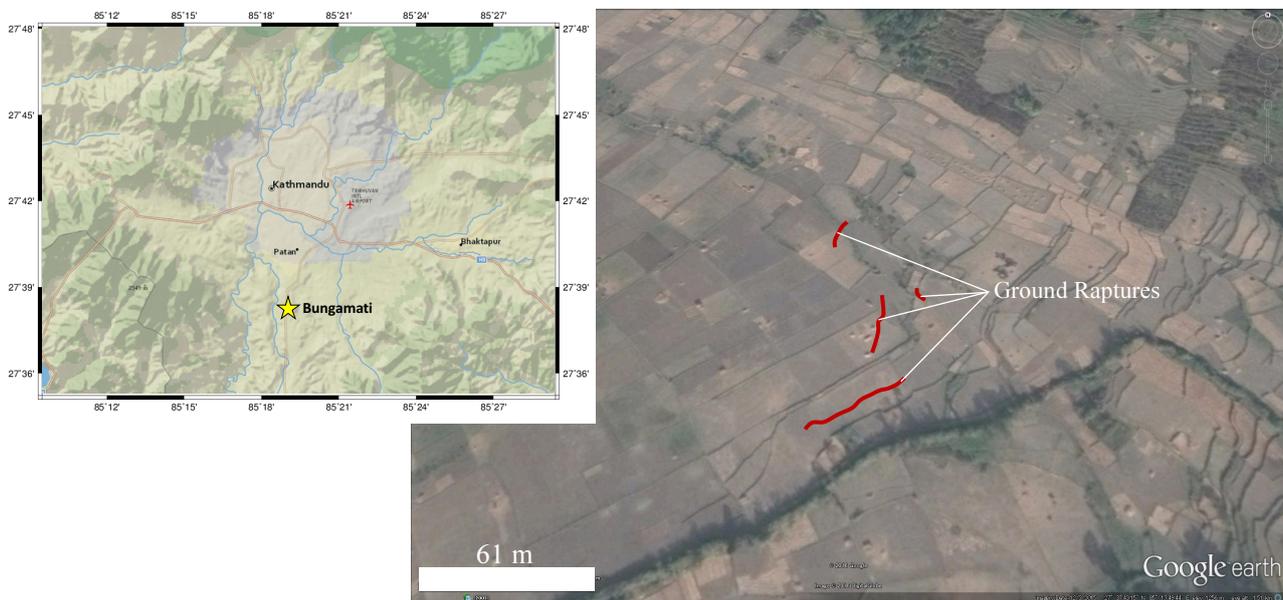
Fig.8 Bungamati liquefaction locations and some observed ground ruptures.

away from Katmandu in direction of SSW (Fig. 8). In this region, Kalimati clay (lacustrine facies) is distributed²⁴), and there are some ponds, so called Bungamati pond. In this investigation, the wide spread ground liquefaction was observed in the Bungamati region as shown in Fig. 9. From satellite image analysis and field survey, the liquefaction area was presumably 0.25 km². At this particular location, there are four ground ruptures at least (see Fig. 8), the length of the ruptures ranges from 20 to over 50 m, and the separation of the ruptures was approximately 5 to 20 cm. On the ground anywhere, boiled soils were observed. The inhabitants at this village mentioned that the ejected boiled soil reached 1 m or more above the ground.

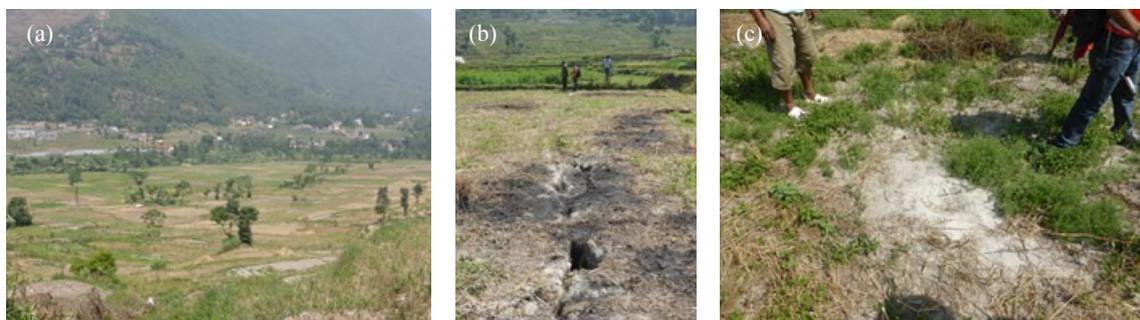
Fig.9 Bungamati liquefaction location. (a) Overview; (b) Example of a rupture; (c) Boiled sand.

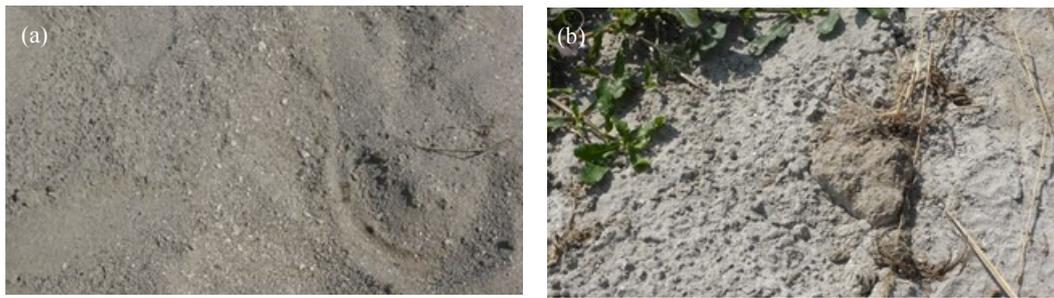
Fig.10 Sampled sands. (a) Coarse sand (sample-1); (b) Fine sand (sample-2).

Grain-size distribution and shear tests were carried out on soil samples from these sand boils. The grain size distribution of boiled soil samples ranged from fine to coarse visually (Fig. 10). Fig. 11 and Table 2 shows the results of shear test, and Fig. 12 shows grain size distributions of soil samples together with liquefaction limits. As noted from Fig. 12, most of the grain-size distributions fall within easily liquefiable zone. Therefore, the observation of widespread ground liquefaction occurred in the Bungamati region by the 25th April, 2015 earthquake was a consequence of natural ground conditions in this region.

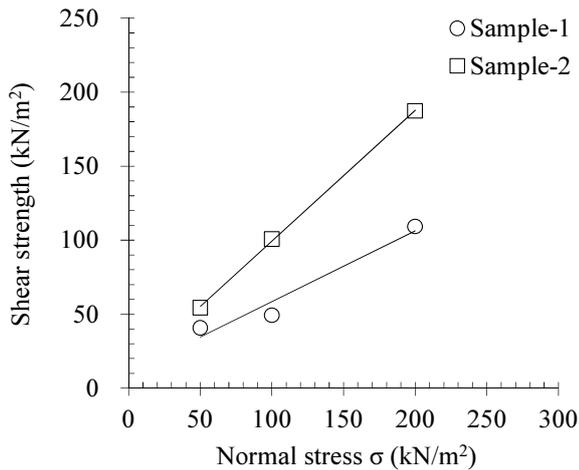
Fig.11 Relationship between normal stress and shear strength.

Sample-1	Sample-2
Internal friction angle (ϕ : deg.)	25.6	41.5
Apparent cohesion (c: kN/m ²)	10.6	11.0

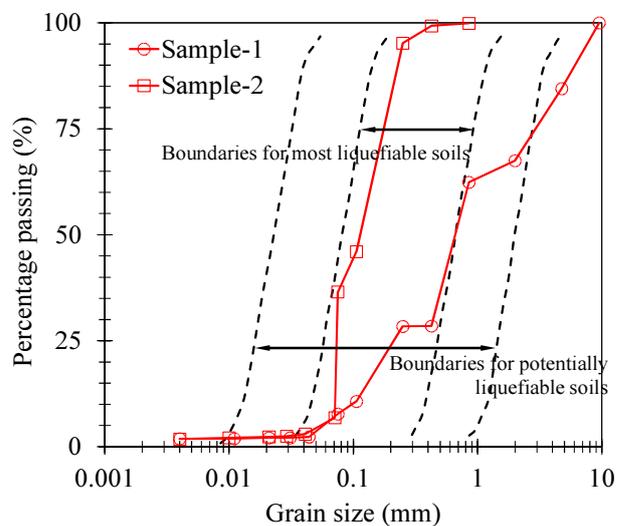
Fig.12 Comparison of grain size distribution of boiled soil samples with liquefiability bounds.

- (5) The wide spread ground liquefaction and many ground ruptures were observed in the Bungamati region. From the grain size distribution test of the boil sands, most of the grain-size distributions fall within easily liquefiable zone. Additionally, according to the comparison study of empirical relations on ground liquefaction, some empirical relations provide good bounds for the maximum limiting distance for ground liquefaction.

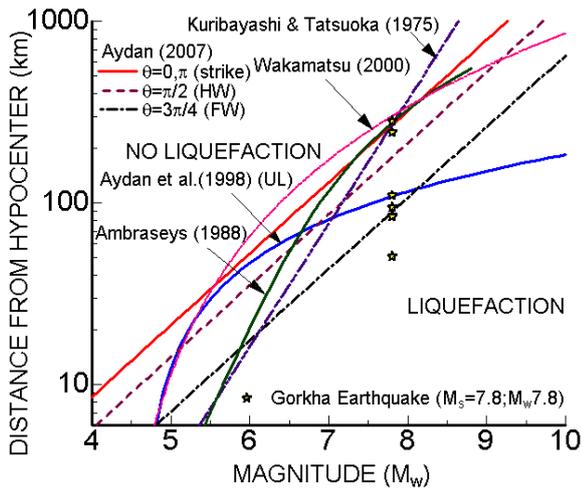
Fig.13 Comparison of empirical relations with observed data on ground liquefaction.

where R_1 , θ , M_w are the hypocentral distance, the angle between the observation point and the strike of the fault and the moment magnitude, respectively. Estimations from this equation together with other available equations are compared with the ground liquefaction data of the 2015 Gorkha Earthquake in Fig. 13 with the considerations of magnitude

conversion as well as the difference between epicentral and hypocenter distances. All of the empirical relations provide good bounds for the maximum limiting distance for ground liquefaction, and Eq. (2) takes into account the faulting orientation also.

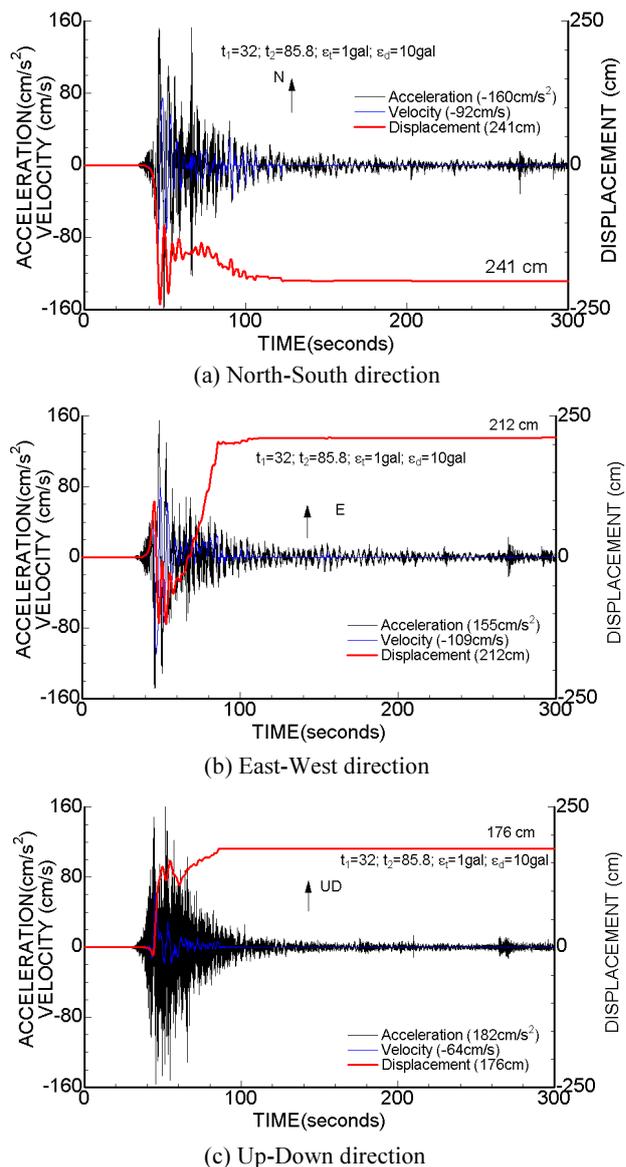
Fig.14 The permanent deformations in Kanthi-path at Kathmandu city.

The permanent deformation is estimated by using acceleration records in Kanthi-path at Kathmandu. Although there are various procedures for evaluating ground velocity and ground displacement from acceleration records, the Erratic Pattern Screening (EPS) method proposed by Ohta and Aydan²⁹⁾ and Aydan and Ohta¹⁴⁾ was employed in this study as this method takes into account the fault rupture duration, p-s wave arrival time difference, instrumental noises and triggering levels.

Fig. 14 shows the permanent deformations with acceleration and velocity in direction of NW, EW and UD. The recorded acceleration data is provided by the Center for Engineering Strong Motion Data (CESMD)³⁰⁾. From this figure, we can infer that the ground was moved by 3.2 m ($=\sqrt{2.41^2 + 2.12^2}$) in direction of SE, and was uplifted by 1.8 m. In this manner, it is possible to evaluate crustal deformations associated with earthquakes from the measured acceleration records. However, there is only one strong motion station in Kathmandu city

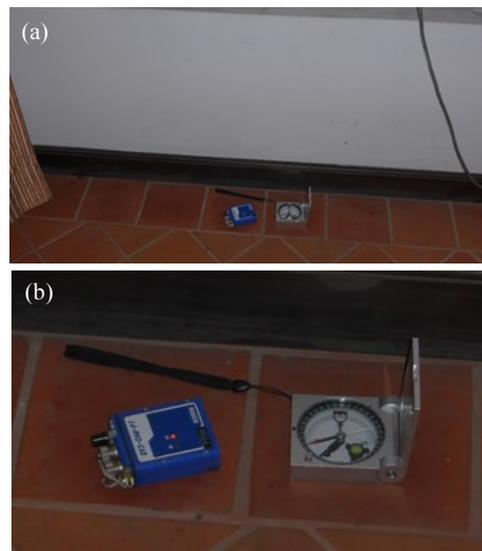
Fig.15 Views of stand-alone-type accelerometer. (a) Installation condition, (b) Zooming in of the instrument.

In this investigation, a compact portable stand-alone type accelerometer was installed in the hotel at Kathmandu city (N27° 43' 9.5", E85° 19' 17.5") as shown in Fig. 15. This accelerometer has been developed by Aydan et al., which can be set to a trigger mode at a selected acceleration level and having a storage capacity of 2 GB. Fig. 16 shows an acceleration record taken during an aftershock (May 30th, 2015(GMT+5:45)). The primary wave and the secondary wave are clearly recorded.

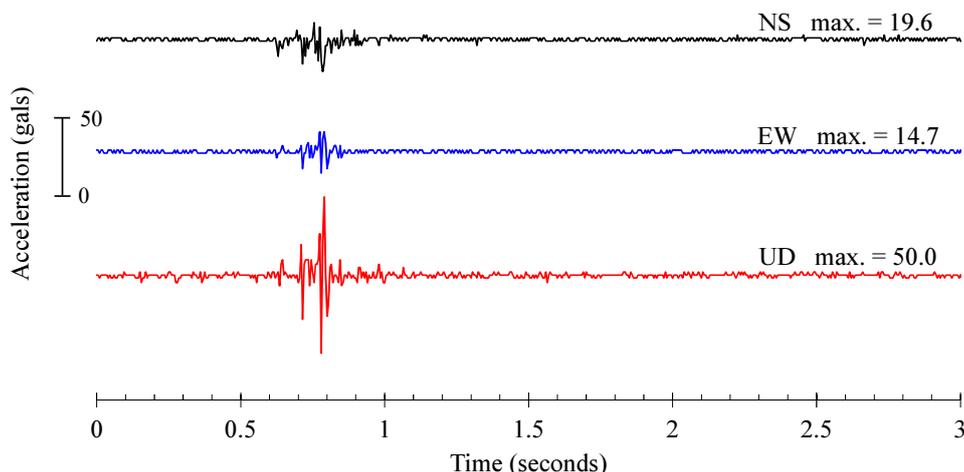
Fig.16 Acceleration records taken on May 30th, 2015 aftershock at Kathmandu.

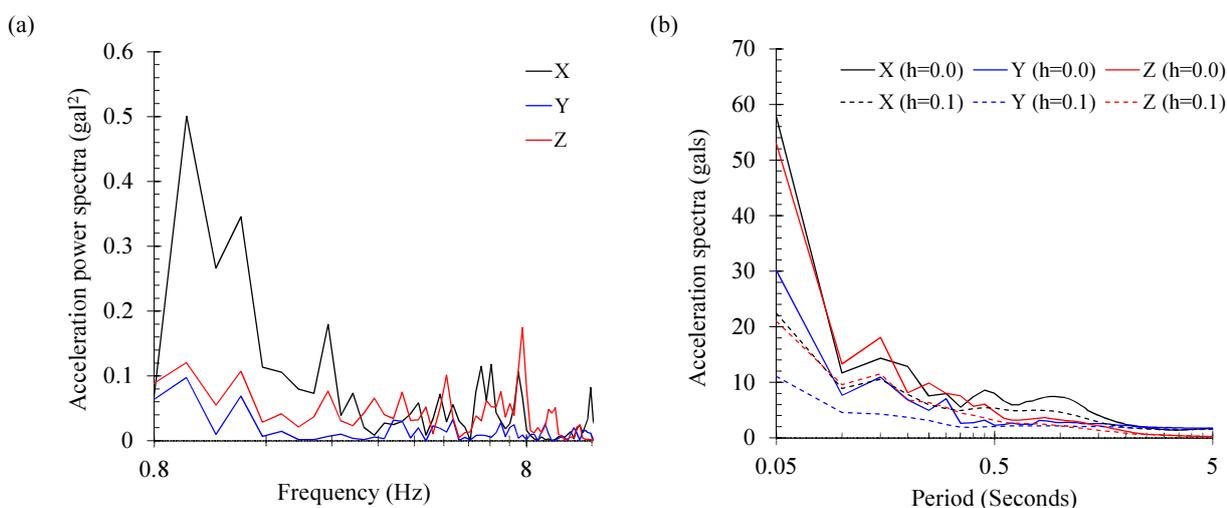
Fig.17 Results of spectral analyses for May 30th aftershock. (a) Fourier power spectra, (b) Acceleration response spectra.

Fig. 17 shows the Fourier spectra and acceleration response spectra of the observed ground motion. Spectra of horizontal direction (X) exhibit well correlated peak acceleration in the vicinity of 1 Hz whereas there is the highest value in the lower frequency area. Although we need to examine the
