## Site Investigation of the Sarpole-Zahab Earthquake, Mw 7.3 in SW Iran of November 12, 2017

### Key Facts

- Hazard Type: Earthquake
- Date of the disaster: November 12, 2017
- Location of the survey : Kermanshah Province, Iran
- Date of the field survey: December 24<sup>th</sup> – 28<sup>th</sup>, 2017

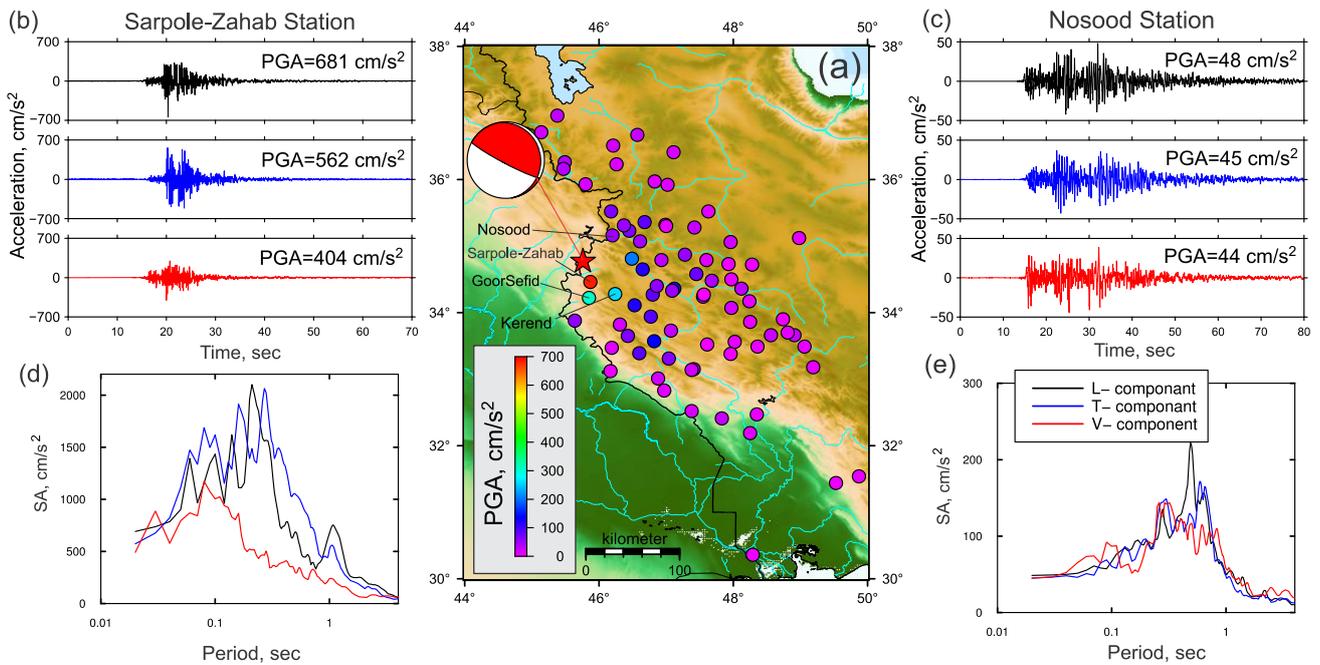
**Fig. 1** (a) Locations of the recording stations together with the obtained maximum PGA values of two horizontal components; (b) and (c) acceleration time series for Sarpole-Zahab and Nosood stations, respectively; (d) and (e) obtained absolute spectral acceleration for Sarpole-Zahab and Nosood stations, respectively.

south and north of the epicenter, respectively, have been selected. The acceleration traces related to these stations are illustrated in **Figs. 1b** and **c**. It is obvious that Sarpole-Zahab station in forward direction had experienced a much larger PGA than Nosood station in the backward direction. To further examine the fault directivity effect, we compared the significant duration ( $D_{SS\%SS\%}$ )<sup>5</sup> obtained from the acceleration time histories of these stations. As this is expected longer duration (30 sec) was recorded at Nosood station in the backward directivity; in contrast, shorter duration (11 sec) was observed at Sarpole-Zahab station in the forward directivity.

**Figs. 1d** and **e** show the absolute spectral acceleration (SA) calculated from strong motions recorded at Sarpole-Zahab and Nosood stations, respectively, which were computed at 5% damping. The figures depict that the predominant ground shaking is with a period of 1sec or less, and there are not many long-period components in the near-fault ground motions. This period range usually affects the 2 to 6 stories structures. Also, the peak values of SA at stations in the forward direction are much larger than those in the backward direction, showing a strong rupture directivity effect.

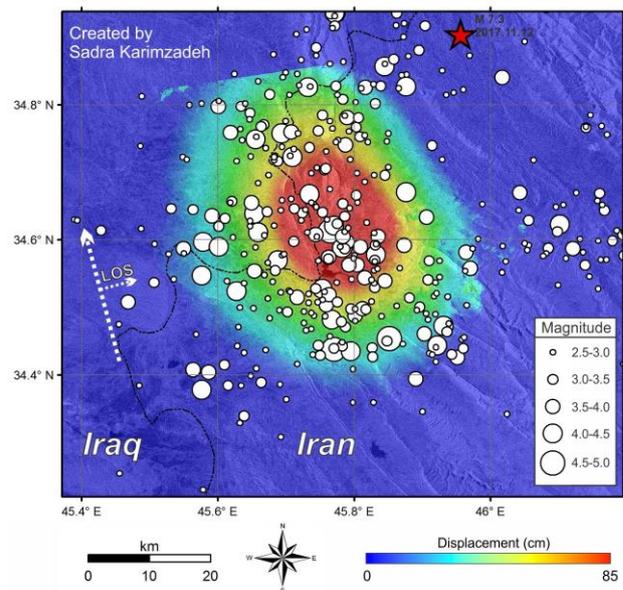
**Fig. 2** InSAR unwrapped displacement map of Sarpole-Zahab Earthquake from high-resolution ALOS-2 data indicating maximum 85 cm displacement in the line-of-sight of the satellite. White circles are aftershocks gathered between 2017/11/12 and 2017/12/01 and red star is the main shock in 2017/11/12.

of 10 m in StripMap mode. The displacement map together with aftershocks (~ 700 recorded aftershocks by Iran seismic network) from 2017/11/12 to 2017/12/1 are shown in **Fig 2**.

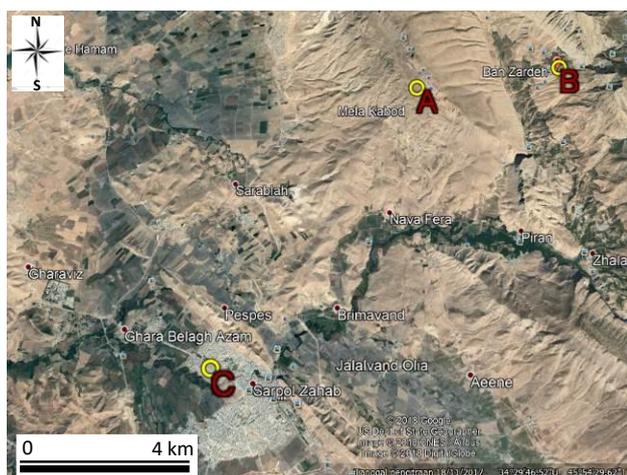
Photo 1 Location of geotechnical damage <sup>6)</sup>.

During the earthquake, several geotechnical damages occurred in different locations as can be seen in **Photo 1**. The Sarpole-Zahab Earthquake triggered massive landslides in the mountainous areas close to Mela Kabood and Goorchi Bashi villages, which located to the north of the Sarpole-Zahab City (Point A in **Photo 1**). Landslides that occurred reach an area of 4 km long and 1 km wide. At some points, significant ground subsidence emerged, with a depth varying from 1 m to a maximum depth of 8 m, as can be seen in **Photo 2**. In addition, the gravitational force arising from the sloping soil surface, together with earthquake force, also triggering a lateral ground deformation, where the soil moved downward and creates ruptures on the ground surface with a width up to 1.5 m. According to the information from the residents, the heavy rain that fell two hours after the earthquake deteriorated the situation. Some residential houses were damaged by landslides, as can be seen in **Photo 3**.

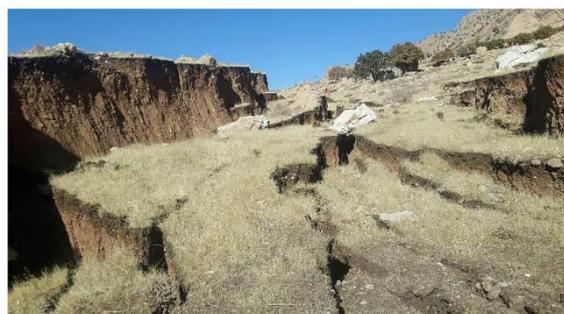
Photo 2 Ground subsidence close to Mela Kabood village

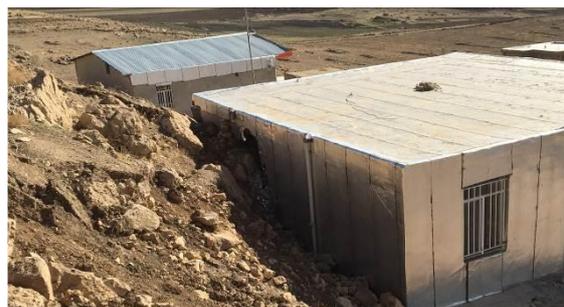
Photo 3 Damaged houses by landslides

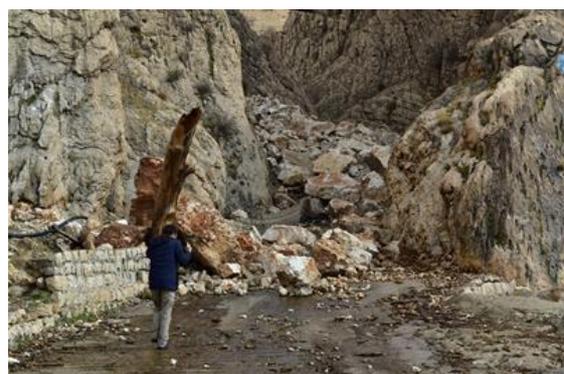
**Photo 4** shows the rock fall that occurred in Ban Zardeh village, located to the north of the city of Sarpole-Zahab as well (Point B in **Photo 1**). This large rock fall along approximately 1.5 km caused the only road that connecting the Ban Zardeh village with Baba Yadegar tomb which is a famous tourist destination, became inaccessible.

Photo 4 Rock fall close to Ban Zardeh Village

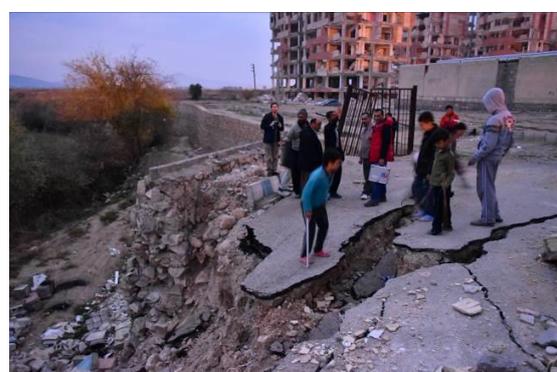
Photo 5 Liquefaction-induced ground deformation

Fooladi district-Maskane Mehr, which located within the city of Sarpole-Zahab (Point C in **Photo 1**). This significant ground deformation is most likely induced by liquefaction at the time of the earthquake, which caused the ground surface moved downward. This area is very prone to liquefaction because there is a river that flows in this area. According to the information from the inhabitants, before the earthquake occurred, the government of Sarpole-Zahab City has planned to relocate residents who live in this area due to high groundwater levels here. The ground deformation occurred in the Fooladi district-Maskane Mehr can be seen in **Photo 5**.

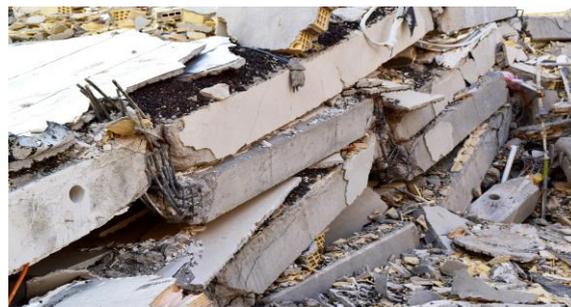
(a) Soft story: According to the RC design code of Iran, columns must be at least 20% stronger than beams. However, damaged columns and undamaged beams were observed in numerous damaged buildings. This implies that columns were weaker than beams, and severe damage and collapse occurred as shown in **Photo 6**.

**Photo 6** Soft story failure at Sarpole-Zahab city.

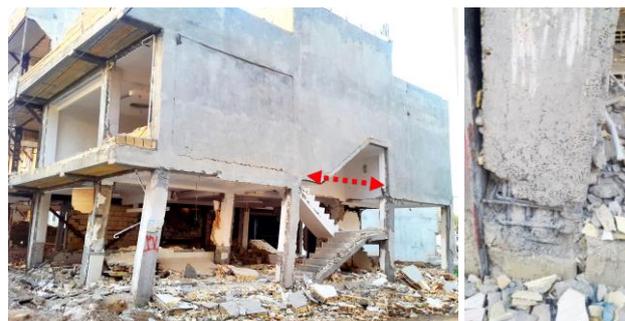
(b) Poor quality concrete material: Multiple cases of damaged RC structures were observed, and this caused concrete damage and failure in these structures (see **Photo 7**).

(c) Improper detailing: 90° hooks instead of 135° hooks of hoop reinforcement of columns was utilized to make confinement in the concrete core (see **Photo 7**). Space interval of hoop reinforcement was not appropriate for confinement at the 1/4 of the upper and lower parts of columns (see **Photo 8**).

**Photo 7** Horizontal irregularities due to lack of one of the beams, poor quality of concrete and utilize of 90° hooks instead of 135° hooks in transverse rebar of columns caused the soft story damage in this building at Sarpole-Zahab.

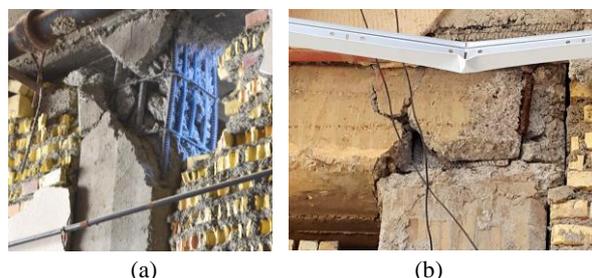
**Photo 8** Improper detailing of rebar at Shohada Hospital of Sarpole-Zahab (a) Big spacing between transverse rebar of columns at special part (b) Short anchorage length at longitudinal rebar of the beams.

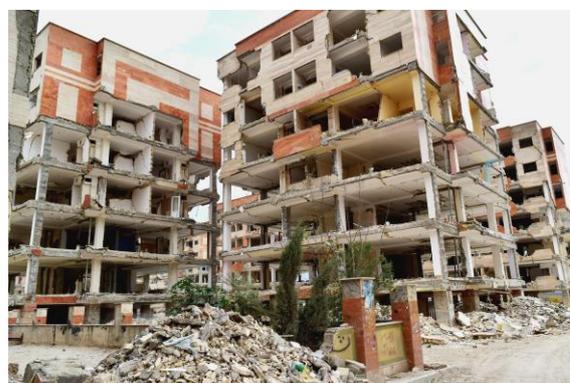
Non-structural element damage was observed. The most considerable damage to concrete buildings was the crack and collapse of in-filled walls. The performance of the structures with RC dual systems and frame systems was better compared to that of the structures with only frame systems, as shown in **Photo 9**.

**Photo 9** Severe non-structural elements damage at Makane-Mehr of Sarpole-Zahab City.

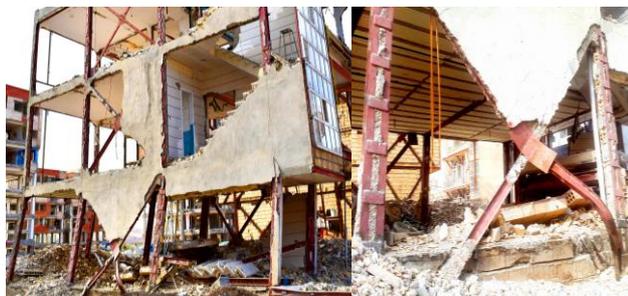
The steel frame was damaged or buckled during the earthquake in a few braces, and buildings were severely damaged, as shown in **Photo 10**. Non-structural element damage was the same as that in concrete buildings.

**Photo 10** Severe damage to a steel building at Sarpole-Zahab City.

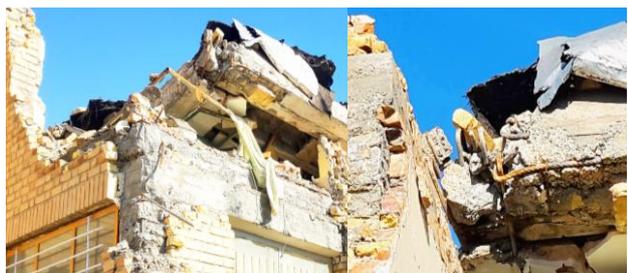
The use of this type of building has increased in villages after promotion by the Housing Foundation of Iran. Severe damage and collapse have been observed in such constructions. The main reason for the damage is the inferior construction of the connection detail of columns and timber being laid horizontally above pillars to support the weight of roofs (see **Photo 11**).

**Photo 11** Damage of Esmat Highschool building in Salase Babajani.

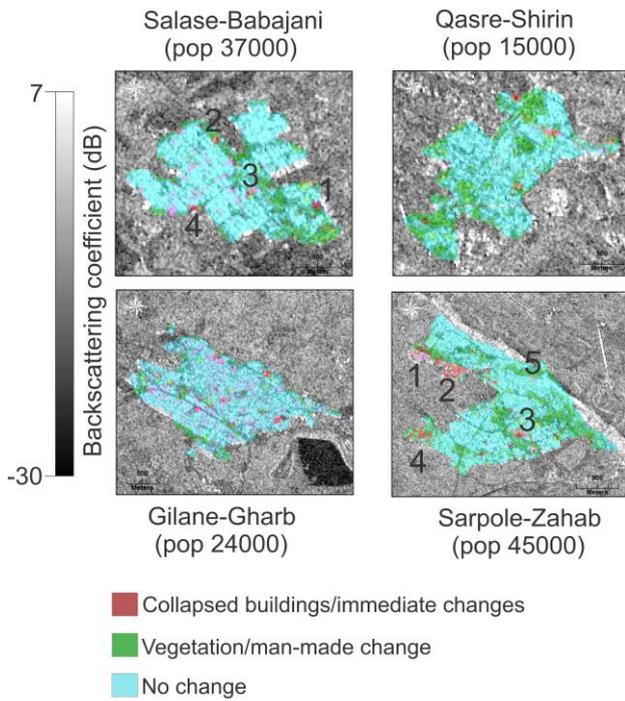
**Fig. 3** Damage proxy maps of the affected cities in Kermanshah province of Iran deduced from multitemporal Sentinel-1 dataset. Population of each city is shown on top. Red pixels indicate collapsed buildings, green pixels indicate vegetation and human activities and blue areas are stable areas. Labels (numbers) are the location of the visited areas.

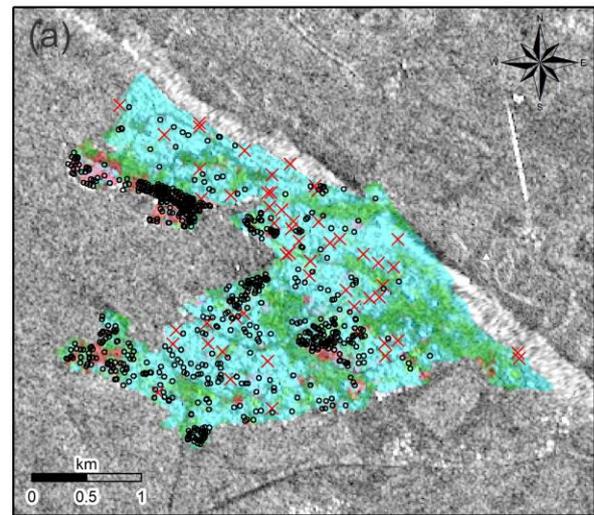
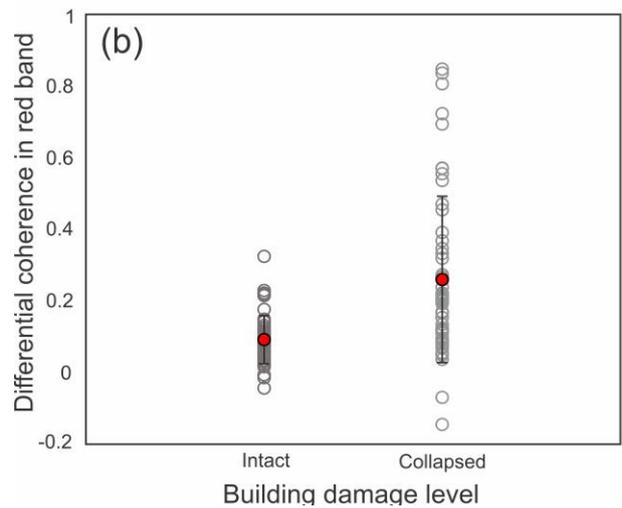
agery<sup>8</sup>). As shown in **Fig. 4**, based on optical images, more than 600 individual buildings (black circles) are damaged in the city. In order to do a fair validation between SAR and optical results, we chose randomly 50 collapsed and intact buildings and calculated their multitemporal differential coherence and relative standard deviations. The results show that differential coherence value from red band is higher among collapsed buildings (**Fig. 4.b**).

**Fig. 4** (a) DPM of Sarpole-Zahab together with collapsed buildings from visual inspections of optical images by UNITAR (black circles). Red cross marks are randomly selected intact buildings in the city. (b) Comparison of level of differential coherence value in red band for selected buildings in each category. Gray circles in collapsed category are randomly selected 50 collapsed buildings acquired from <http://www.unitar.org>. Gray circles in intact category are randomly selected 50 intact buildings in Sarpole-Zahab, Iran. Red circles and black bars are mean pixel values and standard deviations from red band, respectively.

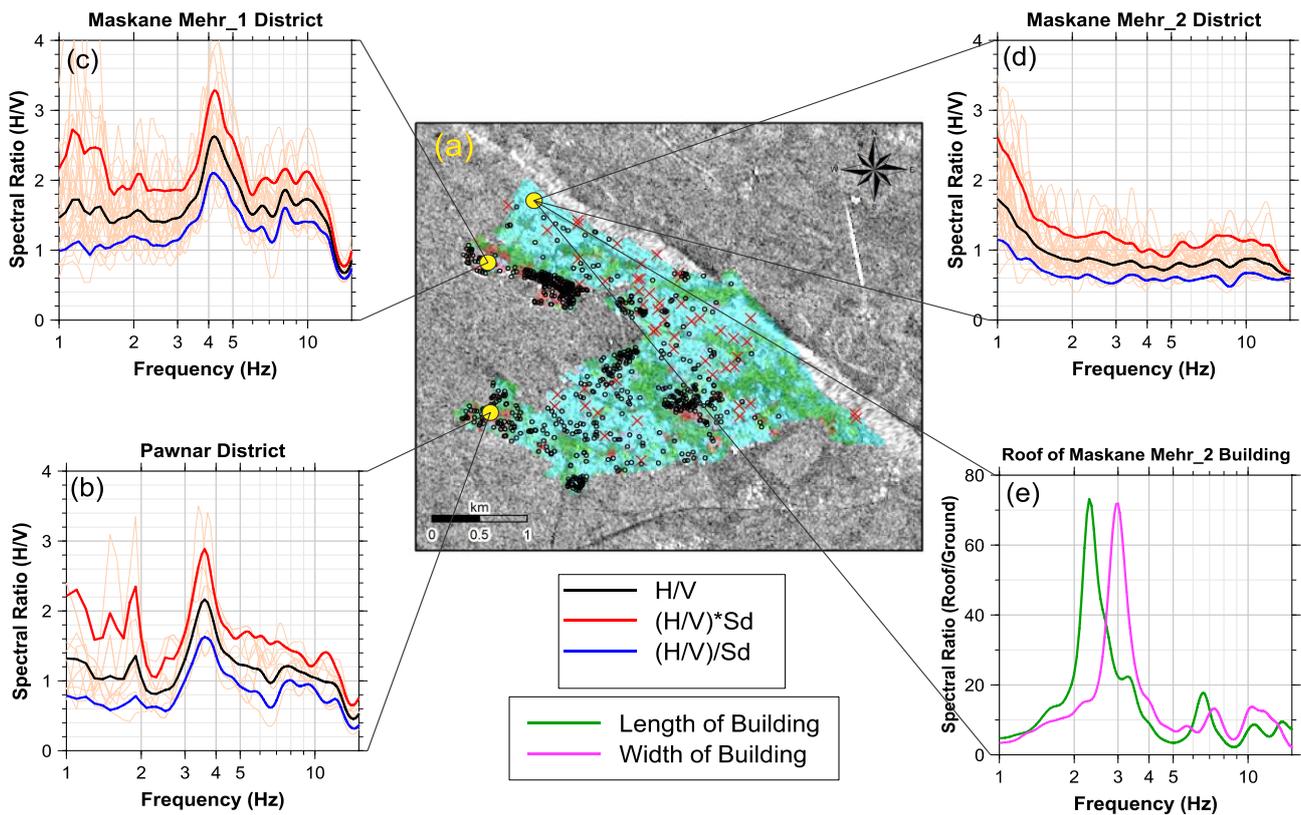
The result of the spectral ratio (H/V) in the Pawnar district is illustrated in **Fig.5b**. As shown, the domi-

**Fig. 5** (a) Location of microtremor measurement points in Sarpole-Zahab city which have been shown by yellow circles; (b), (c) and (d) Obtained spectral ratio (H/V) (black curve), spectral ratio multiplied by standard deviation (red curve), spectral ratio divided by standard deviation (blue curve) in Pawnar, Maskane Mehr\_1 and Maskane Mehr\_2 districts, respectively; (e) computed spectral ratios along length (green curve) and width (magenta curve) at the roof of a 4-story building in the Maskane Mehr\_2 district.

nant frequency and site amplification are 3.60 Hz and 2.16, respectively. Therefore, the soil type can be classified as C and SCII (hard soil) class according to NEHRP<sup>13)</sup> and Japan Road Association codes<sup>14)</sup>. Obtained spectral ratio (H/V) in the Maskane Mehr\_1 site which is depicted in **Fig. 5c** shows dominant frequency of 4.26 Hz with an amplitude of 2.61. This frequency is related to soil class of C and SCII in the mentioned codes. **Fig. 5d** shows computed spectral ratio for the site of Maskane Mehr\_2. The H/V spectra do not show a clear peak, which suggests that there is no strong contrast in the velocity structure. Since this district is very close to the outcrop rocks of a mountain (white area in the north of the city in **Fig. 1(a)**), we think the site condition is rather stiff and effect of near-surface amplification is not large<sup>15)</sup>. As aforementioned, no damages were observed in the buildings of Maskane Mehr\_2 district, and microtremor result was also presented for this site (**Fig. 5d**). To further examine and estimate the natural period of a 4-story building, microtremors measured at the roof one of these buildings. It is evident that in an asymmetrical structure, stiffness is different for the two directions. Therefore obtained period is not the same. In this study, to determine the natural period of the building, spectral amplitude of record of every direction was divided on those ground surface record<sup>16)</sup>. The results for length and width directions of the building have been drawn by green and magenta curves in **Fig. 5e**. It can be seen from the figure that the length and width directions frequencies were 2.30 Hz and 3.0 Hz, respectively. By comparing the site and building frequencies it was conducted that the rather soft buildings have been constructed on a stiff site which reduces the probability of amplification and resonance occurrence during an earthquake. The outcome of microtremor measurement in the site of Kooek villages has been illustrated in **Fig. 6**. The spectral ratio shows a clear peak at a frequency of 3.20 Hz with an amplitude of 2.07. Also, the site classification is similar to those of Pawnar and Makane Mehr\_1 site.

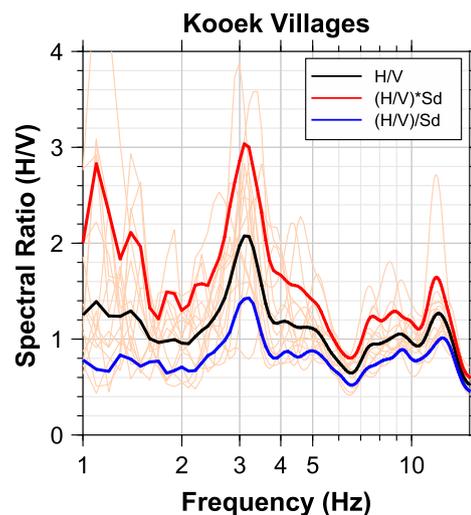
**Fig. 6** Obtained spectral ratio (H/V) (black curve), spectral ratio multiplied by standard deviation (red curve), spectral ratio divided by standard deviation (blue curve) in Kooek villages site.

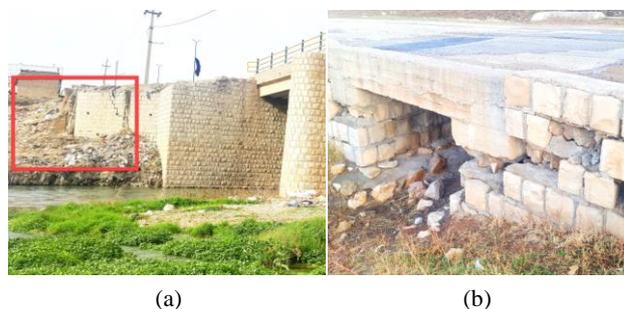
are very common for low span bridges were all safe and ready for use. However, in some cases, there were cracks and even collapse in some parts of stone retaining walls beside the structure of the bridge, like the Sarpole-Zahab main road bridge (see **Photo 12**).

**Photo 12** (a) Damage to the retaining walls beside the bridge of Sarpole-Zahab City, (b) Damage to little stone and concrete bridge at a Village road nearby Sarpole-Zahab
