Study team report of the July 27, 2022 Magnitude (Mw) 7.0 Northwestern Luzon Philippines Earthquake

Key Facts

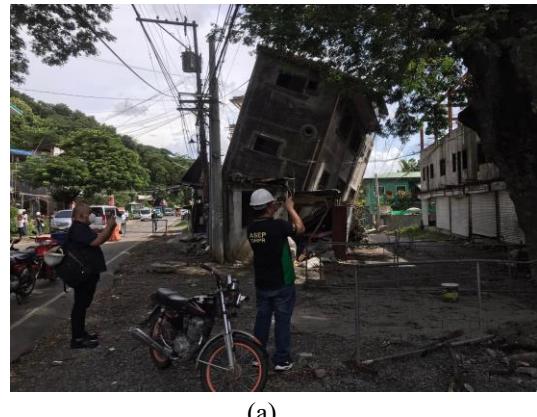
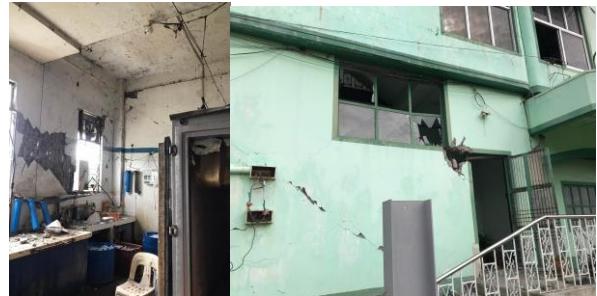
Fig. 6. Examples of damages on residential buildings

- Poor and substandard materials and construction practices: Failures of most of the houses attributed to the poor and substandard materials and construction practices such as but not limited to the use of undersized rebars as reinforcement for concrete hollow blocks (CHB), low quality CHB, undersized CHB (4in) in the case for exterior wall for masonry houses, without practicing the requirement of confinement zone, development lengths and hooks, etc.

- Inadequate reinforcement on openings: Cracks are manifested in large openings such as windows and doors. This type of failure may be attributed to the absence of lintels and additional diagonal reinforcements on openings such as windows and doors.

Example of the residential house that were totally affected by the earthquake is shown in the following. Failure of foundation (see **Fig. 6a**), spalled wall tiles and wall cracks (see **Fig. 6b**), and cracks in openings (see **Fig. 6c**) can be observed.

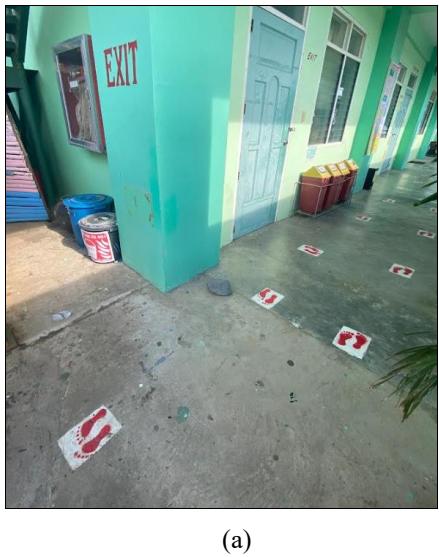
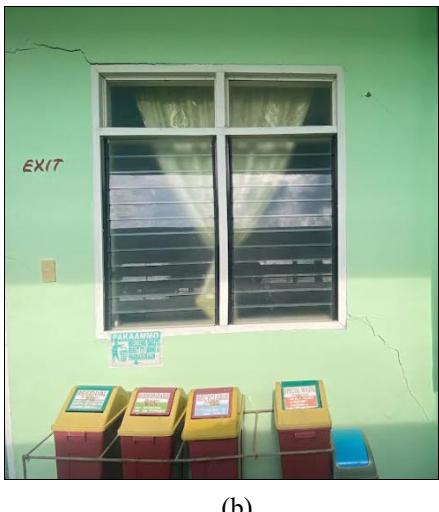
Fig. 8. Damage on 4-storey senior high building of Mabilbila Integrated School

For Mabilbila Integrated School, specifically the 4-storey senior high building, settlement of corridor, disintegration between construction joints (see **Fig. 8a**), fine to large cracks on masonry walls, spalling of plasters, and cracks prevalent in openings (see **Fig. 8b**) were observed.

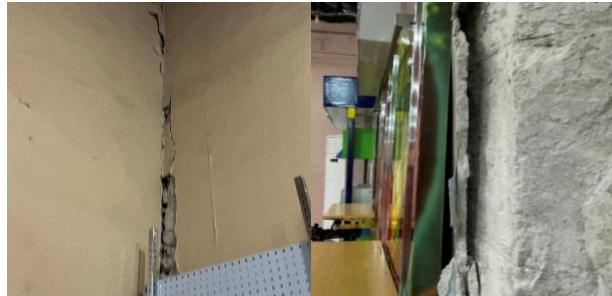
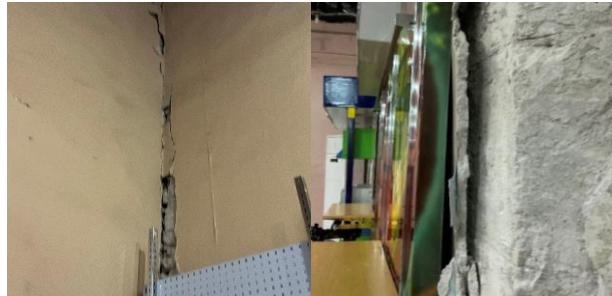
Fig. 9. Damage on Mart 1 Building (Vigan, Ilocos Sur)

Several church and heritage sites can be found in the inspected areas and some of these national cultural treasures are also damaged from the earthquake. In Mart 1 building in Vigan World Heritage Site (WHS), bricks were seen falling off from a wall with a crack from the bottom to the top (see **Fig. 9a**). Separation of the two walls were also seen in one corner of the mall (see **Fig. 9b**), as well as a thick surface plaster separating from a thick brick wall (see **Fig. 9c**).

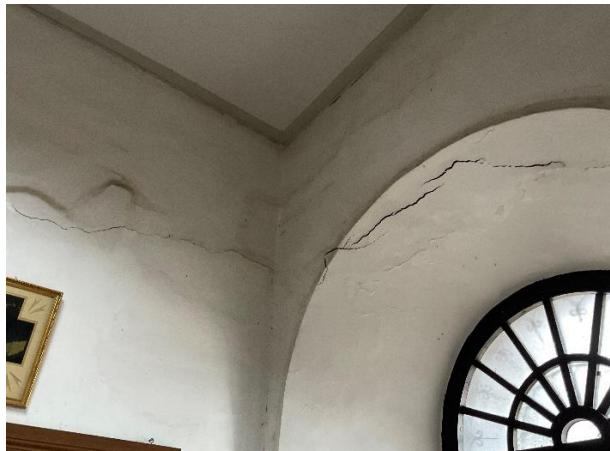
Fig. 10. Damage on Palacio de Arzobispado (Vigan, Ilocos Sur)

Palacio de Arzobispado was also found to have predominantly horizontal cracks on its ground floor (see **Fig. 10a**). Visual inspection shows that these might be a manifestation of the separation of the surface plaster with the bricks and not deep cracks. Two adjacent columns exhibited cracks at its top portion possibly due to two exterior walls from an adjacent structure that might have pushed the columns during the ground shaking (see **Fig. 10b**).

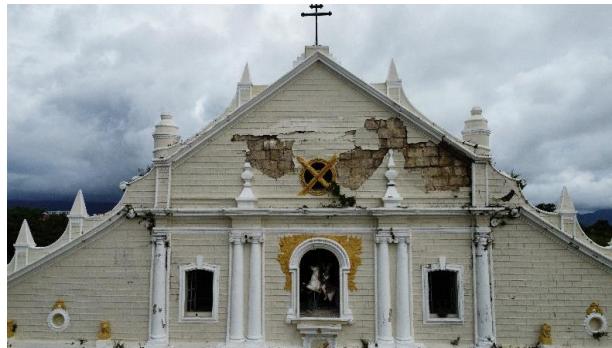
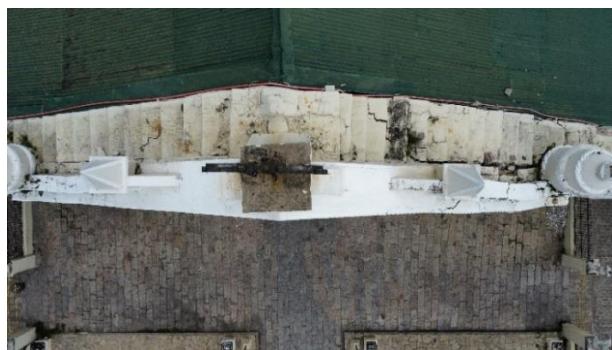
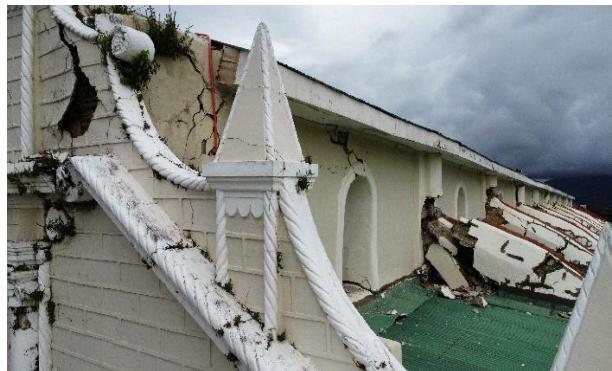
Fig. 11. Damage on Vigan Cathedral

The Vigan cathedral or the Metropolitan Cathedral of the Conversion of St. Paul the Apostle suffered moderate damage during the earthquake from various locations. From the exterior, the most visible damage is the surface plaster on the pediment (front façade) separated and fell to the ground (see **Fig. 11a**). An out-of-plane bending can also be inferred from the photos taken dis-aligning some of the bricks from a vertical alignment. Drone shots also exposed large cracks and wall separation on the pediment (see **Fig. 11b**) and minor to moderate damage on what appears to be part of the buttress (see **Fig. 11c**). From the inside, debris of bricks near the entrance fell off from the ceiling of the choir loft (see **Fig. 11d**).

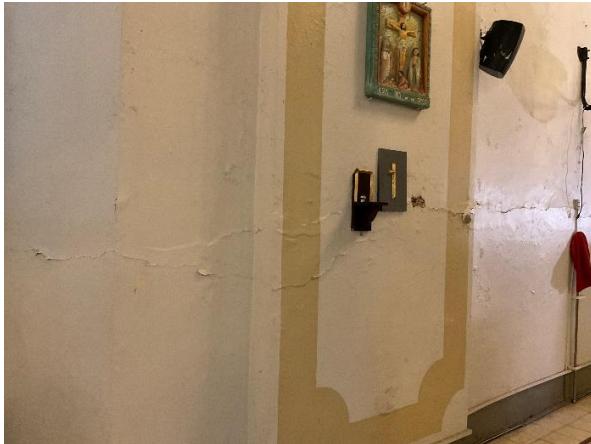
Fig. 12. Damage to Bantay Church

Bantay Church or the Parish of Saint Augustine of Hippo were observed to have horizontal cracks especially on the right side of the church facing the altar (see **Fig. 12**). However, it cannot be ascertained

if the cracks are deep or only at the surface. Thus, GPR tests were recommended for verification of the crack's depth.

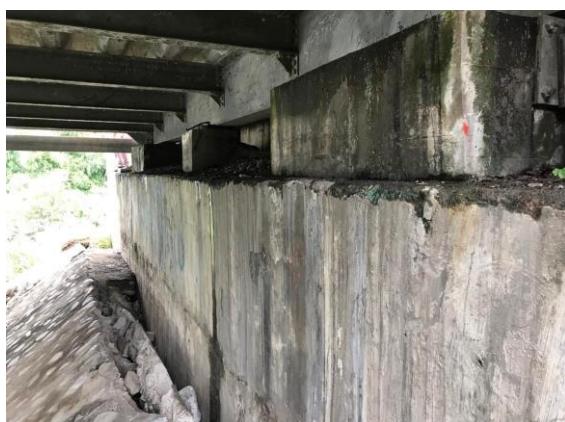
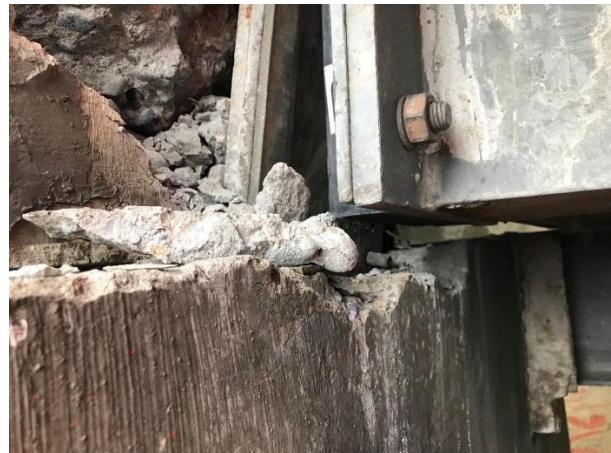
Fig. 13. Damaged Don Mariano Marcos Bridge (Tayum, Abra)

During the site inspection of the Don Mariano Marcos Bridge in Tayum, Abra, it was found that there was no safe access to go under the bridge. There was also a visible buckling of the top chord cross-bracings on one end of the bridge, but there is no structural damage found on its main members (see **Fig. 13**). It was considered as generally safe to operate but intensive structural assessment was still recommended.

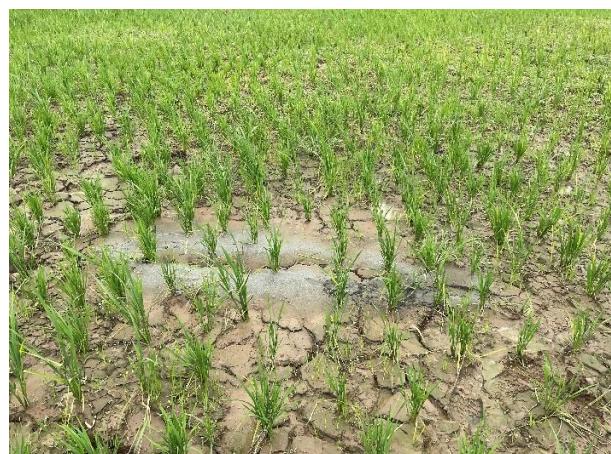
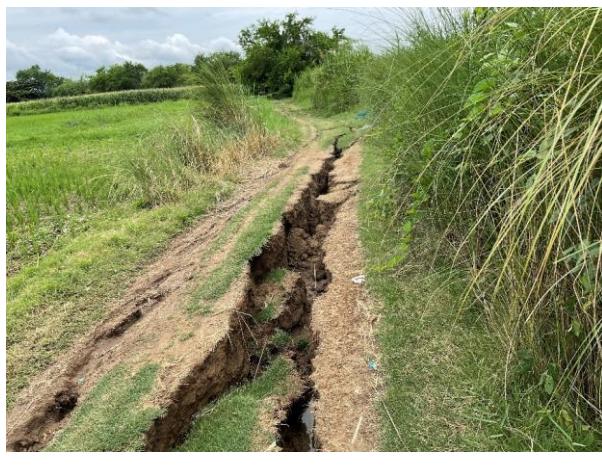
Fig. 14. Sand boils and ground fissure in San Vicente, Ilocos Sur

Sand boils and ground fissures were also found by the team near a river in San Vicente, Ilocos Sur (see **Fig. 14a & b**).
