オルモック市洪水対策事業

構造物と非構造物対策

レイテ島、フィリピン共和国

建設技研インターナショナル

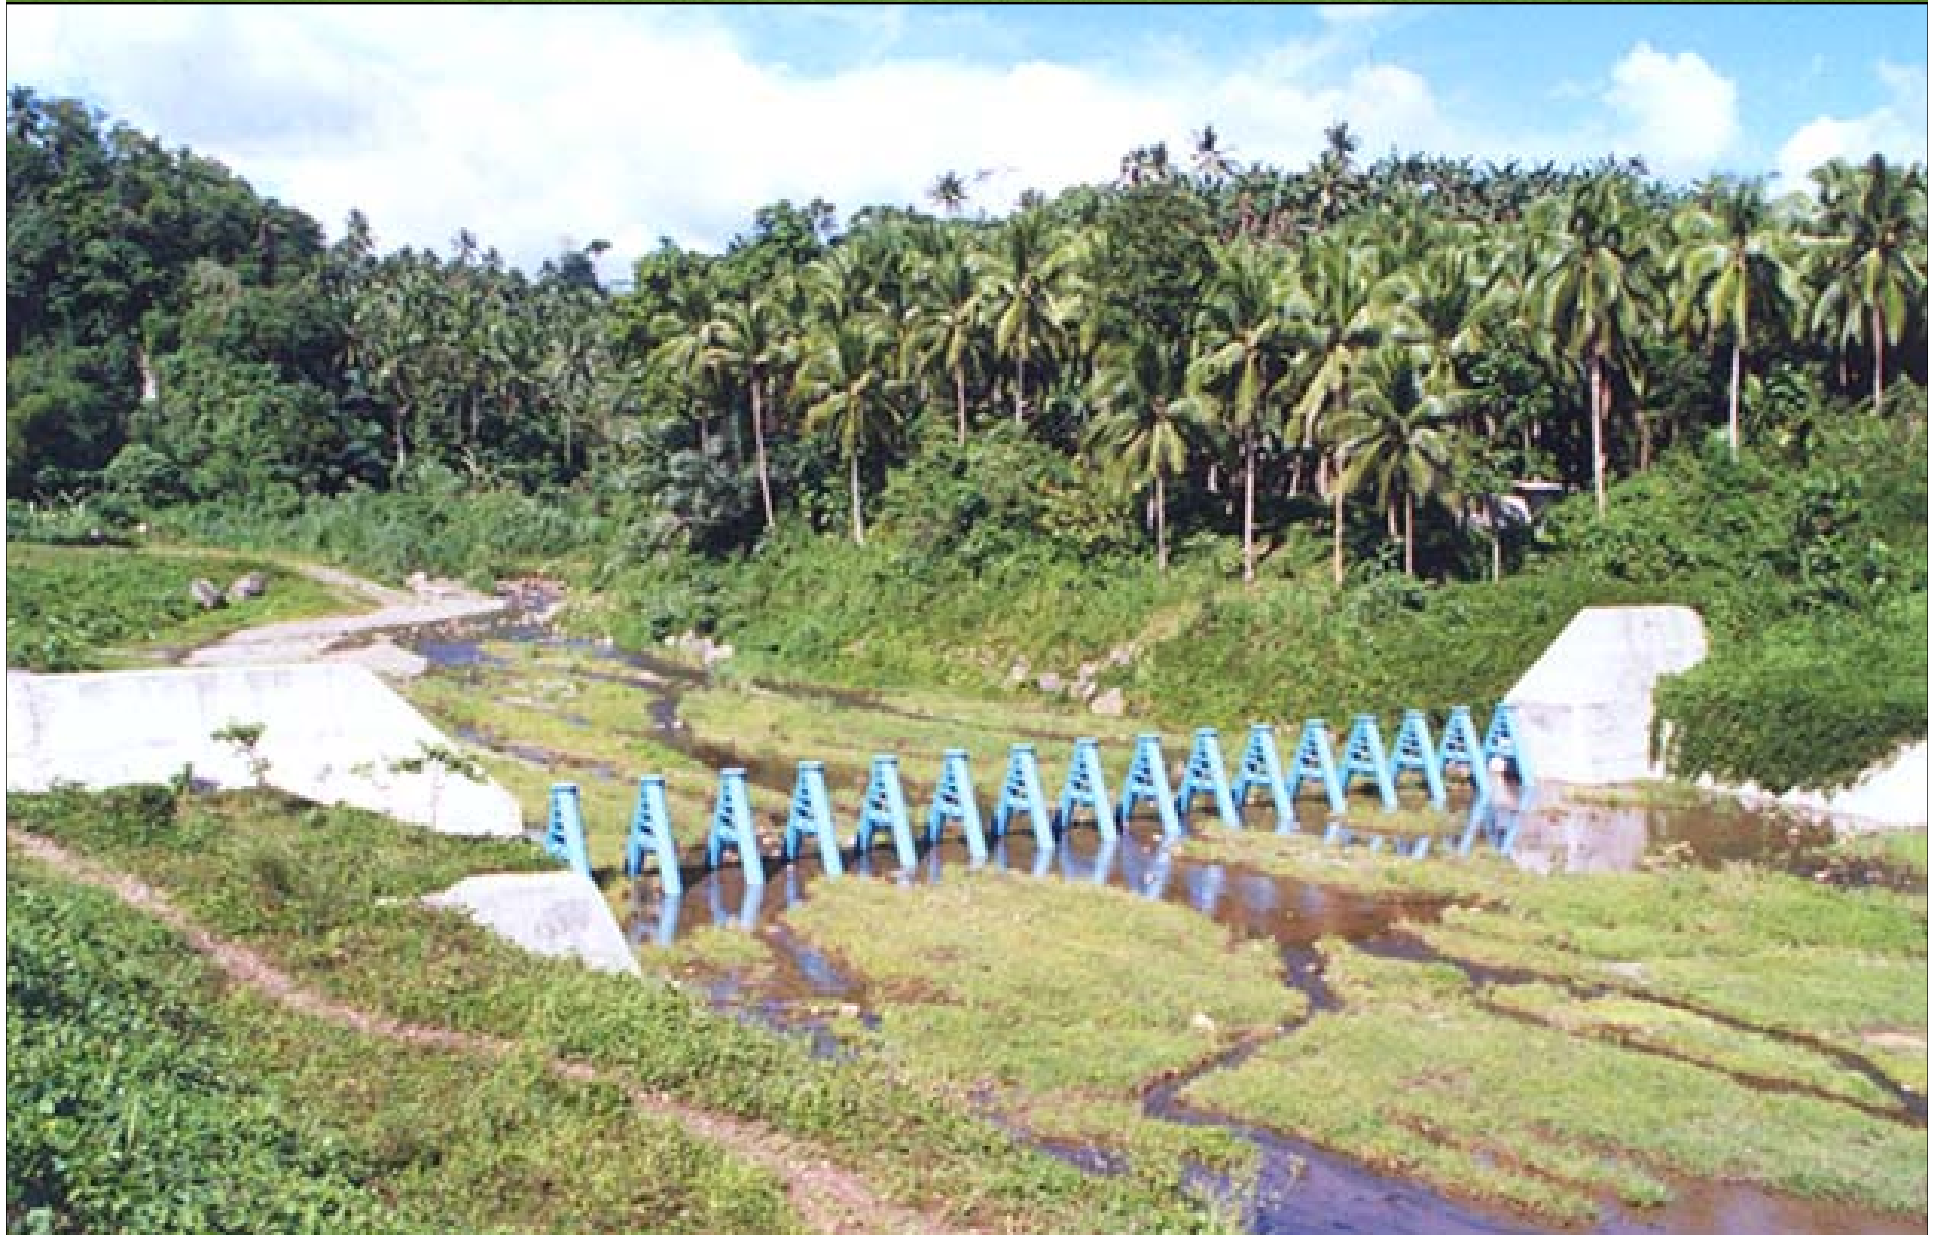
TYPICAL type for ANILAO and MALBASAG Slit DAM

TYPICAL SECTION OF SLIT DAM

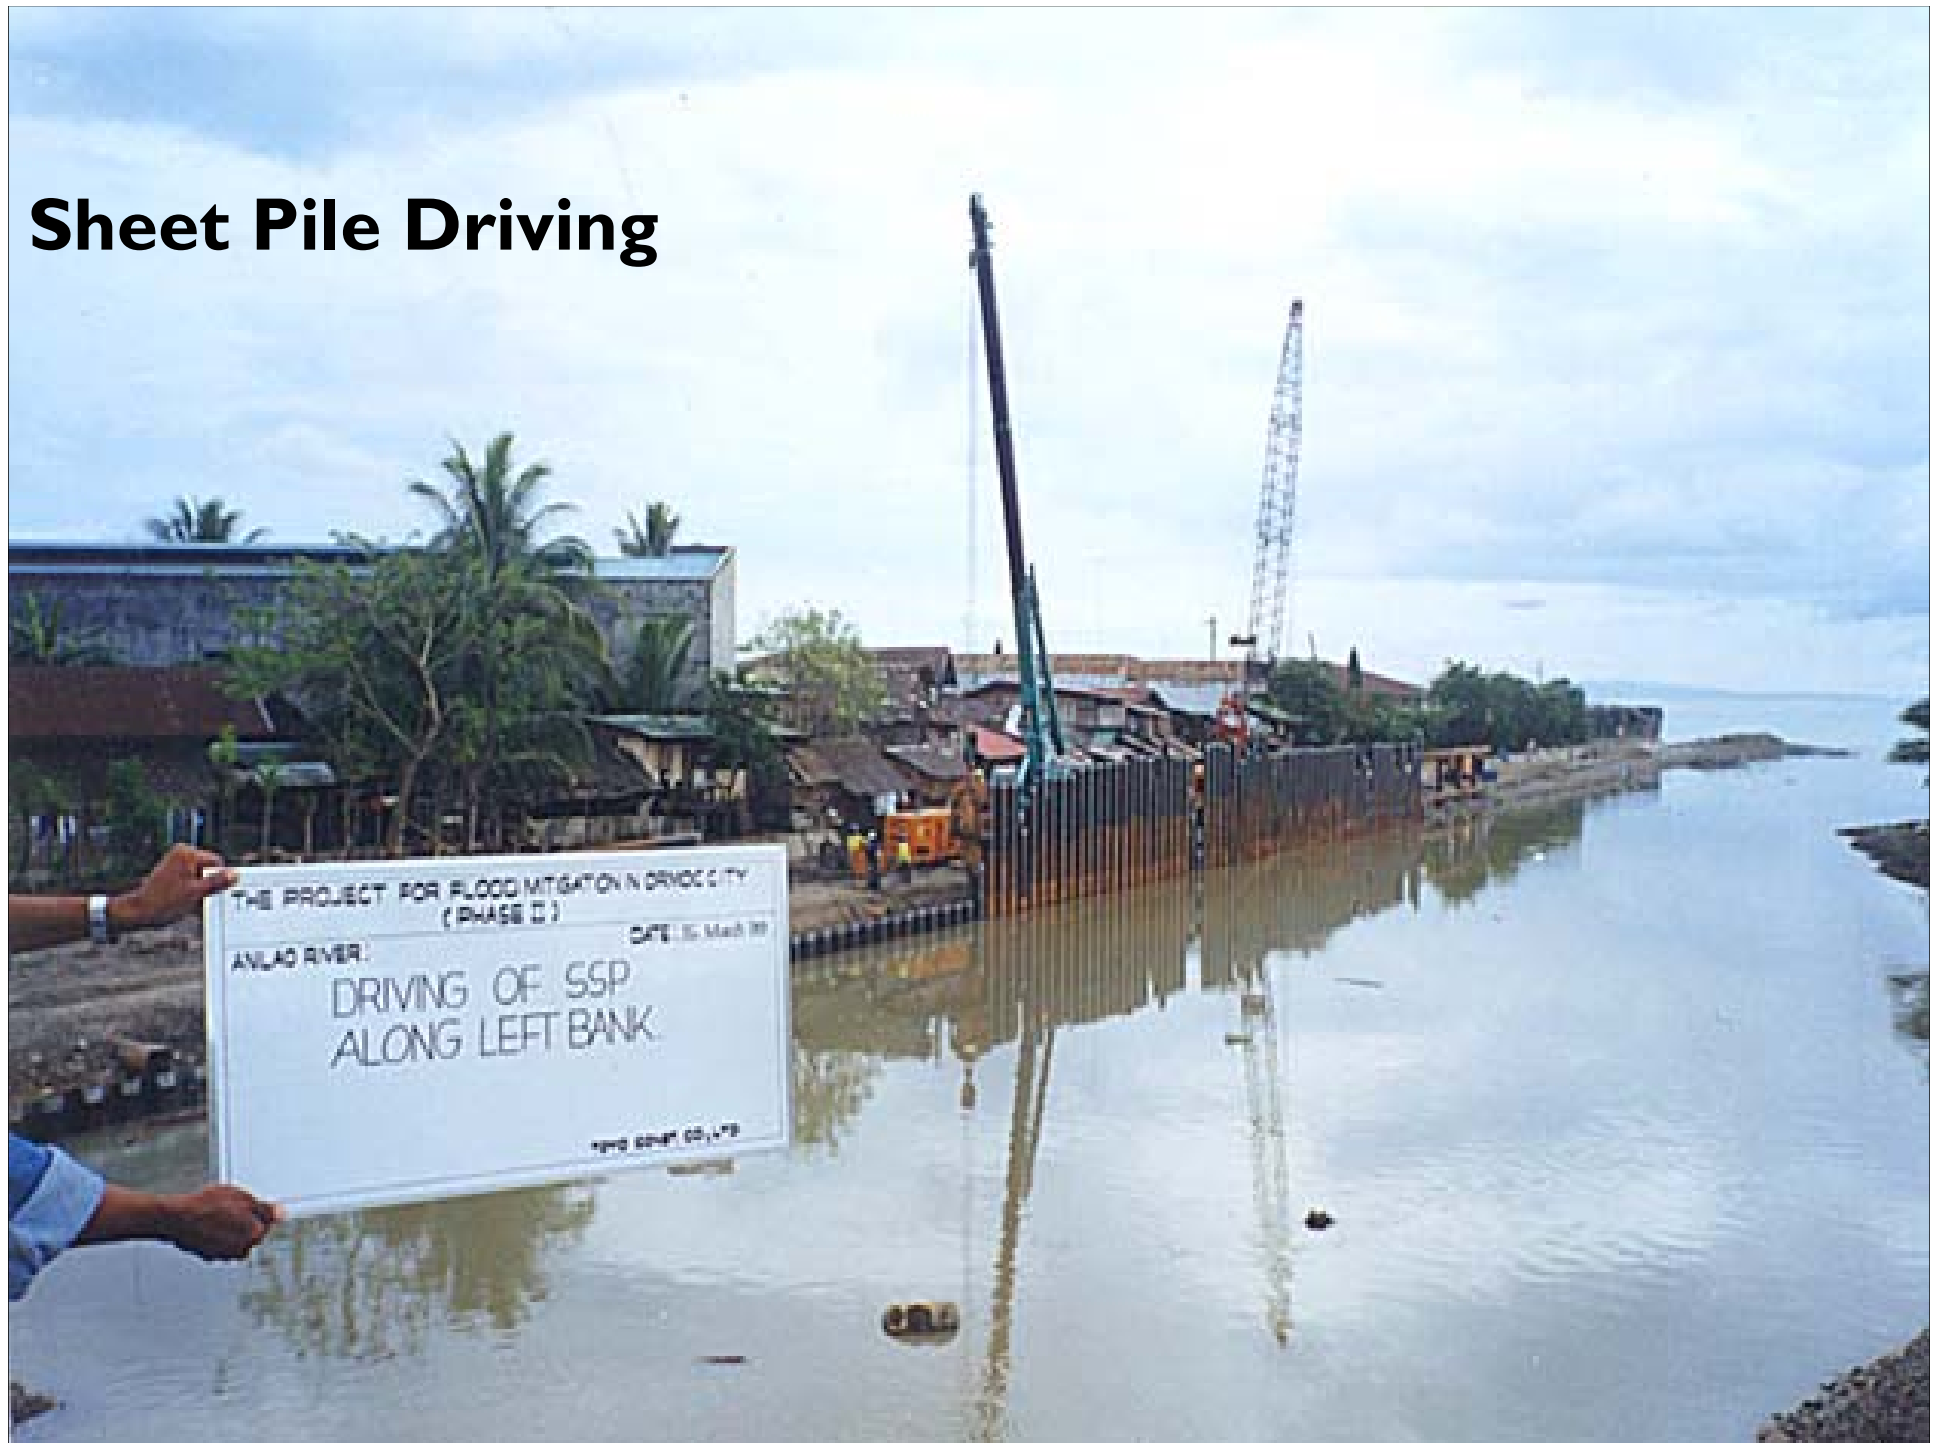
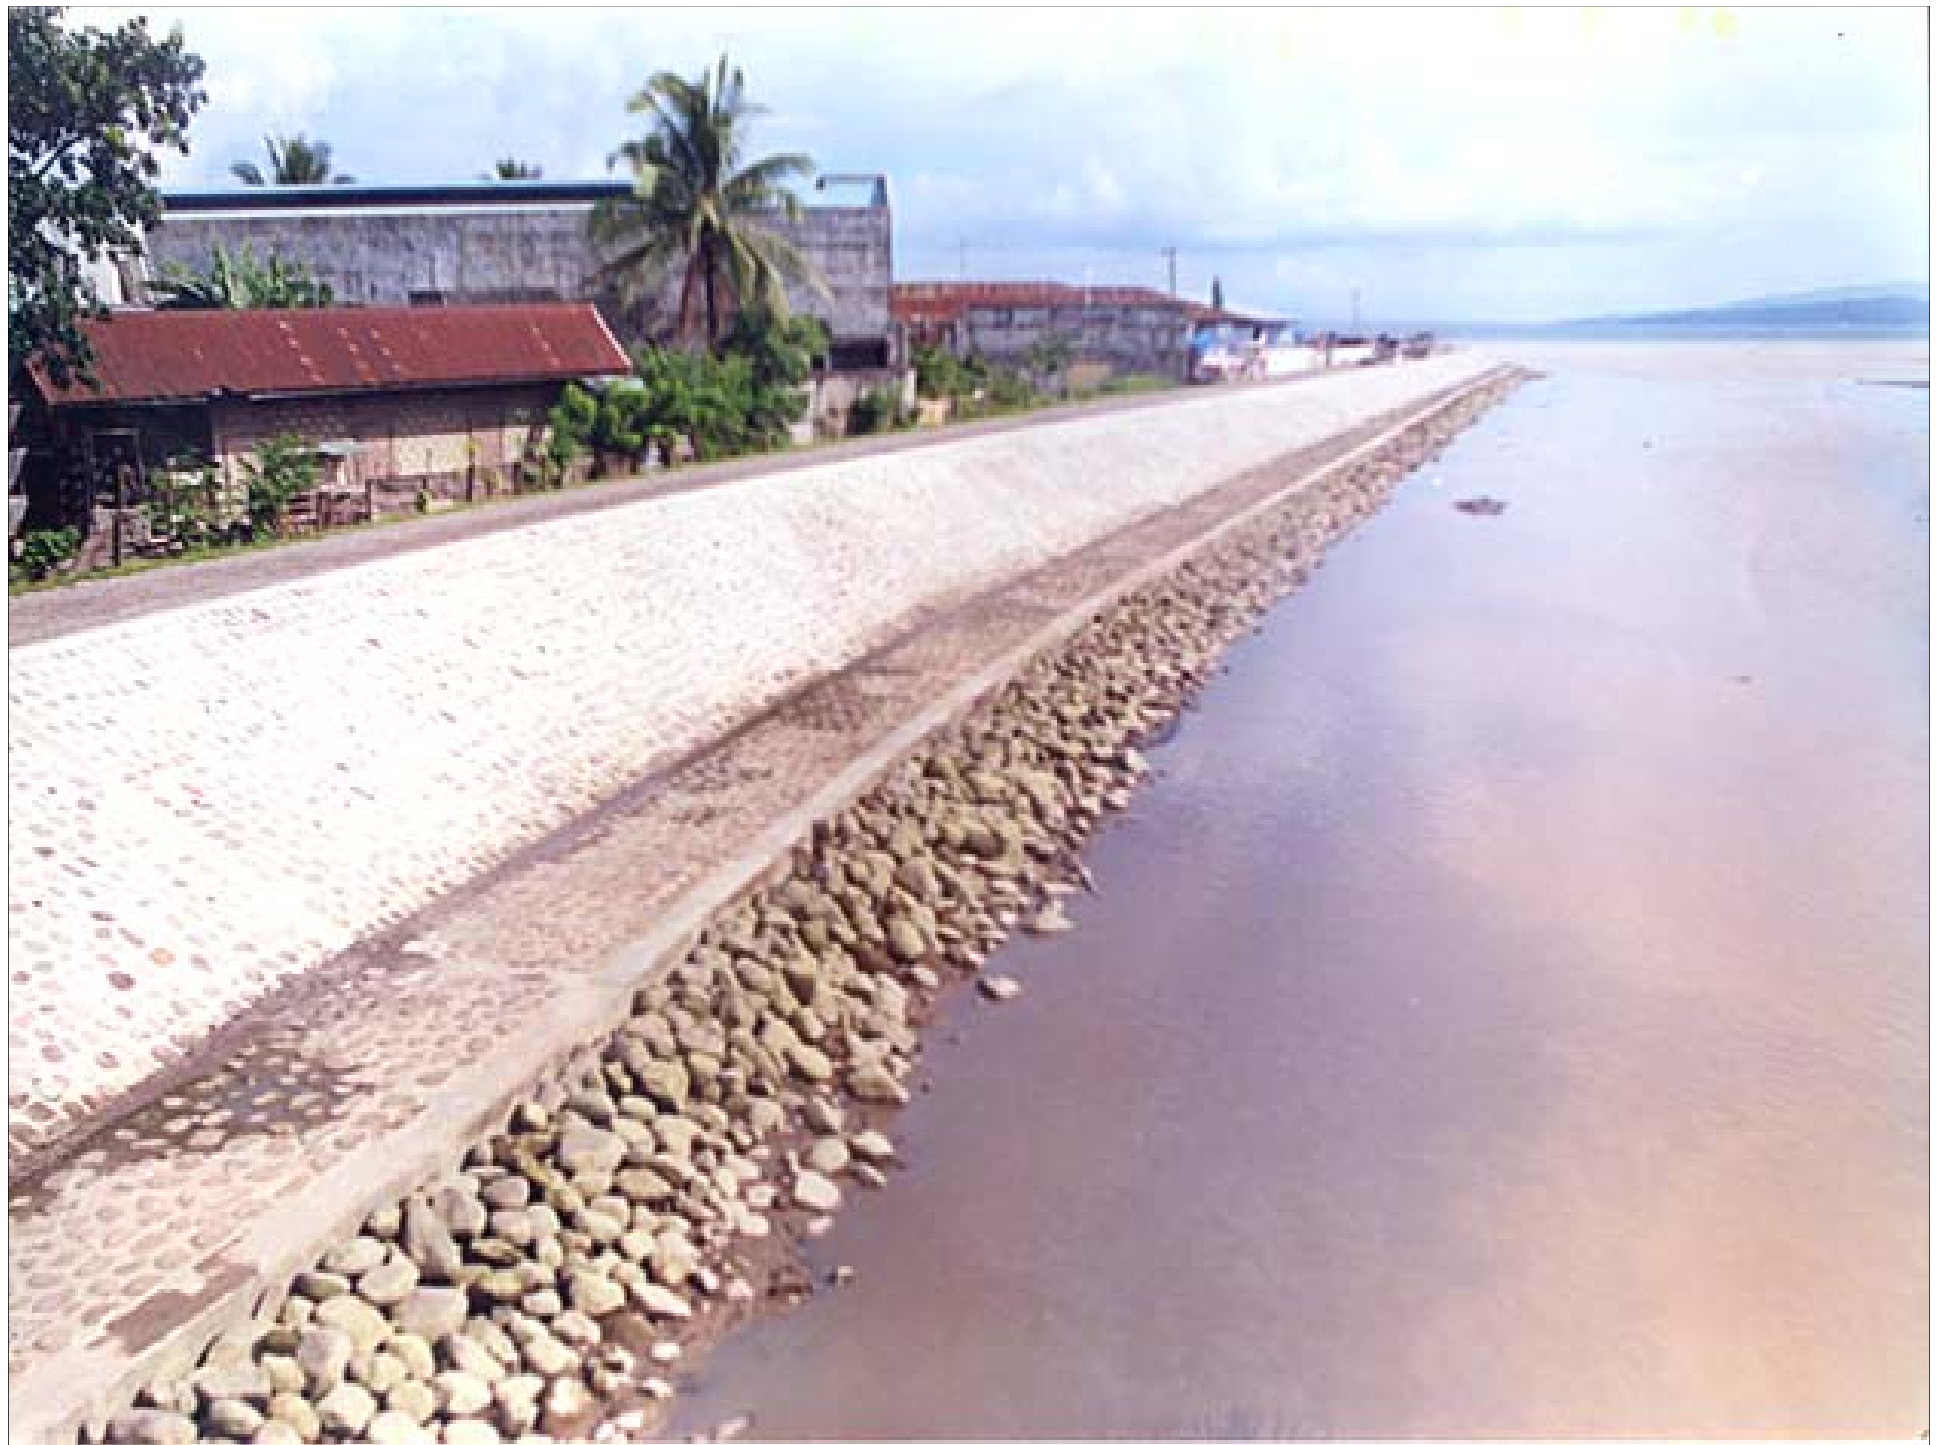
Sheet Pile Driving

General Plan for Steel Sheet Pile Type Revetment

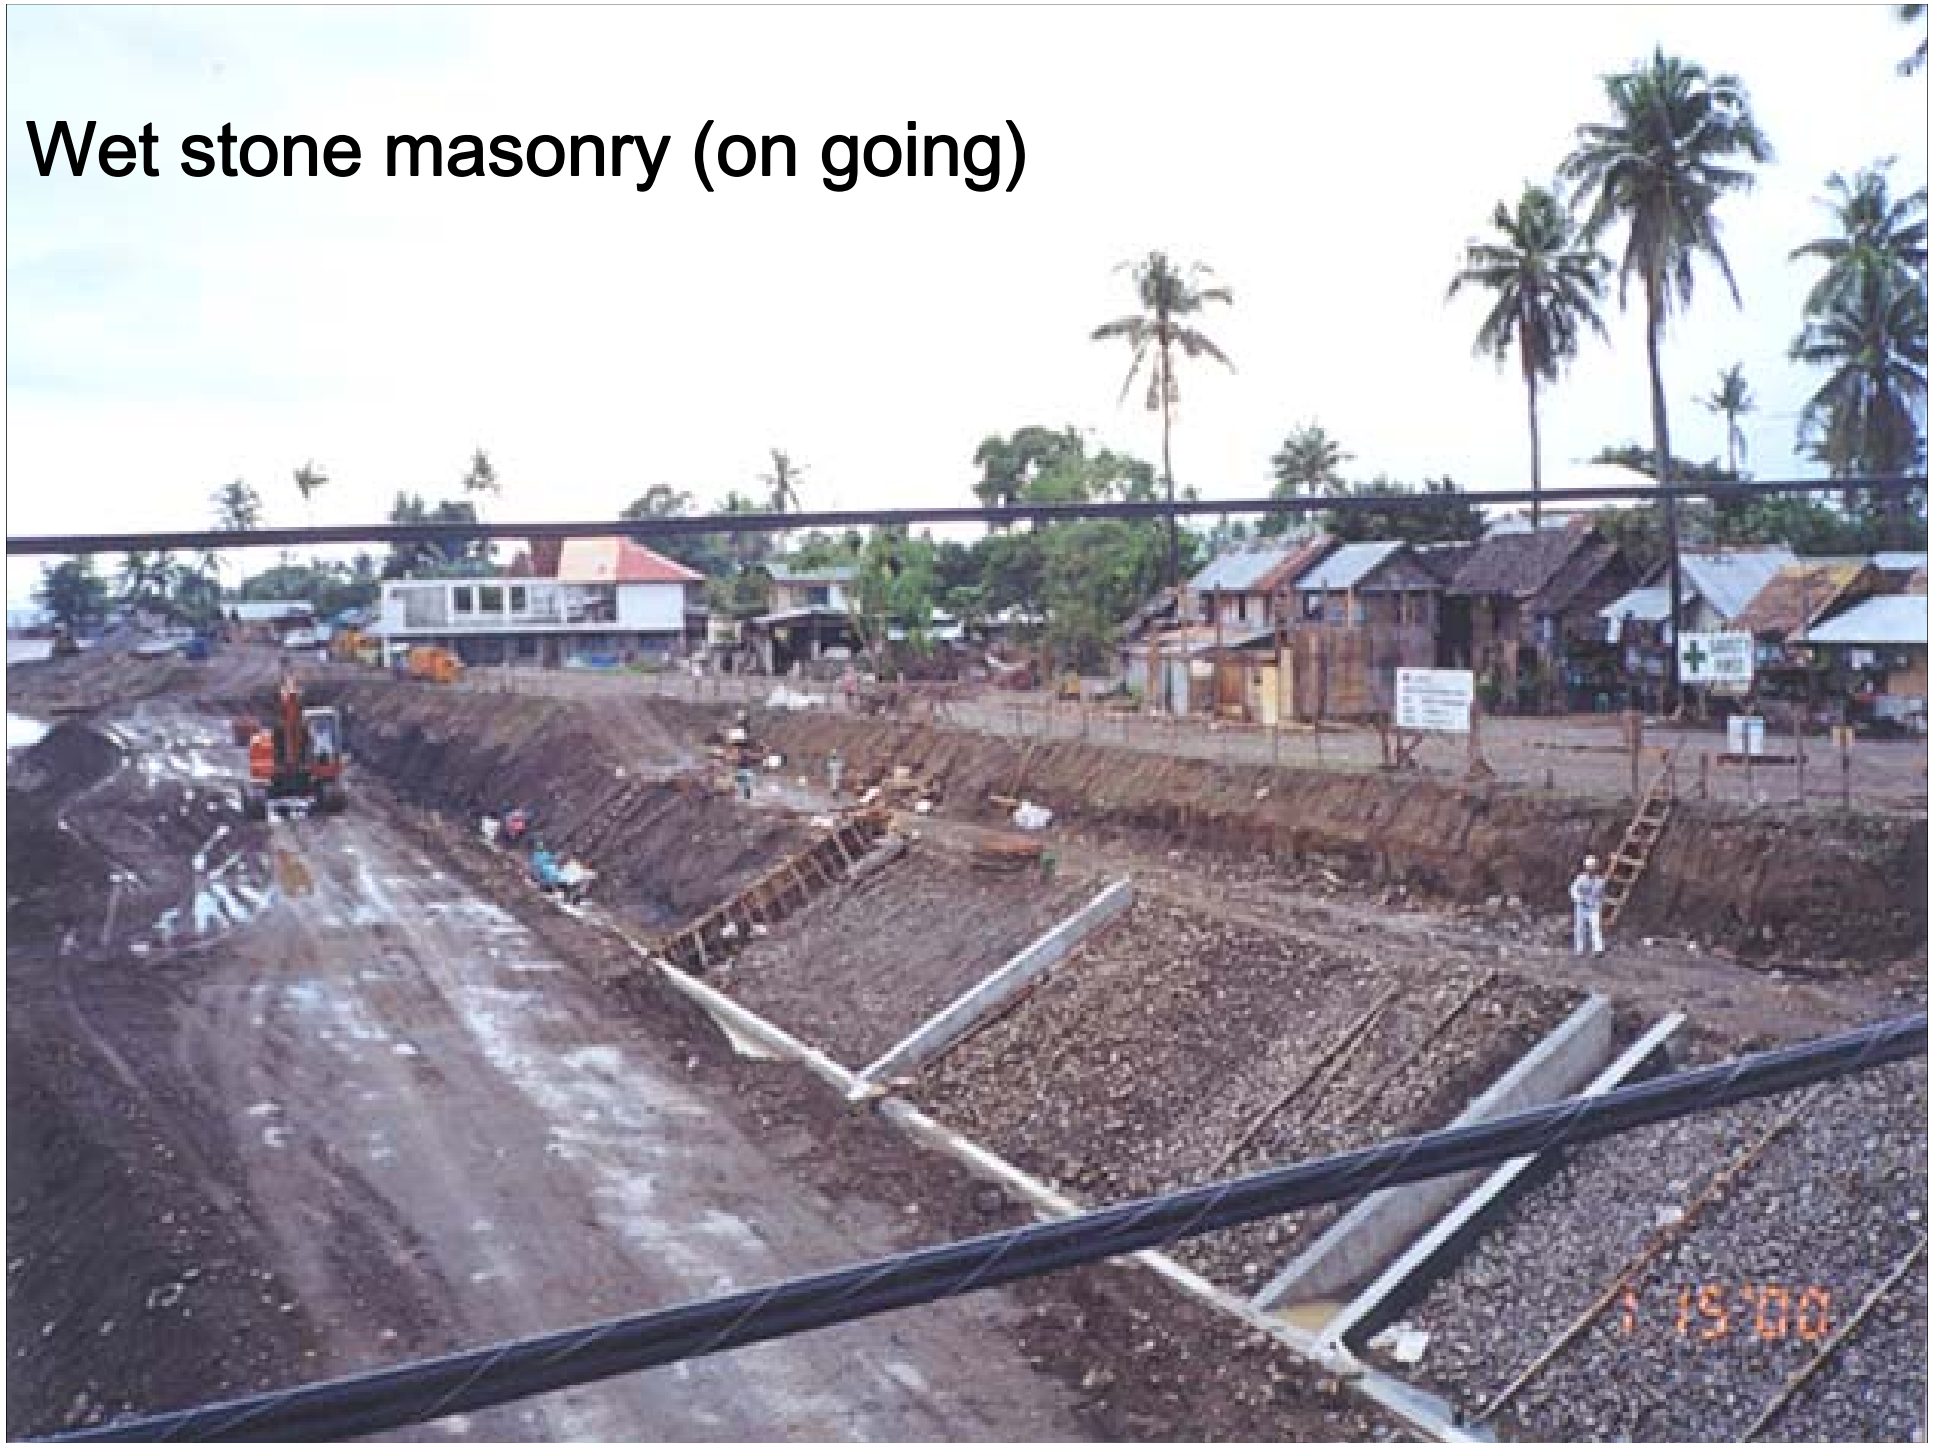
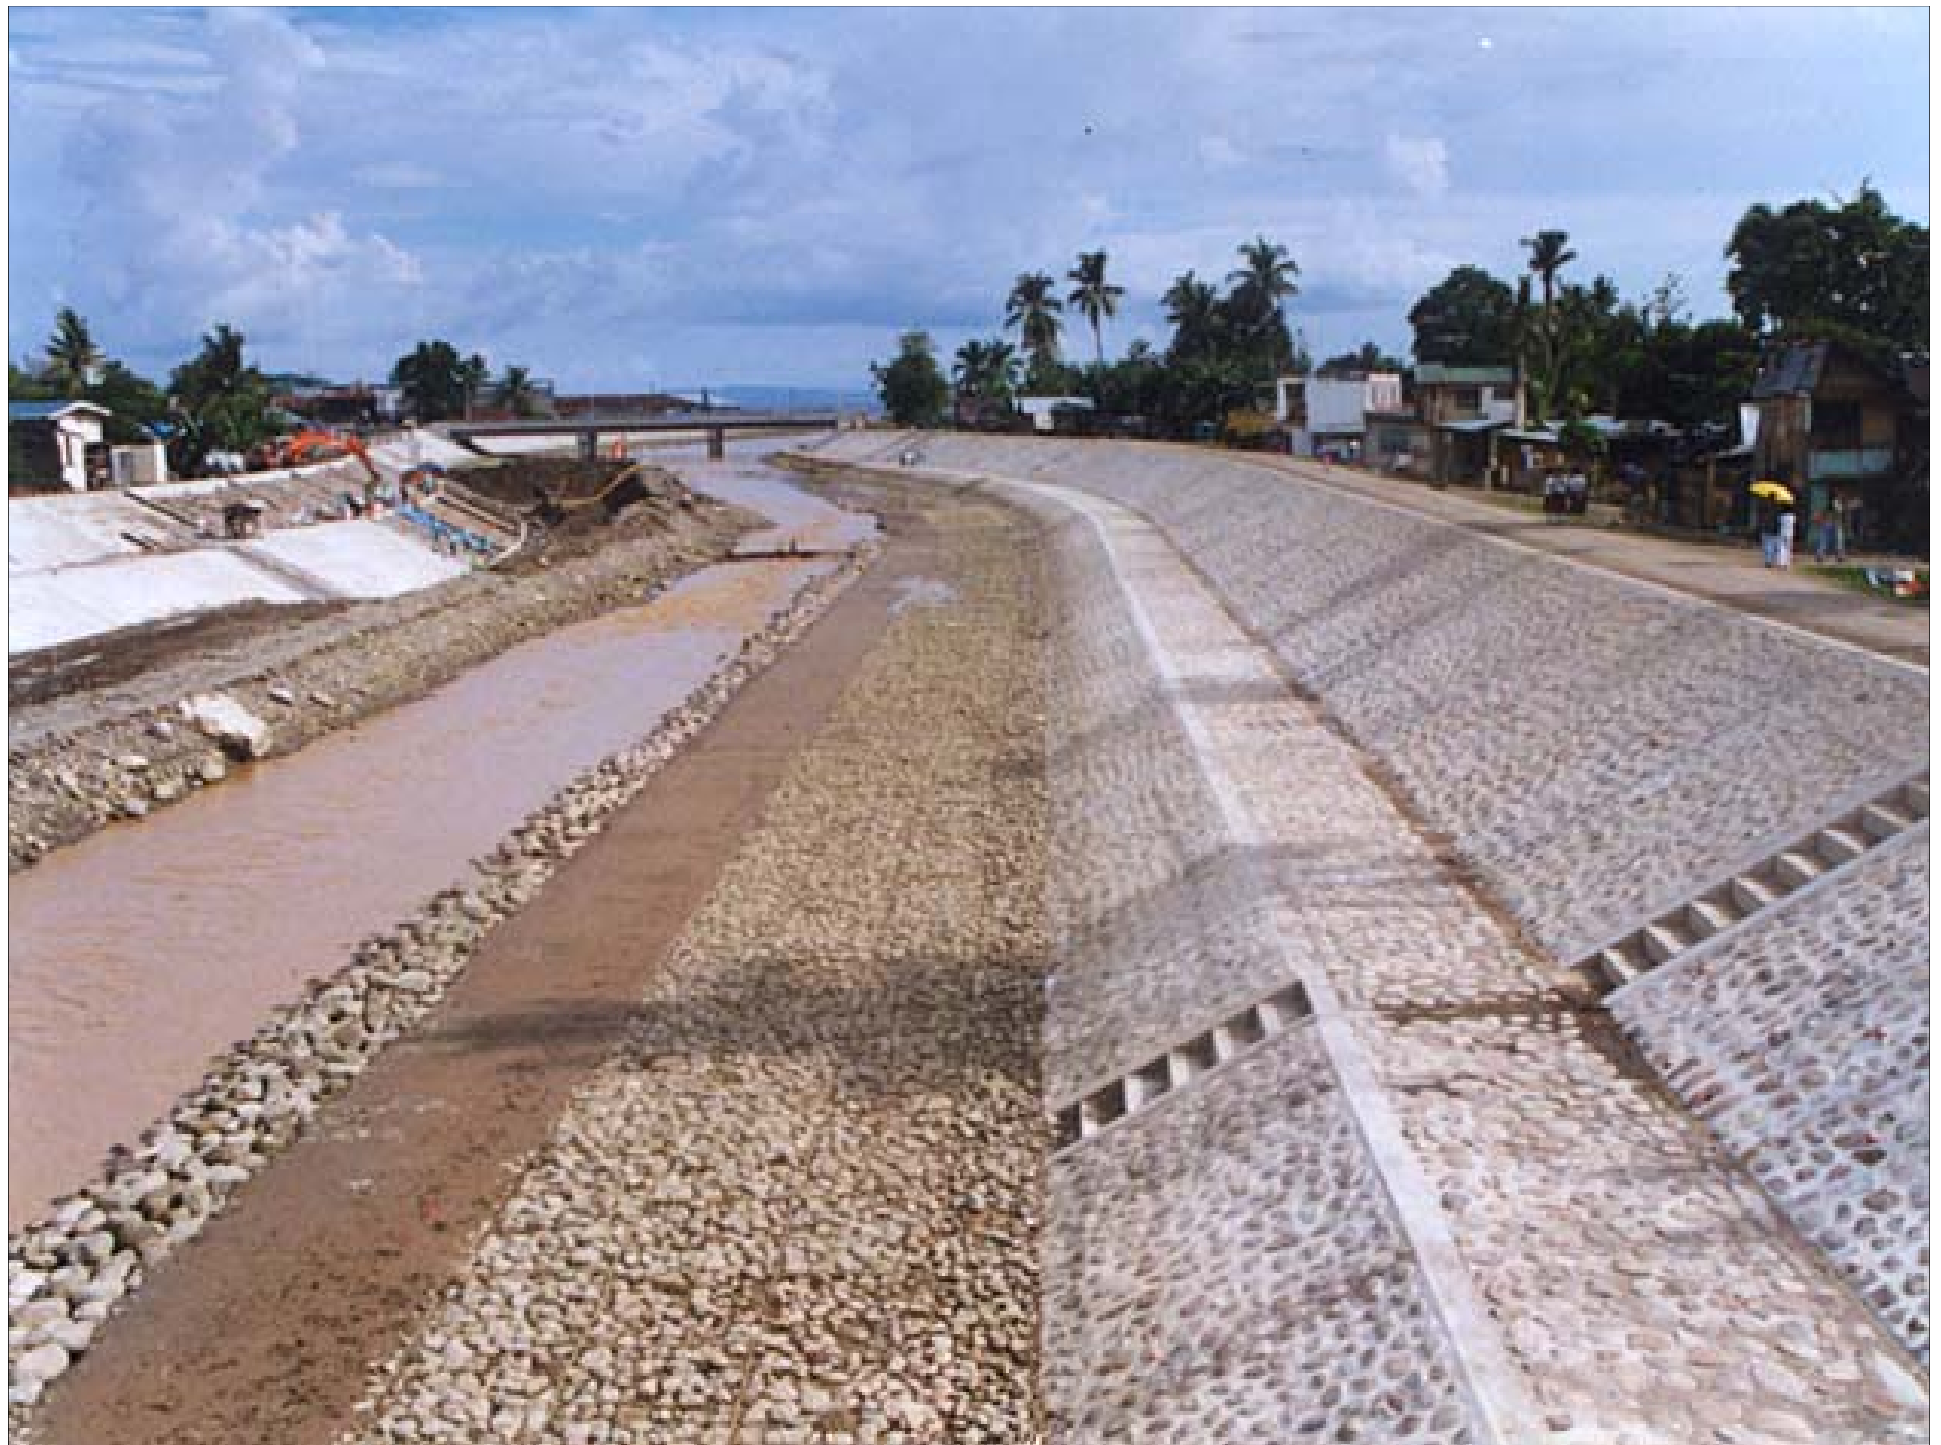
Wet stone masonry (on going)

General Plan for Wet Stone Masonry Type Revetment

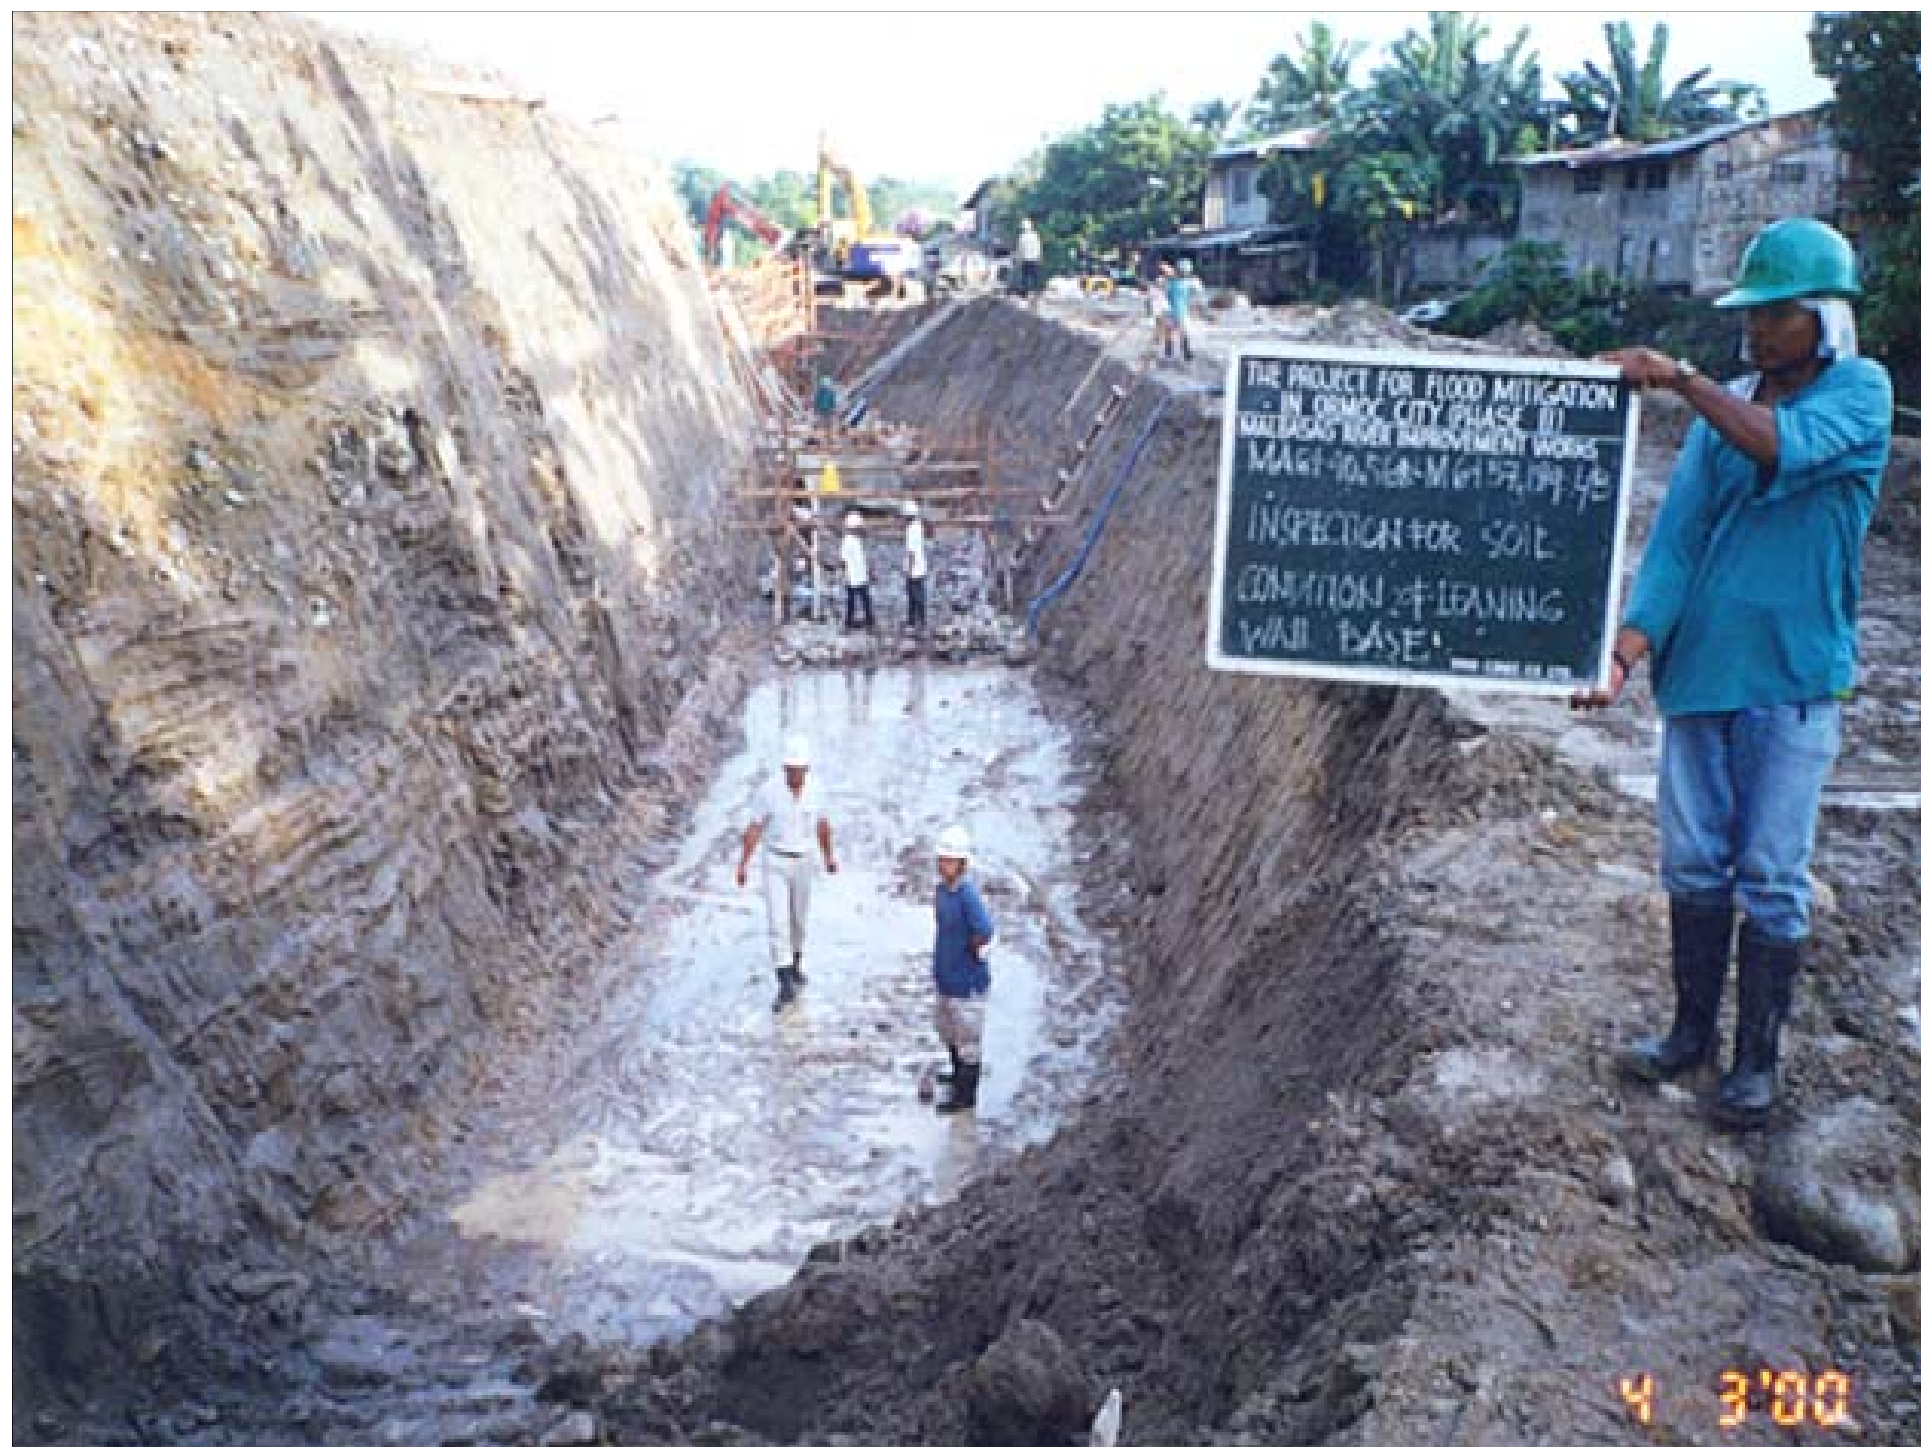
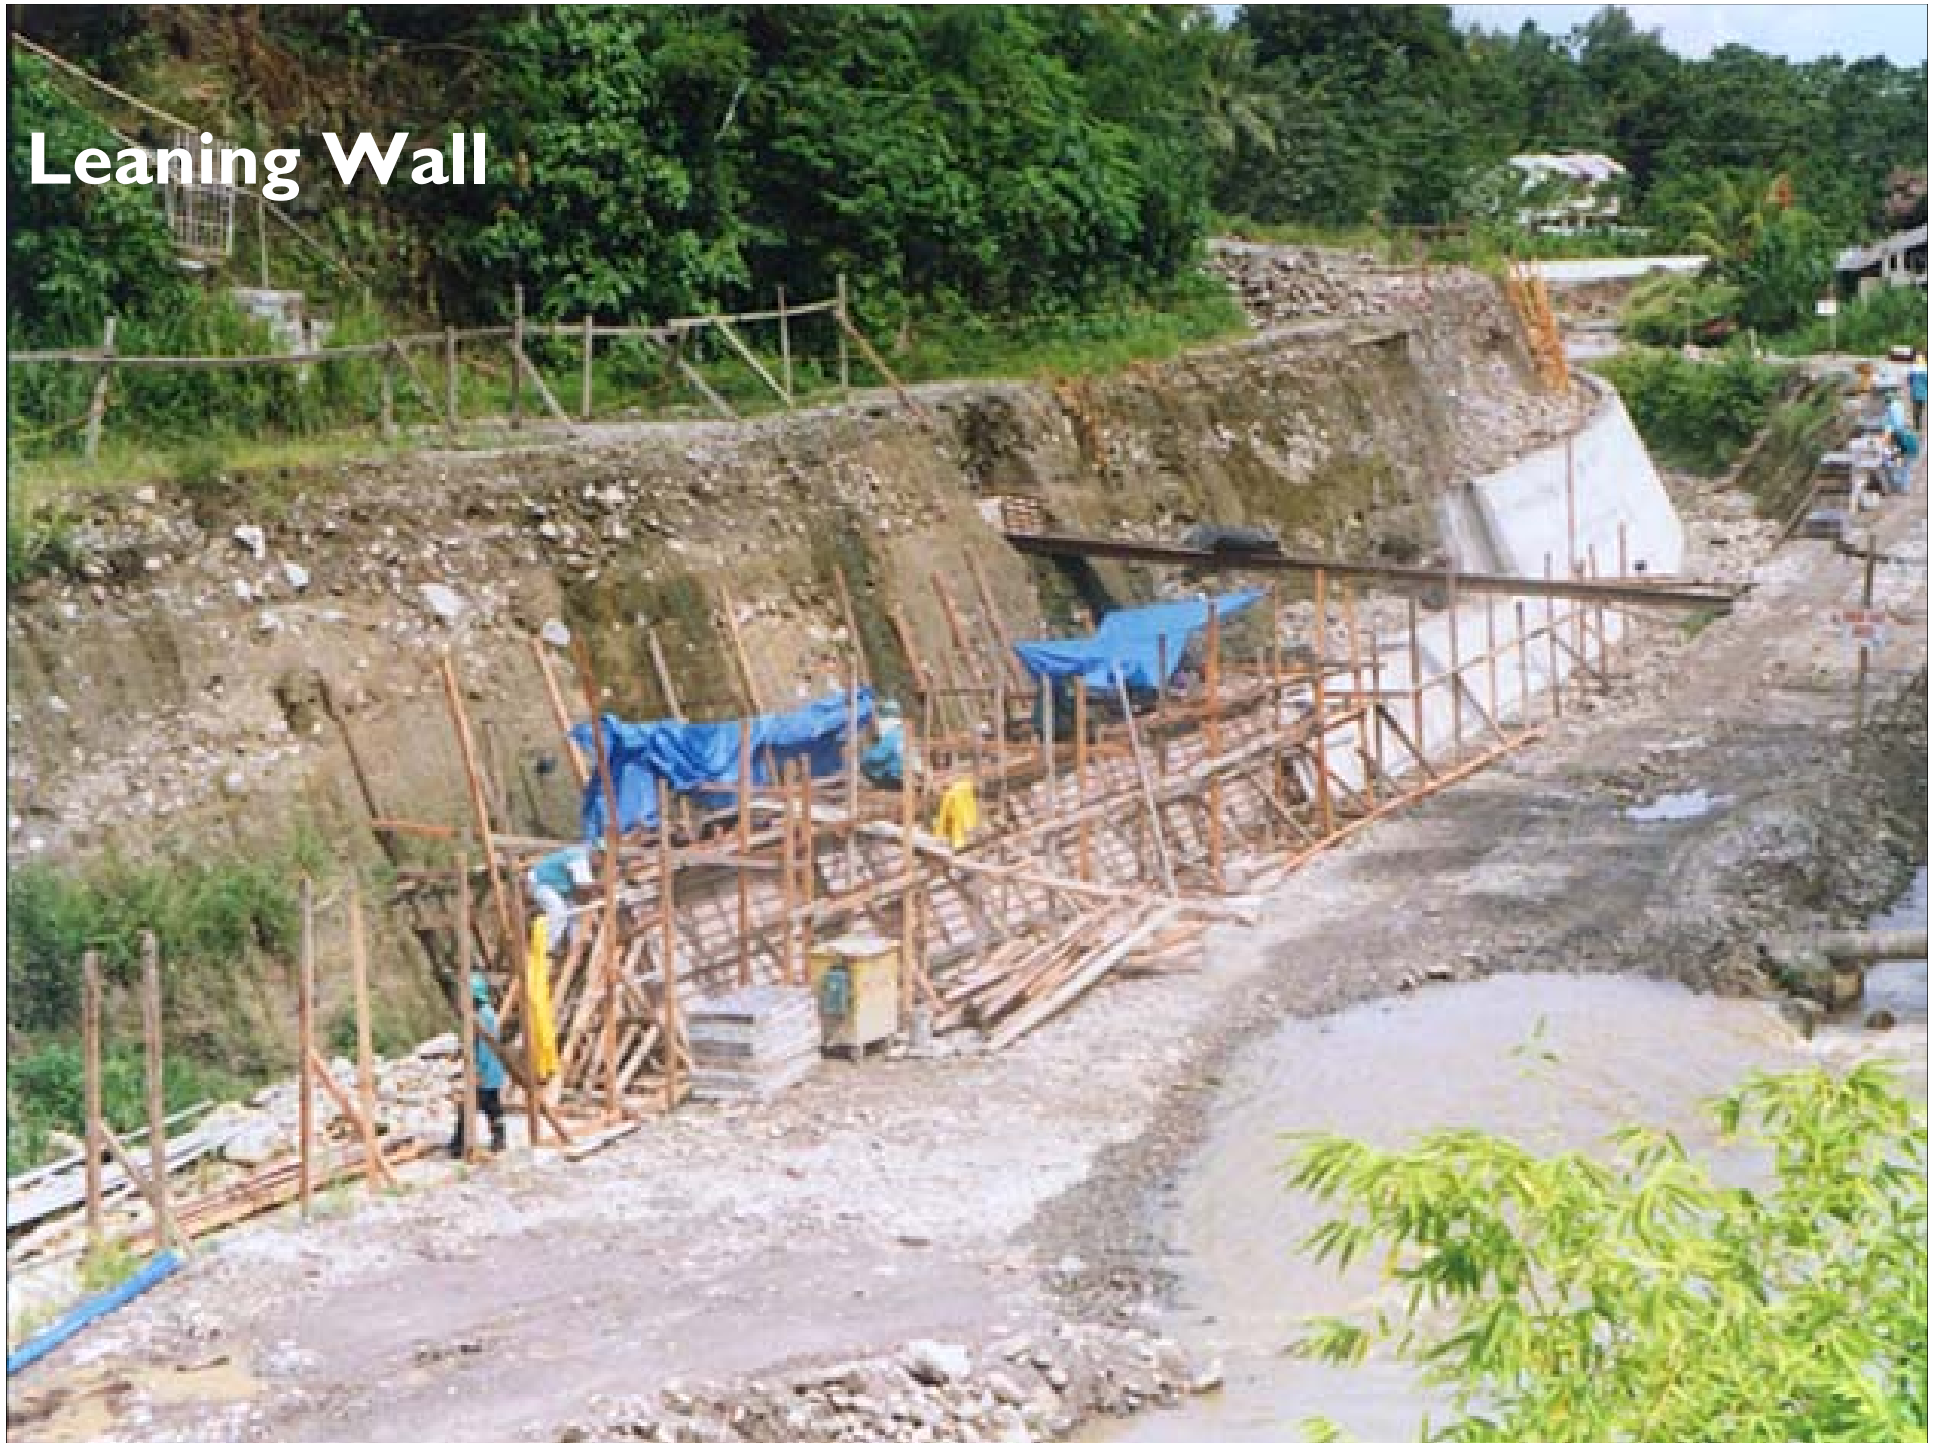
Leaning Wall

General Plan for Retaining Wall Type Revetment
