オルモック市洪水対策事業

構造物と非構造物対策

レイテ島、フィリピン共和国

建設技研インターナショナル

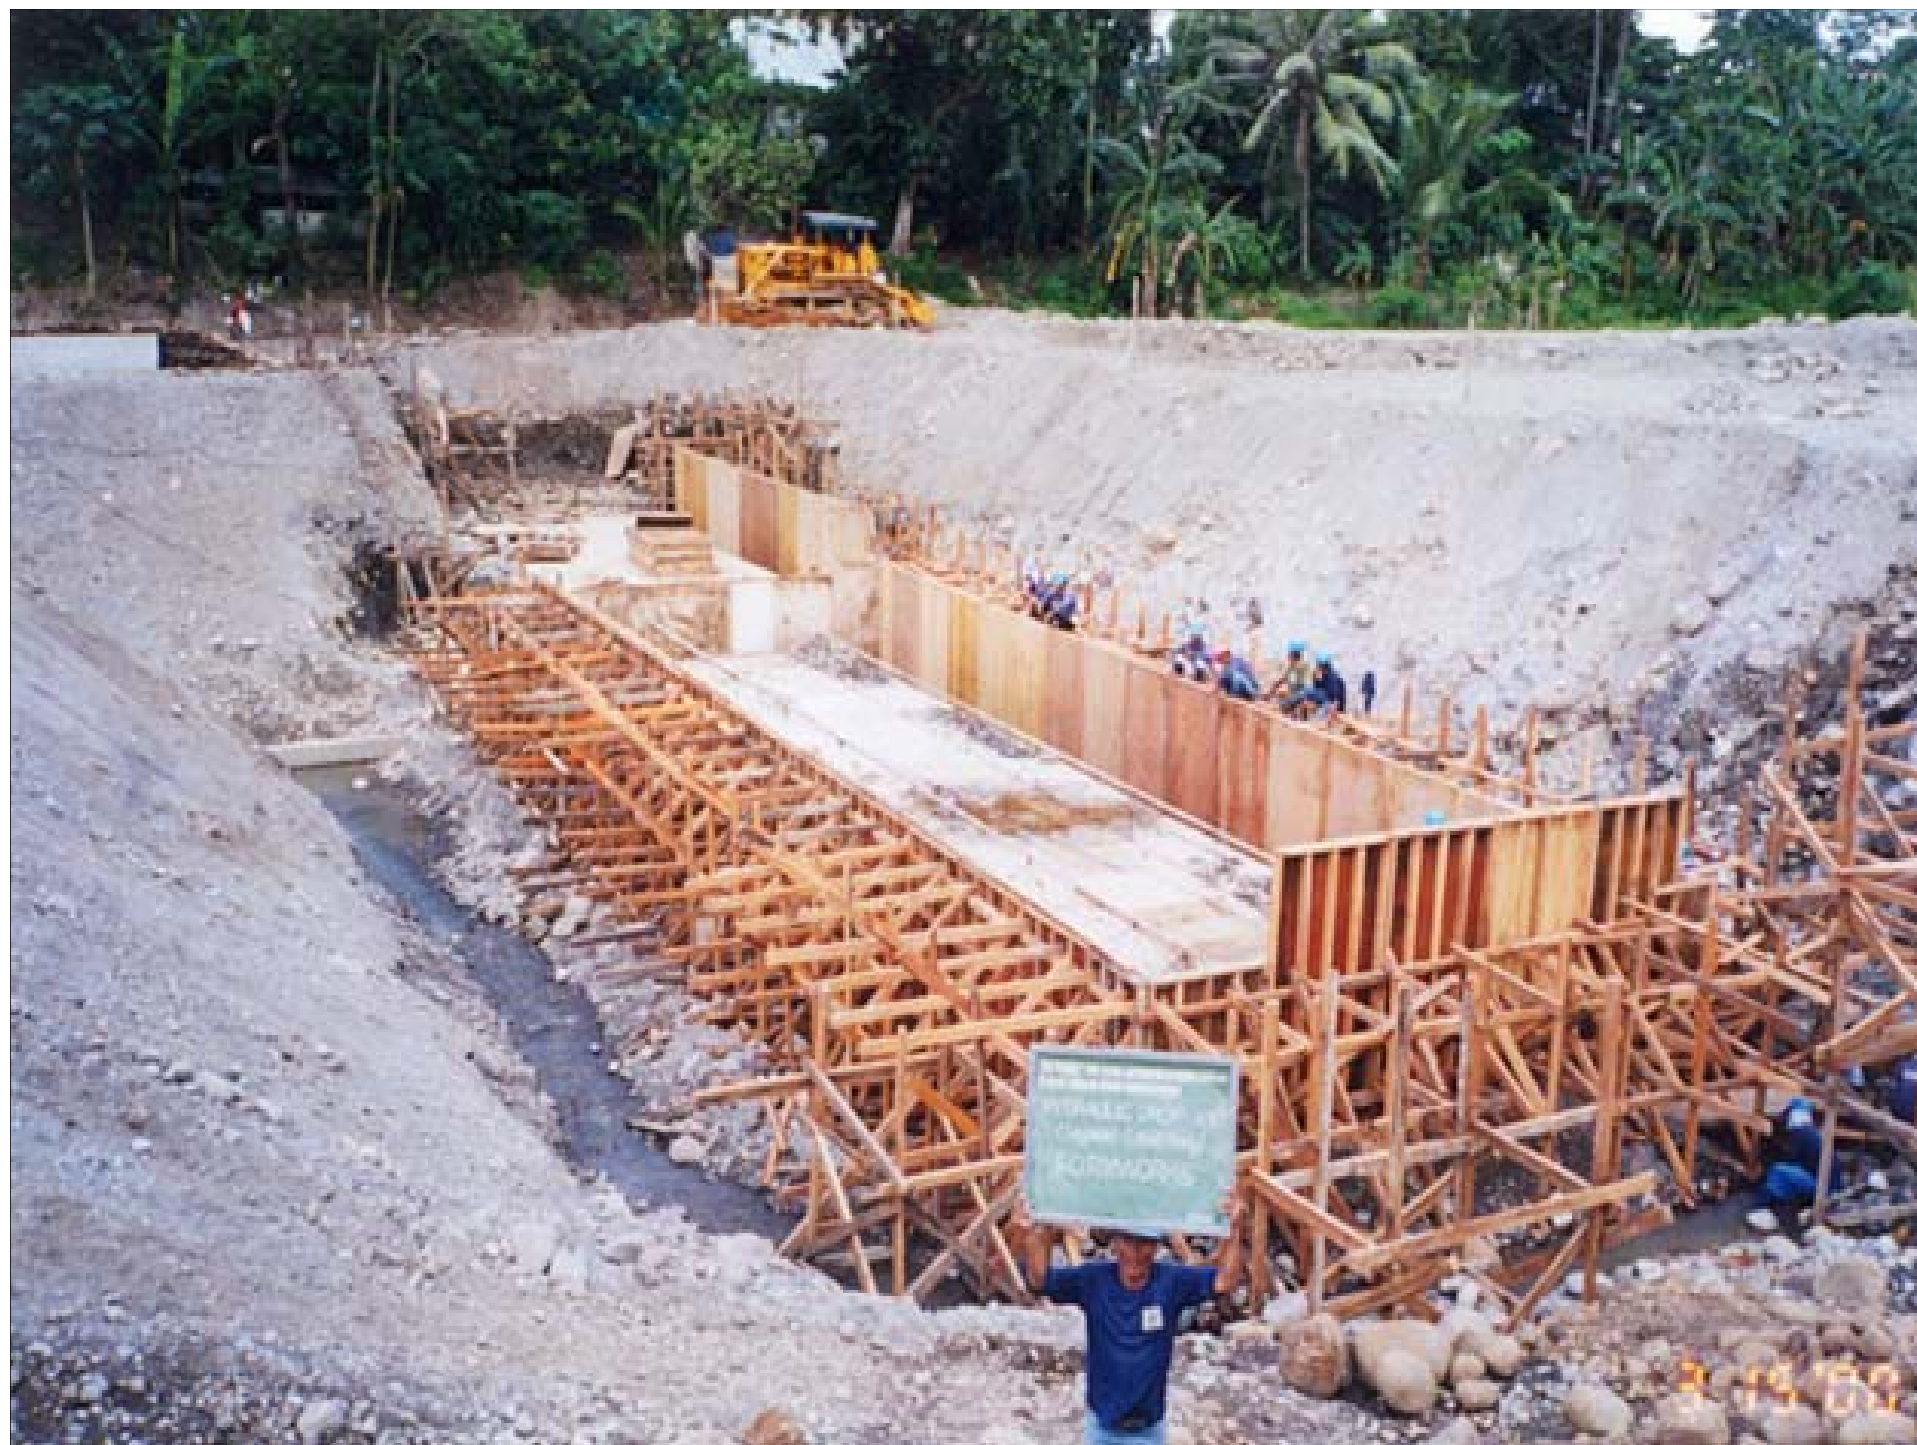
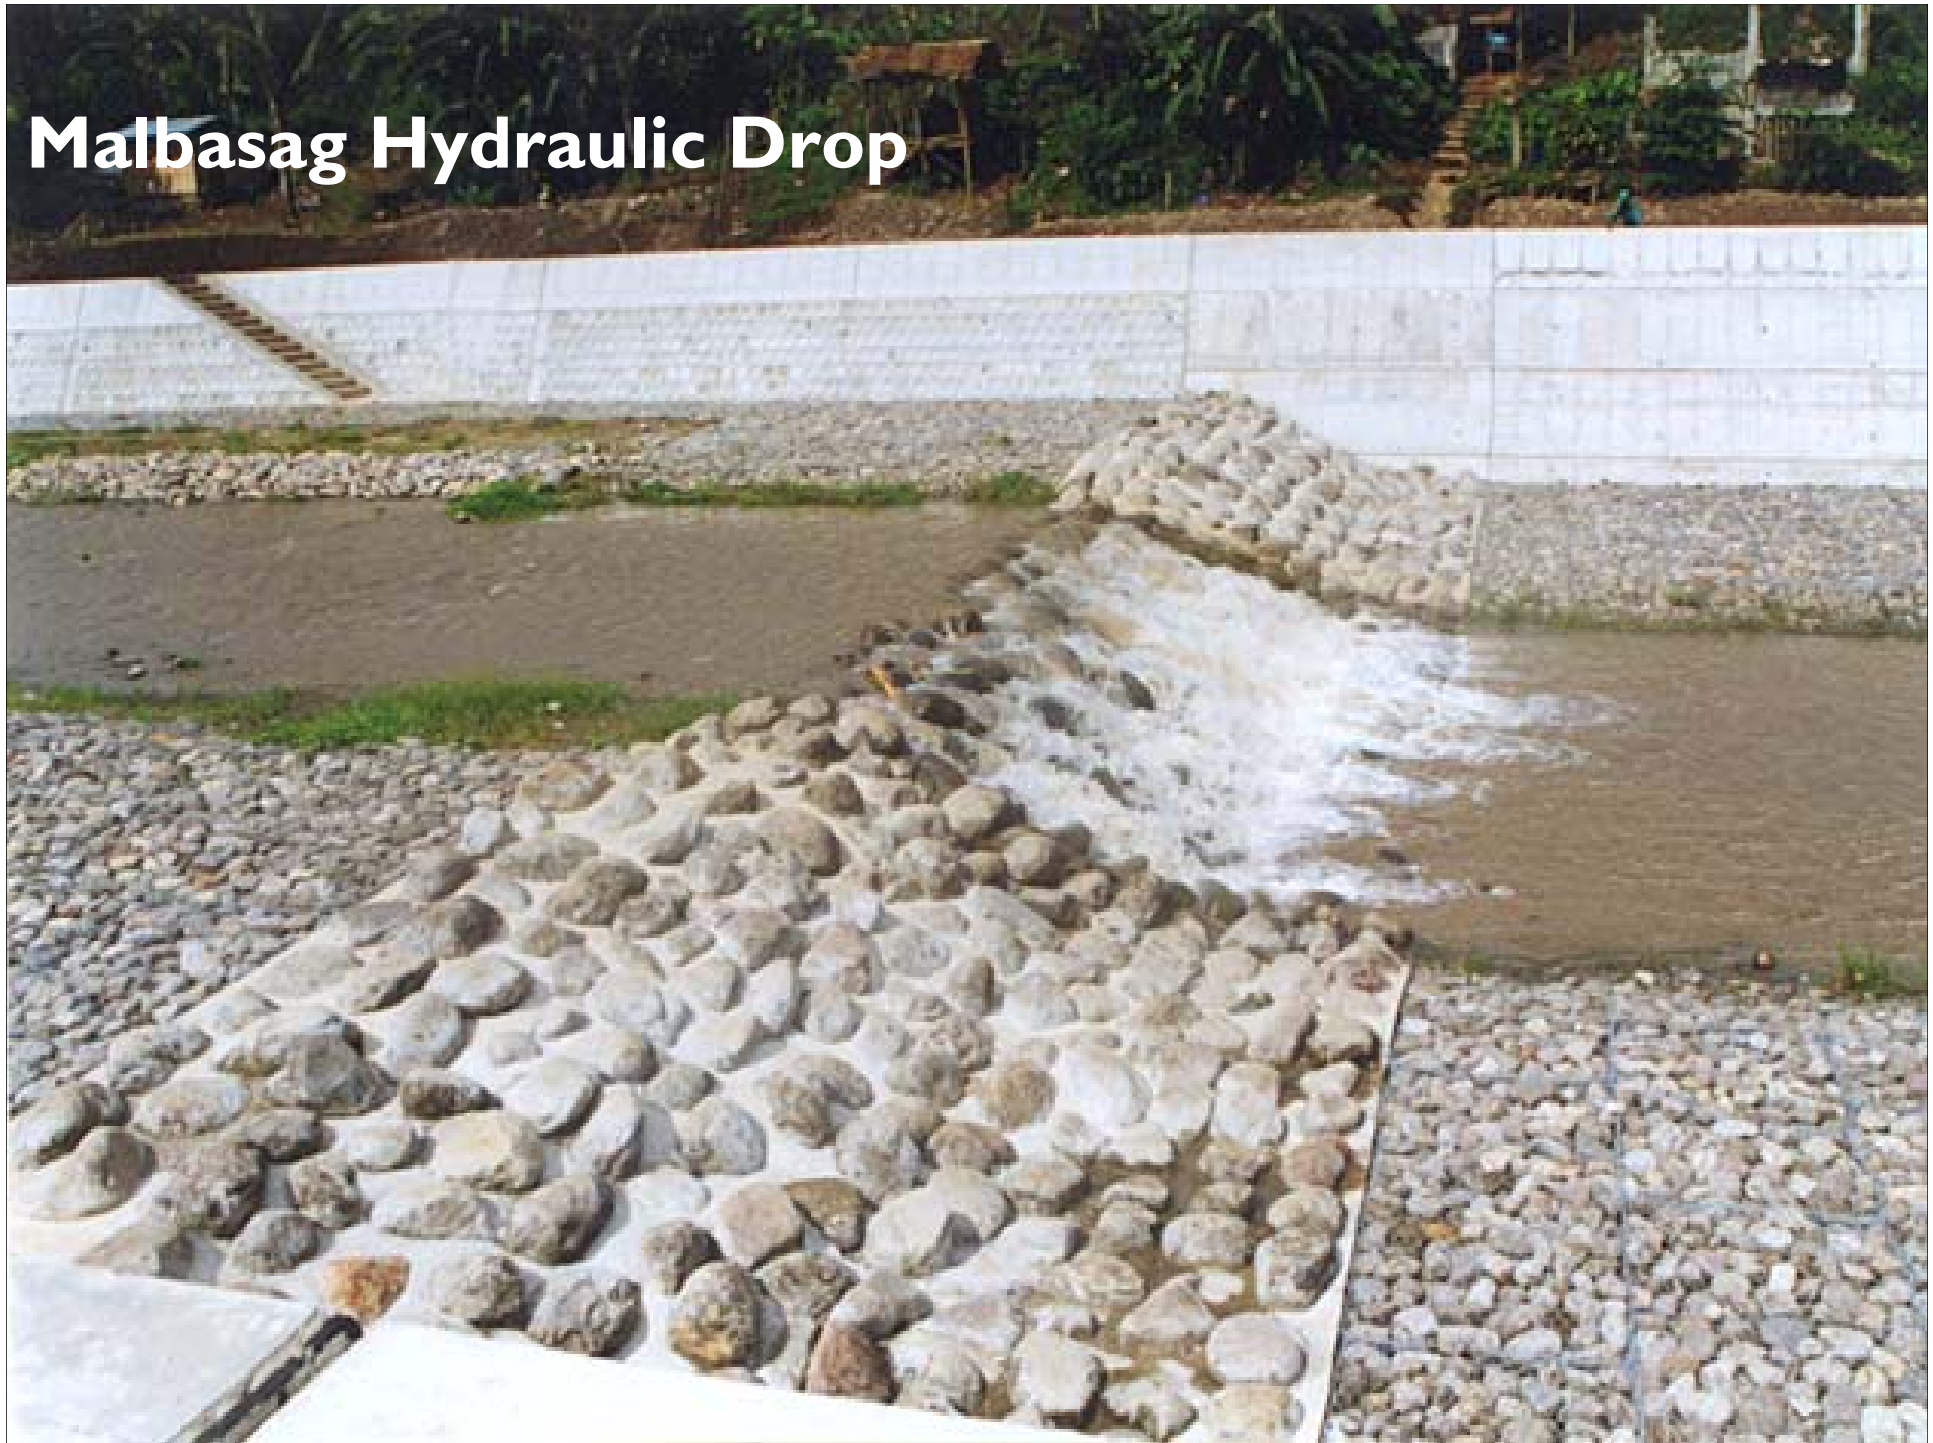
Malbasag Hydraulic Drop

General Plan for Hydraulic Drop

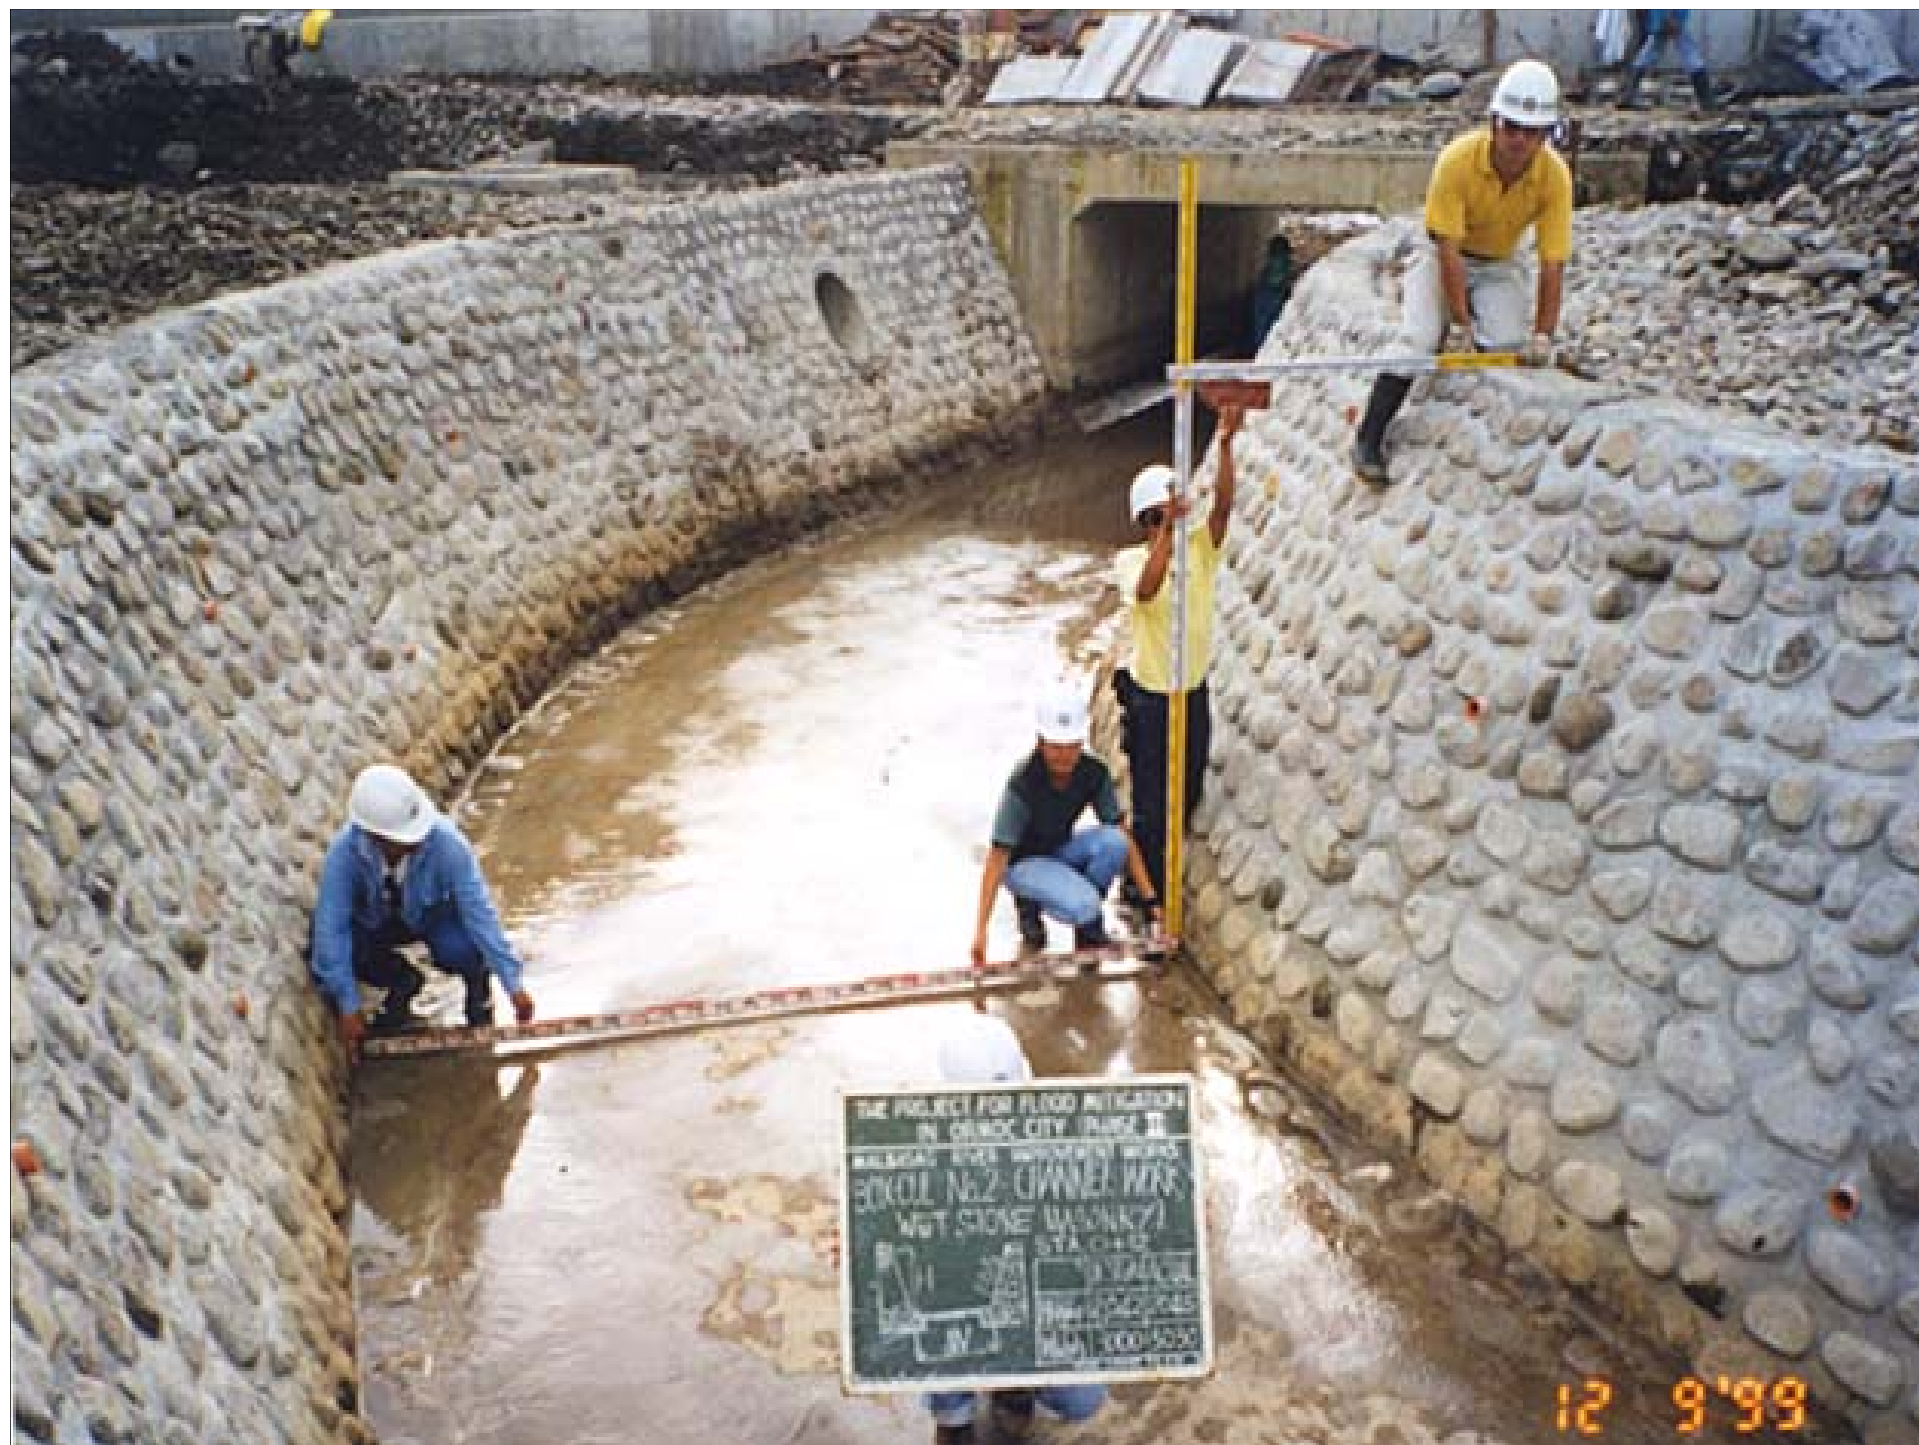
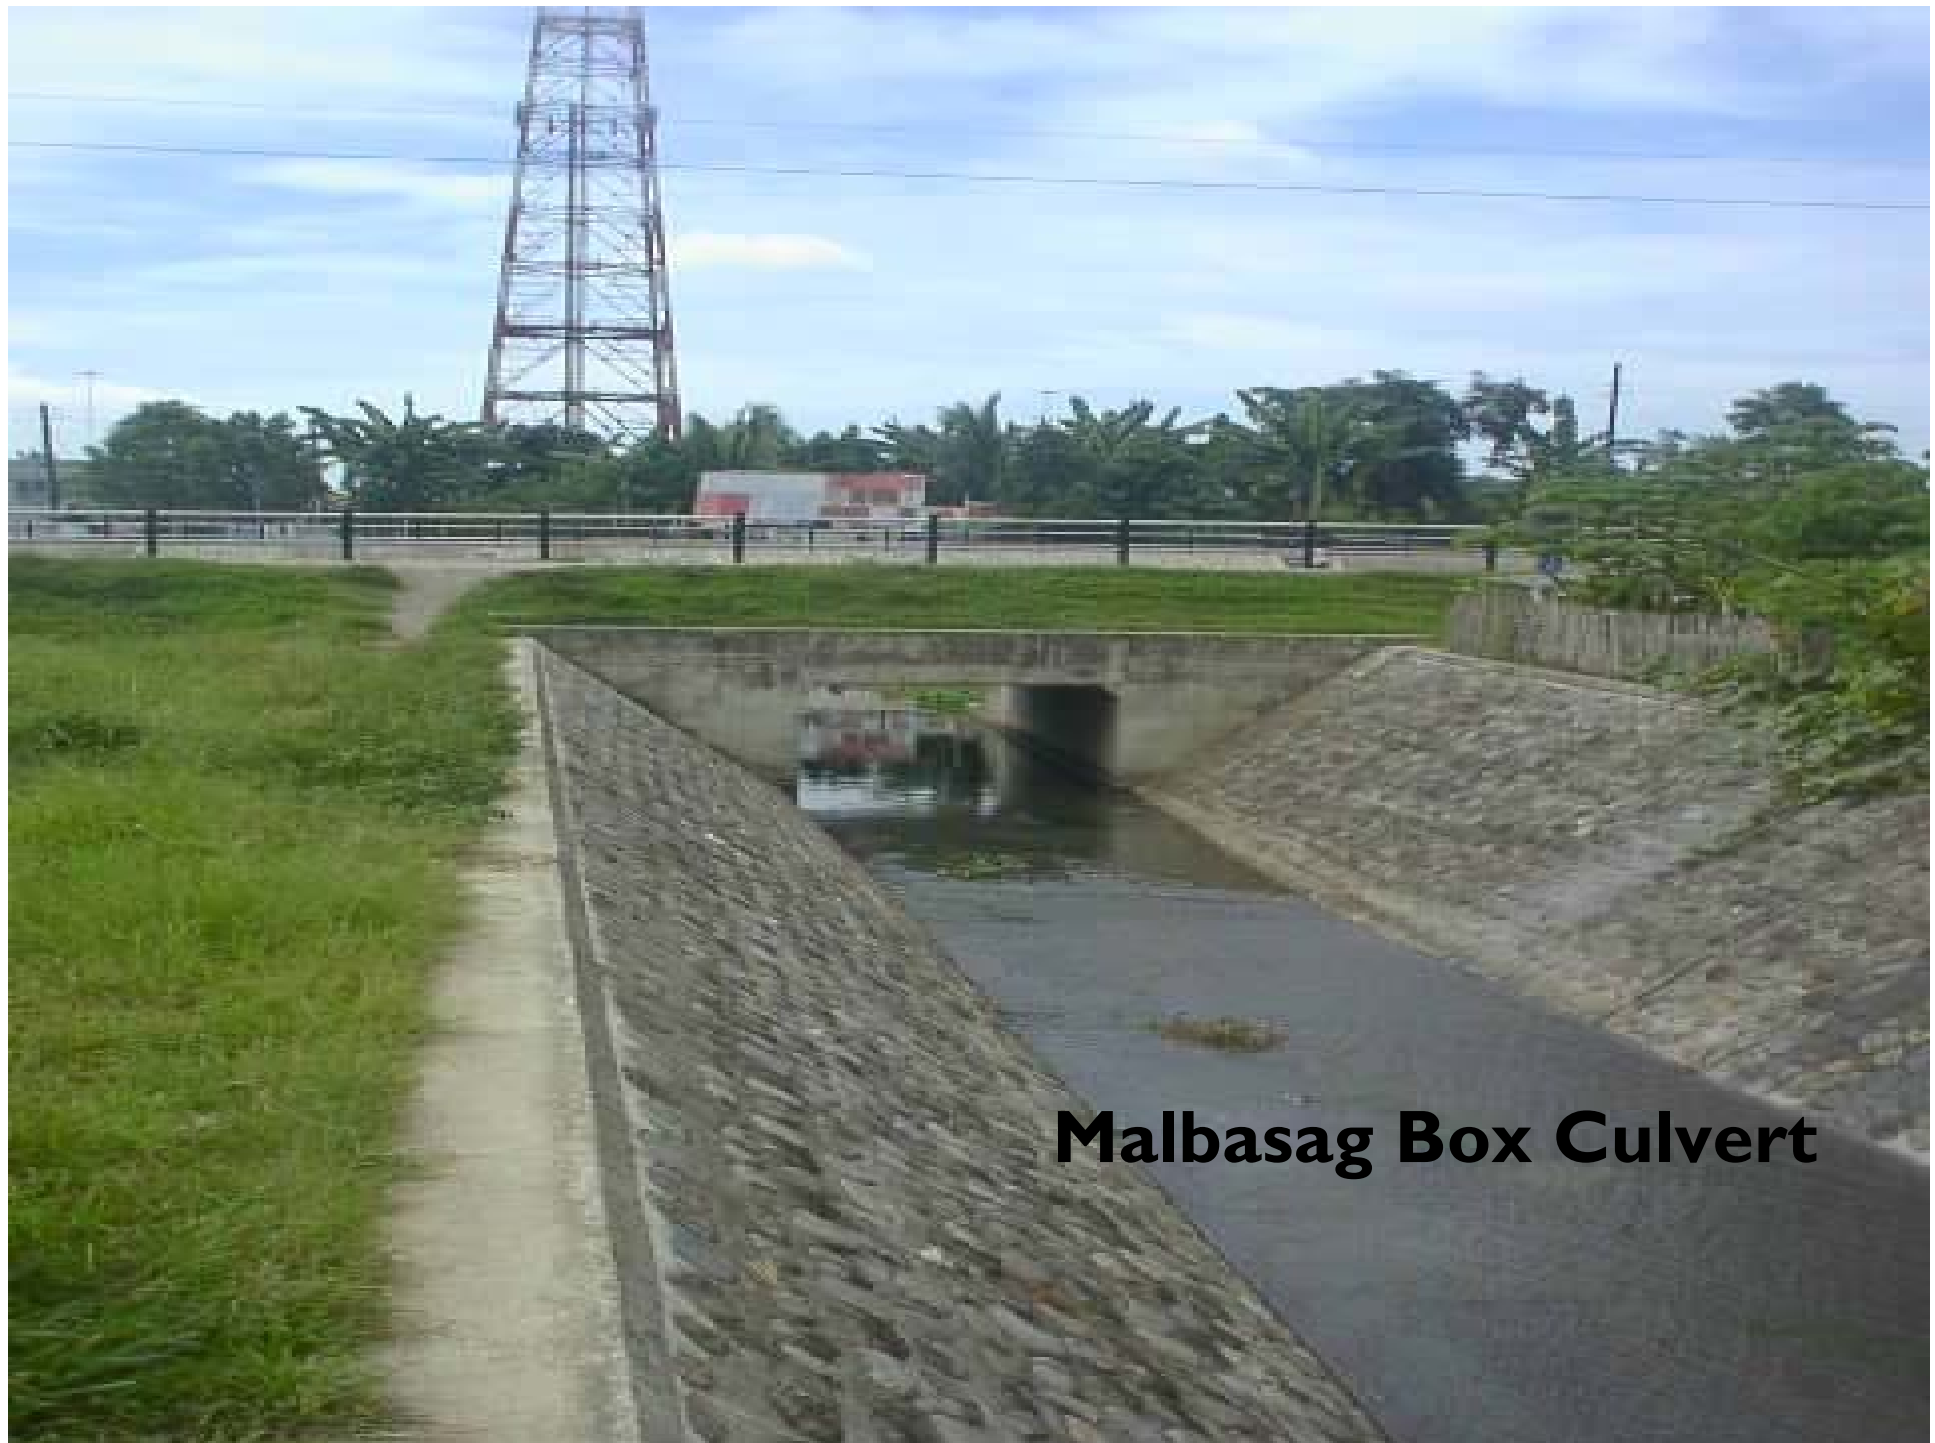
Malbasag Box Culvert

General Plan for Box Culvert

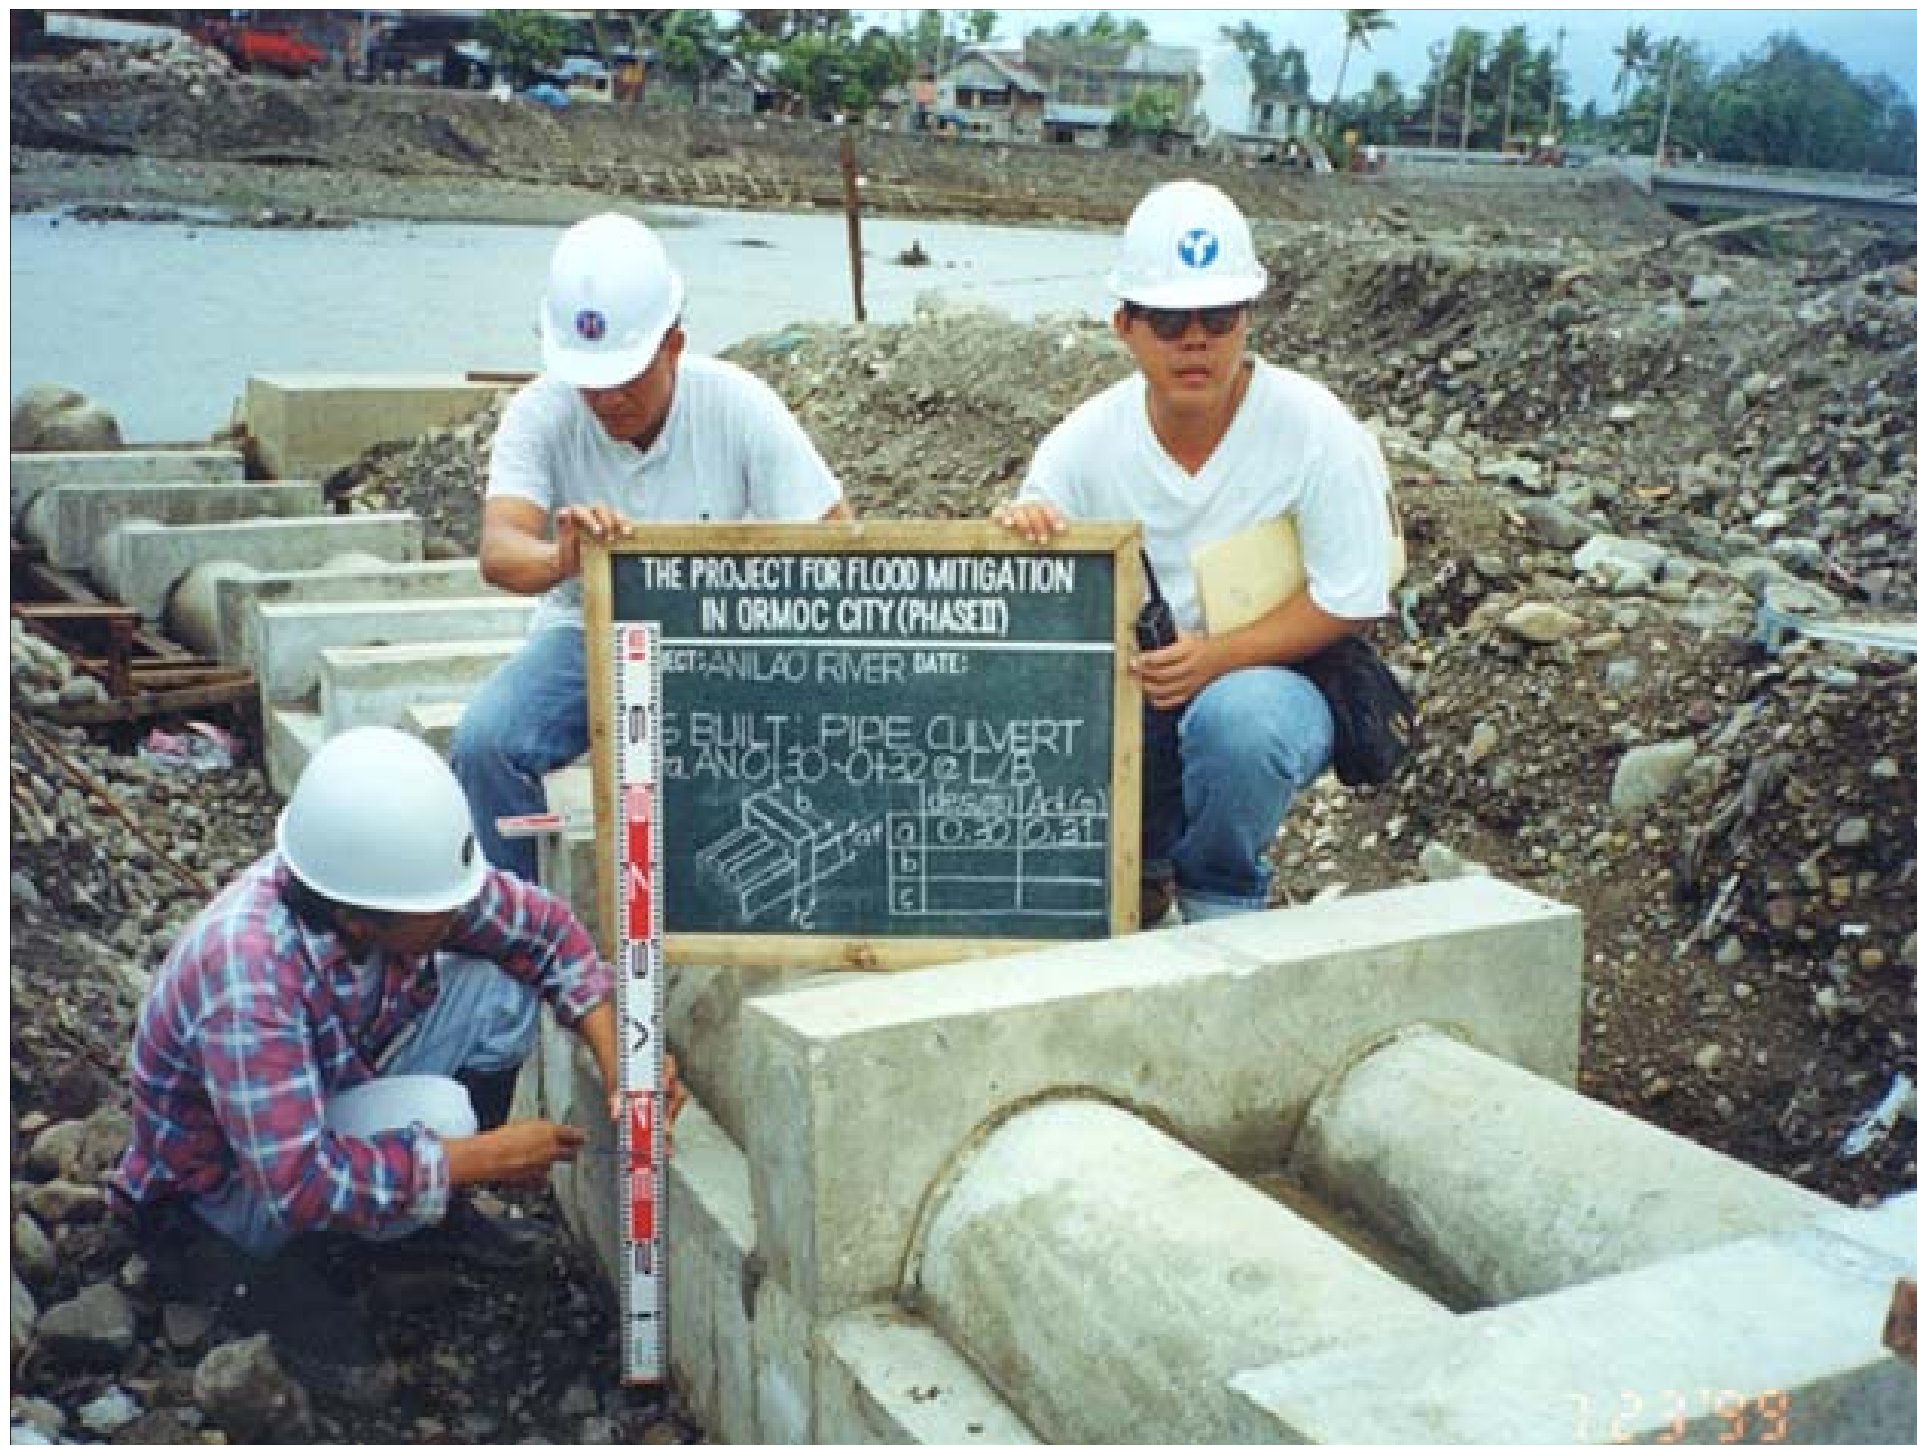
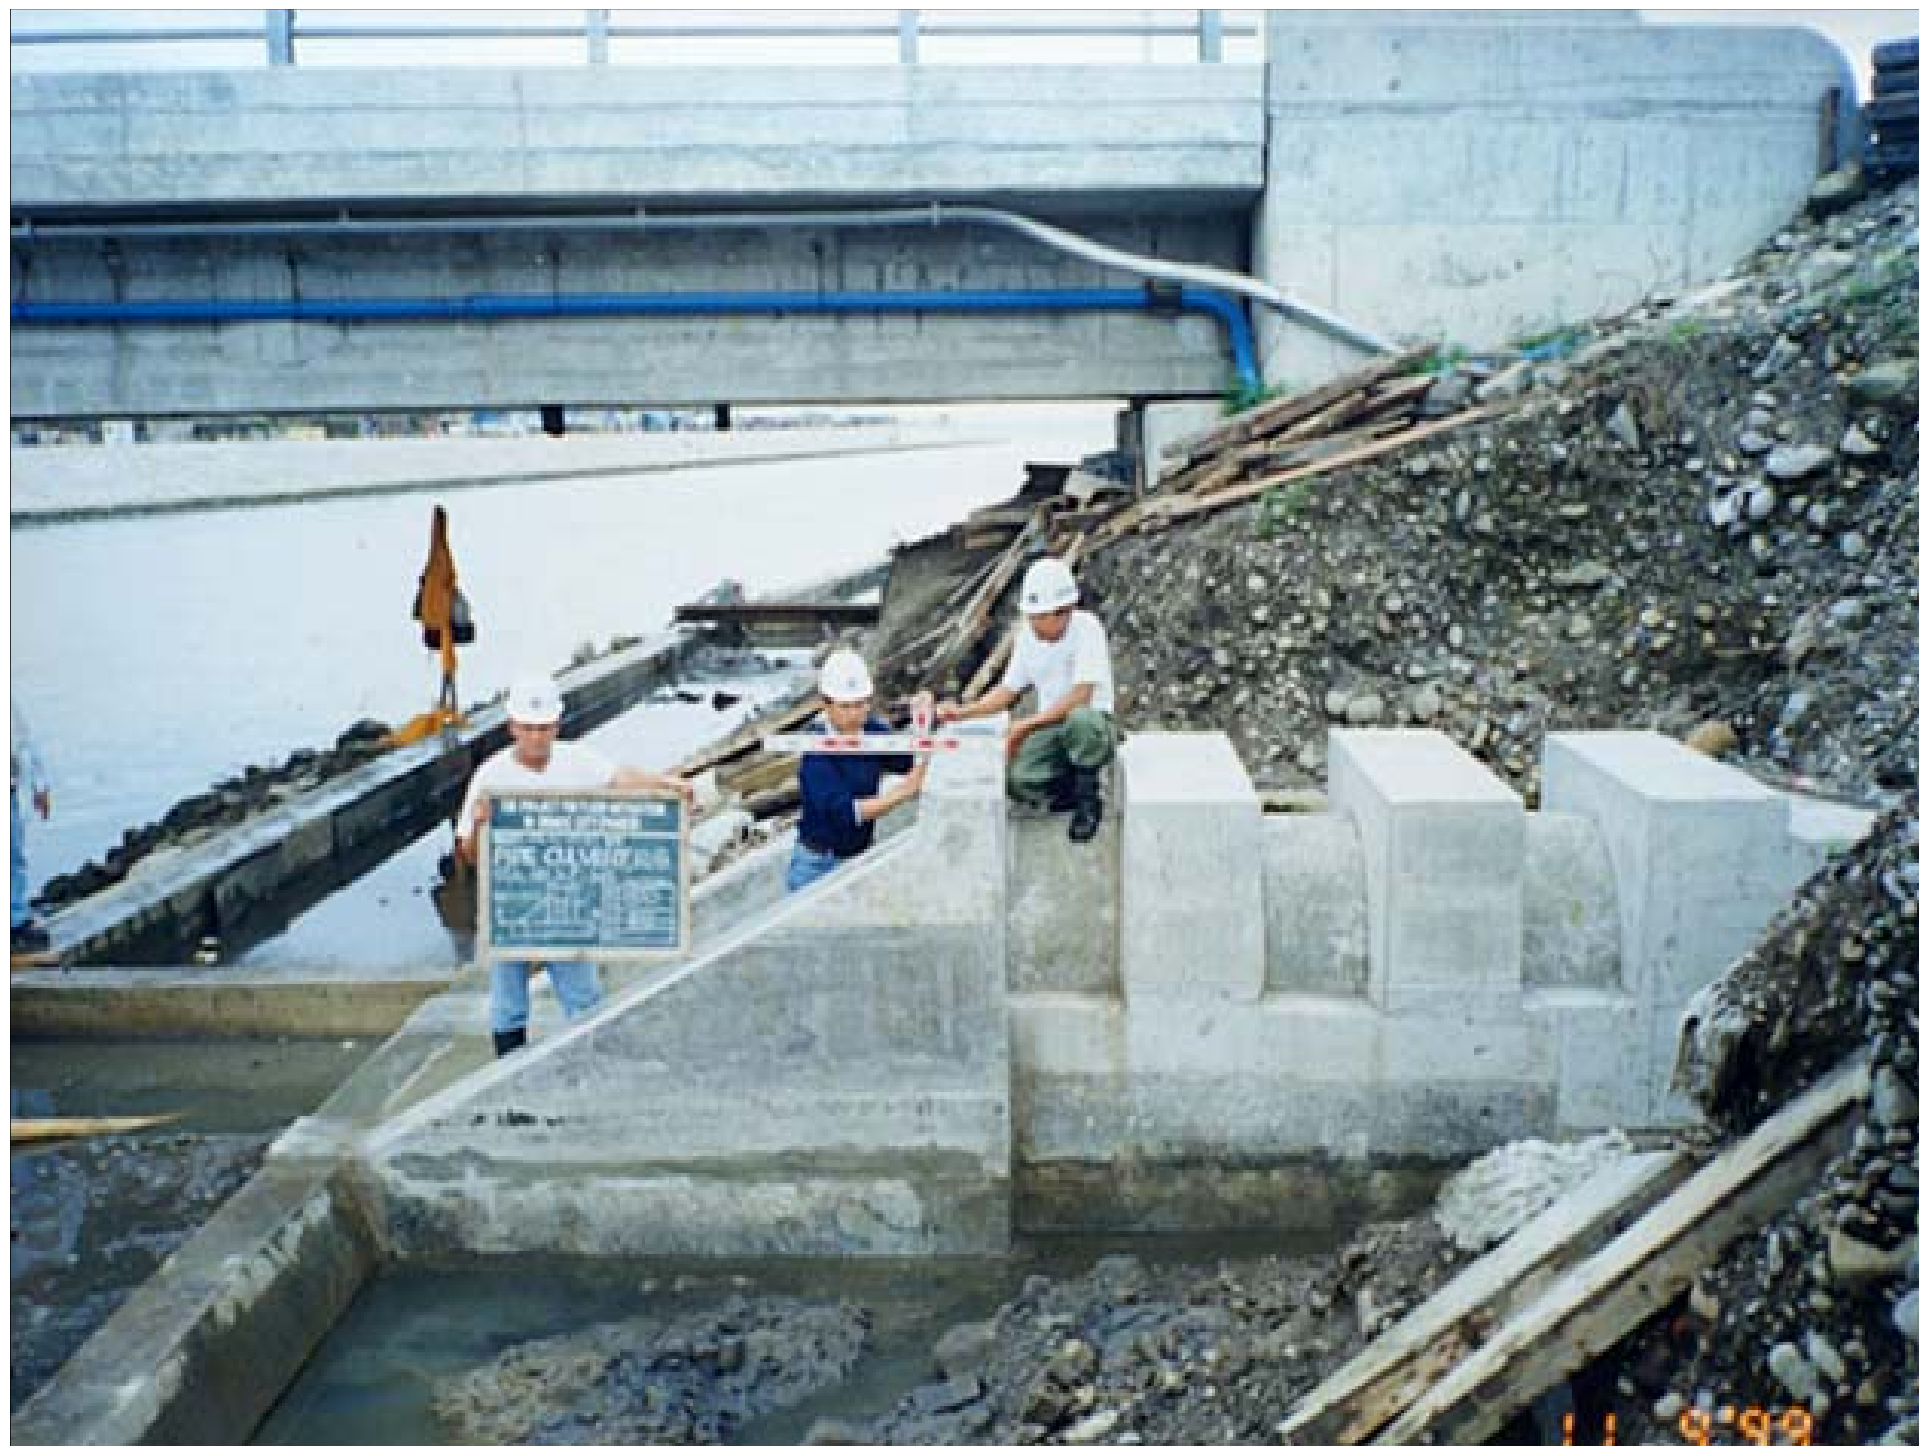
General Plan for Pipe Culvert

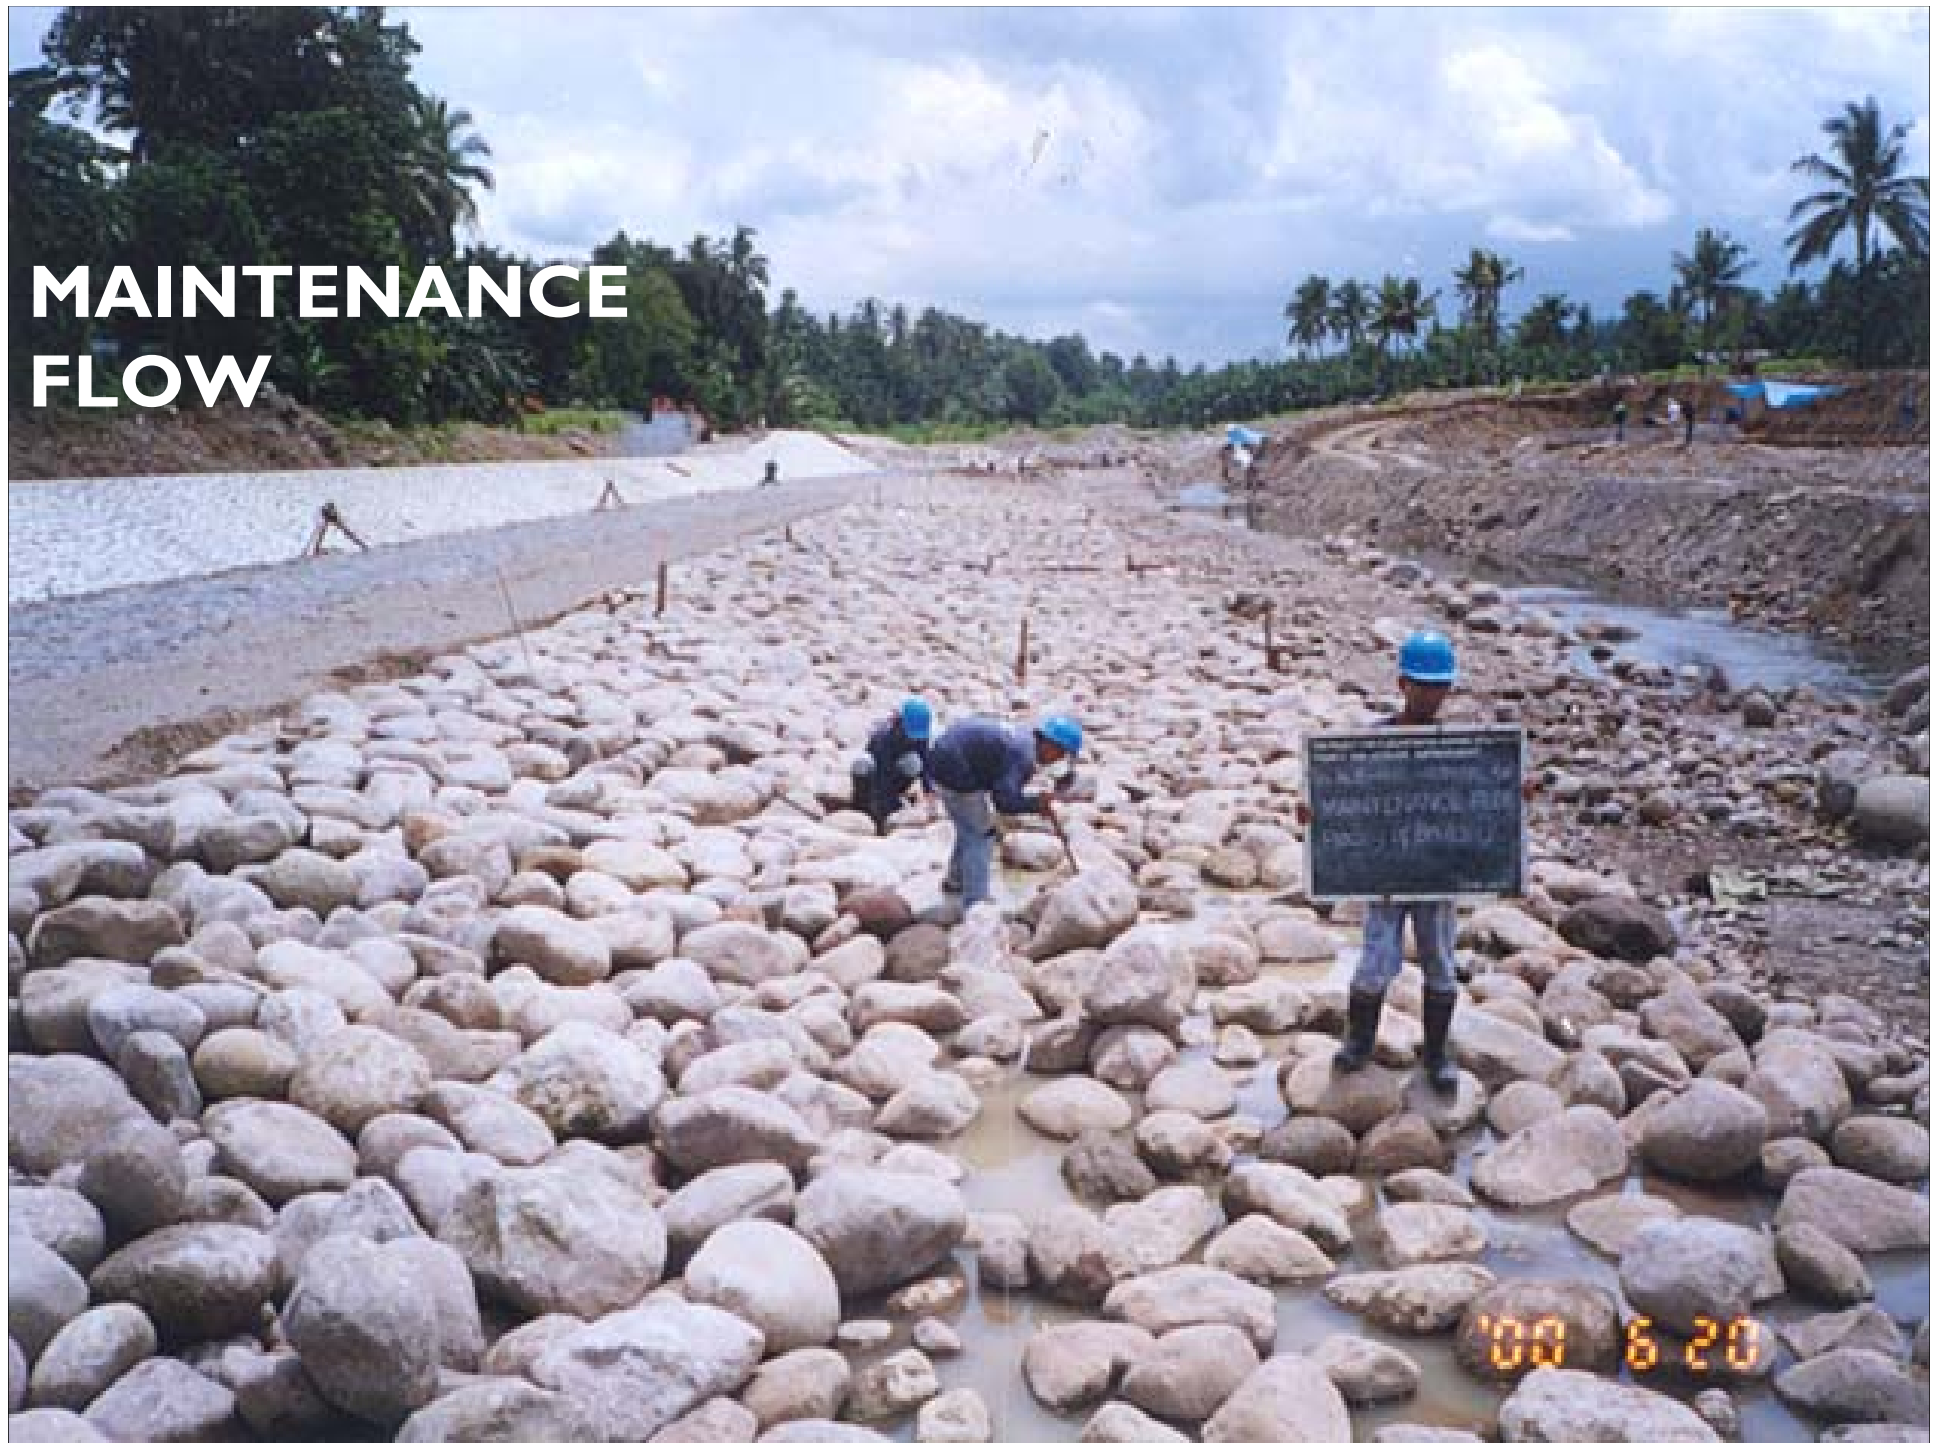
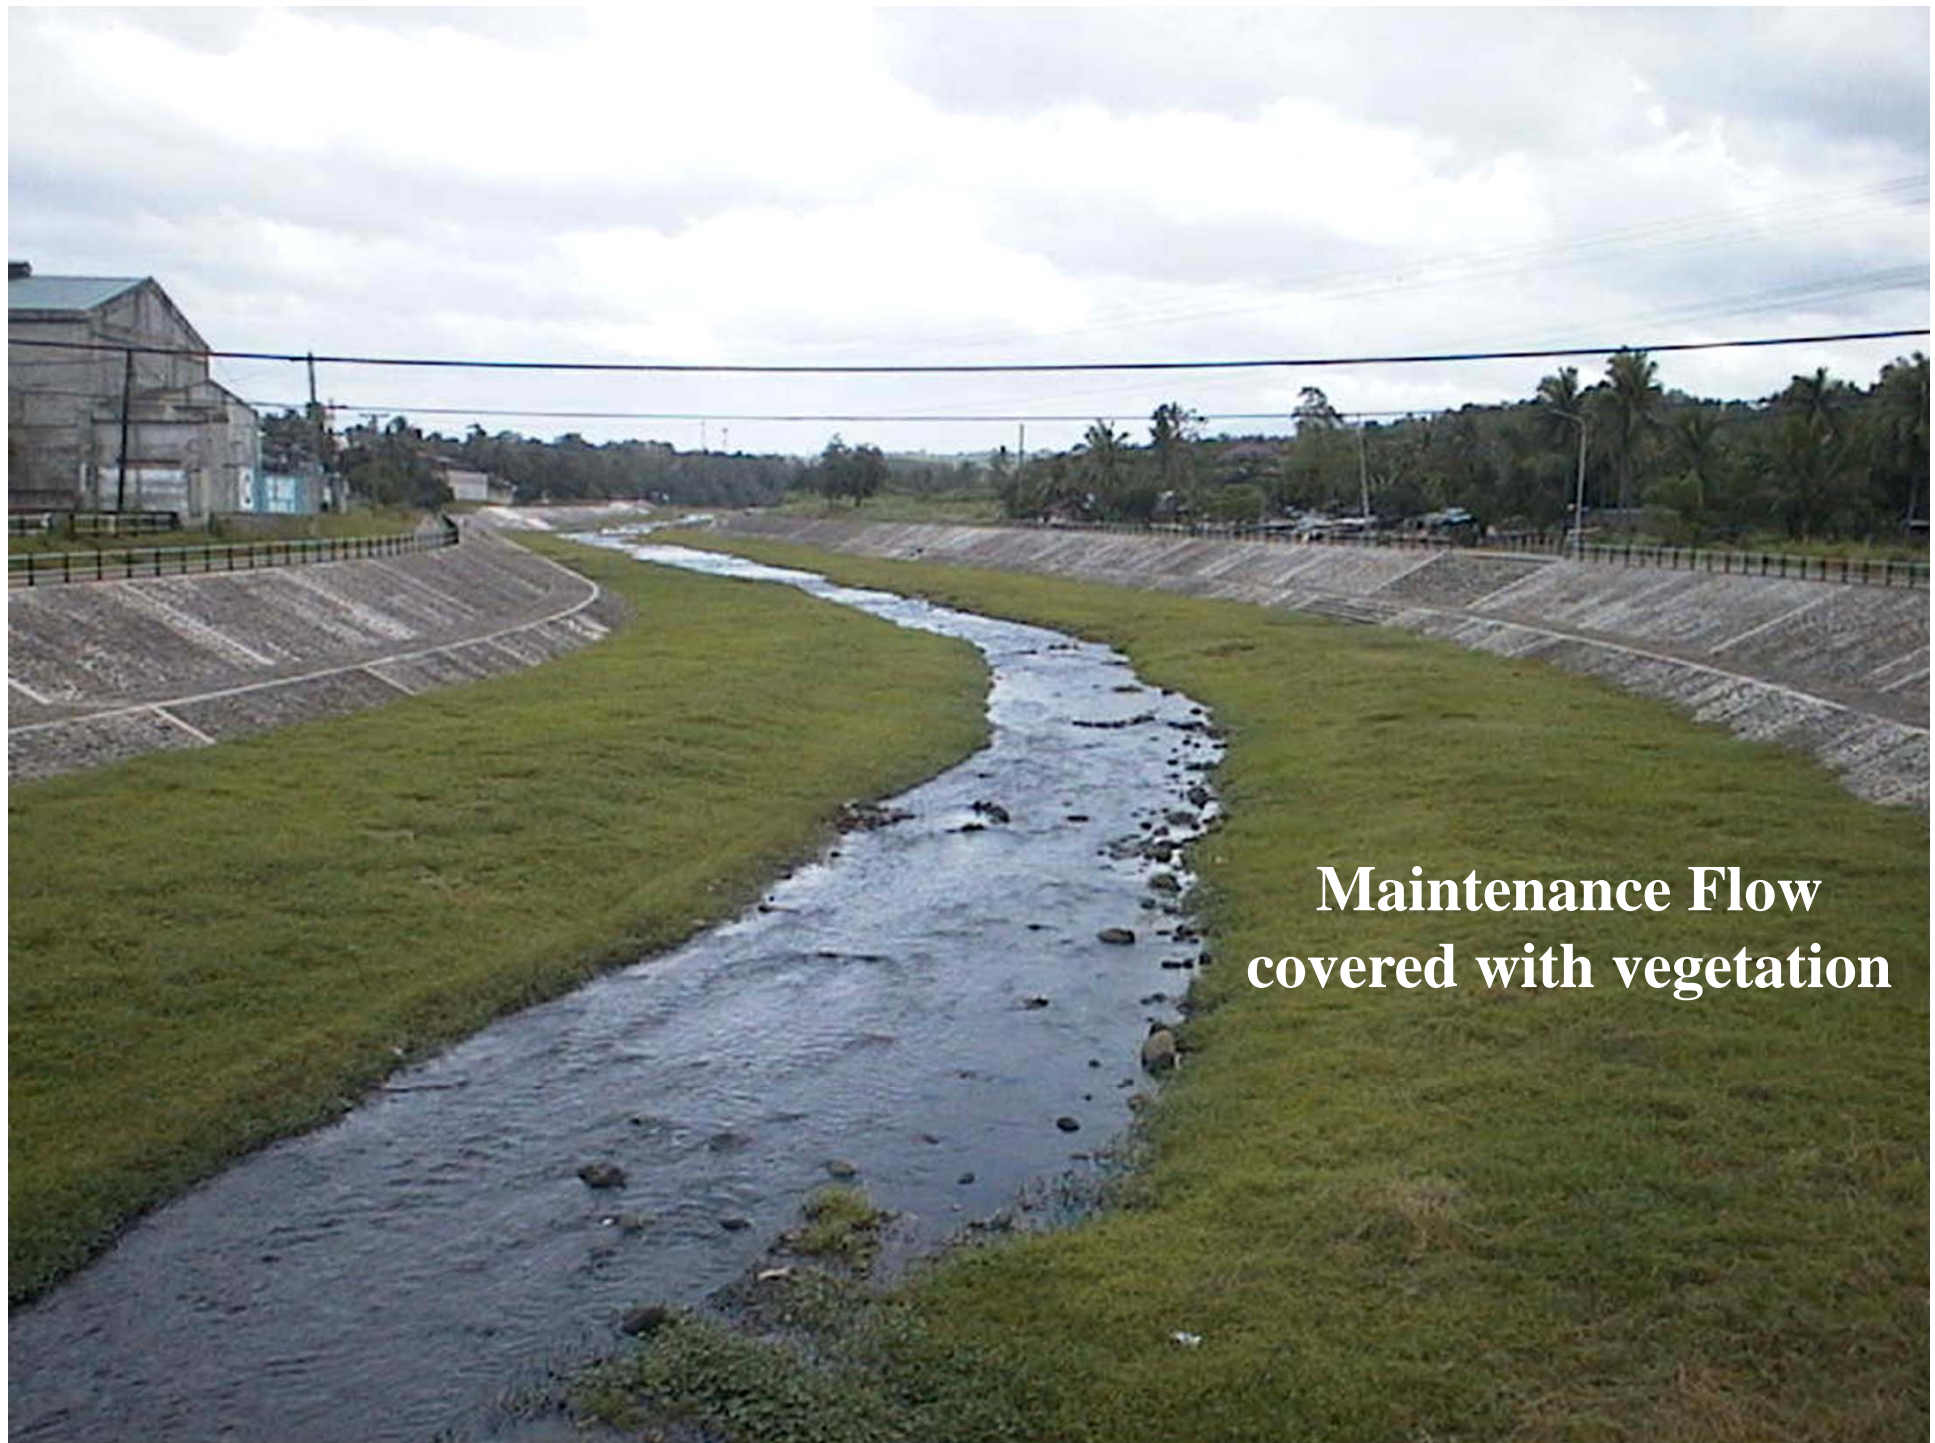
MAINTENANCE FLOW

**Maintenance Flow
covered with vegetation**
