オルモック市洪水対策事業

構造物と非構造物対策

レイテ島、フィリピン共和国

建設技研インターナショナル

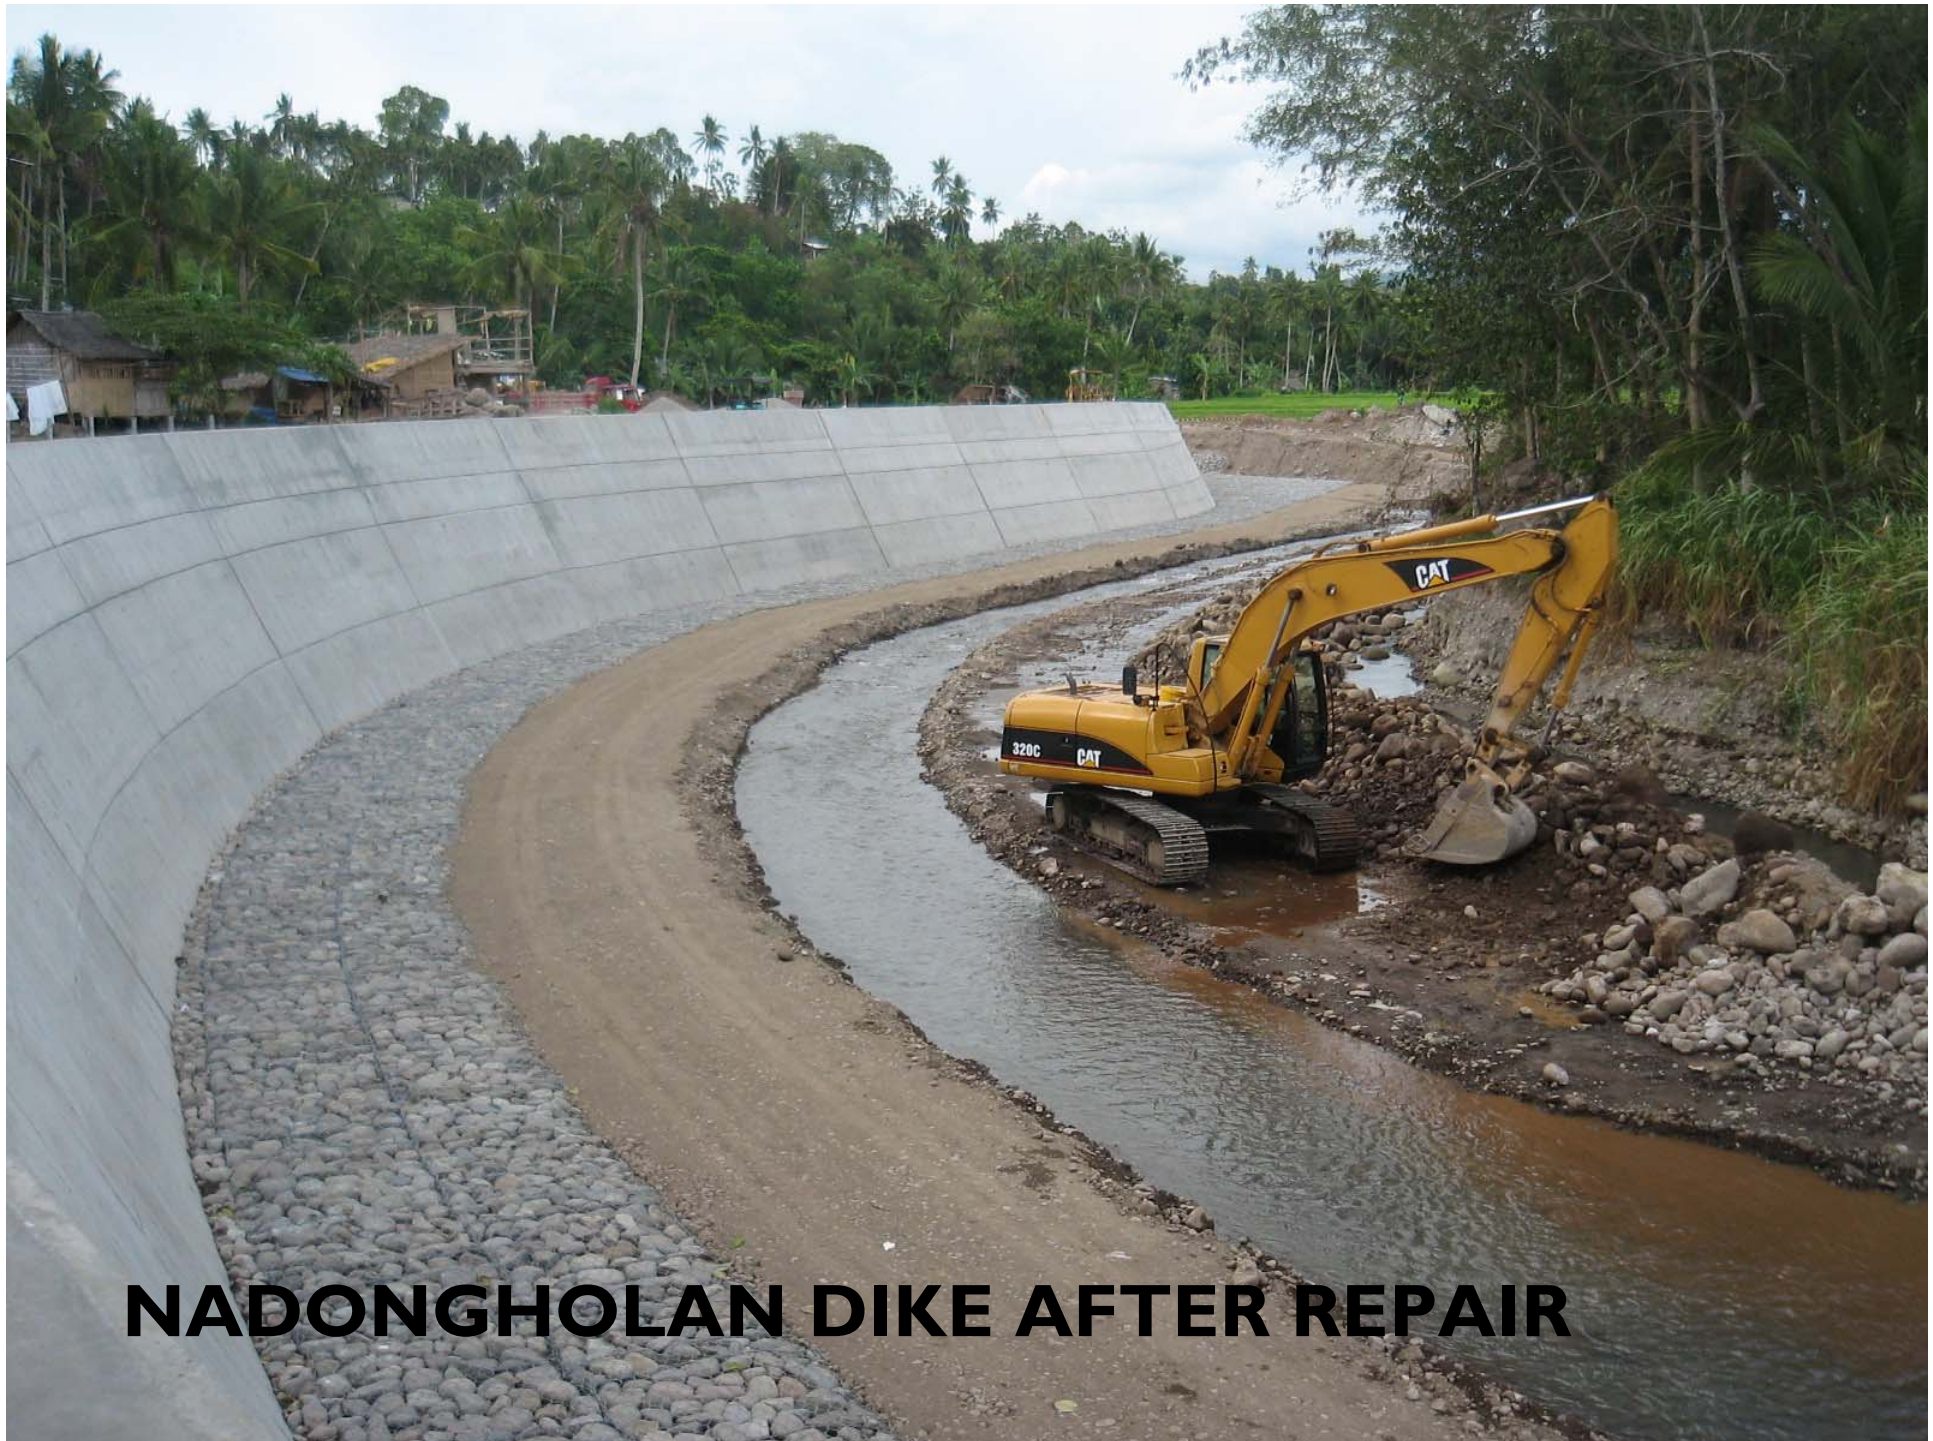
NADONGHOLAN DIKE AFTER REPAIR

**Nadongholan Dike
constructed after the
flood in 1991 under ADB
funding was damaged.
The damaged section was
outside the JICA Grant
Aid assisted project
completed in 2001.**

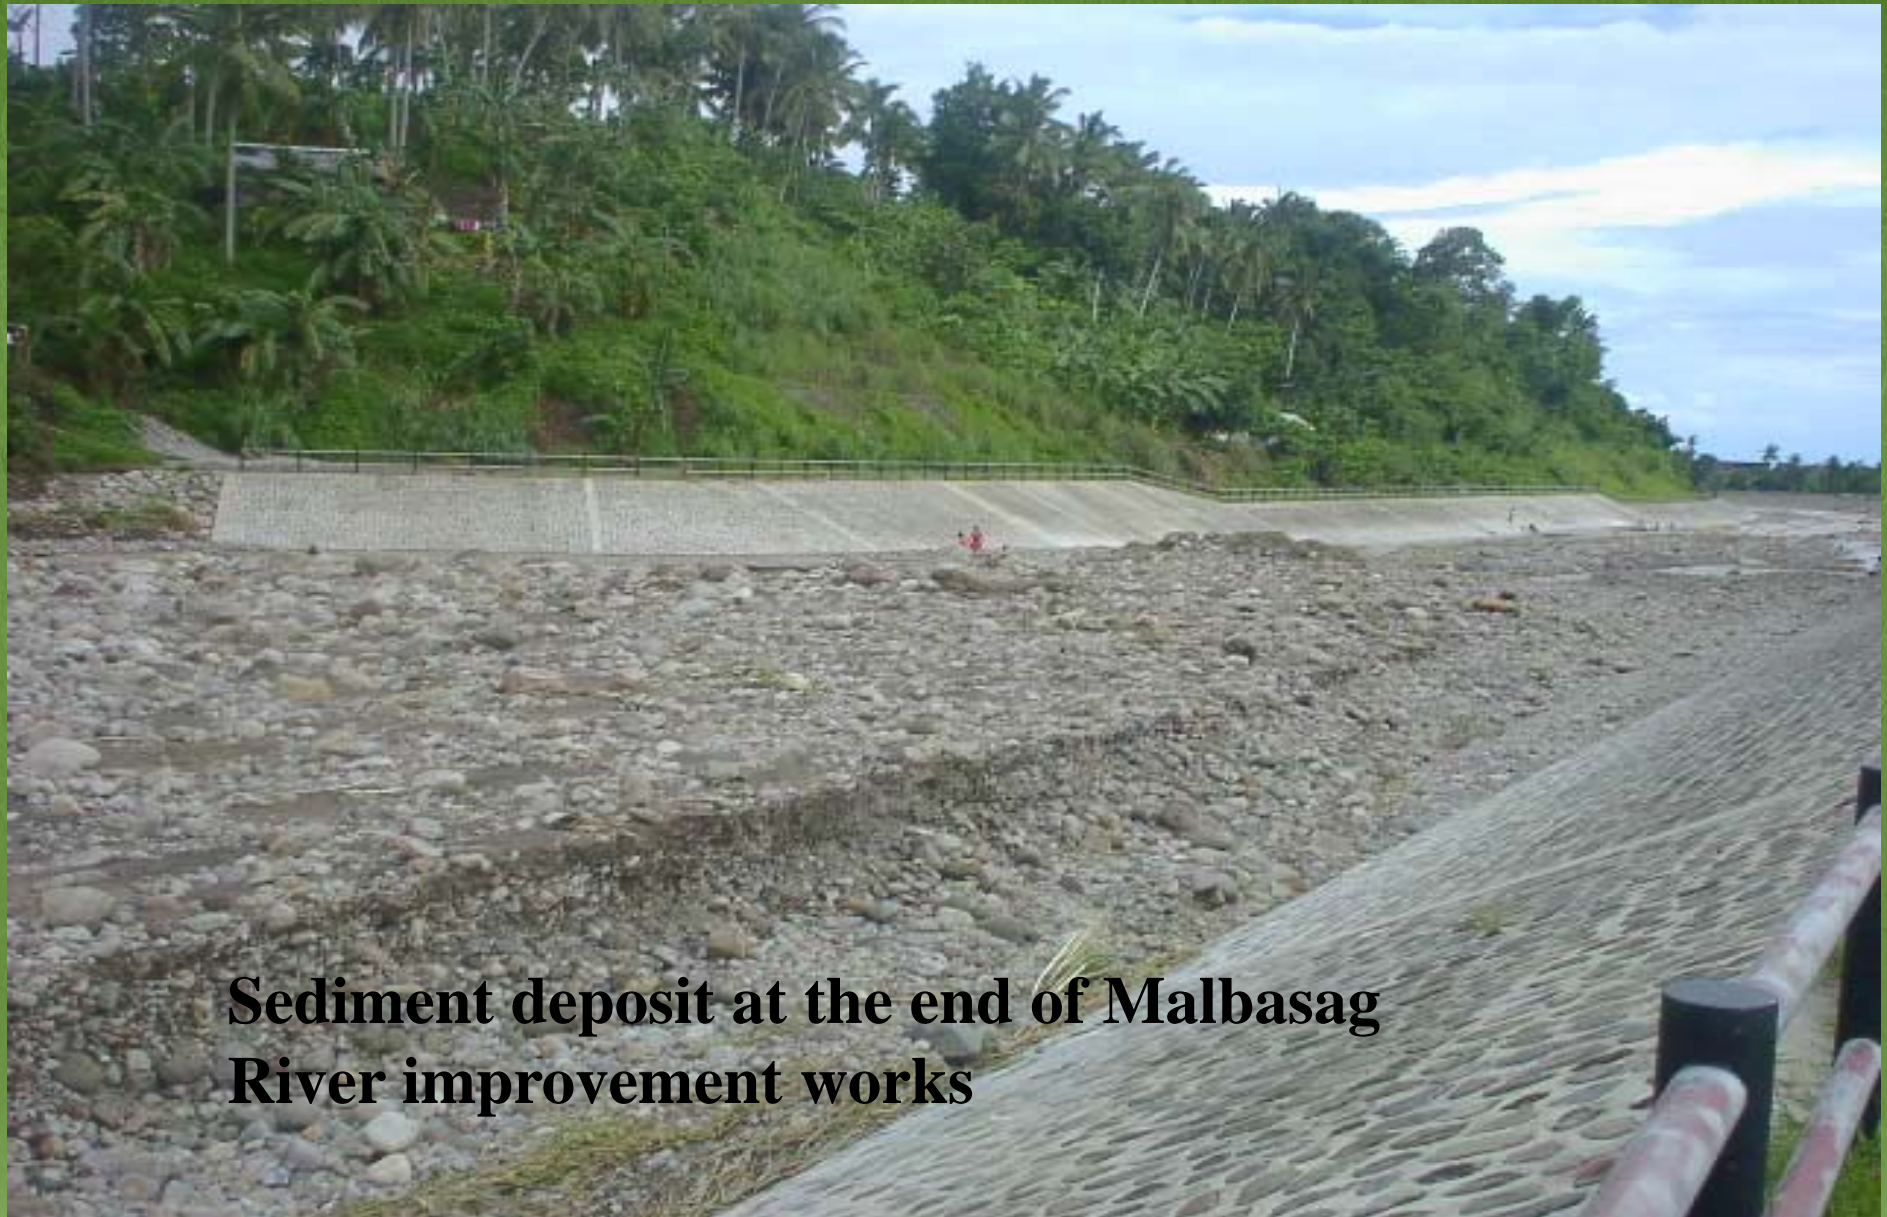
Malbasag River – End of Project

**Sediment deposit at the end of Malbasag
River improvement works**
