# Local Resilience after Recent Flood Disaster in Japan

Miho OHARA

International Centre for Water Hazards and Risk Management (ICHARM)

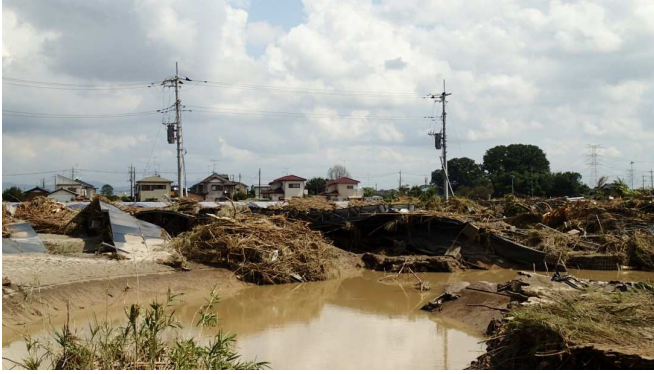
6:00 a.m. Over Topping at Wakamiyado

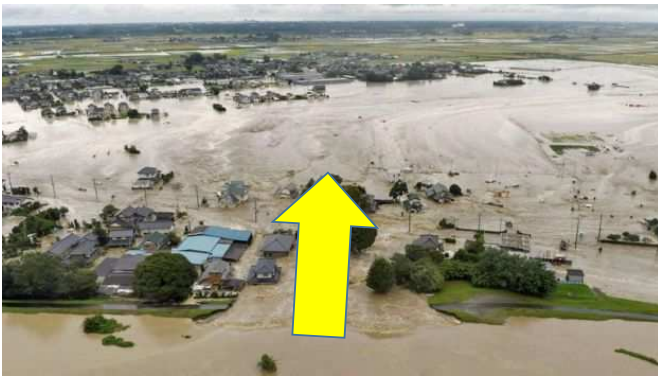
12:50 p.m. Levee Breach at Misaka

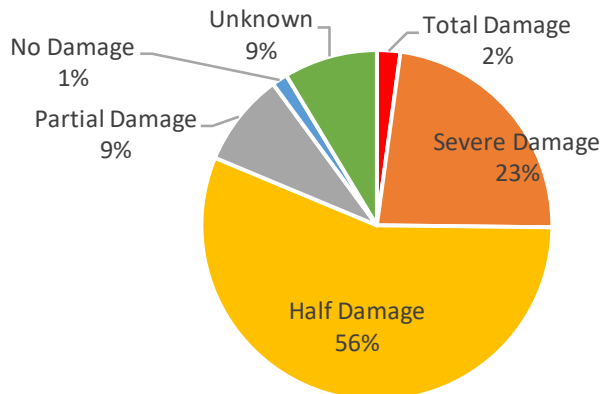
Damage Level of 142 repaired houses

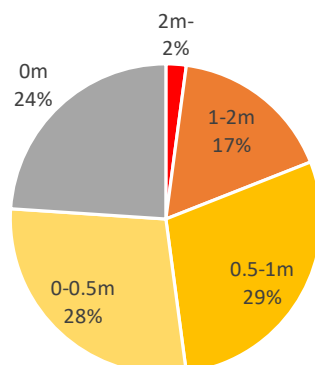
Inundation height above the first floor level of 142 repaired houses

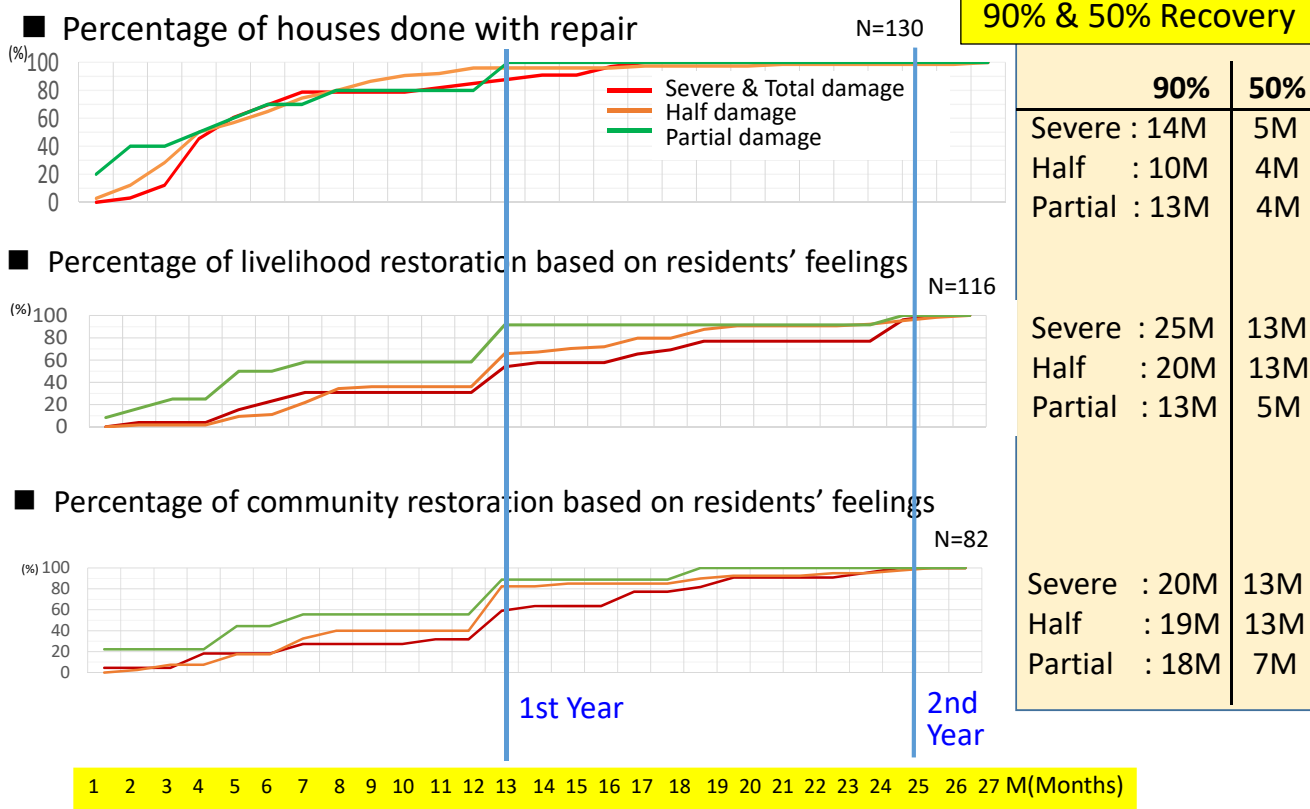
# Resilience observed from Interview Survey for House Owners

90% Recovery ⇒ House repair: 1 year, Residents' feelings: 1-2 year

-It took about one year for 90% of the owners of damaged houses to complete repairing their houses. Even after they finished repairing the houses, they have various kinds of anxiety.

-It took about one or two years for 90% of the residents to start feeling that their life and community returned to its original condition.

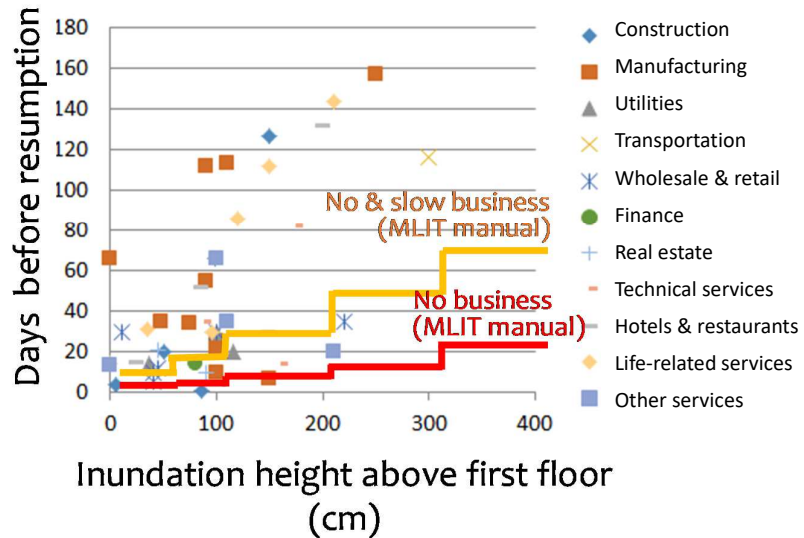
Relationship between inundation height and business disruption

Actual business disruption was severer than estimation based on an MLIT (Ministry of Land, Infrastructure, Transport and Tourism) manual. Some businesses experienced disruption due to suspension of water supply even with low inundation.

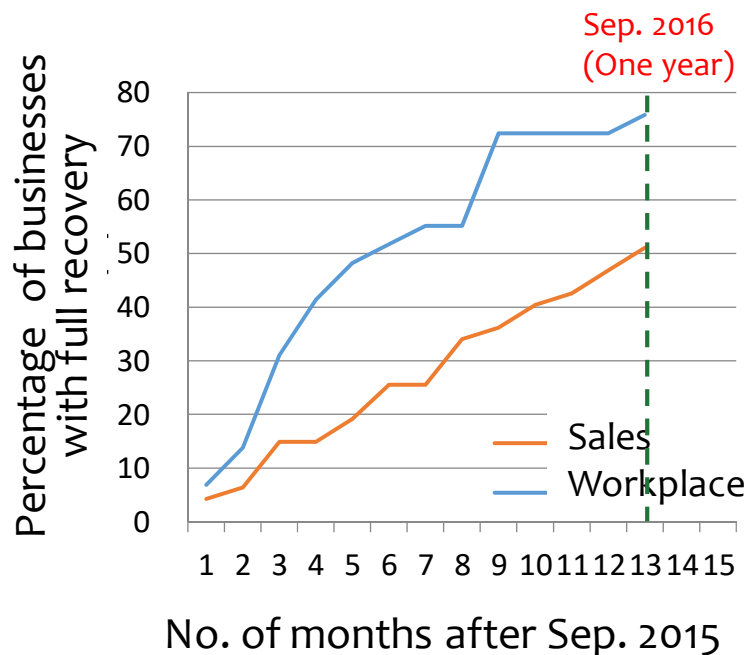
Trends of recovery of sales and workplace

Only half of the businesses achieved 100% sales recovery a year after the disaster.

-Only half of the surveyed businesses achieved 100% sales recovery a year after the disaster.

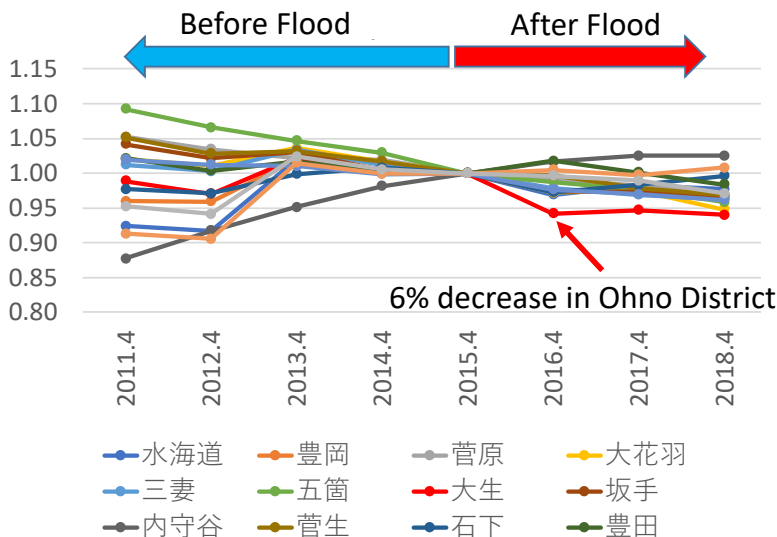
The rate of population change in each district before and after the flood  
(Population in April 2015 before the flood=1)
