The First JSCE-ASCE Joint Symposium
on Infrastructure Resilience

Countermeasures against Kumamoto Earthquake 2016

Yasuo Morita, Ministry of Land,
Infrastructure, Transport and Tourism
(Former Director General, Kumamoto
Office of Rivers and National Highways)

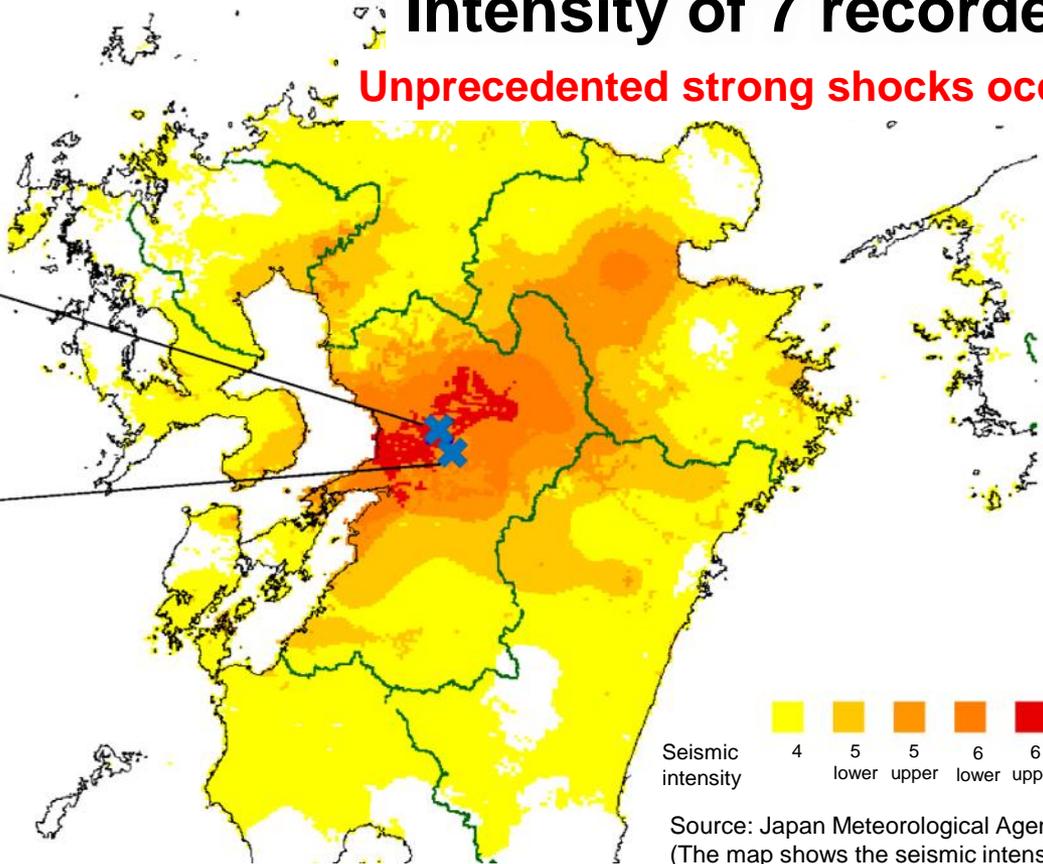
Seismic intensity map

Intensity of 7 recorded twice
Unprecedented strong shocks occurred in series

April 16, 1:25 a.m.,
M 7.3, maximum seismic intensity 7

April 14, 9:26 p.m.,
M 6.5, maximum seismic intensity 7

Seismic intensity 4 5 lower 5 upper 6 lower 6 upper 7

Source: Japan Meteorological Agency (The map shows the seismic intensity distribution of the earthquake on April 16)

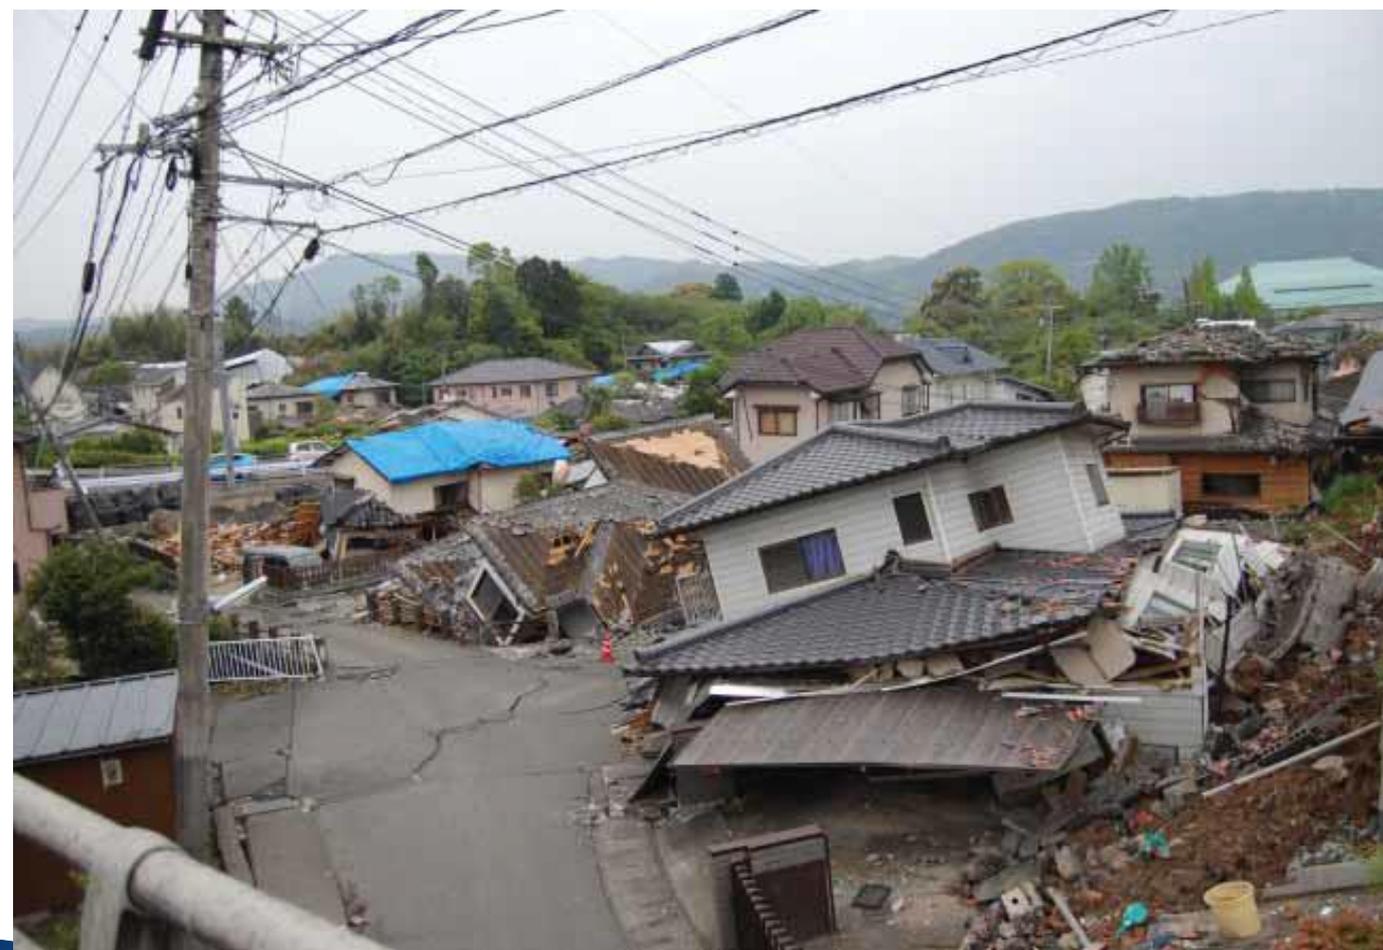
Mashiki Town (April 23, 2016)

Tremendous damage occurred also on transportation infrastructures such as an airport, roads and railways, in addition to human damage caused by collapse of many houses and landslides and damage on essential utilities such as electricity, gas and water supply. Thus, the earthquake caused immense problems to prefectural residents and to the economy such as small and medium-sized companies, agriculture, forestry and fishery, and tourism.

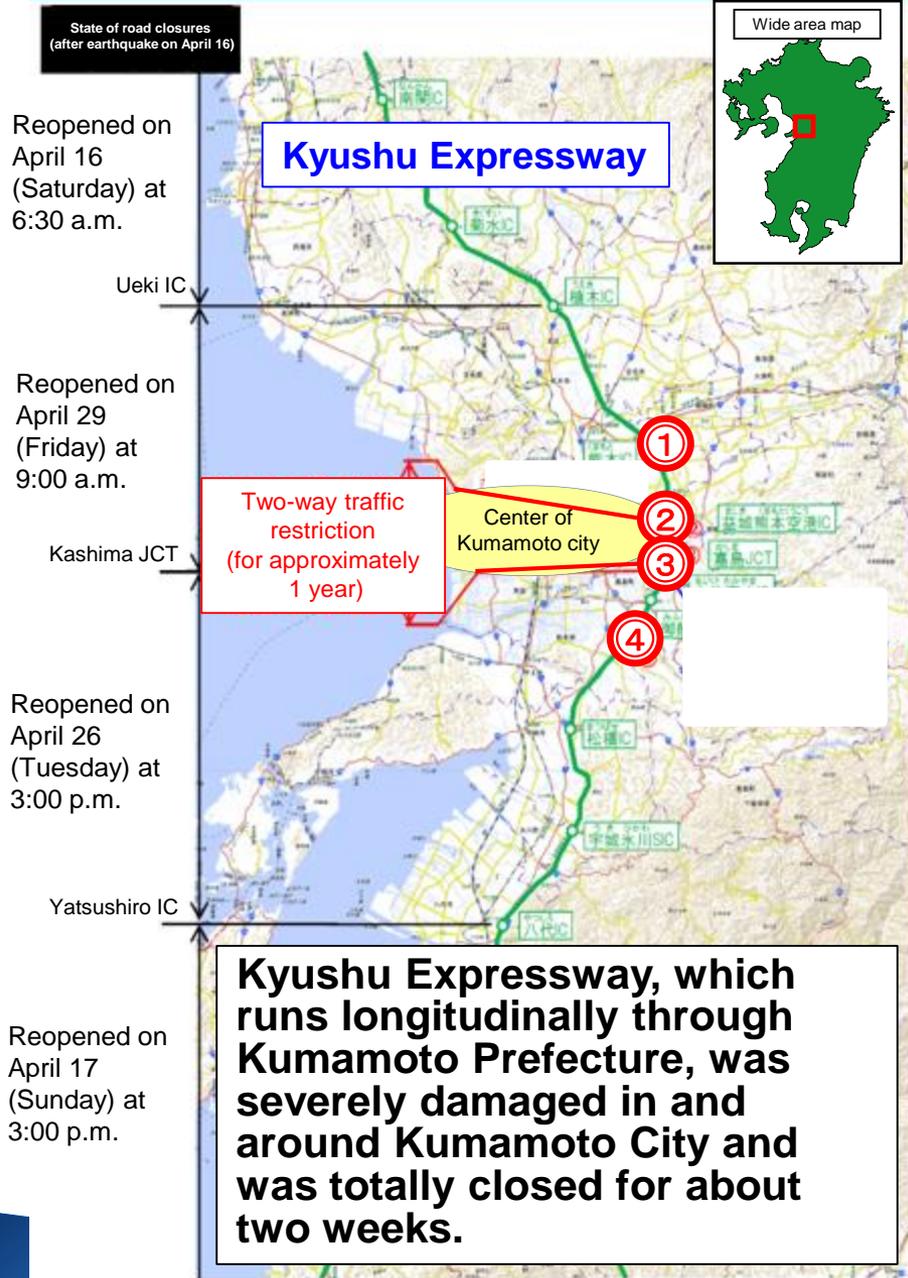
Damage to Kyushu Expressway

(1) Inclined bridge columns

(2) Collapse of road embankment

(3) Disconnected bridge beams

(4) Collapse of overpass

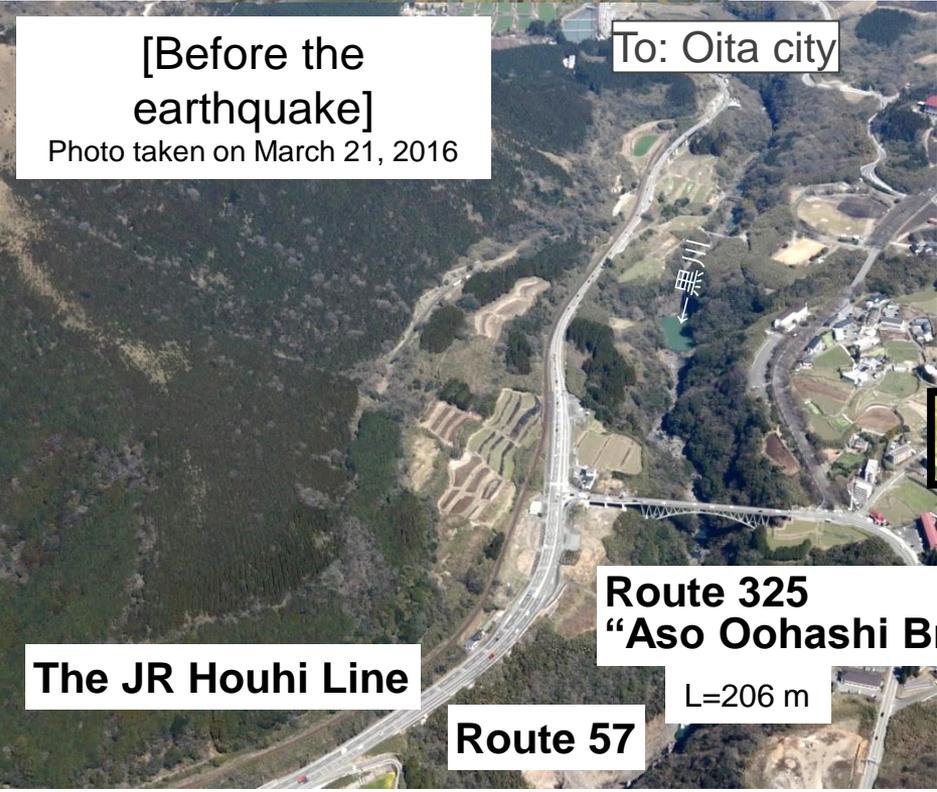
[Before the earthquake]
Photo taken on March 21, 2016

Route 325
"Aso Ohashi Bridge"

L=206 m

Route 57

The main shock on April 16 caused a large-scale slope failure 700 m long and 200 m wide in Minami-Aso Village (the entrance part on the west side of Aso Caldera) and severed Route 57, a major road connecting Kumamoto, Aso and Oita, and the JR Houhi Line. "Aso Ohashi Bridge" of Route 325 that connects the road to Route 57 also collapsed.

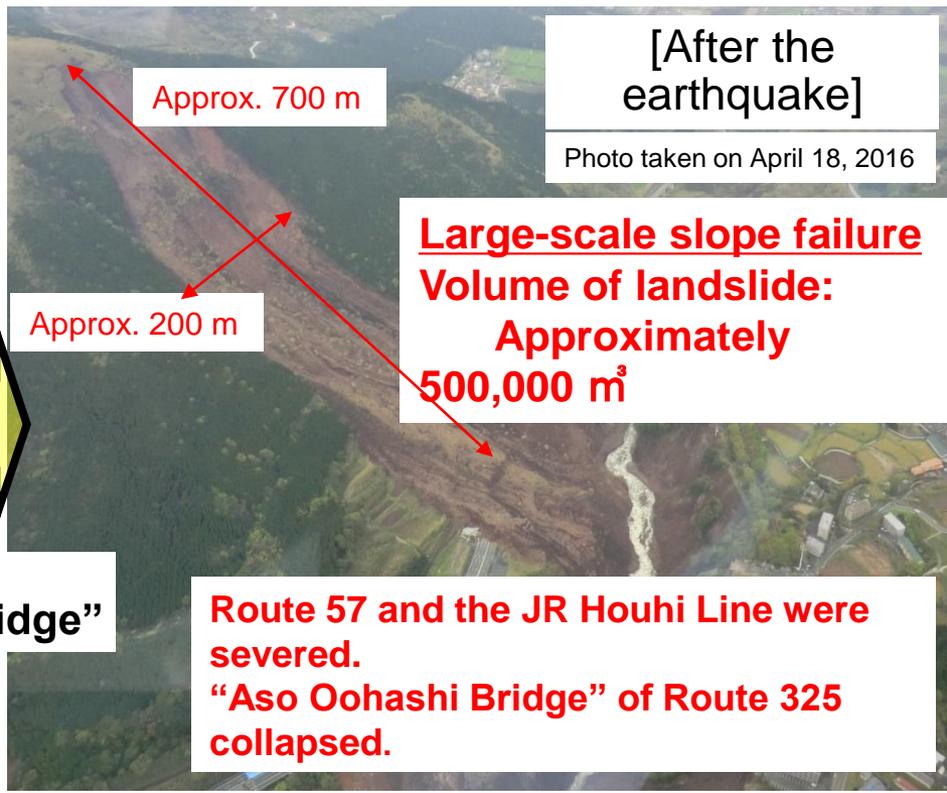
[After the earthquake]
Photo taken on April 18, 2016

Approx. 700 m

Approx. 200 m

Large-scale slope failure
Volume of landslide:
Approximately
500,000 m³

Route 57 and the JR Houhi Line were severed.
"Aso Ohashi Bridge" of Route 325 collapsed.

Minami-Aso Village (the entrance part on the west side of Aso Caldera)

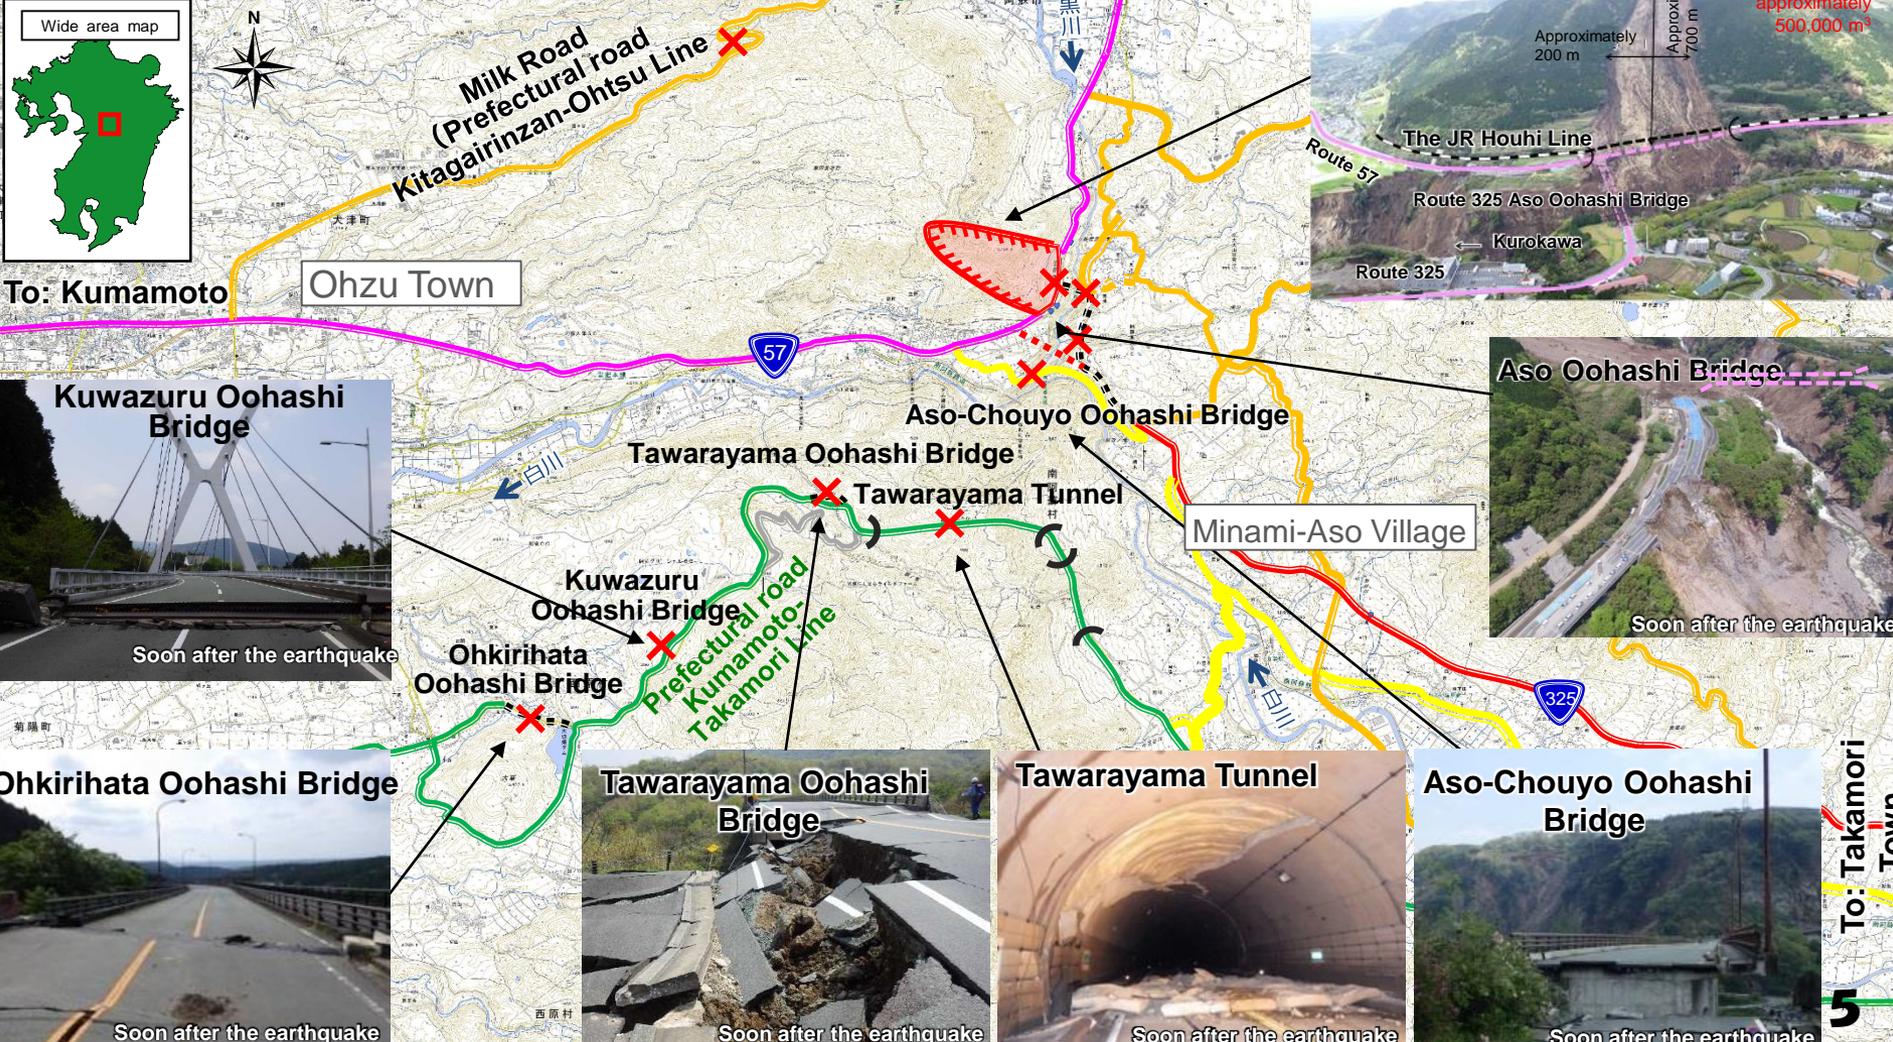
Devastation Situation of Major Roads between Kumamoto and Aso

Furthermore, prefectural road Kumamoto-Takamori Line (Tawarayama Tunnel and a group of long bridges) and Aso-Chouyo Oohashi Bridge (village road) were severely damaged, paralyzing traffic of more than 20,000 to 30,000 vehicles per day.

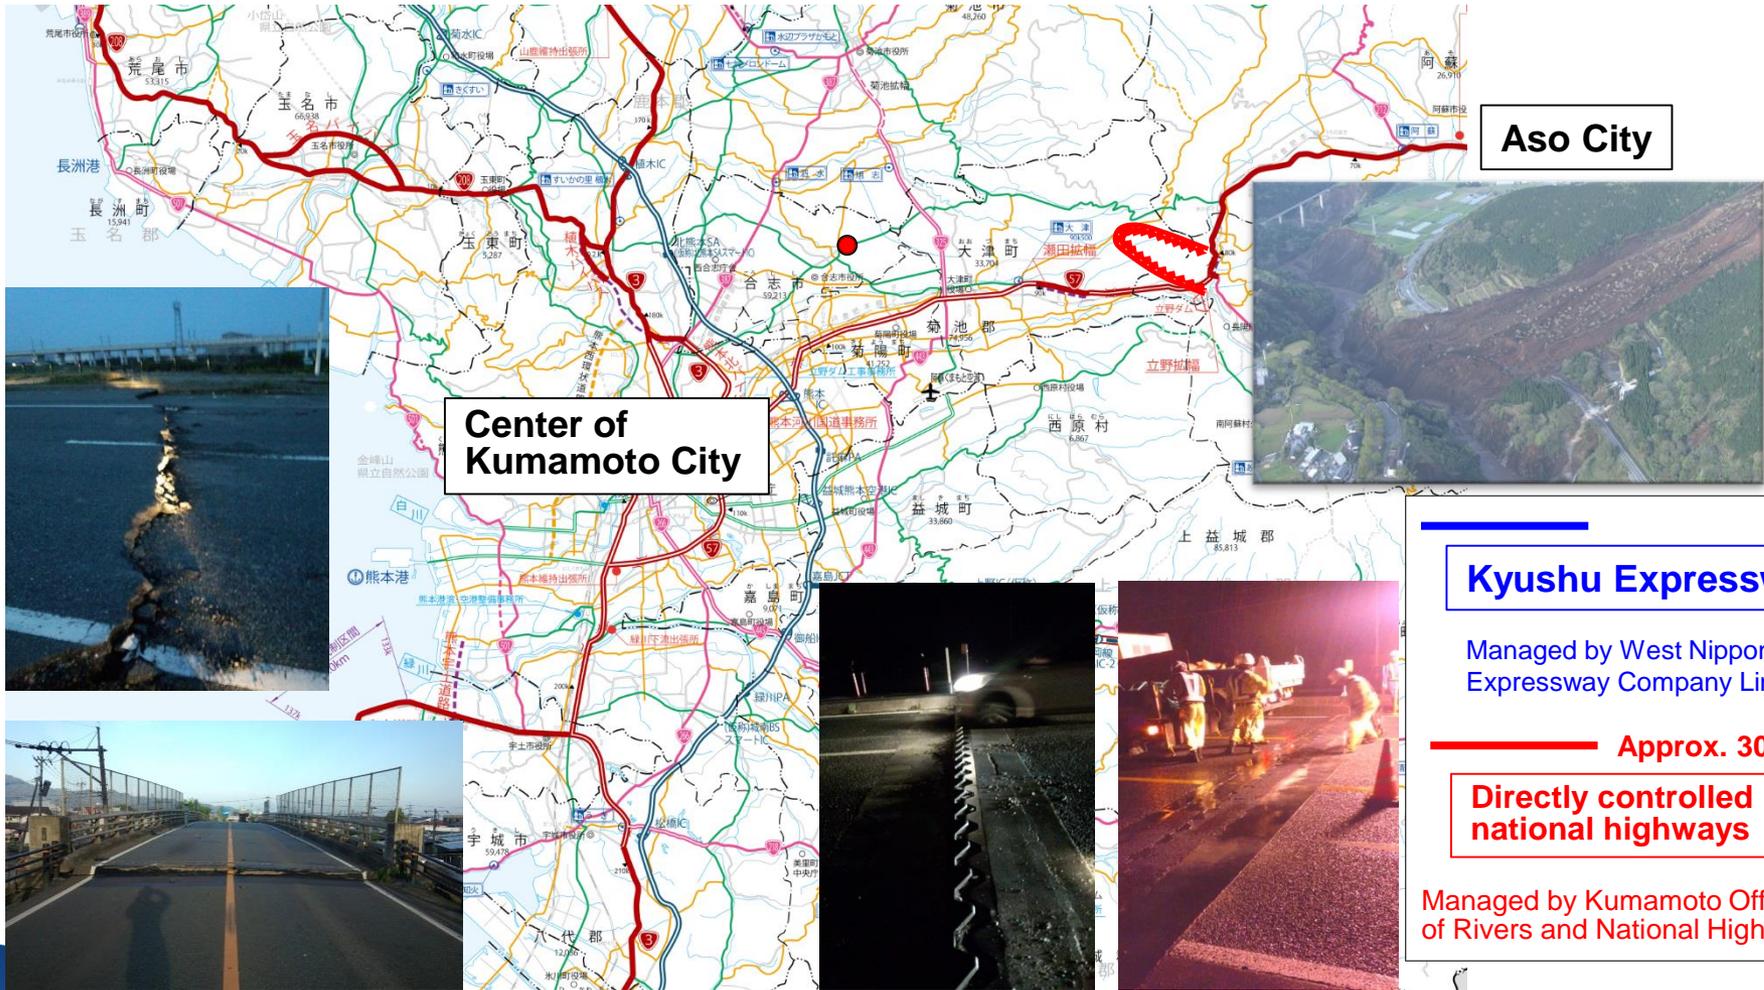
Kyushu Expressway

Managed by West Nippon Expressway Company Limited

Approx. 300 km

Directly controlled national highways

Managed by Kumamoto Office of Rivers and National Highways

Because Kyushu Expressway was totally closed for about two weeks after the earthquake, securing of traffic on national highways, which run parallel with the expressway and are under direct control of the National Highway Office, became a top priority issue. The main shock of April 16 **also caused severe damage, such as sinkholes on road surfaces and bumps near bridges, on the direct-controlled national highways. However, all emergency restoration was completed to allow normal traffic within 24 hours after the main shock, except one site damaged by the large-scale slope failure (Route 57 in Minami-Aso Village).**

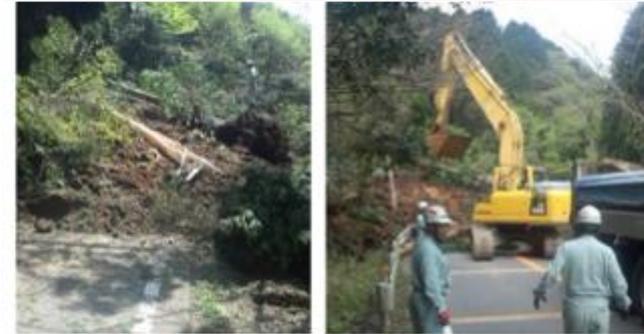
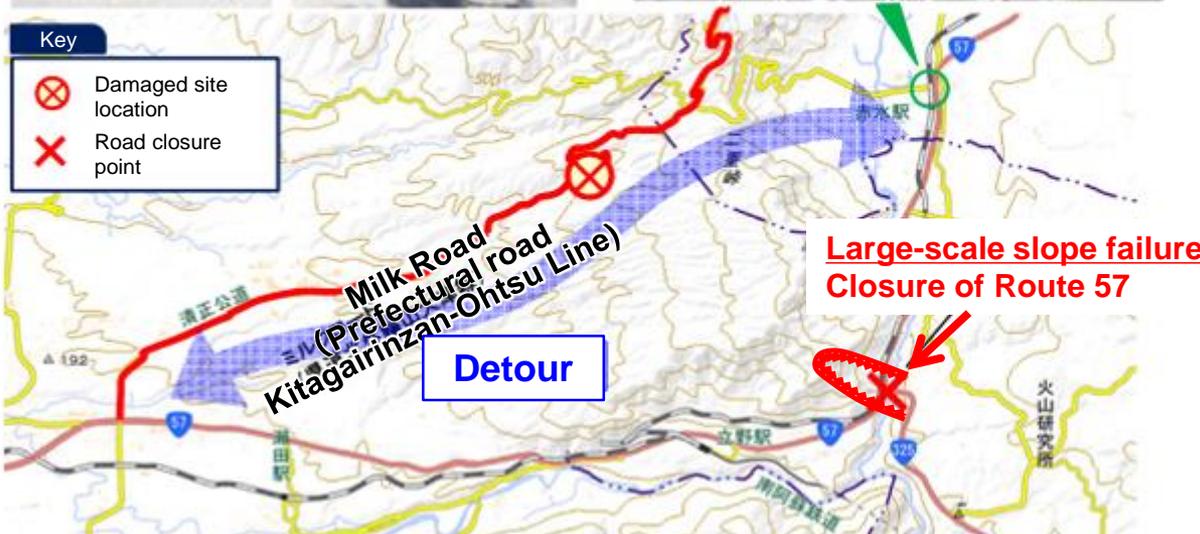
Condition of emergency restoration work of Route 57 detour

Key

- ⊗ Damaged site location
- ✗ Road closure point

As a detour route for Route 57, which was closed by a landslide, restoration of damaged parts of the prefectural road was expedited and ordinary vehicles (except large-sized or heavy-duty vehicles) could use the road two days after the earthquake. In addition, we helped (partly took over) the emergency restoration work of national and prefectural roads managed by Kumamoto Prefecture to support emergency medical services/rescue activities, transportation of critical materials and restoration of the residents' daily lives.

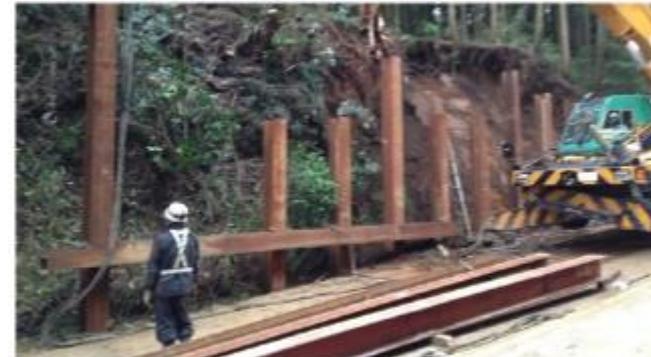
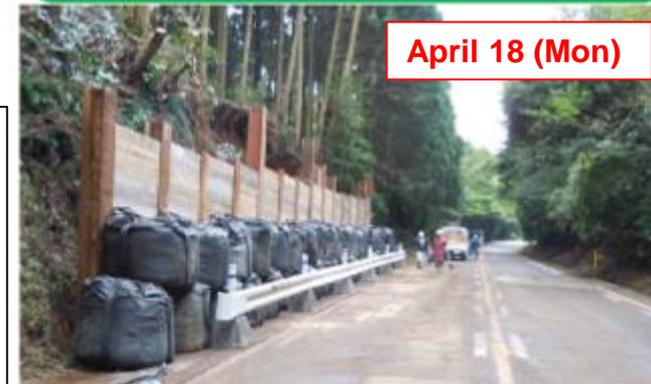
Completed restoration work

April 18 (Mon)

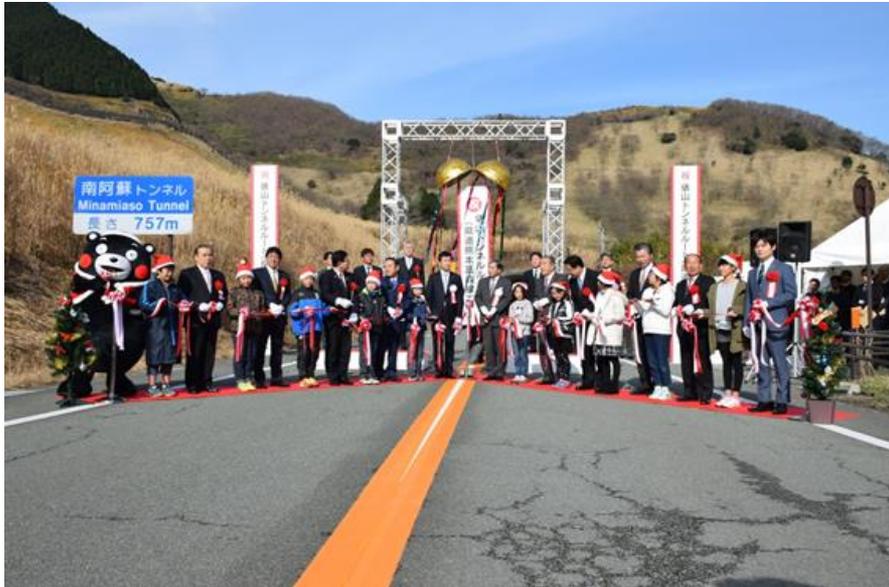
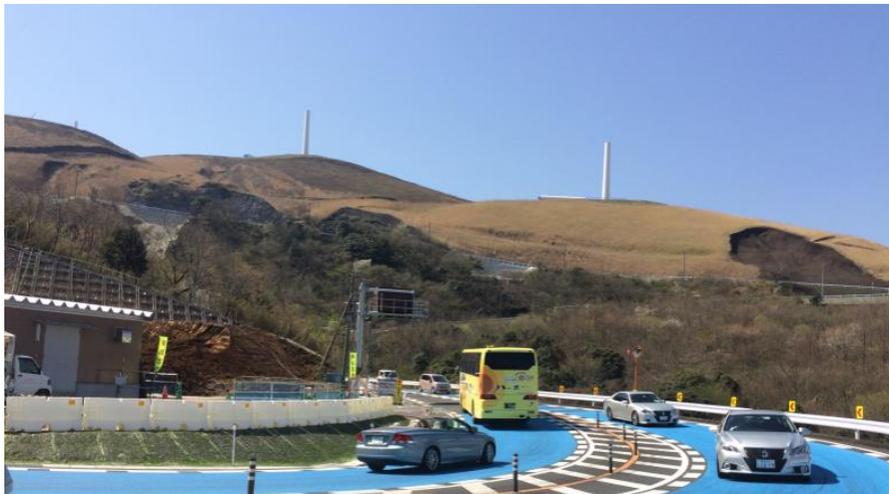
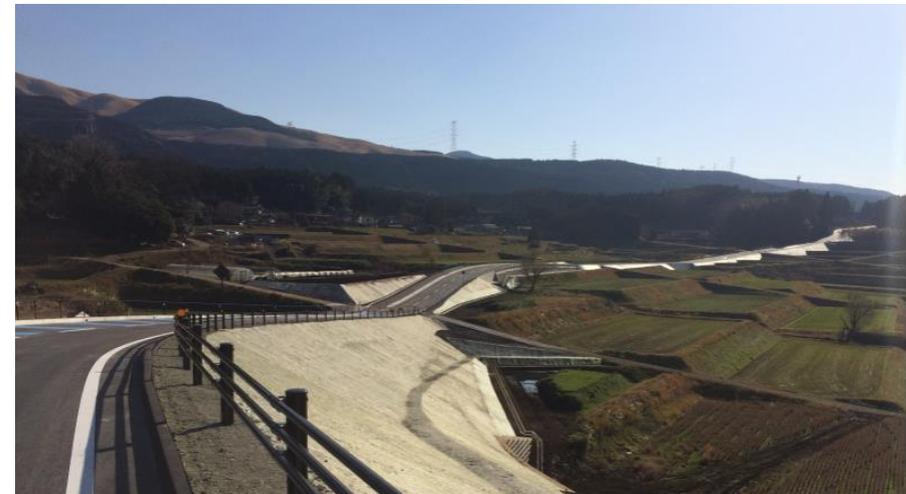
Opening of Tawarayama Tunnel Route (December 24, 2016)

Factors contributing to the early opening of Tawarayama Tunnel Route, which was highly appreciated as “the best Christmas gift”, were understanding and cooperation of landowners and authorities concerned, hard work round-the-clock by contractees and the management ability of in-house engineers.
