Down-hole seismometer arrays near liquefied Tokyo Bay Area and Landslides in the Upper-stream Reach of Abukuma River (Material for the JSCE briefing session at IIS on April 11th, 2011)

Kazuo KONAGAI, Takashi KIYOTA, Hiroyuki KYOKAWA, and Toshihiko KATAGIRI
IIS, University of Tokyo

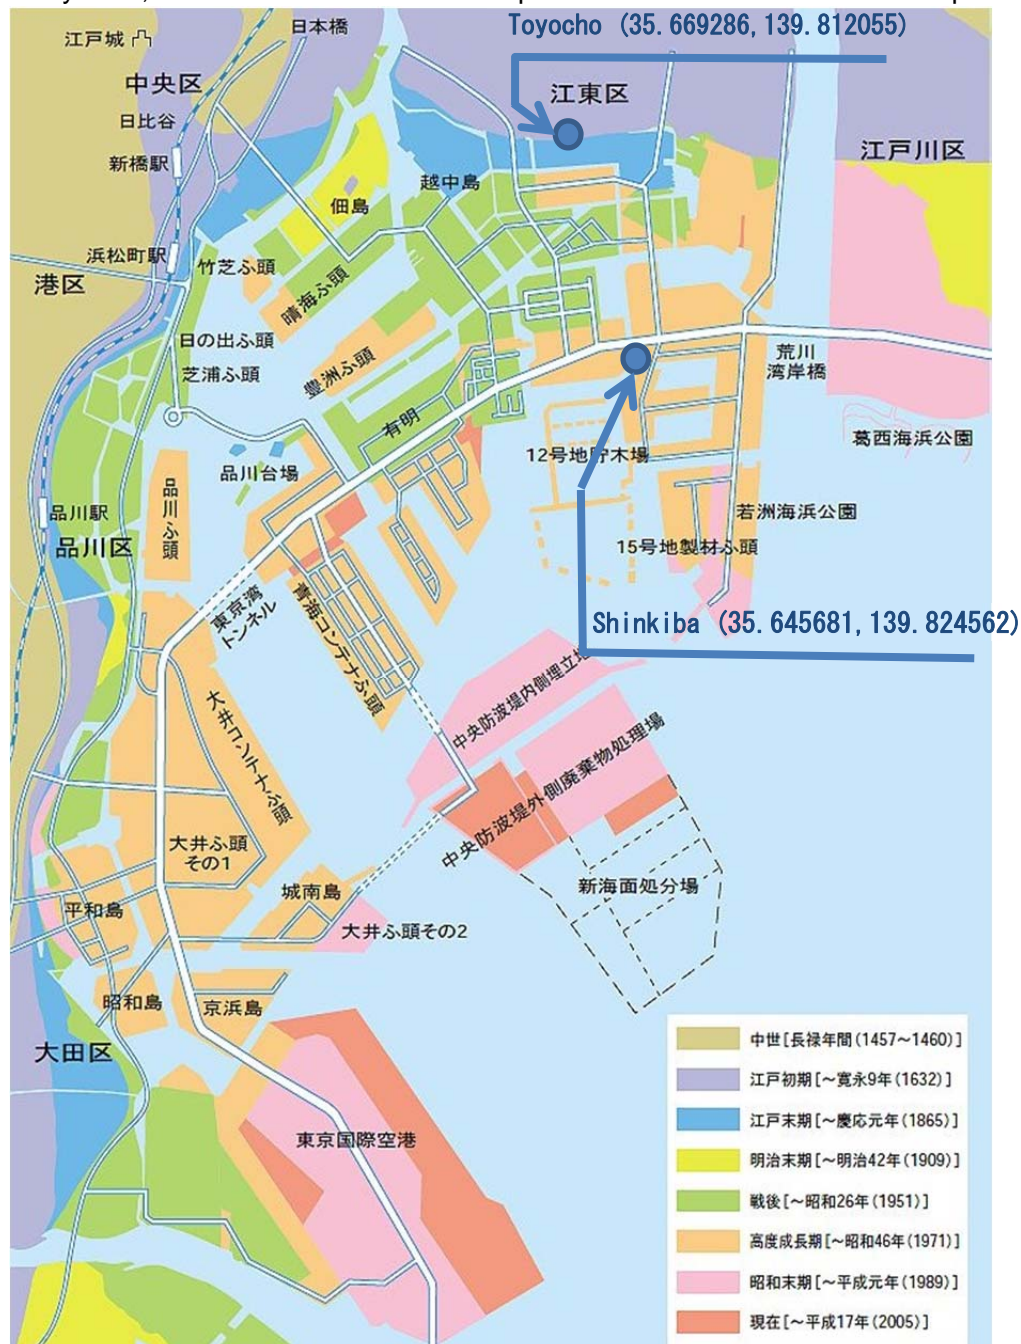
Fig. 1 Locations of seismometers and times of landfilling (after “the history of Tokyo Port, MLIT”¹⁾)

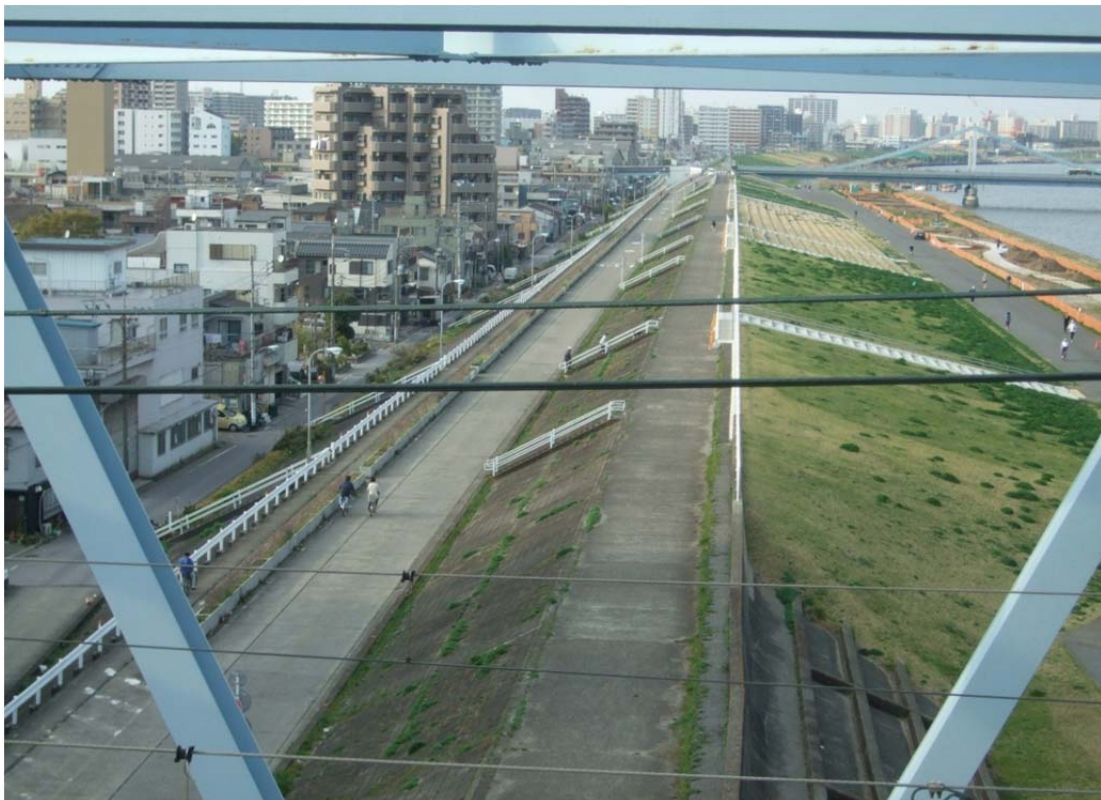
Fig. 3(a) Upstream view of low-lying area near Arakawa Bridge of the subway Tozai line (35.665856,139.842868, Location is shown in Fig. 2): The area has been suffering from a serious land subsidence problem.

A 124km² area behind the sea-frontal reclaimed lands had been suffering from serious ground subsidence due to overuse of ground water and gas. Subsidence finally stopped immediately after a set of laws for limiting excessive use of underground water was enacted in 1970th. However, the area remained several meters below sea level without any clear sign of rebound and thus a serious concern of inhabitants of the area. This earthquake with its epicenter 380km northeast of Tokyo has caused little damage to the low-lying areas. It was fortunate that no damage to river and sea banks, drainage pump stations was reported. However there were clear marks of tsunami surge along river banks (see Fig. 3b), and inhabitants need to remain careful for a possible near-field earthquake.

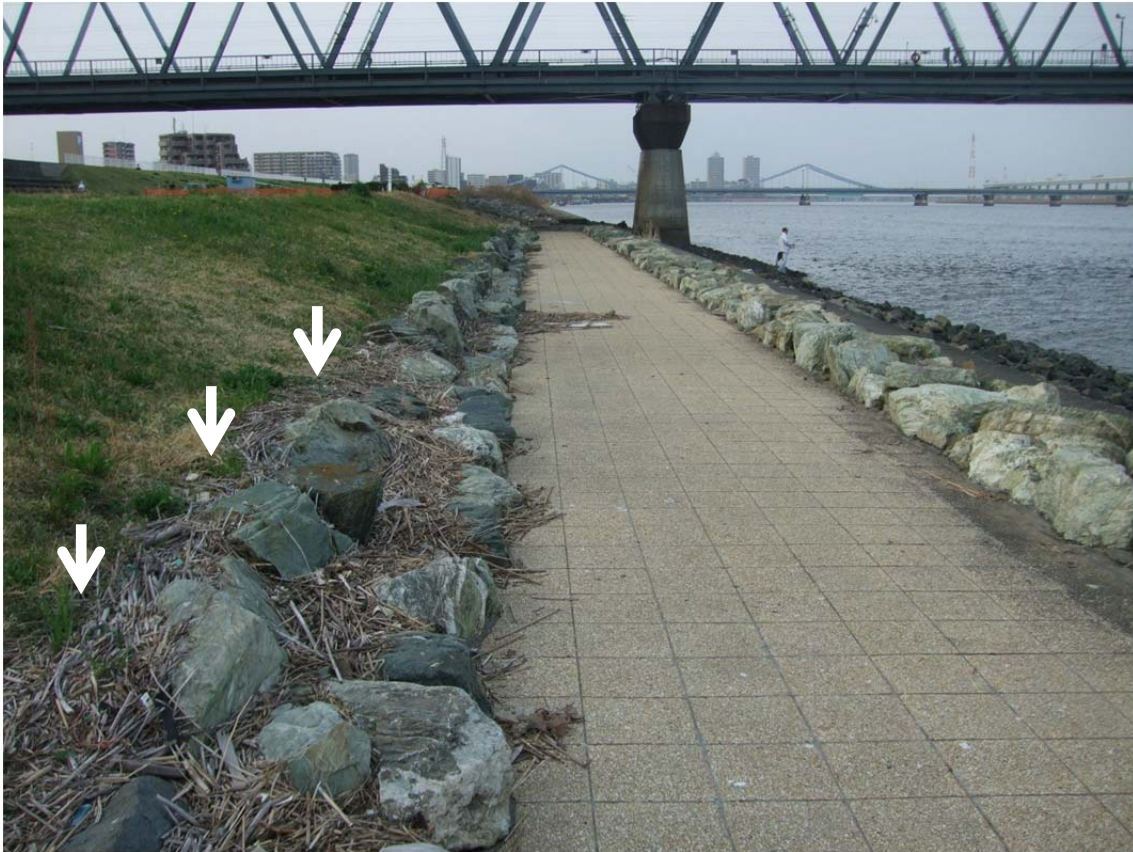
Fig. 3(b) Tsunami marks along the right bank of Arakawa River
(Photo taken at 17:30, 2011/04/10, at 35.665856,139.842868)

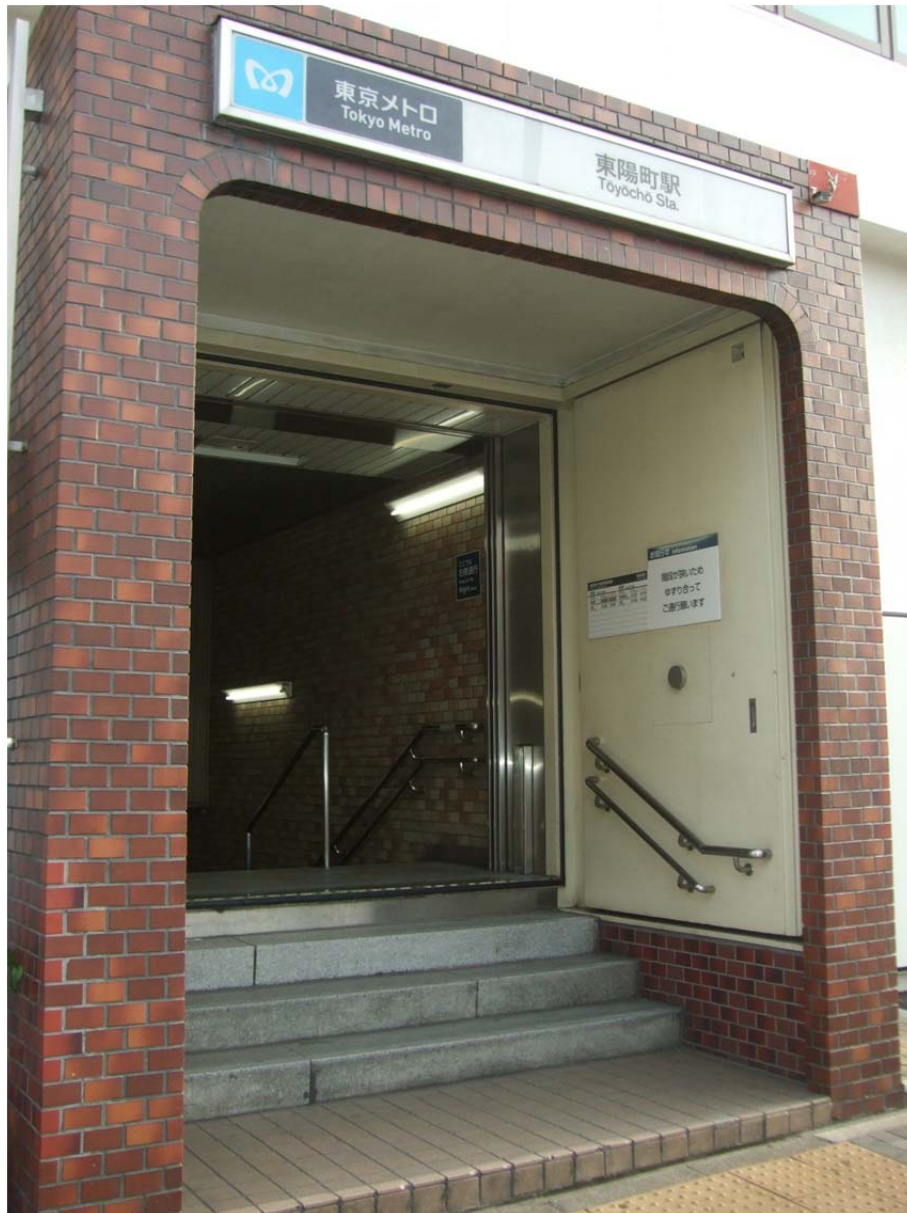
Fig. 4(b) Raised entrance of Toyochō Subway Station at 35.669469,139.816766: The entrance has a watertight door.

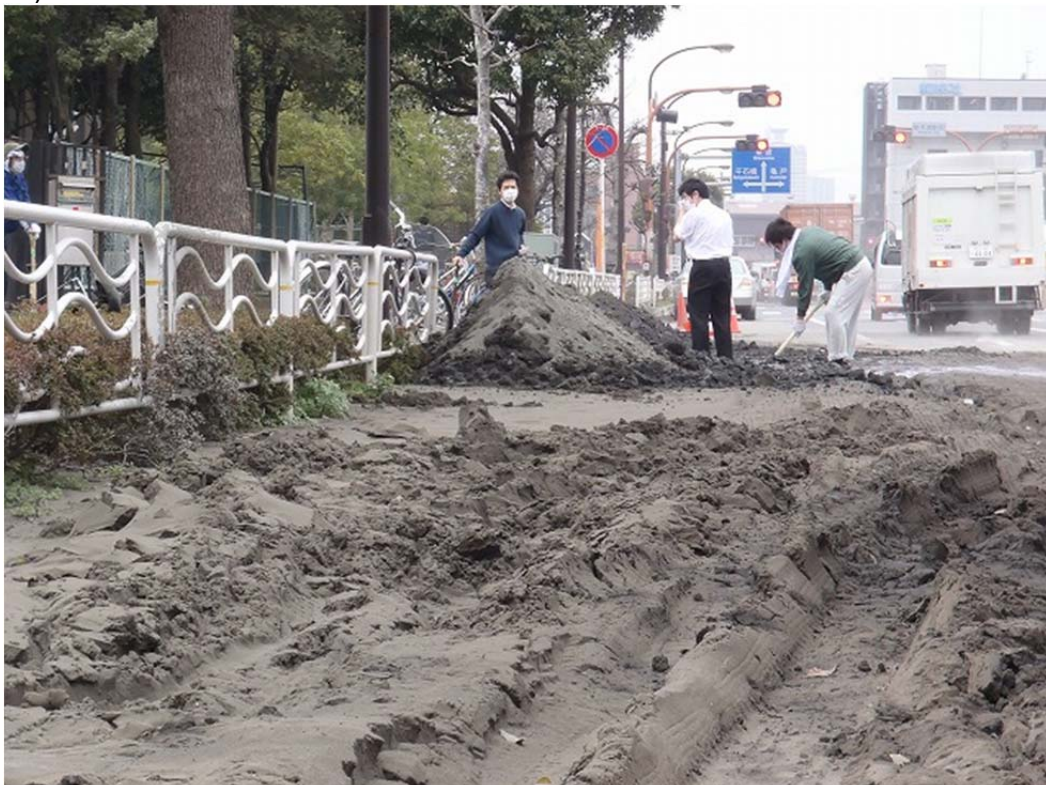
Fig. 10 Liquefied sand near Shinkiba subway station (photo on 2011/03/15 by T. Kiyota.
 Location: 35.644812,139.828148)

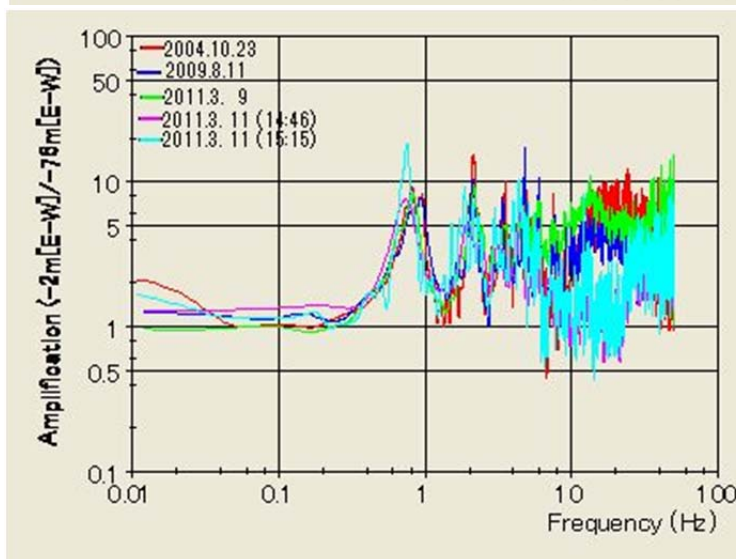
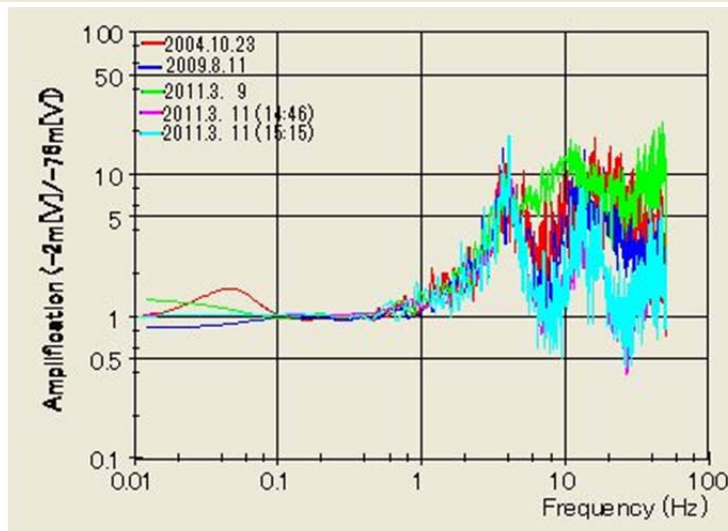
Fig. 11. Frequency-domain amplifications for 6 major ground motions observed at Shinkiba: The first peak appears at around 0.8Hz and 4Hz for lateral and vertical motions, respectively. Differing from those at Toyochi (Fig. 7), amplification curves for the March 11th quake and its aftershock at 15:15 on the same day deviate from the others as the frequency increases above 4 to 5 Hz.

2. At Shinkiba site, frequency-domain amplifications for 6 major ground motions show the first peak appearing at around 0.8Hz and 4Hz for lateral and vertical motions, respectively. Differing from those at Toyocho, amplification curves for the March 11th quake and its aftershock at 15:15 on the same day deviate from the others as the frequency increases above 4 to 5 Hz. Liquefactions were found around the observation site.

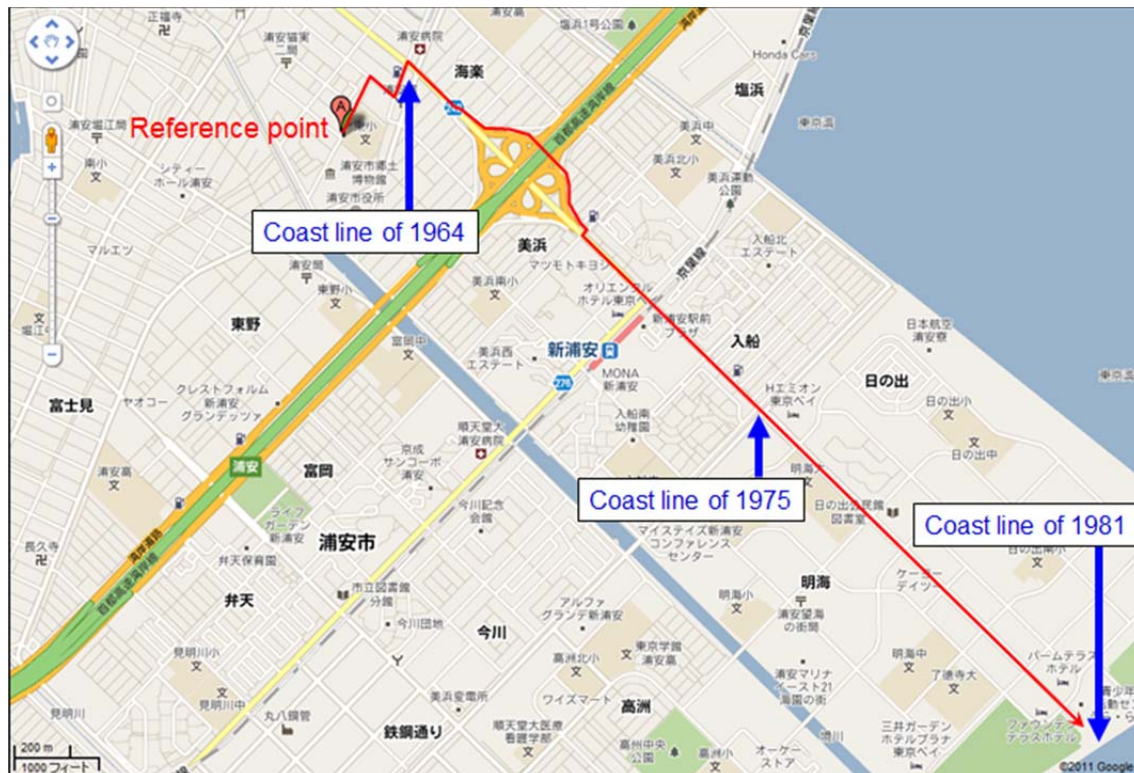
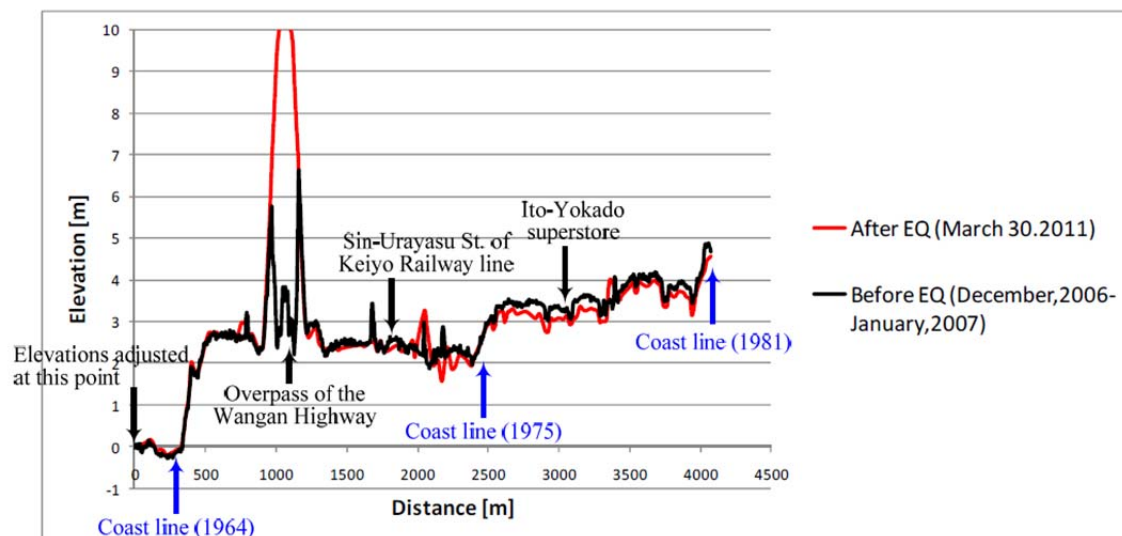
☒ 13 Elevations along Line-01 in Urayasu city before and after the quake of March 11th 2011

A dual-frequency DGPS survey was conducted on March 30, 2011 in Urayasu Coastal Area. Two lines (Line-01.kmz and Line-02.kmz) were taken. Elevations along Line-01 (Fig. 13(a)) were compared with those from a 1m-resolution DEM for the same area (December 2006 to January 2006).

Some points with GDOP values larger than 3, representing lower GPS positional precision, were discarded, and yet there are some points of low positional precision. Moreover the earthquake have caused serious nation-wide misalignments of triangulation points. Therefore, the figures are just a rough-and-ready indication of subsidence.

Fig. 13(b) shows the stepped configuration along Line-01 indicating there have been twice large landfiling activities since 1964. It may be premature, before taking many lines, to say something with confidence from this figure but some noticeable subsidence (about 0.3 to

0.4m) can be seen within an about 1km wide brush along the boundary between the first and second landfills. This wide brush may extend in east-west direction as shown in both Fig. 14(a) and 14(b).

3. At Shin-urayasu area, Liquefactions were serious. The result of a dual-frequency DGPS survey, which was conducted on March 30, 2011, showed some noticeable subsidence (about 0.3 to 0.4m) within an about 1km wide brush along the boundary between the first and second landfills. This wide brush may extend in east-west direction.

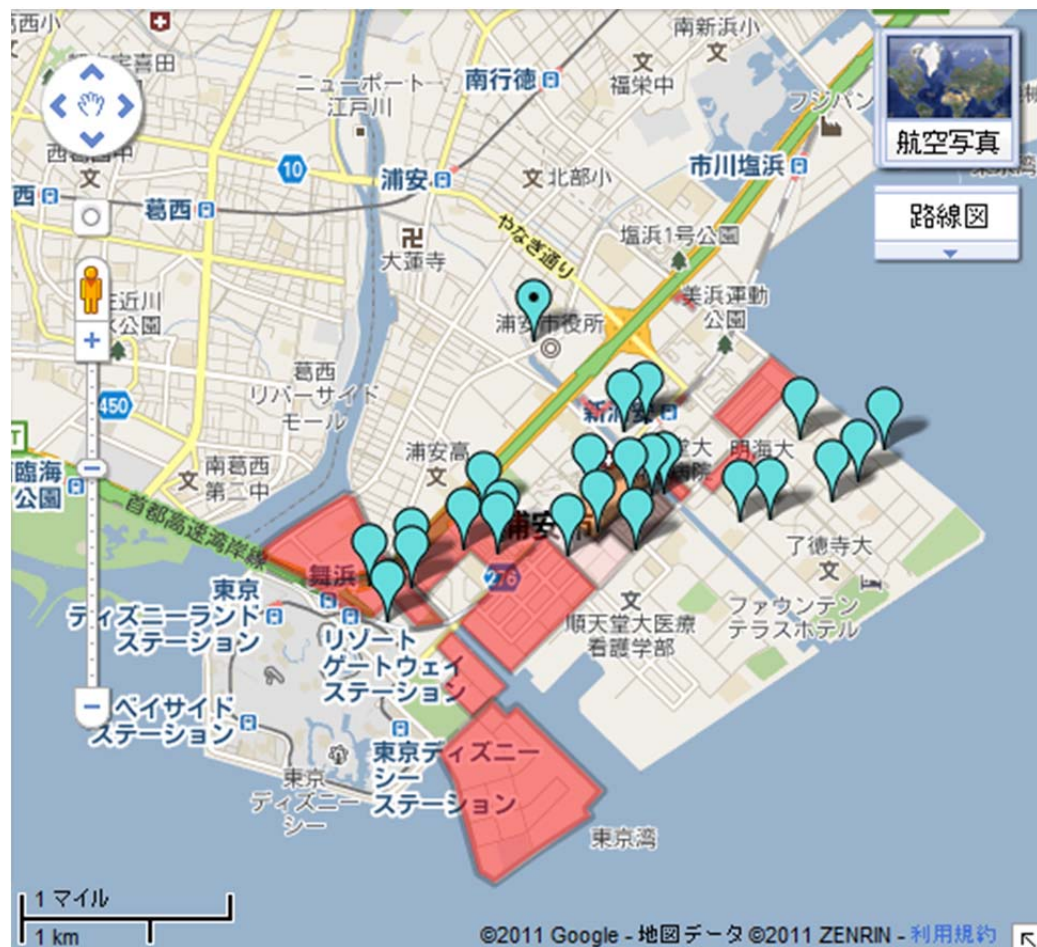
Fig. 14(a) Locations of temporary water supply valves⁵⁾

Blue place marks: Temporary water supply valves, Colored areas: purple= it will take a long time to restore water supply systems, orange= water supply restored, red= sewage system cannot be used (as of April 10th, 2011).

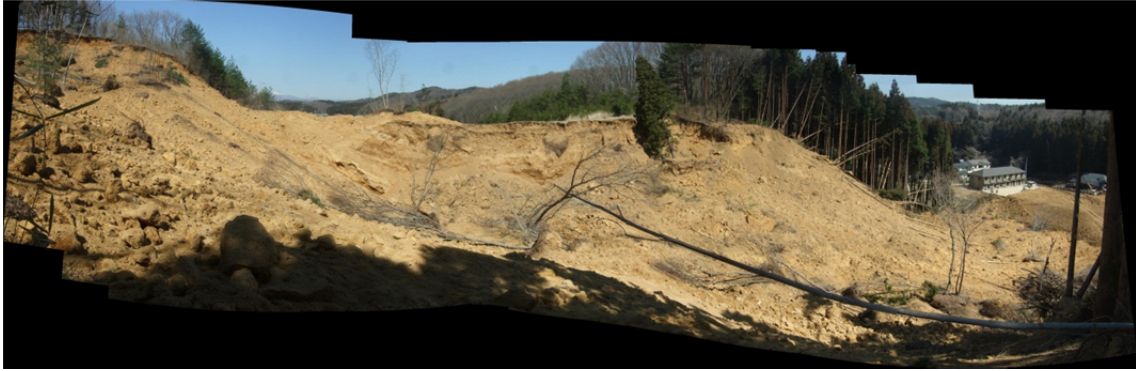
Fig. 17 Landslide #1 in Fig. 16: 13 people were killed in the debris. Exposed slip surface; 110m wide, 205m long, 31m high. Location of Photo point: 37.138253,140.217605

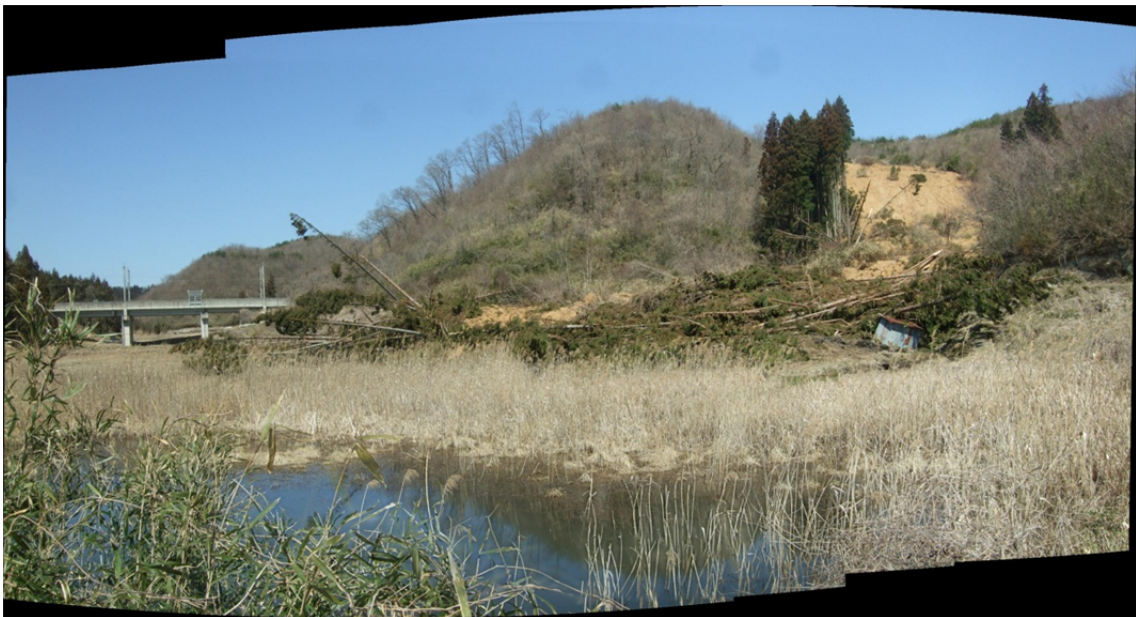
Fig. 18 Landslide #2 in Fig. 16. Soil mass slid around the south mouth of a Shinkansen railway tunnel. 50m wide, 300m long, 60m high. Photo location: 37.174611,140.238848

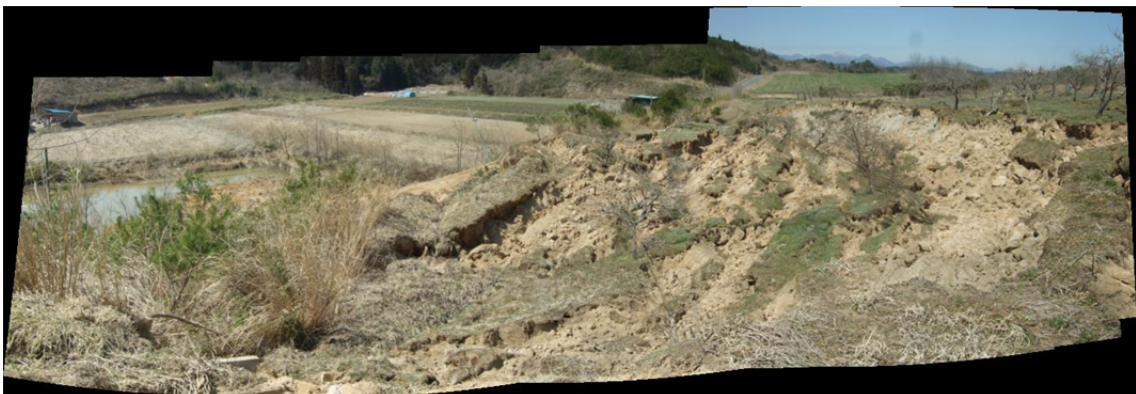
Fig. 19 Landslide #3 in Fig. 16. 60m wide, 99m long, 15.6m high. Photo location: 37.213788,140.276721

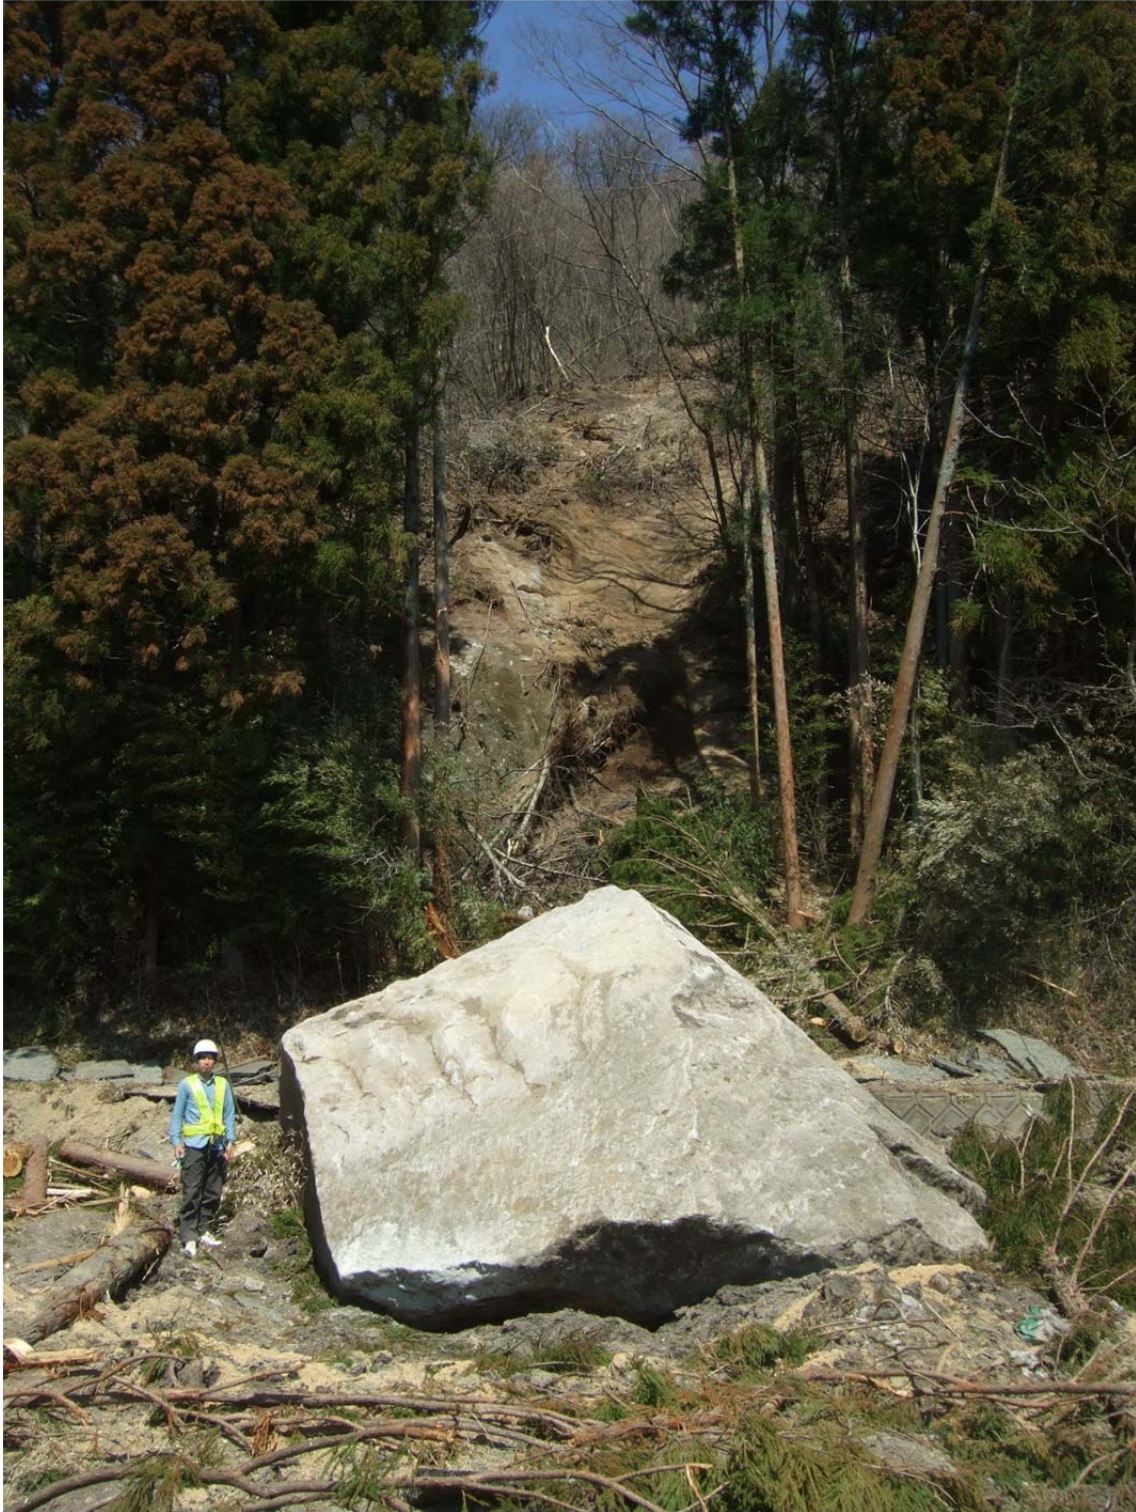
Fig. 20 Rock fall #7 in Fig. 16. Photo location: 37.230448,140.185461

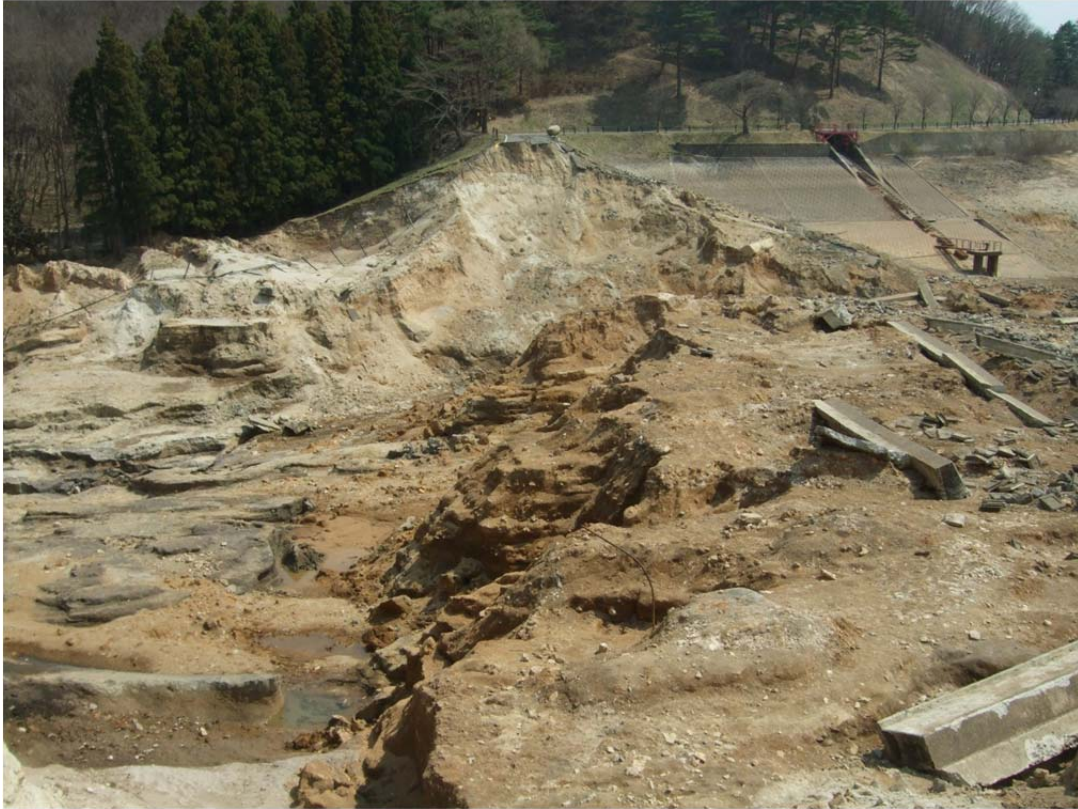
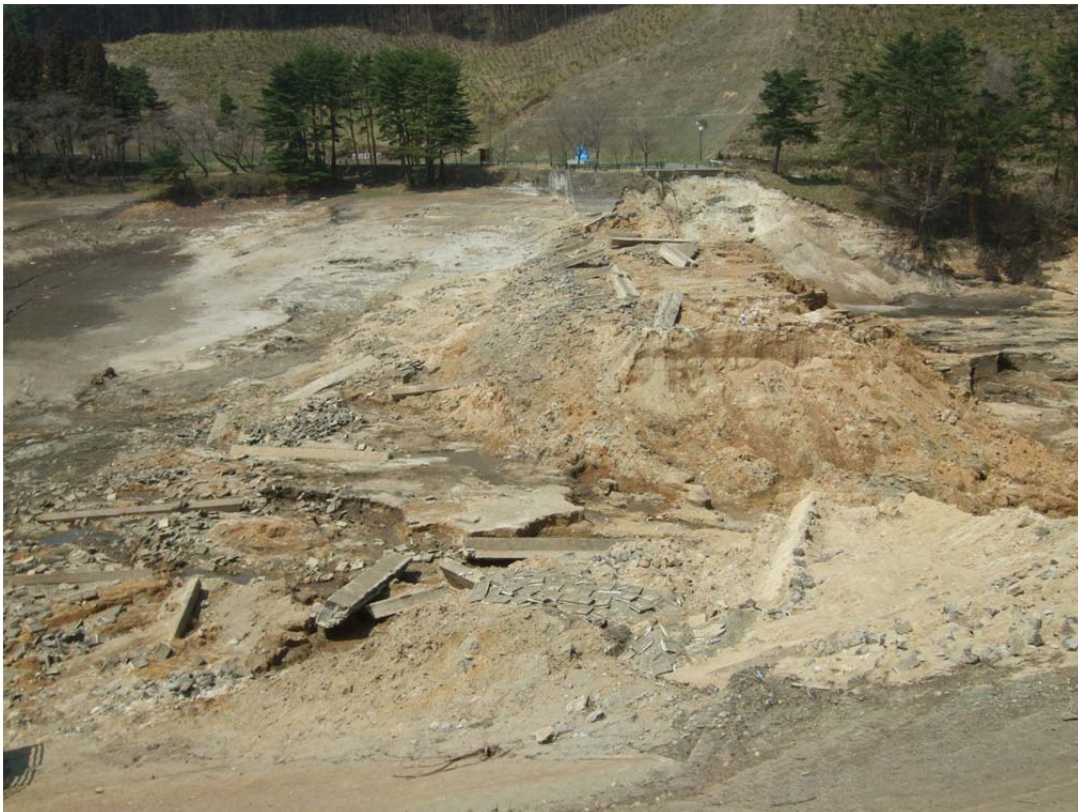
Fig. 21 Breached Fujinuma Dam (Placemark #8 in Fig. 16). Photos above and below show respectively breached dam body from left and right abutments. There is a subsided/slid soil mass of the upstream slope spreading over the lake bottom; the slide may have been followed by the subsidence of the entire dam body and thus water-overtopping.
